## RE: Inspection of Water Licence 2BE-COR0608, 2BE-CGP1012, 2BE-CGR1012, July 7 2013

## WATER LICENCE INSPECTION REPORT

<b>Date:</b> 4 July 2013	Licensee Rep. (Name/Title): None present		
Licensee: Stornoway Dia	mond Corp.		2BE-COR0608, 2BE-CGP1012, 2BE-CGR1012 egion projects)

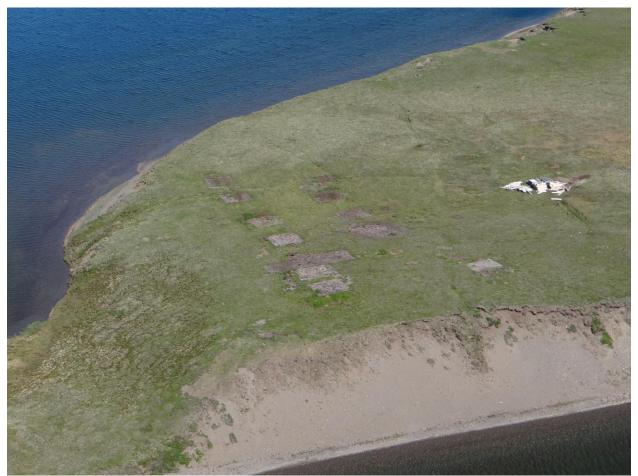
CGP / COR - Eureka Camp (N67°01'33.7" W113°39'04.6"): Core boxes present; small garbage visible and holes to be backfilled.

Figure 1. Eureka Camp July 4 2013.

Comments: Reclamation work needed at Eureka camp: backfilling of holes, removal of small garbage, determine if contamination remains near the core racks from the potential spill noted in 2009. In comparing the 2009 and 2013 photos, it appears that the core racks were moved to where the barrels were in 2009.

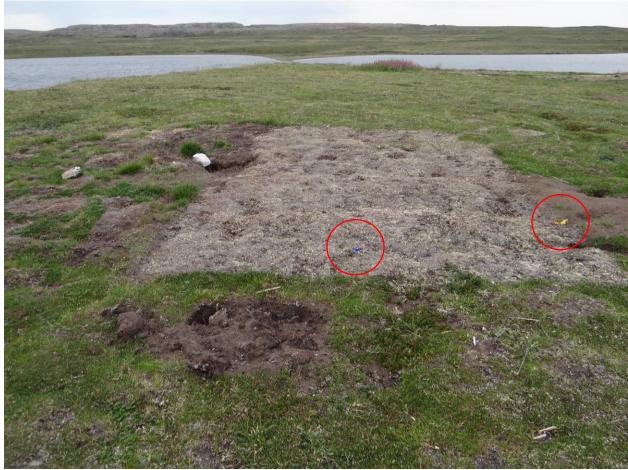
Solid Waste: Waste has been removed. Small garbage remains at the Eureka camp site.

Figure 2. Tent outlines with small garbage visible and holes to be backfilled.

Part I item 4: Backfill or restore all sumps to the pre-existing natural contours of the land.

Part I item 5: Removal of all materials.

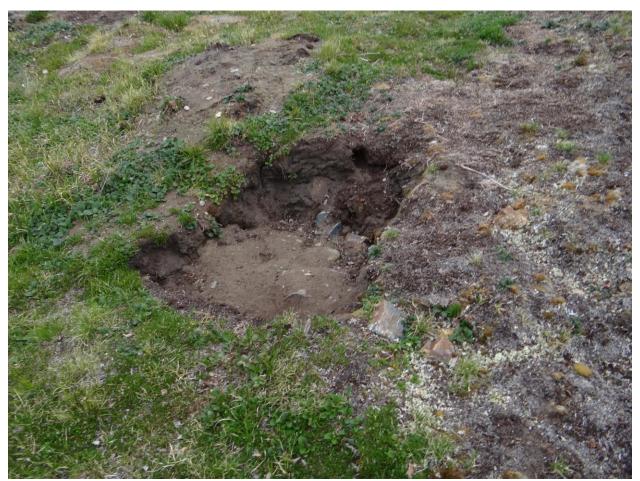
Figure 3. Holes to be backfilled.

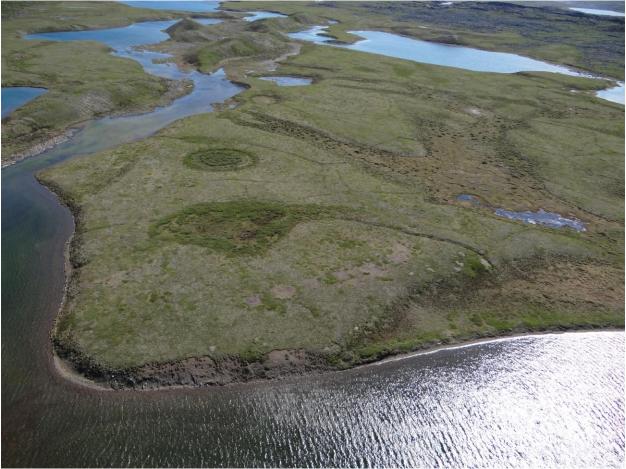
COR - Jubilee Camp (N67°31′54.9" W113°18′23.5"): Camp location was discernible; camp is removed. Vegetation re-growth is occurring.

Figure 4. Jubilee Camp, reclaimed.

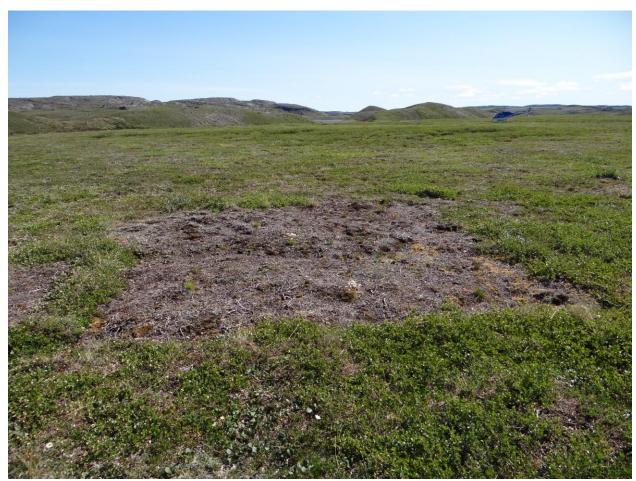
Figure 5. Vegetation re-growth beginning at Jubilee tent pad sites.

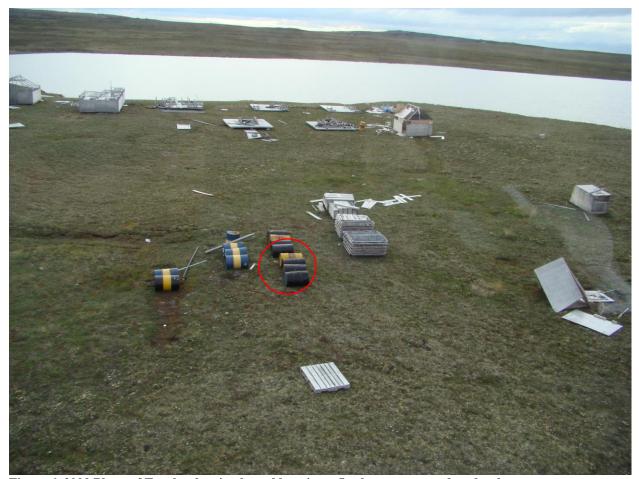
July 14, 2009: WRO Melissa Joy visited the Eureka Camp following the 2008 closure. She noted 3 leaking drums and no secondary containment. No spill was reported when the camp was re-opened, and no mention is made in the N2010C0010 final plan of a spill clean-up.

Figure 6. 2009 Photo of Eureka showing barrel locations. Leakers were noted as the closest row to core racks.

As identified under Non-compliance. A report is to be submitted to the Inspector showing that the work has been done. Please ensure that the area near the core racks where barrels were stored in 2009 is carefully examined for any signs of contamination. Licences 2BE-COR0608 and 2BE-CGP1012 are not to be cancelled until this work has been completed to the satisfaction of the Inspector. As no work was conducted under 2BE-CGR1012, this licence can be cancelled when administrative requirements to the NWB are satisfied.
