WATER LICENCE INSPECTION FORM

Licensee	Licensee Representative
Peregrine Diamonds Ltd	Alan O'Connor
Licence No. / Expiry	Representative's Title
2BE-CHI1218	Program Manager
Land / Other Authorizations	
N2012C0024	
Date of Inspection	Inspector
05 September 2017	Jonathan Mesher
Activities Inspected	
<input type="checkbox"/> Municipality <input type="checkbox"/> Drilling <input type="checkbox"/> Mining <input type="checkbox"/> Construction <input type="checkbox"/> Reclamation <input type="checkbox"/> Fuel Storage <input type="checkbox"/> Roads/Hauling <input checked="" type="checkbox"/> Other: CH-6 Water Source <input checked="" type="checkbox"/> Other: fuel spill

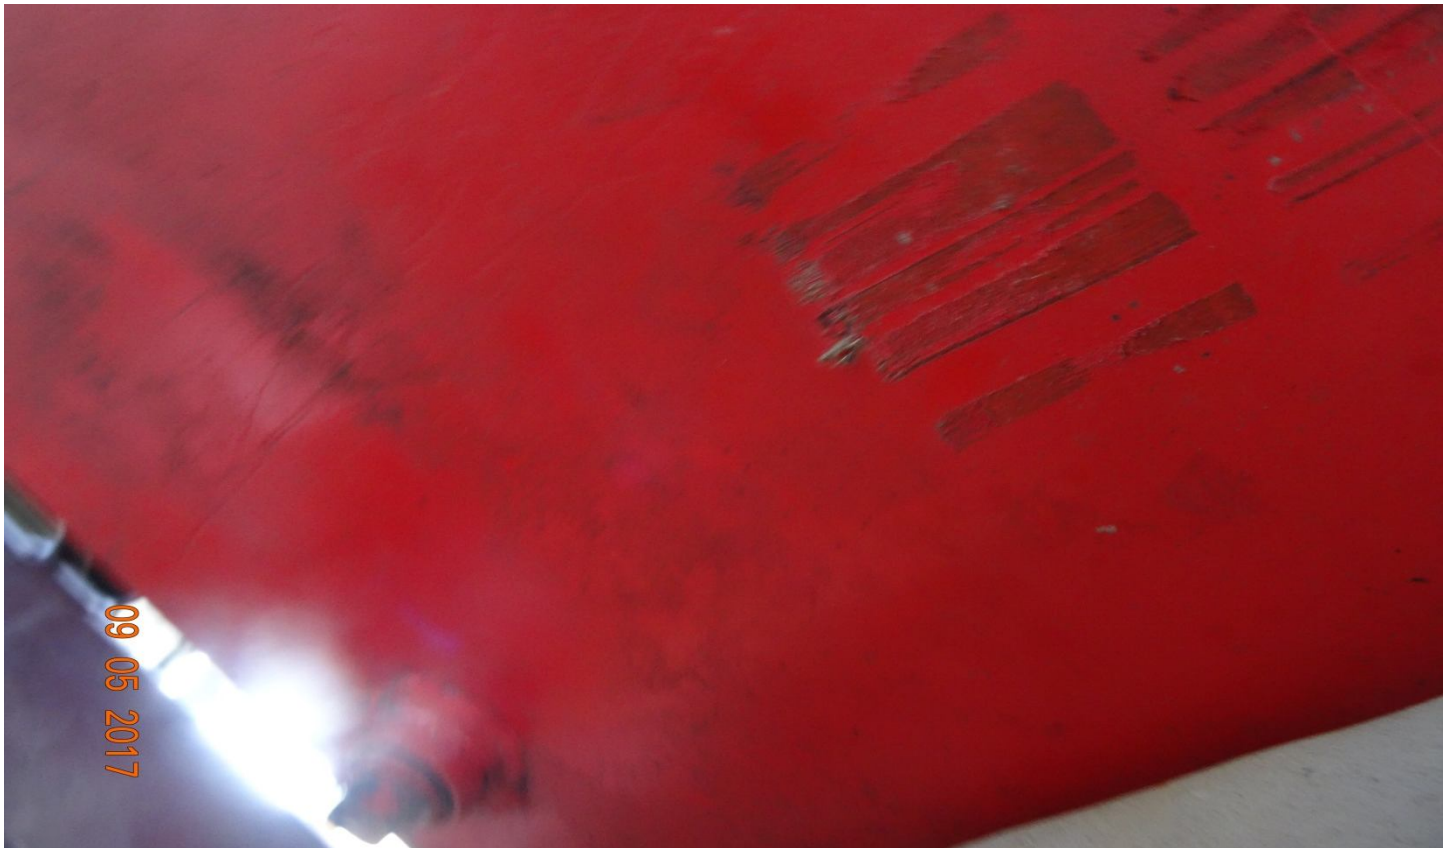
5. The spill was caused by a loose drain plug on the fuel supply tank for the water heater (see figure1). This water heater had recently been brought to site.

Figure 1: drain plug at the bottom of fuel tank for the diesel fuel operated water pump.

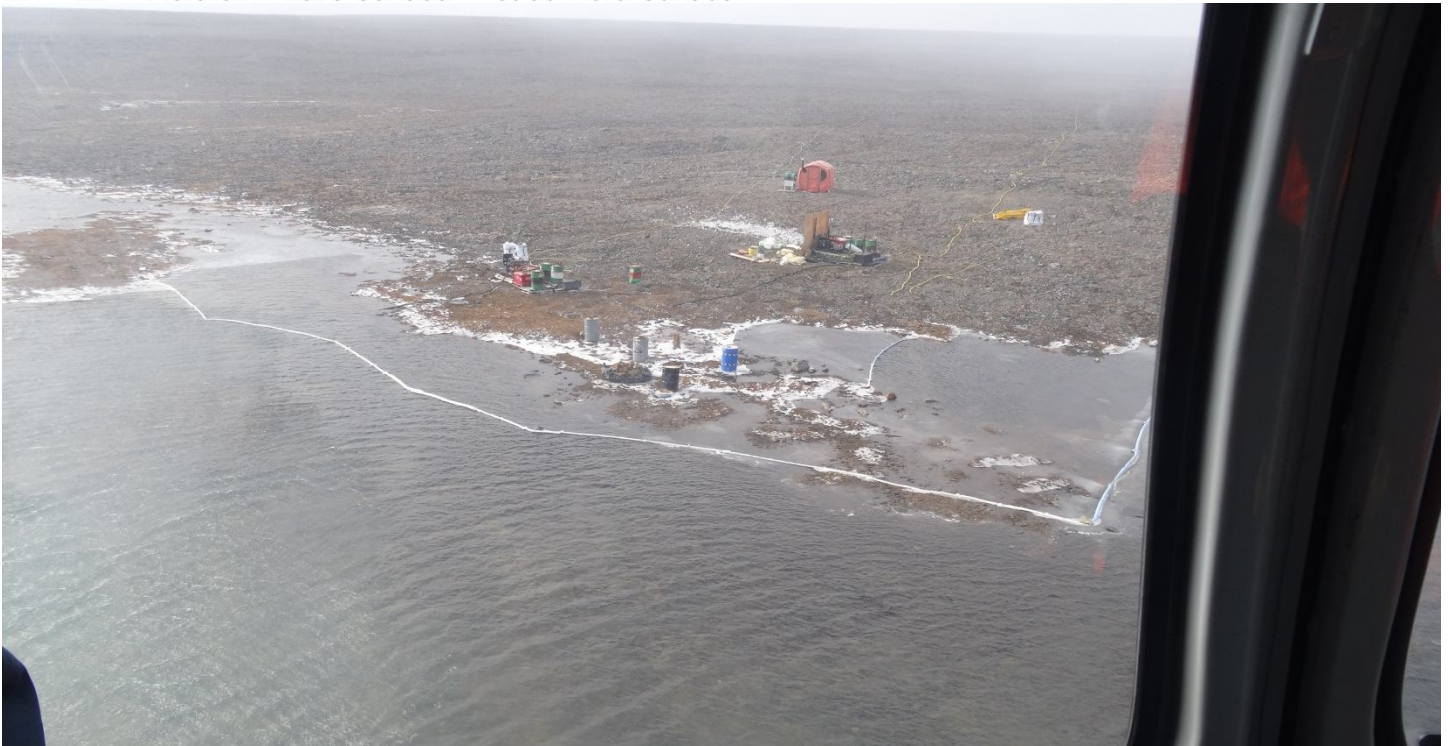
6. The secondary containment was inadequate and unable to contain the spill.
7. While on site it appeared that the licensee had only partially sealed off the spill area with booms and left the downstream area of the containment open. The licensee informed the inspector that rainfall on September 4th and 5th had significantly changed the water level and that the spill had been contained prior to the rains. You can see the different water levels by comparing Figure 2 and figure 4 below.

It was noted that the pump and all appurtenant structures, including the fuel tank required to pump water from its original source to the drill, appears to be located with-in 31 metres of a water body.

Figure 2: pump, fuel and spill response kit. **Note:** that the original position of the water pump and fuel tank during the incident was between the standing barrels closer to the effected water body.

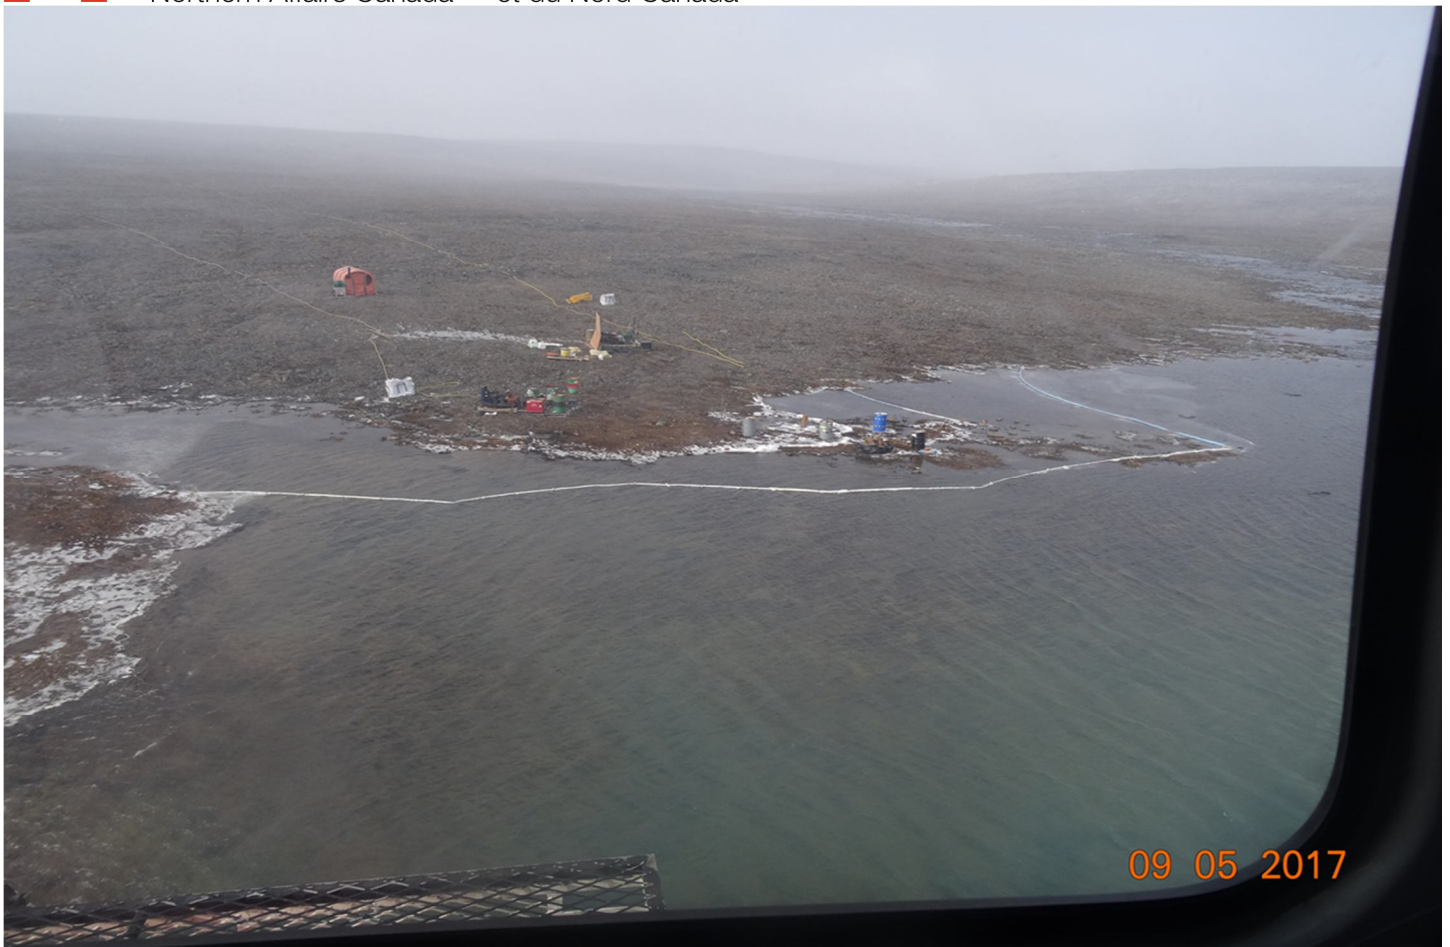
Figure 3: Note no oil absorbing pads or booms places downstream, toward Left of the picture.
