WATER LICENCE INSPECTION FORM

Licensee	Licensee Representative
DeBeers Canada Inc.	David Willis
Licence No. / Expiry	Representative's Title
2BE-CHI1823	Environmental and Community Coordinator
Land / Other Authorizations	Land / Other Authorizations
N2012C0024	
Date of Inspection	Inspector
July 25, 2019	Joseph Monteith
Activities Inspected	
<div><input checked="" type="checkbox"/> Camp<input checked="" type="checkbox"/> Drilling<input type="checkbox"/> Mining<input type="checkbox"/> Construction<input type="checkbox"/> Reclamation<input checked="" type="checkbox"/> Fuel Storage</div> <div><input type="checkbox"/> Roads/Hauling<input checked="" type="checkbox"/> Other: Tailings (CH-07)<input type="checkbox"/> Other:</div>

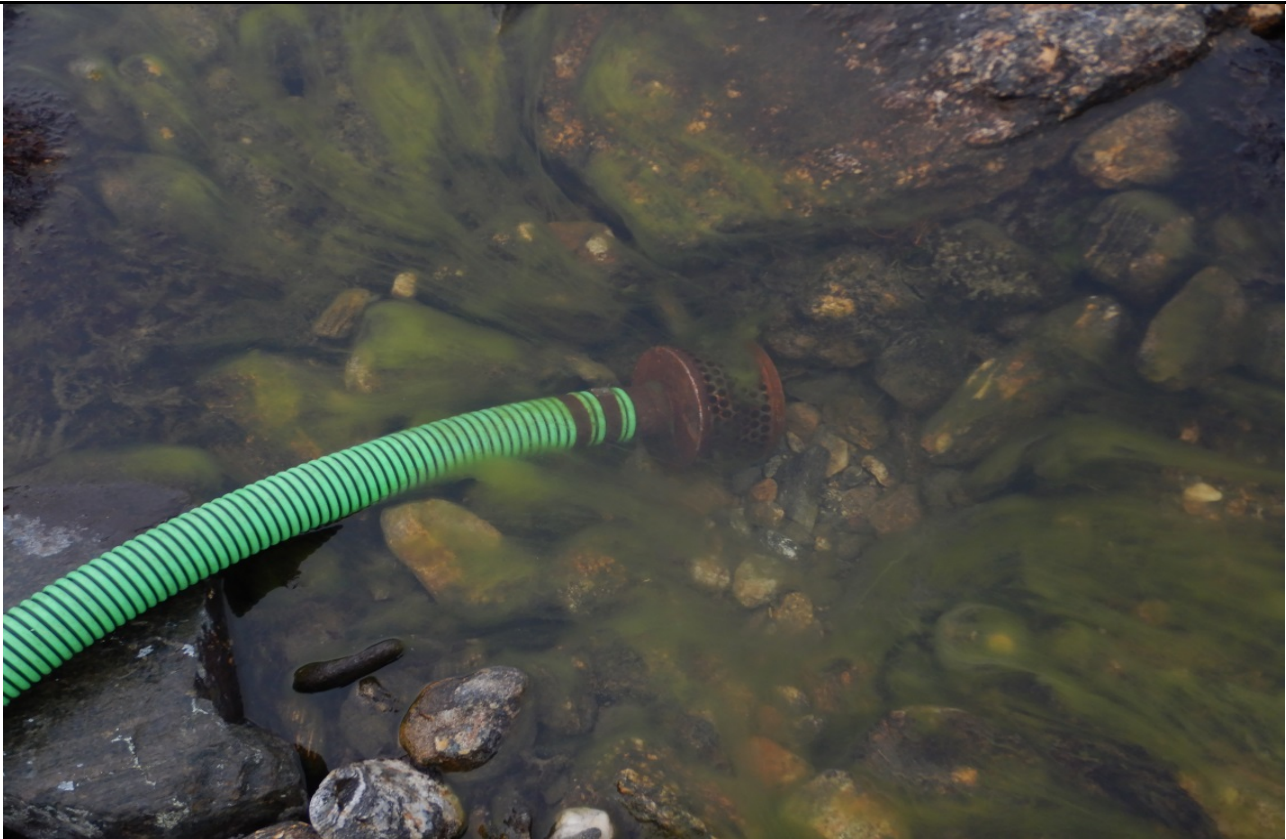
Photo Log #
Photo 3

3. Water withdrawal location. Water pump (photo 2) Hose in water, fish mesh screen observed. Stream hasn't been drawn down. But is a very low flow. Signs of algae growth (photo 3).

Description: fish mesh screen – algae growth

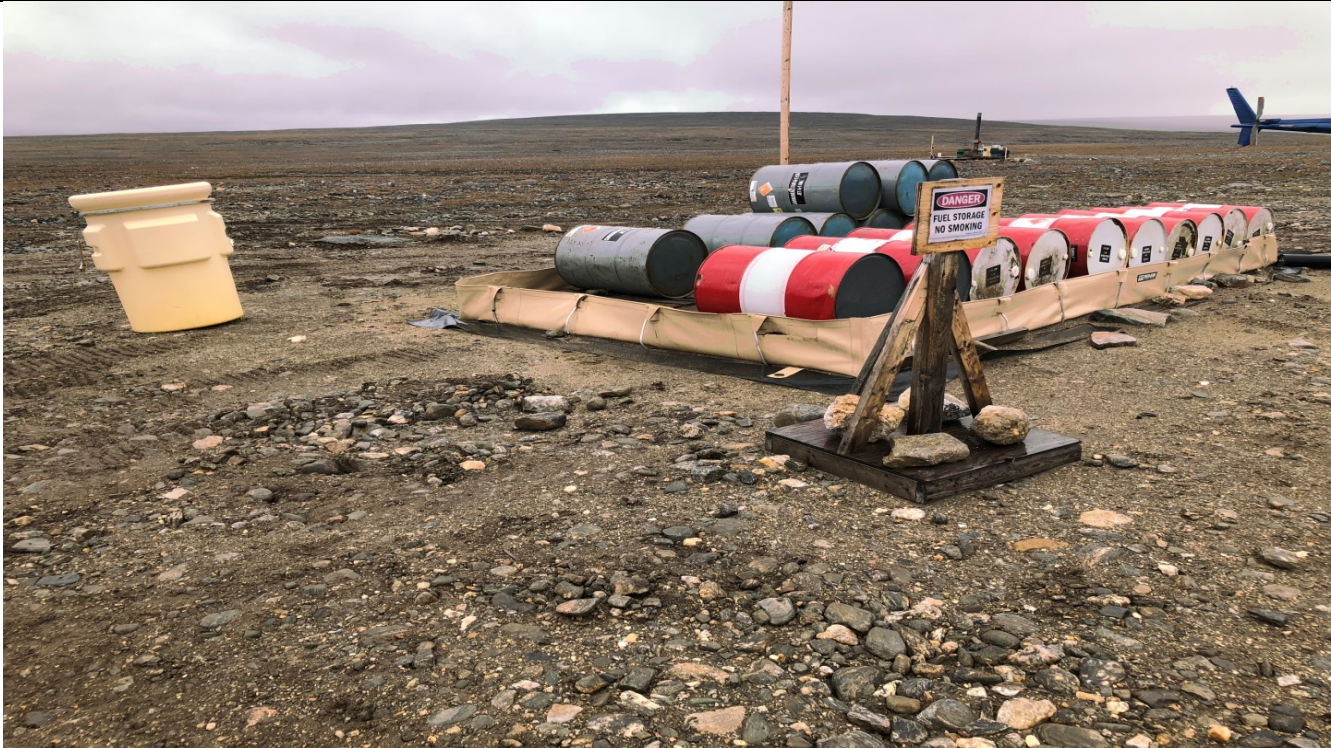
Photo Log #
Photo 4

Description: Discovery Camp - Fuel Cache 1 - 27 barrels of Jet-A fuel in secondary containment

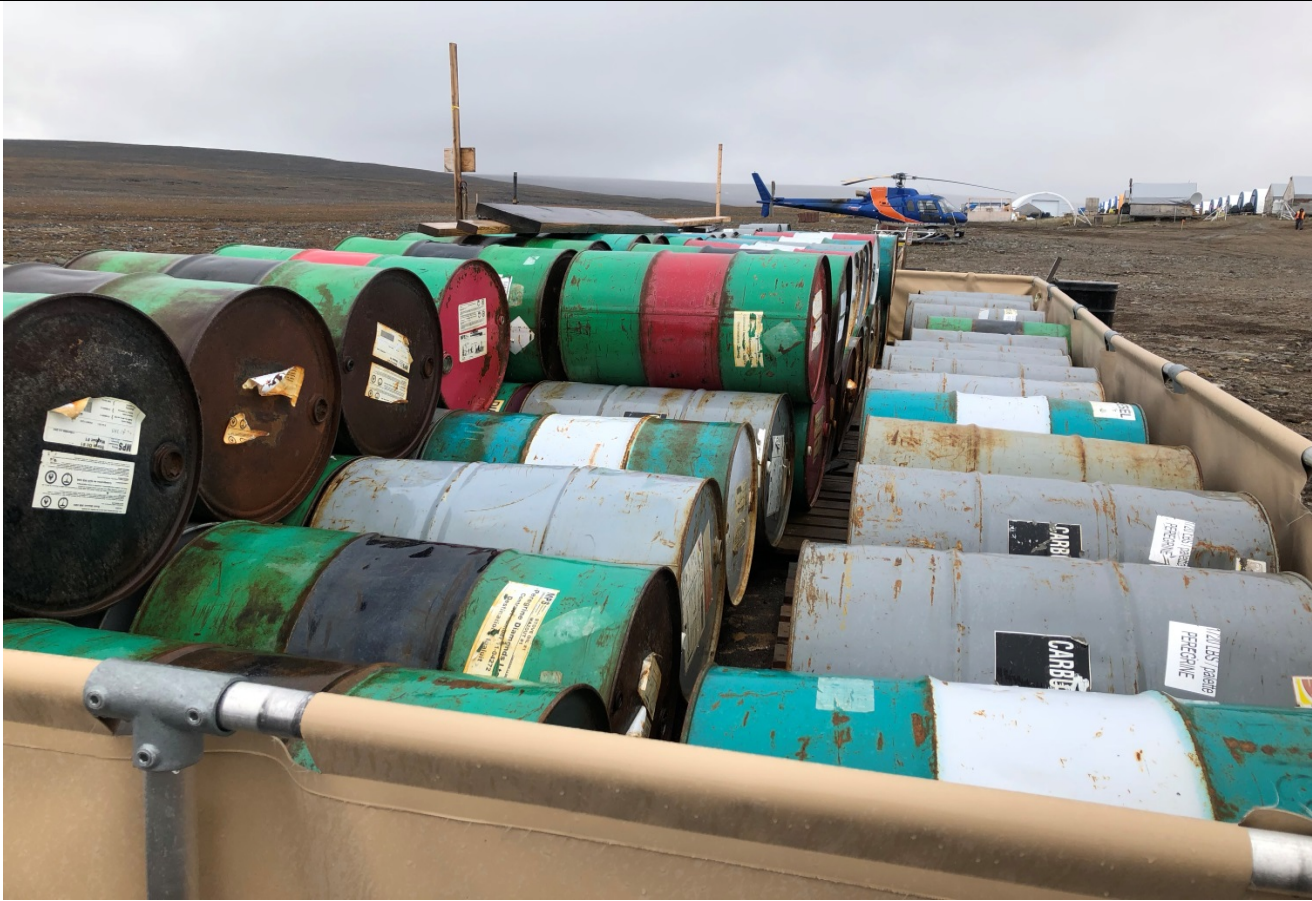
Photo 4

Description: Fuel Cache – Approximately 60 drums of fuel in secondary containment, spill kit observed.

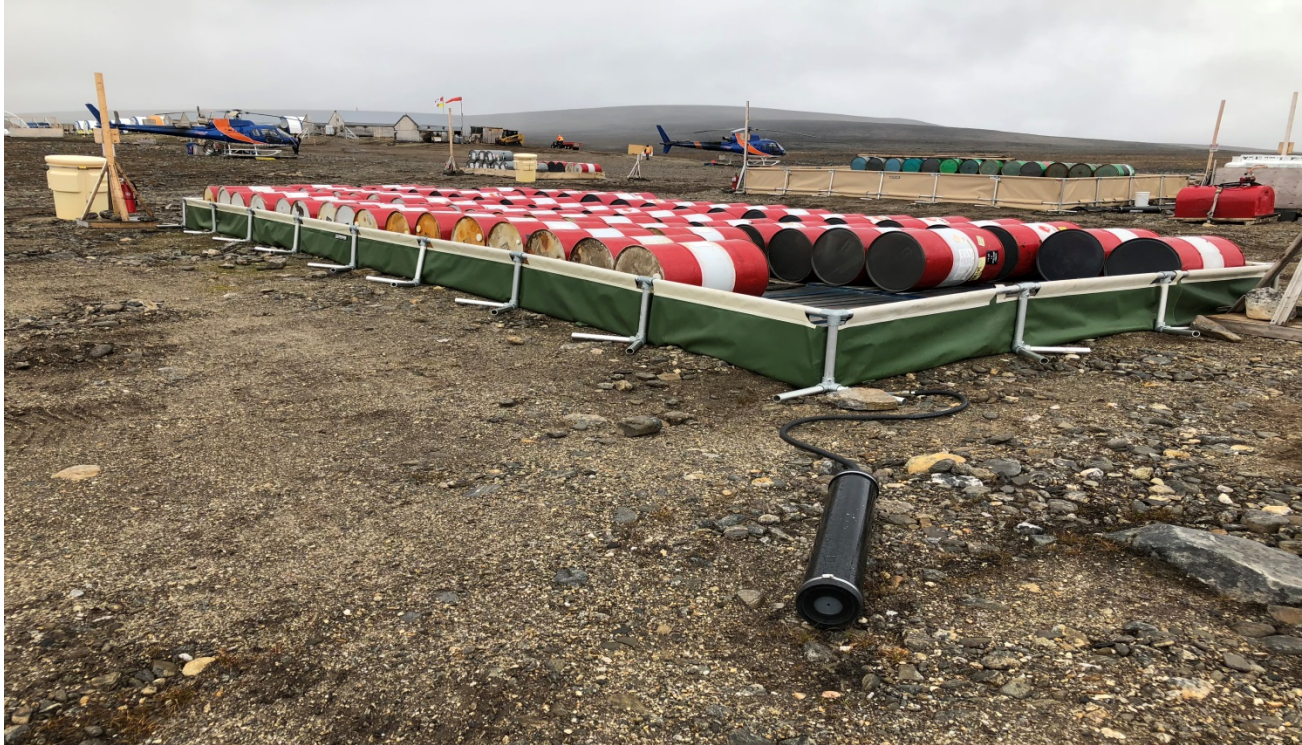
Photo 5

6. Fuel Cache 3 - approximately 65 drums of fuel in secondary containment with Spill Kit next to Fuel Cache and proper signage. (photo 5)
7. 2x Methanol drums (photo 6).

Description: Fuel cache 3, Approximately 65 drums of fuel in secondary containment, with spill kit and Signage observed.

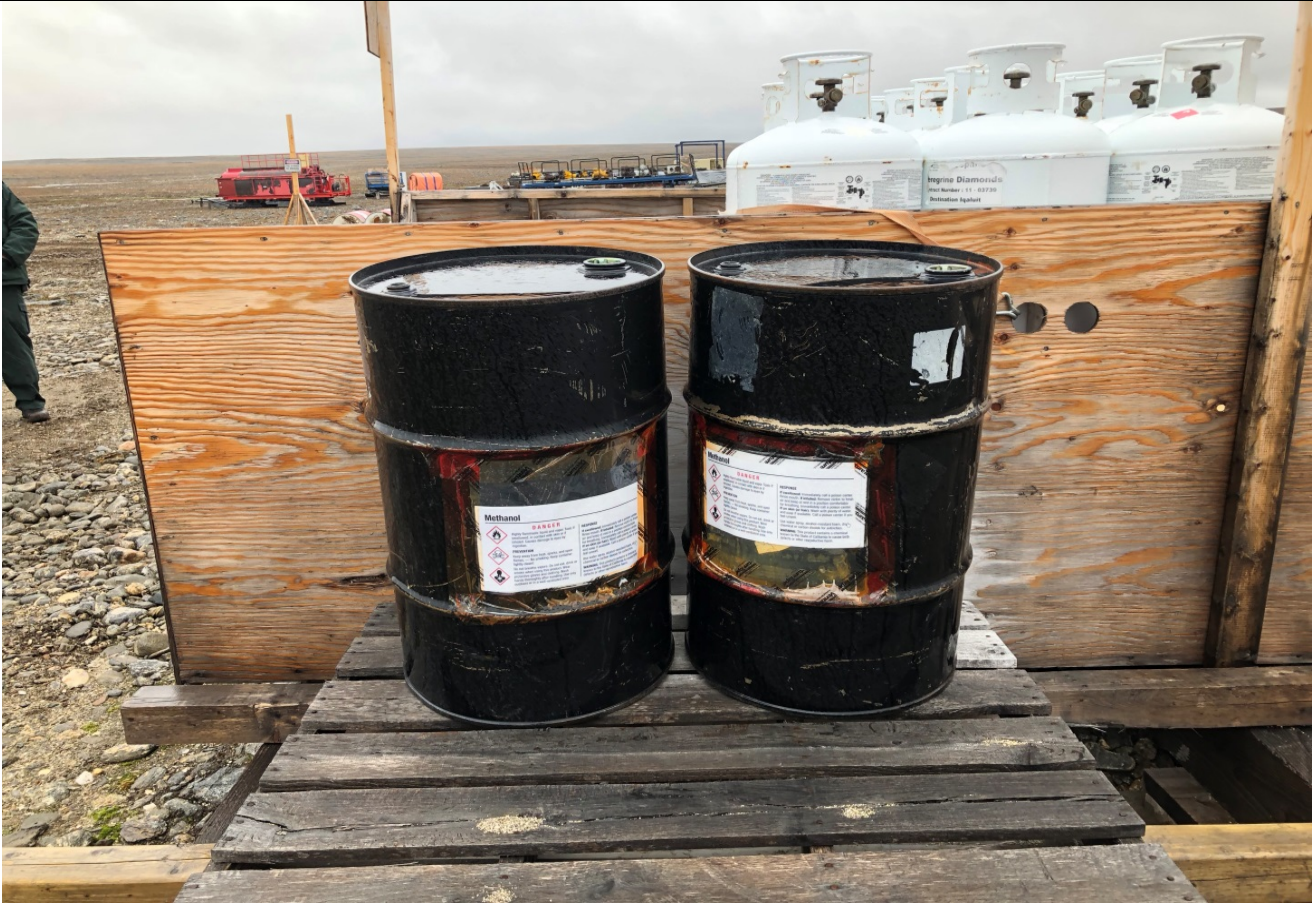
Photo 6

Description: 2x barrels of Methanol.

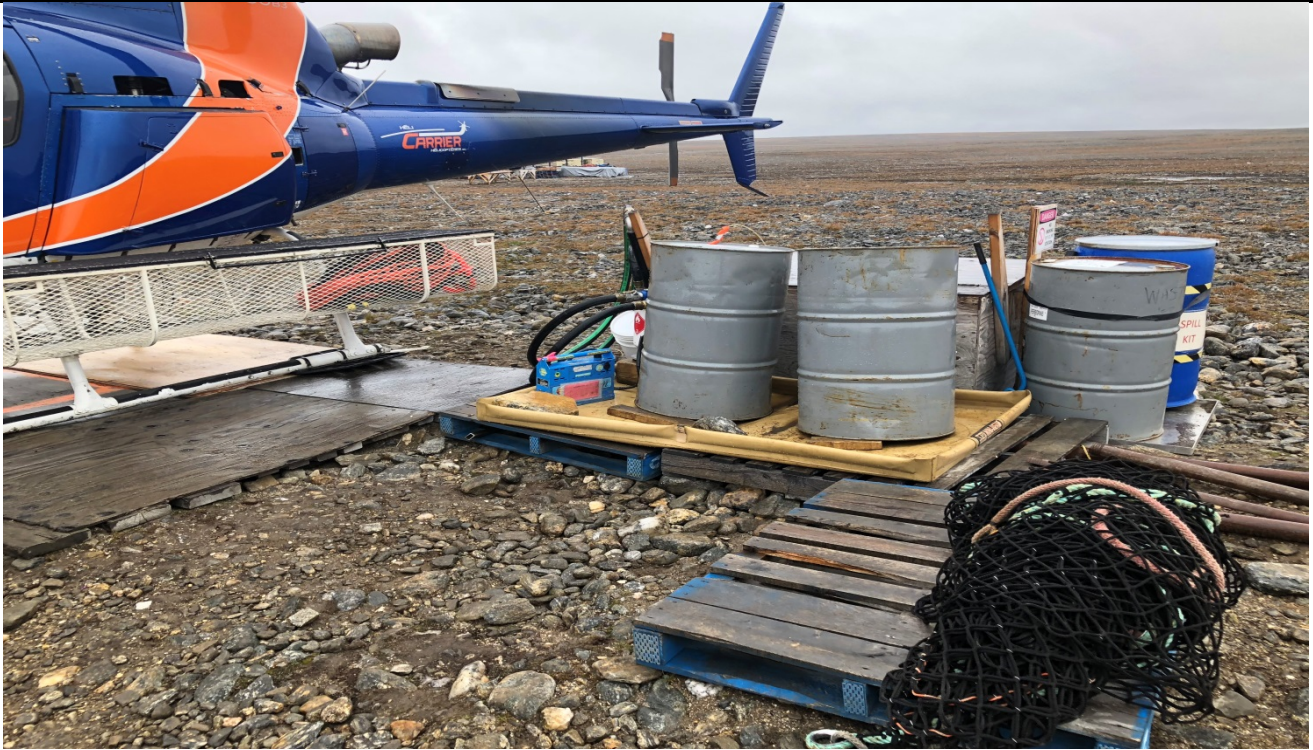
Photo 7

Description: Fuel Transfer Station for helicopter refuelling.

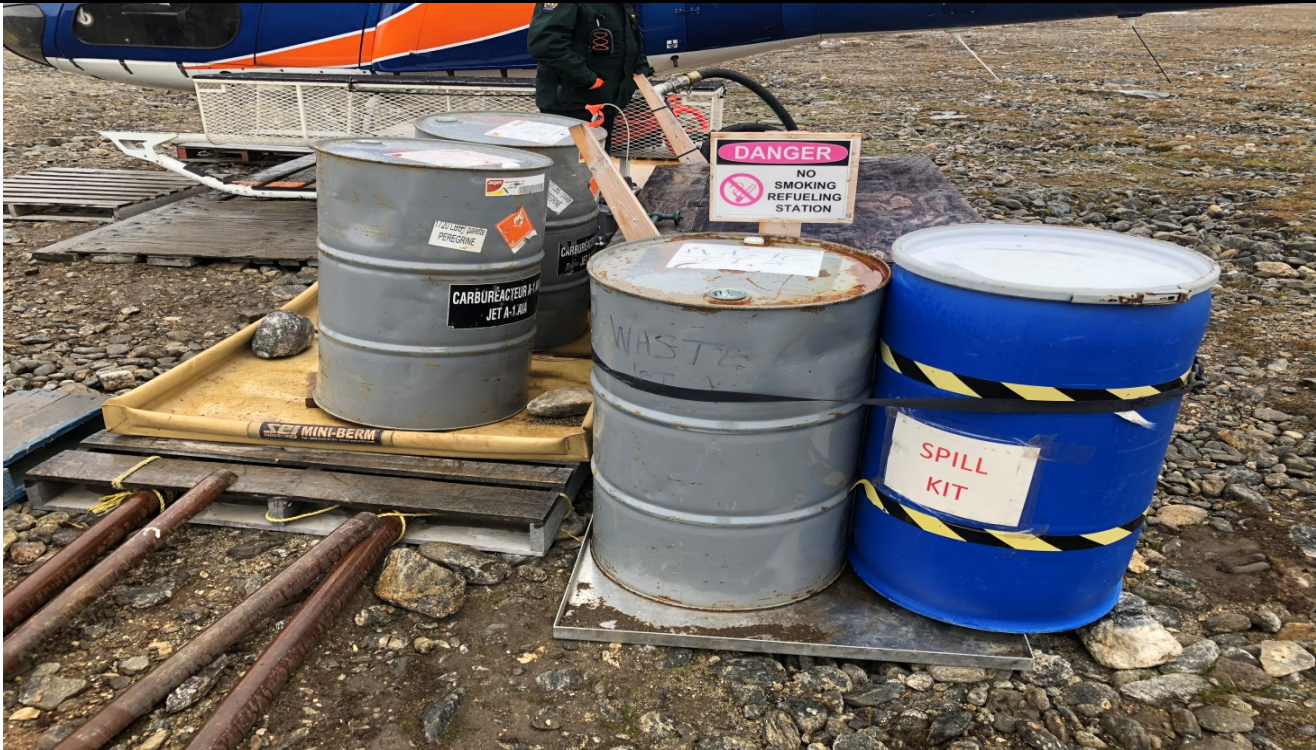
Photo 8

Description: Spill Kit at the Helicopter Transfer Station. 2x berms. Waste oil drum

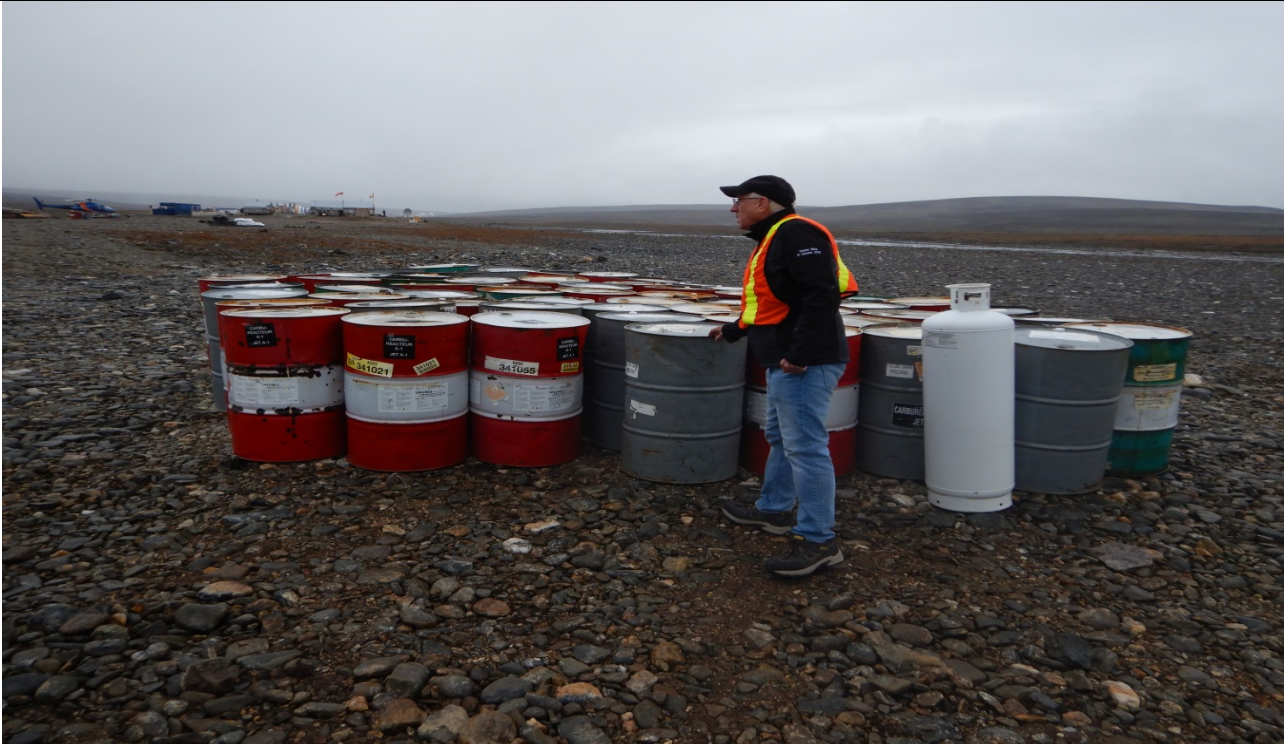
Photo 9

Description: Empty fuel drums ready for departure.

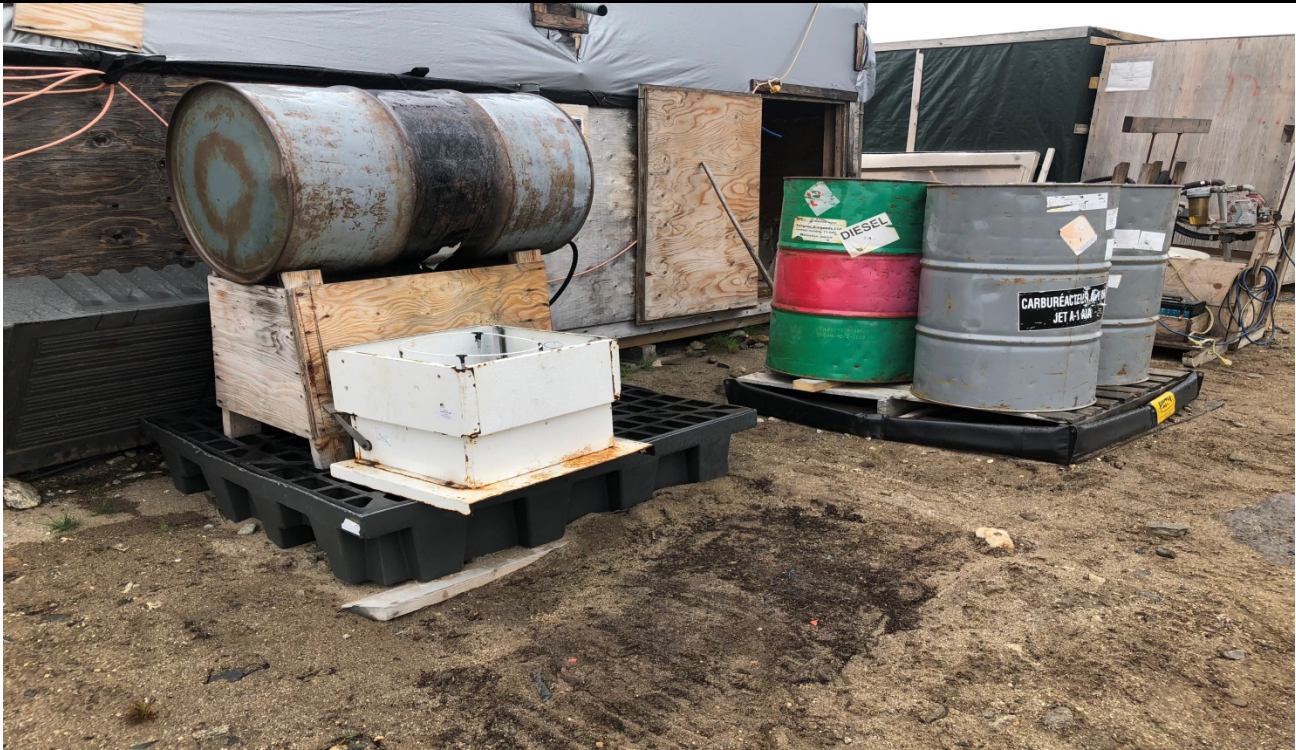
Photo 10

Description: Storage tank for camp in secondary containment.

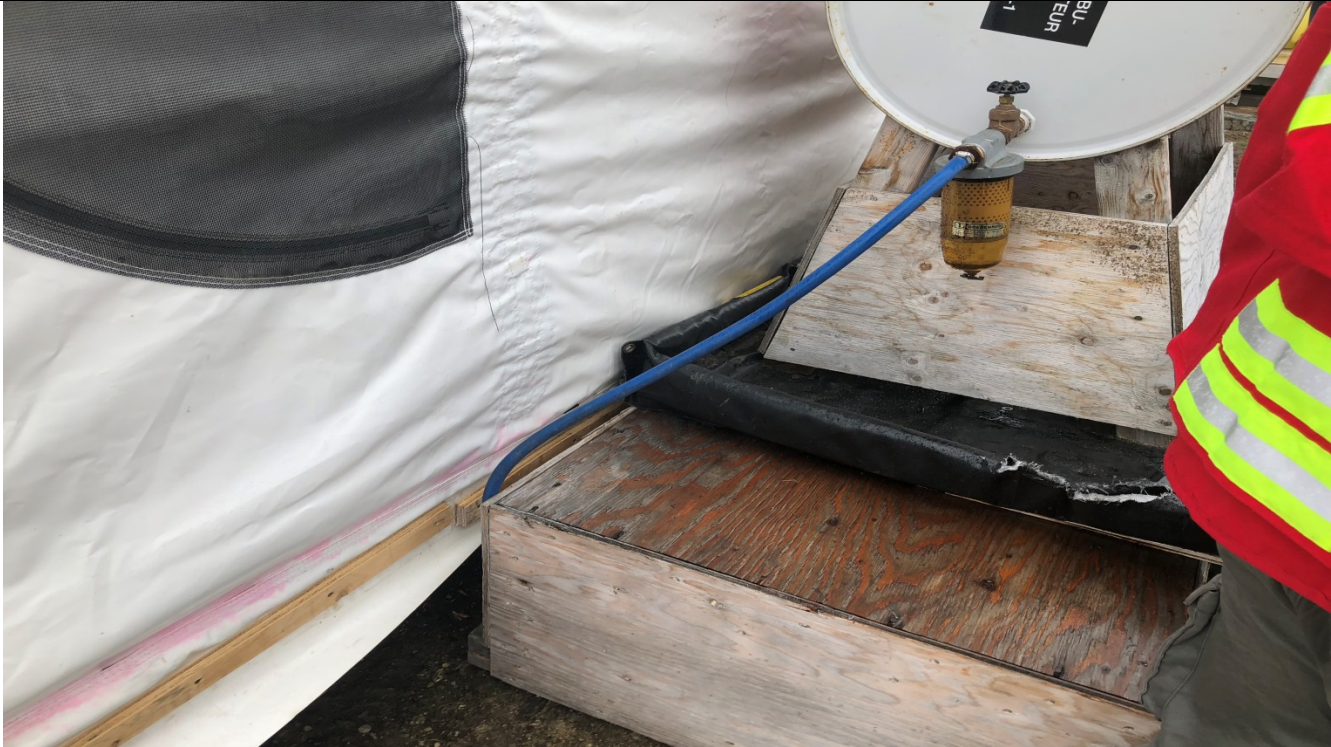
Photo 11

Description: Secondary containment on storage tank for heating damaged.

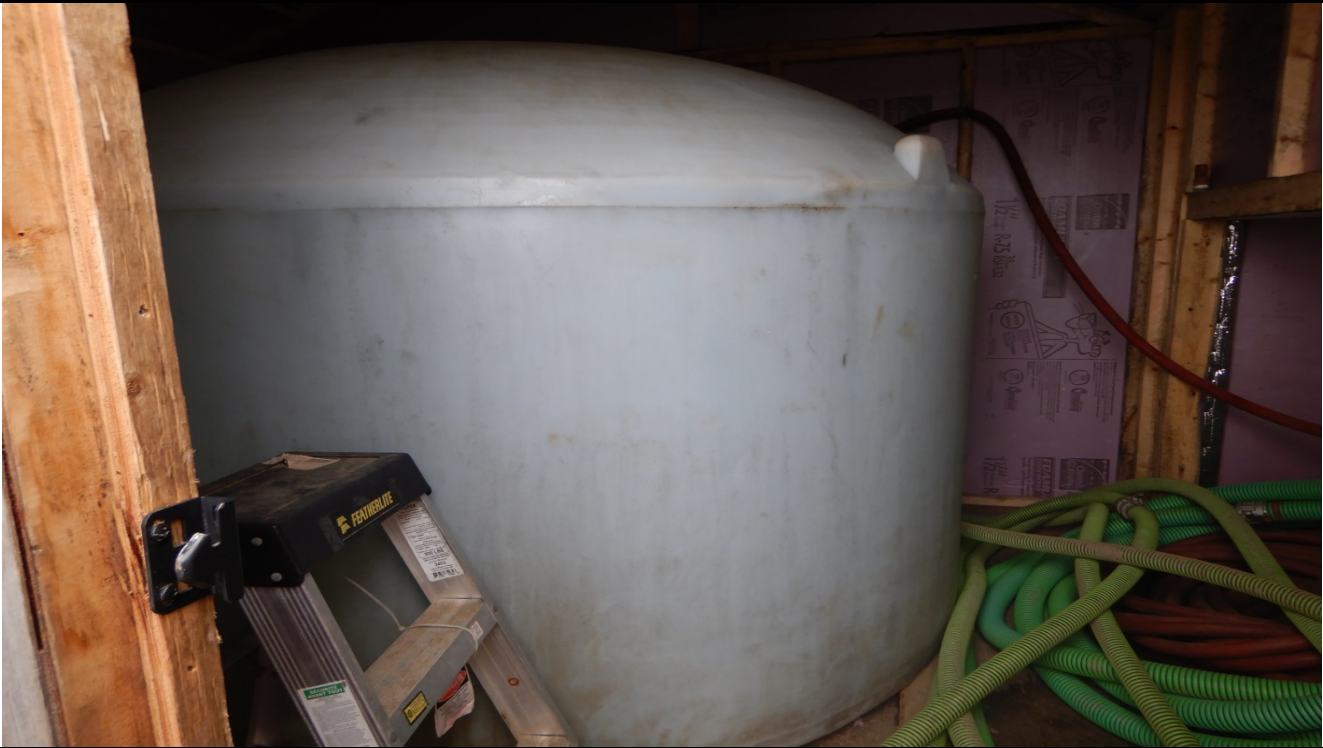
Description: larger water storage tank. Situated behind 3 x water storage tanks, and in added section to the building.

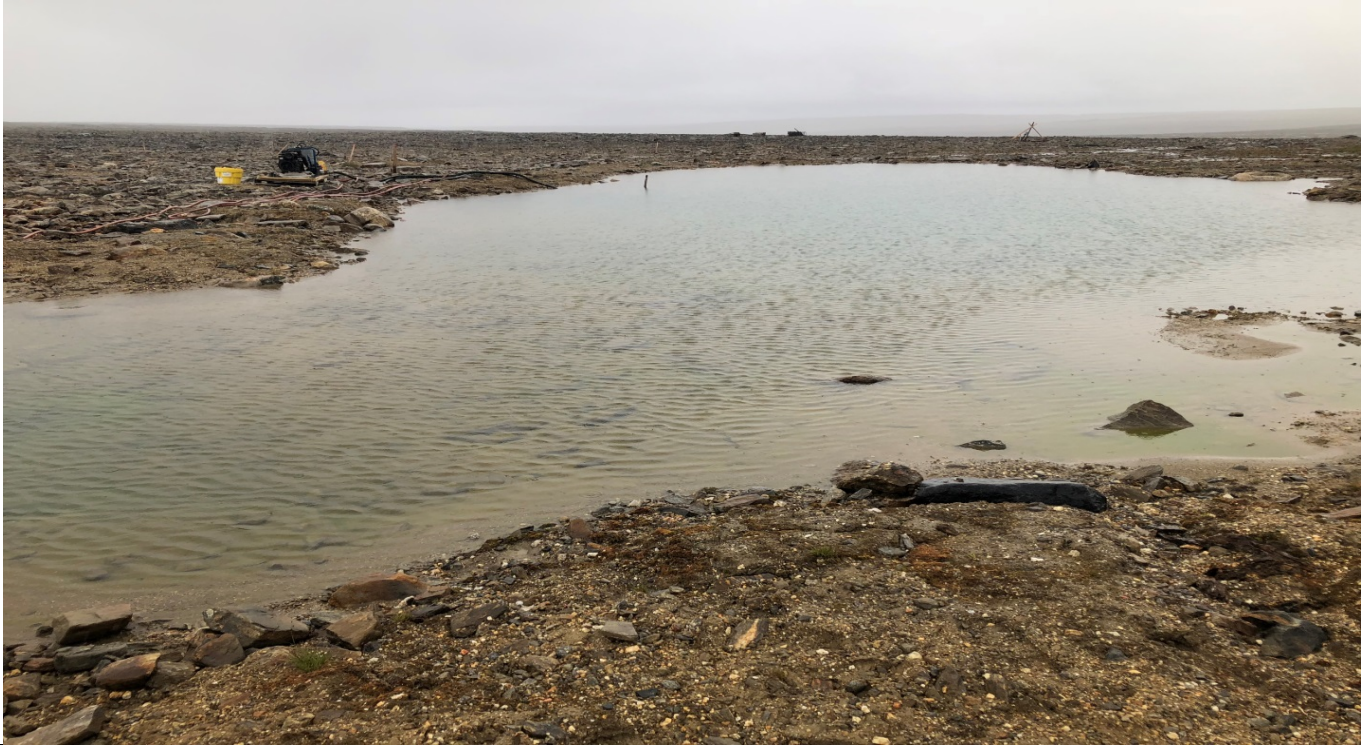
Photo 18

Description: footprint of sump for recycling drill water pump on other side. Drill Core shacks and monitoring station on the horizon.

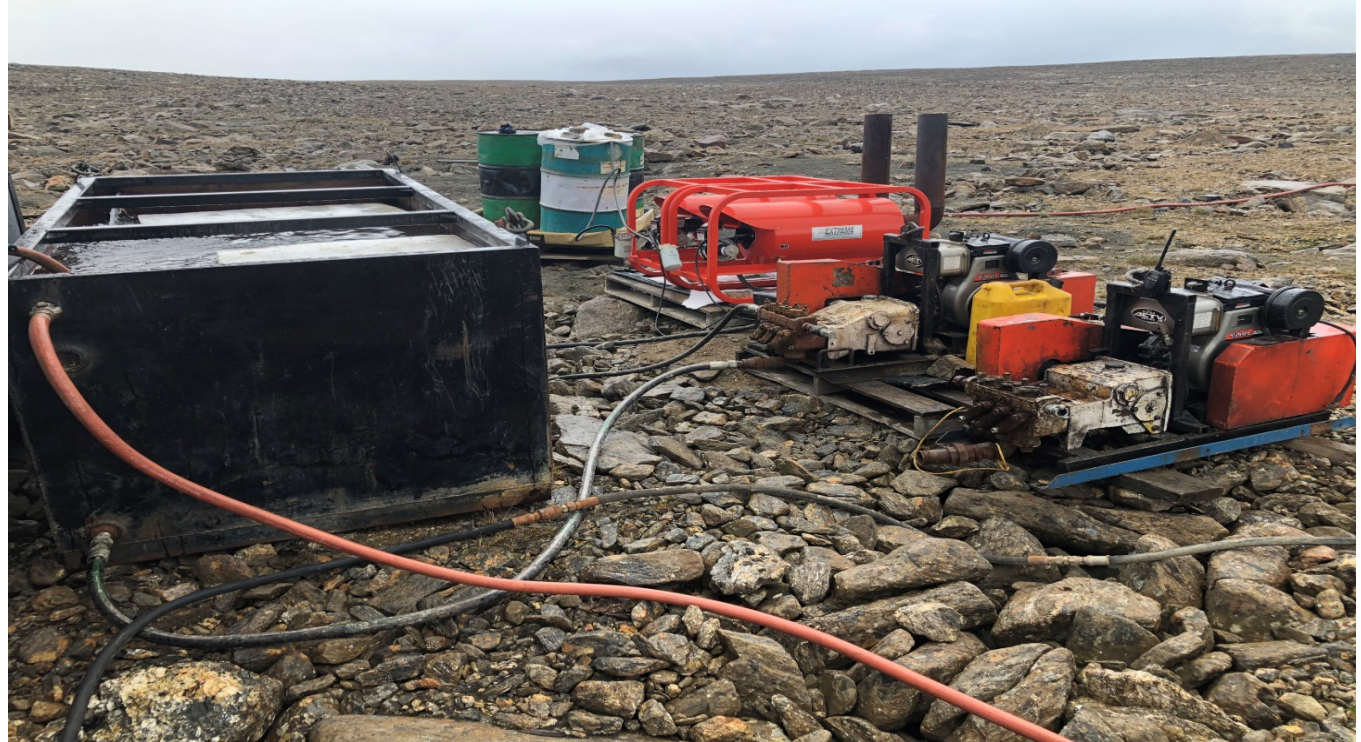
Photo 19

Description: Drill water storage tanks, water pumps, and fuel tanks for water pumps. Secondary containment for fuel storage.

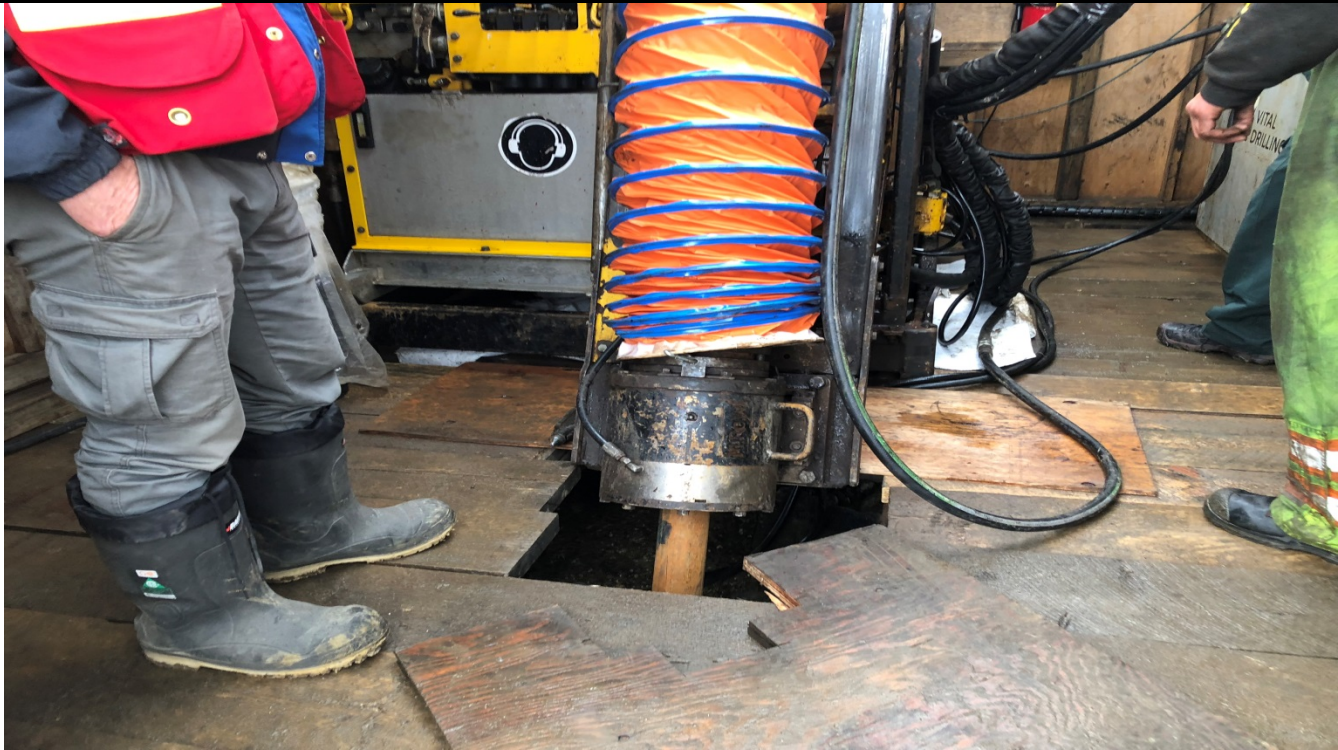
Photo 20

Description: Drill shack – Drilling active. Shut down for our inspection of site.

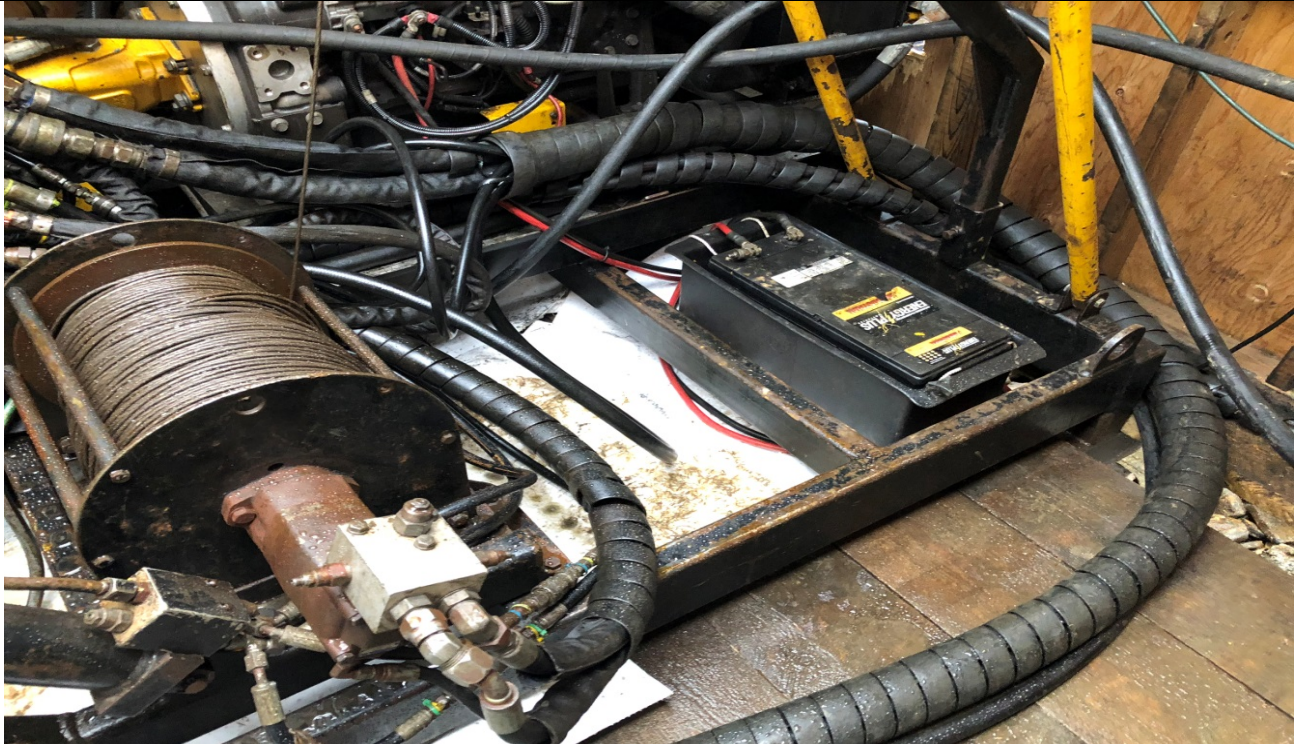
Photo 21

Description: Drill motor base, has hydrocarbon absorbant pads to mitigate the impact of a hydrocarbonspill. Battery installed.

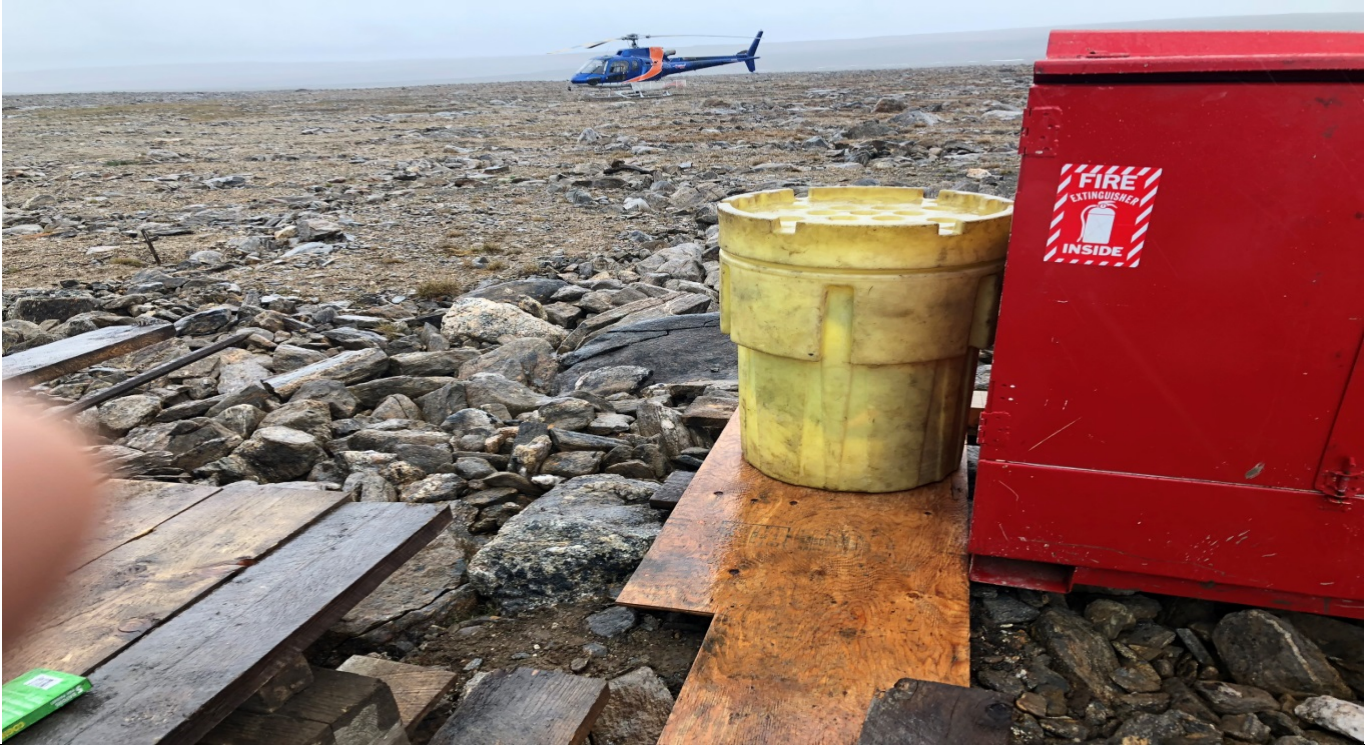
Photo 22

Description: double walled fuel storage tank. With spill kit next to storage tank.
