WATER LICENCE INSPECTION FORM

Licensee	Licensee Representative
DeBeers Canada Inc.	David Willis
Licence No. / Expiry	Representative's Title
2BE-CHI1823	Environmental and Community Coordinator
Land / Other Authorizations	Land / Other Authorizations
N2018C0002	
Date of Inspection	Inspector
August 18, 2021	Joseph Monteith
Activities Inspected	
<input checked="" type="checkbox"/> Camp <input type="checkbox"/> Roads/Hauling	<input checked="" type="checkbox"/> Drilling <input checked="" type="checkbox"/> Other: Tailings (CH-07), Drill site CH-06
<input type="checkbox"/> Mining	<input type="checkbox"/> Construction <input type="checkbox"/> Other:
<input type="checkbox"/> Reclamation	<input checked="" type="checkbox"/> Fuel Storage

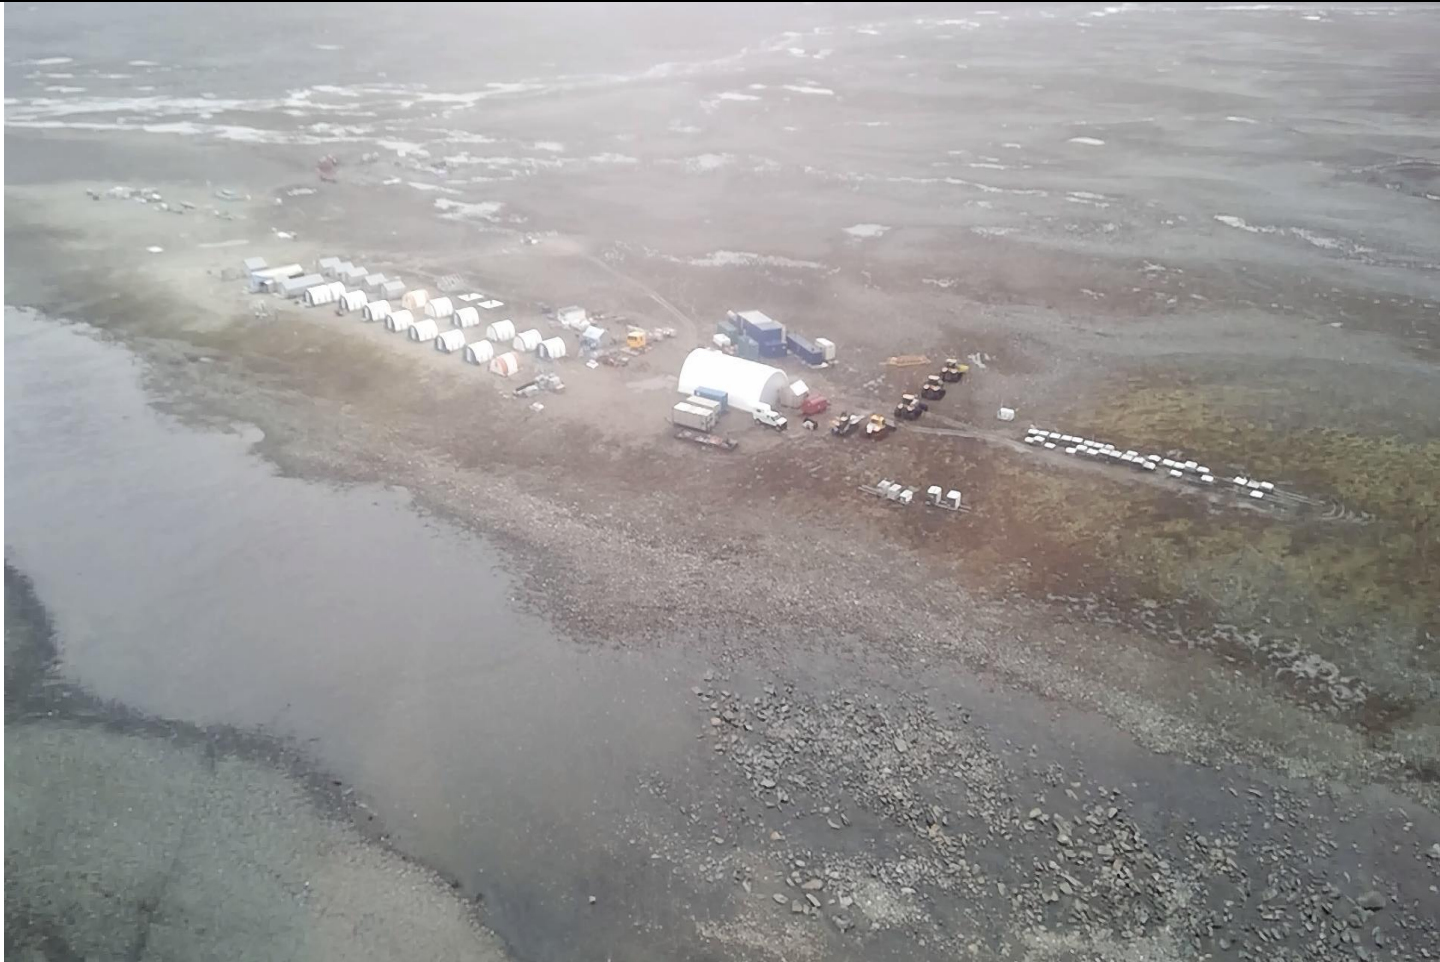
Date	Camera	Inspector
July 25, 2019	Nikon Cool Pix	Joseph Monteith
Photo Log #	Location	
Photo 1	Chidliak –Discovery Camp

Description: Discovery Camp – Active site

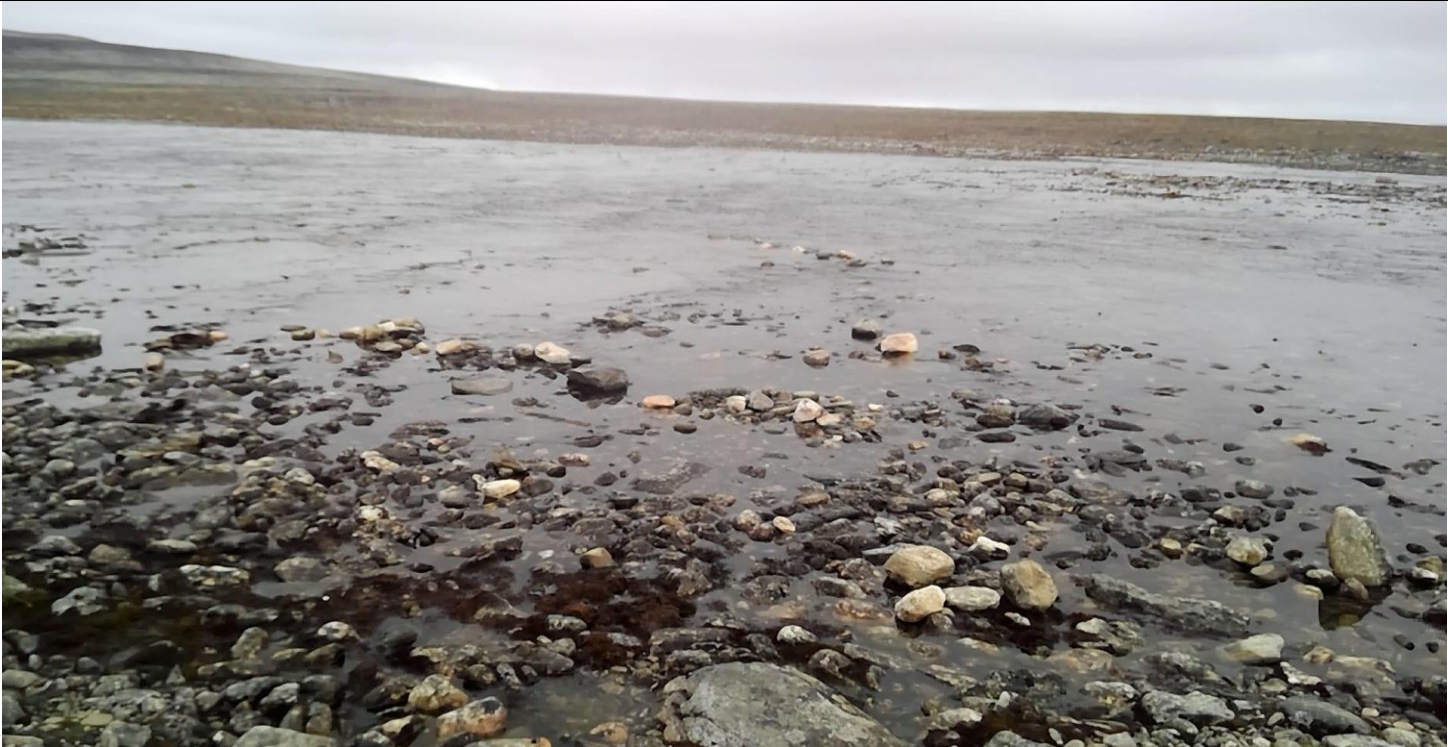
Photo Log #	Location
Photo 2	Chidliak – Discover Camp Water Source

- 3. Water withdrawal location. Water pump (photo 2) No hose in water, no fish mesh screen observed. Stream hasn't been drawn down. But is a very low flow. Signs of algae growth, site was in a state of seasonal closure due to COVID (photo 3).

Description: Site of water withdraw

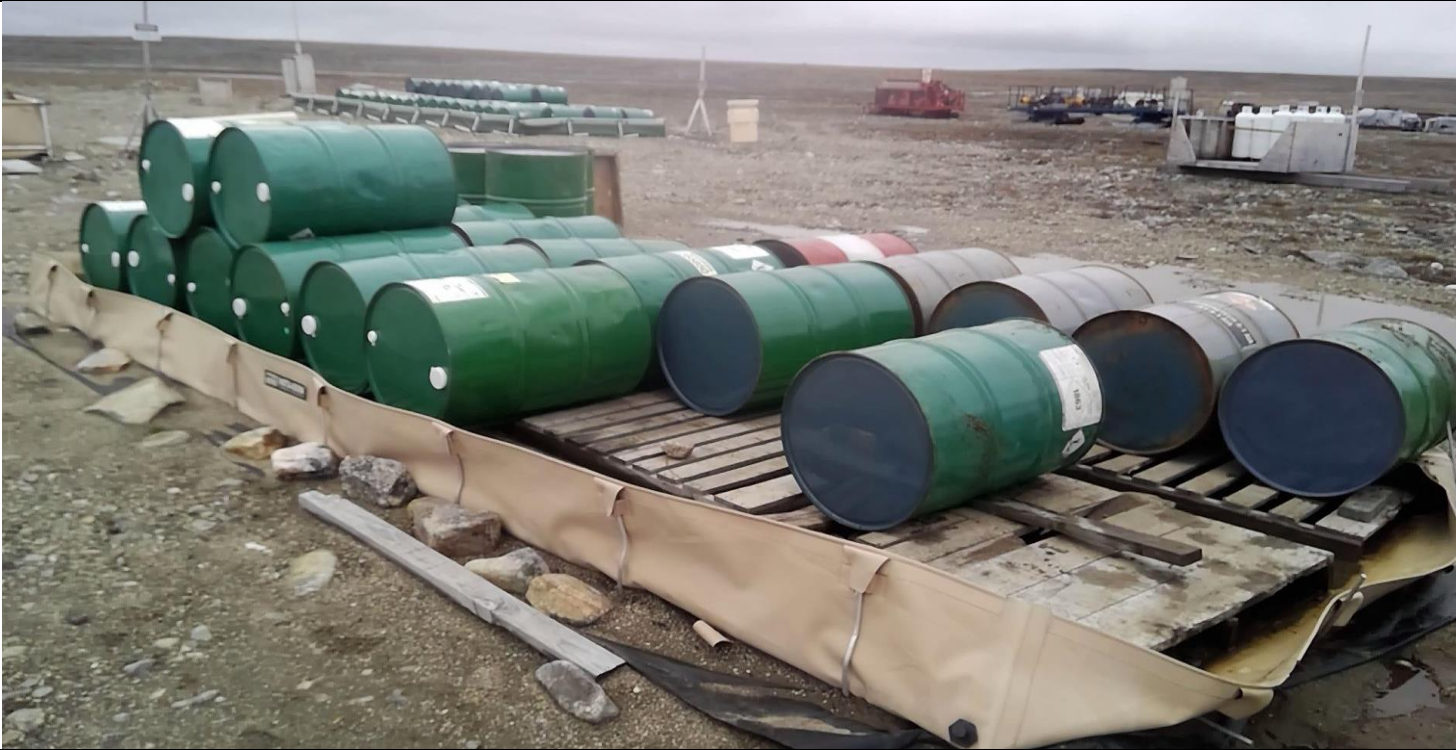
Photo 3

- 4. Fuel Cache 1 - 26 barrels of fuel in secondary containment. Signage observed, spill kit observed (photo 3).
- 5. Fuel Cache 2 –approximately 60 barrels of diesel in secondary containment. Signage observed (photo 4).

Description: Discovery Camp - Fuel Cache 1 – 26 barrels of Jet-A fuel in secondary containment

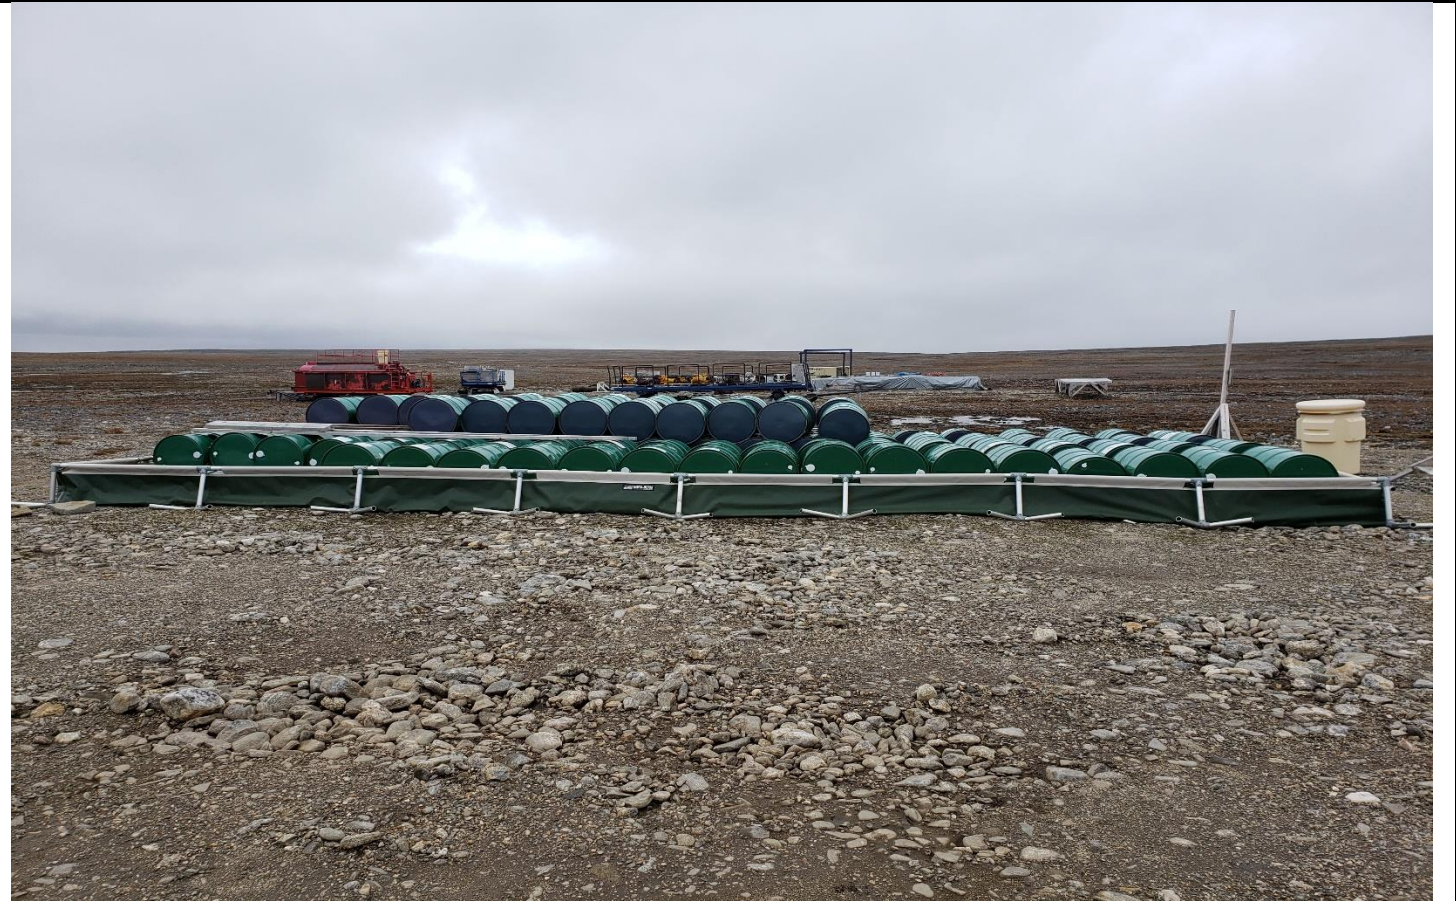
Photo 4

Description: Fuel Cache – Approximately 60 drums of fuel in secondary containment, spill kit observed.

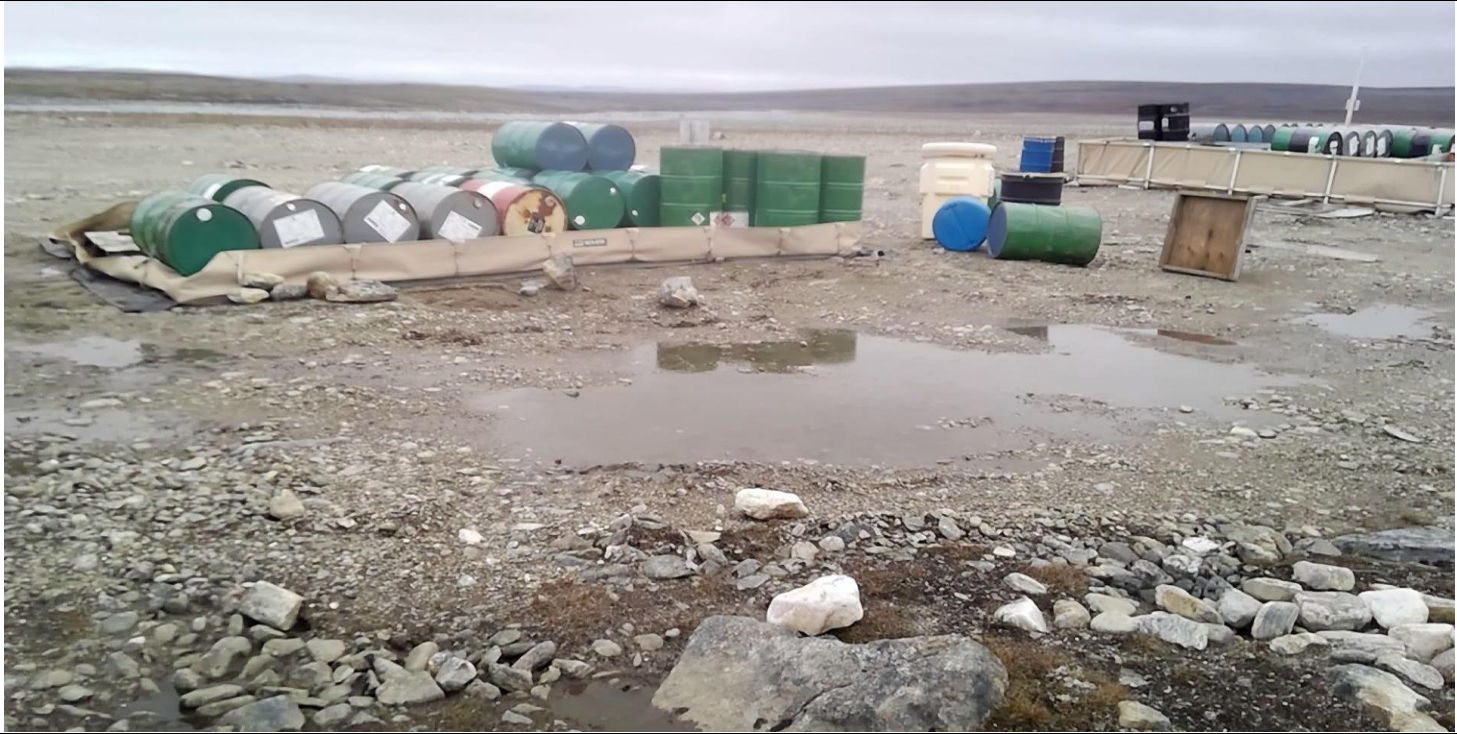
Photo 7

- 17. Site of Spill 2017-230. Sign of grey water (photo 14).
- 18. Site of Spill Report 2017-320 (photo 15).
- 19. Site of Spill Report 2017-320 – sign of grey water. No samples taken.
- 20. A few spill reports should have been submitted for the leak on Fuel cache 3, the discharge of berm water due to disconnected carbon filter, and sheening next to the helicopter refuelling cache(photos 5, 7, 23).

Description: Fuel Transfer Station for helicopter refuelling. Signs of spills. Fuel Cache 3 in the background

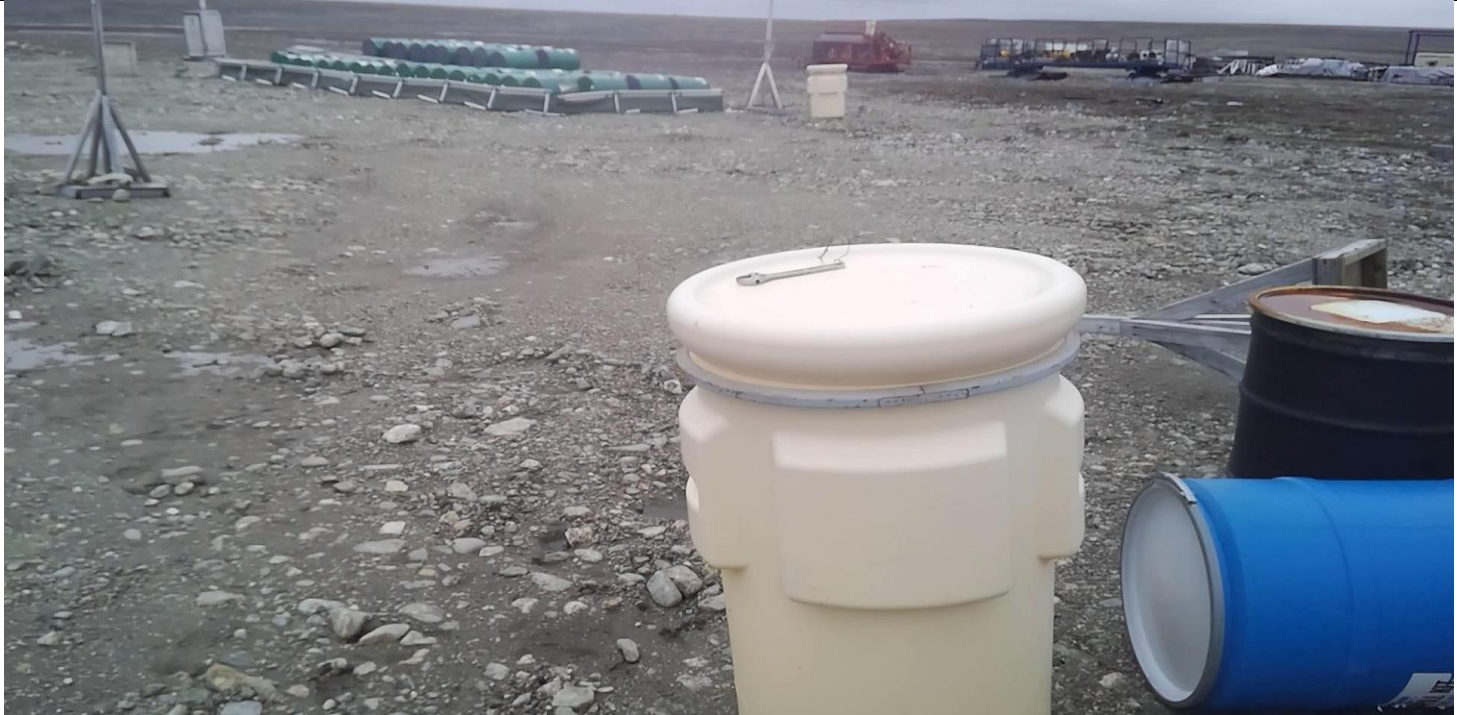
Photo 8

Description: Spill Kit at the Helicopter Transfer Station.

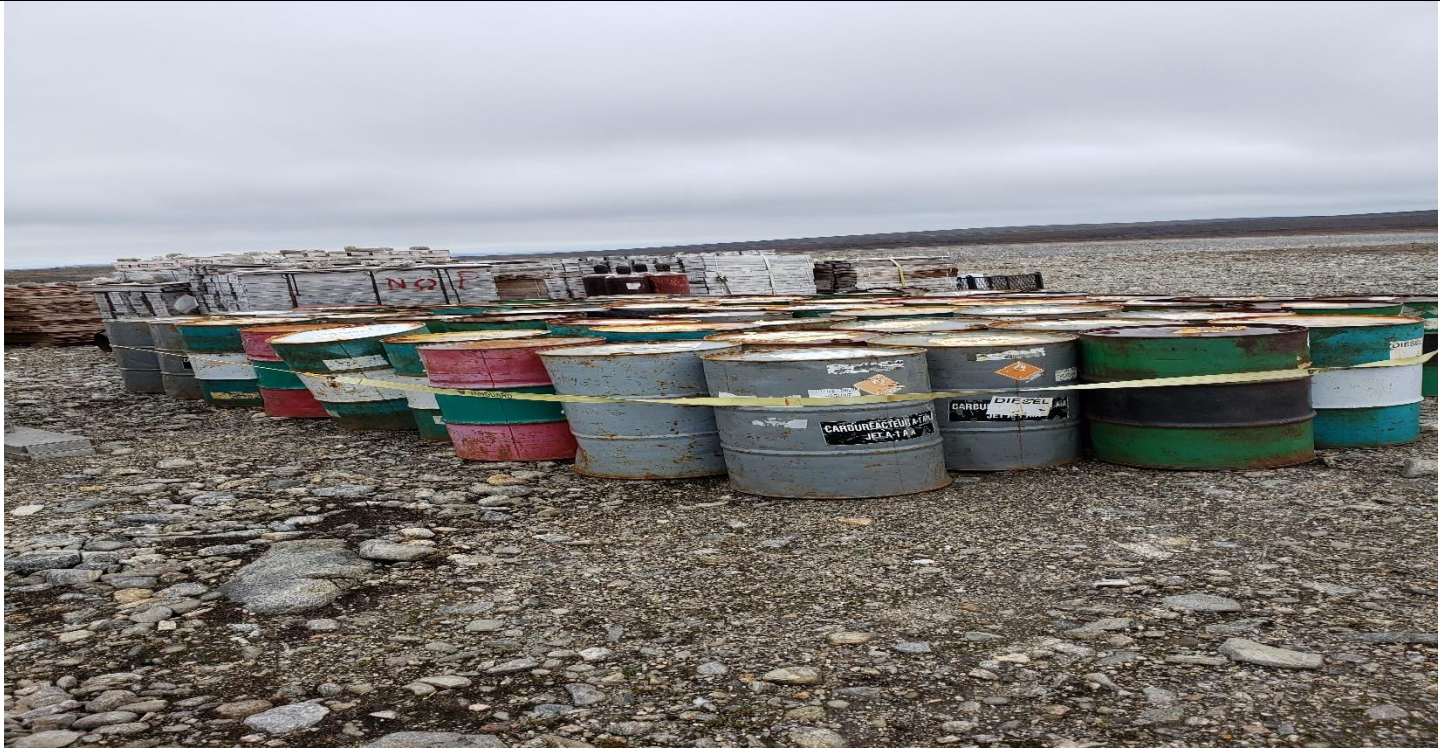
Photo 9

Description: Empty fuel drums ready for departure.

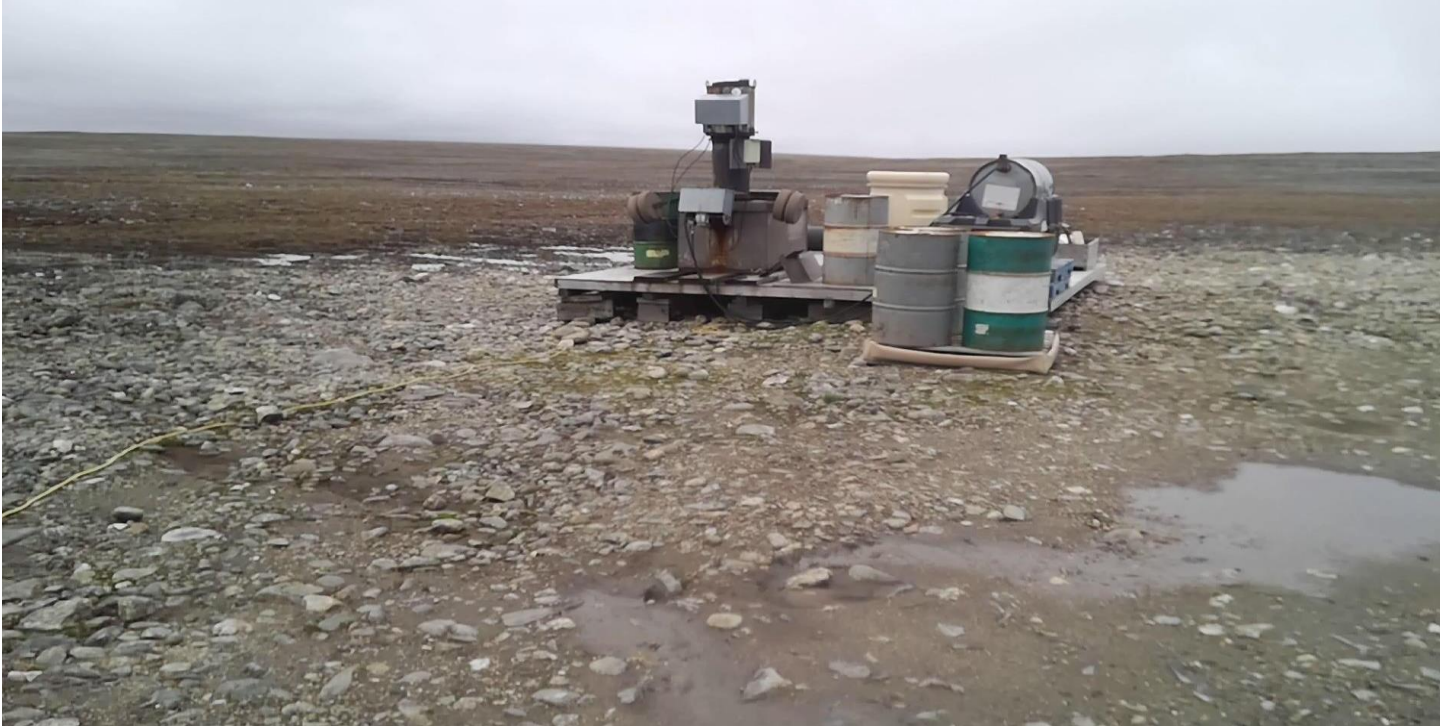
Photo 10

Description: Incinerator, fuel cache in secondary containment, spill kit

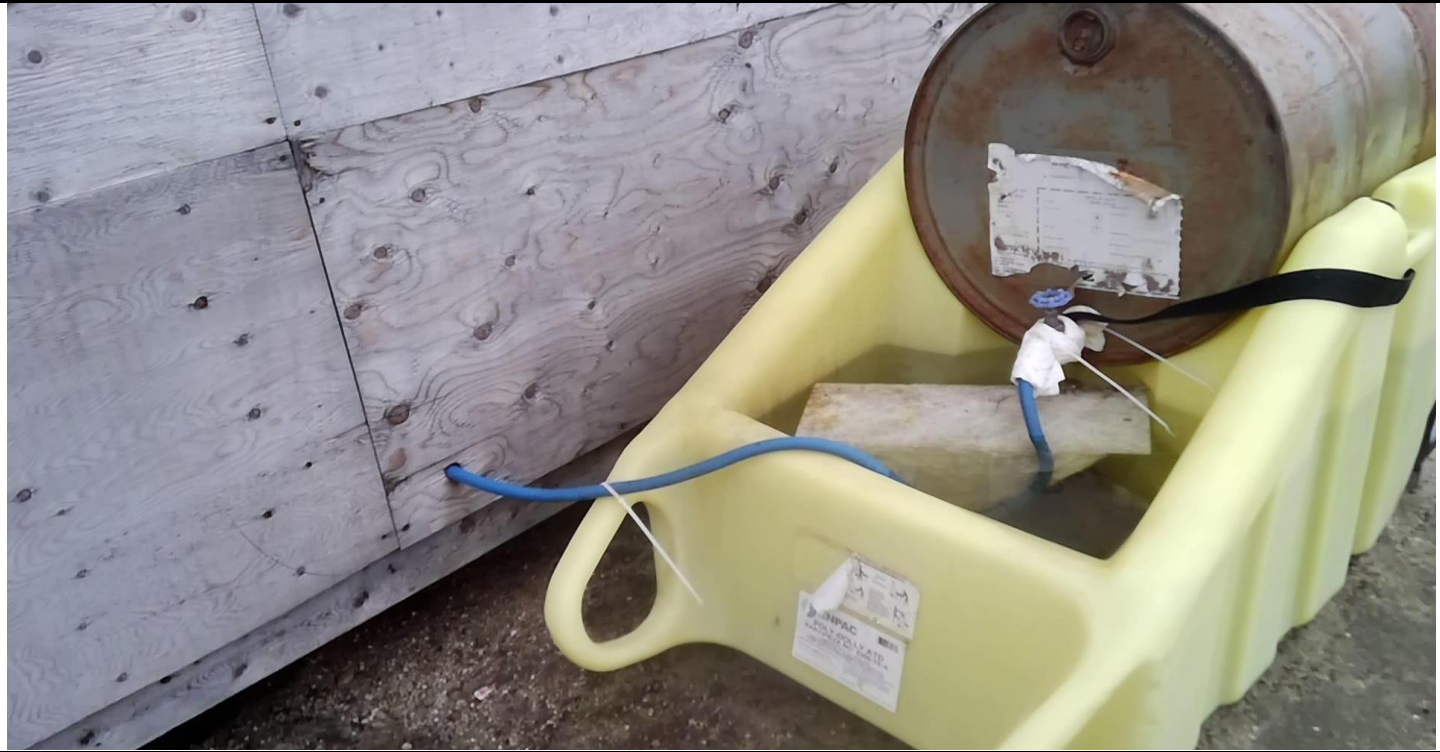
Photo 11

Description: Secondary containment on storage tank for heating full.

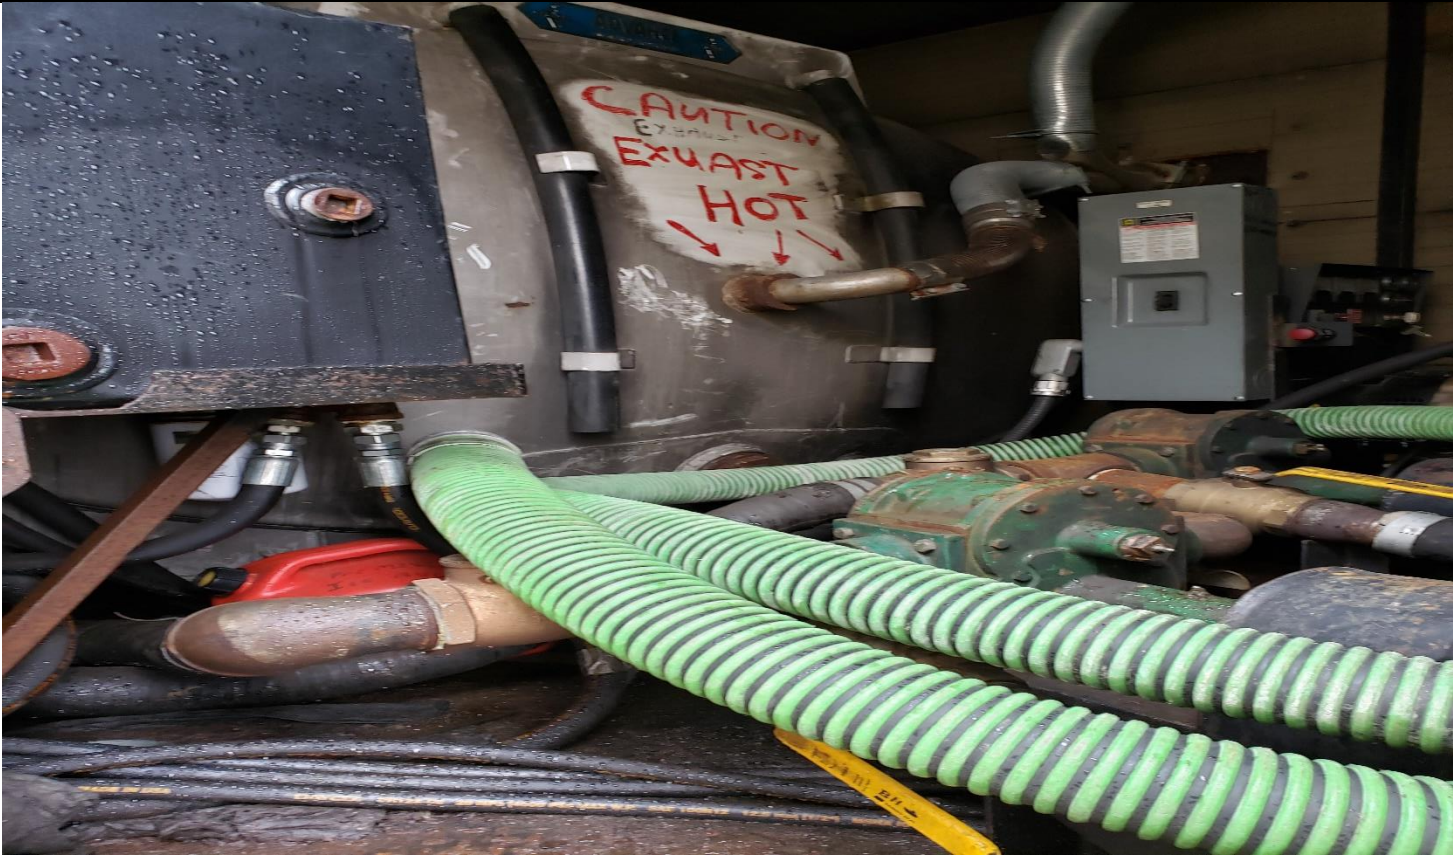
Photo 12

Description: Mobile Water Storage tanks

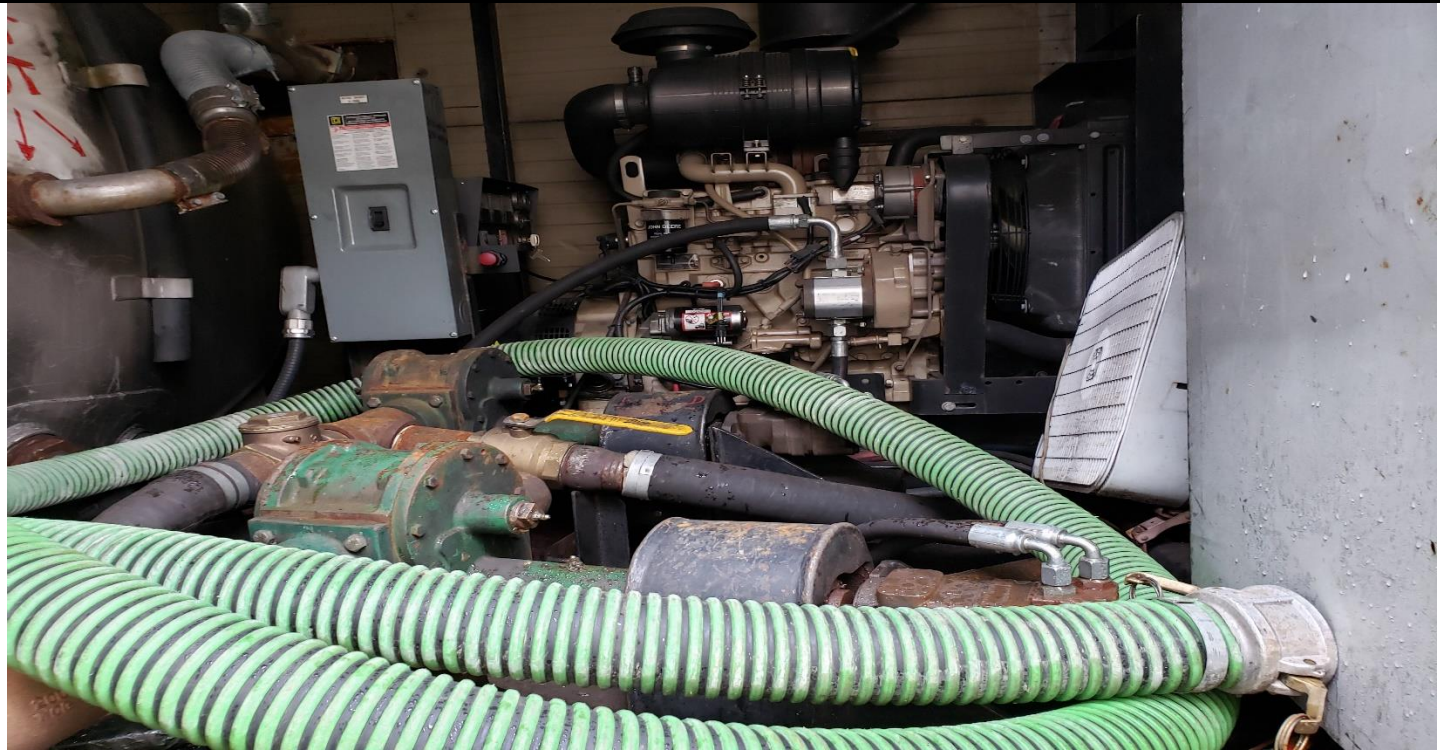
Photo 13

Description: Mobile Water Storage Tank

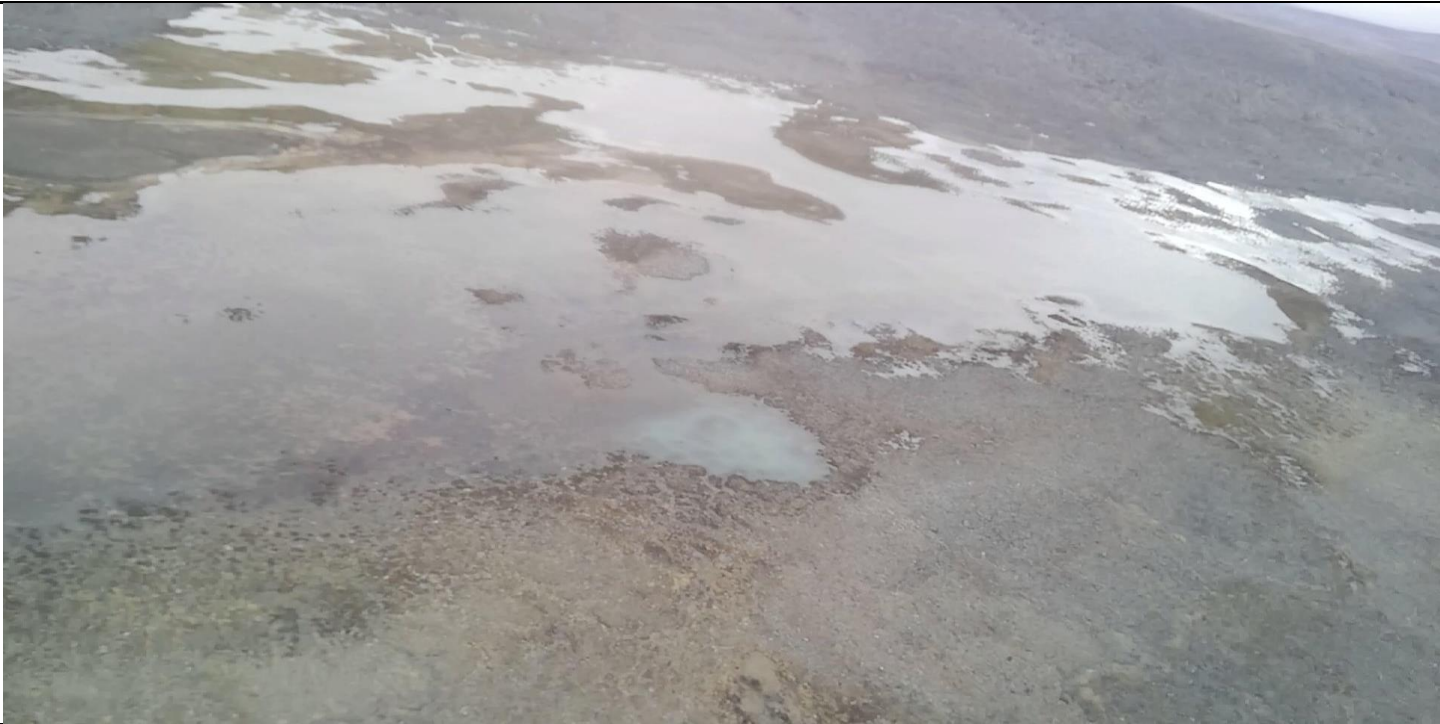
Photo 14

Description: Site of Spill Report 2017-320. No signs of spill or spill migration. Drum observed along the coasts of the river.

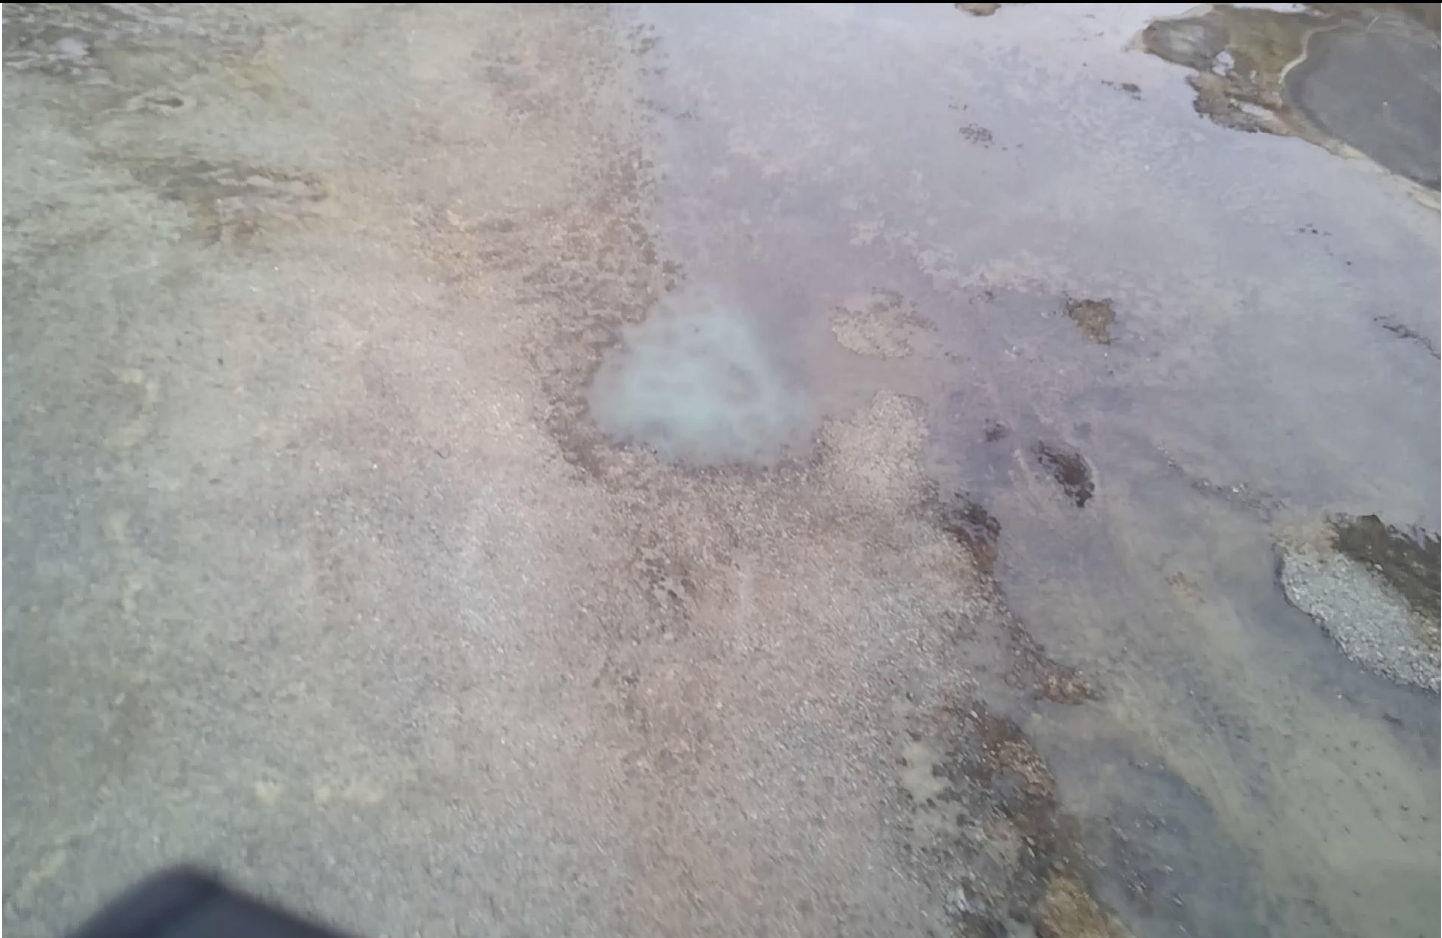
Photo 15

Description: Site of Spill Report 2017-320 – No sign of spill, or spill migration

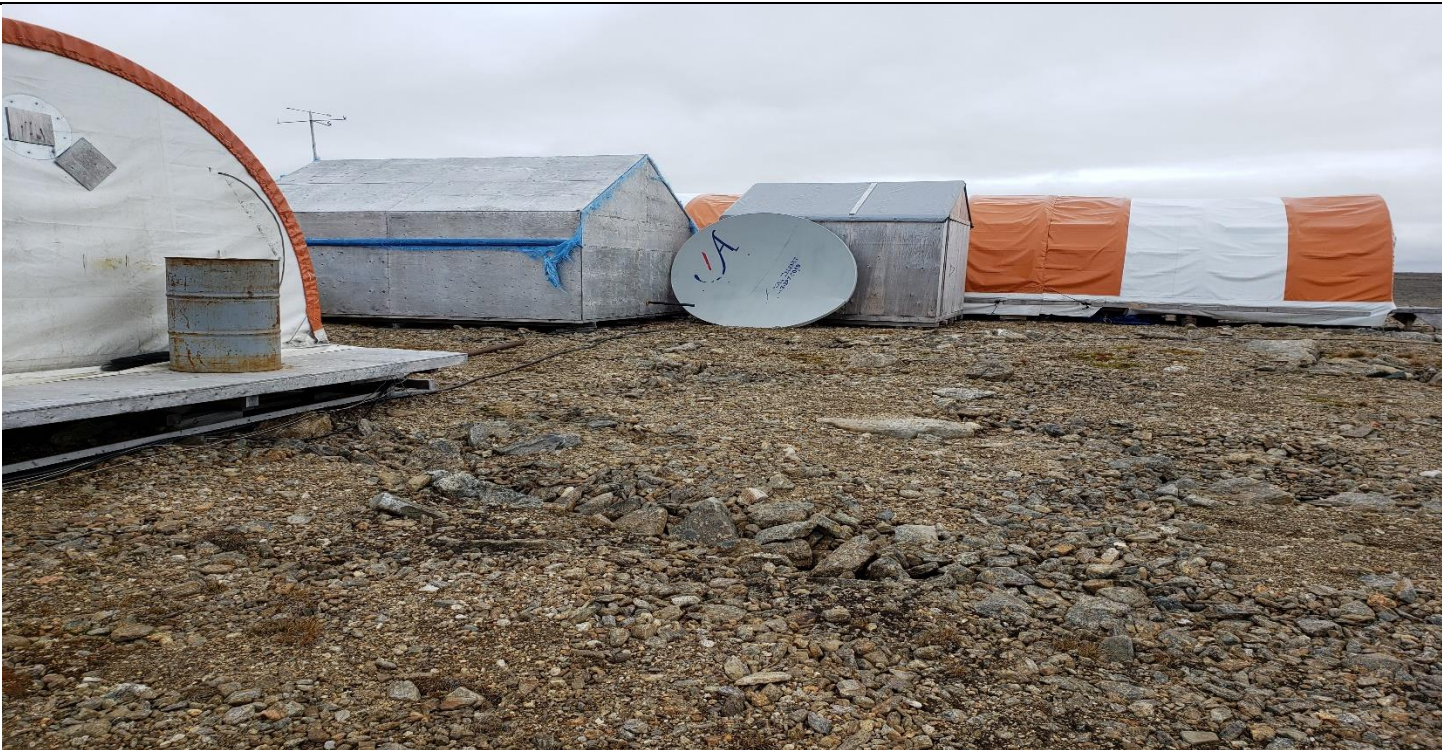
Photo 16

Description: CH-06 Campsite

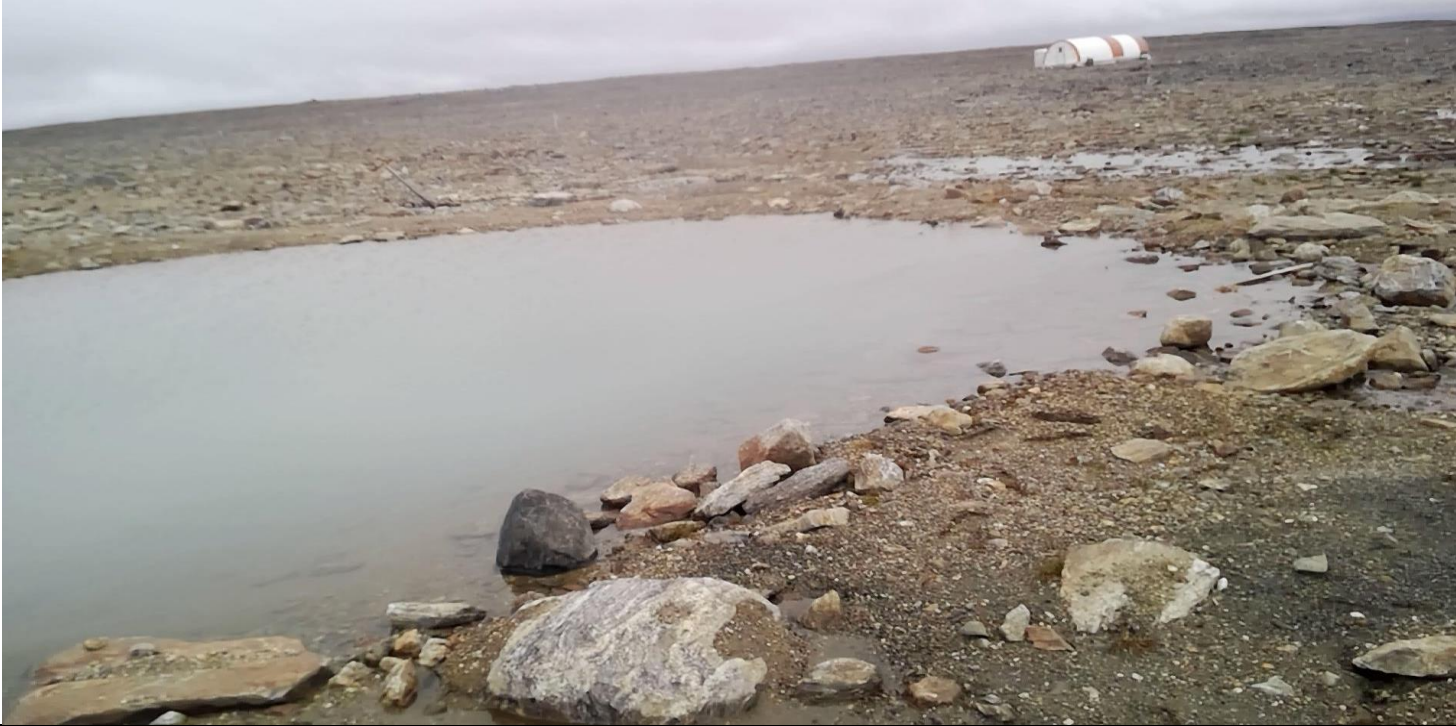
Photo 17

Description: Drill water sump pit.

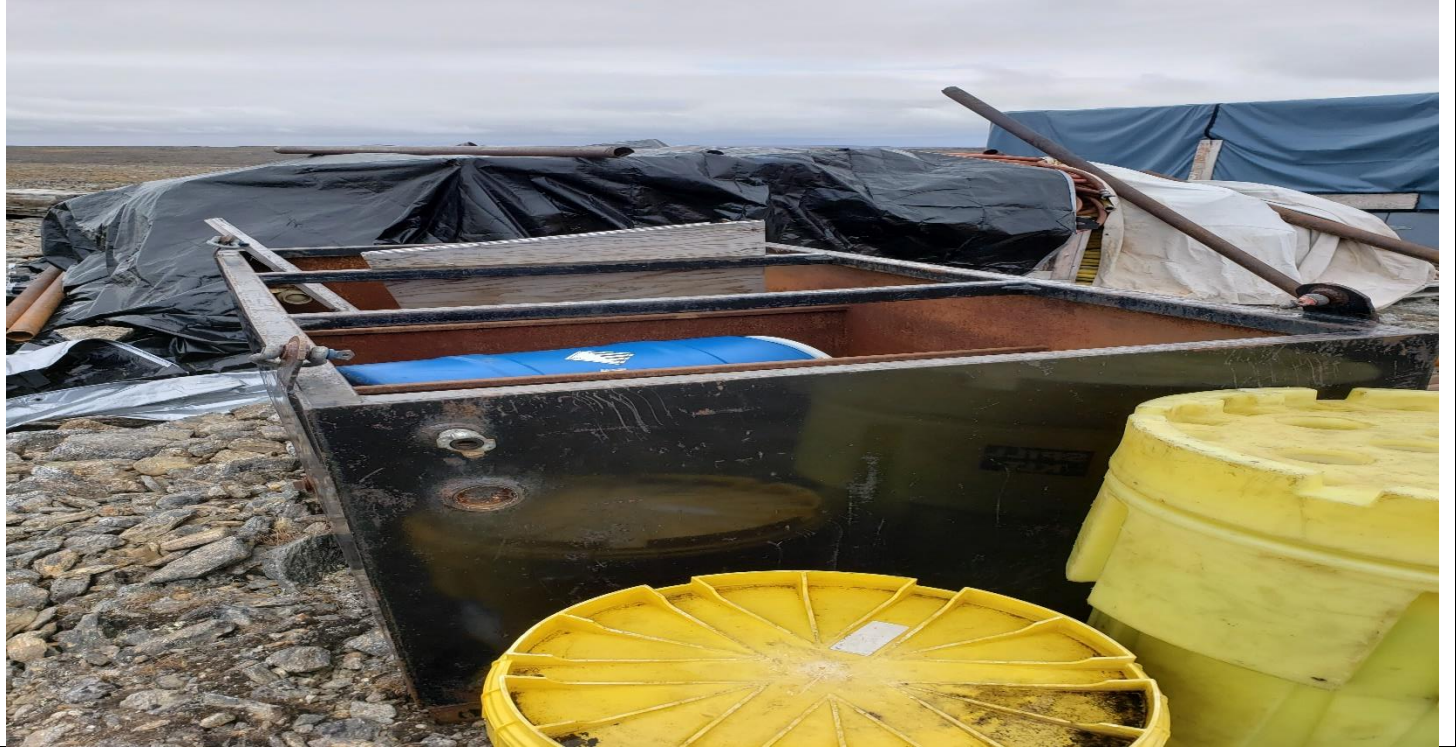
Photo 18

Description: Drill water storage tanks, water pumps, and fuel tanks for water pumps. Secondary containment for fuel storage.

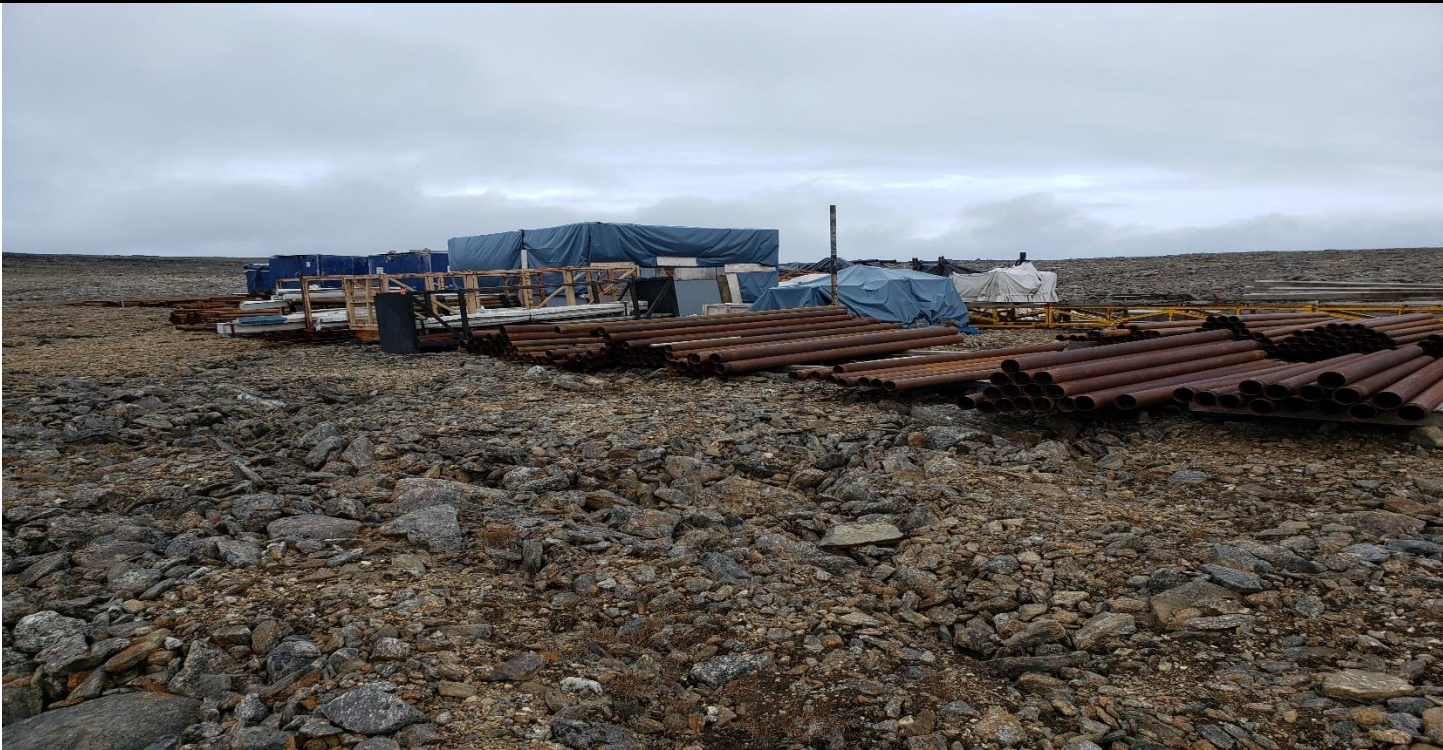
Photo 19

Description: Drill shack – Drilling inactive. Shut down due to COVID.

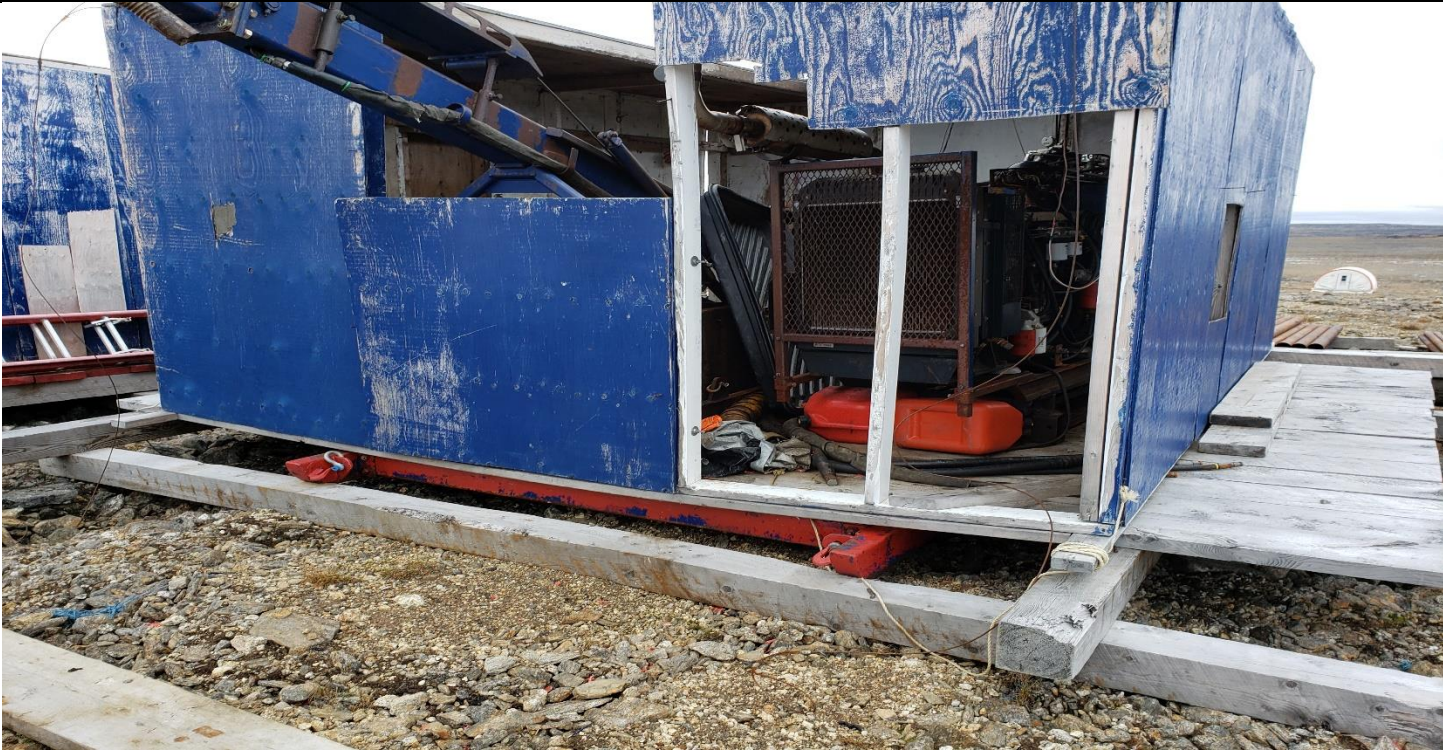
Photo 20

Description: Drill Shack, motor exposed to the outside elements due to damage to the shack.

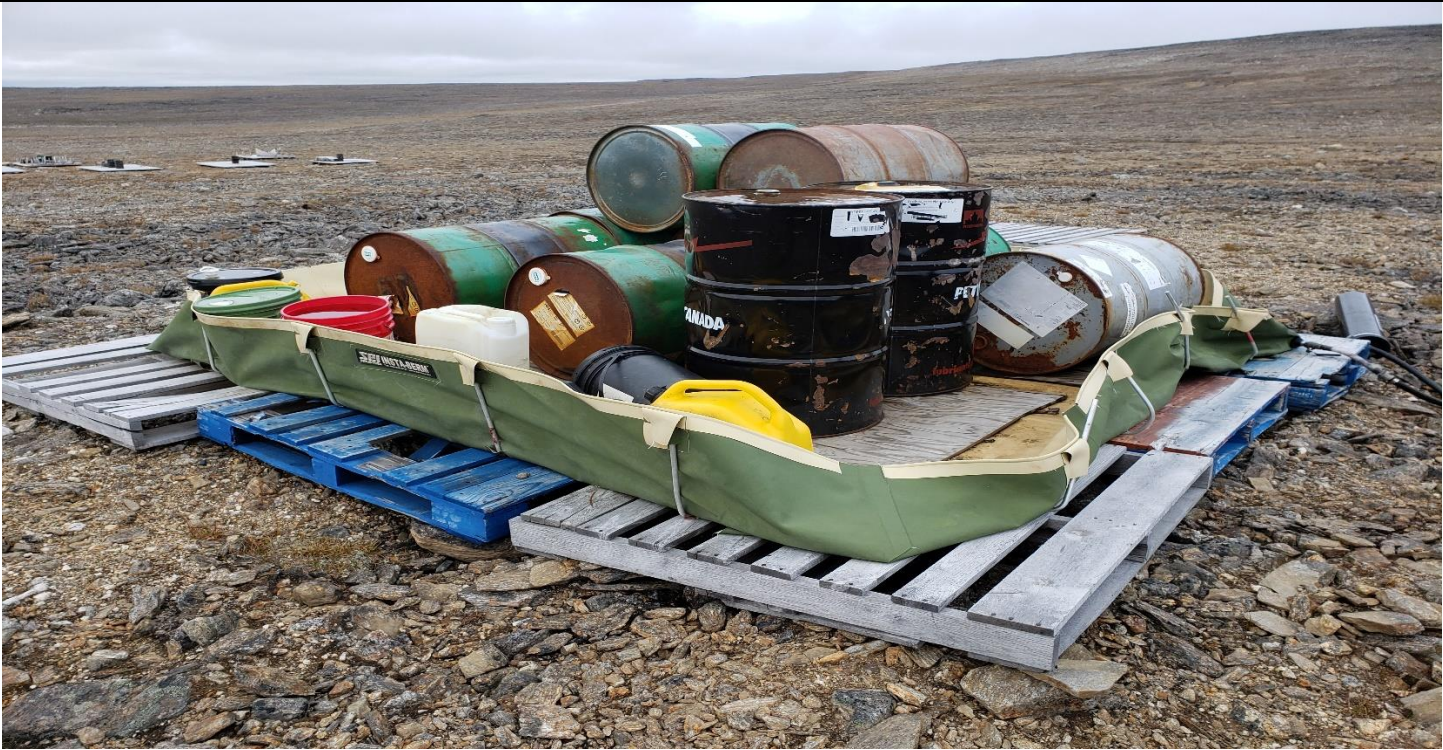
Photo Log #	Location
Photo 21	Chidliak – CH-06

Description: fuel cache in secondary containment. Spill Kit Observed in close proximity. Walls compromised. Secondary containment did not contain any liquid.
