WATER LICENCE INSPECTION FORM

Licensee	Licensee Representative
DeBeers Canada Inc.	David Willis
Licence No. / Expiry	Representative's Title
2BE-CHI1823	Environmental and Community Coordinator
Land / Other Authorizations	Land / Other Authorizations
N2018C0002	
Date of Inspection	Inspector
August 18, 2021	Joseph Monteith
Activities Inspected	
<input checked="" type="checkbox"/> Camp <input type="checkbox"/> Roads/Hauling	<input checked="" type="checkbox"/> Drilling <input checked="" type="checkbox"/> Other: Tailings (CH-07), Drill site CH-06
<input type="checkbox"/> Mining	<input type="checkbox"/> Construction <input type="checkbox"/> Other:
<input type="checkbox"/> Reclamation	<input checked="" type="checkbox"/> Fuel Storage

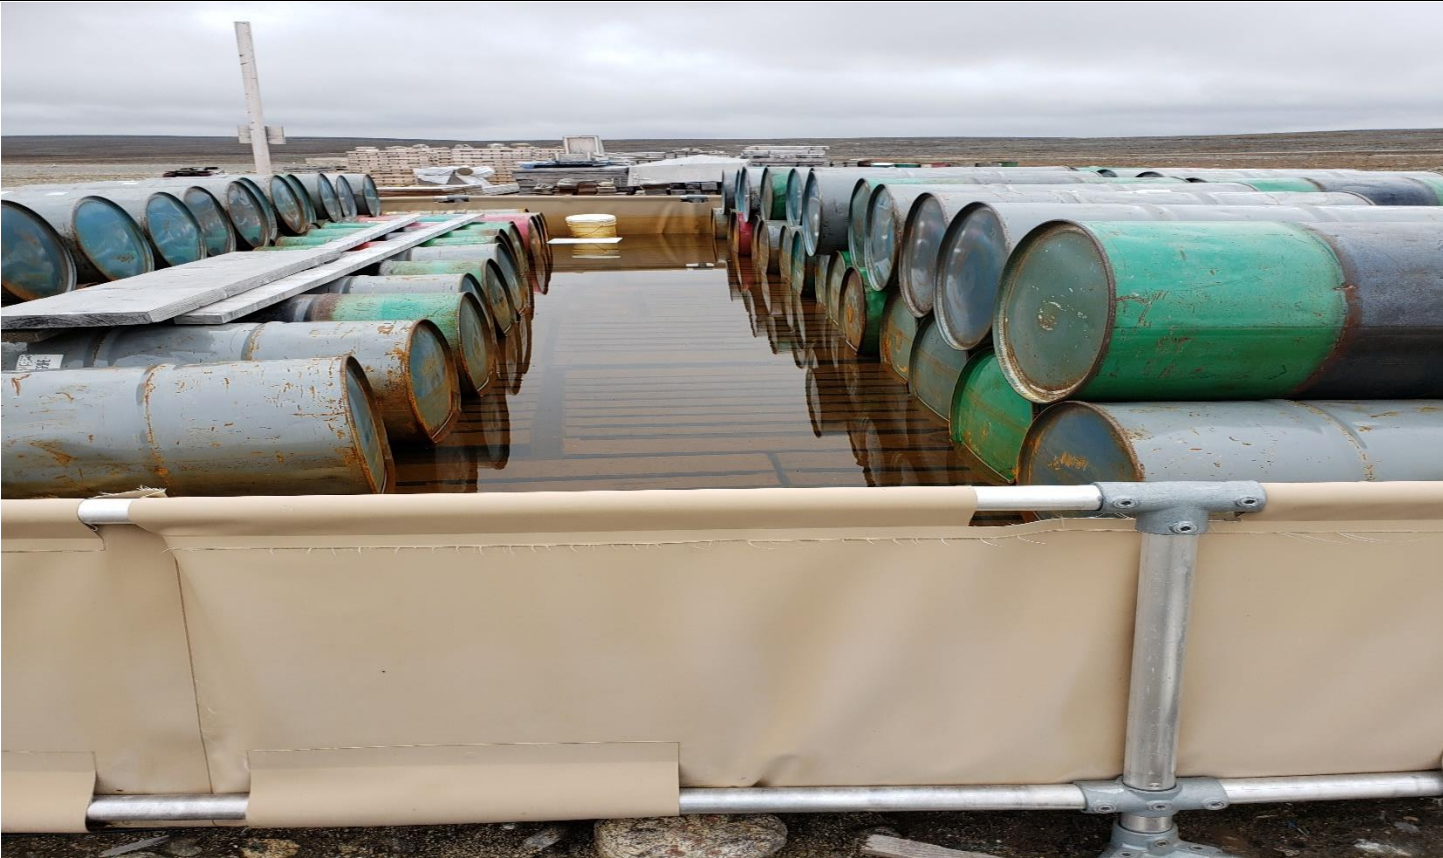
Photo Log #	Location
Photo 22	Chidliak – Discovery Camp

- 6. Fuel Cache 2 – Carbon Filter was disconnected, and the berm was not sealed (photo 5 ).
- 7. Spill Kit, and Fuel Transfer Station box (photo 6).
- 8. Fuel Cache 3 – Approximately 60 drums of Jet-A fuel. Berm contained liquid, but a leak was observed (photo 22, 23)

Description: fuel cache 3 in secondary containment. Liquid contained in berm. Leak on the carbon filter observed.

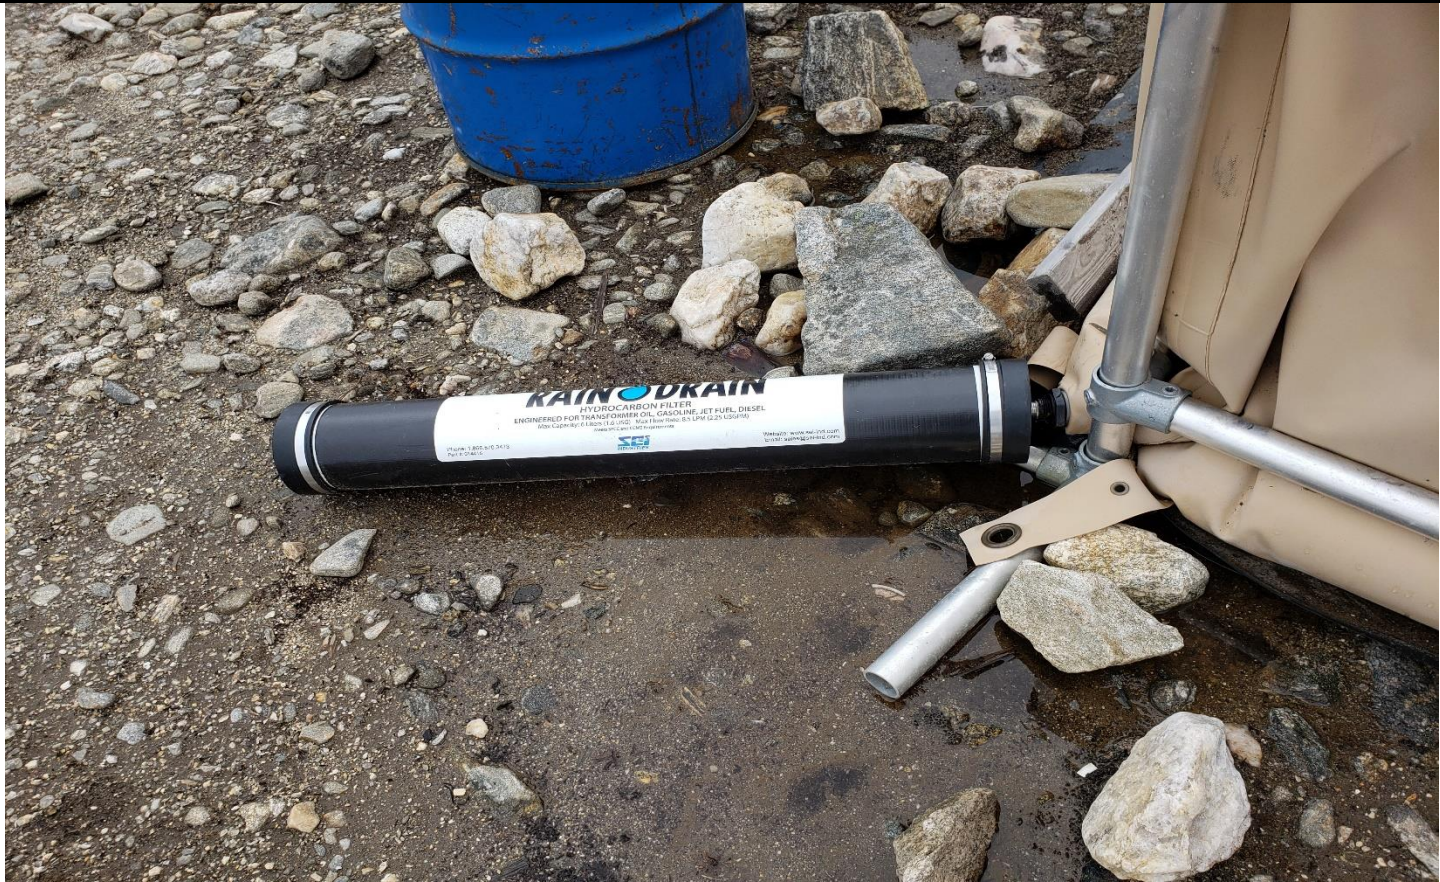
Photo 23

- 17. Site of Spill 2017-230. Sign of grey water (photo 14).
- 18. Site of Spill Report 2017-320 (photo 15).
- 19. Site of Spill Report 2017-320 – sign of grey water. No samples taken.
- 20. A few spill reports should have been submitted for the leak on Fuel cache 3, the discharge of berm water due to disconnected carbon filter, and sheening next to the helicopter refuelling cache(photos 5, 7, 23).

Description: fuel cache in secondary containment. Carbon filter “rain drain” sprung a leak at the connection point.

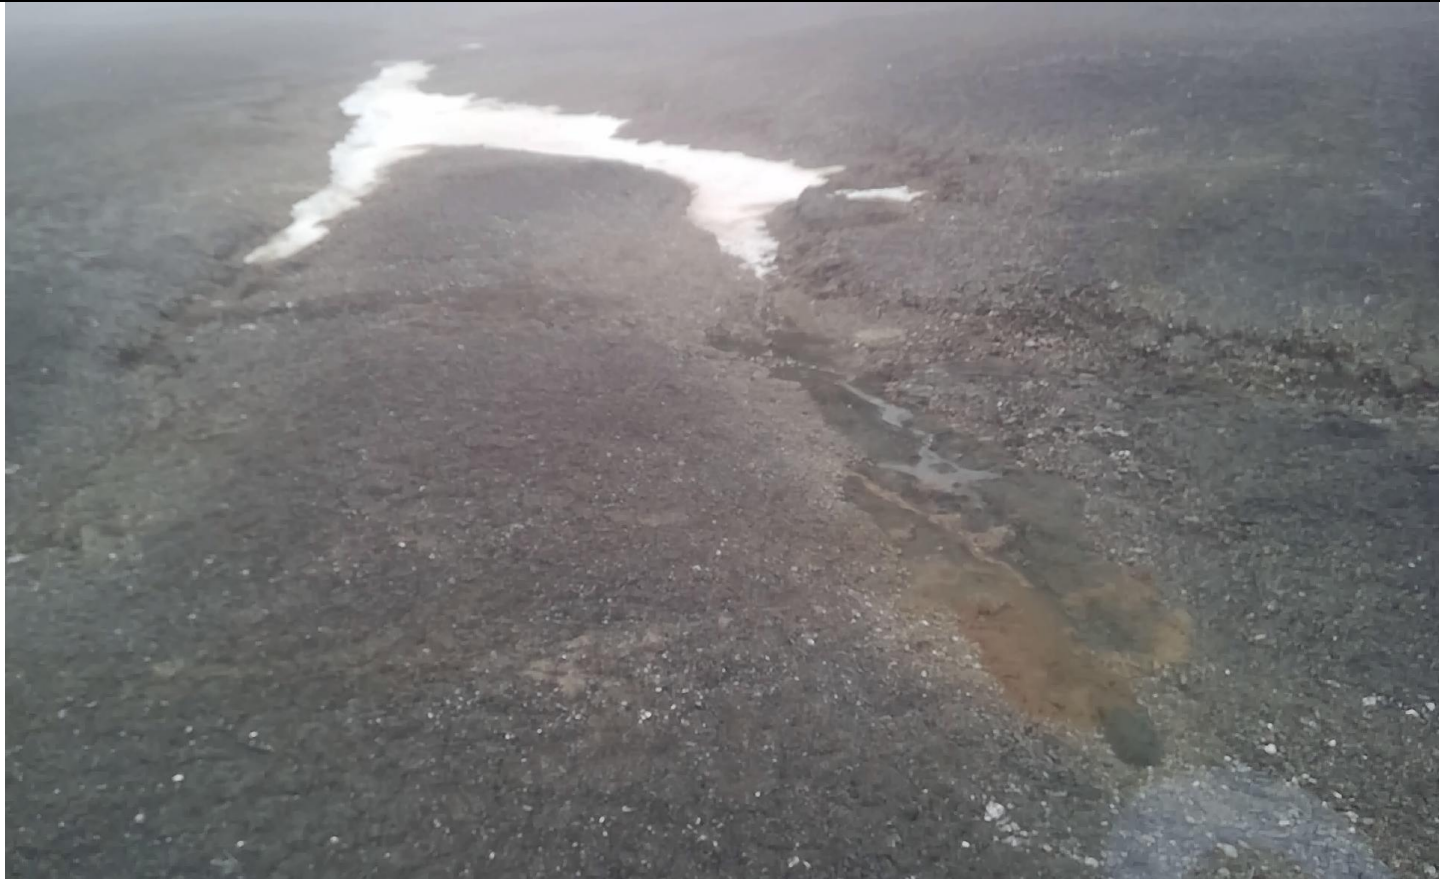
Photo 24

Description: CH-07 Tailings

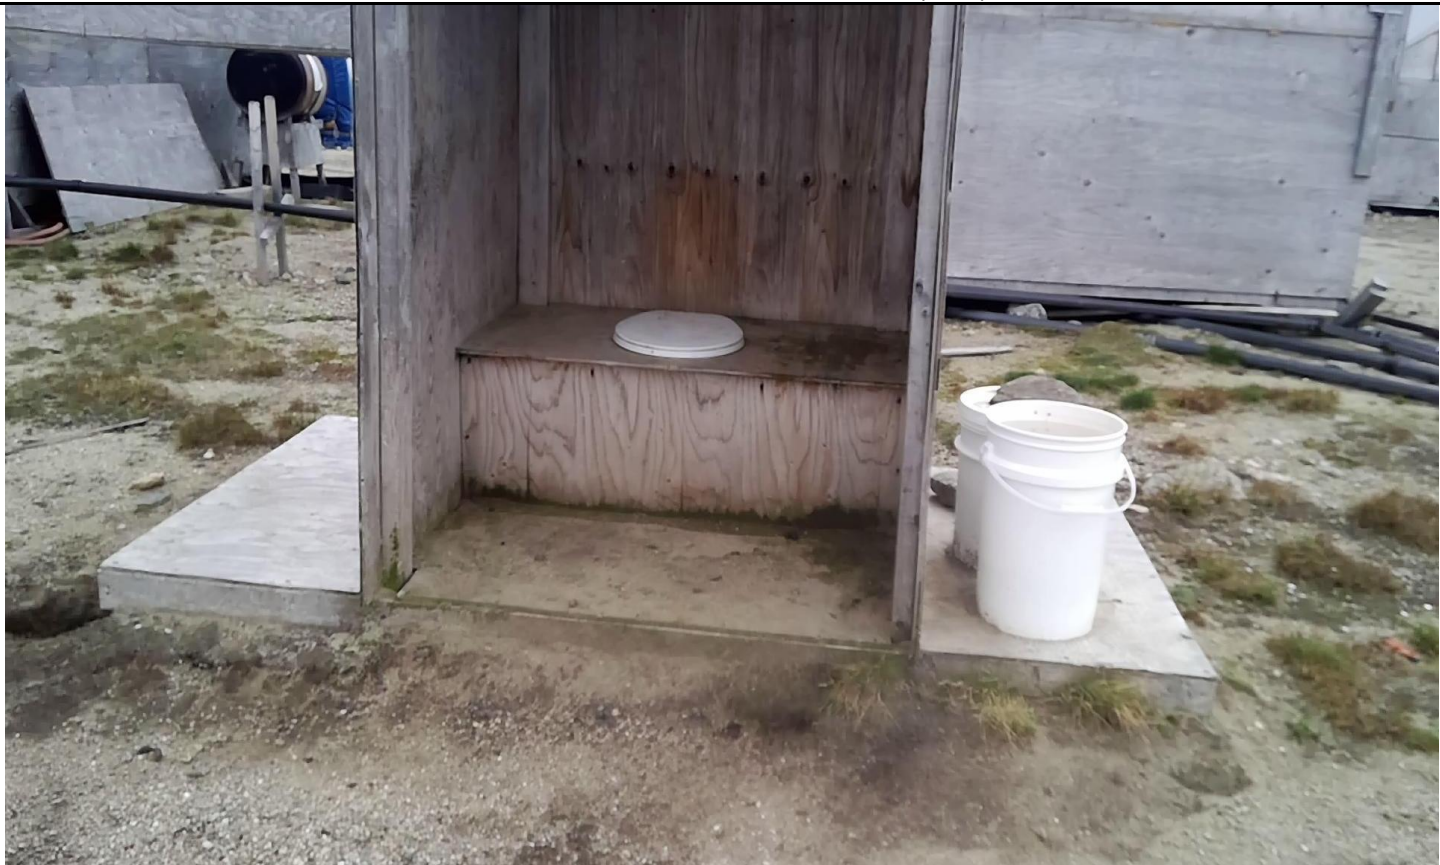
Photo 27

Description: Latrine for brown water waste
