09 August 2012

## **REPORT ON A SPILL INCIDENT AT DISCOVERY CAMP AIRSTRIP APRON, CHIDLIAK PROJECT: DISCOVERED AND CLEANED UP BETWEEN 01 AND 04 AUGUST 2012**

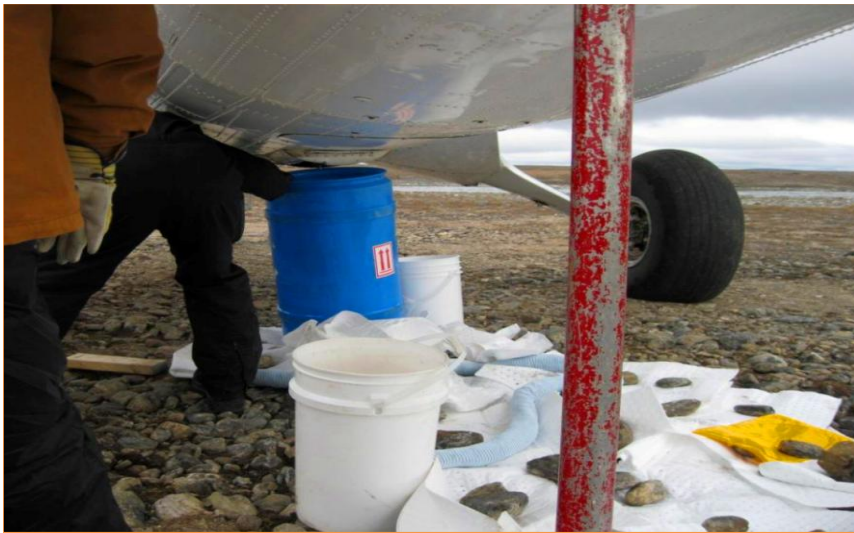
Left: Spill-kit drum, pails captured 25L immediately.  
Above: Spill pads on fuel trail.

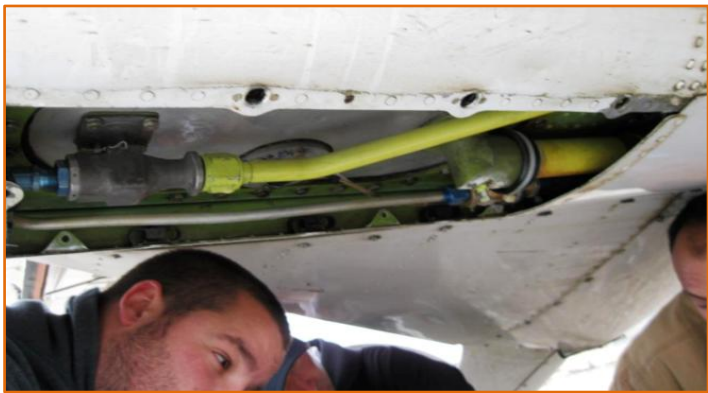
Above: Heli engineers had a bolt that fit the drain.  
Right: Long view of fuel trail on apron.

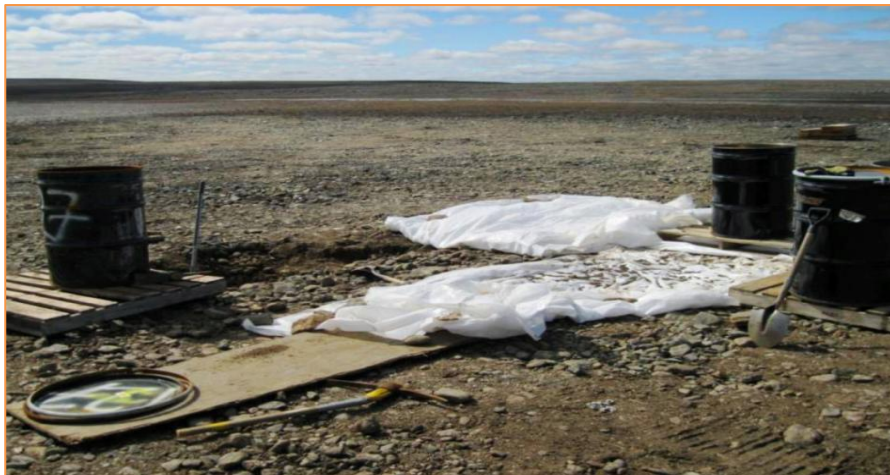
Far left: Rocks and cobbles were shovelled onto tarps and then into drums.  
Left: Typical drum of material retrieved.

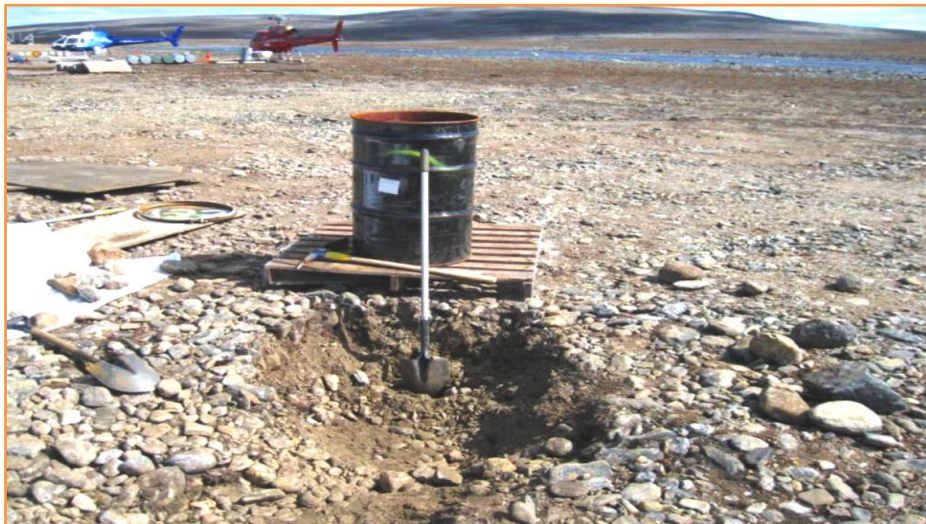
Above: Cobbles, rocks and gravelly, silty soil was shovelled out and placed in containers. Right: Peregrine staff backfilled area with clean native material from the apron area.

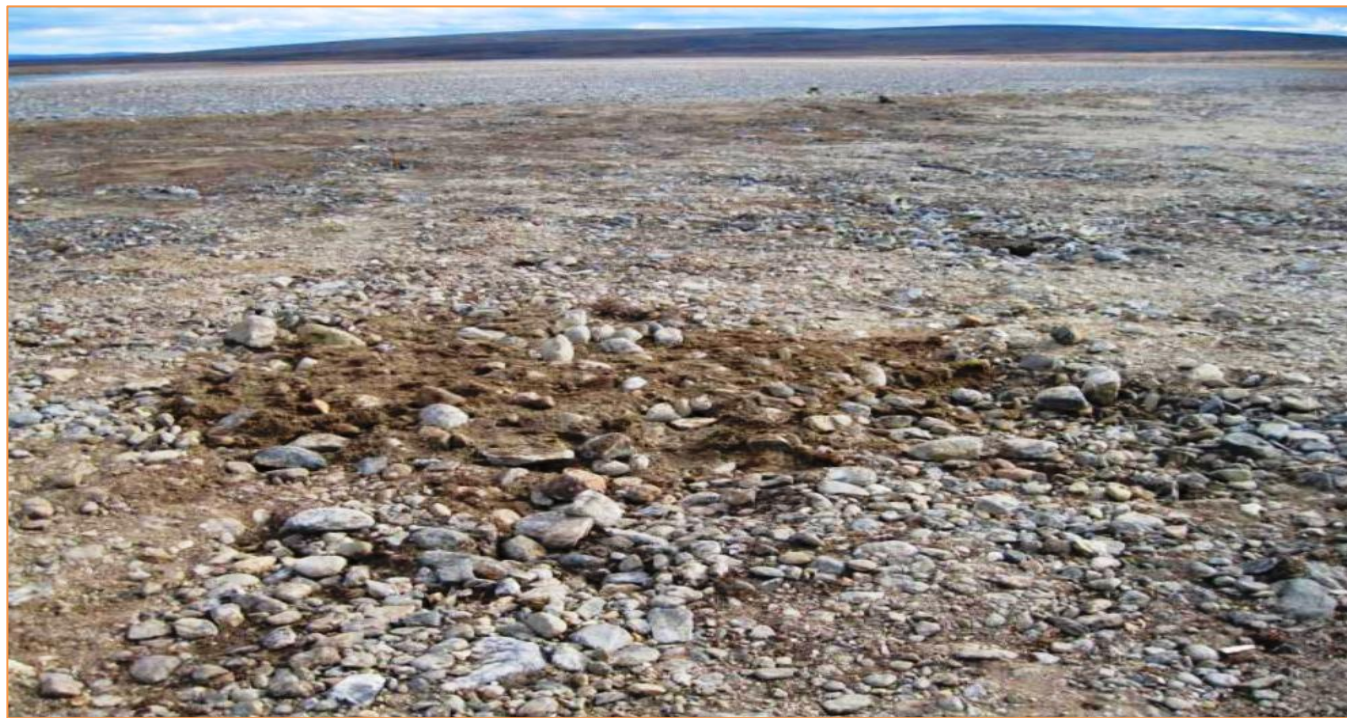
Left: View of main spill area after backfill with clean native material. (Completion date of cleanup: 04 August 2012.)
