09 August 2012

REPORT ON A SPILL INCIDENT AT DISCOVERY CAMP AIRSTRIP APRON, CHIDLIAK PROJECT: DISCOVERED AND CLEANED UP BETWEEN 01 AND 04 AUGUST 2012

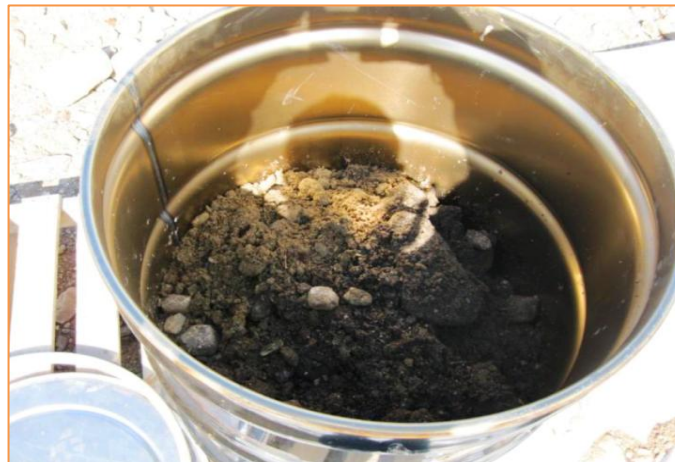
Far left: Rocks and cobbles were shovelled onto tarps and then into drums.
Left: Typical drum of material retrieved.

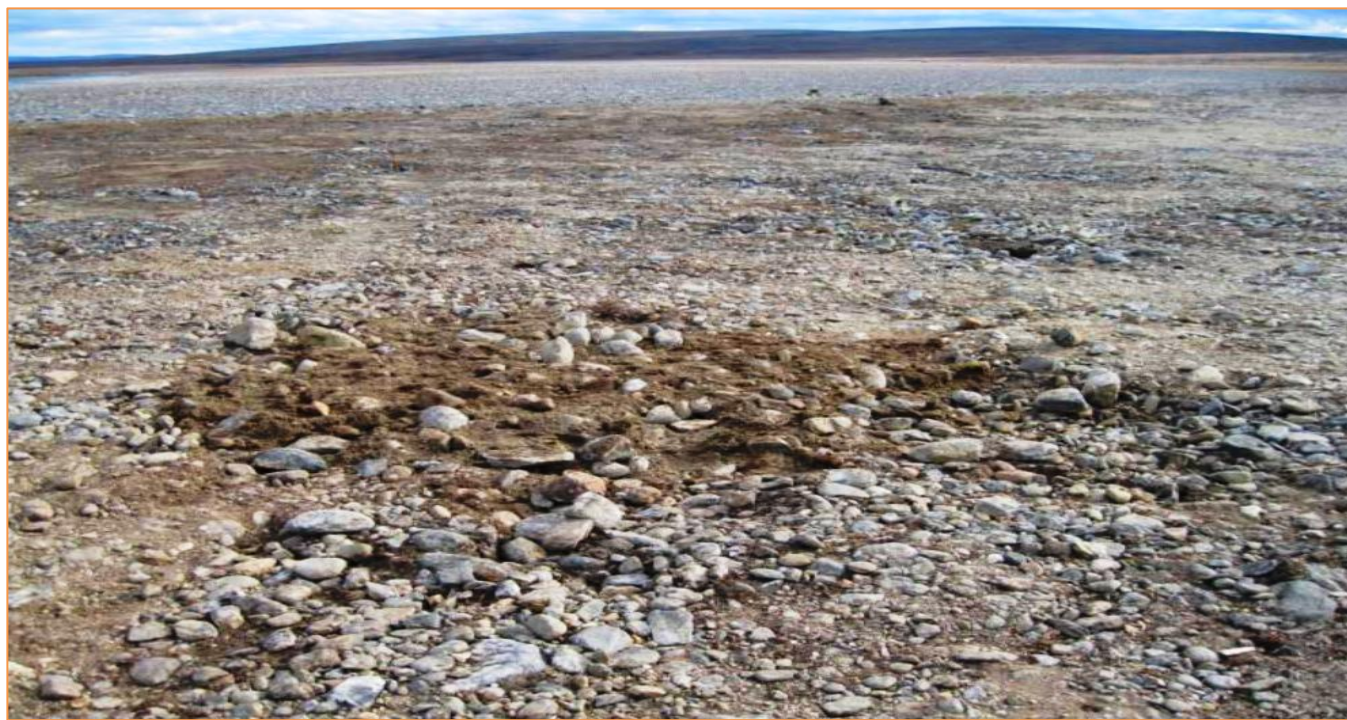
Left: View of main spill area after backfill with clean native material. (Completion date of cleanup: 04 August 2012.)
