# Water Licence Inspection Report

<b>Authorization</b>	<b>Representative</b>
<b>2BE-CHI2333</b>	<b>David Willis</b>
<b>Authorization No. / Expiry</b>	<b>Representative's Title</b>
<b>May 2033</b>	<b>Environmental and Community Coordinator</b>
<b>Other Authorization/s</b>	
<b>Activities Inspected</b>	
<input checked="" type="checkbox"/> Camp <input type="checkbox"/> Drilling <input type="checkbox"/> Mining <input type="checkbox"/> Construction <input type="checkbox"/> Reclamation <input type="checkbox"/> Fuel Storage <input type="checkbox"/> Roads/Hauling <input type="checkbox"/> Winter Hauling <input type="checkbox"/> Camp, Private <input checked="" type="checkbox"/> Other (Drill site, unmanned)

On June 17, 2023 I, Isaiah James Bolt, Inspector with the Crown Indigenous Relations and Northern Affairs Canada, (CIRNAC and for the purpose of this report hereafter referred as the “ Inspector”), Along with Fellow Inspector Joseph Monteith of CIRNAC, conducted an on site inspection of **2BE-CHI2333’s** Discovery Camp and CH-06 drill site to verify compliance of the conditions of their water license.

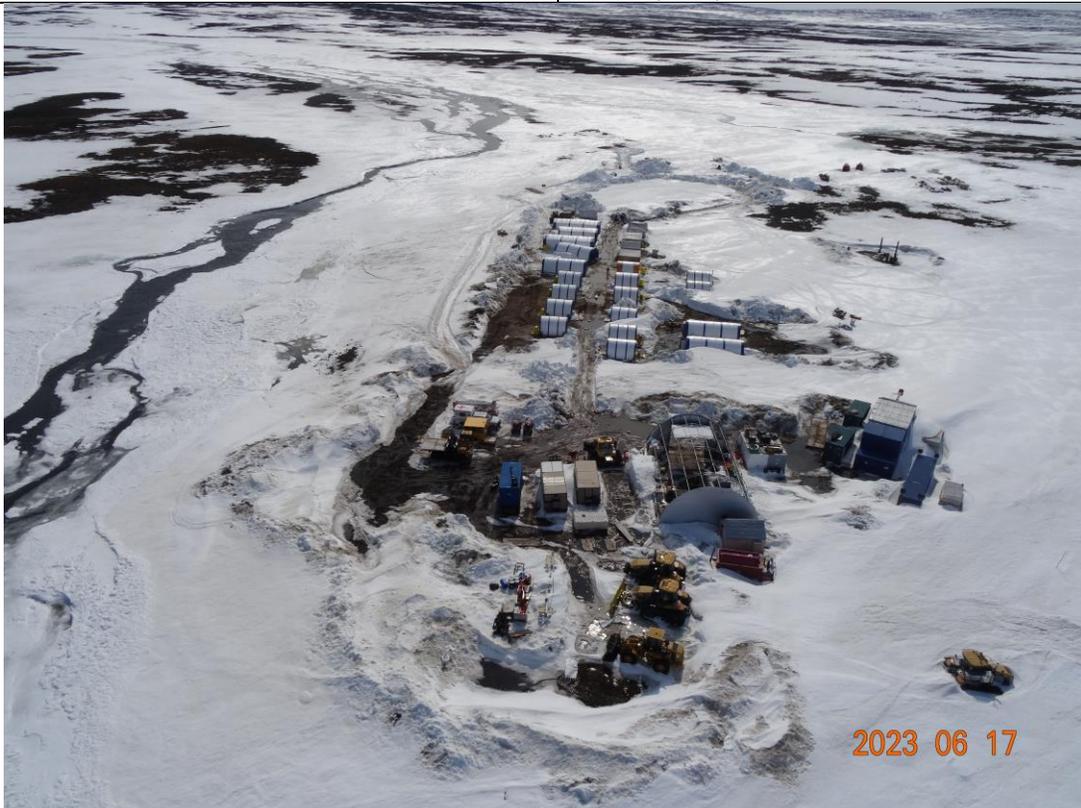
Date:	Authorization Number:	Camera/Model:	Inspector
Monday, April 17, 2023	2BE-CHI2333	Sony Cyber Shot, DSCHX50V	Isaiah James Bolt
Photo No.	Location		
Photo #1	Discovery Camp

1. Aerial Photo taken (Photo #1) showing camp foot print, snow cover hides a lot of equipment and fuel.
2. Monteith and Bolt arrive at the kitchen to have a meeting with David Willis to discuss water usage, updates and other information relevant to the inspection.

**Description:**  
Aerial Photo shows most of discovery Camp, some equipment, berms and fuel were hidden under the snow.

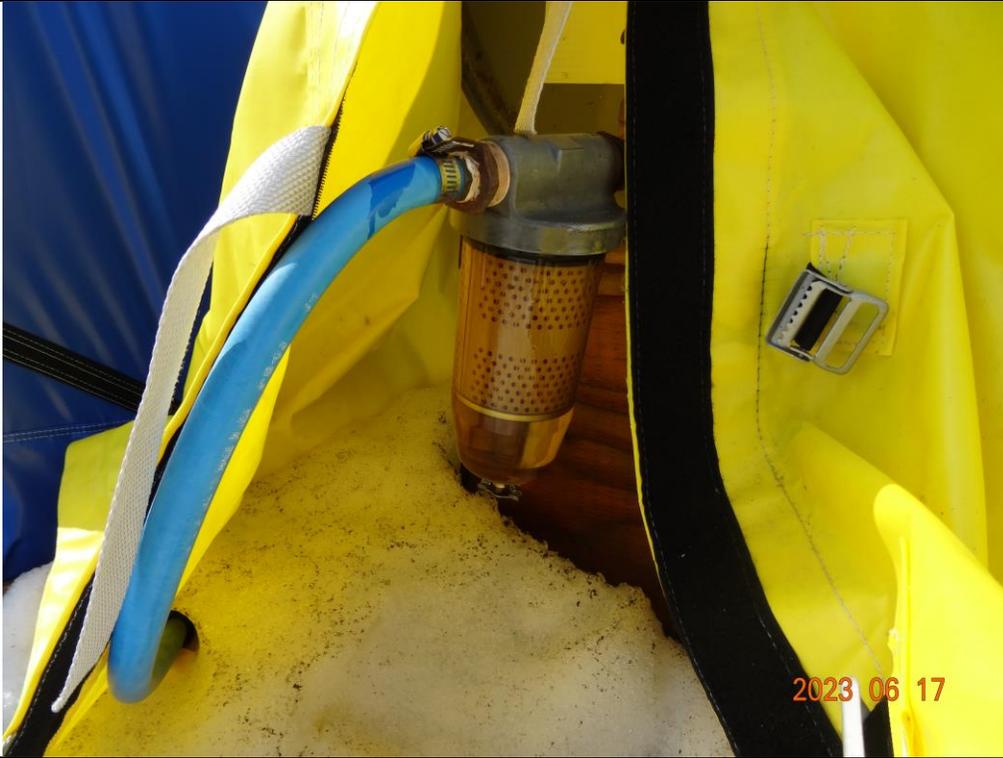
Photo No.  
Photo #2

3. Upon arrival to the kitchen tent, David Willis showed Inspector Bolt an example stand and secondary containment that holds and contains the fuel for the tent heaters.(Photo #2) Immediately, Inspector Bolt noticed a drip of clear liquid come from the fuel water separator. Upon inspection of the filter, Monteith, Bolt and Willis all witnessed more drips and found an active leak of diesel fuel. The fuel drips were contained to the yellow secondary containment that the fuel barrel was standing in, but the secondary containment was full of snow and water. David Willis mentioned he will write up a spill report for that incident, and quickly, one of the other employees had began tightening the fittings, which stopped the leak.

-Active Diesel fuel leak found outside kitchen, David Willis had already submitted the spill report. (*spill – 2023278*, NT/NU Spills database)

1. An active Leak was observed on site. David Willis mentioned he was going to write a spill report for the leaking diesel. A spill was submitted. (*Spill – 2023278*)
2. Standing water and snow inside secondary containment outside accommodations shall be tested for hydrocarbons.
3. Fuel hoses are deteriorating on the outer rubber. (old age, dried from the sun)
4. CH-06 Fuel berm has compromised walls, and therefor cannot contain any leaks or spills.

Photo Shows the fuel/water separator that had an active leak. drips were coming from the bottom of the cup. The barrel, barrel stand and secondary containment were all covered with this yellow cover. Snow had accumulated in the secondary containment under the cover.

1. No Actions required for non-compliance issue #1., David Willis had submitted the spill to the spill Line.
  2. All accumulated snow/water in each secondary containment, shall be tested for hydrocarbons.
  3. Change cracking and deteriorating fuel hoses that could cause leaks, spills.
  4. Install a new fuel storage berm at CH-06 Drill site.
- Please respond to the above stated actions required and send proof of compliance to CIRNAC Fields Operations by September 22, 2023.

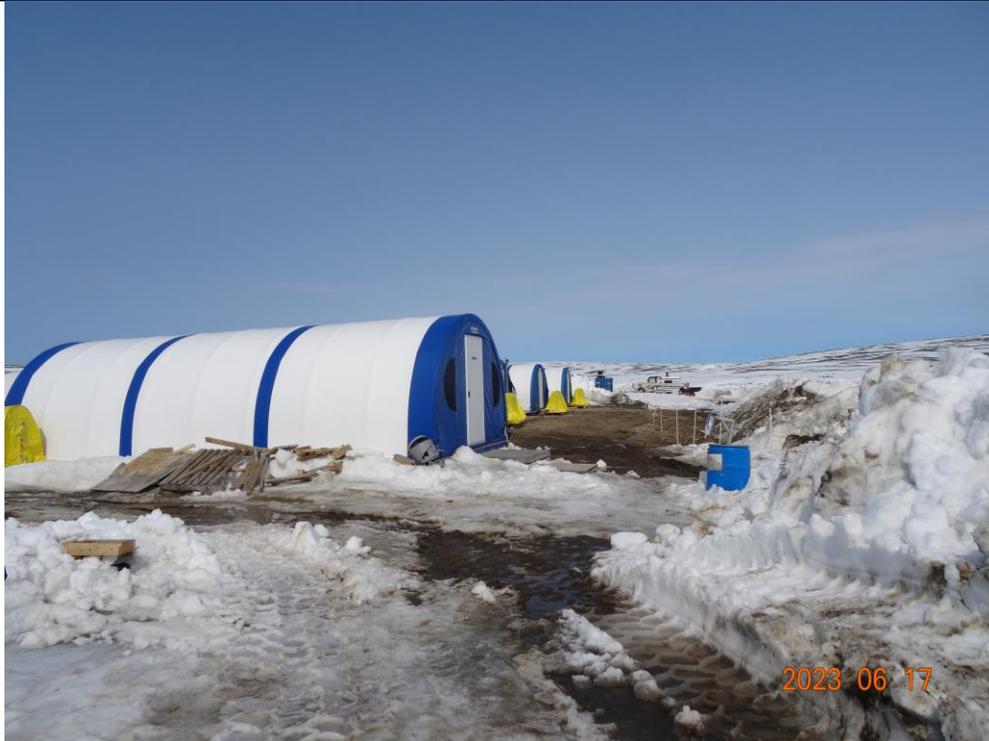
Photo No.  
Photo #3

4. The amount of snow on site made it difficult to see any staining and leaks on the ground. (Photo #3)
5. All of the weather-haven accommodations had a barrel of fuel outside them, each barrel had a stand inside secondary containment and a rain cover to prevent rain getting into the containment, Although, they had accumulated snow over the winter, and many of them had standing water inside the secondary containment. (Photo #4)

This photo shows the East side of the main accomodations (closest to creek), and the amount of snow still present during inspection.

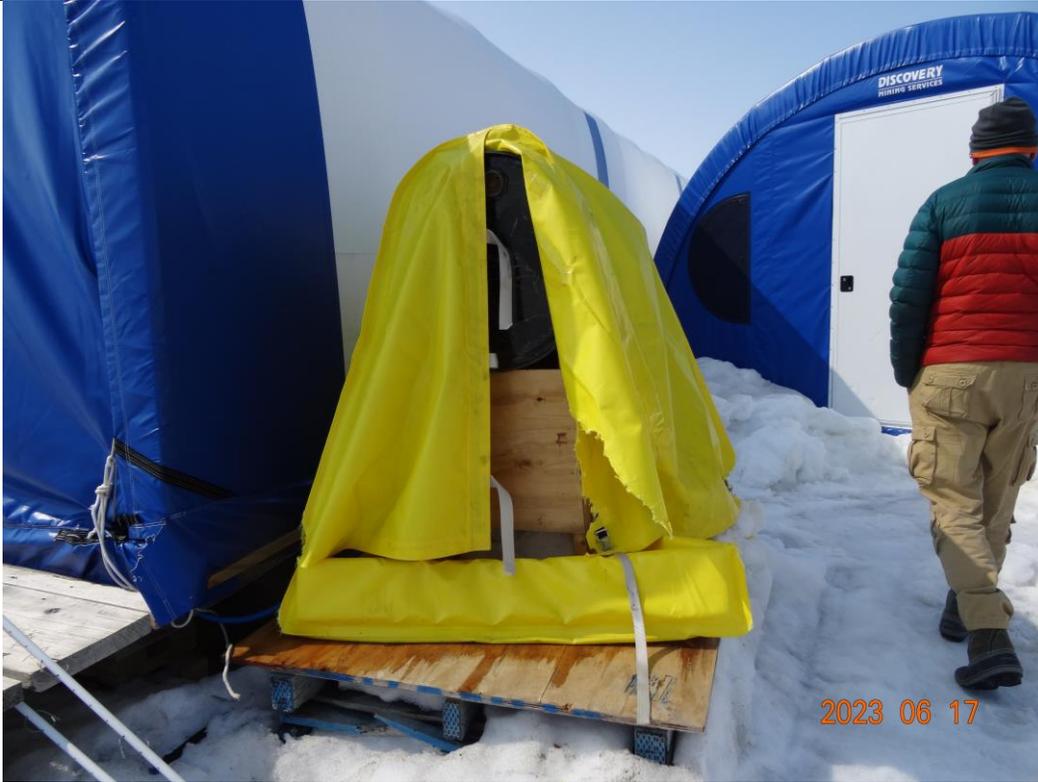
Photo #4

Photo of the fuel barrel, secondary containment, cover, and fuel stand.

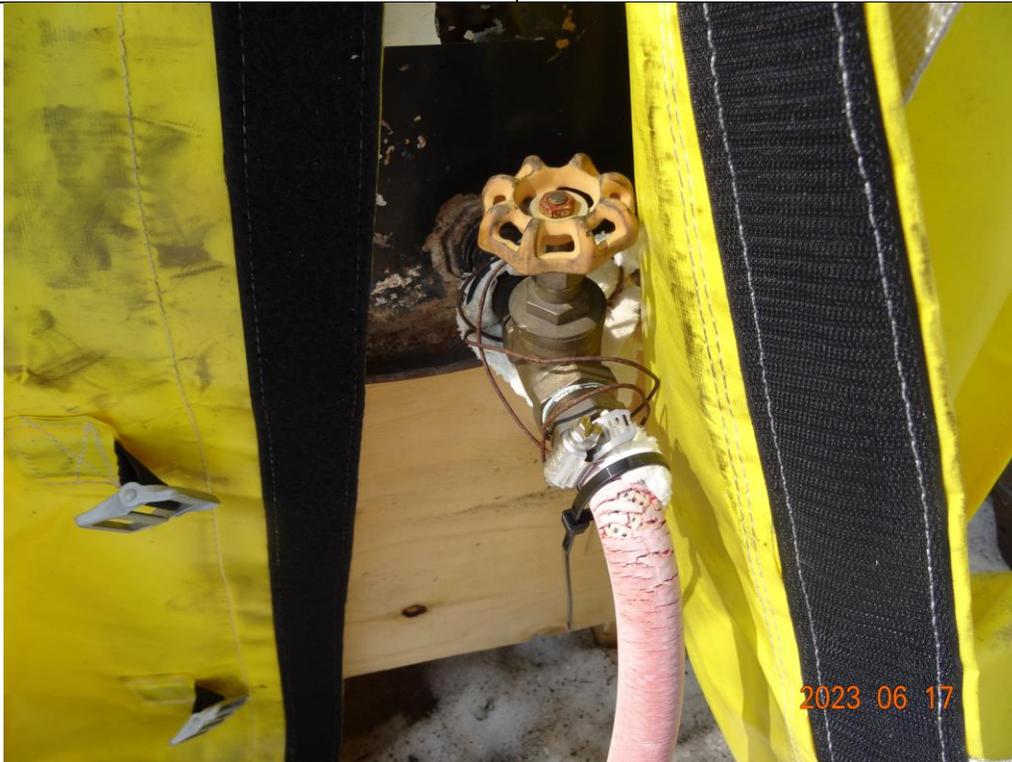
Photo #5

6. The hoses that connect the fuel barrels outside, to the heaters inside the accommodations are beginning to deteriorate. (see photo #5) Bolt noted there are lots of spill kits present on site, but still suggested hoses be replaced.

Photo shows a dried out fuel hose with cracks on the outer rubber.

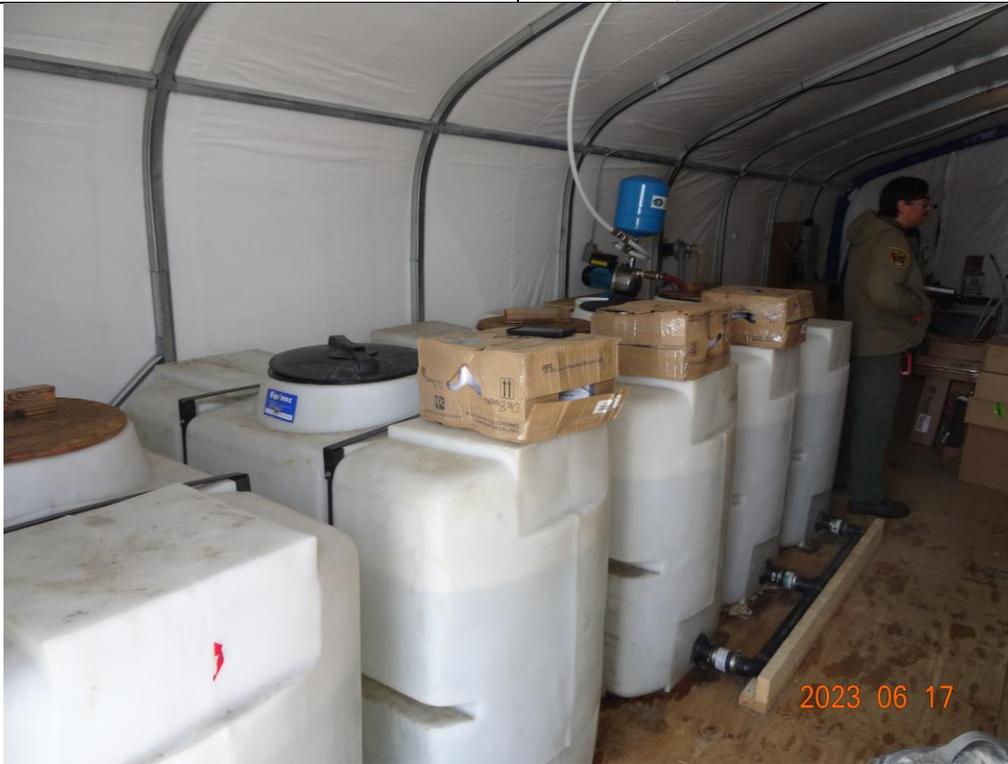
Photo No.  
Photo #6

7. Inside the water treatment tent: there are 5, 325 Gallon water tanks (Photo #6)
8. Water is pumped through filters and then a UV light for treatment. Water is then run to a hot water heater if necessary for laundry or showers. (Photo #7)

**Description:**  
This photo shows the 5 water storage tanks (325 Gallon water tanks)

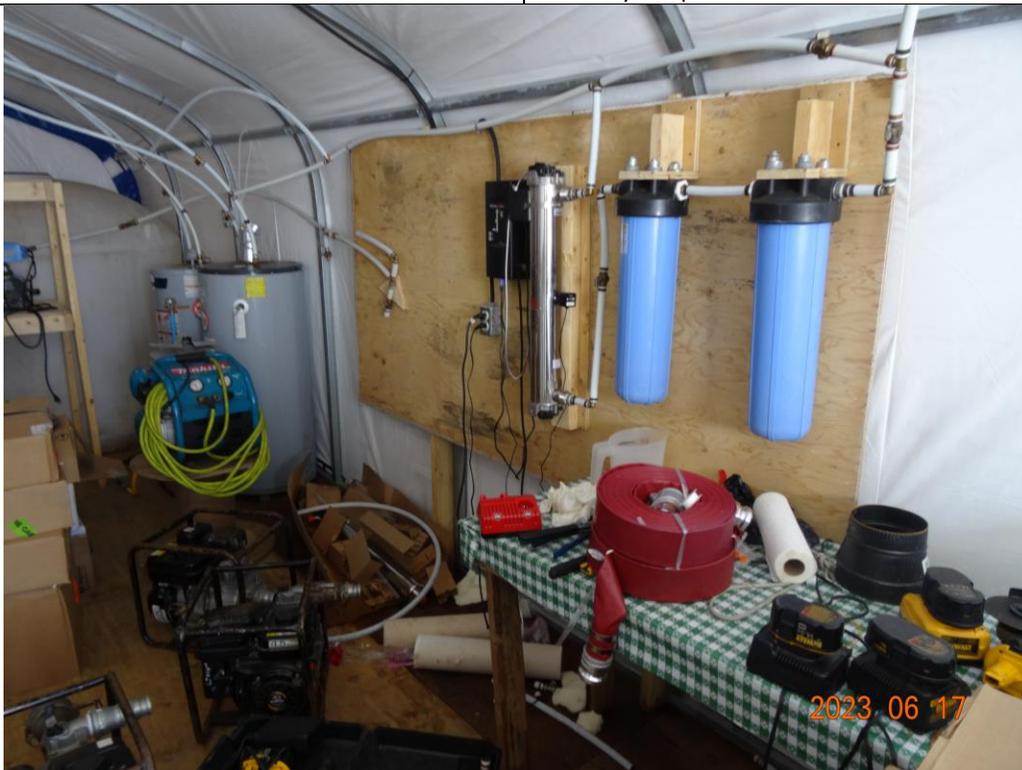
Photo No.  
Photo #7

**Description:**  
This photo shows the water treatment system, water flows from the hose on the top right of the pictures, and makes its way to the heaters.

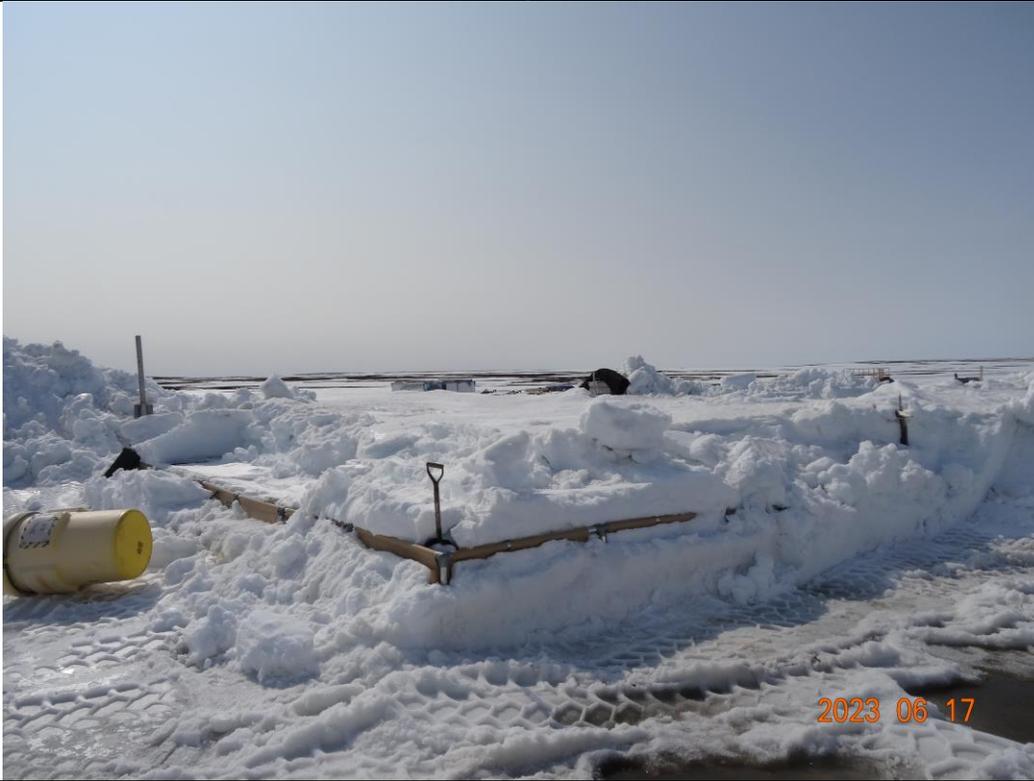
Photo No.	Location
Photo #8	Discovery Camp

9. The laundry room has 2 washers, 2 dryers, 5 showers and 2 large sinks.
10. Fuel storage area was full of snow. Many of the fuel berms were buried and unable to be inspected. Much of the fuel we did observe on site were secondary contained. (Photo #8)

Photo shows fuel cache buried in snow.

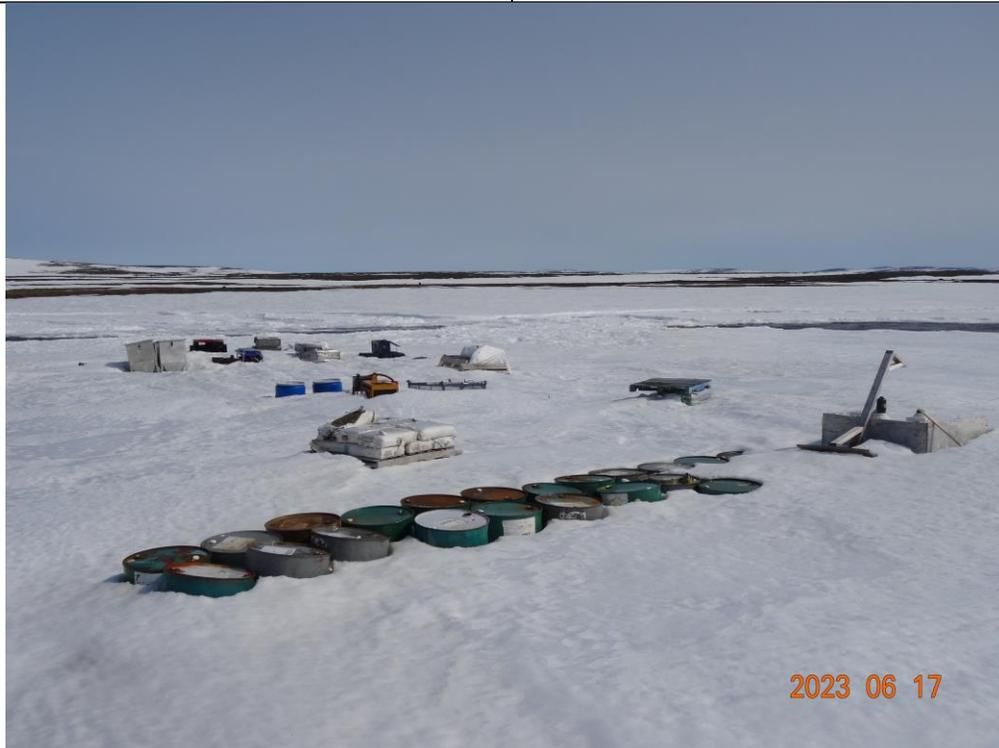
Photo No.	Location
Photo #9	Discovery Camp

11. Further south from the fuel storage is more equipment, most of it was buried, only the tops were visible. No concerns were noted. (photo #9)

Further south from the fuel berms, more equipment and empty barrels buried in snow.

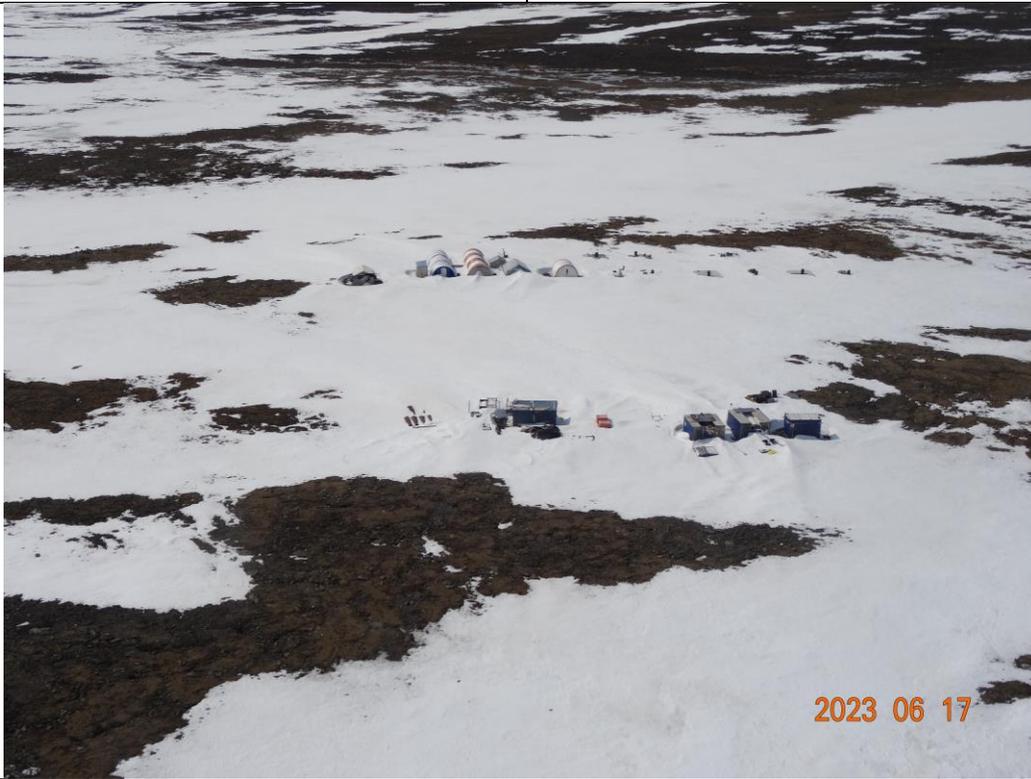
Photo No.  
Photo #10

Description:  
Aerial photo of CH-06 and Drills

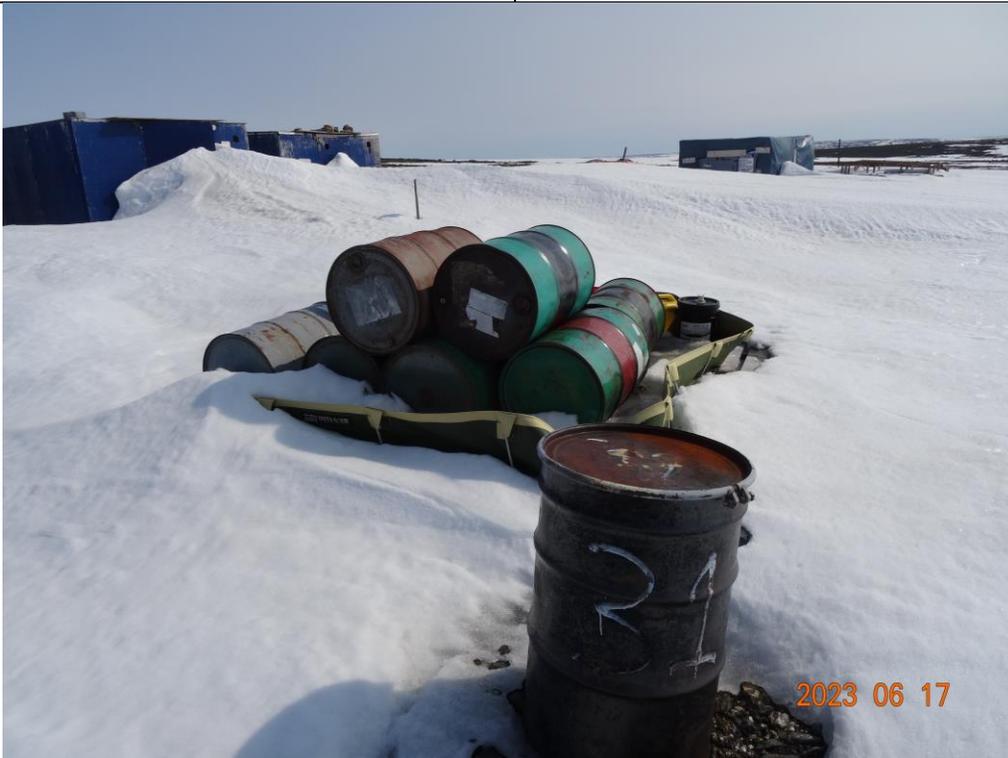
Photo No.  
Photo #11

12. When we arrived at the drill site an aerial Photo of CH-06 was taken. (Photo #10)
13. CH-06 Fuel cache, 9 barrel of fuel stored in a mobile containment berm. Snow and Ice were present in the berm. The walls of the berm were collapsed and would not hold any fluids (Photo #11)
14. Inspector Monteith Noted Large batteries (like truck batteries) still present on a generator and still wired in. (photo #12)
15. 3 drills, 1 drill shack, 1 generator, 3 towing platforms, 3 weather havens, 4 wooden shacks, no open doors or animal attractants.
16. Tenting floor foundations on site, empty barrels on each floor mark the locations if they end up beneath snow cover. No Concerns (photo #13)
17. Spill kits were observed on site. (Photo #14 and #15)

Description:  
Photo Shows 9 barrels, 2 jerry cans, and various unlabelled containers stored in secondary containment, the berm is filled with snow and ice.

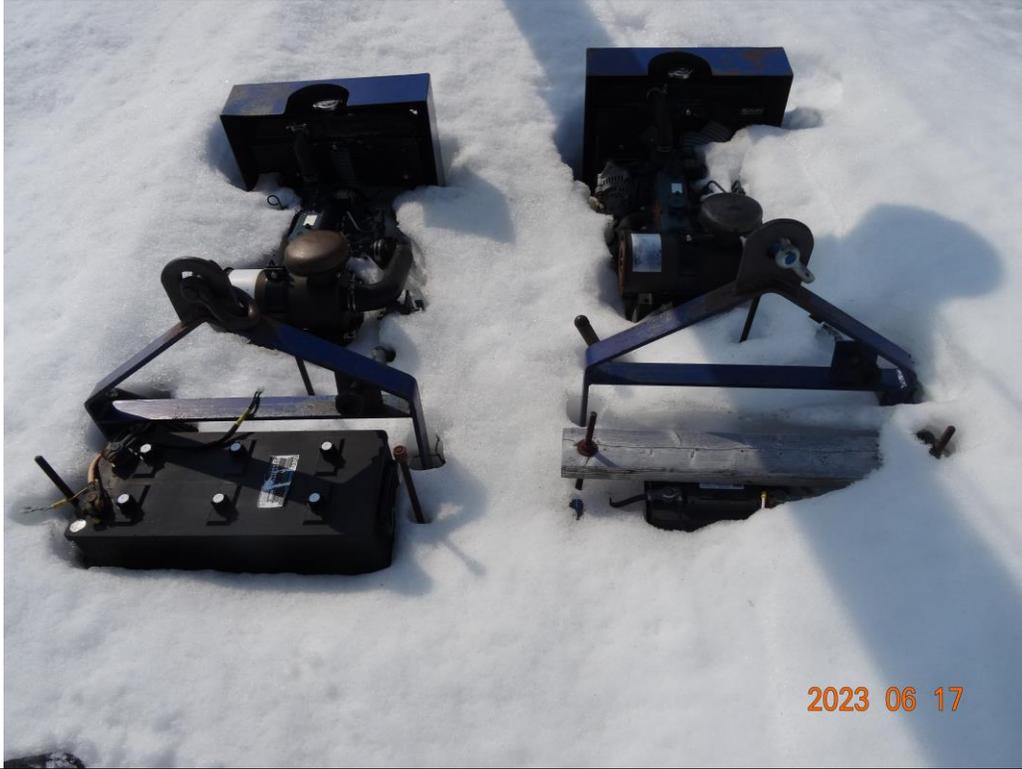
Photo No.  
Photo #12

Description:  
Photo of 2 batteries still hooked up to the equipment, and are exposed to the elements.

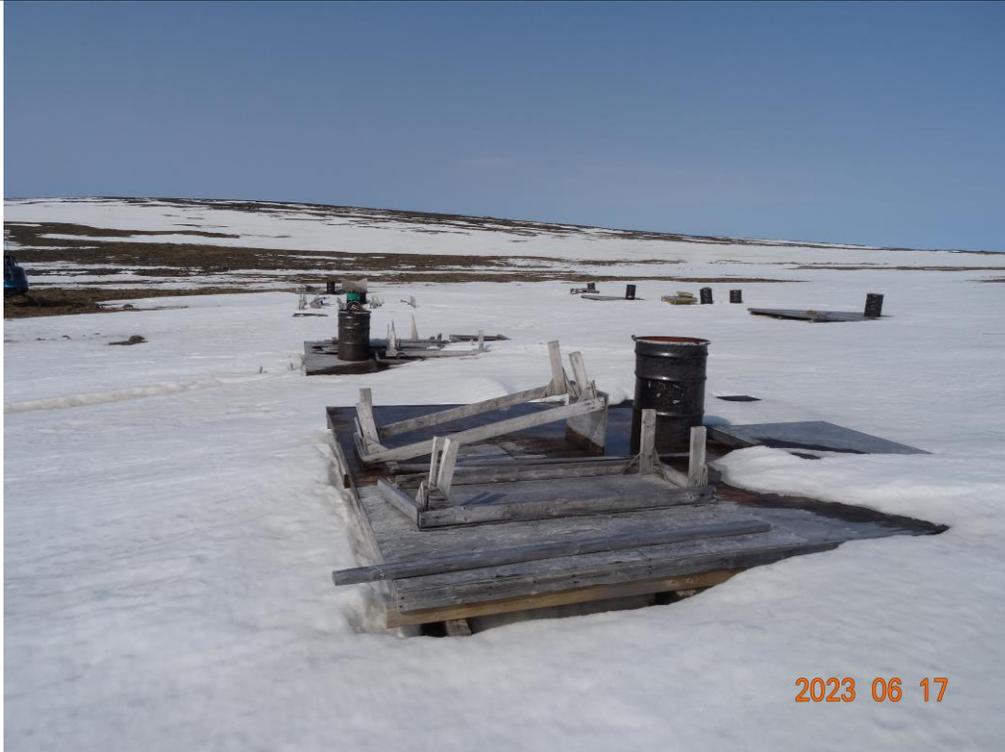
Photo No.  
Photo #13

Description:  
This image shows Tenting platforms, benches, and an empty barrel on each platform to mark their locations.

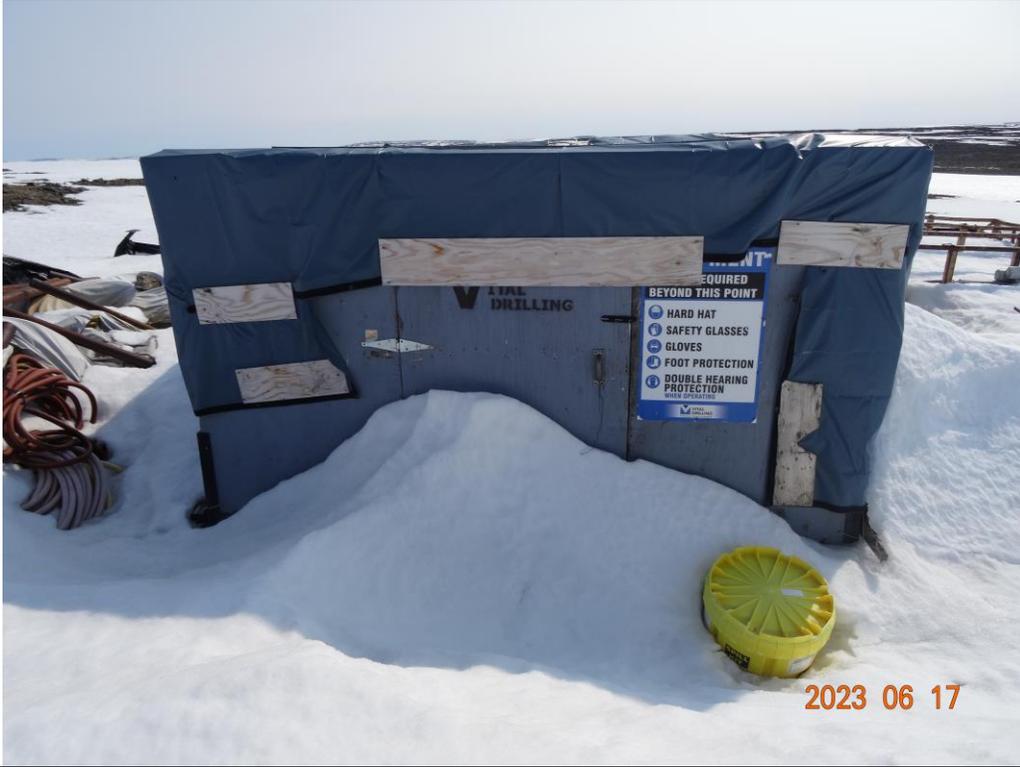
Photo No.  
Photo #14

Description:  
Photo shows one of the drills, with a spill kit present.

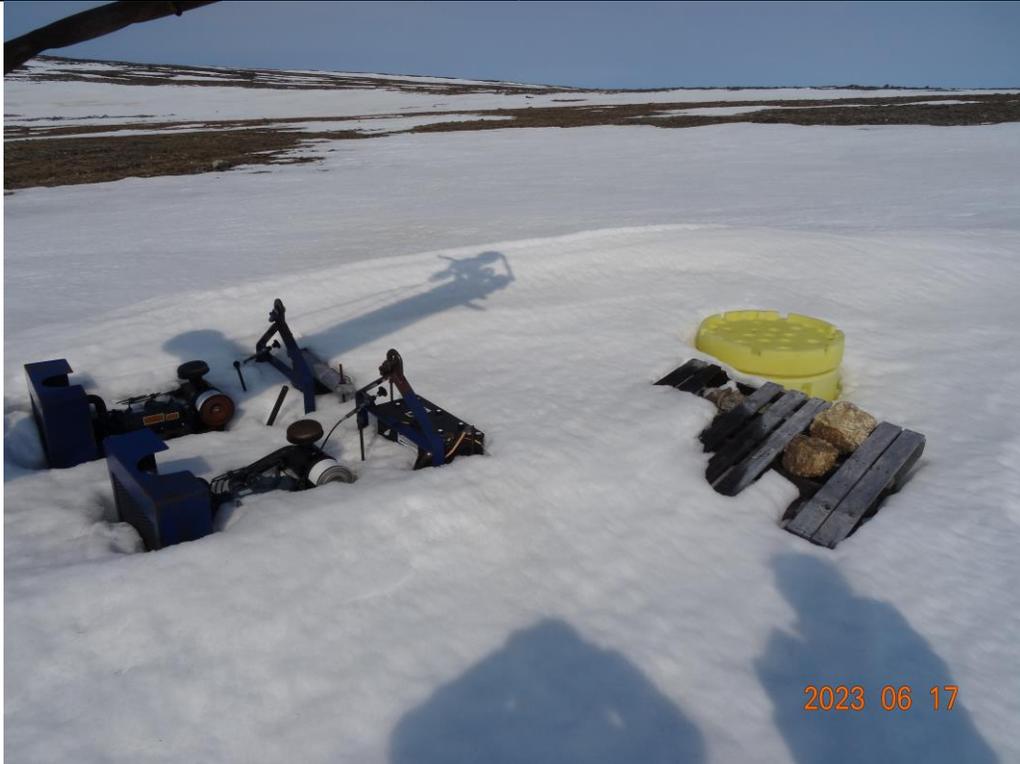
Photo No.  
Photo #15

Description:  
This Photo shows another spill kit at CH-06, in a different location than the one above.
