# Water Licence Inspection Report

On June 17, 2023 I, Isaiah James Bolt, Inspector with the Crown Indigenous Relations and Northern Affairs Canada, (CIRNAC and for the purpose of this report hereafter referred as the “ Inspector”), Along with Fellow Inspector Joseph Monteith of CIRNAC, conducted an on site inspection of **2BE-CHI2333’s** Discovery Camp and CH-06 drill site to verify compliance of the conditions of their water license.

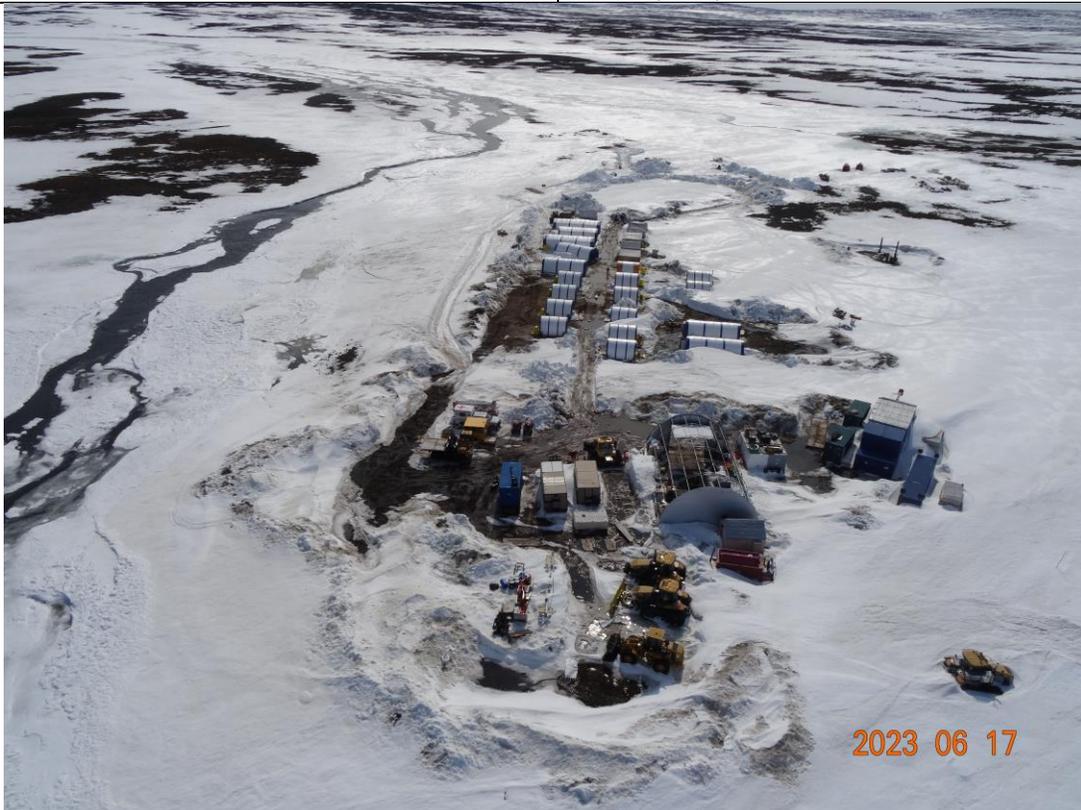
<b>Date:</b> Monday, April 17, 2023	<b>Authorization Number:</b> 2BE-CHI2333	<b>Camera/Model:</b> Sony Cyber Shot, DSCHX50V	<b>Inspector</b> Isaiah James Bolt
<b>Photo No.</b> Photo #1	<b>Location</b> Discovery Camp

1. Aerial Photo taken (Photo #1) showing camp foot print, snow cover hides a lot of equipment and fuel.
2. Monteith and Bolt arrive at the kitchen to have a meeting with David Willis to discuss water usage, updates and other information relevant to the inspection.

**Description:**  
Aerial Photo shows most of discovery Camp, some equipment, berms and fuel were hidden under the snow.

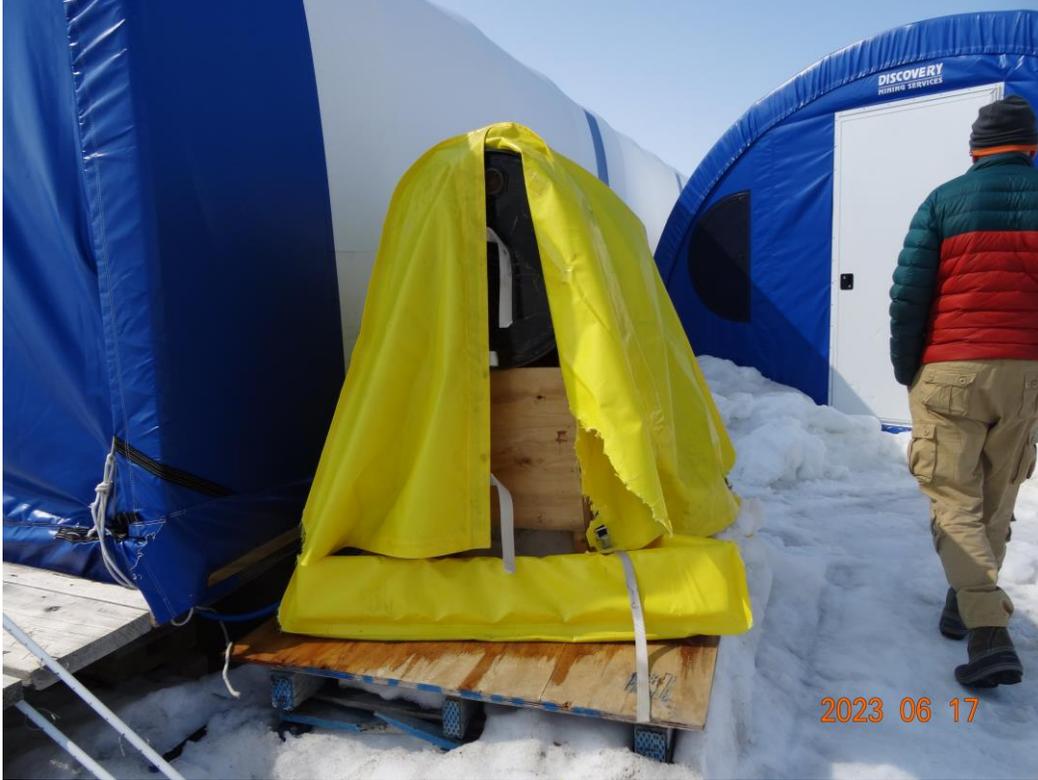
Photo #4

4. The amount of snow on site made it difficult to see any staining and leaks on the ground. (Photo #3)
5. All of the weather-haven accommodations had a barrel of fuel outside them, each barrel had a stand inside secondary containment and a rain cover to prevent rain getting into the containment, Although, they had accumulated snow over the winter, and many of them had standing water inside the secondary containment. (Photo #4)

Photo of the fuel barrel, secondary containment, cover, and fuel stand.

1. No Actions required for non-compliance issue #1., David Willis had submitted the spill to the spill Line.
  2. All accumulated snow/water in each secondary containment, shall be tested for hydrocarbons.
  3. Change cracking and deteriorating fuel hoses that could cause leaks, spills.
  4. Install a new fuel storage berm at CH-06 Drill site.
- Please respond to the above stated actions required and send proof of compliance to CIRNAC Fields Operations by September 22, 2023.

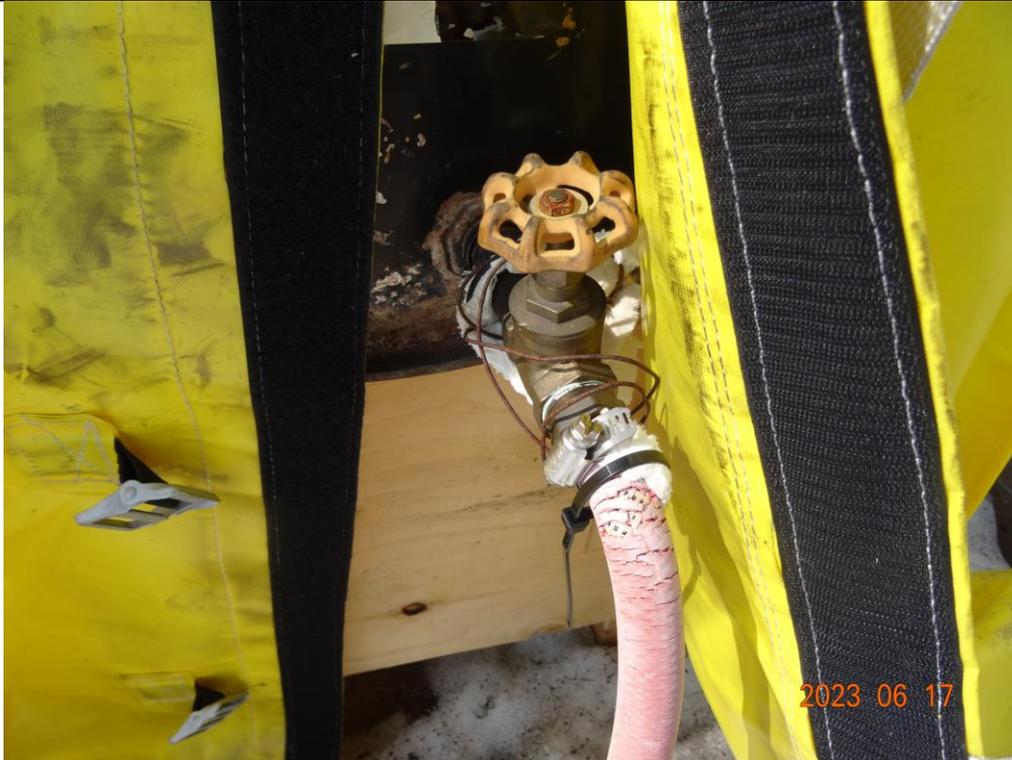
Photo #5

6. The hoses that connect the fuel barrels outside, to the heaters inside the accommodations are beginning to deteriorate. (see photo #5) Bolt noted there are lots of spill kits present on site, but still suggested hoses be replaced.

Photo shows a dried out fuel hose with cracks on the outer rubber.

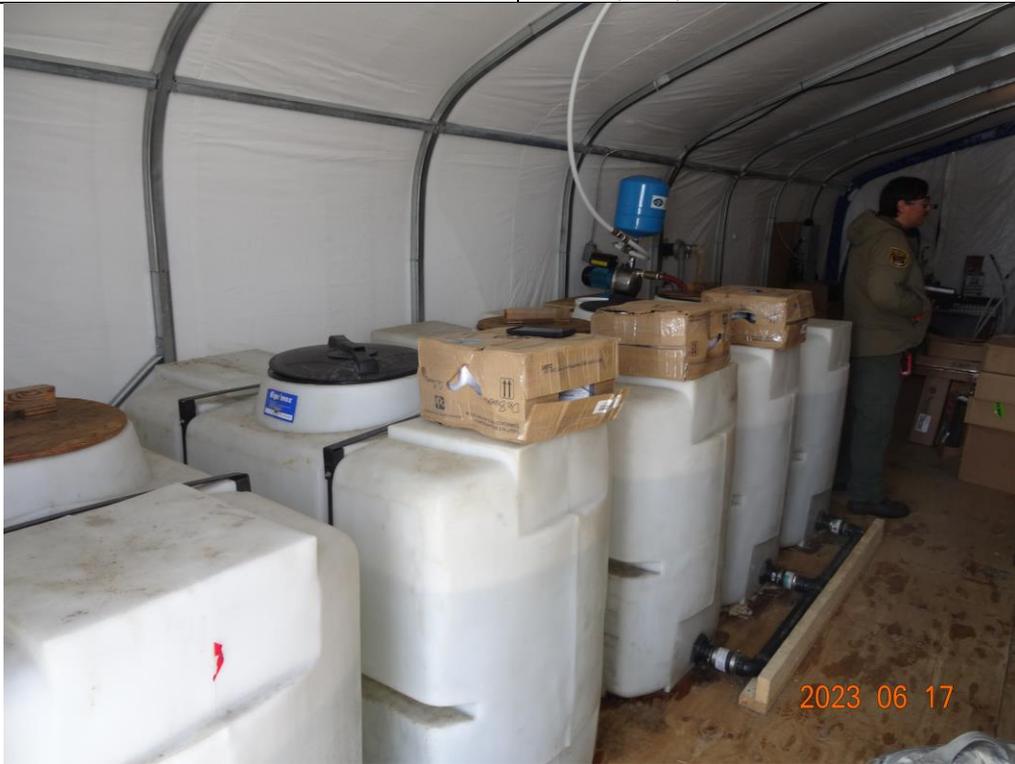
Photo No.  
Photo #6

Description:  
This photo shows the 5 water storage tanks (325 Gallon water tanks)

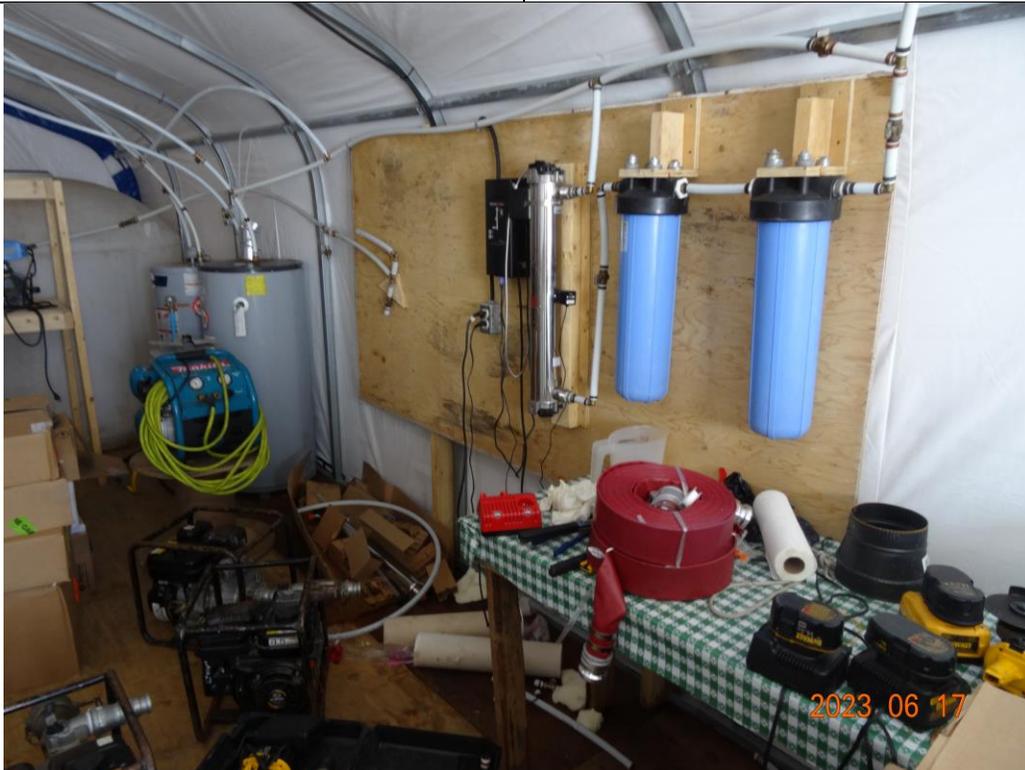
Photo No.  
Photo #7

Description:  
This photo shows the water treatment system, water flows from the hose on the top right of the pictures, and makes its way to the heaters.

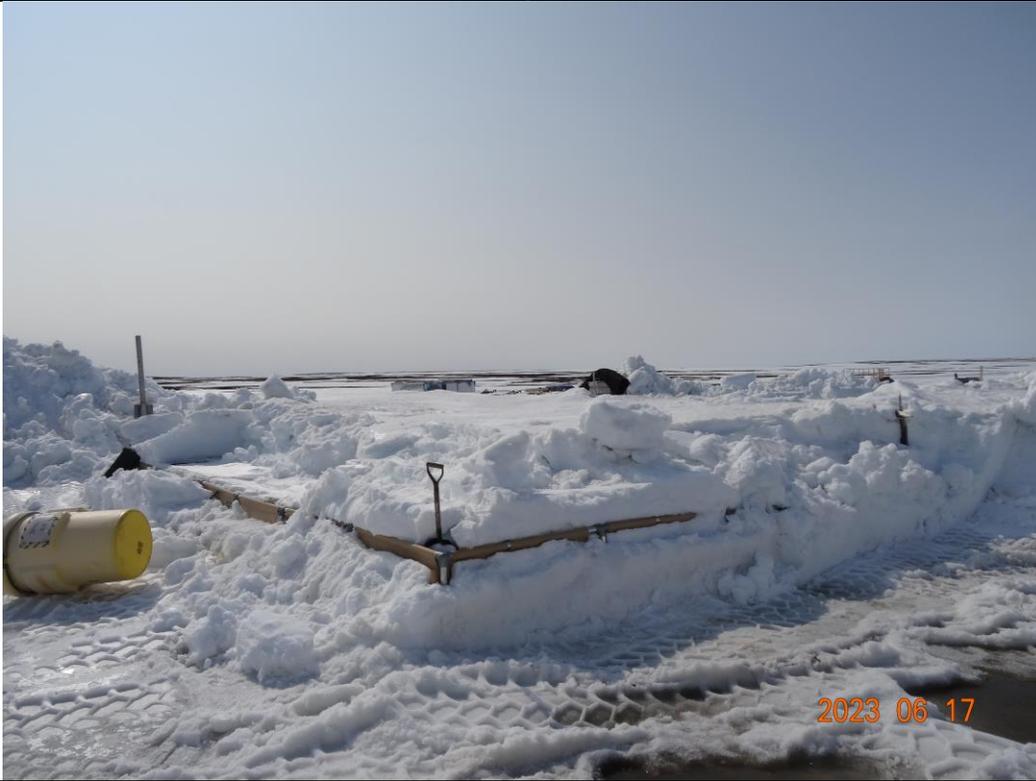
Photo No.	Location
Photo #8	Discovery Camp

9. The laundry room has 2 washers, 2 dryers, 5 showers and 2 large sinks.
10. Fuel storage area was full of snow. Many of the fuel berms were buried and unable to be inspected. Much of the fuel we did observe on site were secondary contained. (Photo #8)

Photo shows fuel cache buried in snow.

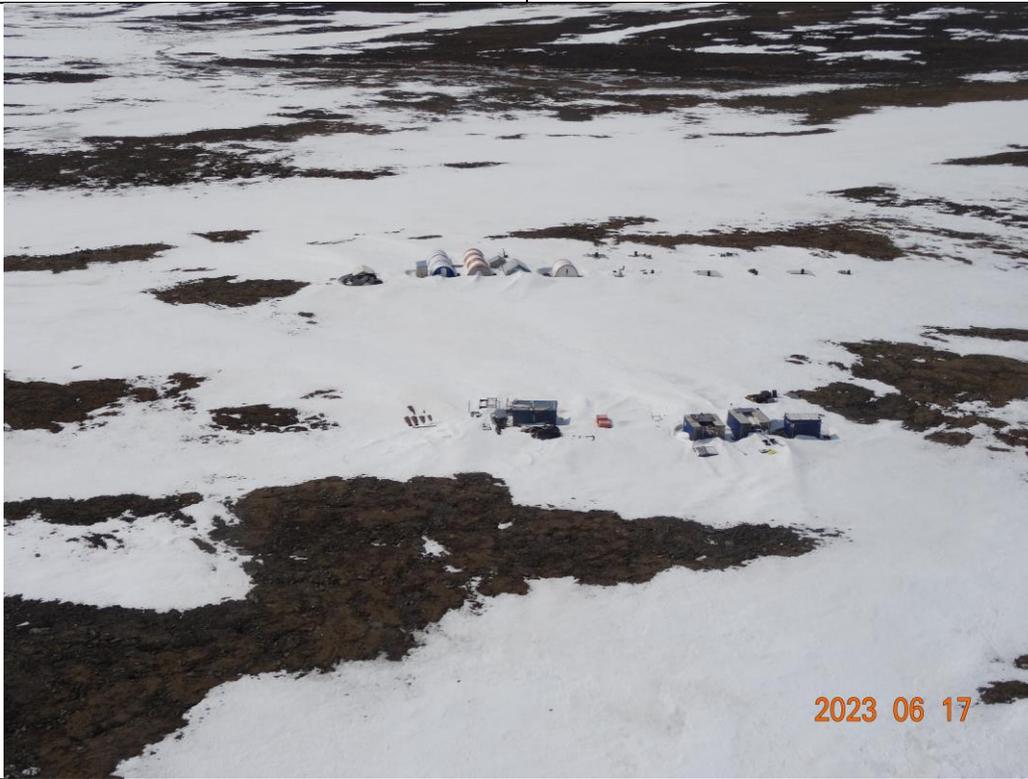
**Photo No.**  
Photo #10

**Description:**  
Aerial photo of CH-06 and Drills

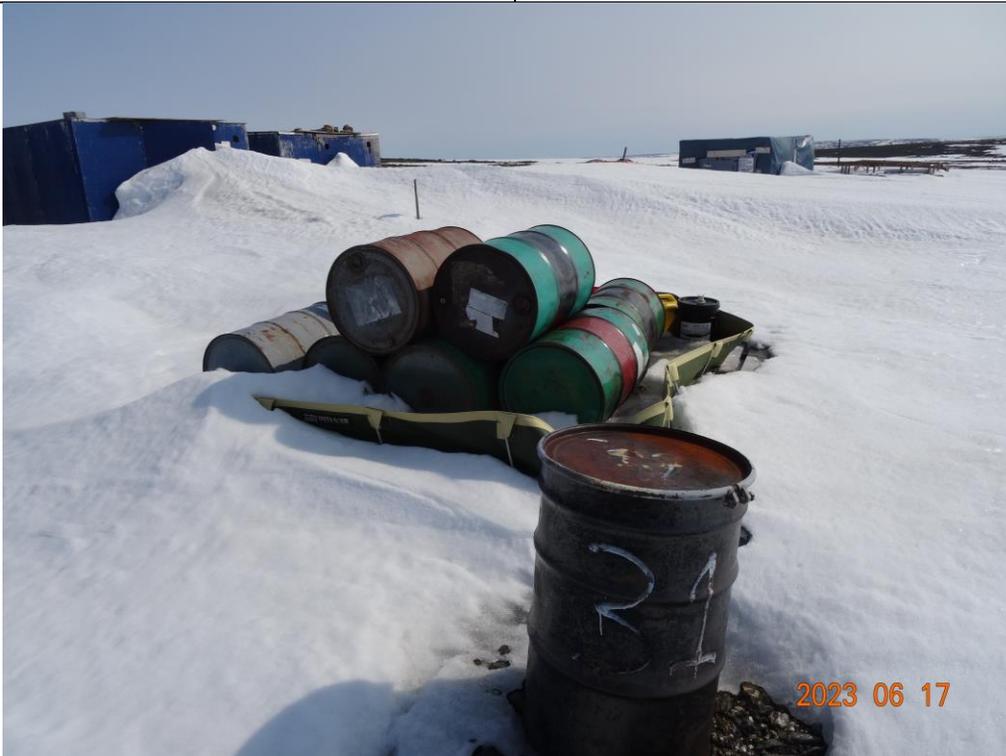
**Photo No.**  
Photo #11

12. When we arrived at the drill site an aerial Photo of CH-06 was taken. (Photo #10)
13. CH-06 Fuel cache, 9 barrel of fuel stored in a mobile containment berm. Snow and Ice were present in the berm. The walls of the berm were collapsed and would not hold any fluids (Photo #11)
14. Inspector Monteith Noted Large batteries (like truck batteries) still present on a generator and still wired in. (photo #12)
15. 3 drills, 1 drill shack, 1 generator, 3 towing platforms, 3 weather havens, 4 wooden shacks, no open doors or animal attractants.
16. Tenting floor foundations on site, empty barrels on each floor mark the locations if they end up beneath snow cover. No Concerns (photo #13)
17. Spill kits were observed on site. (Photo #14 and #15)

**Description:**  
Photo Shows 9 barrels, 2 jerry cans, and various unlabelled containers stored in secondary containment, the berm is filled with snow and ice.

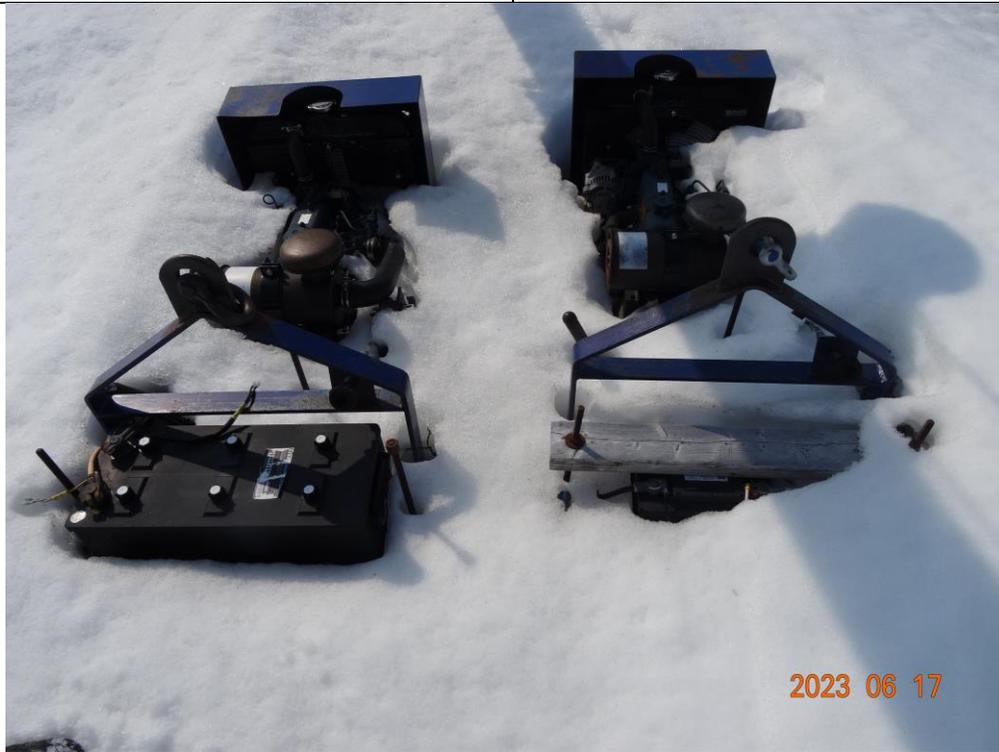
Photo No.  
Photo #12

**Description:**  
Photo of 2 batteries still hooked up to the equipment, and are exposed to the elements.

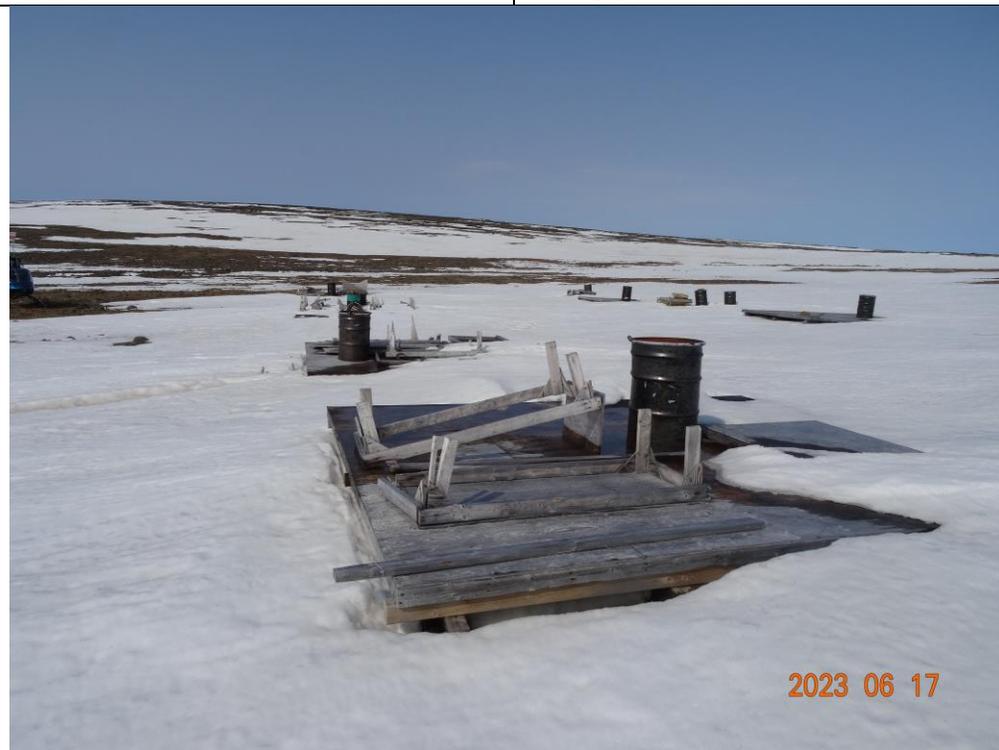
Photo No.  
Photo #13

**Description:**  
This image shows Tenting platforms, benches, and an empty barrel on each platform to mark their locations.

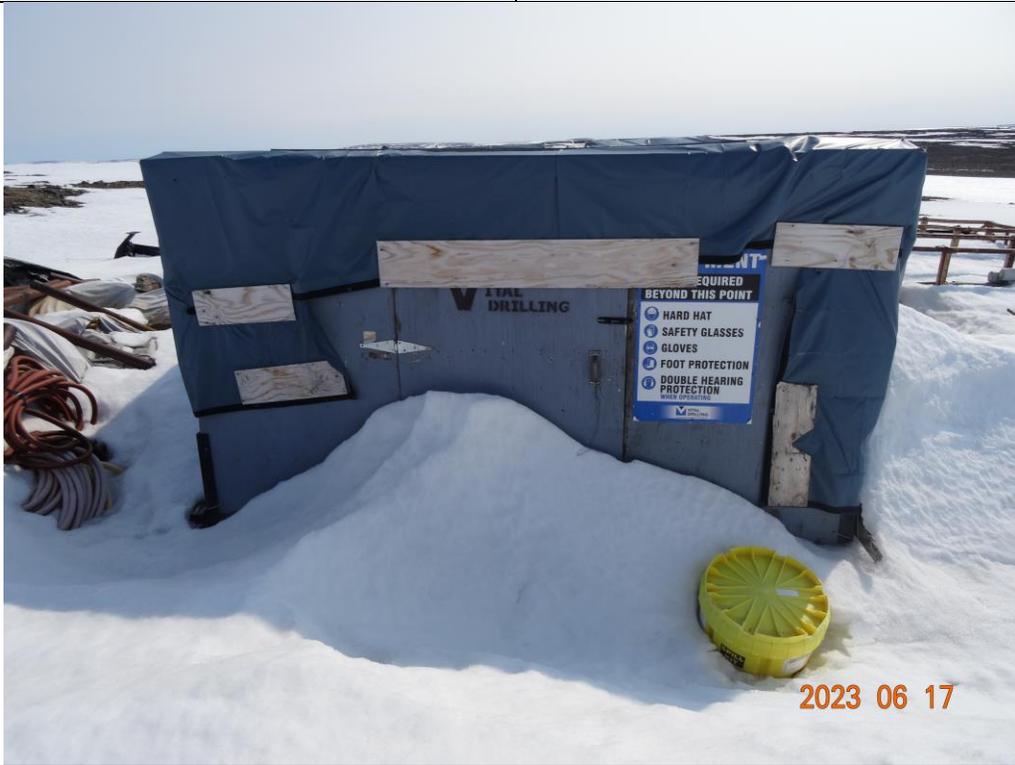
Photo No.	Location
Photo #14	CH-06 Drill Site

**Description:**  
Photo shows one of the drills, with a spill kit present.

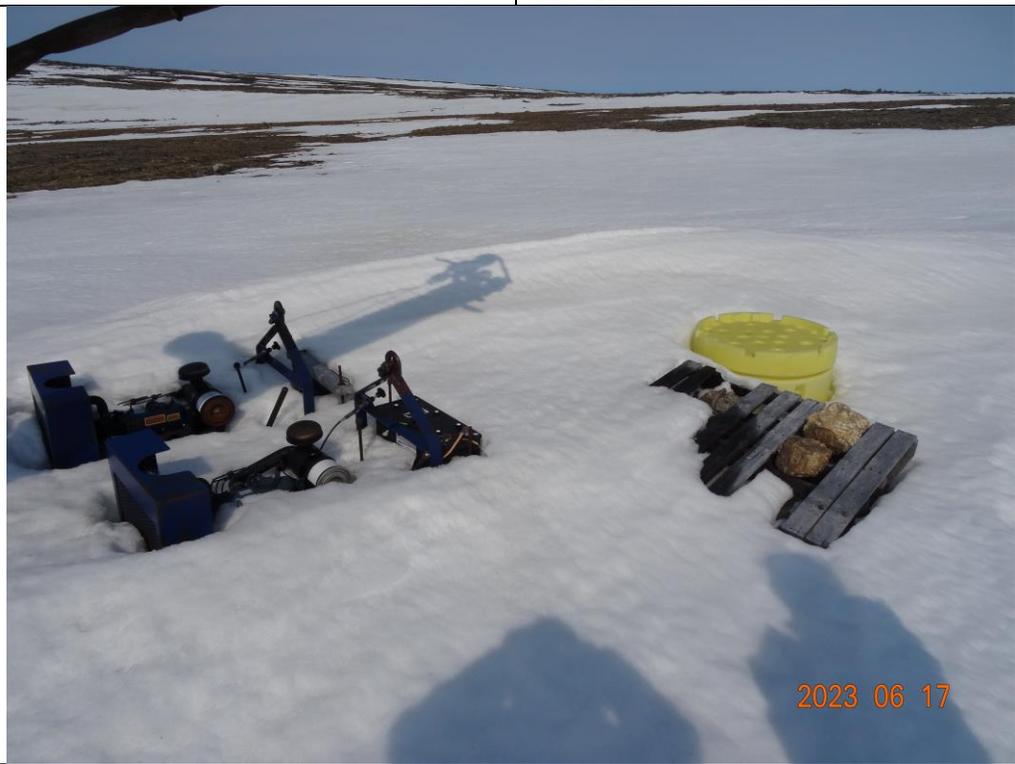
Photo No.	Location
Photo #15	CH-06 Drill Site

**Description:**  
This Photo shows another spill kit at CH-06, in a different location than the one above.
