WATER LICENCE INSPECTION FORM

Licensee		Licensee Representative	
Shear Diamonds Ltd (formally Shear Minerals Ltd.)		Unknown	
Licence No. / Expiry		Representative	
2BE-CHU0813/ September 1 st , 2013		--	
Land / Other Authorizations		Land / Other Authorizations	
Camp is on IOL		N2009C0002 (formally N2003C0009)	
Date of Inspection		Inspector	
15/07/16		WRO C. Wilson	
Activities Inspected			
<input checked="" type="checkbox"/> Camp	<input type="checkbox"/> Drilling	<input type="checkbox"/> Mining	<input type="checkbox"/> Construction
<input type="checkbox"/> Roads/Hauling	<input checked="" type="checkbox"/> Other:		<input type="checkbox"/> Reclamation
			<input checked="" type="checkbox"/> Fuel Storage

Water Licence no. 2BE-CHU0813 is issued to Shear Minerals Ltd. (“the proponent”) October 6th, 2008 for the use of water and deposit of waste associated with the Churchill Diamond Project (“the project”). On July 15th, 2016 a joint inspection was conducted of the project by Indigenous and Northern Affairs Canada’s, Water Resource Officer, Christine Wilson and Kivalliq Inuit Association’s Land Use Inspector, Jeff Tulugak.

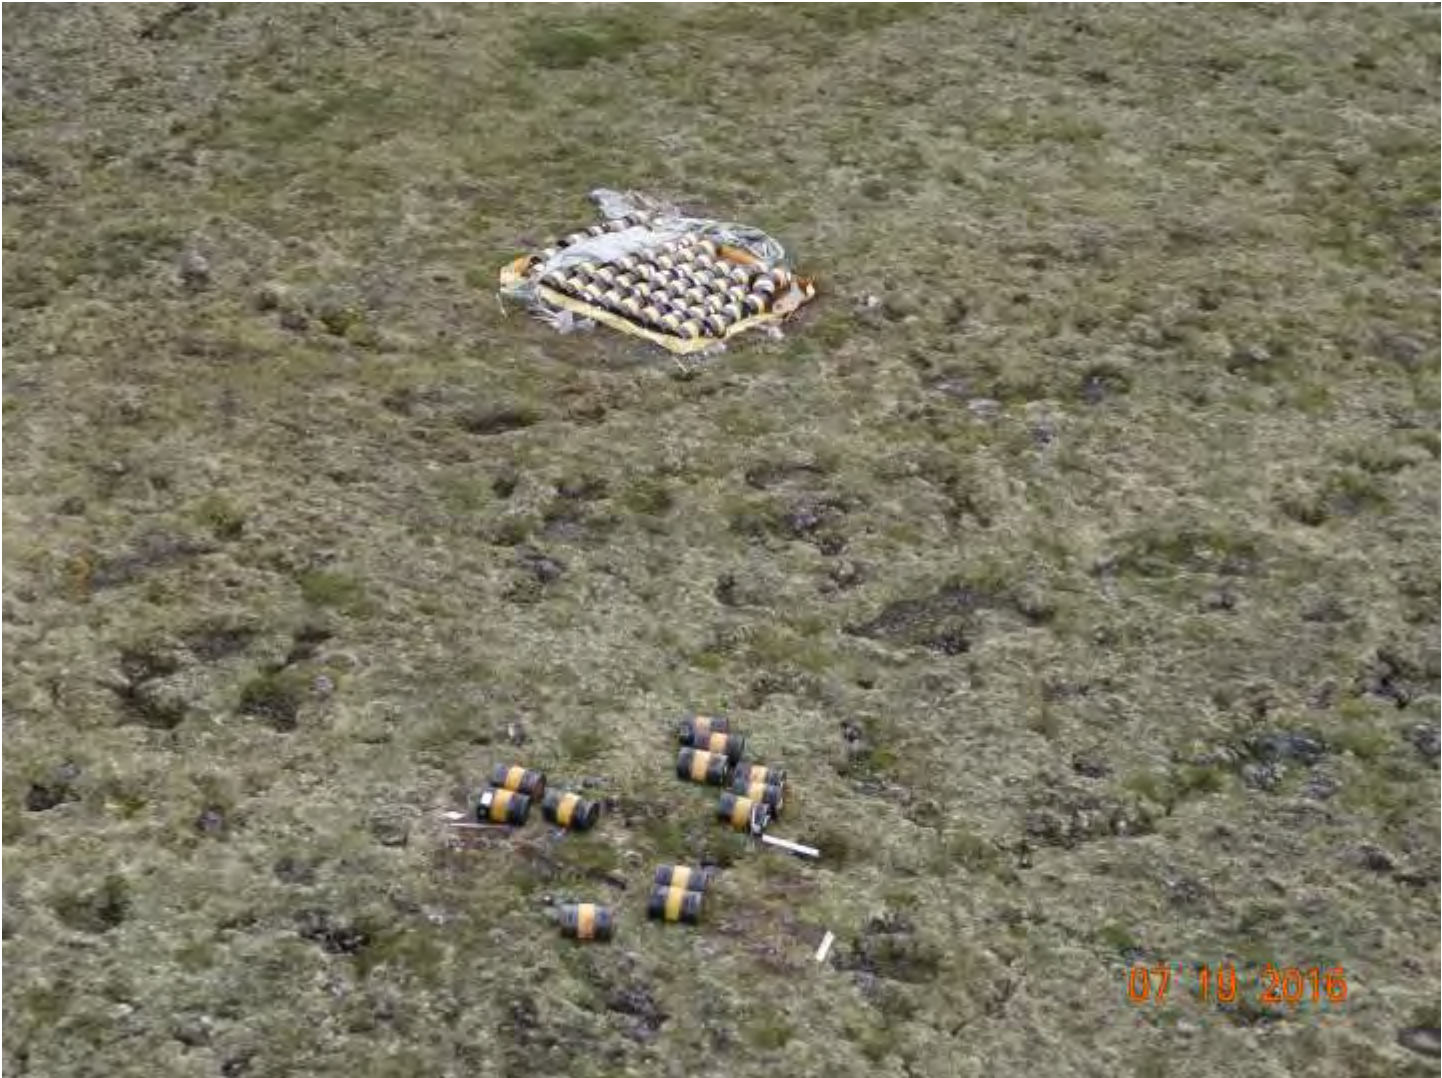
3. A cache located North West of the camp has 56 drums of expired aviation fuel. The berm is full of water, which has a sheen and smells of hydrocarbons.

Photo 3: North West (referred to by the proponent as Jigsaw) Cache, 56 Full drums of Aviation Fuel

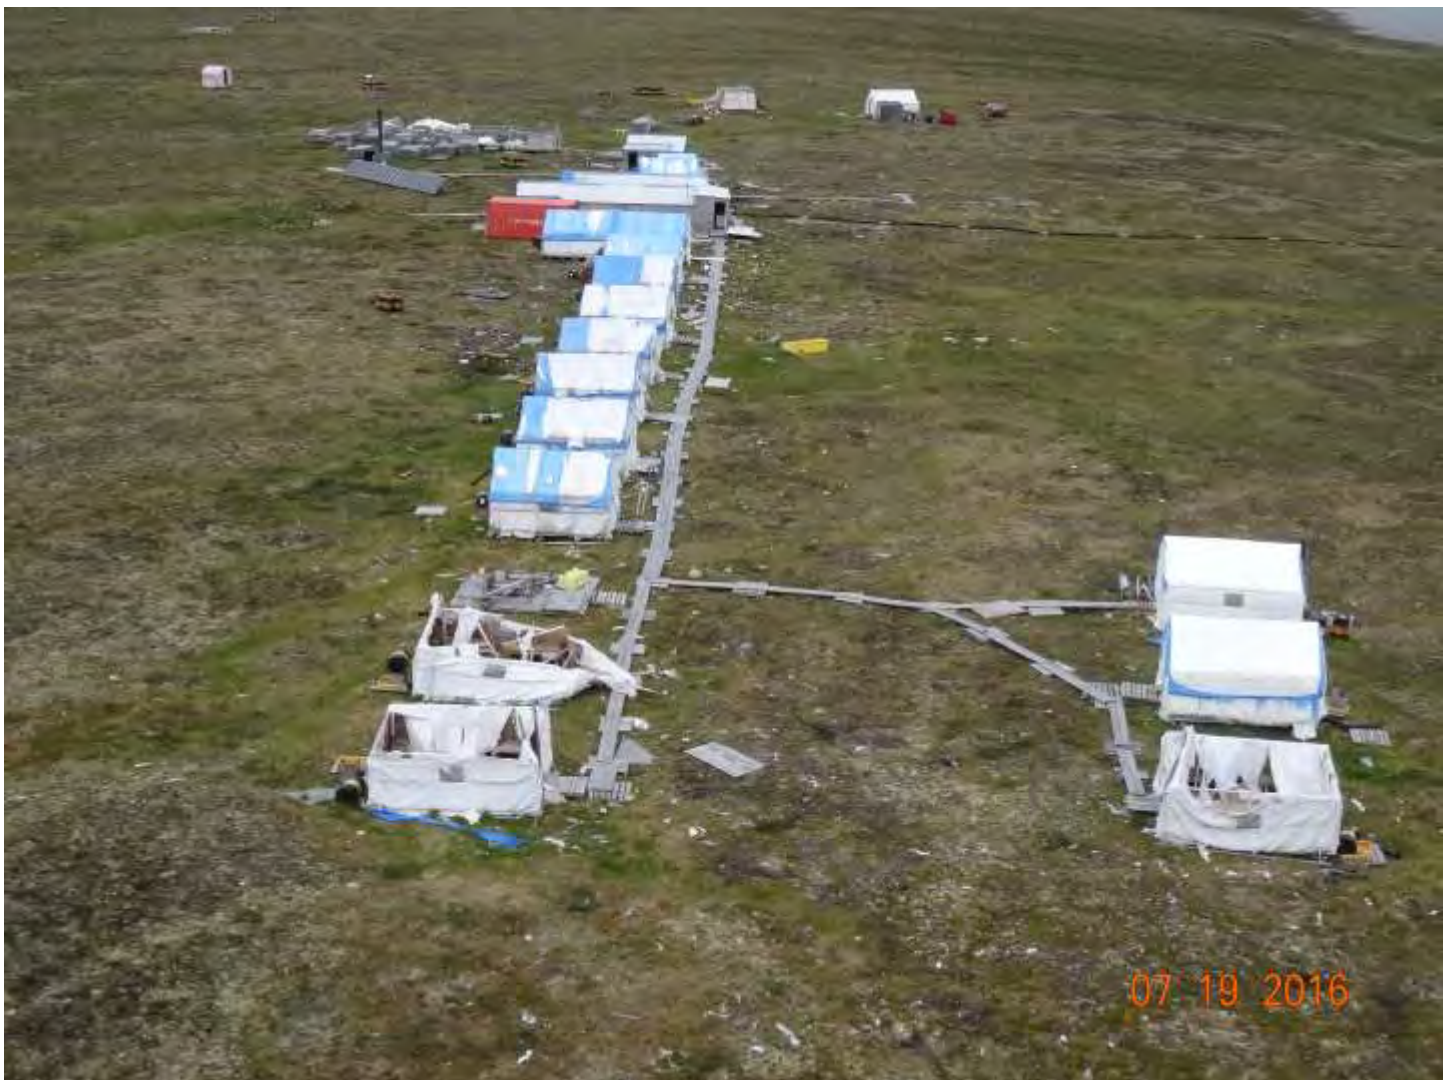
8. A lot of materials have become windblown and littering the land proximal to the project.
9. The area used as a sump is located on the West side of the camp; the tundra is eroded but has vegetation has begun growing back.

Photo 7: Josephine Camp looking North, dilapidated tents, windblown debris

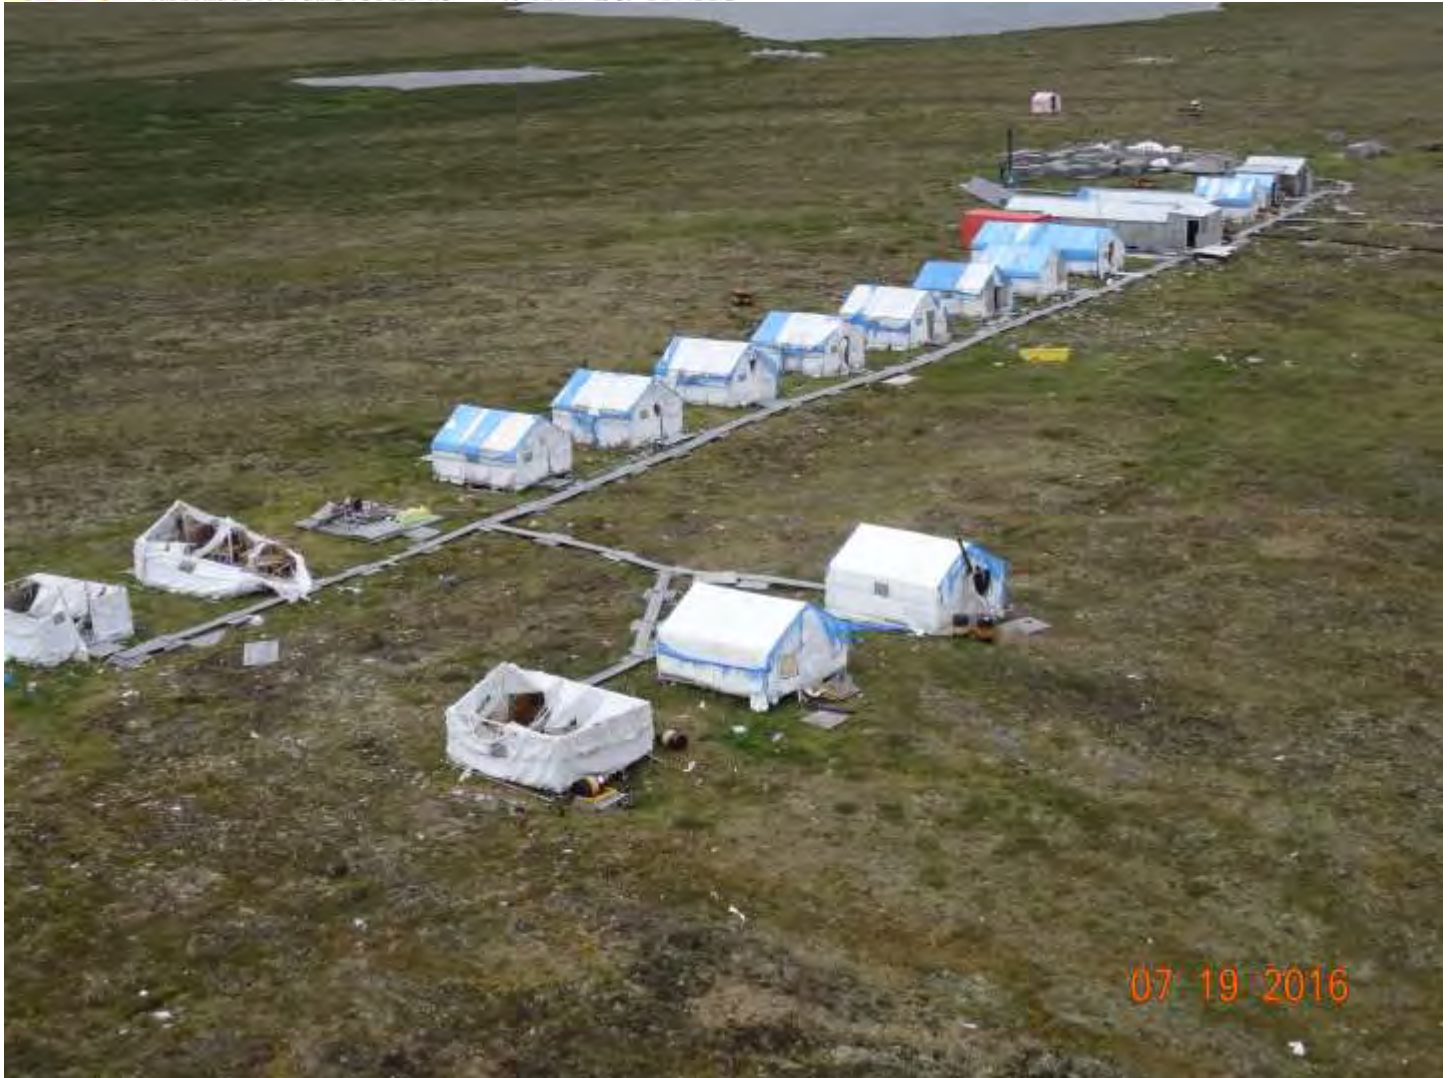
Photo 8: Josephine Camp looking North West, unmonitored partial fuel drums of fuel drums

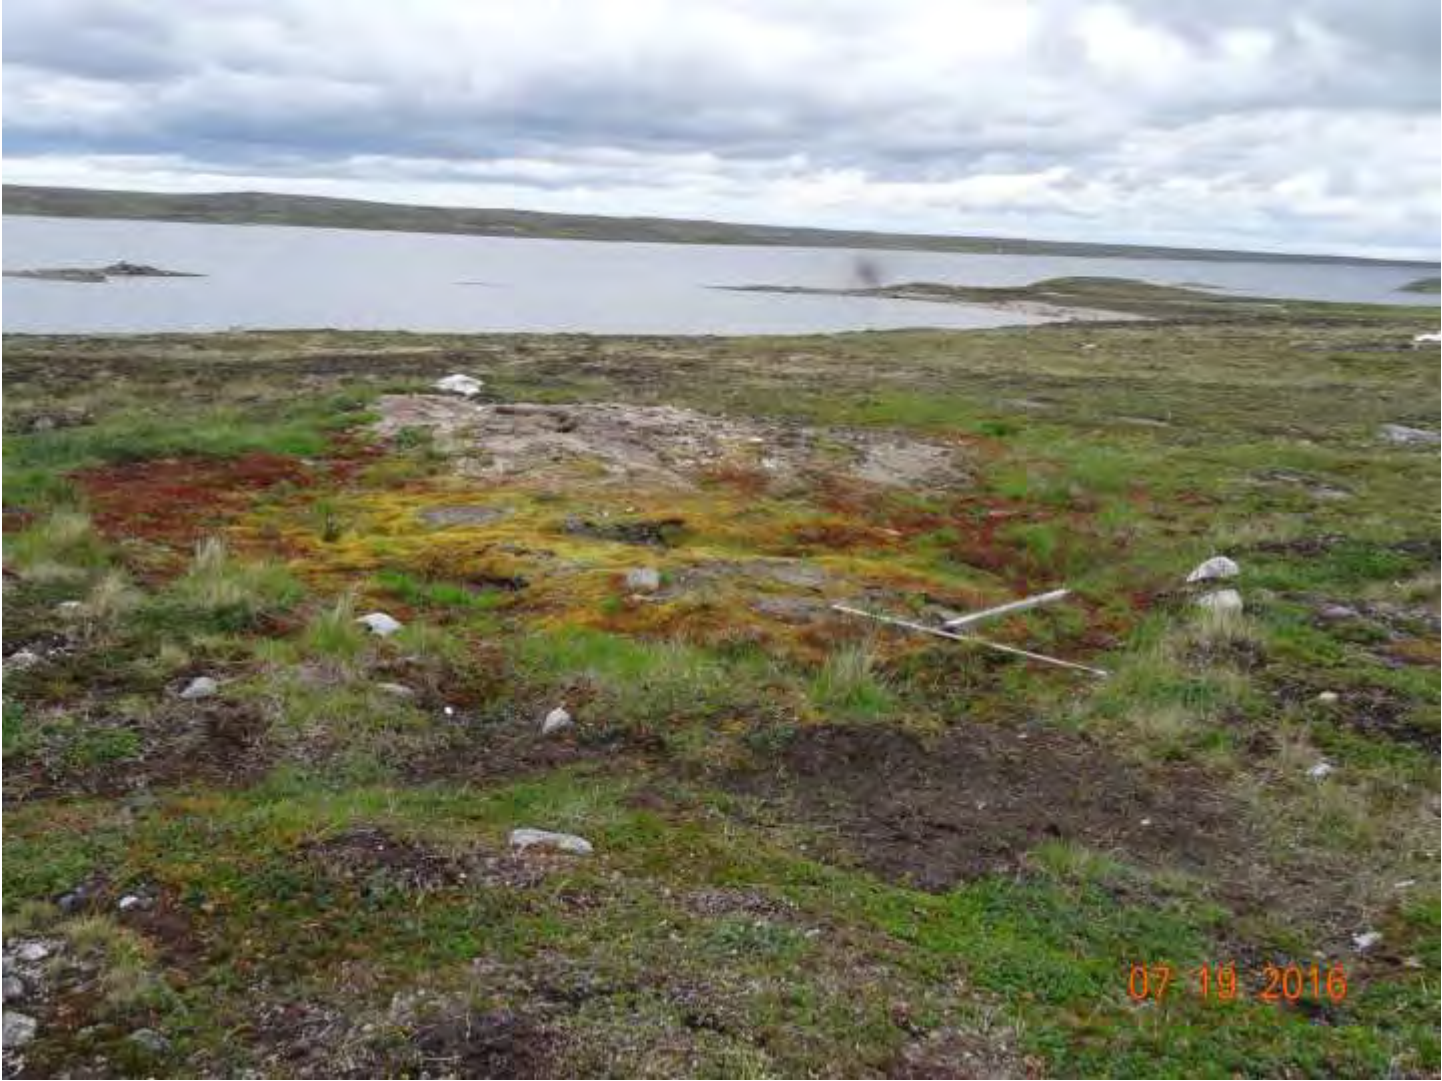
6. The ground surrounding the North West cache has staining which may be associated with spilled hydrocarbons.
7. An area approximately located at N63° 12’ 26.61”, W91° 14’ 56.5” should be noted as an area of potential concern. The vegetation is discoloured and different from the surrounding vegetation.

Photo 26: Discoloured Foliage, uneven ground, Area of Concern (N63° 12' 26.61", W91° 14' 56.5")

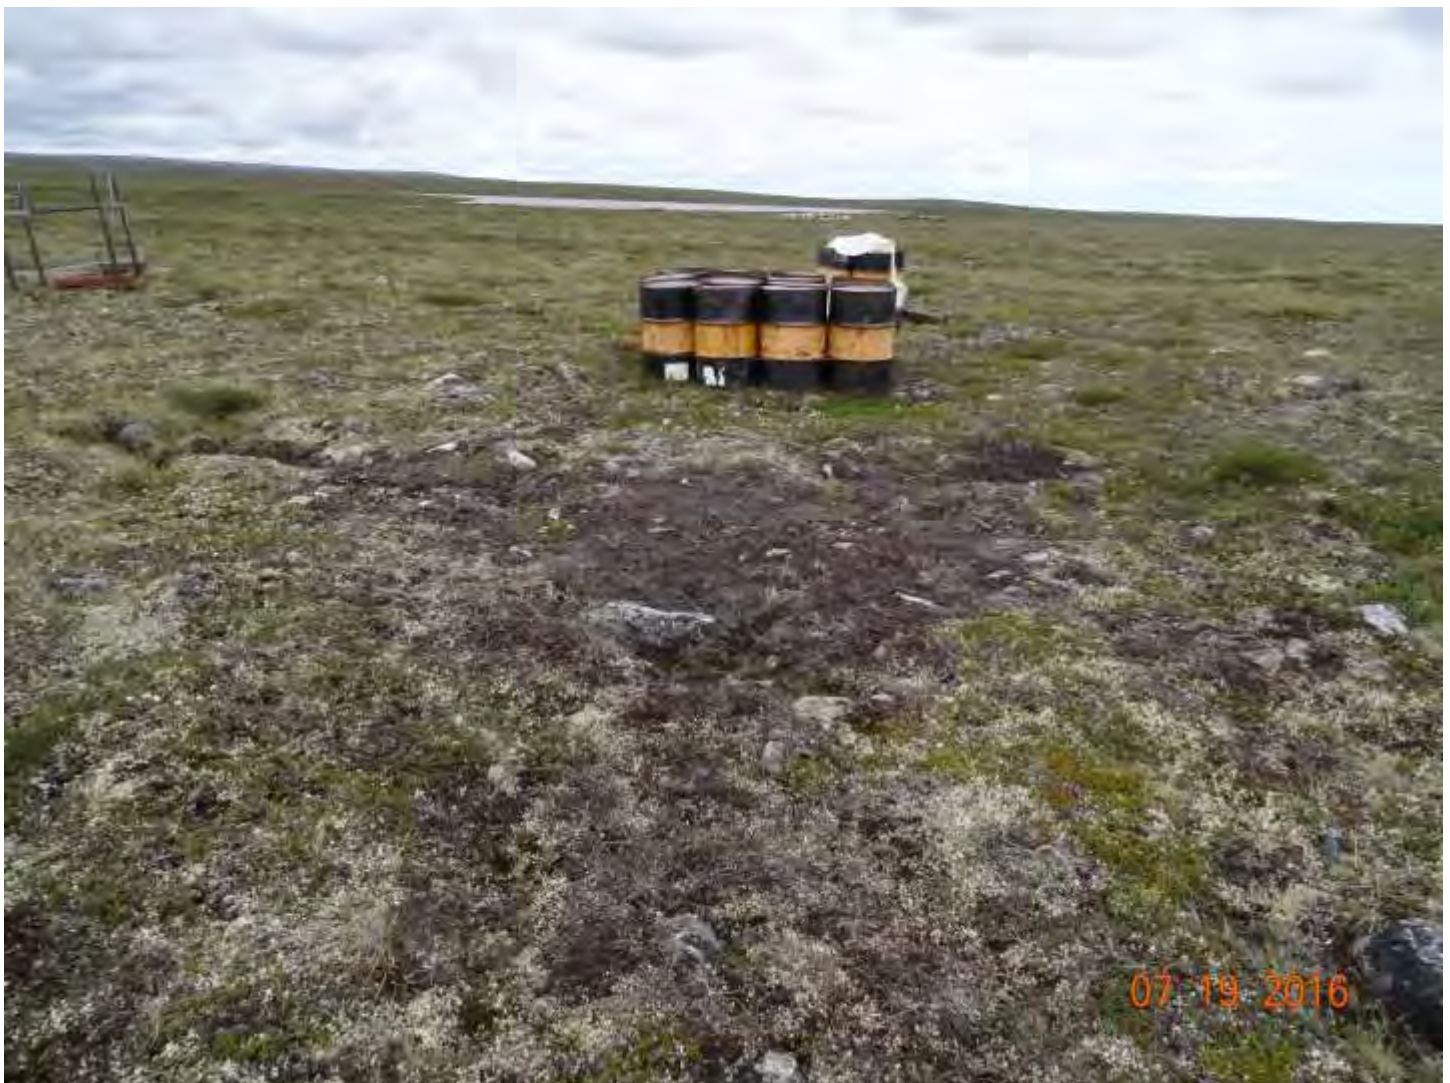
Photo 45: Discoloured tundra, Drums with unknown content

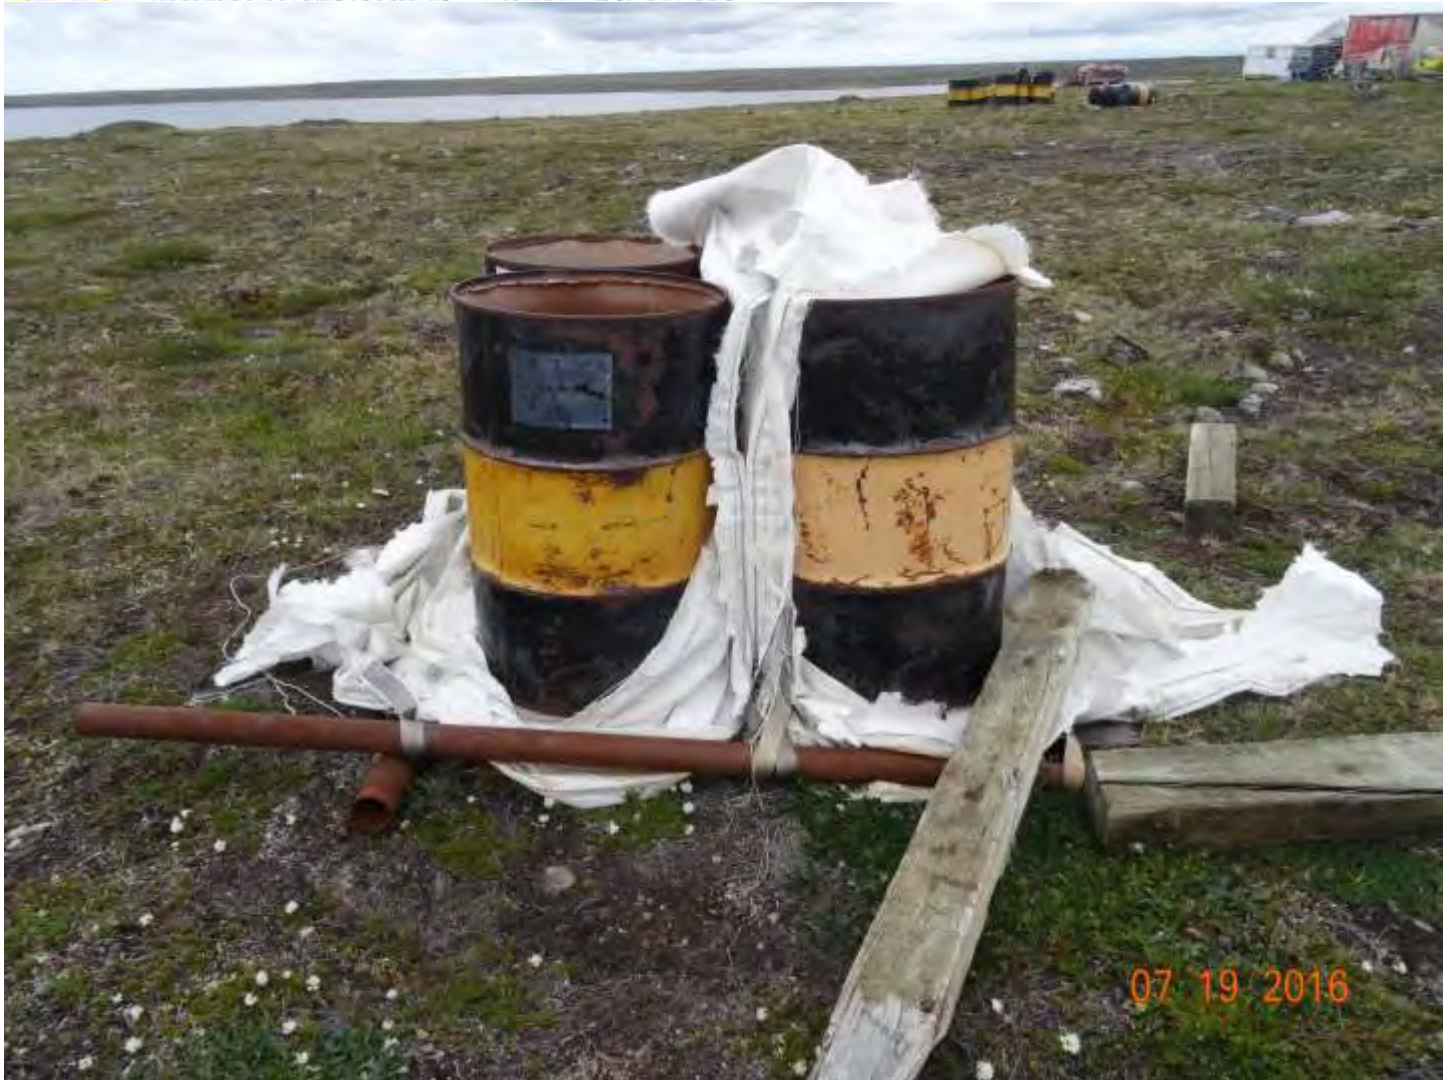
10. Four open drums, tied together with rope, at approximately N63° 12’ 27.45” W91° 15’ 8.7” are ¼ full of an unknown black, thick liquid.

Photo 48: three drums with unknown black materials

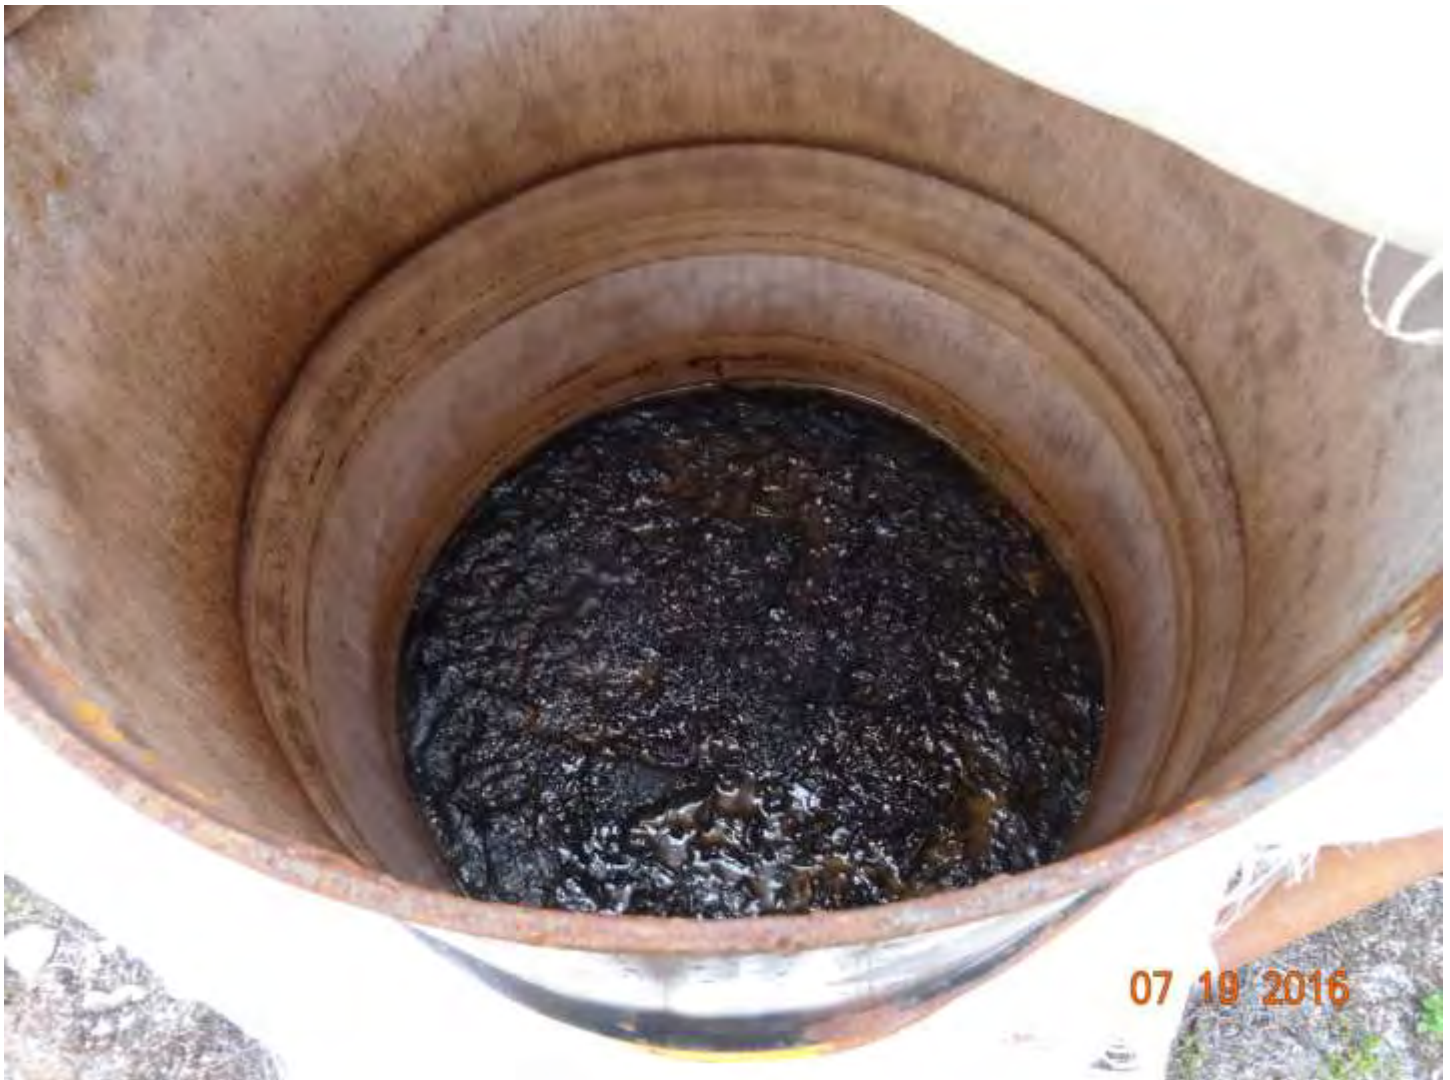
Photo 49 Black unknown materials in drum

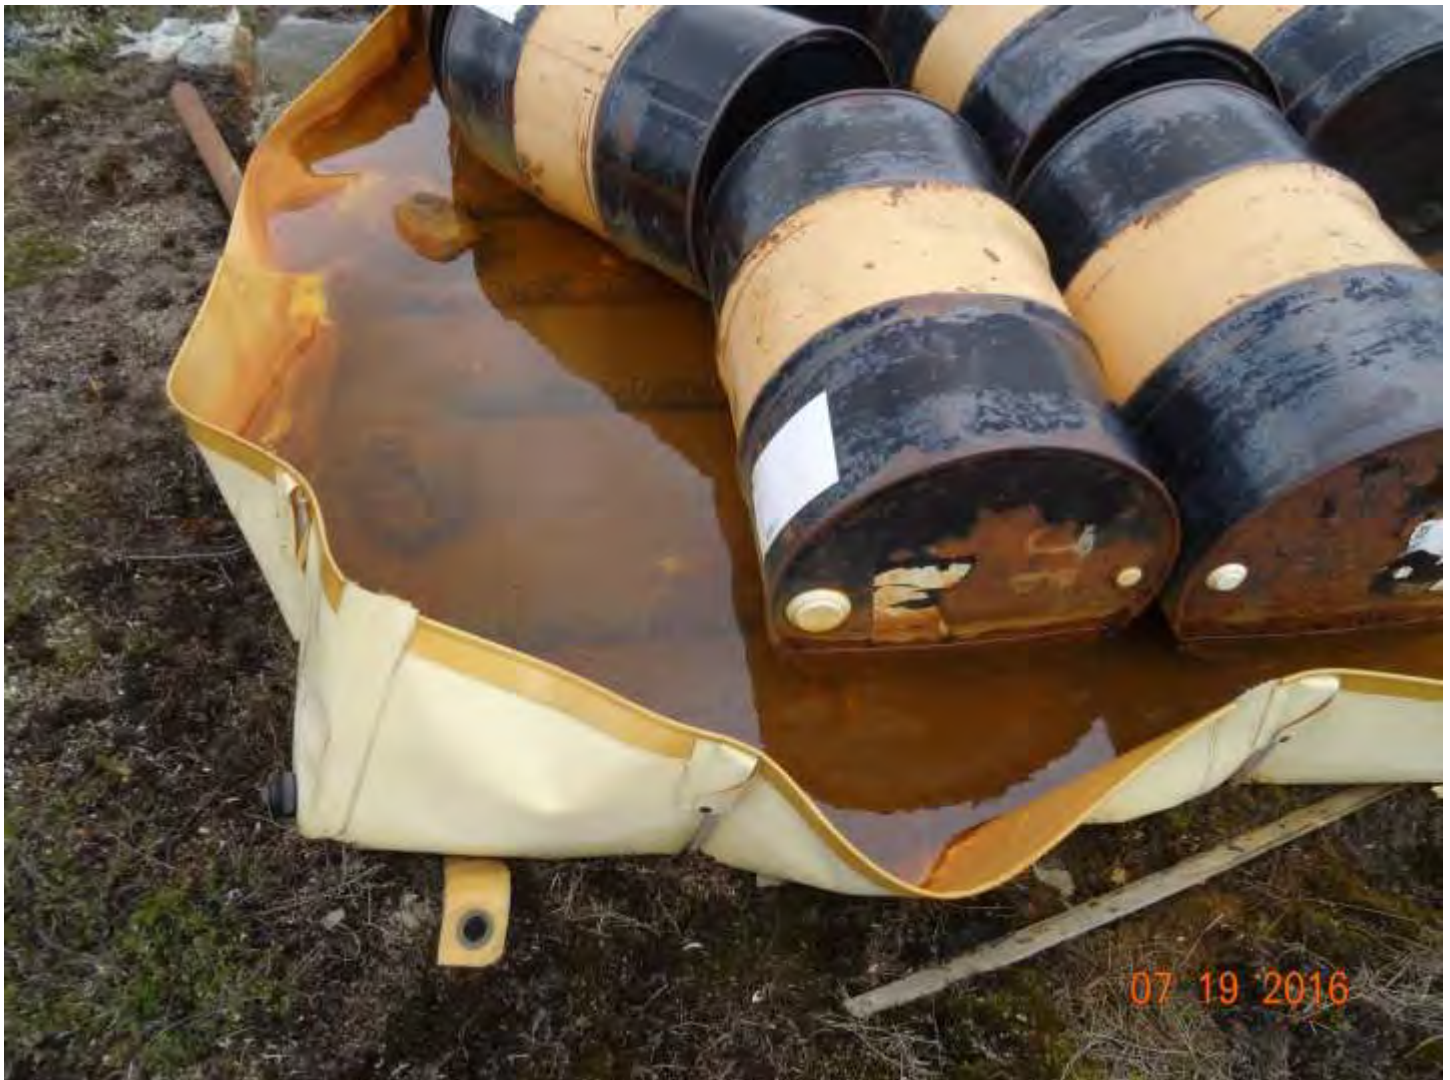
5. The waste water inside the secondary containment berms is especially concerning as the drums integrity is becoming compromised due to improper storage.

Photo 51: North West Cache, contaminated water

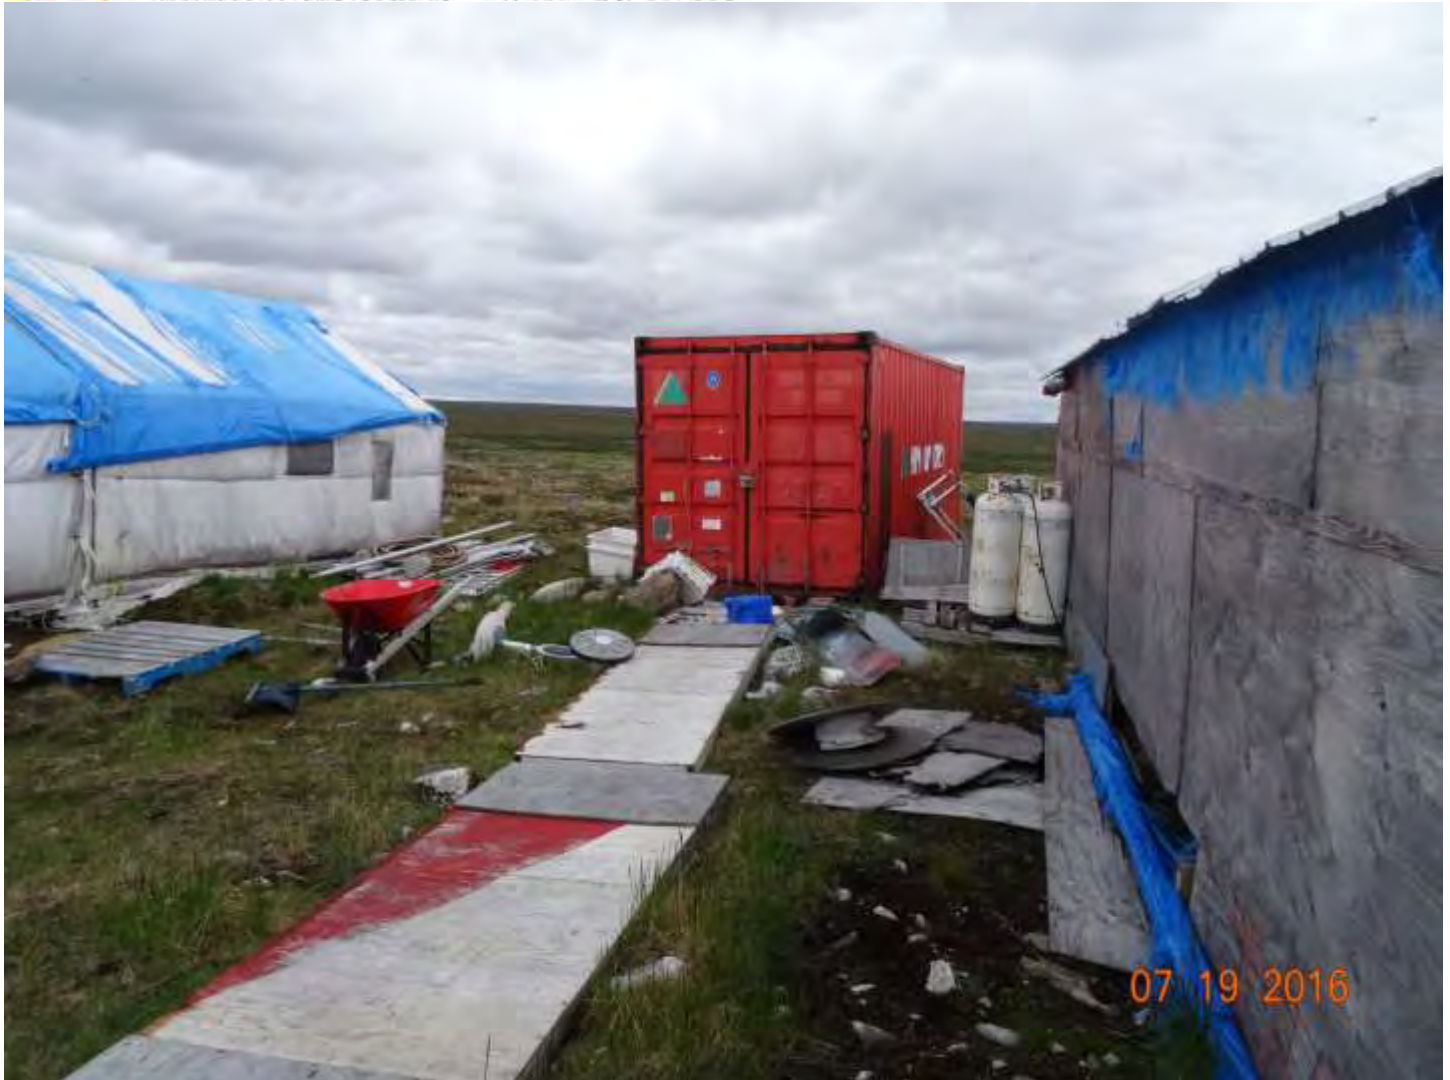
Photo 60: Waste and debris

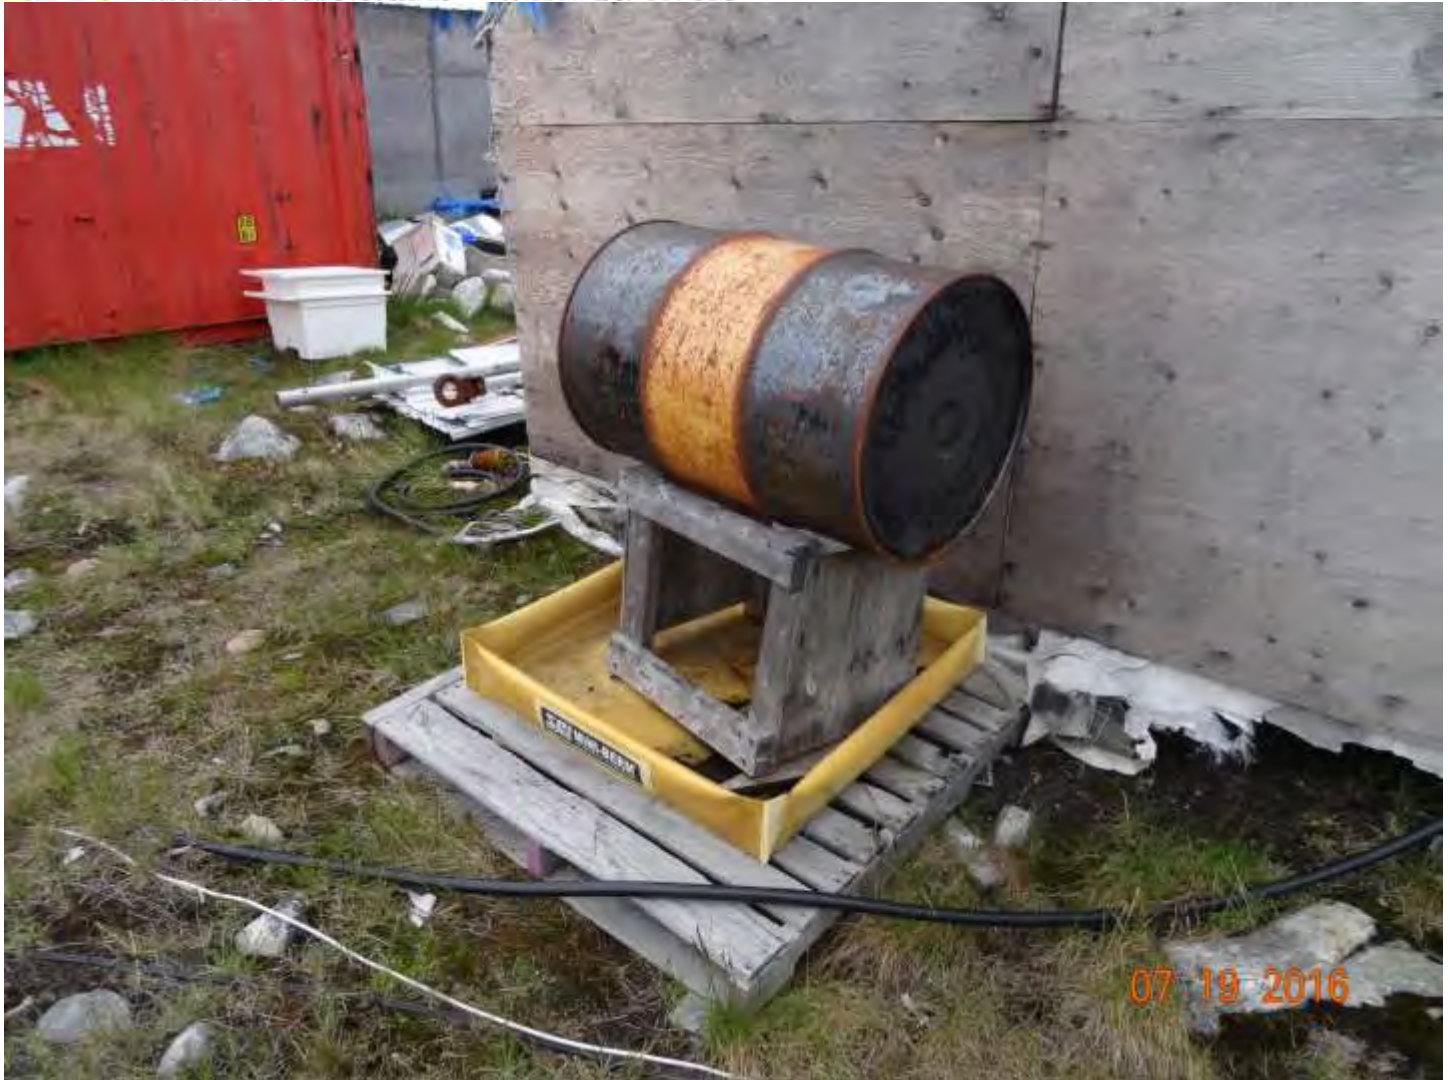
Photo 66: Unmaintained drums
