☒ Original  
☐ Follow-Up Report

Permittee		Representative	
Tundra Copper Corp			
Permit No. / Expiry		Representative's Title	
N2015C0009			
Other Authorizations		Land / Other Authorizations	
Water Licence 2BE-COP1416			
Date of Inspection		Inspector	
13 August 2016		Baba Pedersen	
Activities Inspected			
<input checked="" type="checkbox"/> Camp	<input checked="" type="checkbox"/> Drilling	<input type="checkbox"/> Mining	<input type="checkbox"/> Construction
<input type="checkbox"/> Roads/hauling	<input type="checkbox"/> :Other	<input type="checkbox"/> Other:	<input type="checkbox"/> Reclamation
			<input checked="" type="checkbox"/> Fuel Storage

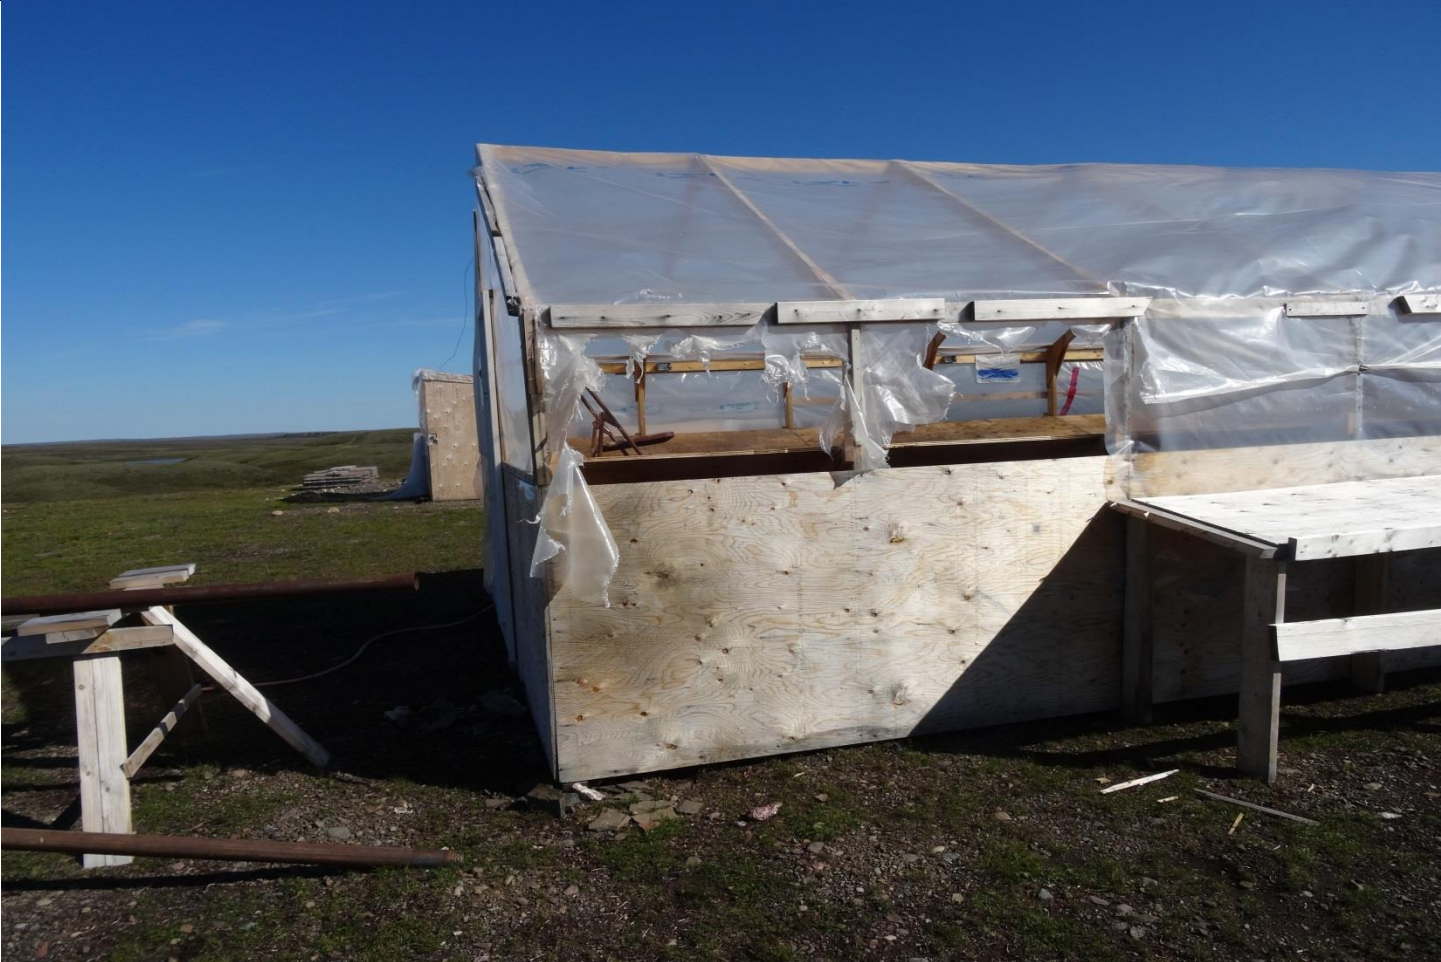
1. At the Drill Site everything has been removed and the Site has been nicely cleaned up. 2. The Camp Site is In-Active, some of the Structures have Wind/Weather/Animal Damage ( <b>Photos 1 &amp; 2</b> ) and the adjacent Fuel Caches ( <b>Photos 3, 4 &amp; 5</b> ) have signs of internal Fuel/Grease Spills and the Secondary Containment is failing. 3. The Airfield Fuel Cache/Staging Area is also In-Active and is in a very messy state, the Secondary Containment ( <b>Photos 6, 7 &amp; 8</b> ) is failing and is almost half full of Contaminated looking Water with obvious signs of Fuel and Grease spillage inside.				
SECTION 3		<input type="checkbox"/> Comments	<input type="checkbox"/> Non-Compliance with Act or Regulations	<input checked="" type="checkbox"/> Action Required
From discussions I have had with Kikiak Contracting here in Kugluktuk, I understand that Tundra Copper is not planning to operate the Hope Lake Camp anymore and have requested Kikiak Contracting to remove everything back to Kugluktuk via winter Cat Train. First, if this is indeed the plan then <b>a separate Land Use Permit will be required for the Cat Train</b> , and second, if the Camp area is to be removed then there are 4 separate Secondary Containment/Sumps ( <b>Photos 9, 10, 11 &amp; 12</b> ) that will be required to be reclaimed properly and the 2 Secondary Containment areas at the Camp and 1 Secondary Containment area at the Airfield will all need to be emptied and cleaned WHEN THE GROUND IS NOT FROZEN. The Camp and Airfield Staging Area cannot only be cleaned up during the winter, summer work is required as well.

Date	Camera	Inspector	Authorization
2016 August 13		Baba Pedersen	
Photo Log # 7948		Location Hope Lake Camp	
Photo 1			
Description: Weather Damage to Structure

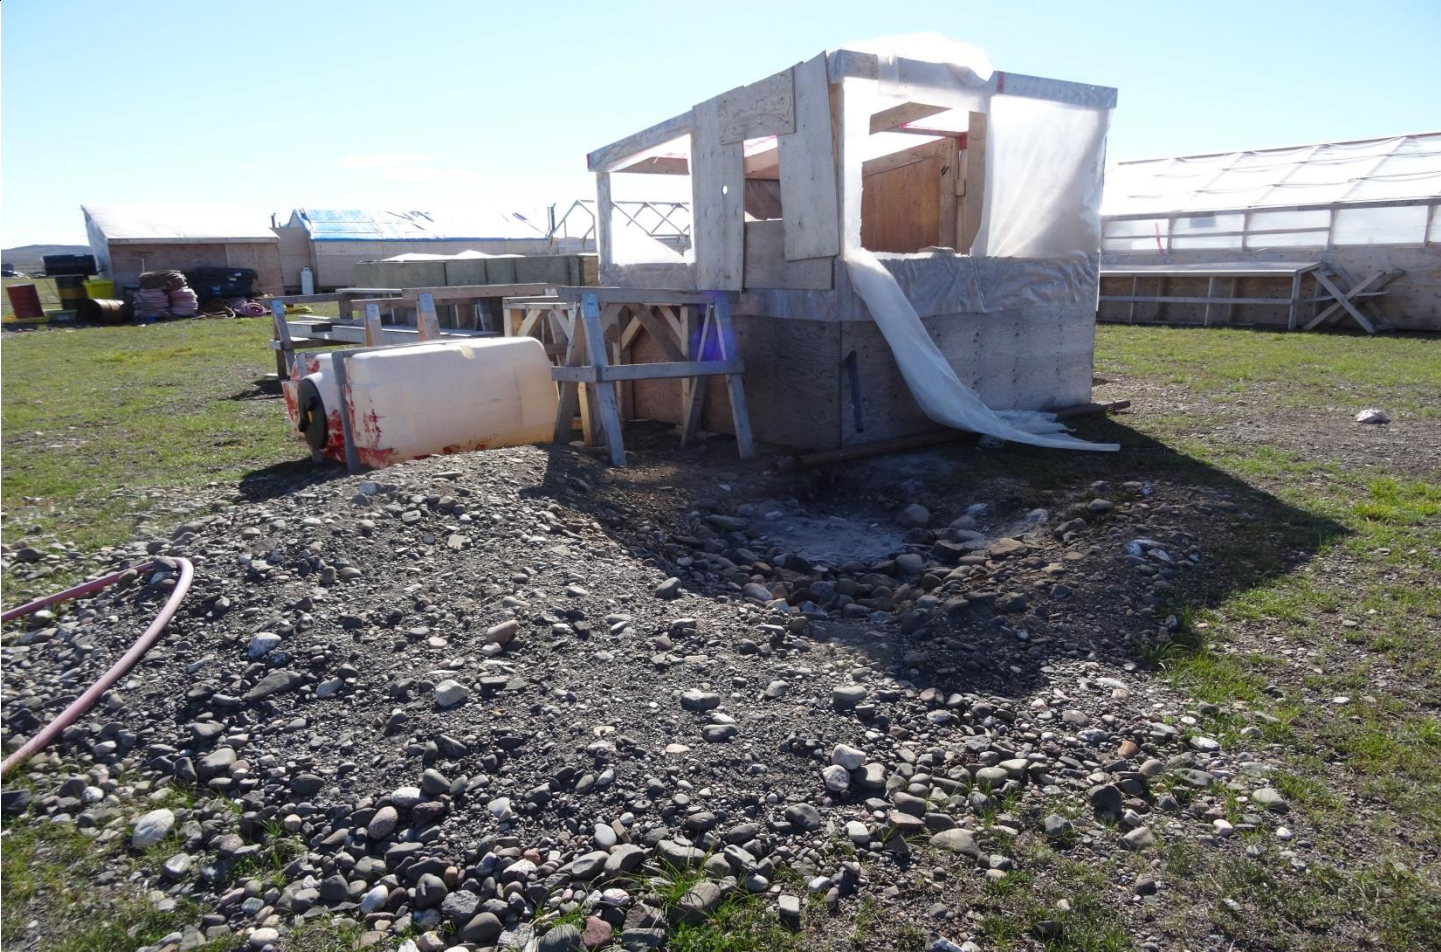
Photo Log # 7956	Location Hope Lake Camp
Photo 2	
Description: Weather Damage to Structure

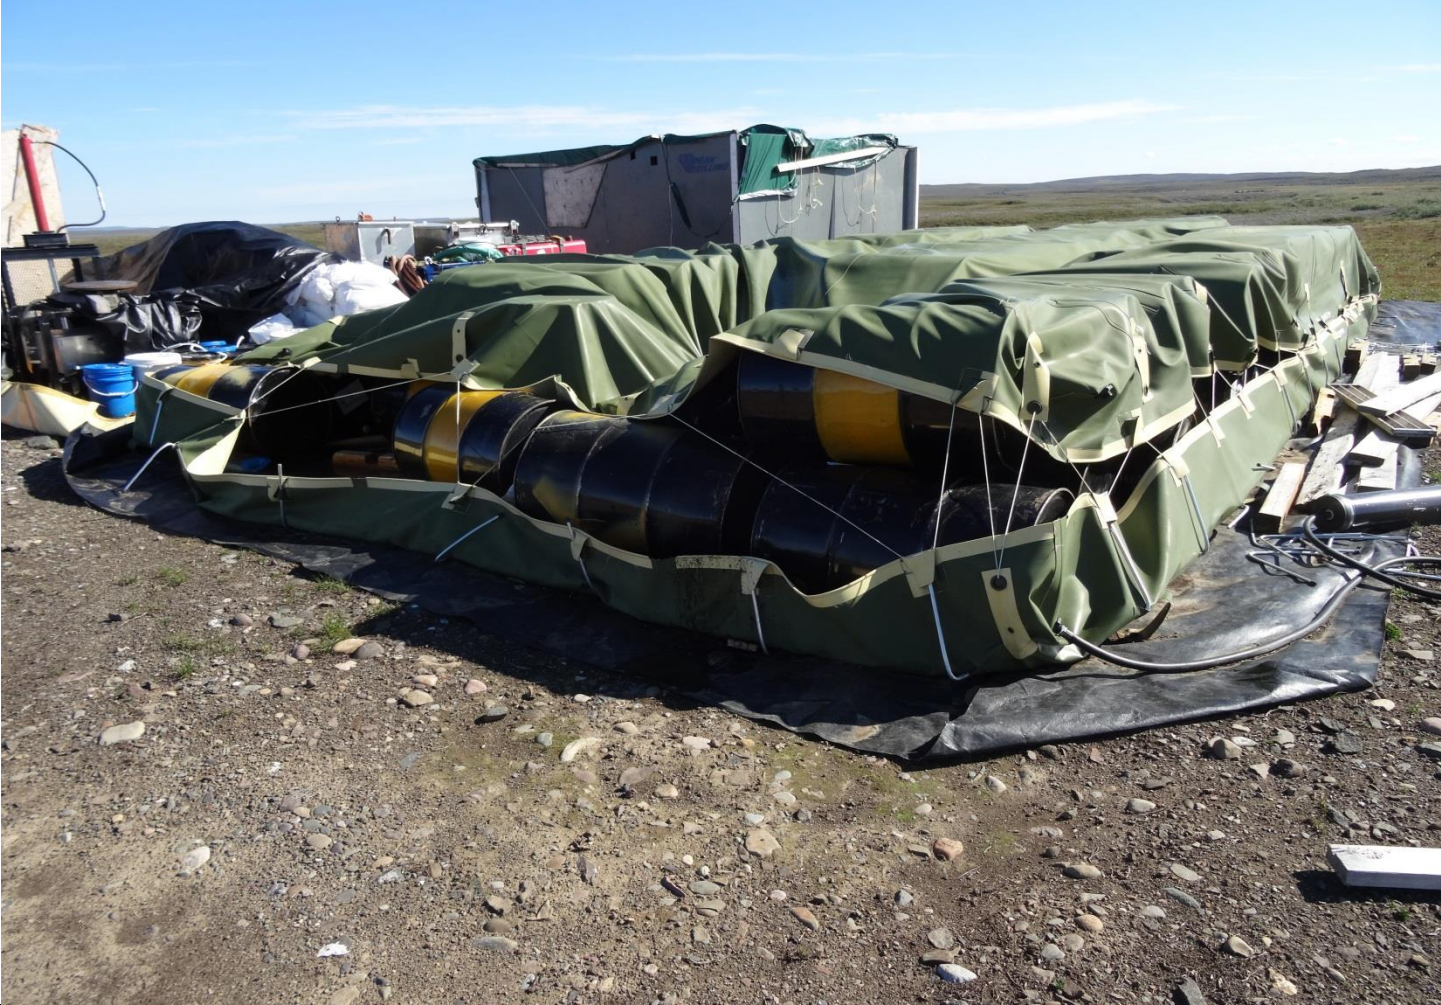
Photo 3

Description: Failing Secondary Containment on Fuel Cache

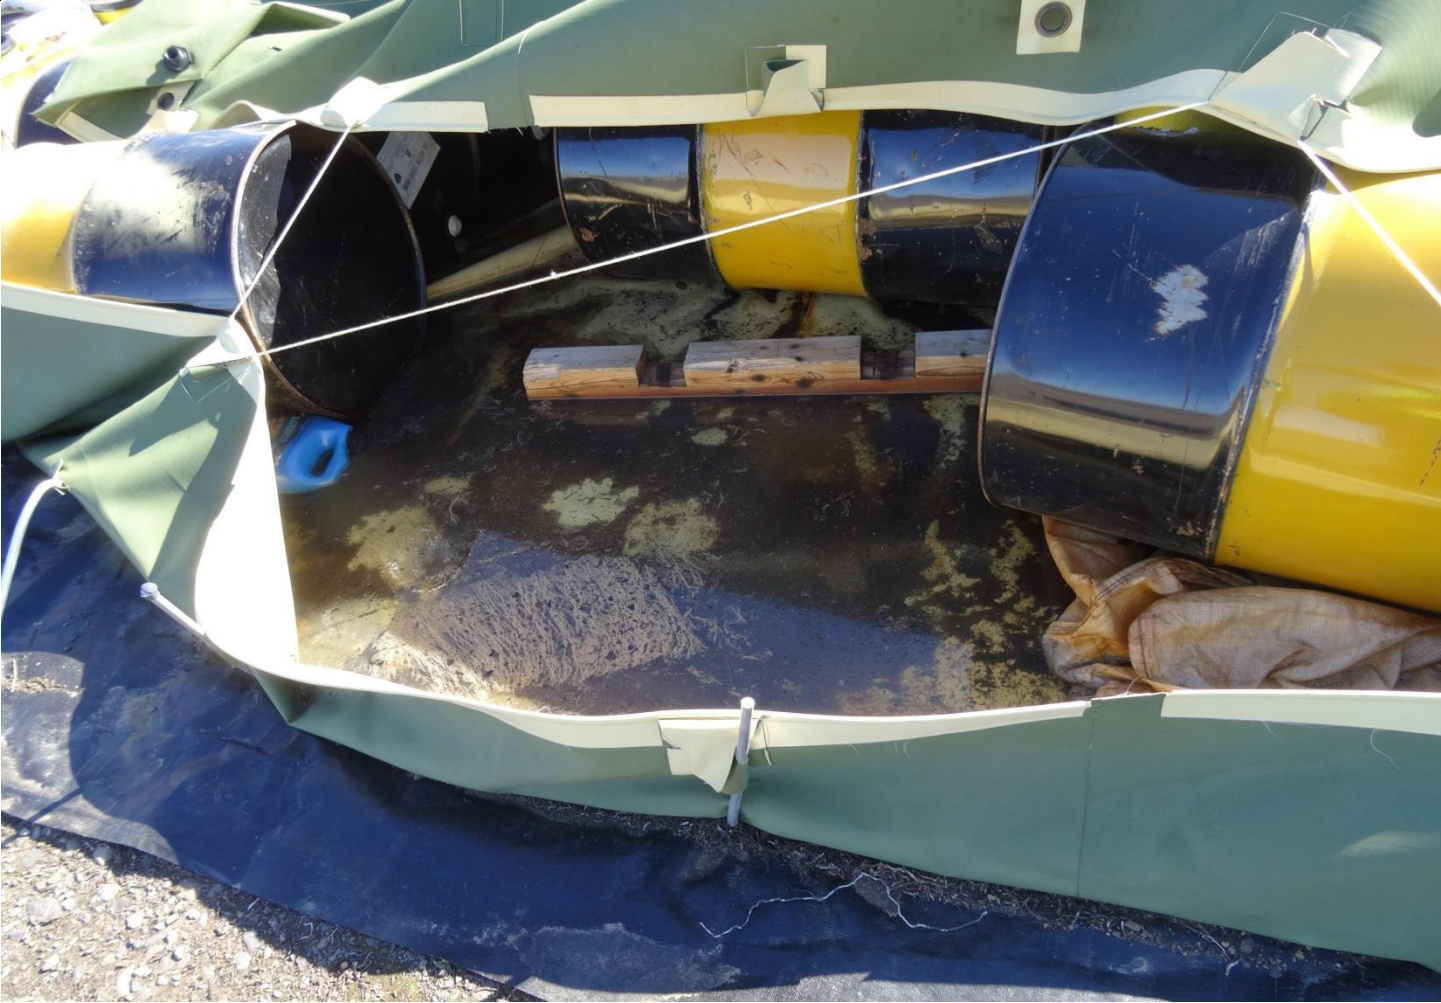
Photo 4

Description: Visible Grease/Oil Sheen inside Fuel Cache Secondary Containment

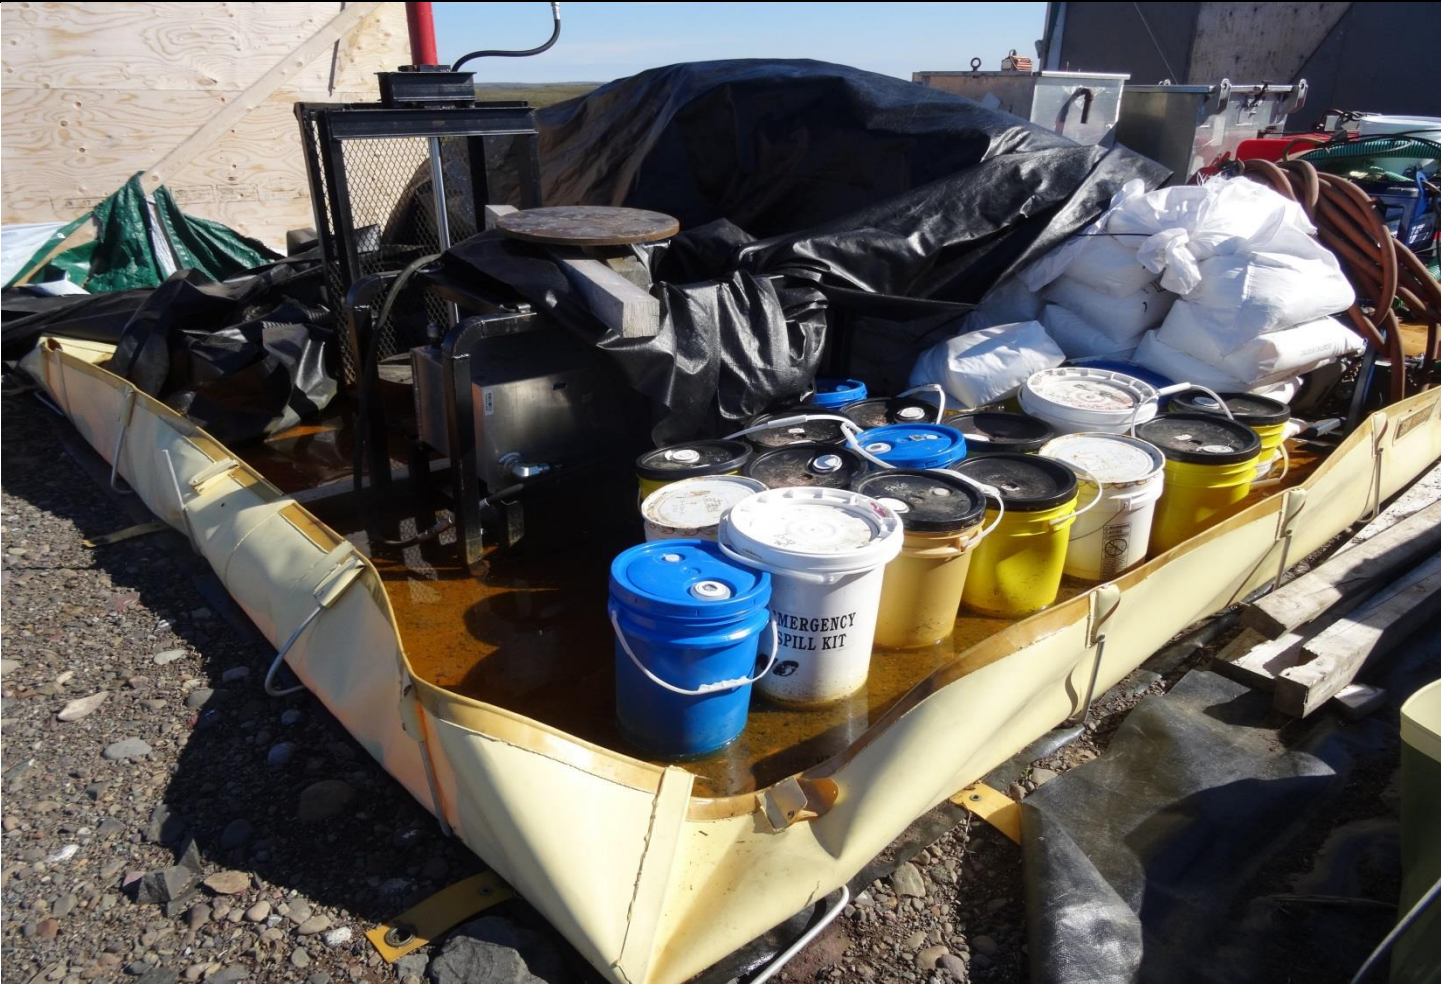
Photo 5

Description: Failing Secondary Containment on 2<sup>nd</sup> Drum/Hazardous Material Cache

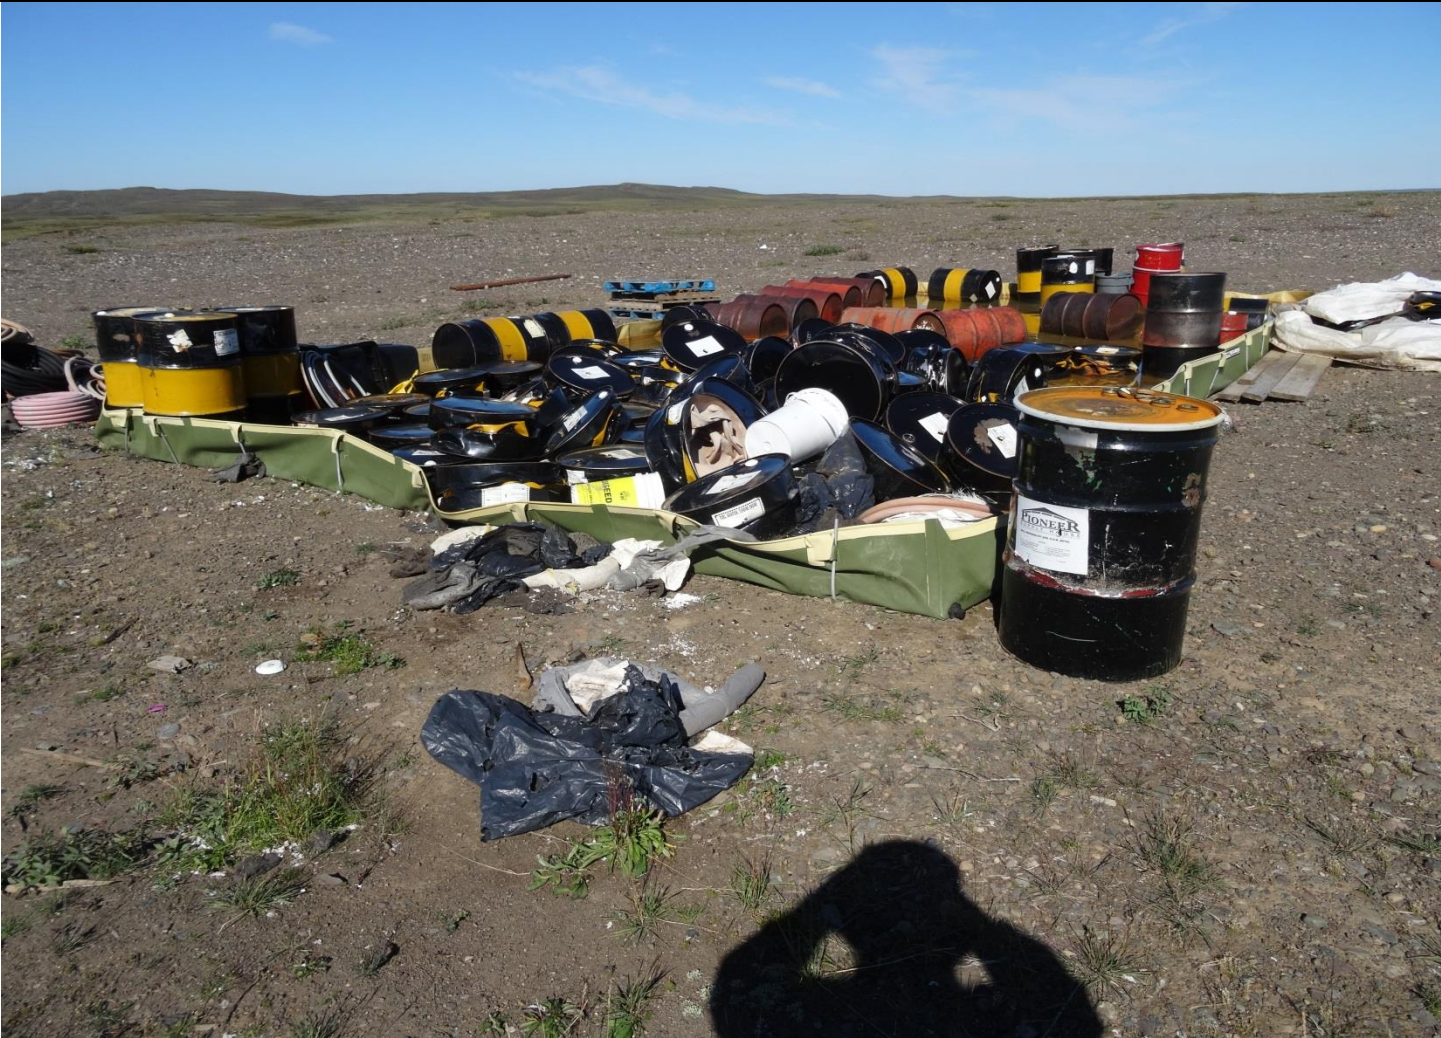
Photo 6

Description: Drum/Hazardous Material Cache Failing Secondary Containment

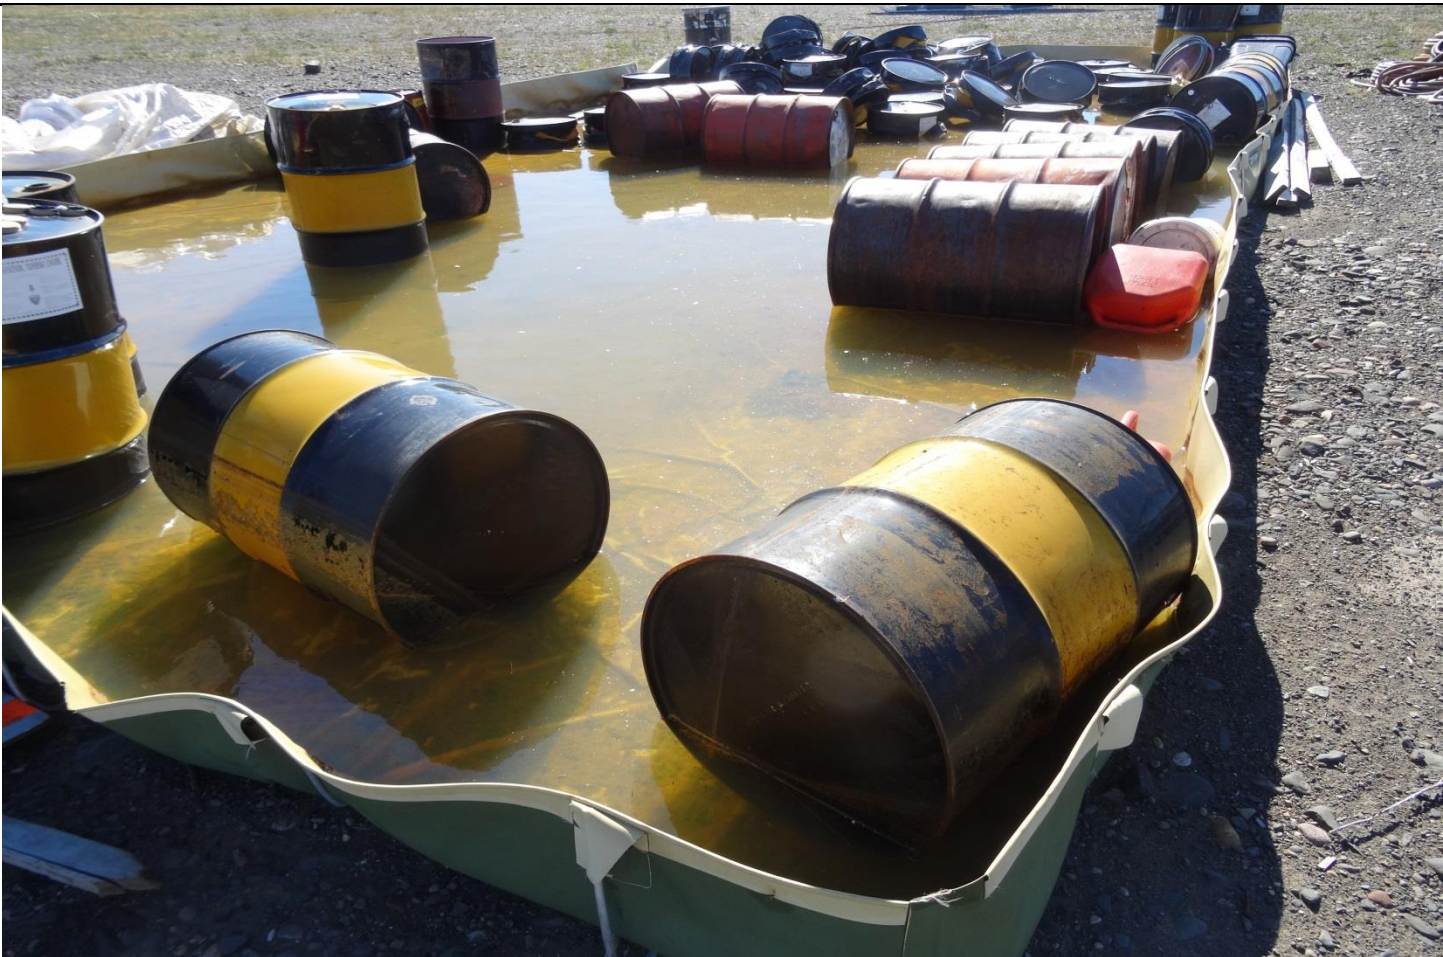
Photo 7

Description: Contaminated Water inside Secondary Containment

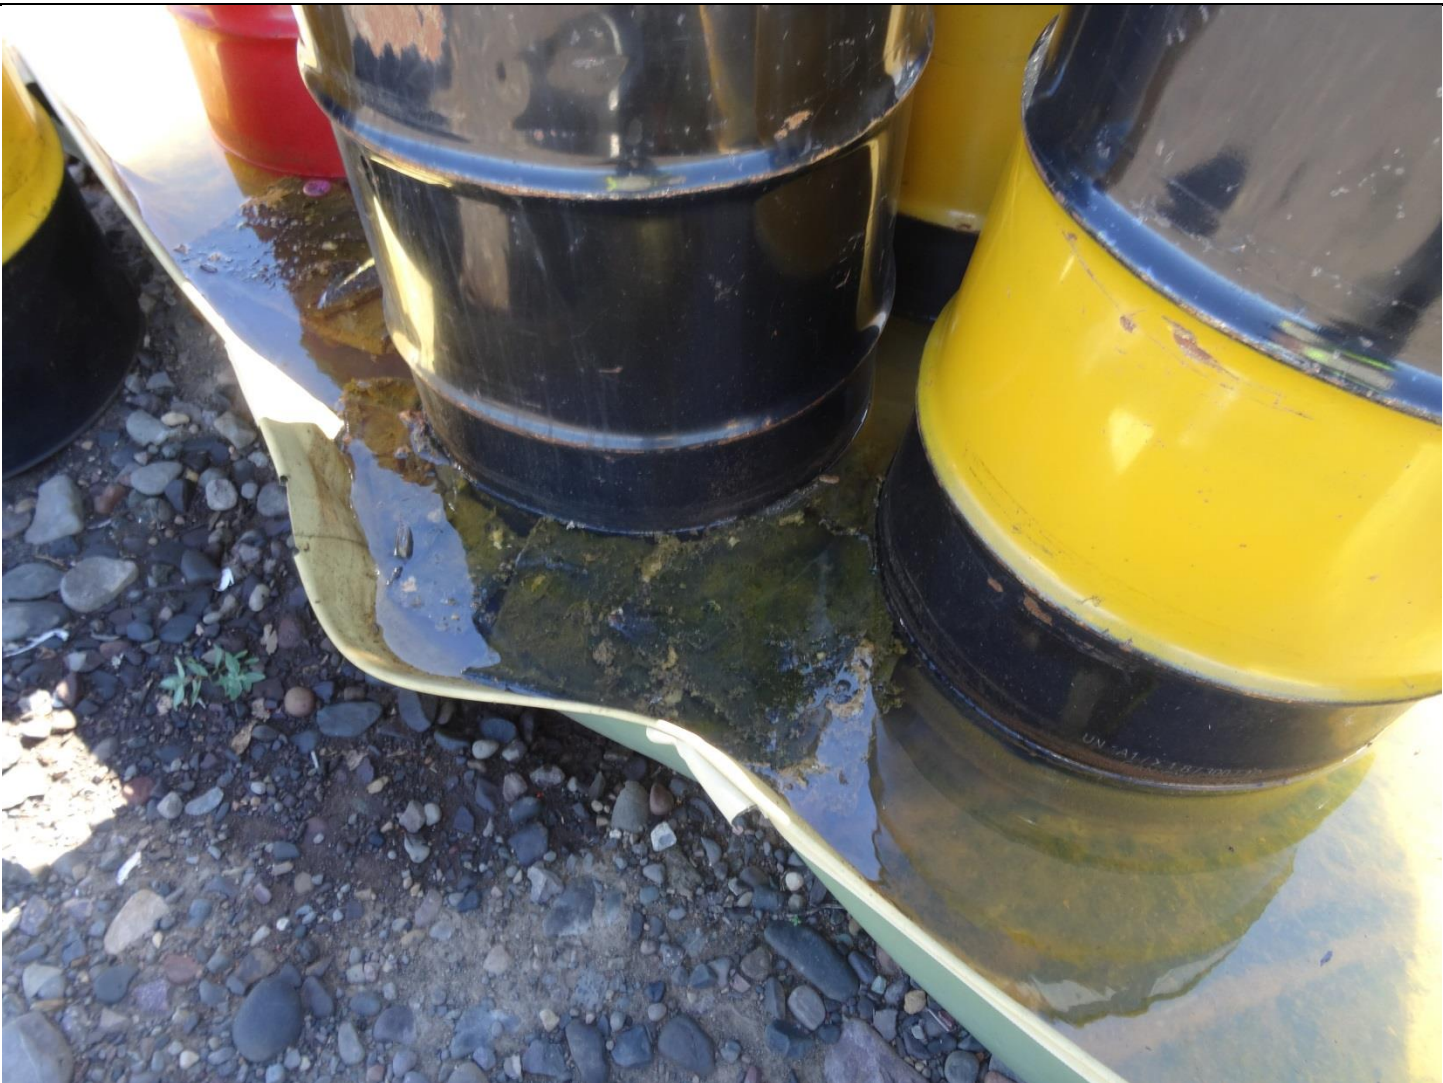
Photo 8

Description: Visible Oil/Grease Sheen inside Secondary Containment

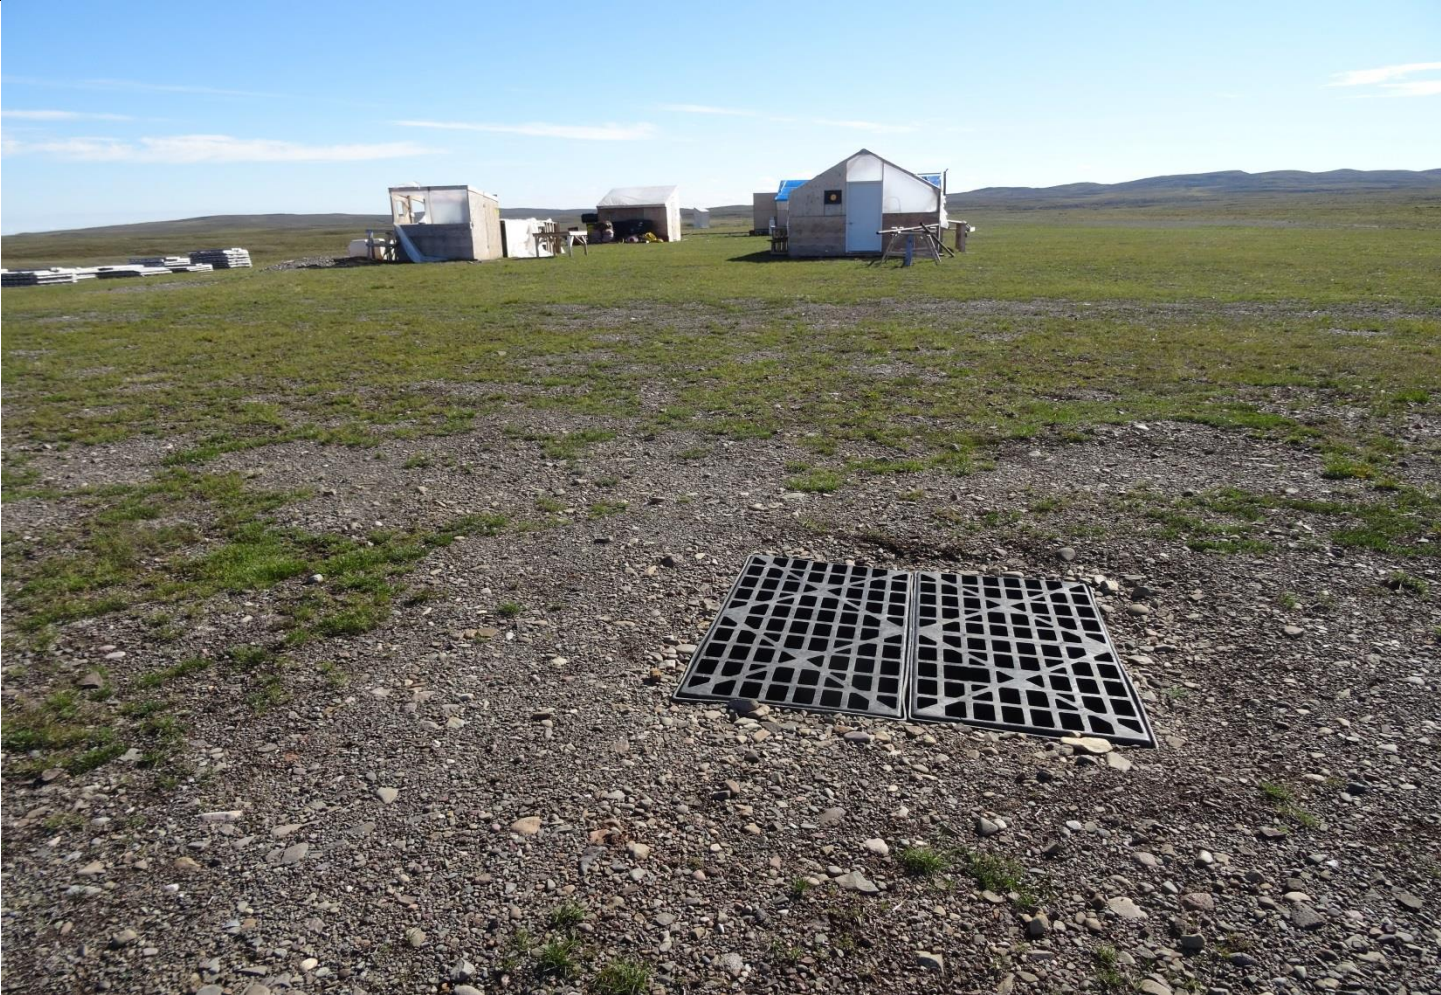
Photo 9

Description: Helicopter Refueling Secondary Containment buried into the ground requiring removal/remediation

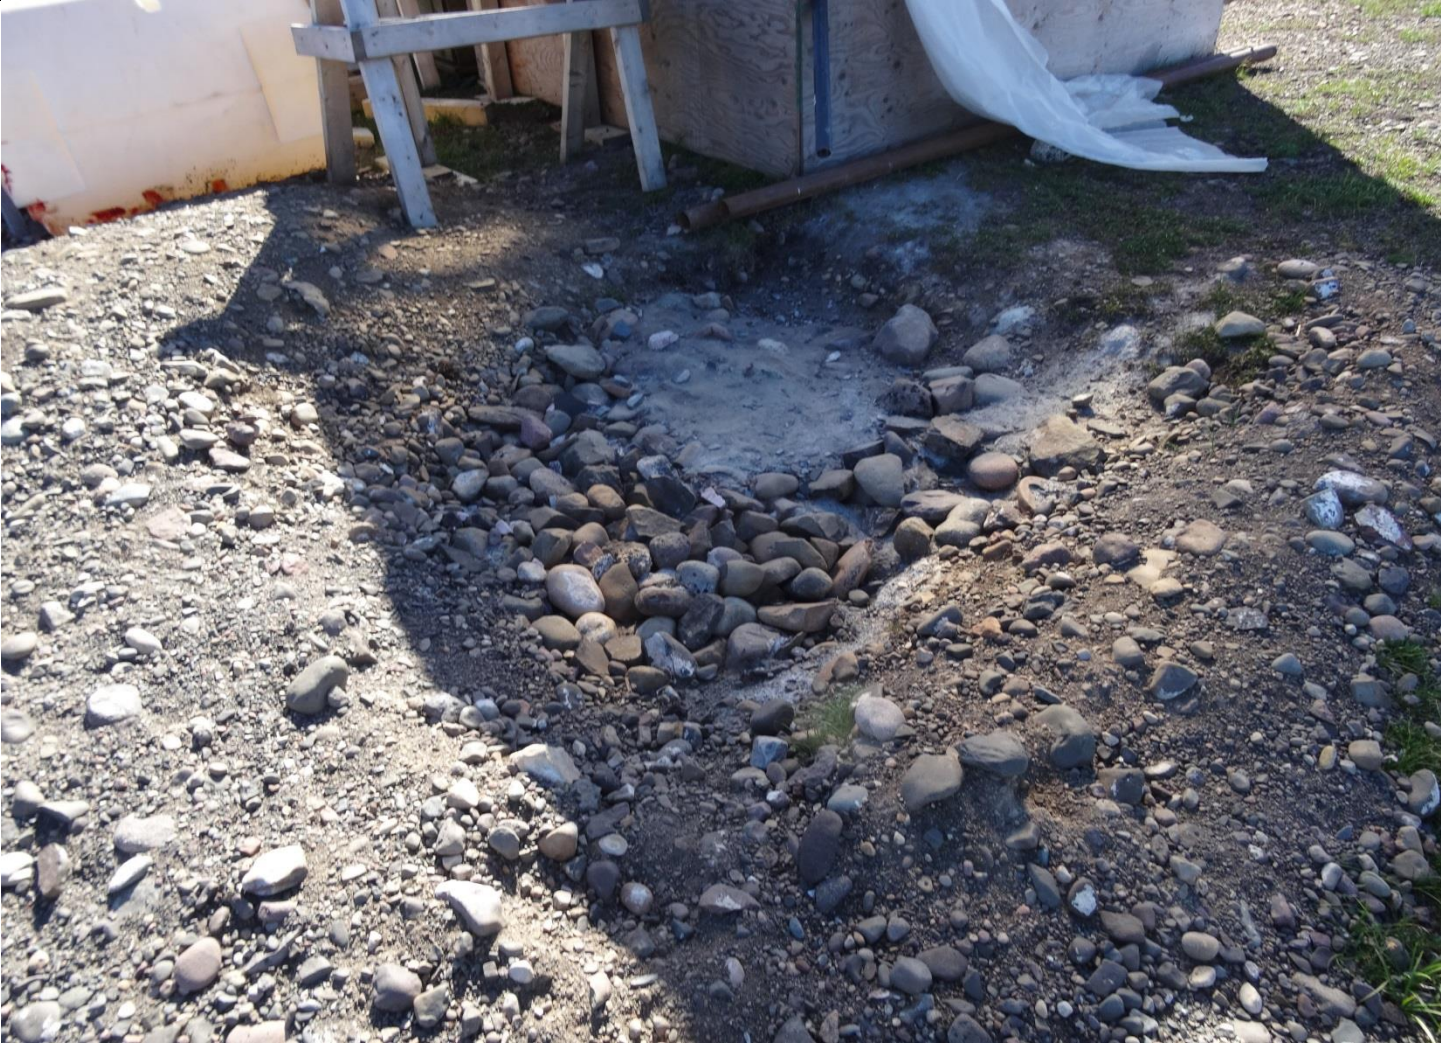
Photo 10

Description: Sump #1 requiring Treatment/Remediation

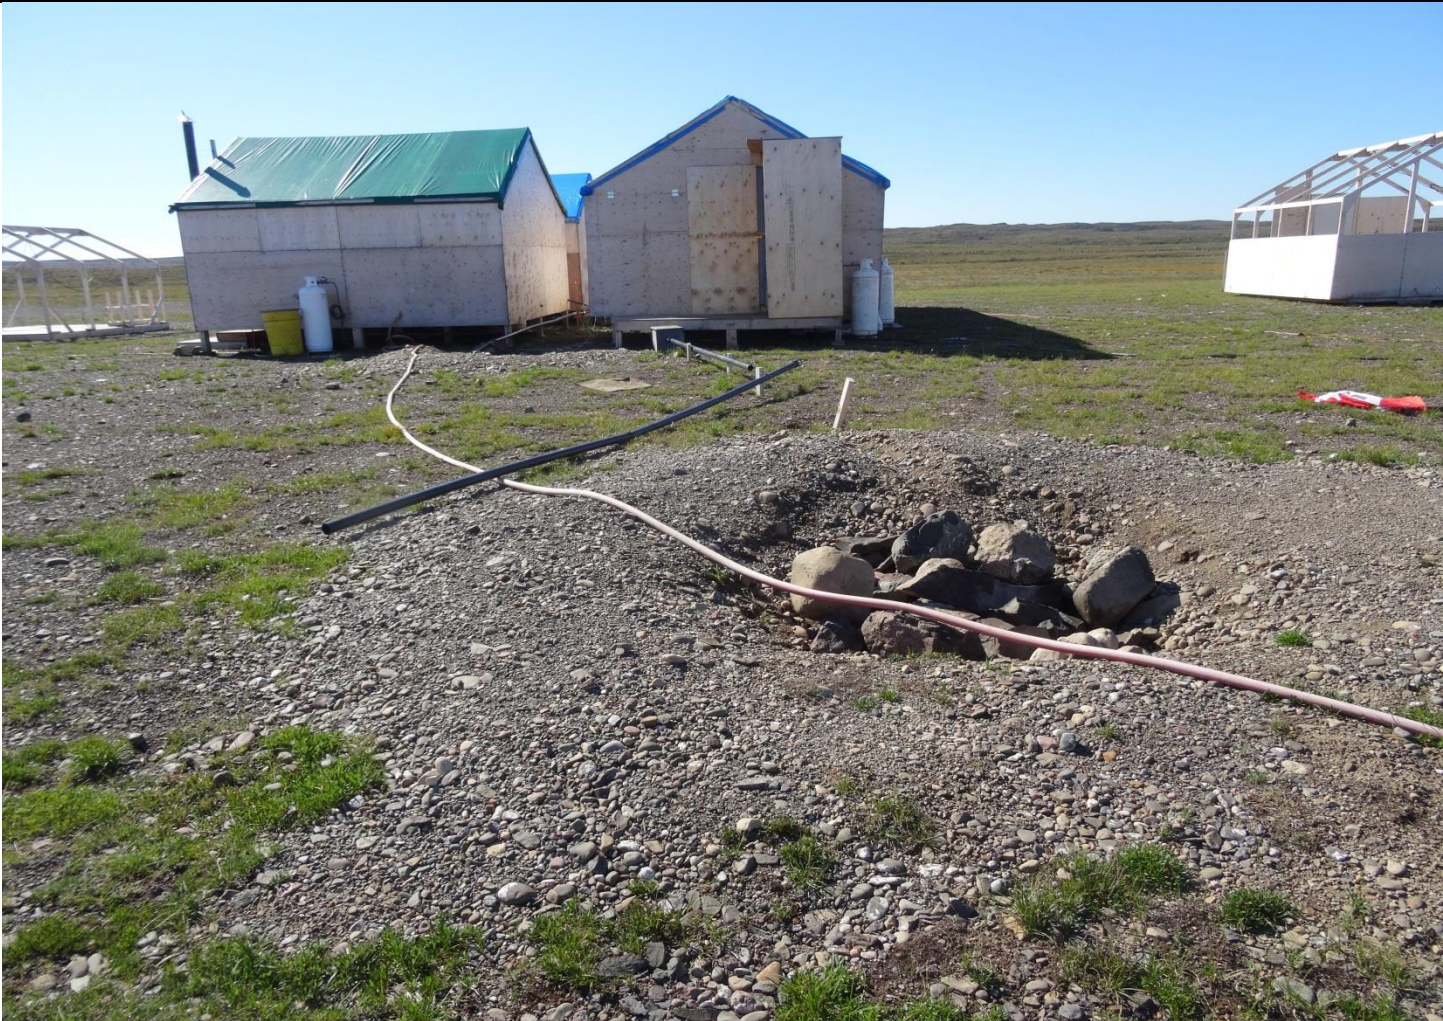
Photo 11

Description: Sump #2 requiring Treatment/Remediation

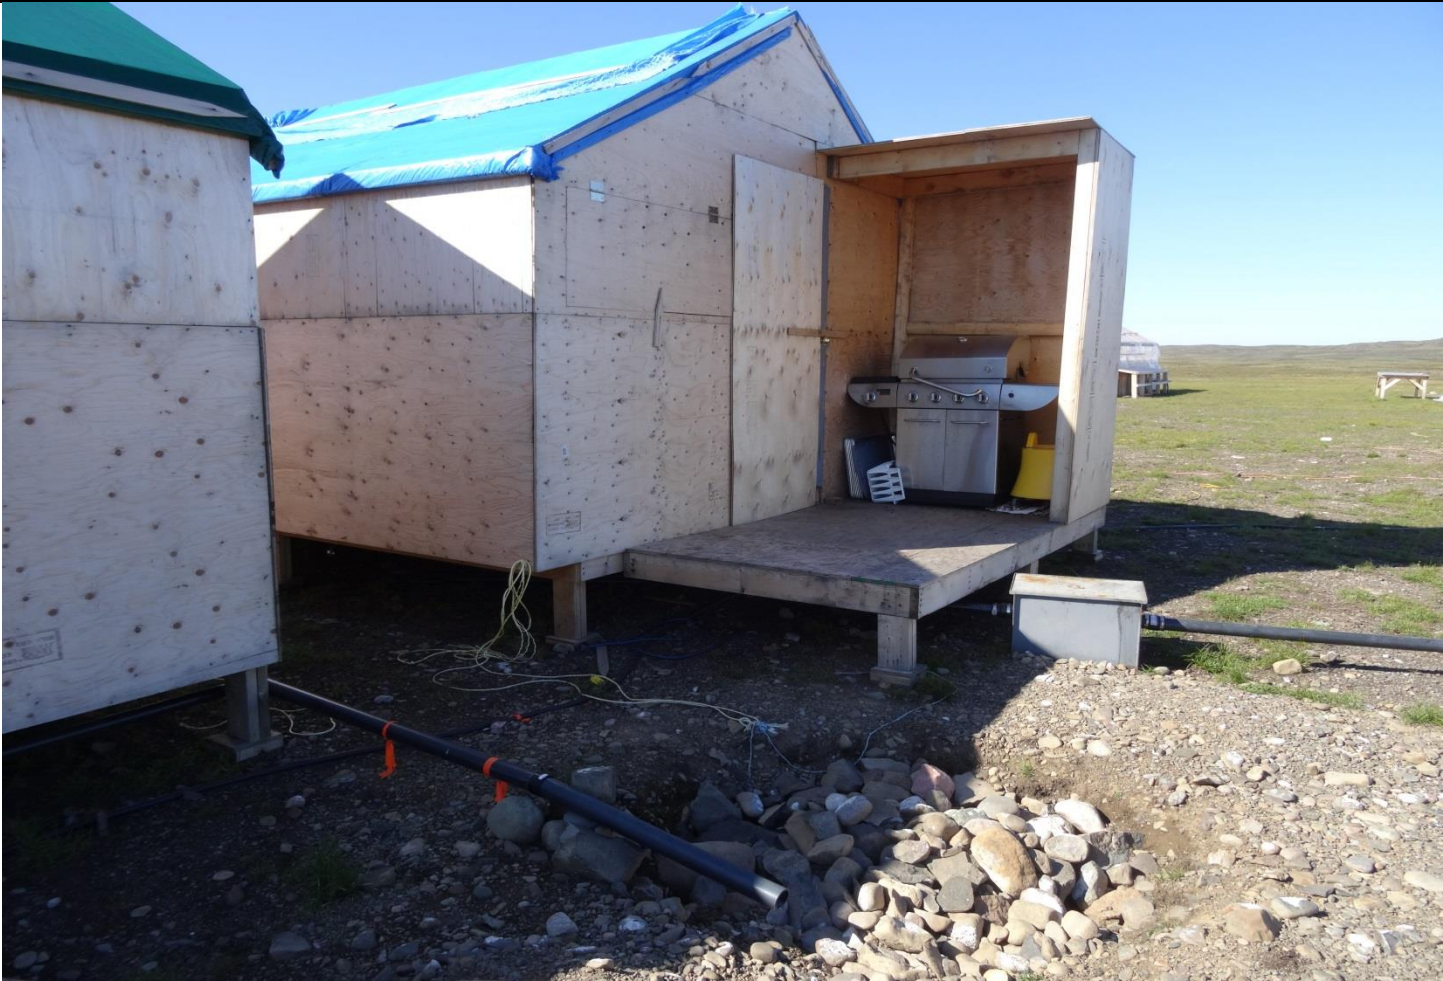
Photo 12

Description: Sump #3 requiring Treatment/Remediation
