## **REMEDIAL ACTION REPORT**

Detailing work completed to address  
*2013 Land Use Inspection Report and 2014 Water Licence Inspection Report*

### **COMMITTEE BAY PROJECT Kitikmeot Region, Nunavut Territory, Canada**

30 September 2014

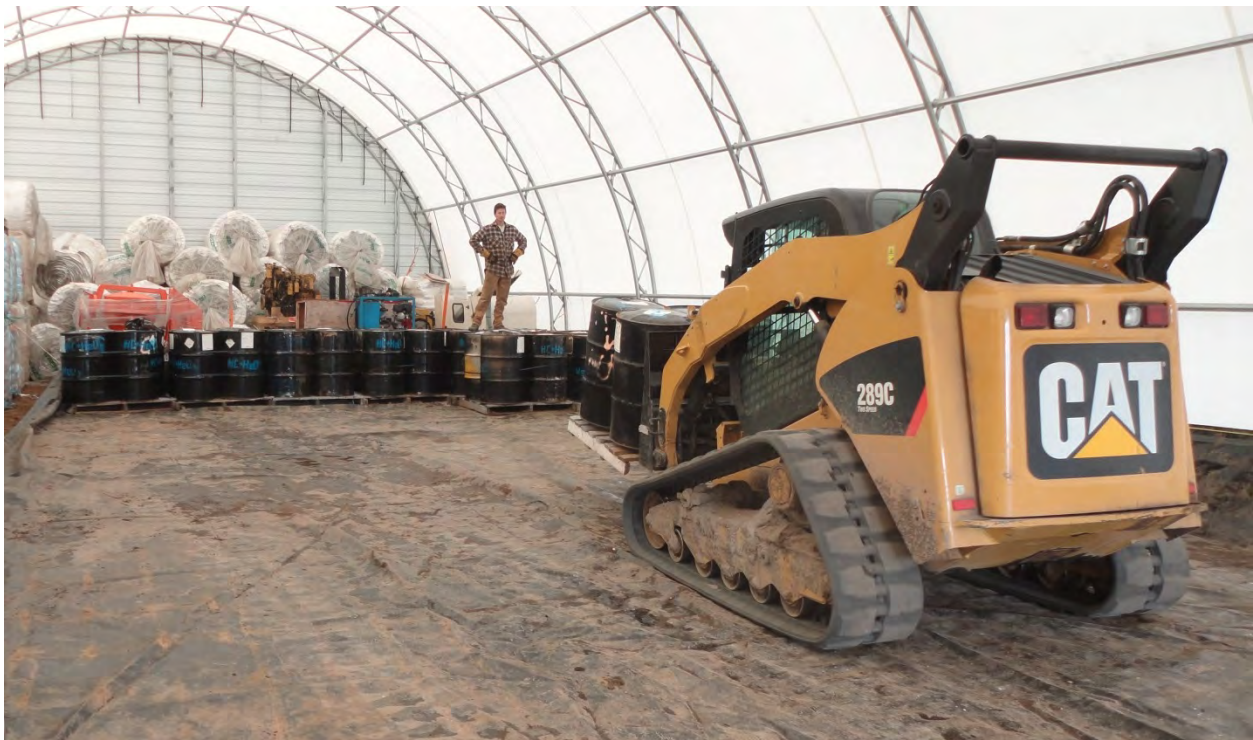
Figure 1 – Hazardous Waste being moved to berm located in Quonset #2.

All hazardous waste previously stored on the laydown between Hayes camp and the Hayes Camp airstrip was inspected, consolidated, repackaged into empty drums where appropriate, sealed, labelled, palletized and strapped and moved to a 25' x 50' x 24" berm set up within Quonset #2. Hazardous waste products and quantities stored in Quonset #2 are presented in table 2.

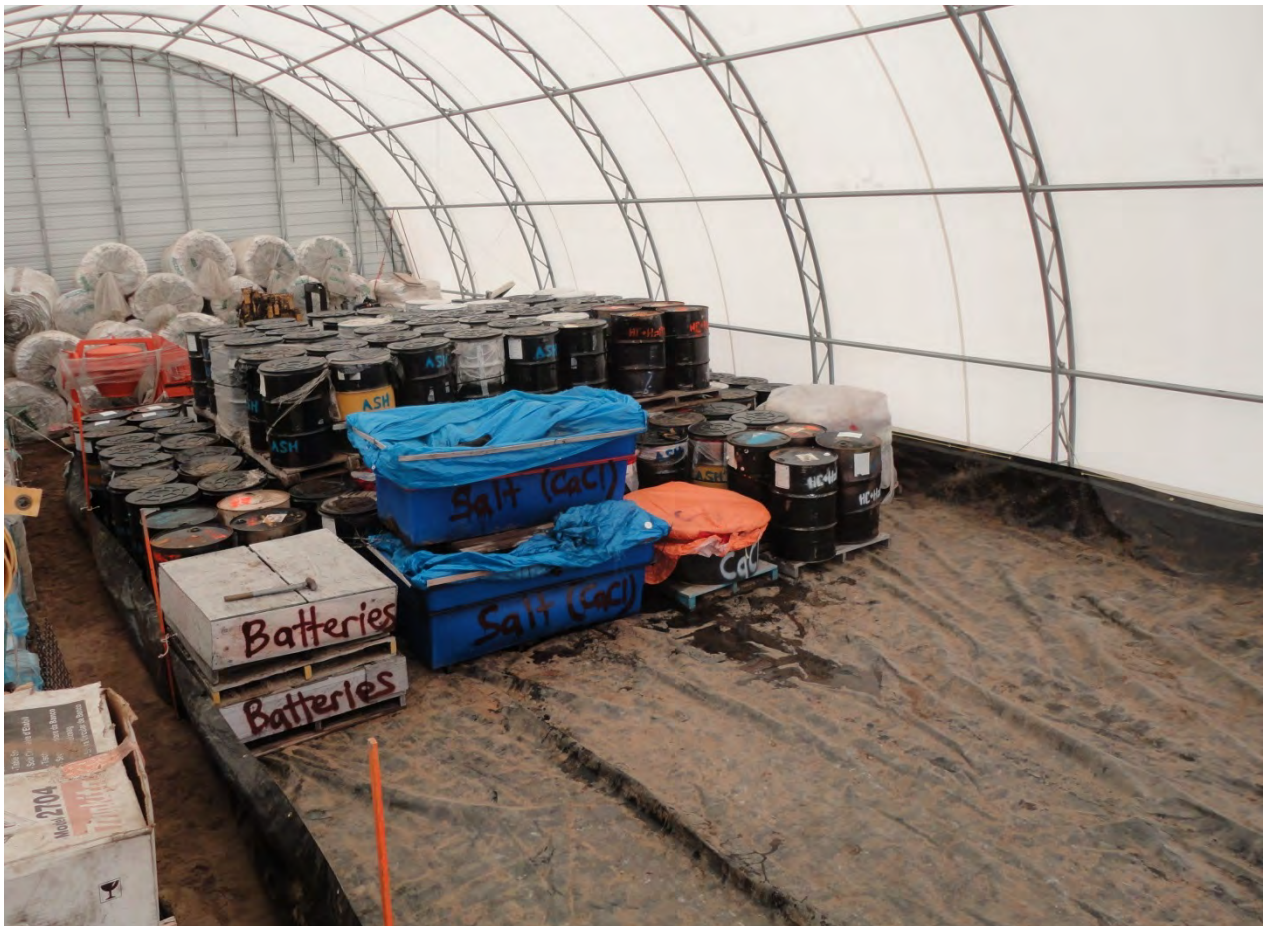
Figure 3 – Hazardous waste in berm

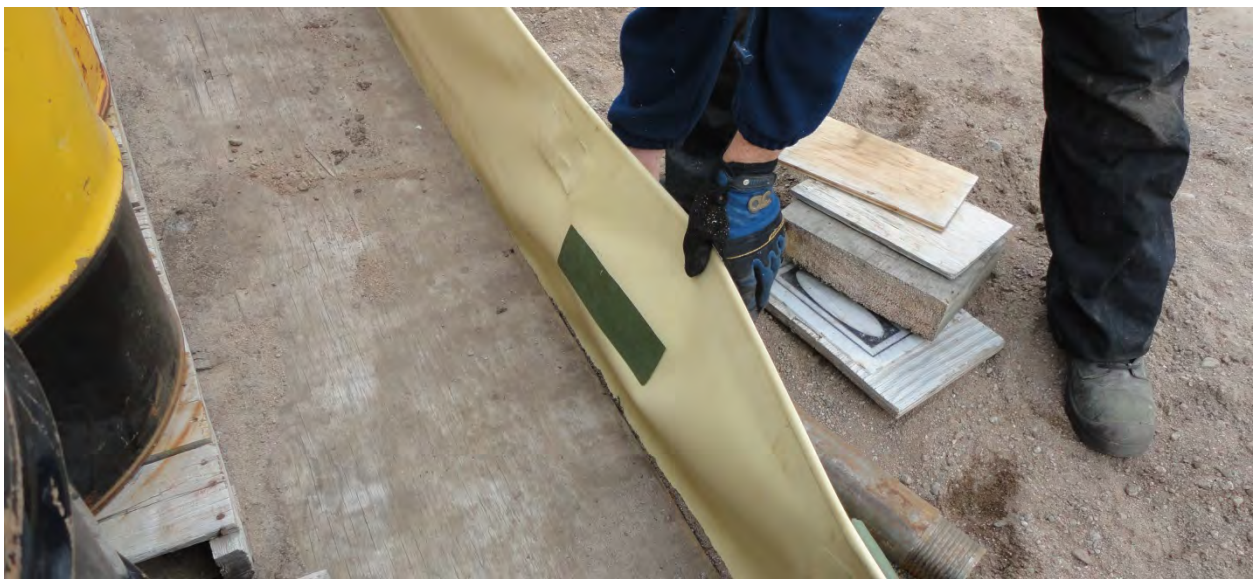
Figure 7 – Patching damaged fuel berm

- Berms were inspected for any contained water, hydrocarbons or damage.
- Any contained water within the berm was drained out through rain drains with newly installed replacement hydrocarbon filters.
- Any damage to the berm was repaired
- Berms support brackets were inspected, repaired or replaced as necessary.
- Fuel drums inside the berms were inspected for leaks.
- Fuel drums within the berms were reorganized and empty drums were added to the berm to reduce gaps and prevent the cover from collecting and ponding water.
- Berm covers and tie down attachments were repaired.
- Berm covers were installed using used drill rods, anchors and UV resistant polyester rope to ensure durability.
- Rain drains were removed and berm drain valves closed or bungs reinstalled.
- Signs were reinstalled where necessary.

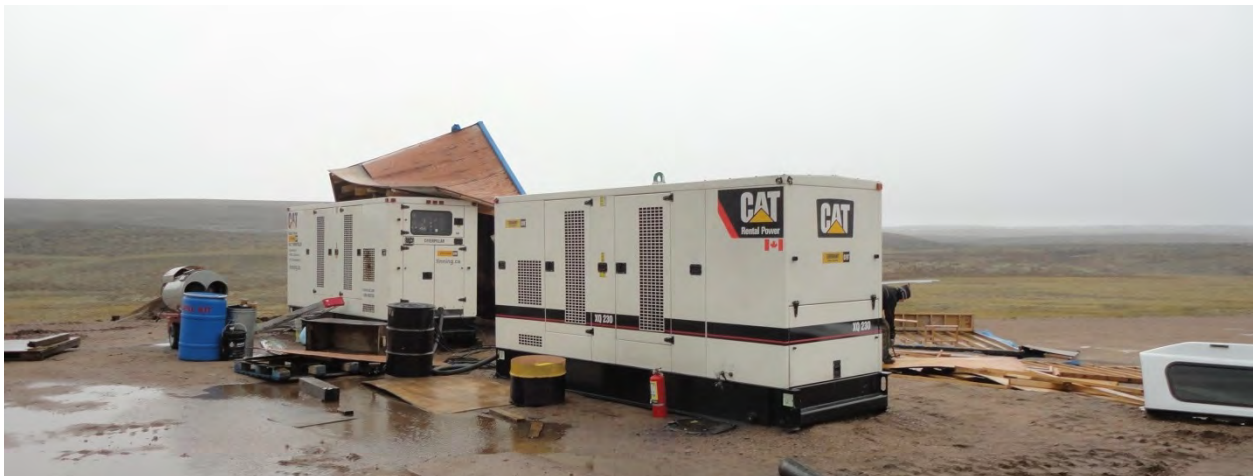
Figure 12 – Demolished Power Generation Shack

The power generation shack housing the Hayes Camp generators that was destroyed during the strong wind was removed, salvaged and a new shack constructed. All garbage and debris from the damaged shack was removed.

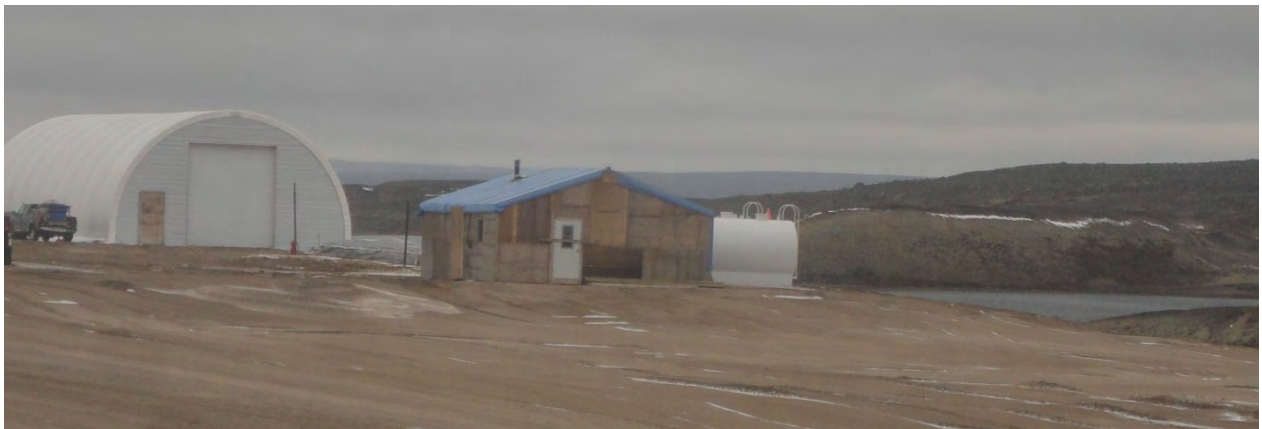
Figure 14 – Rebuilt Generator shack. All debris from damaged shack removed. (Same view as 2014 Inspection Report Figure 20)

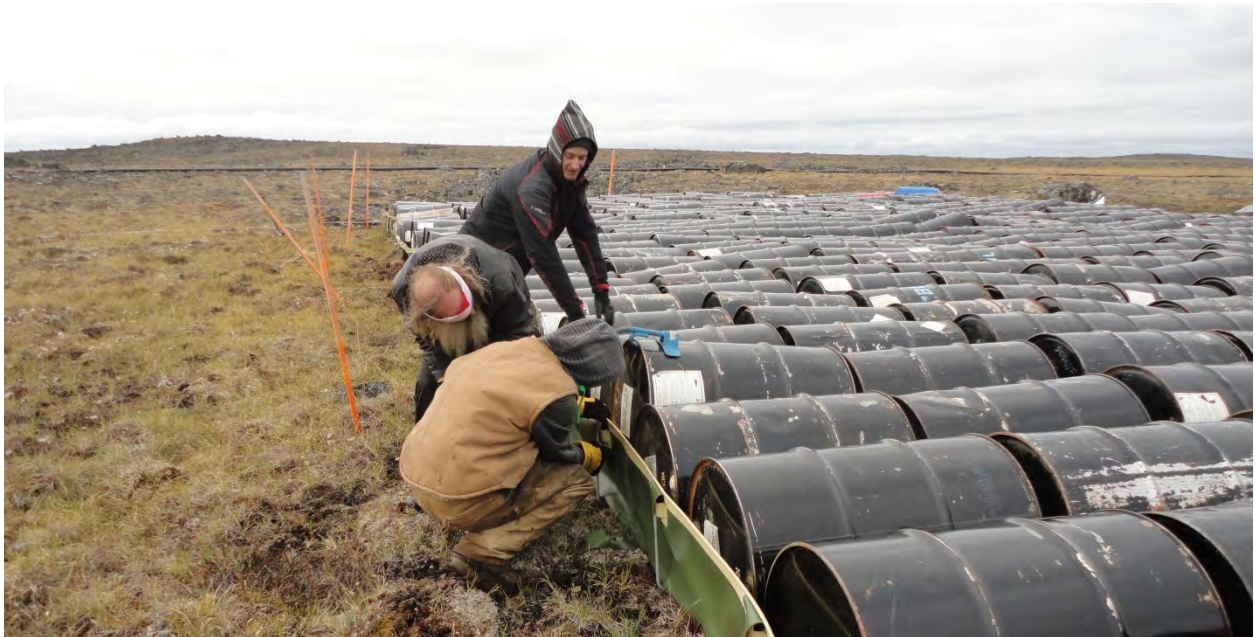
Figure 20 – Replacing damaged support brackets on berm 3 at Three Bluffs.

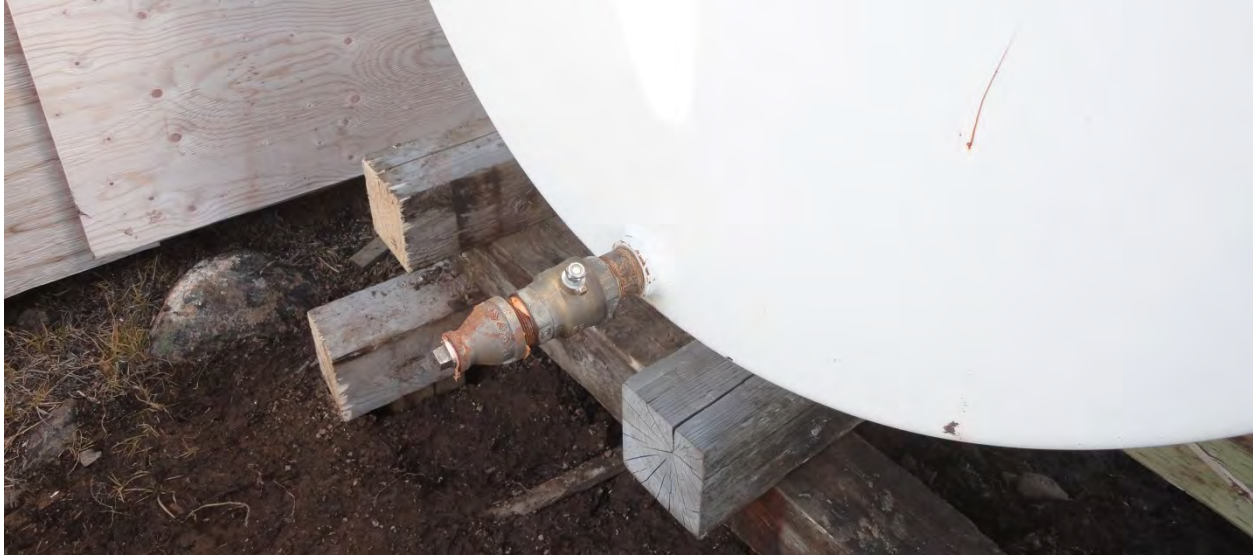
Figure 29 – Fuel hoses were removed from the base of the tank, the valve handle removed and a bung installed to prevent any accidental discharge.

The double walled fuel tank at the boiler was inspected and a decision was made to relocate the tank and reconstruct a solid base for the tank. All hoses were removed from the base of the tank. The valve handle was removed and a bung installed to eliminate any risk of accidental discharge.

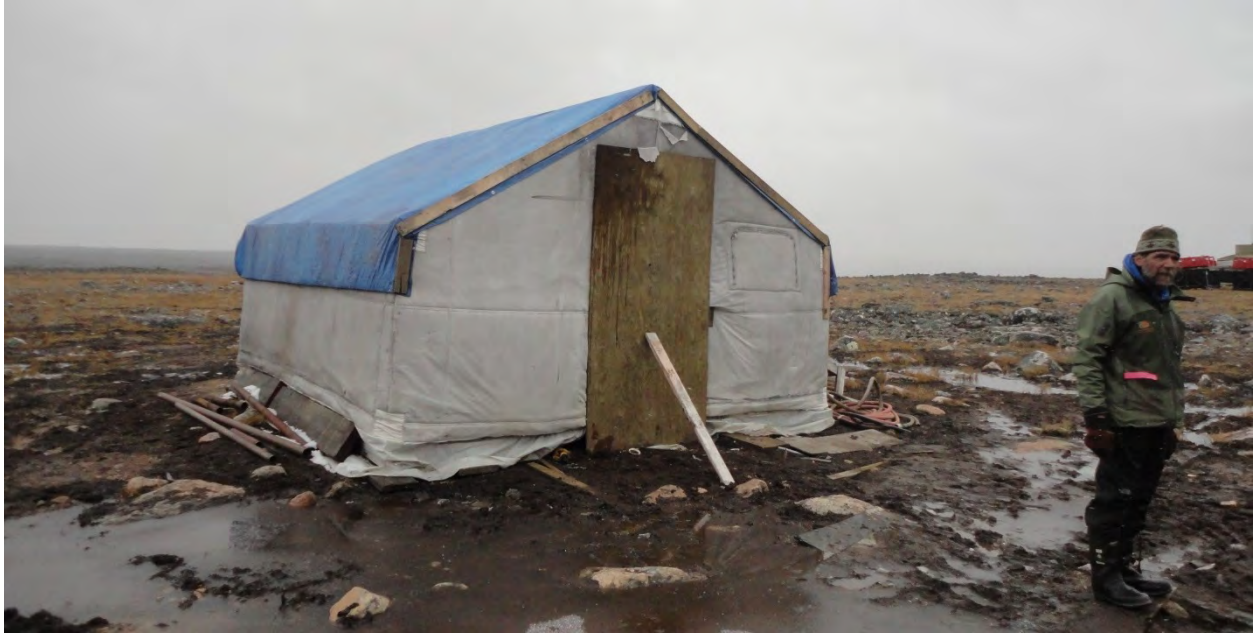
Figure 31 – Repaired drill storage tent at Three Bluffs drill grid.

The storage tent at the drillers` laydown at the Three Bluffs drill grid was repaired and secured for winter.

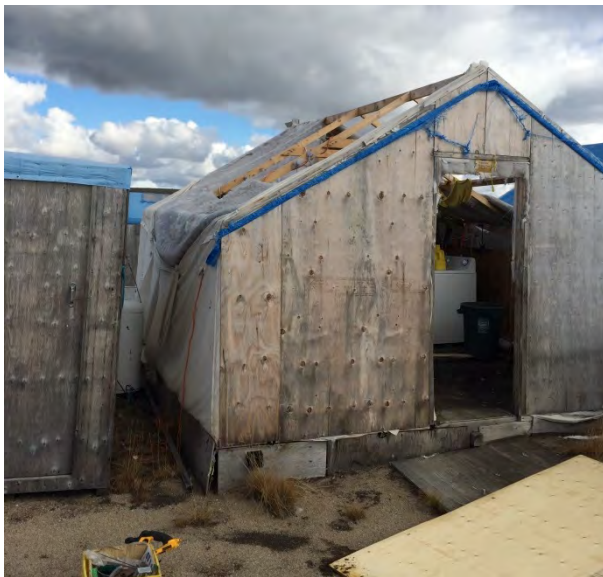
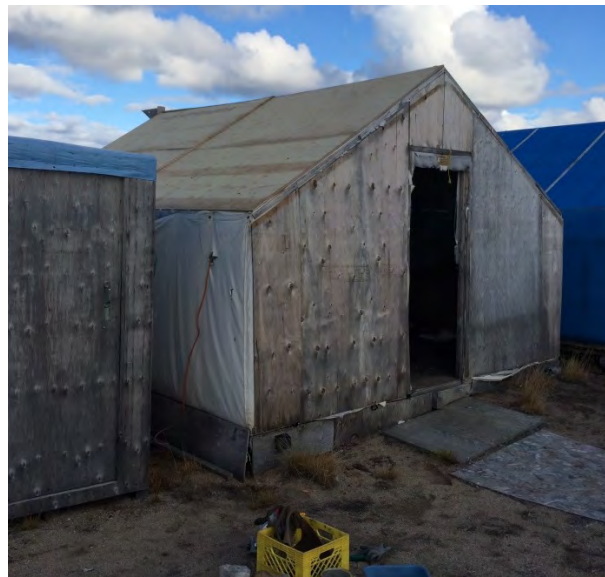
Figure 32 – Repaired roof at Bullion Camp.

NCGC completed camp maintenance at Bullion camp during the 2014 program. Damaged tents were repaired wherever possible. One tent was re-roofed. A number of canvasses were removed from the tent frames where the extent of damage was beyond repair.

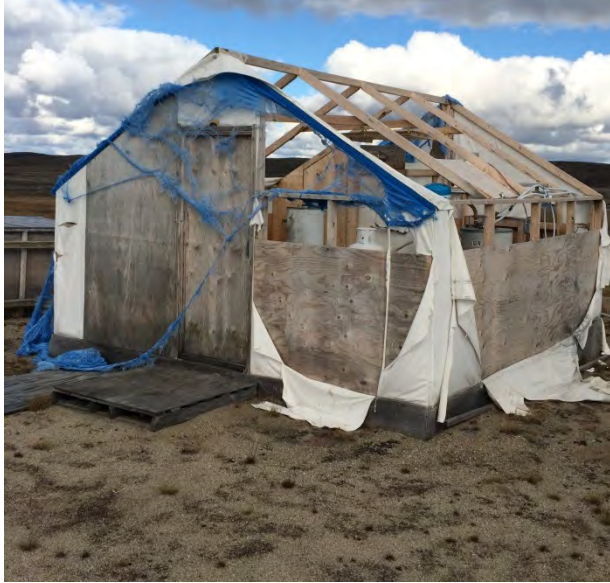
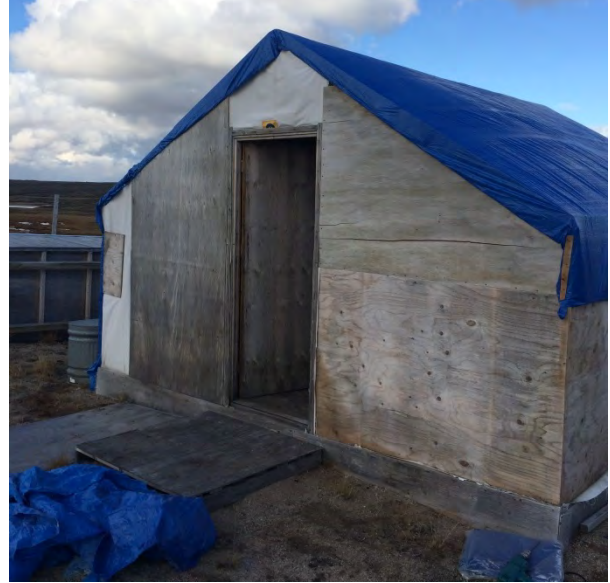
Figure 33 – Repaired tent at Bullion Camp.

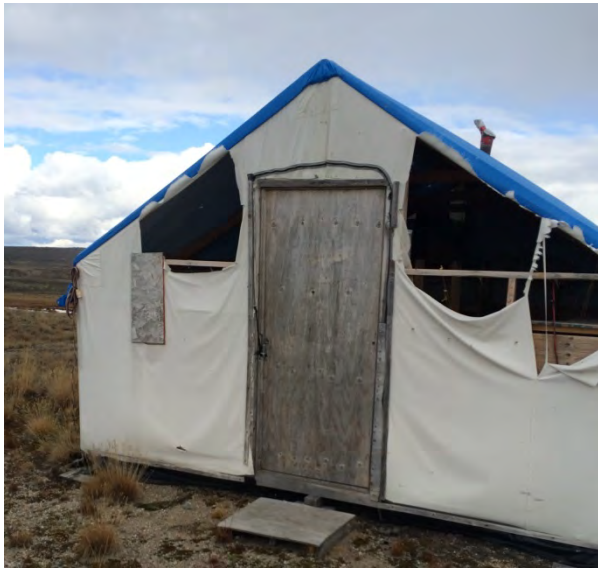
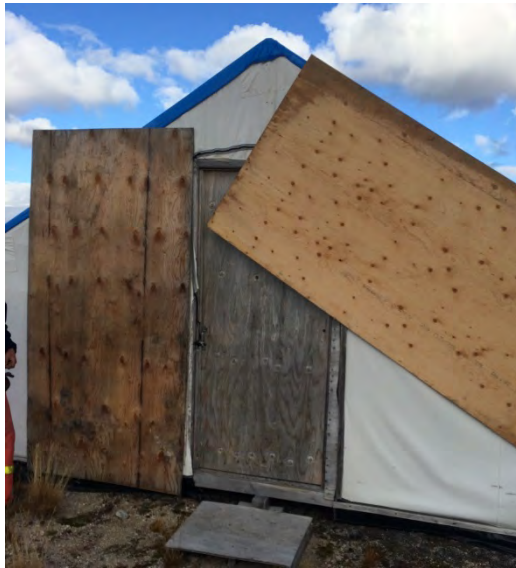
Figure 34 – Repaired tent canvas at Bullion Camp.

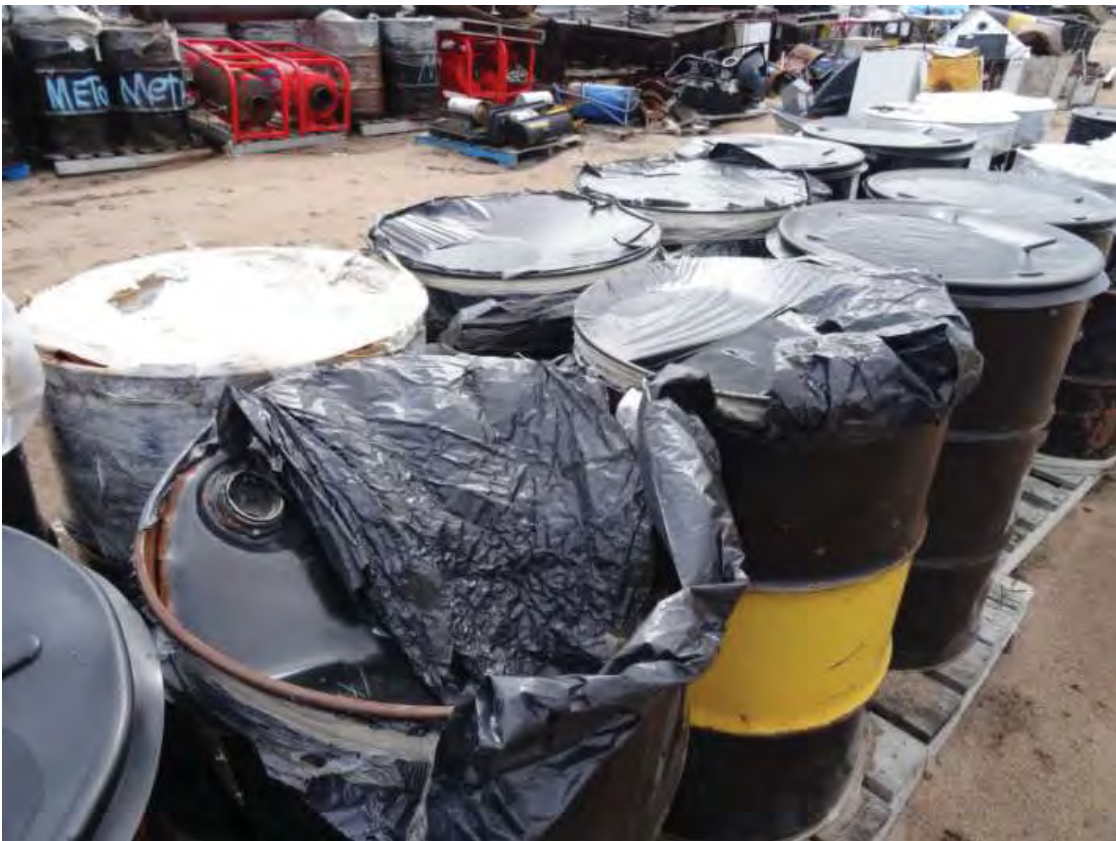
Figure 4. Barrels are no longer sealed.

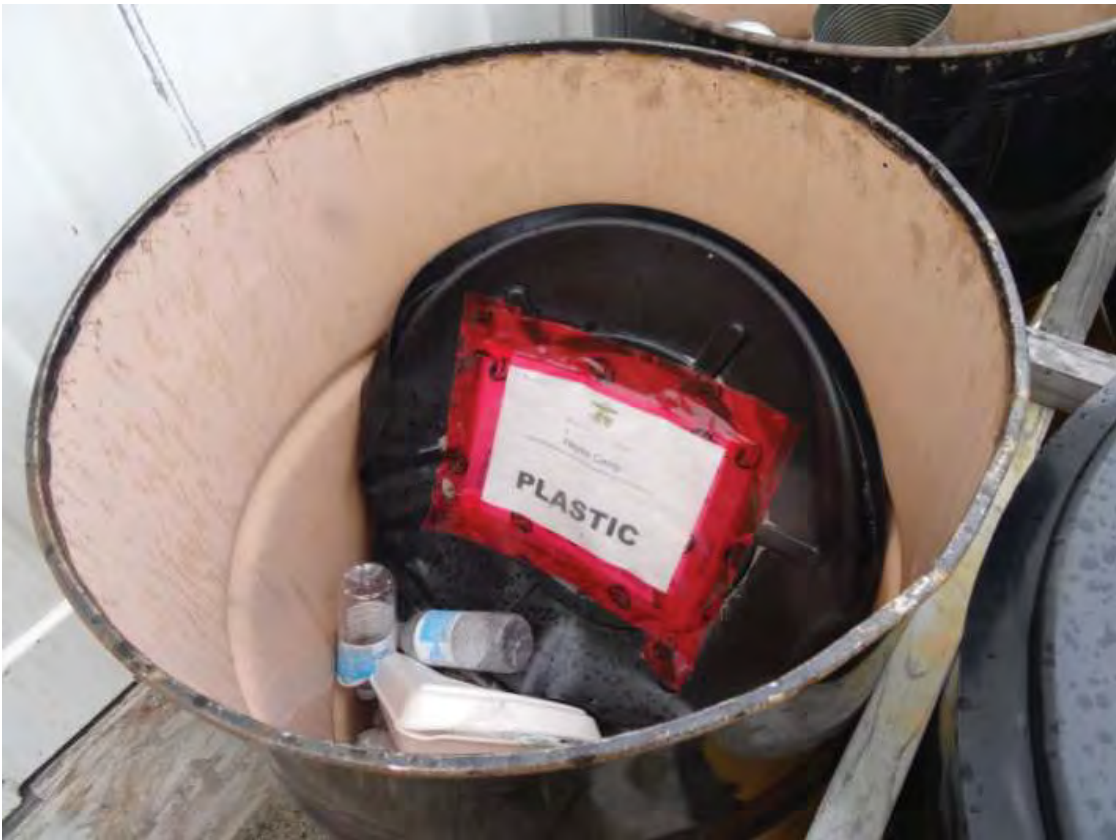
Figure 8. Garbages within the camp were not emptied.

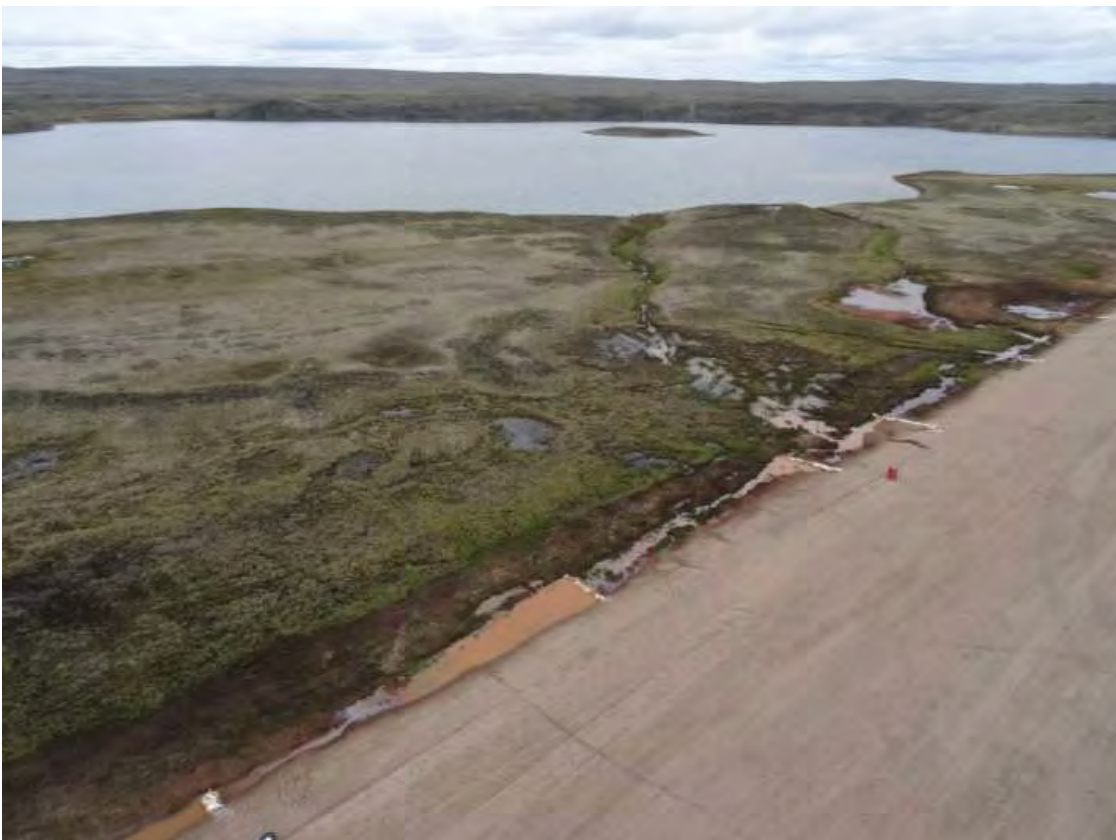
Figure 16. Pooling/ponding on the side of the airstrip; sediment evident in water flowing down-slope.

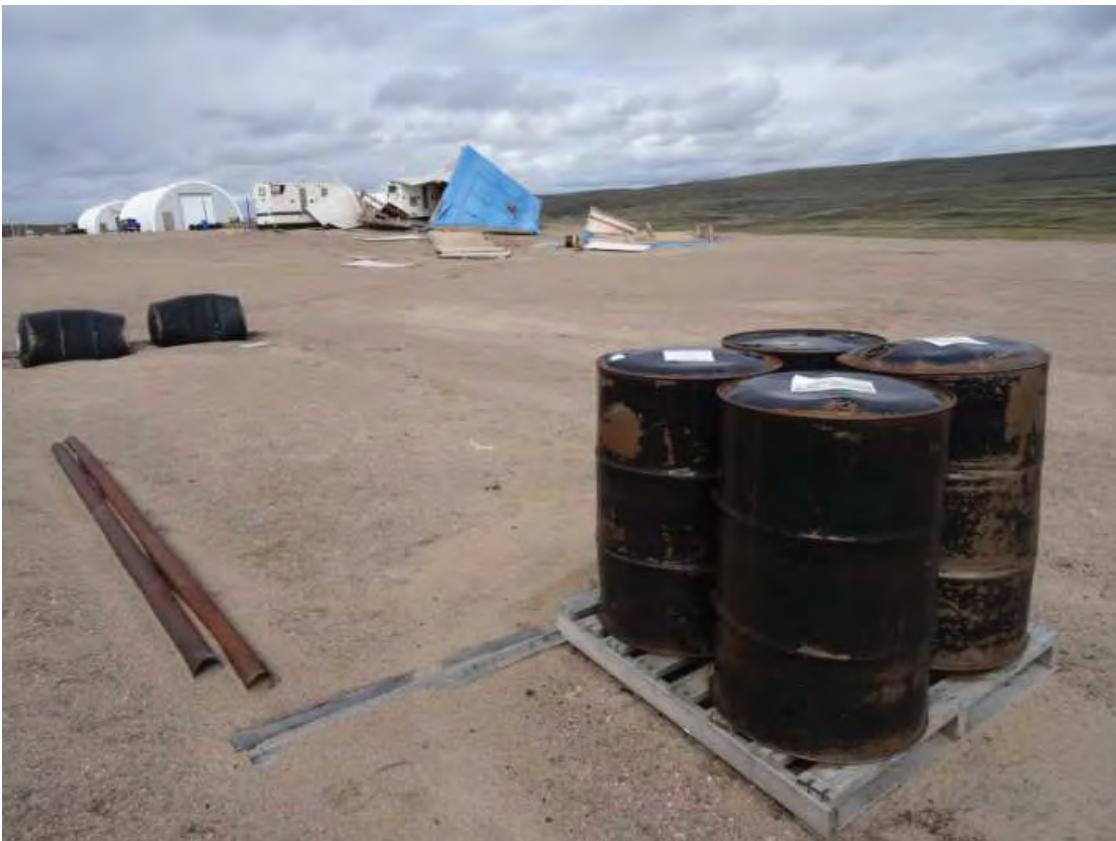
Figure 20. Full diesel barrels at the airstrip.

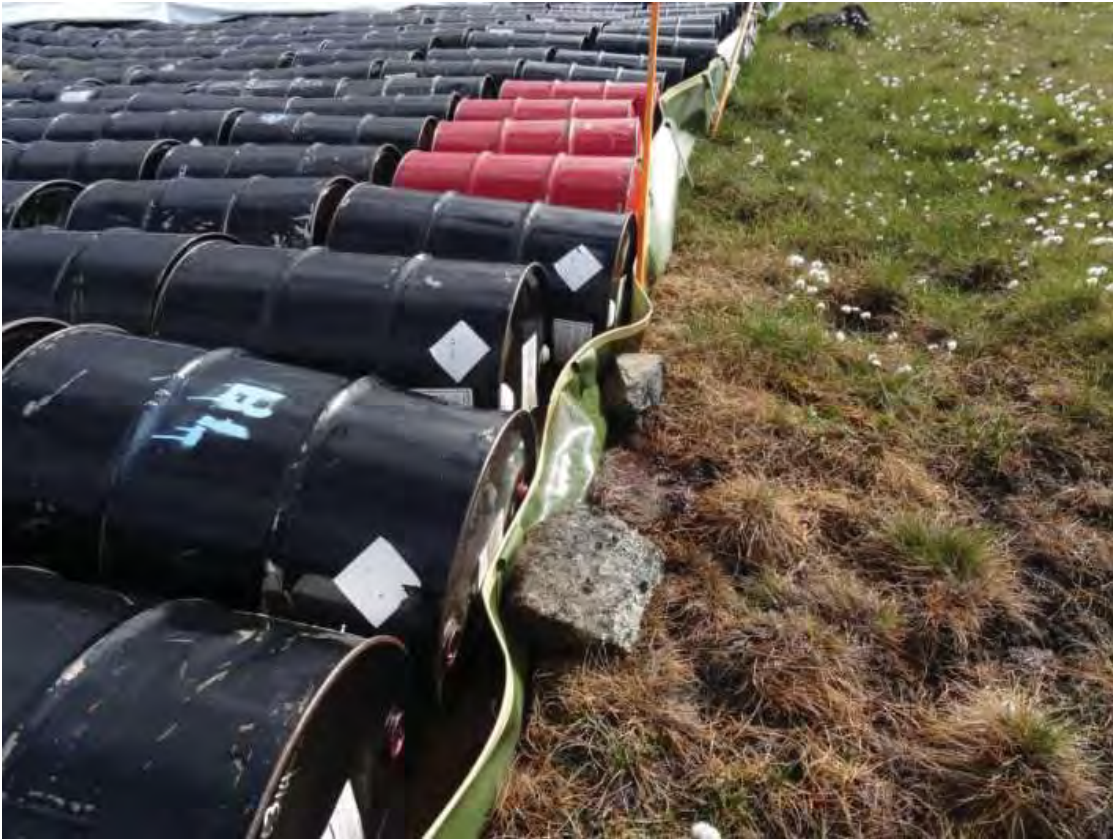
Figure 25. I propped up the side for a temporary fix. More precipitation will cause further overflow of contaminated water.

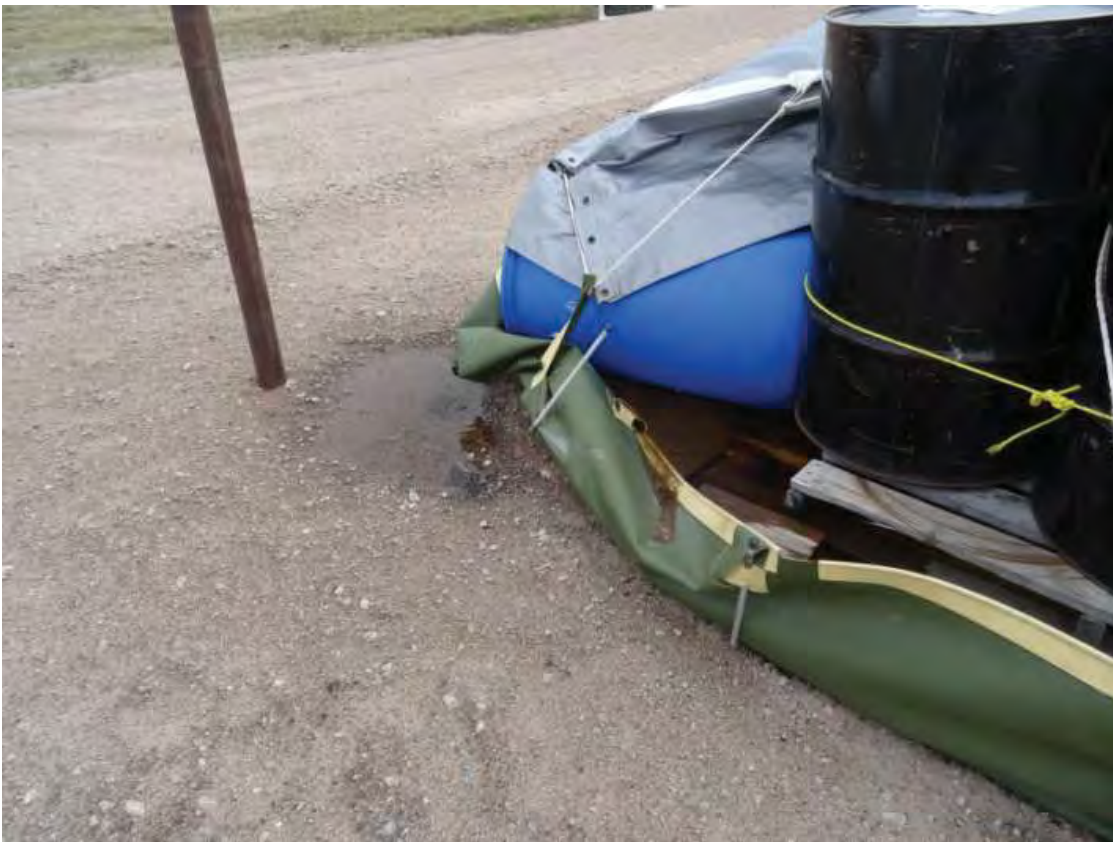
Figure 26. Hayes Camp berm; corner dripping. No obvious contamination at this time.
