## **REMEDIAL ACTION REPORT**

Detailing work completed to address  
*2013 Land Use Inspection Report and 2014 Water Licence Inspection Report*

### **COMMITTEE BAY PROJECT Kitikmeot Region, Nunavut Territory, Canada**

30 September 2014

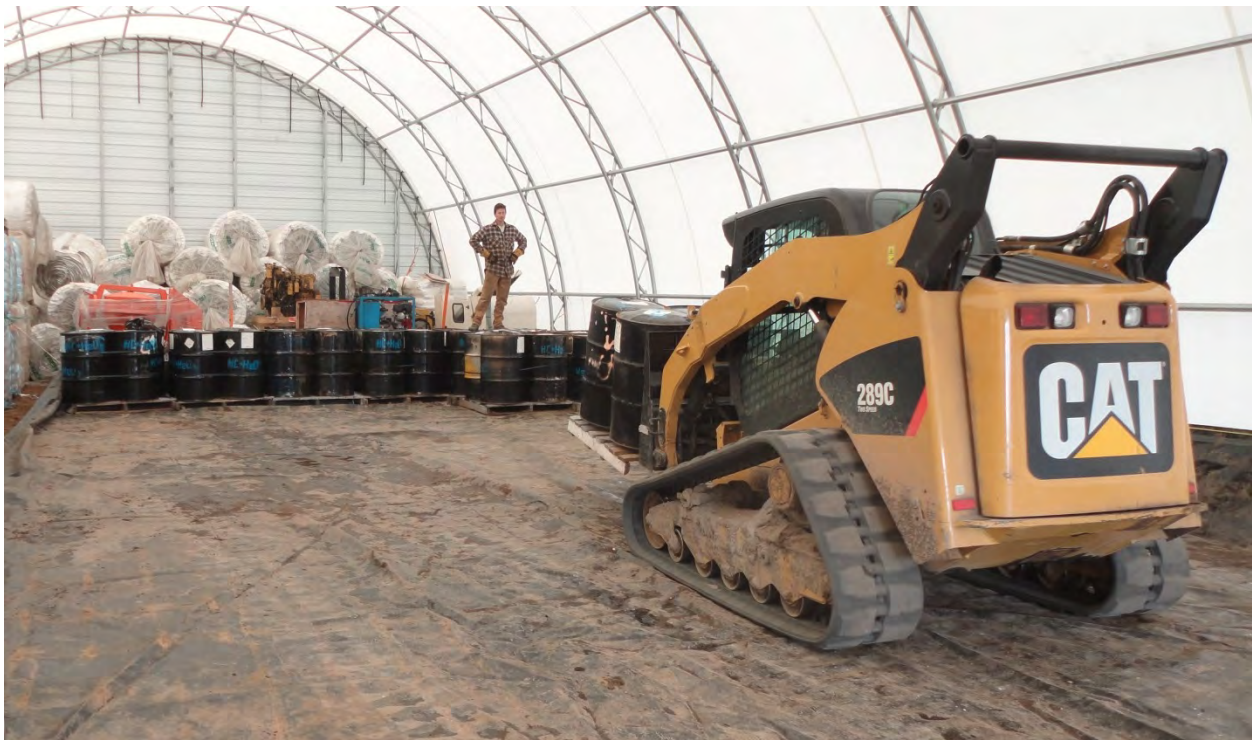
Figure 1 – Hazardous Waste being moved to berm located in Quonset #2.

All hazardous waste previously stored on the laydown between Hayes camp and the Hayes Camp airstrip was inspected, consolidated, repackaged into empty drums where appropriate, sealed, labelled, palletized and strapped and moved to a 25' x 50' x 24" berm set up within Quonset #2. Hazardous waste products and quantities stored in Quonset #2 are presented in table 2.

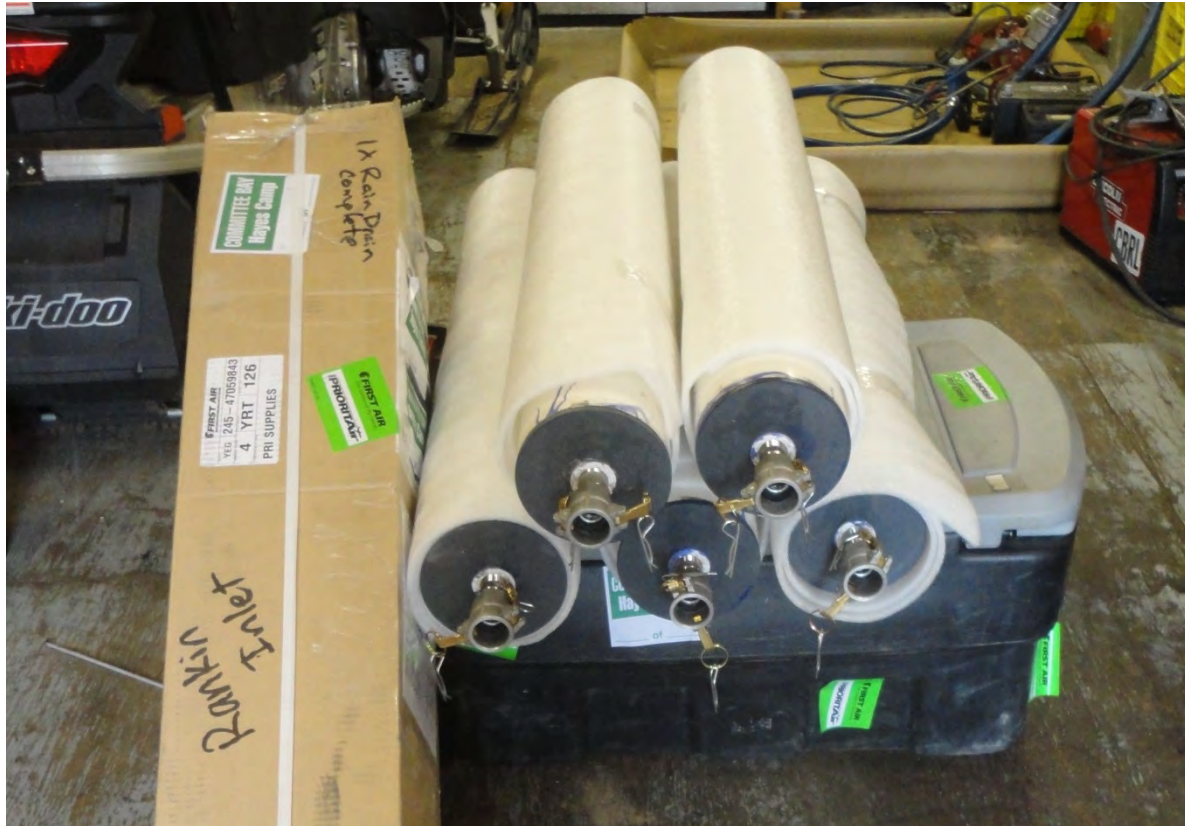
Figure 4 – New rain drain filters ready for installation

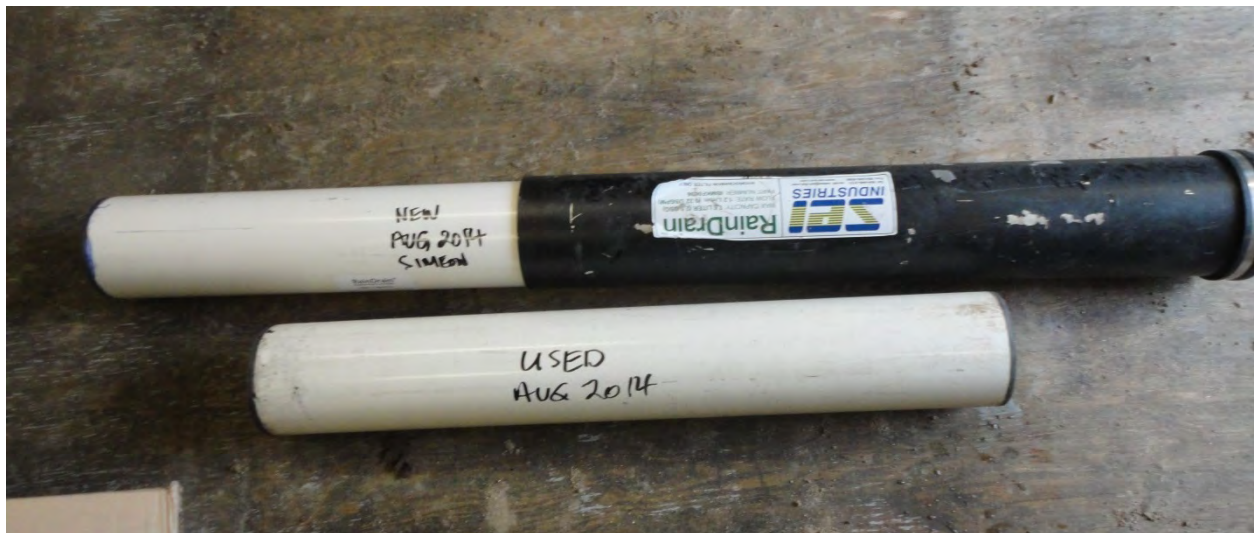
Figure 5 – Rain drain filters replaced.

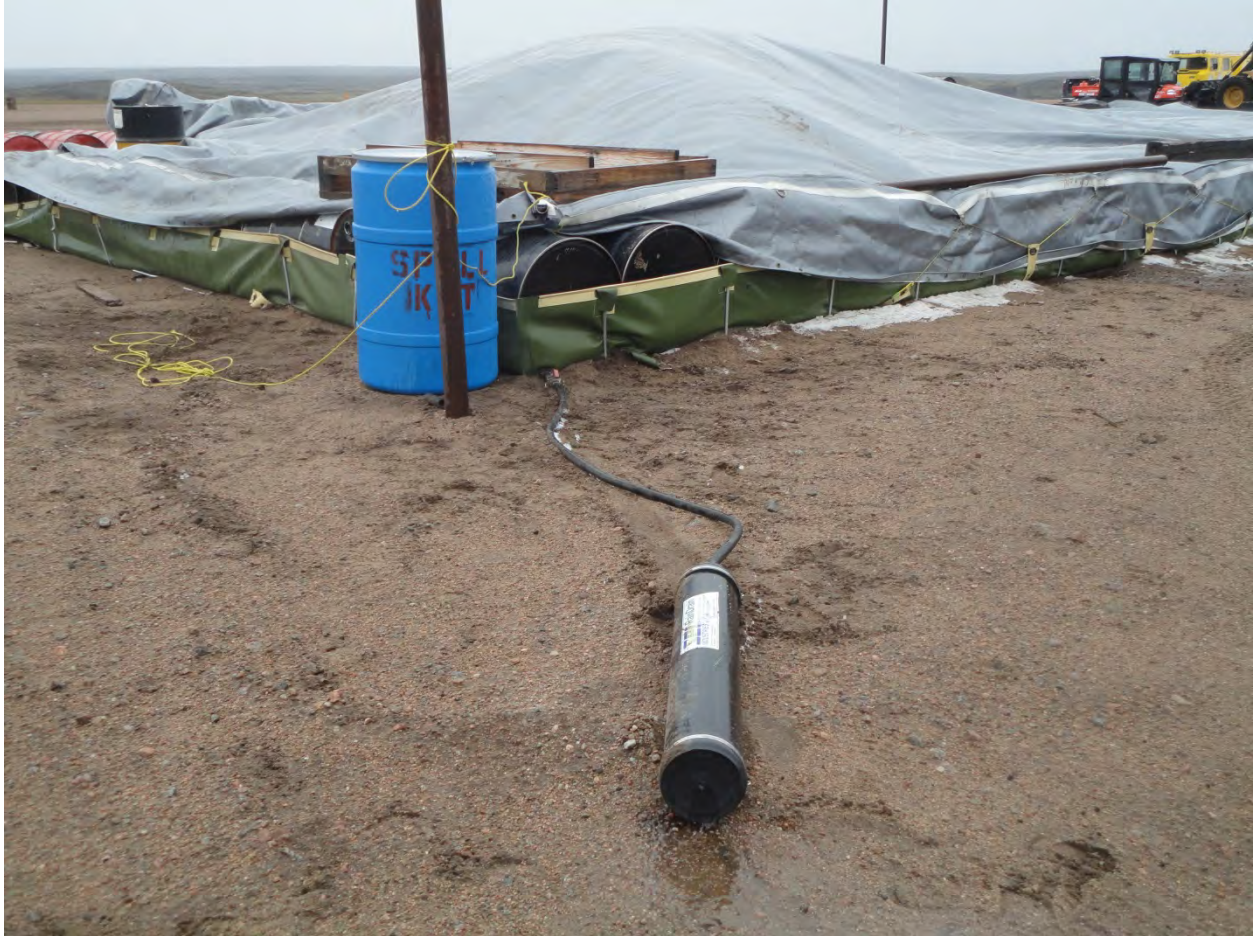
Figure 6 – Rain Drain filters attached to drain water from berm

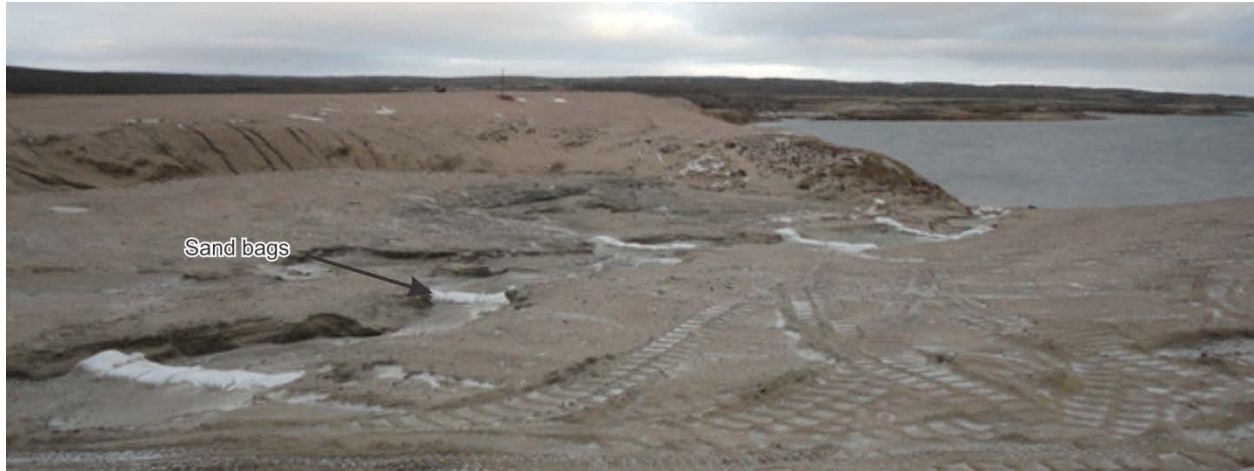
Figure 11 – Erosion control measures implemented (view southeast)

- Filling new erosion ruts with sandbags to prevent further erosion
- Creating sand bag dams on steep slopes to reduce the velocity of moving water and prevent further erosion. Dams were constructed using permeable burlap sand bag to minimize ponding of water.
- Silt fences were installed on gentle slopes to collect sediment and prevent entry into Sandspit Lake.

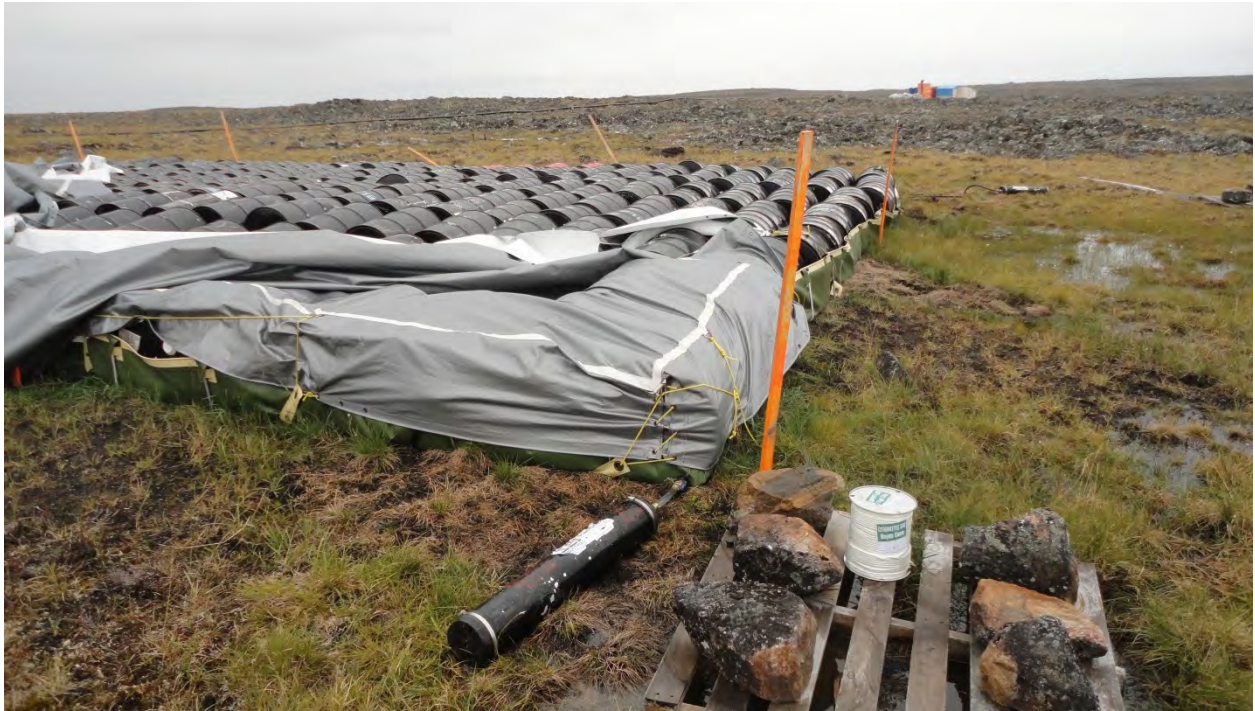
Figure 18 – Two 'Rain Drain' filters attached to Berm 2 (2014 Inspection Report Figure 24) to treat hydrocarbon contaminated water

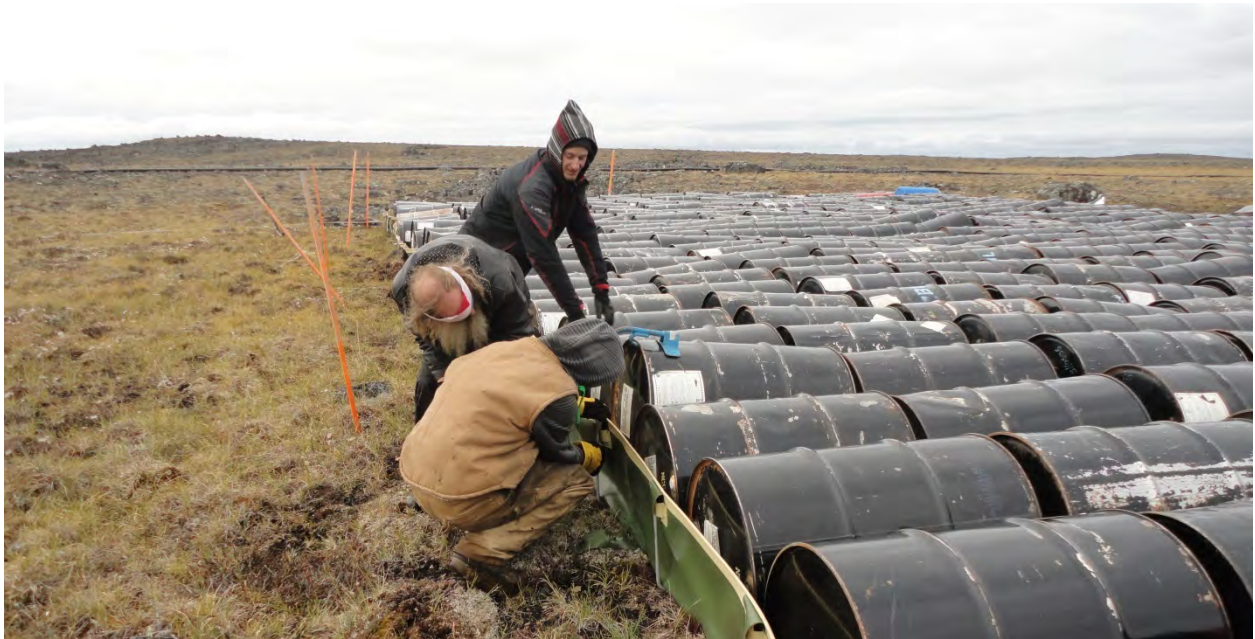
Figure 20 – Replacing damaged support brackets on berm 3 at Three Bluffs.

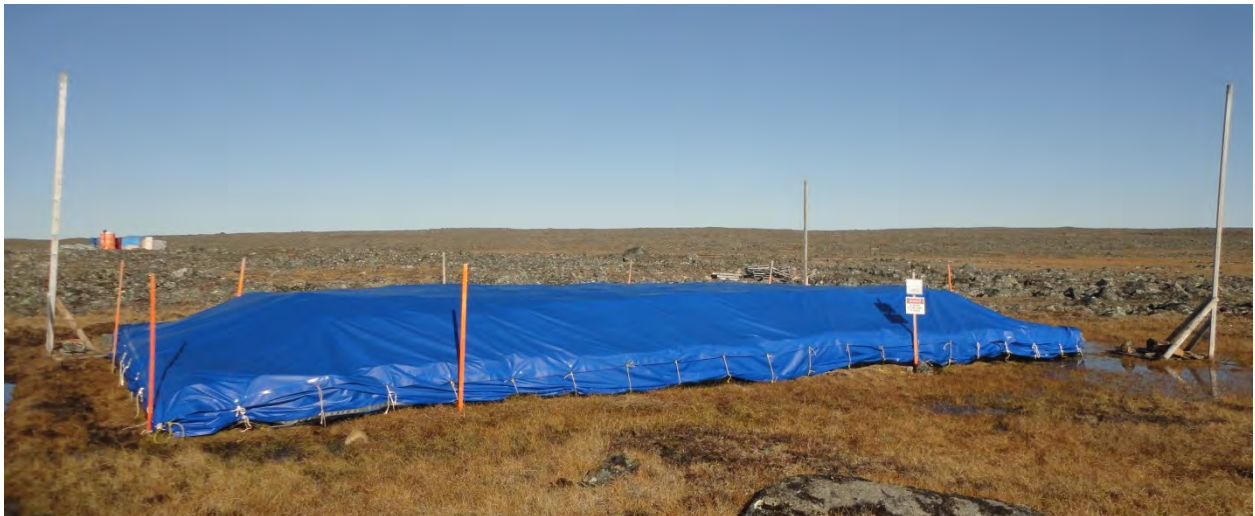
Figure 24 – Fuel Berm 1 at Three Bluffs (2014 Inspection report Figures 11 and 14)

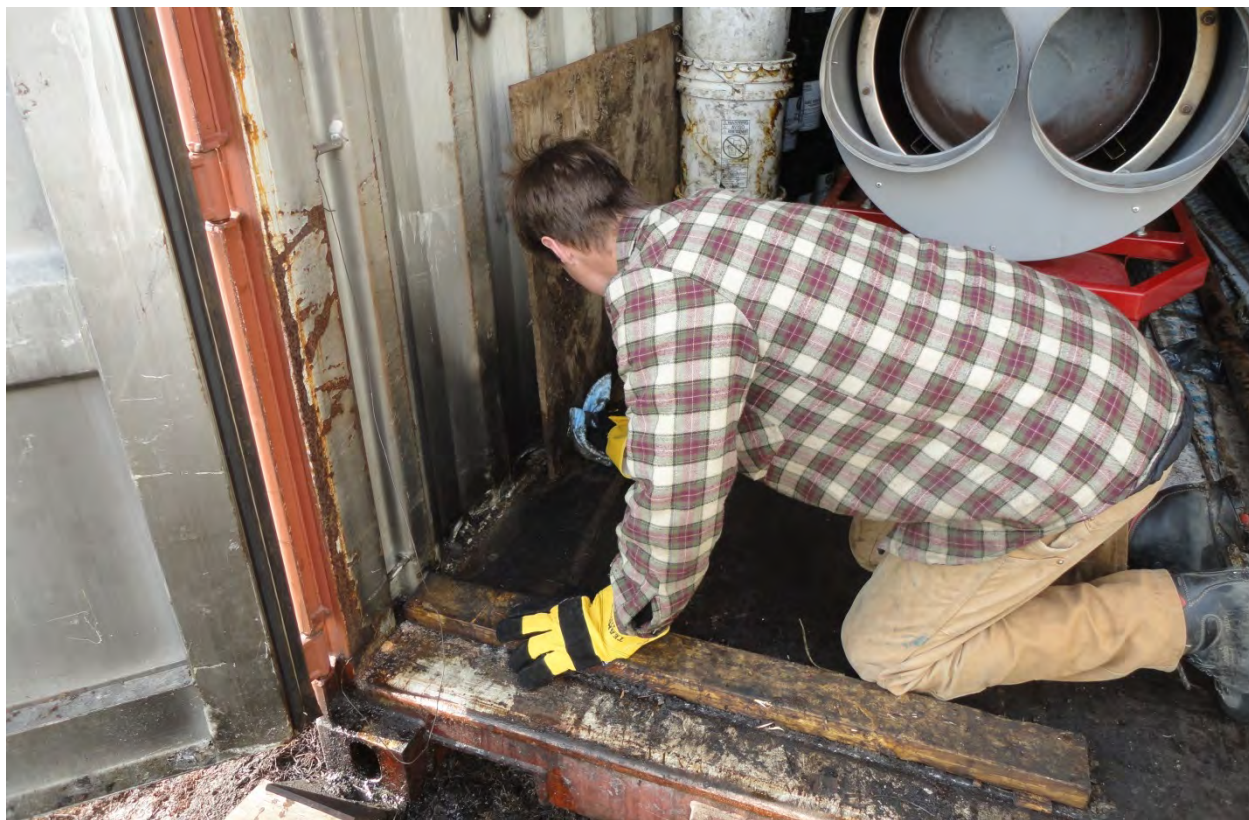
Figure 26 – Cleaning up contamination within red sea container

The red sea container (leaking contaminated water out the door) was inspected for the source of contamination. A leaking container of biodegradable drilling additive was identified as the source of contamination and was placed inside suitable containment. Residual drilling additive was removed from the sea container floor and contaminated soil was excavated, placed in a sealed drum and transported back to Hayes Camp and stored within containment in Quonset #2.

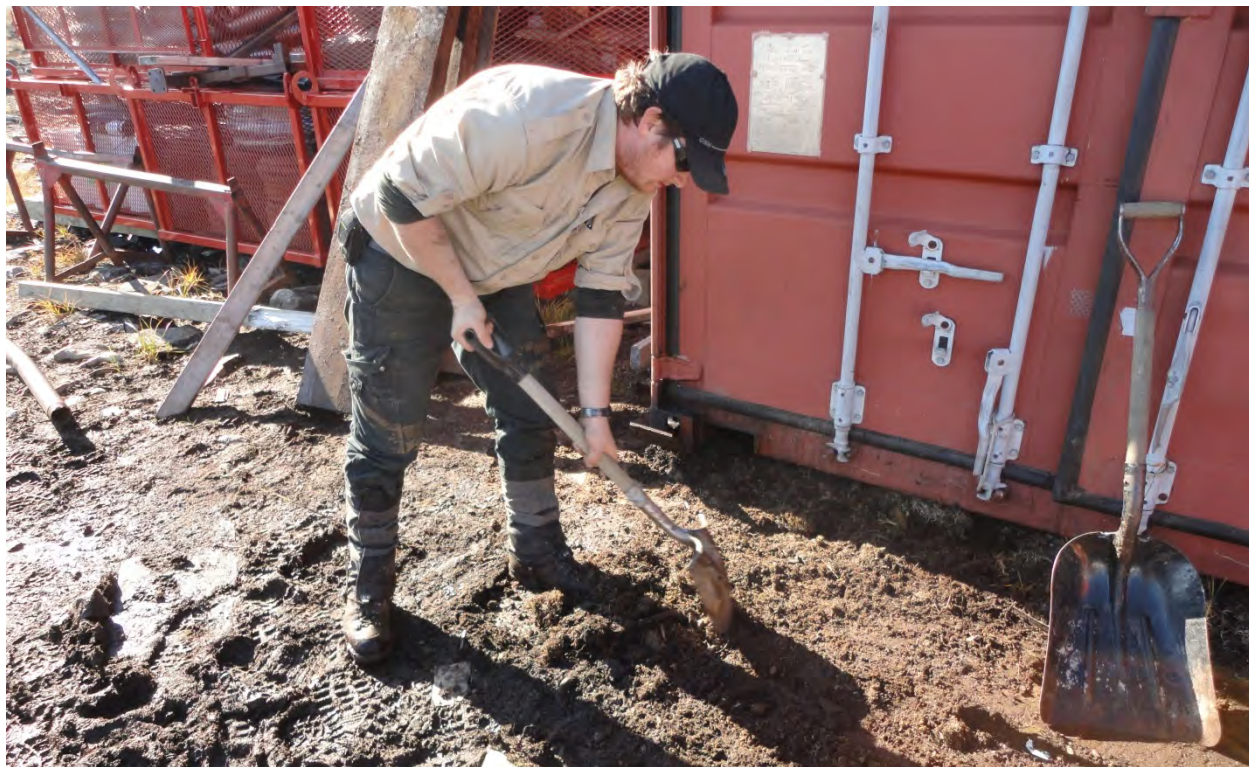
Figure 26 – Removing contaminated soil from door of red sea container.

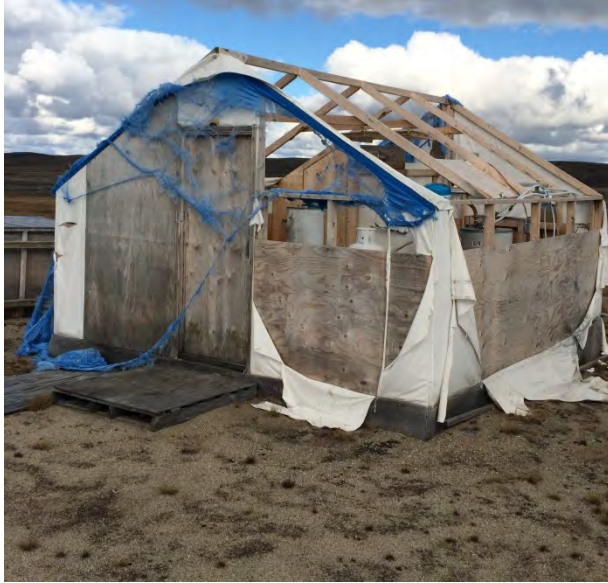
Figure 33 – Repaired tent at Bullion Camp.

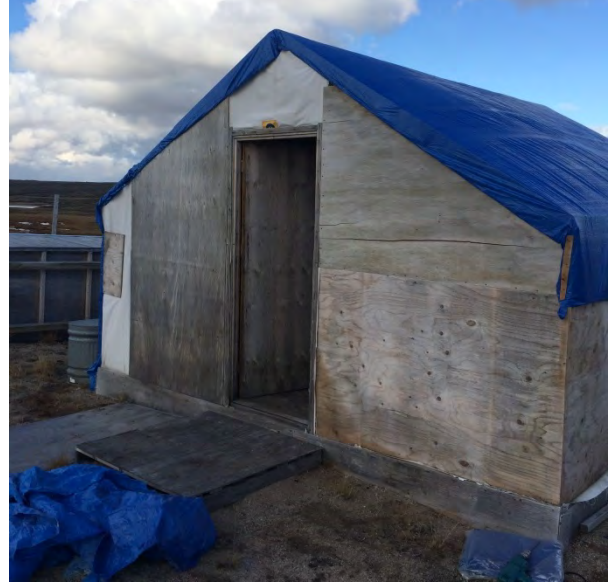
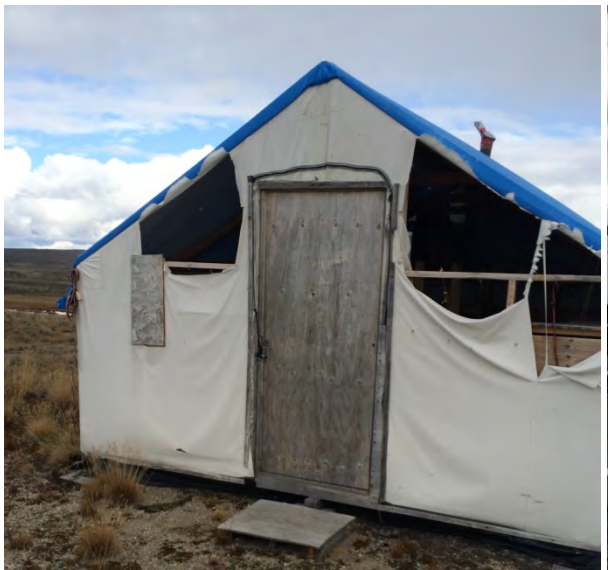
Figure 34 – Repaired tent canvas at Bullion Camp.

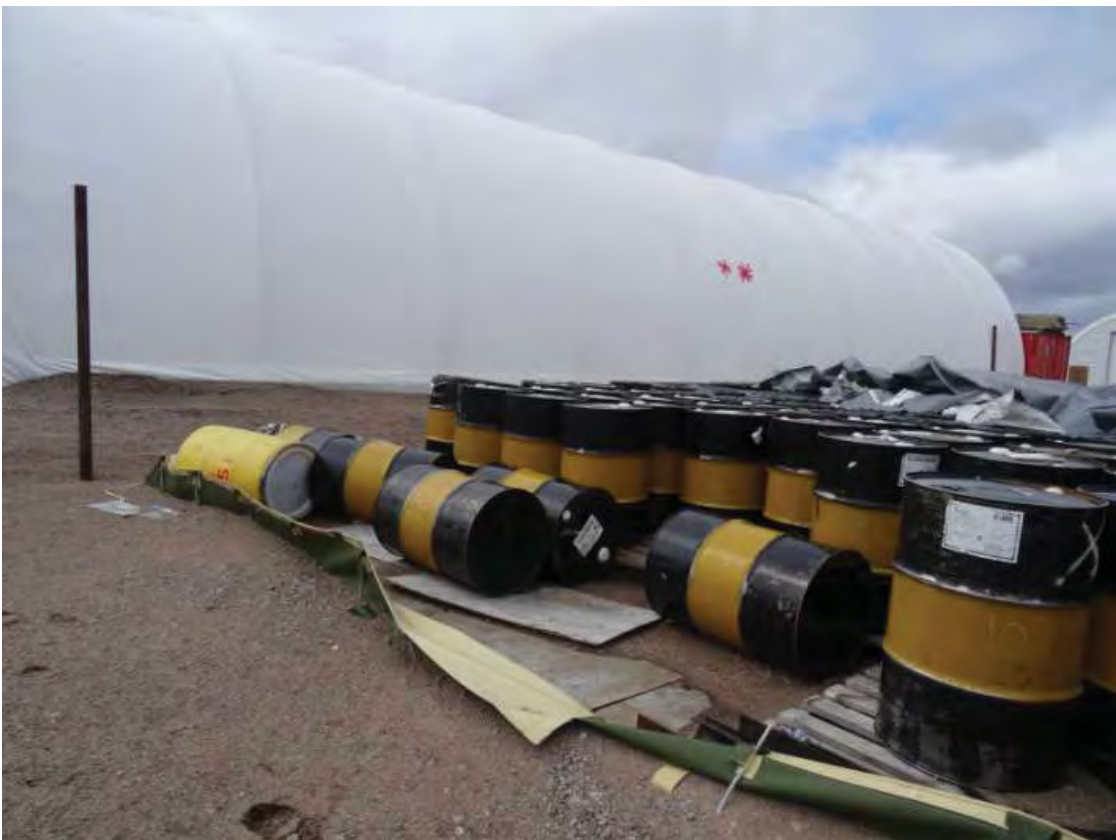
Figure 10. Hayes berm collapsed.

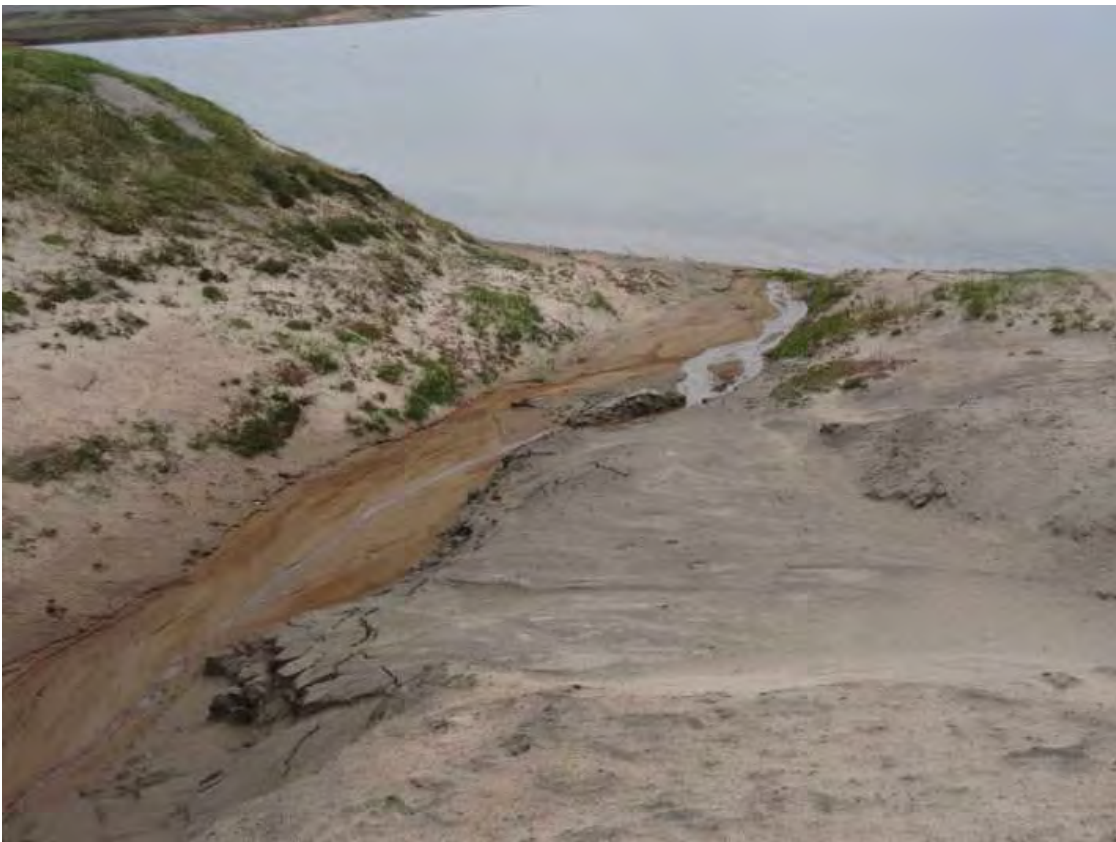
Figure 18. Camp drainage: original flow on left, new channel on right.

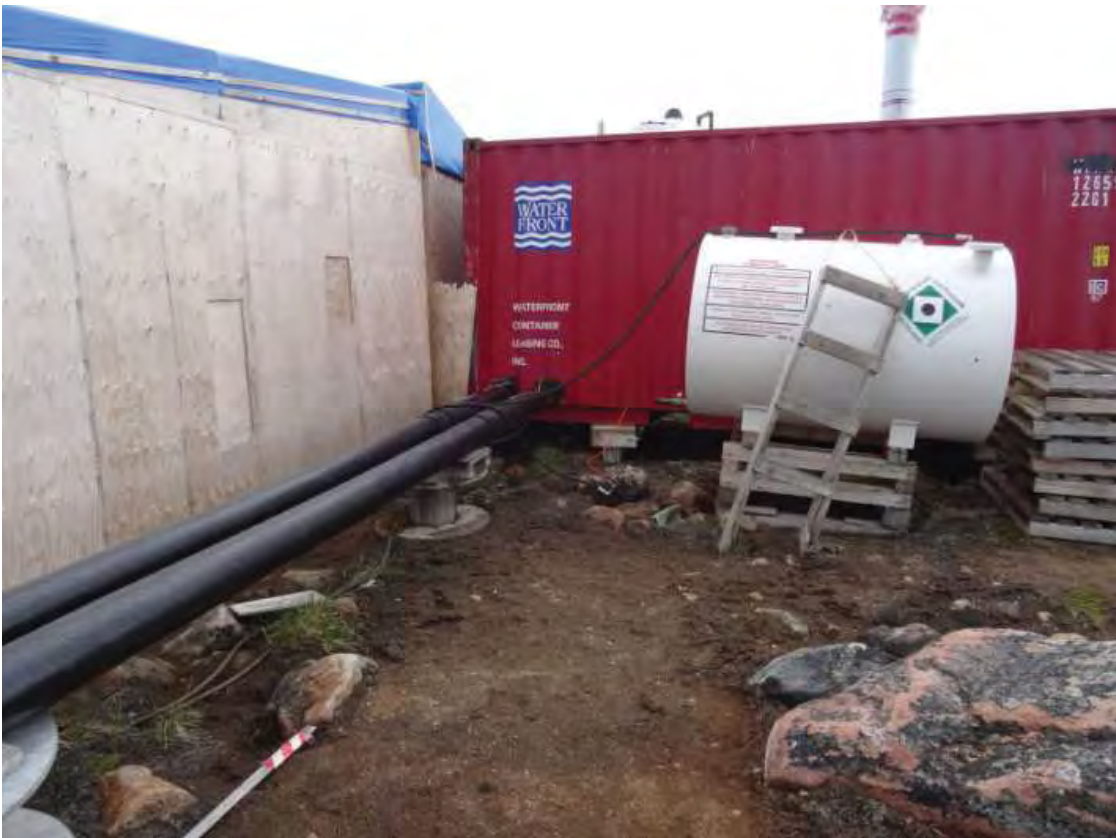
Figure 22. While tank may be double-walled, the hoses and valves are not. Secondary containment is required.
