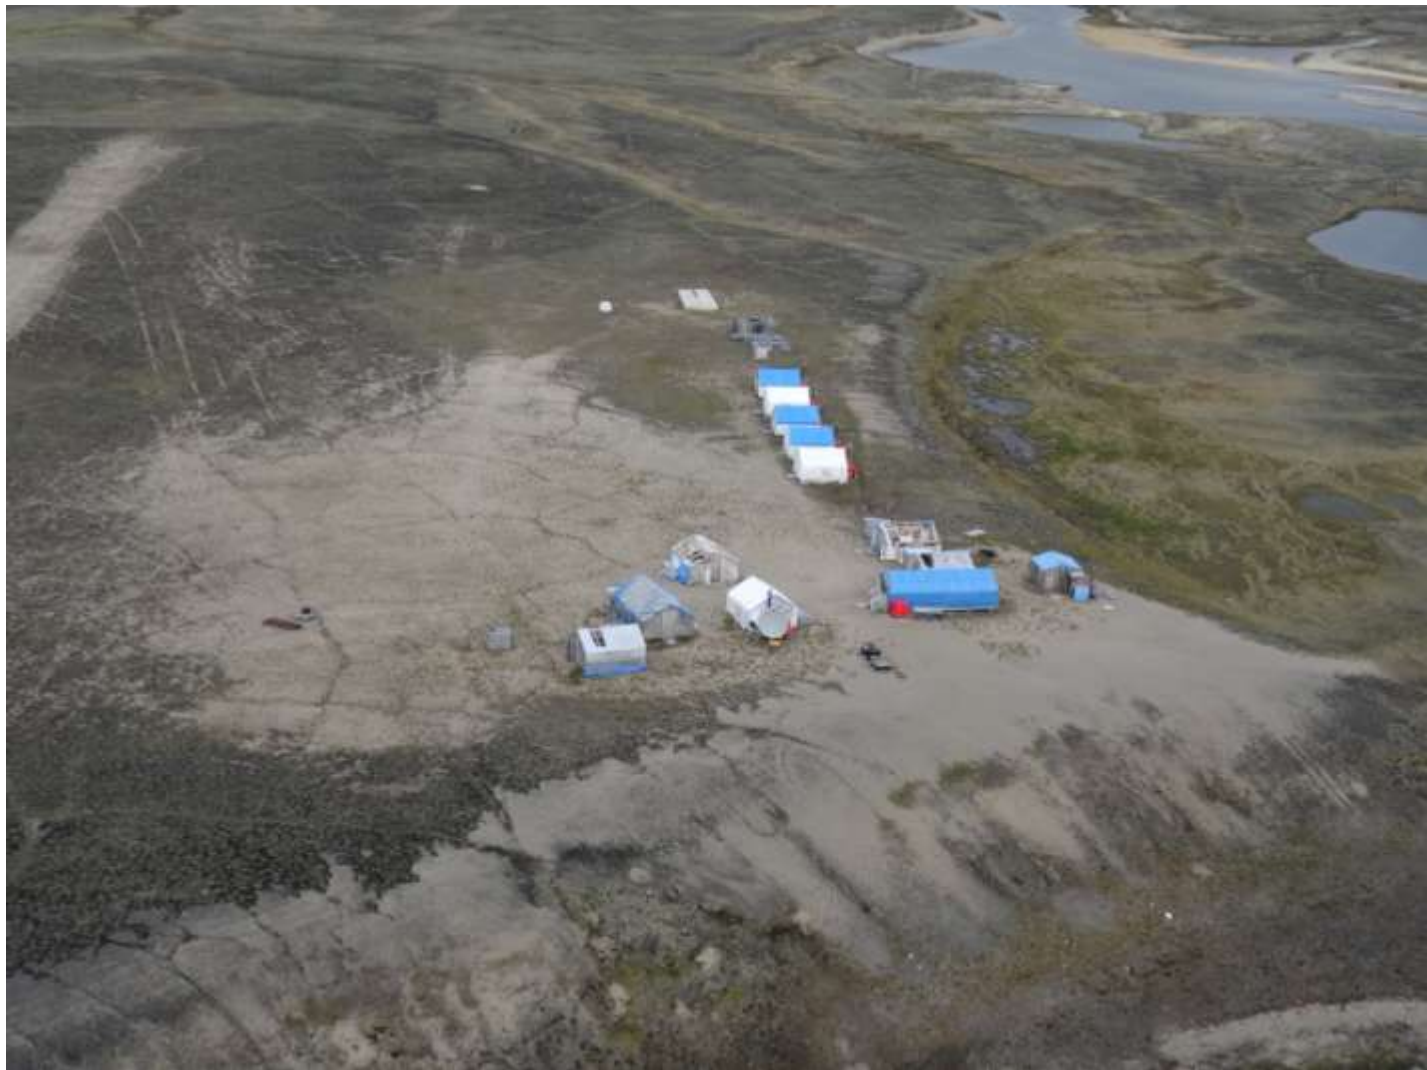
Figure 1. Bullion Camp. Berm is intact. Some tents are torn.

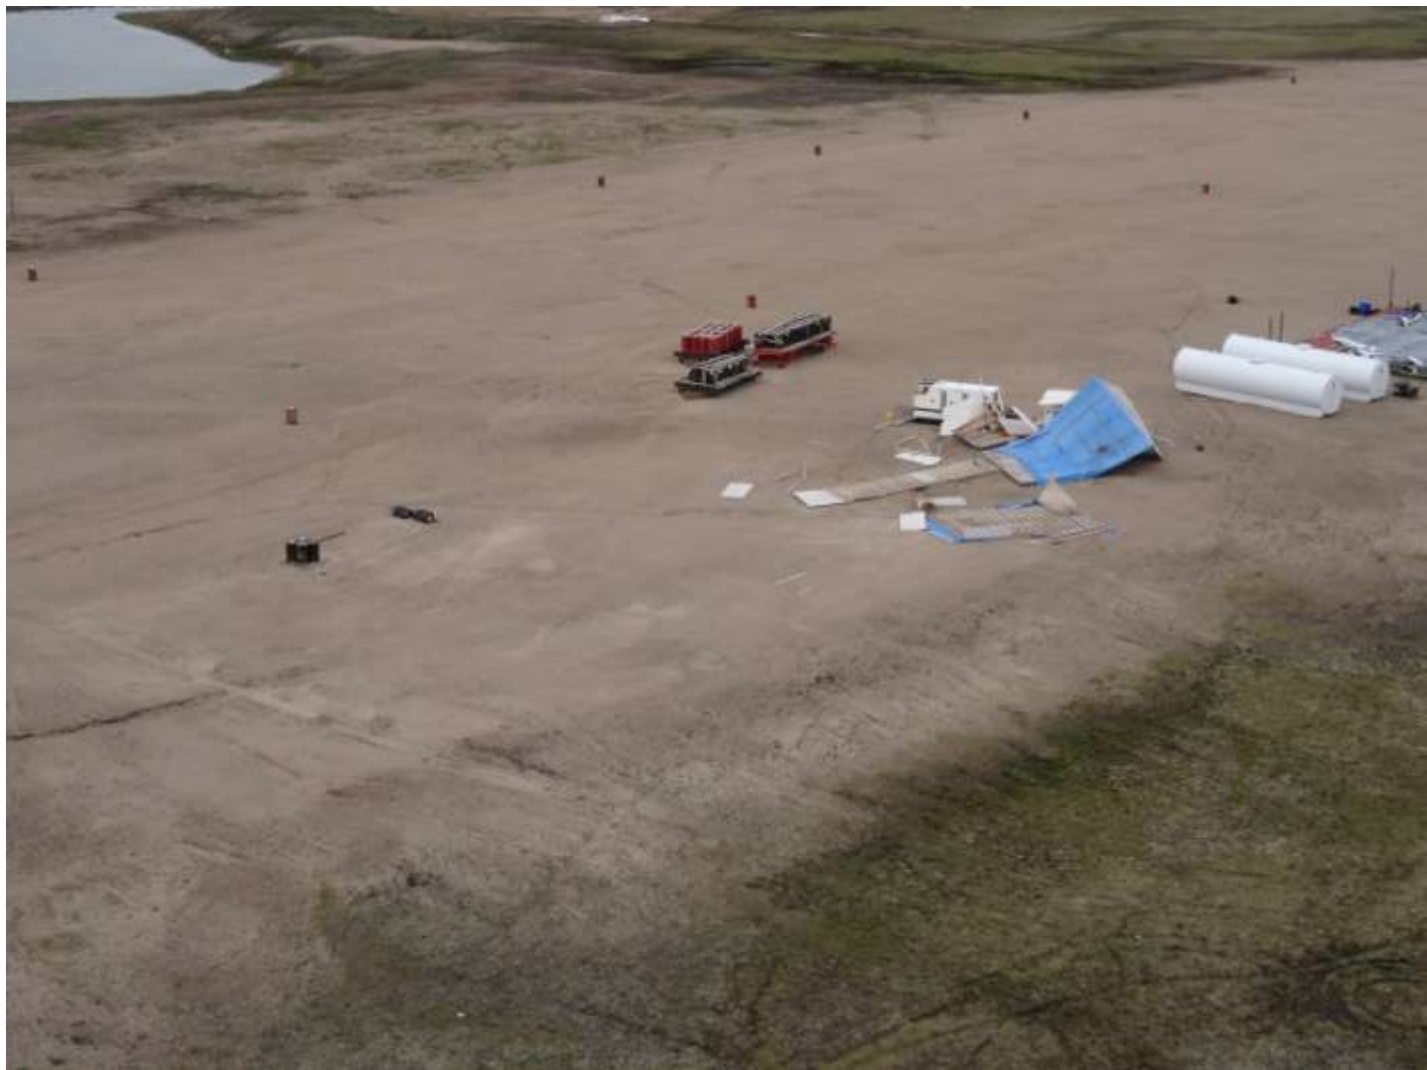
Figure 2. Lay-down at Hayes Camp. Building demolished.

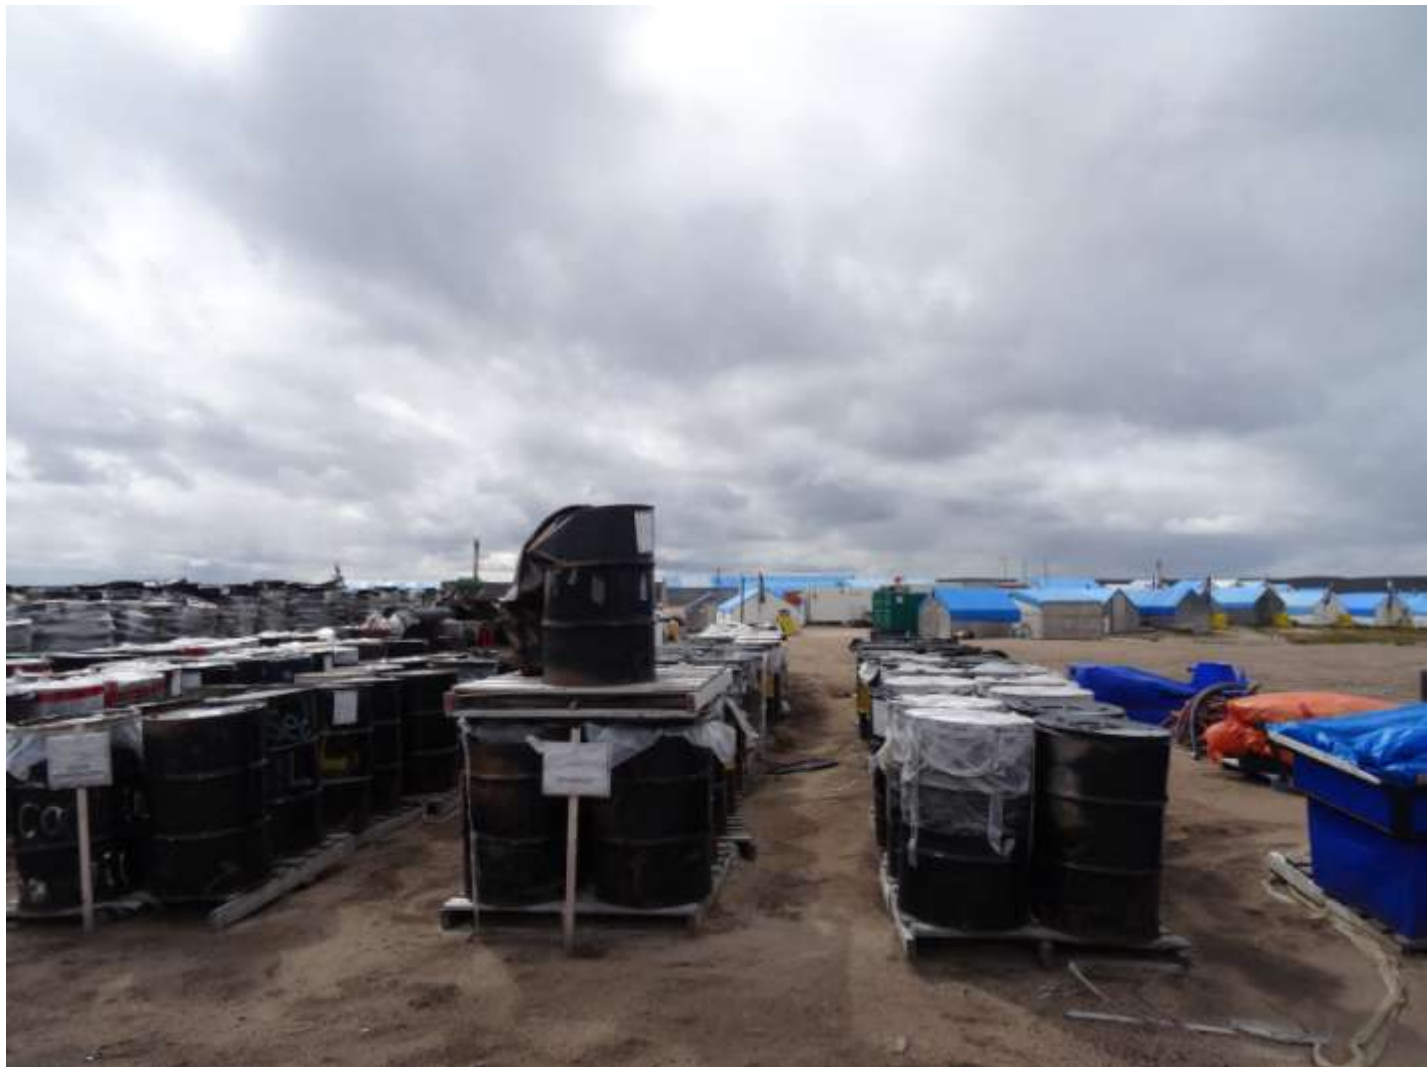
Figure 3. Waste area at Hayes. Garbage barrels.

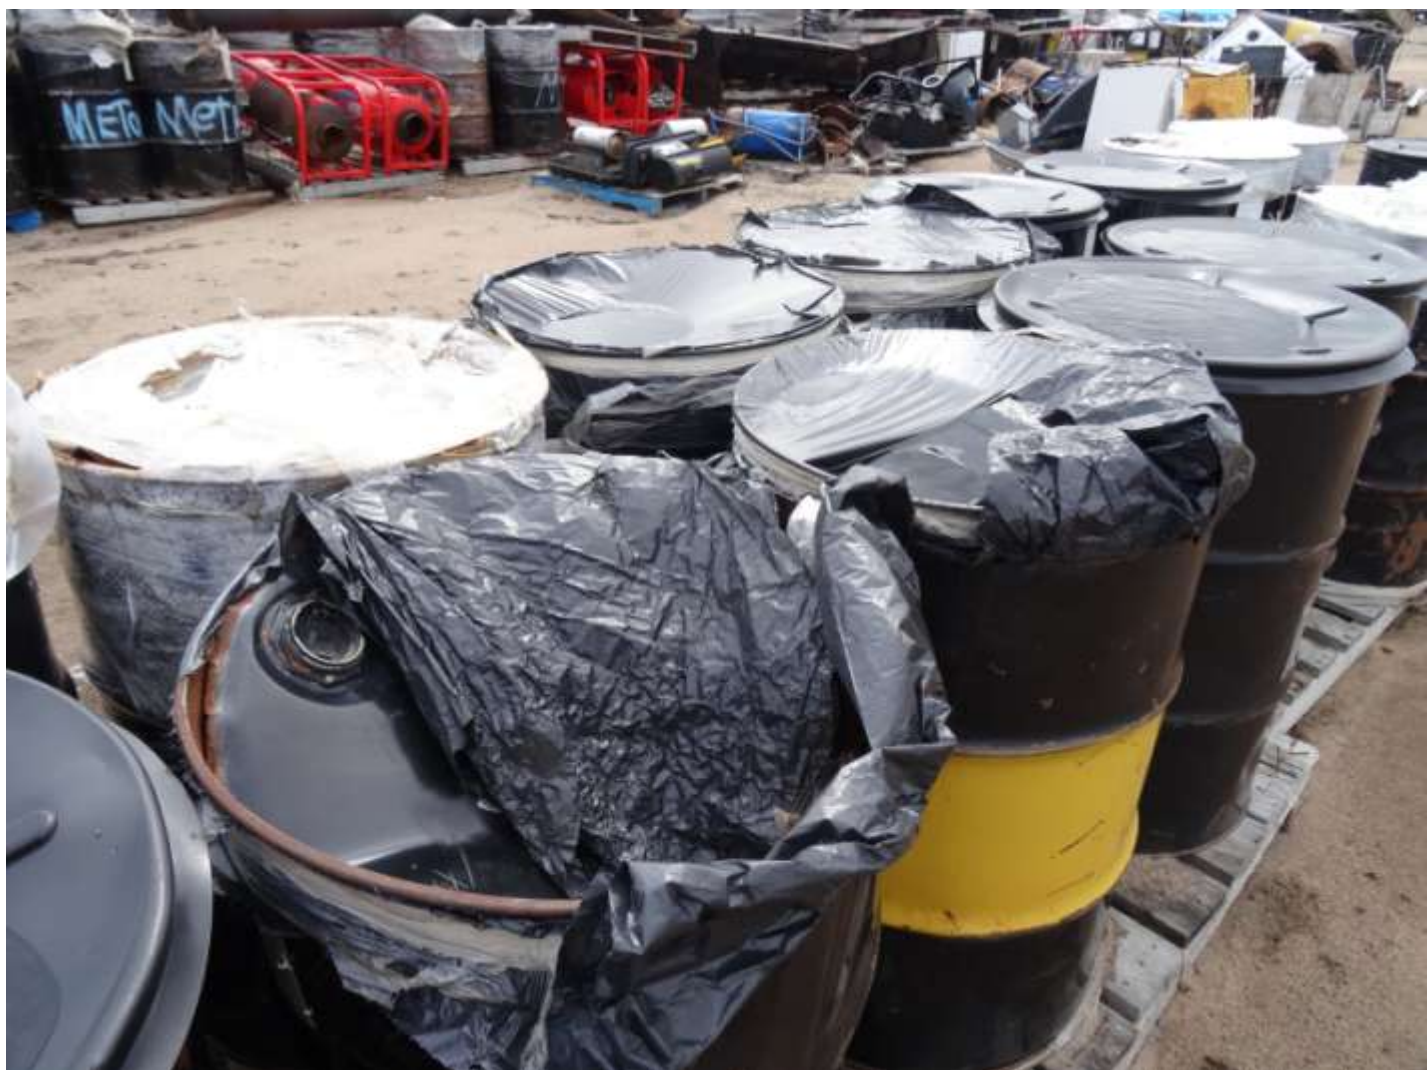
Figure 4. Barrels are no longer sealed.

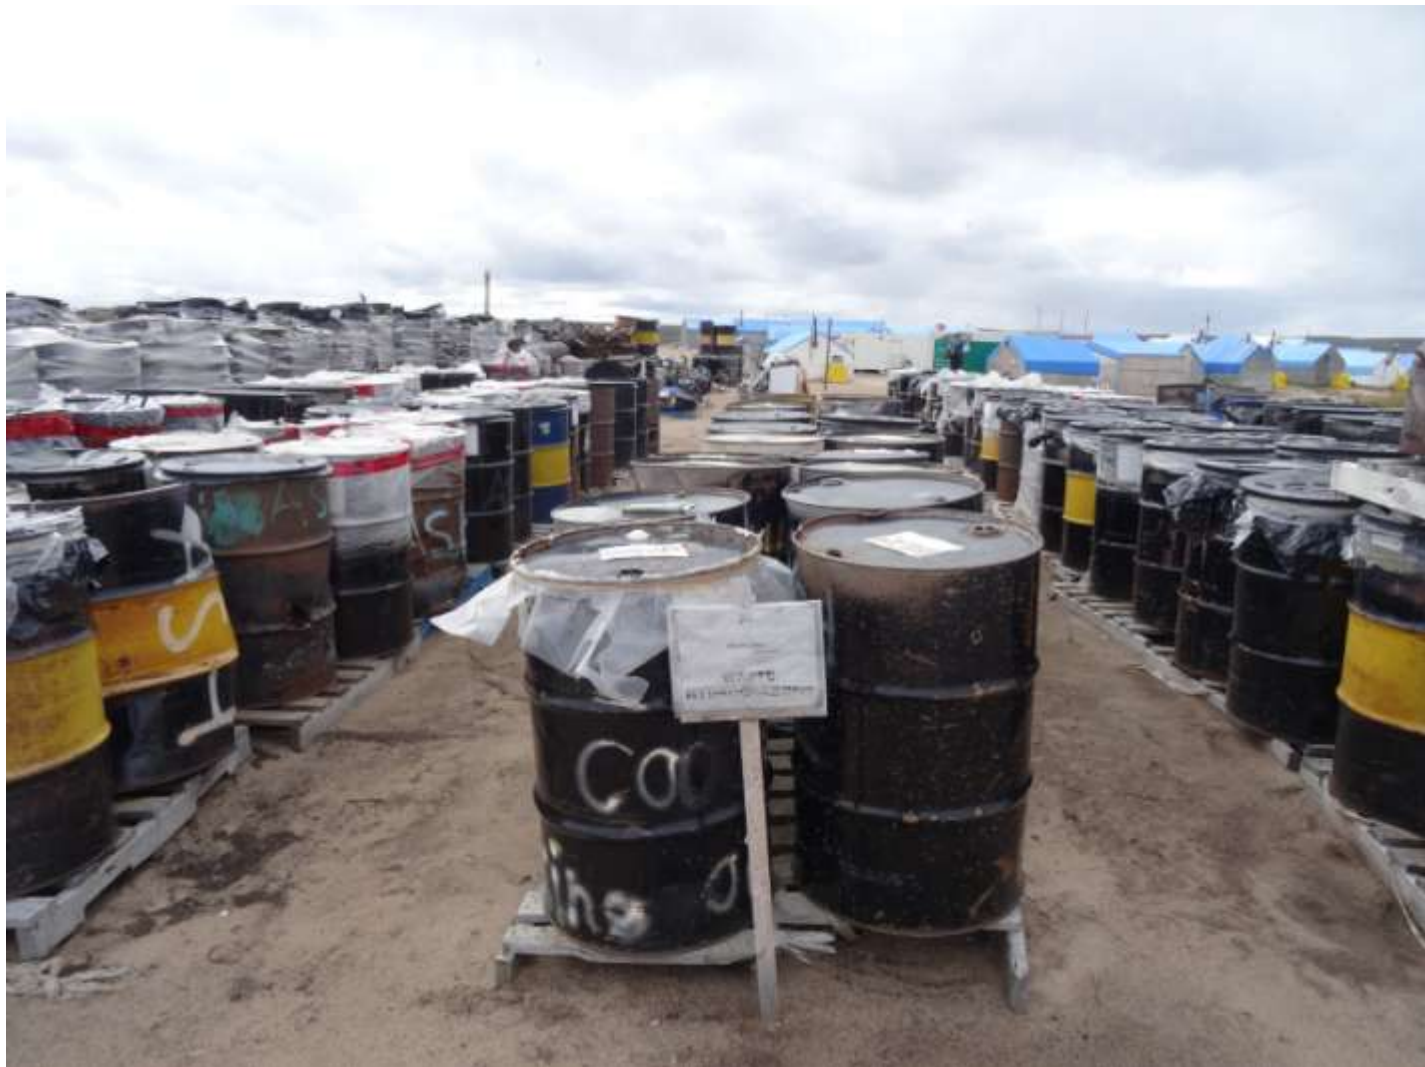
Figure 5. Waste Hydrocarbons should have been removed from site.

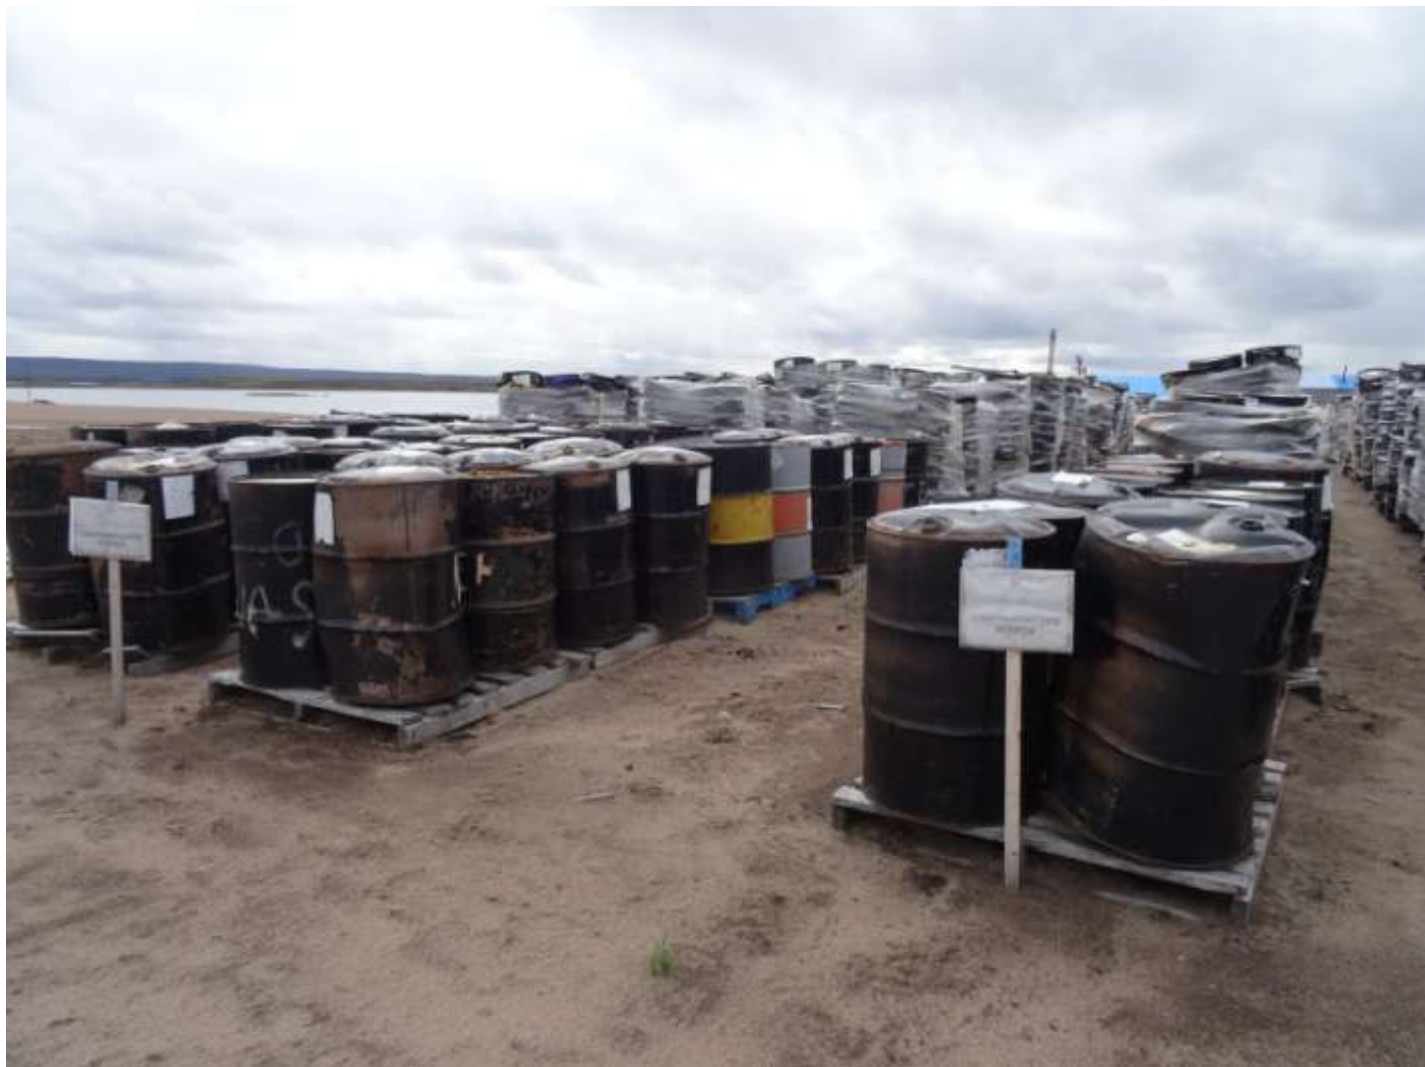
Figure 6. Contaminated water should be removed from site.

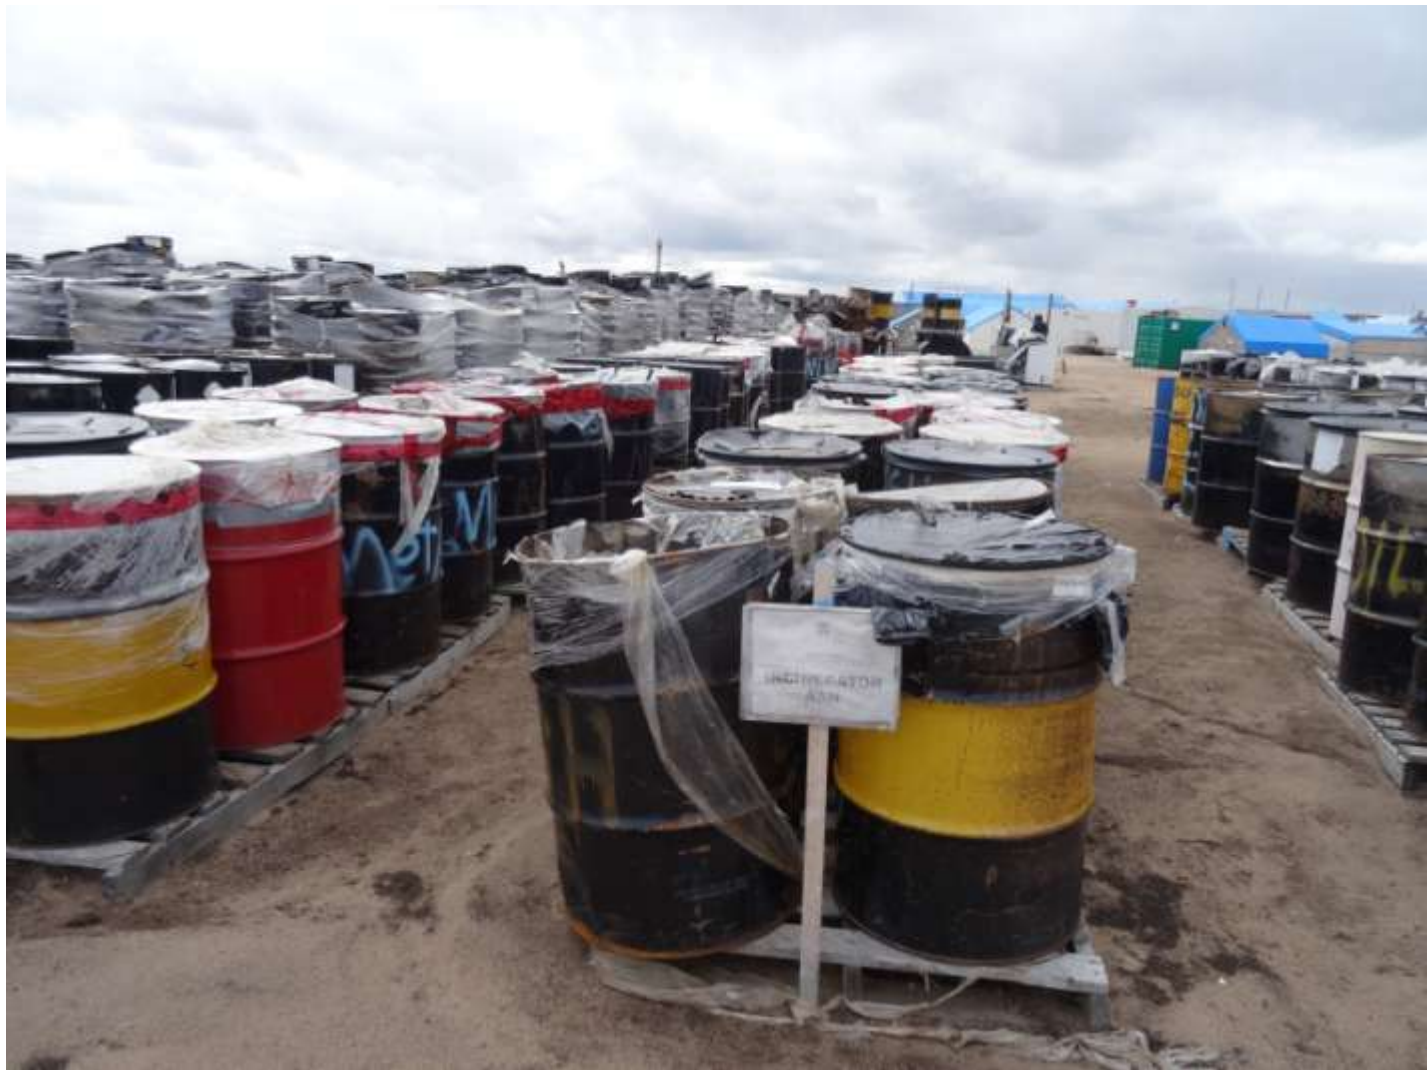
Figure 7. Incinerator Ash should be removed from site.

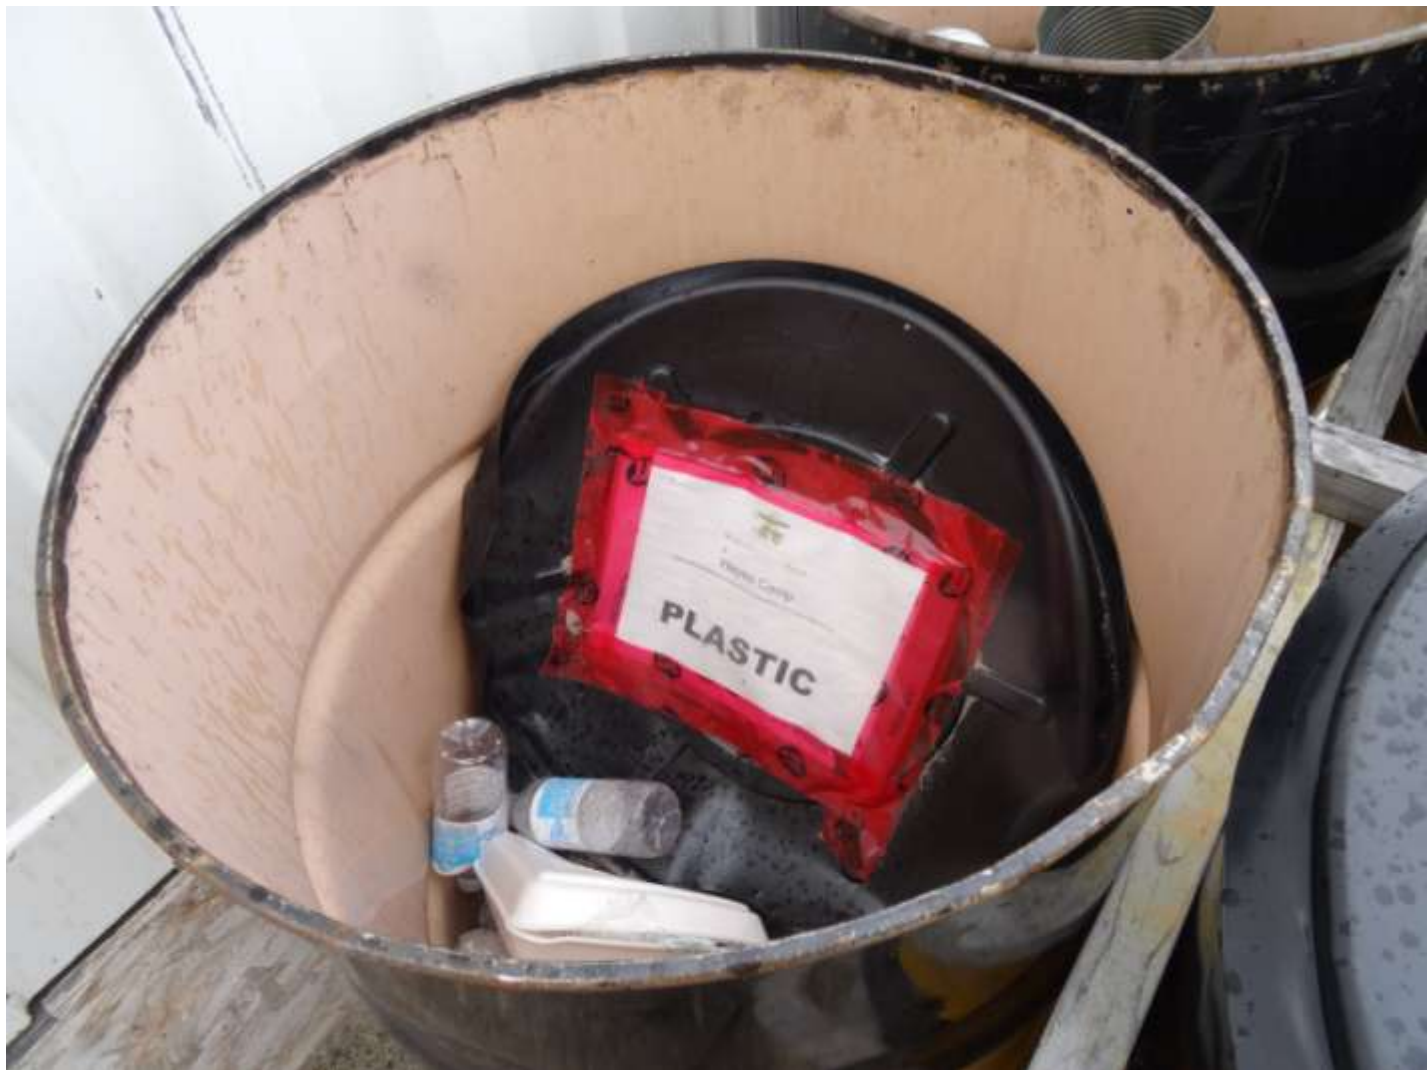
Figure 8. Garbages within the camp were not emptied.

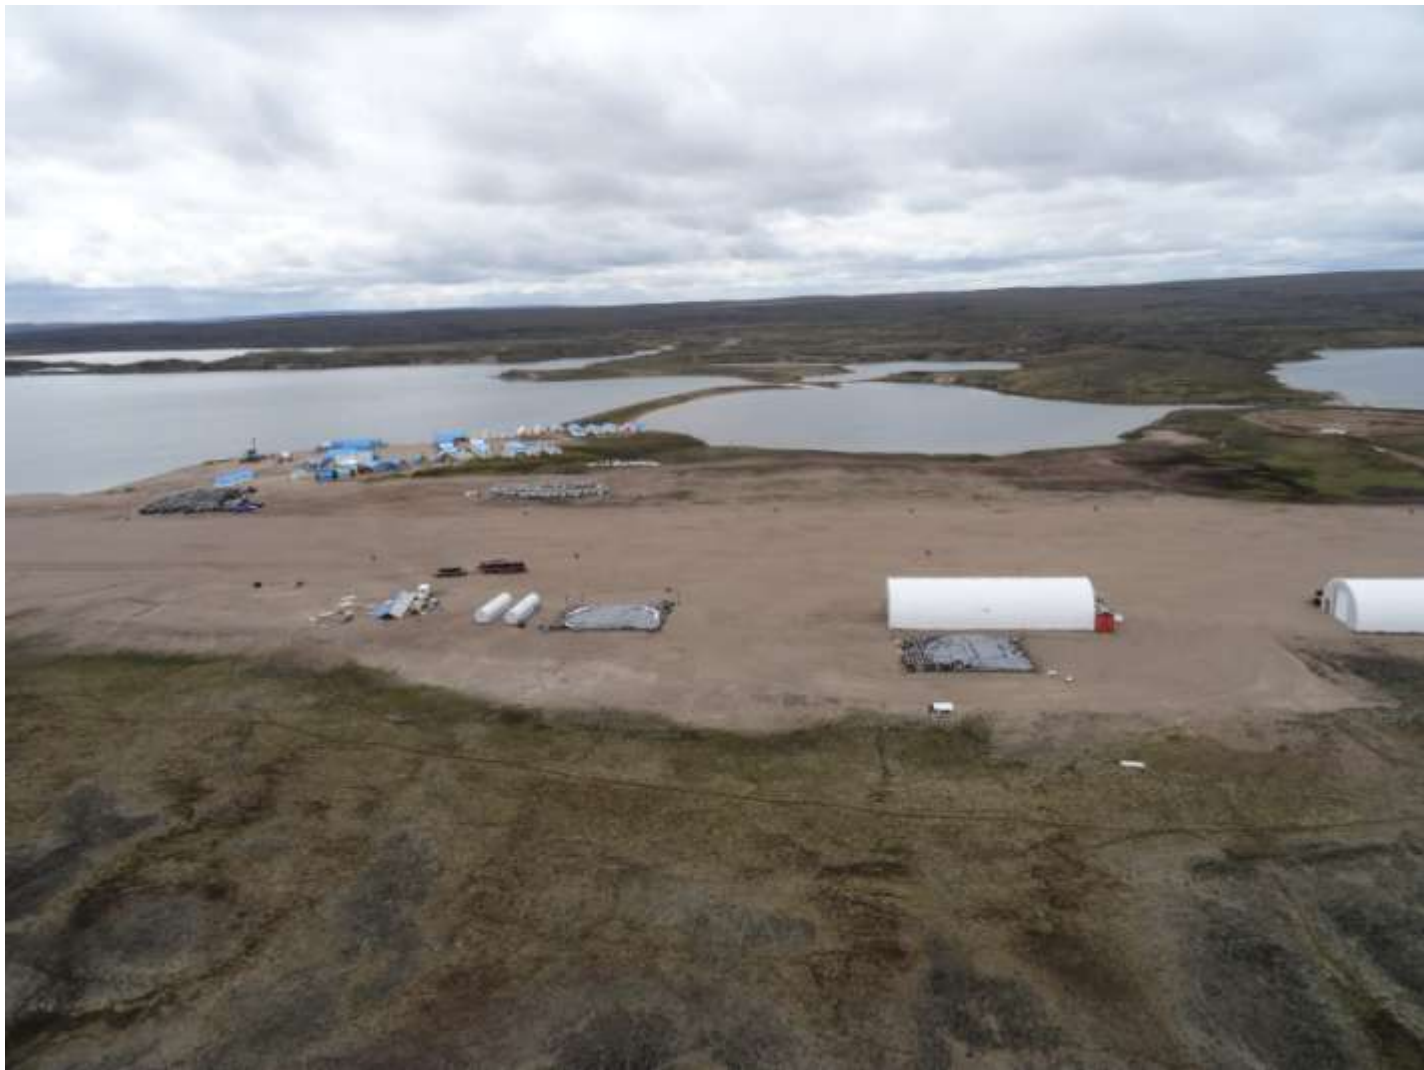
Figure 9. Aerial view of Haves berms.

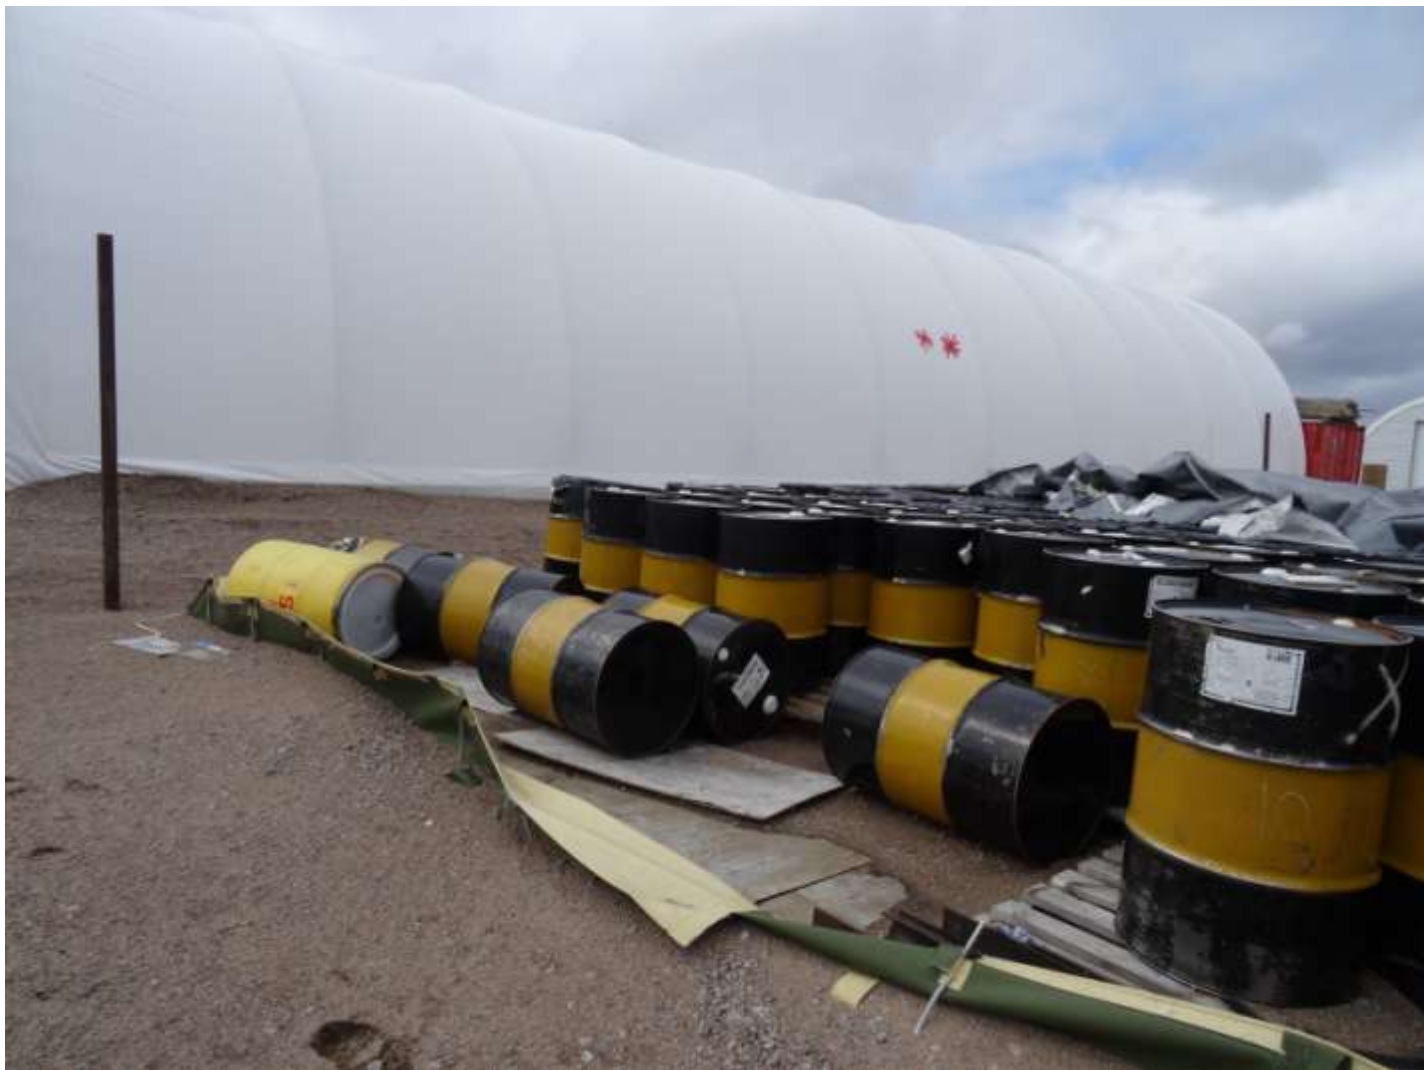
Figure 10. Hayes berm collapsed.

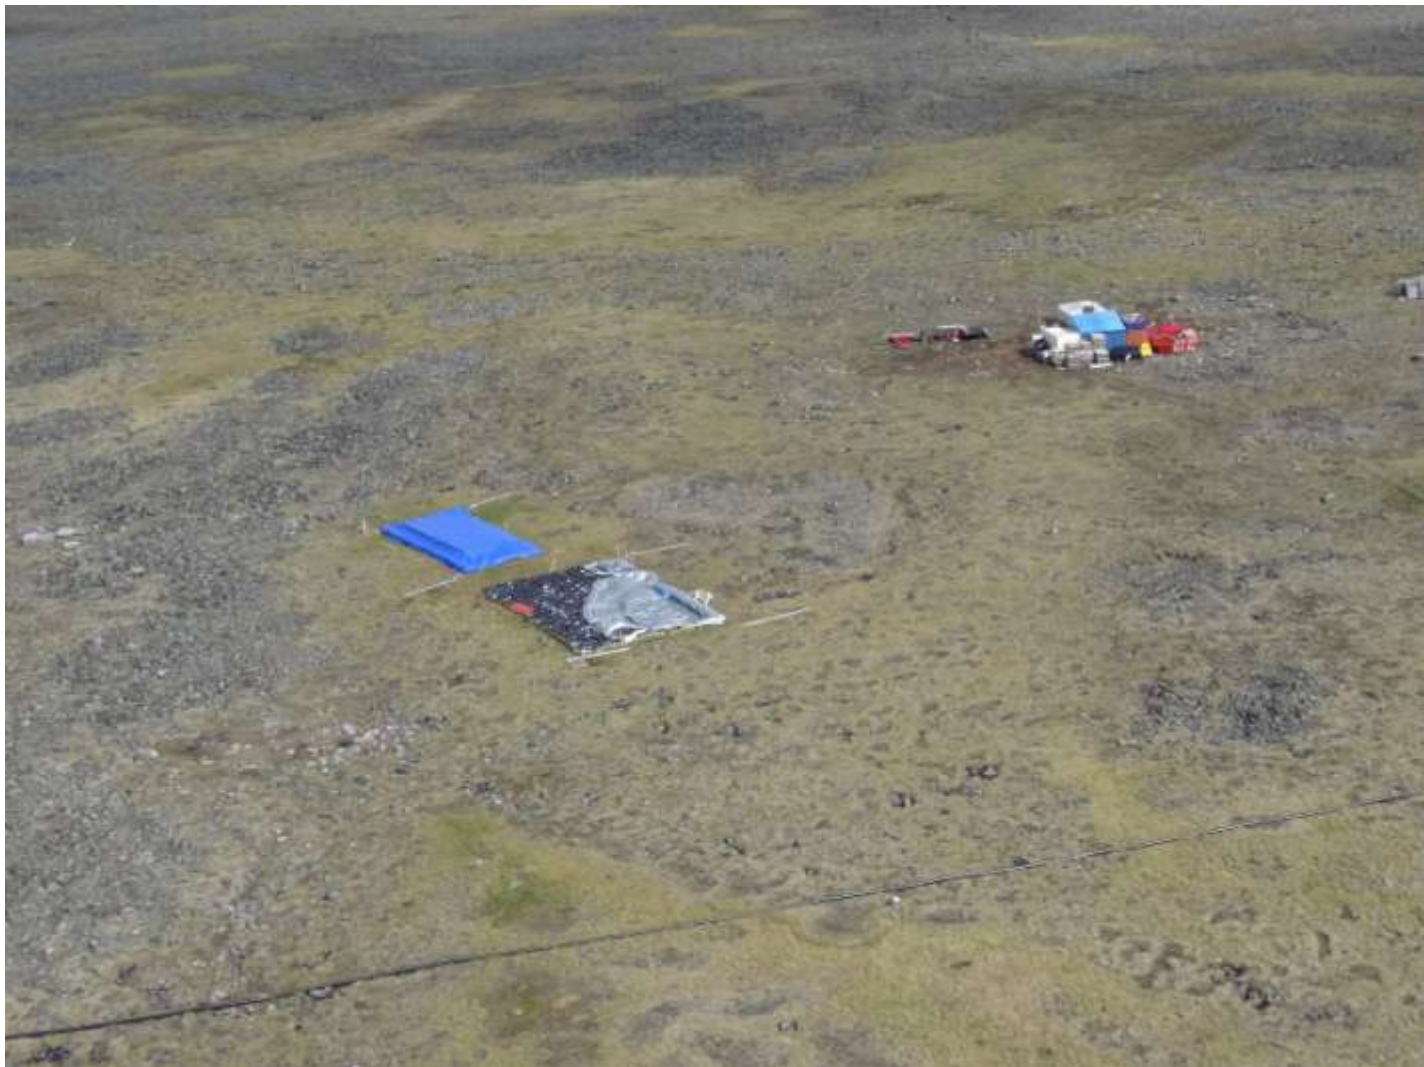
Figure 11. Berms at Three Bluffs.

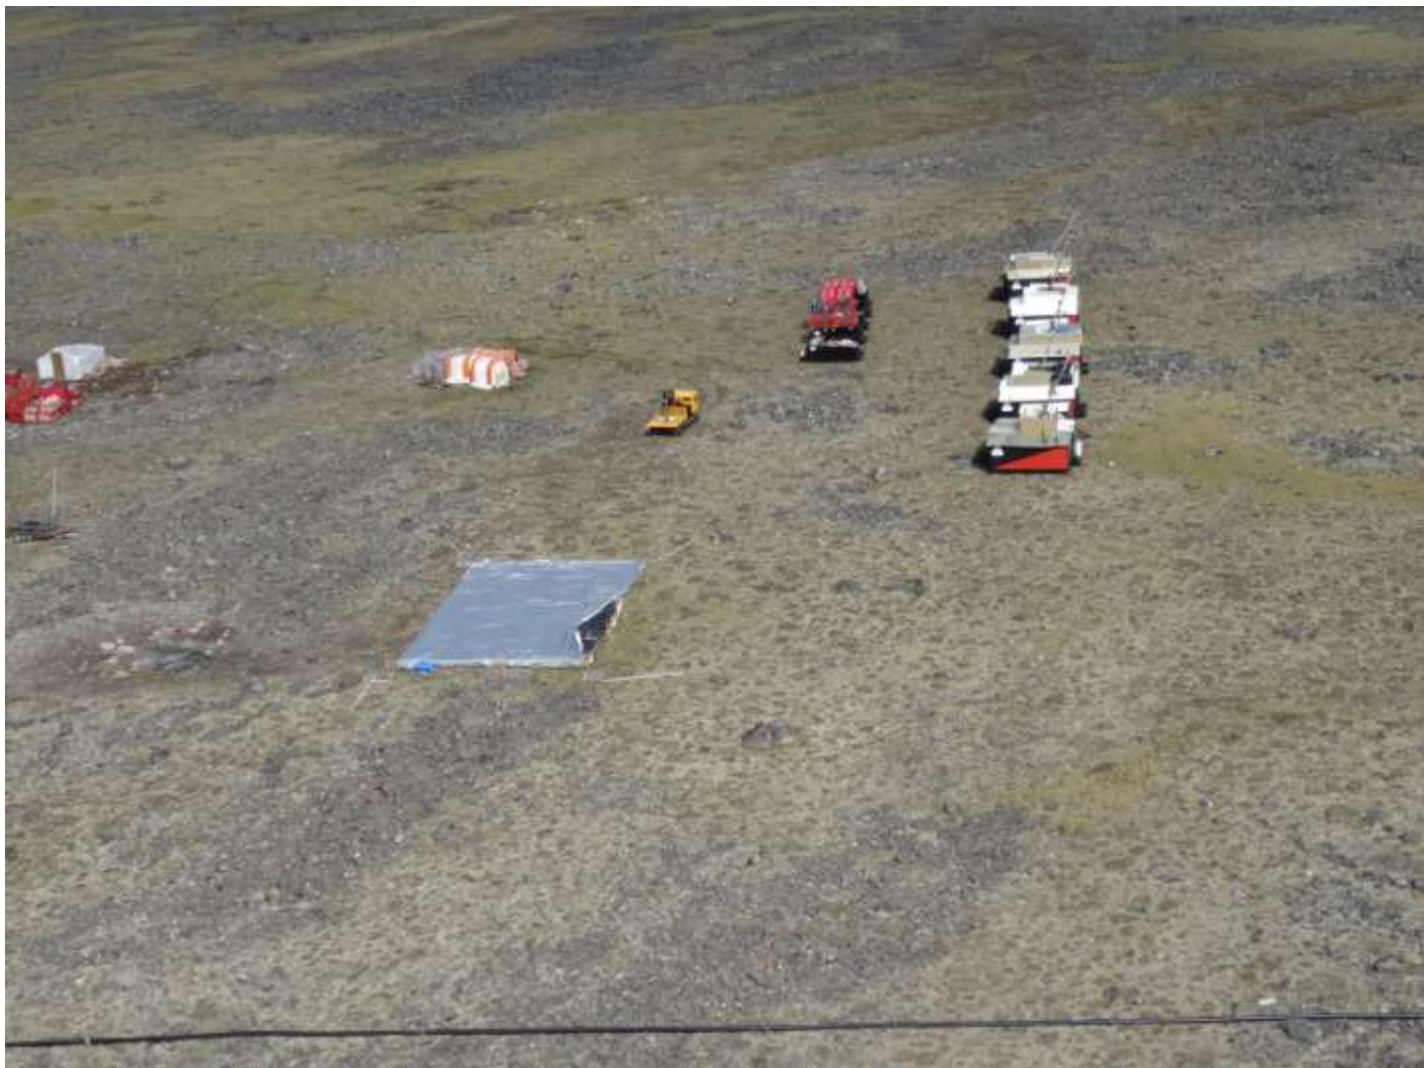
Figure 12. Third berm at Three Bluffs.

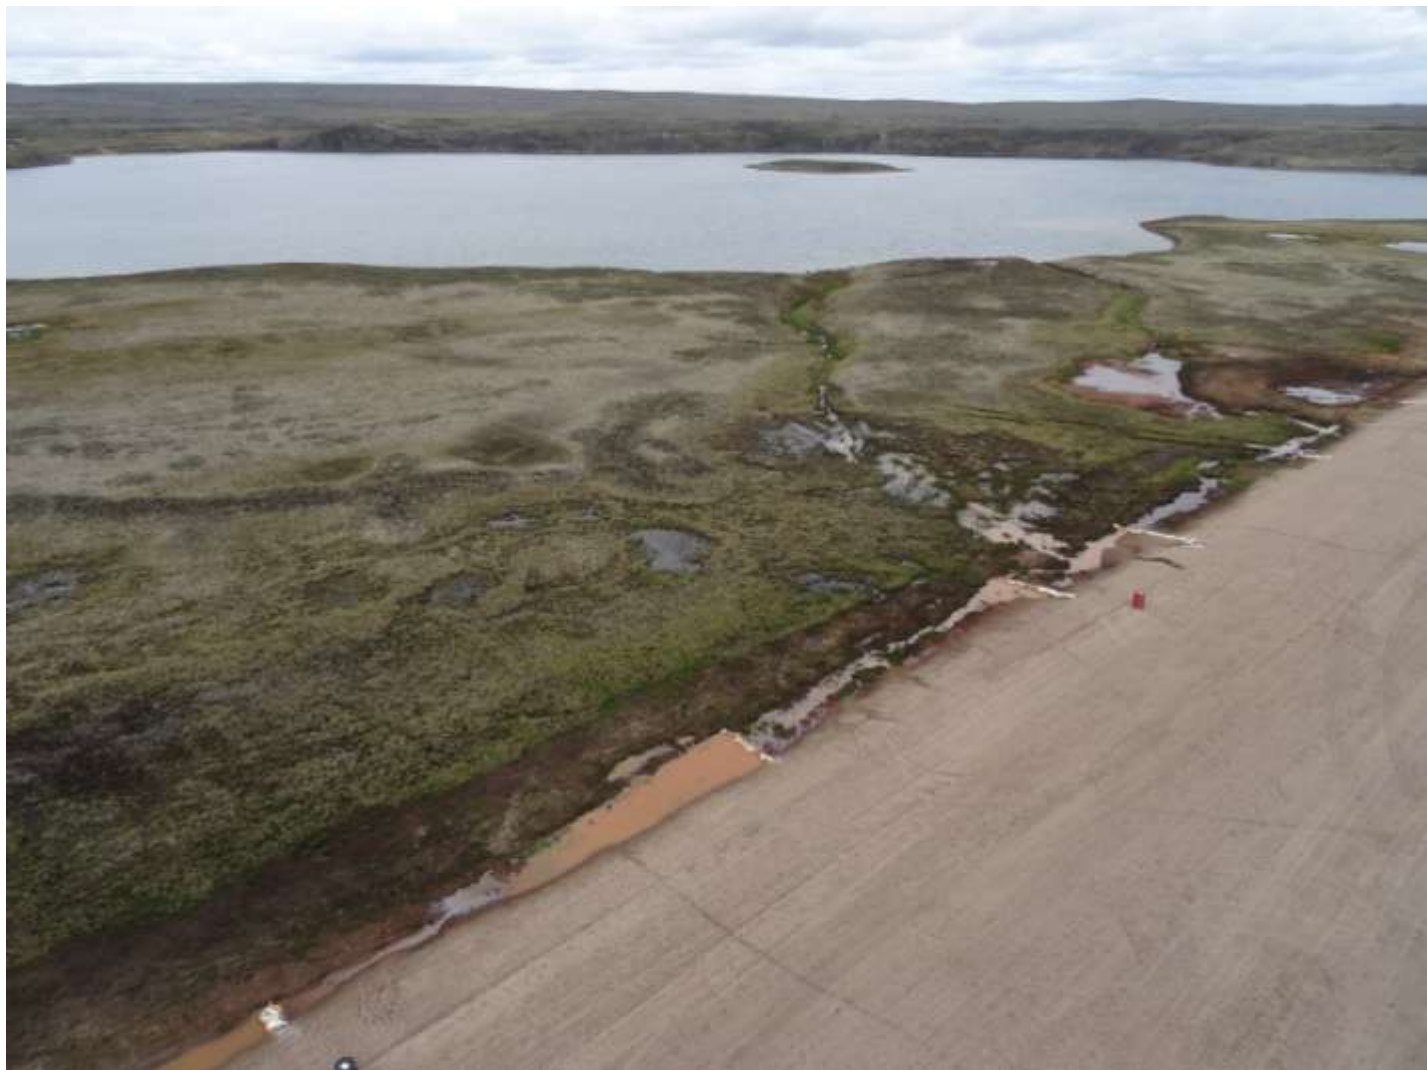
Figure 16. Pooling/ponding on the side of the airstrip; sediment evident in water flowing down-slope.

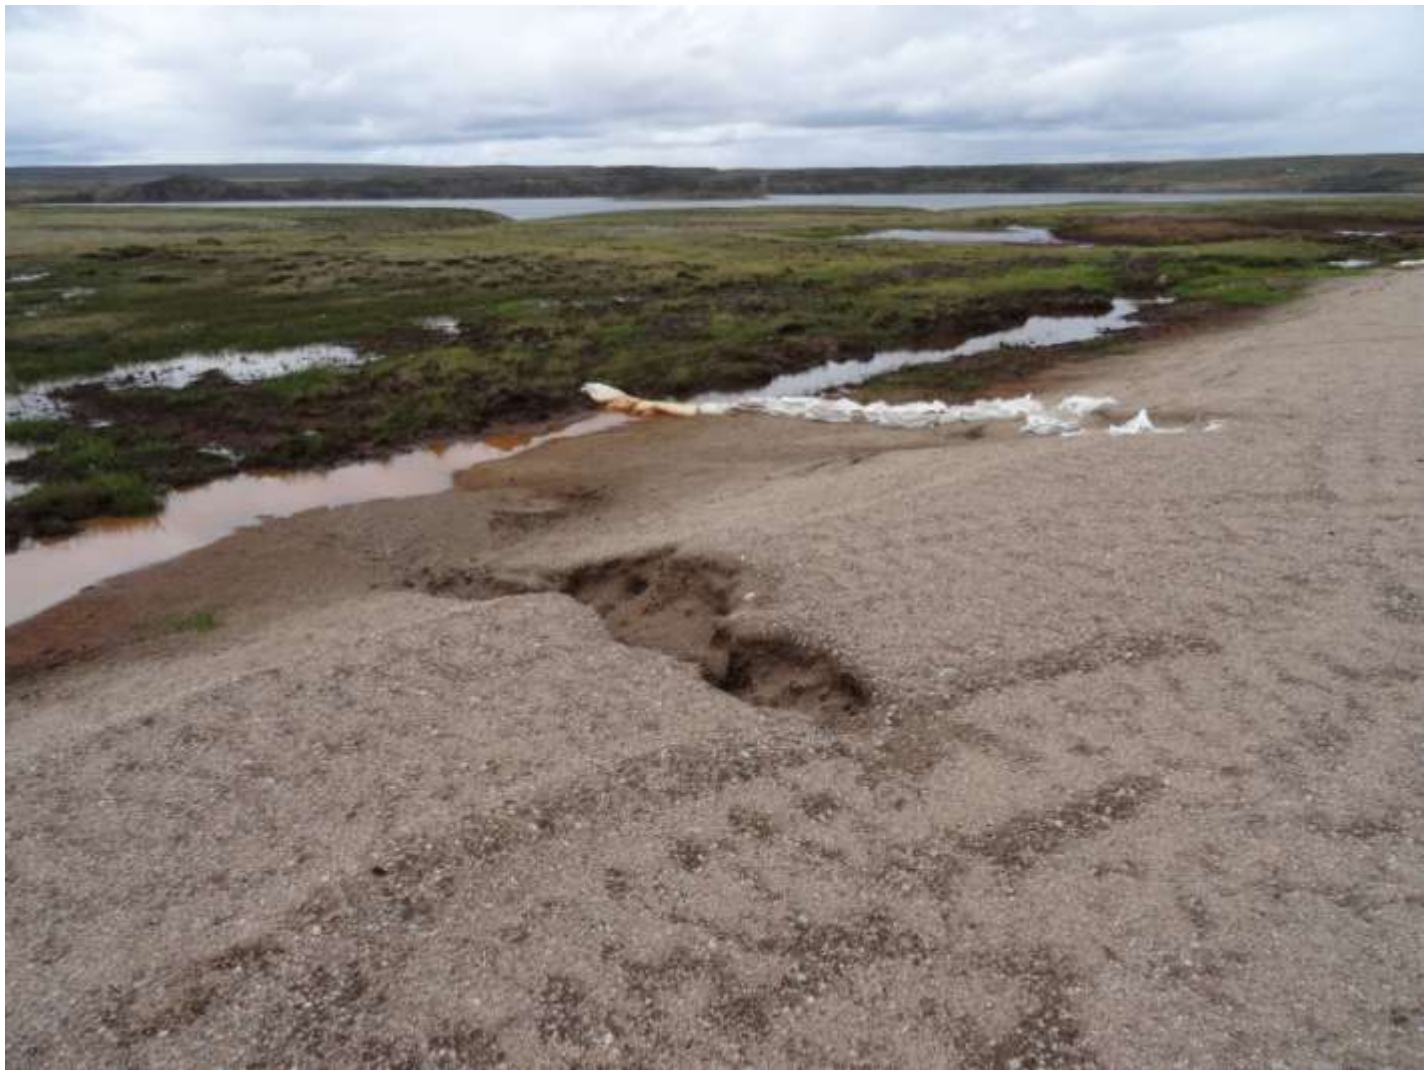
Figure 17. Permafrost degradation leading to deterioration of airstrip and sediment in the water.

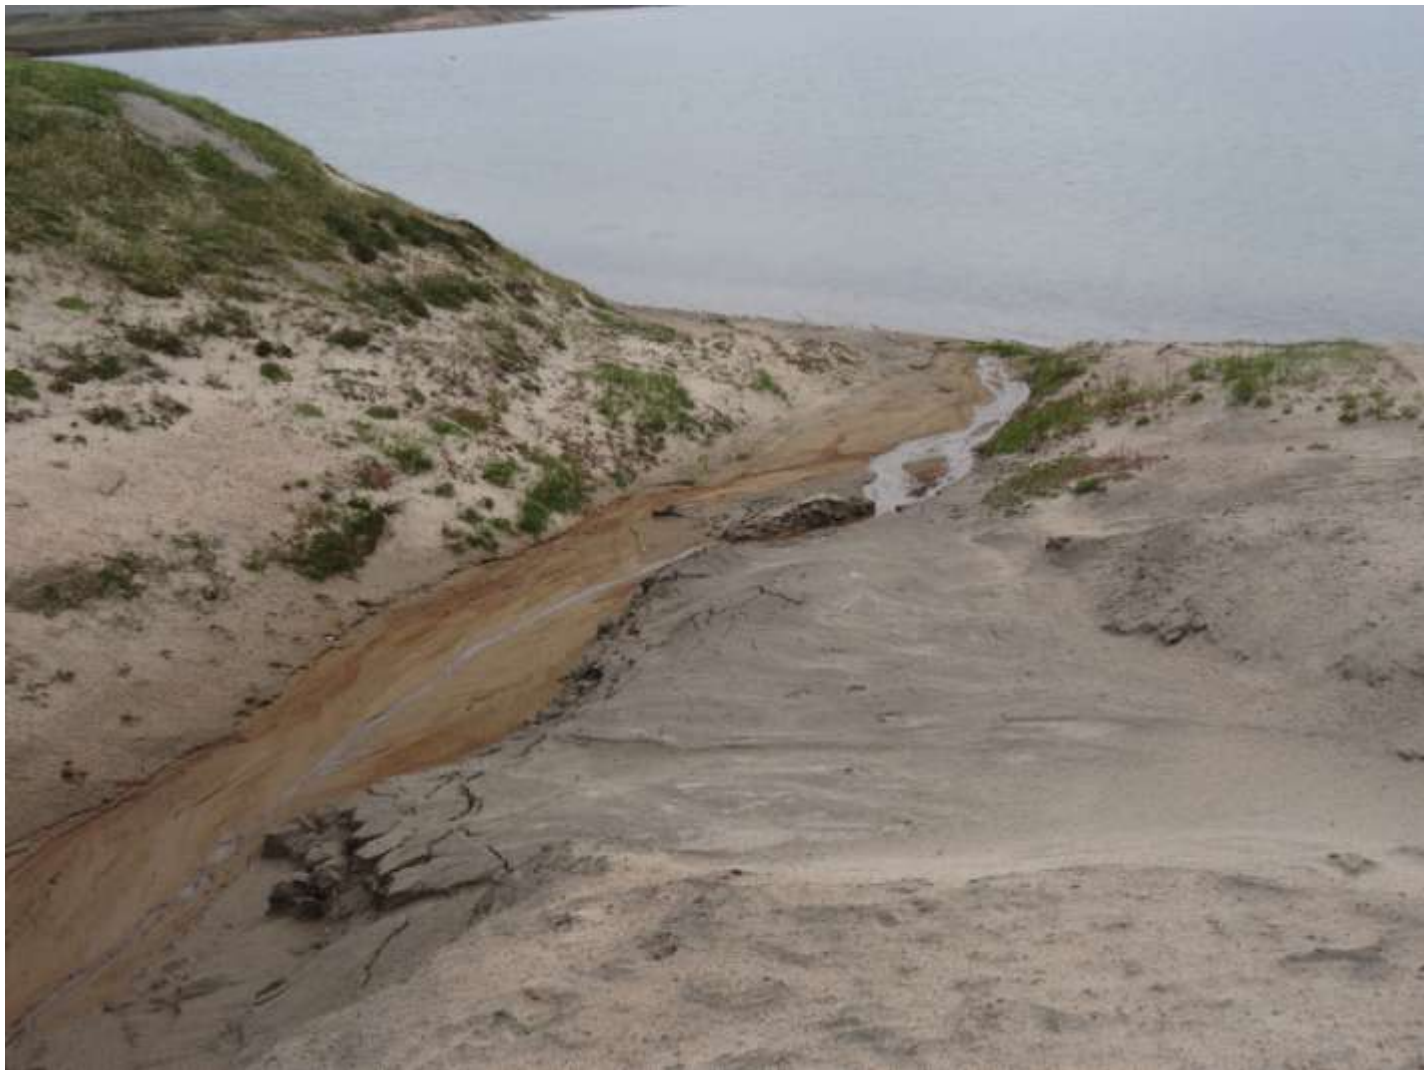
Figure 18. Camp drainage: original flow on left, new channel on right.
