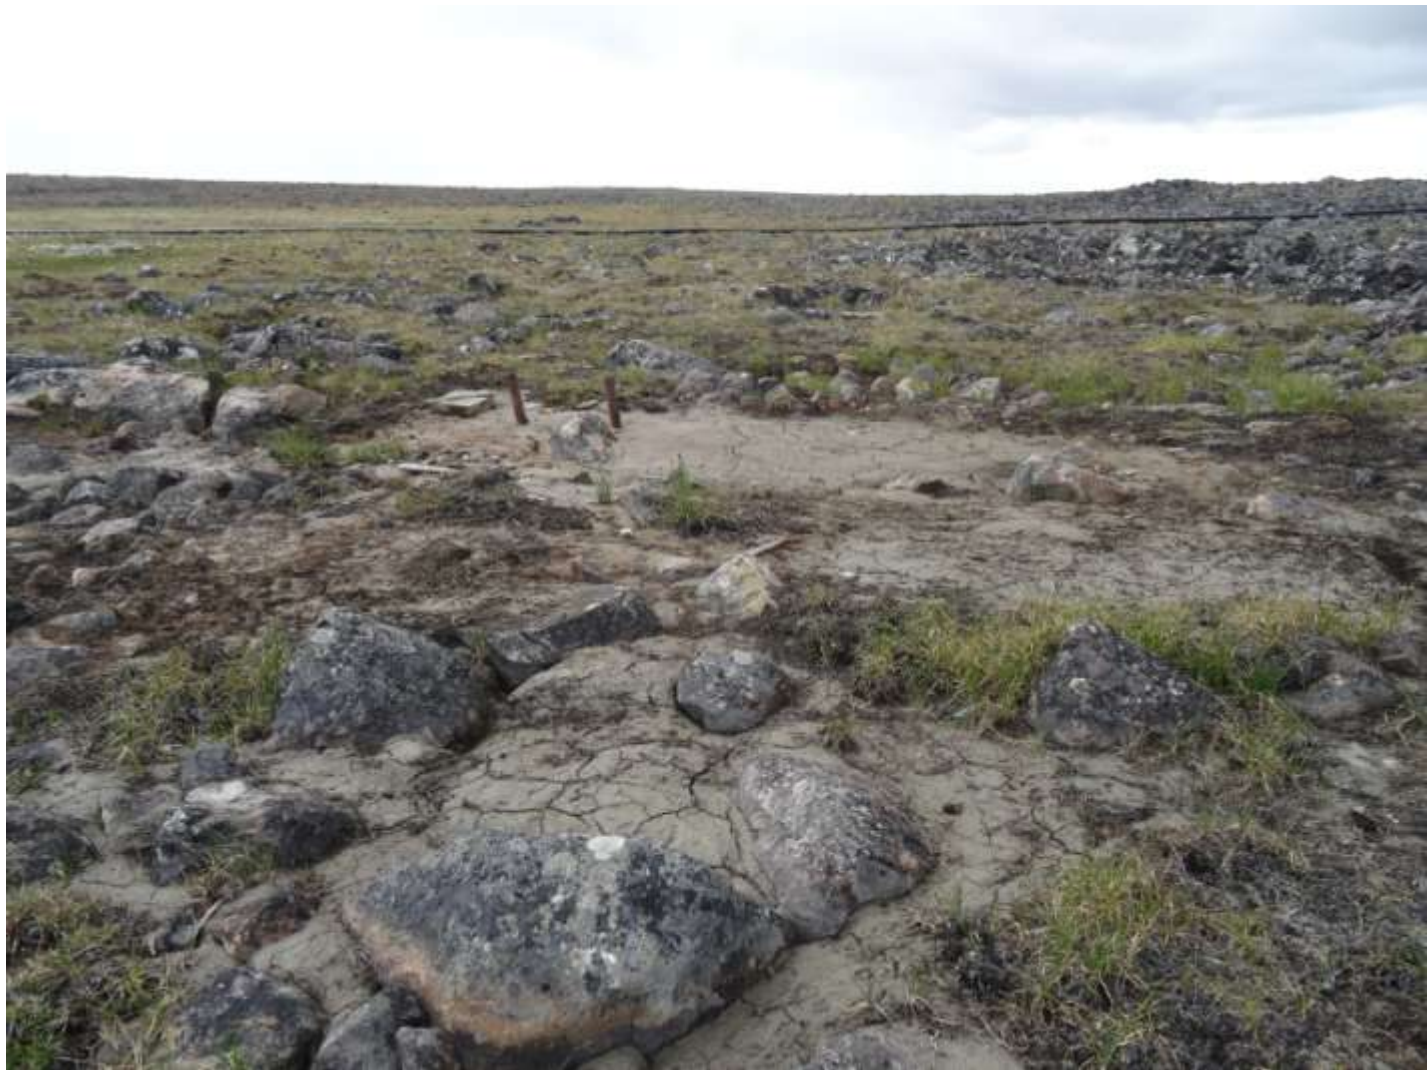
Figure 19. Drill sites require reclamation.

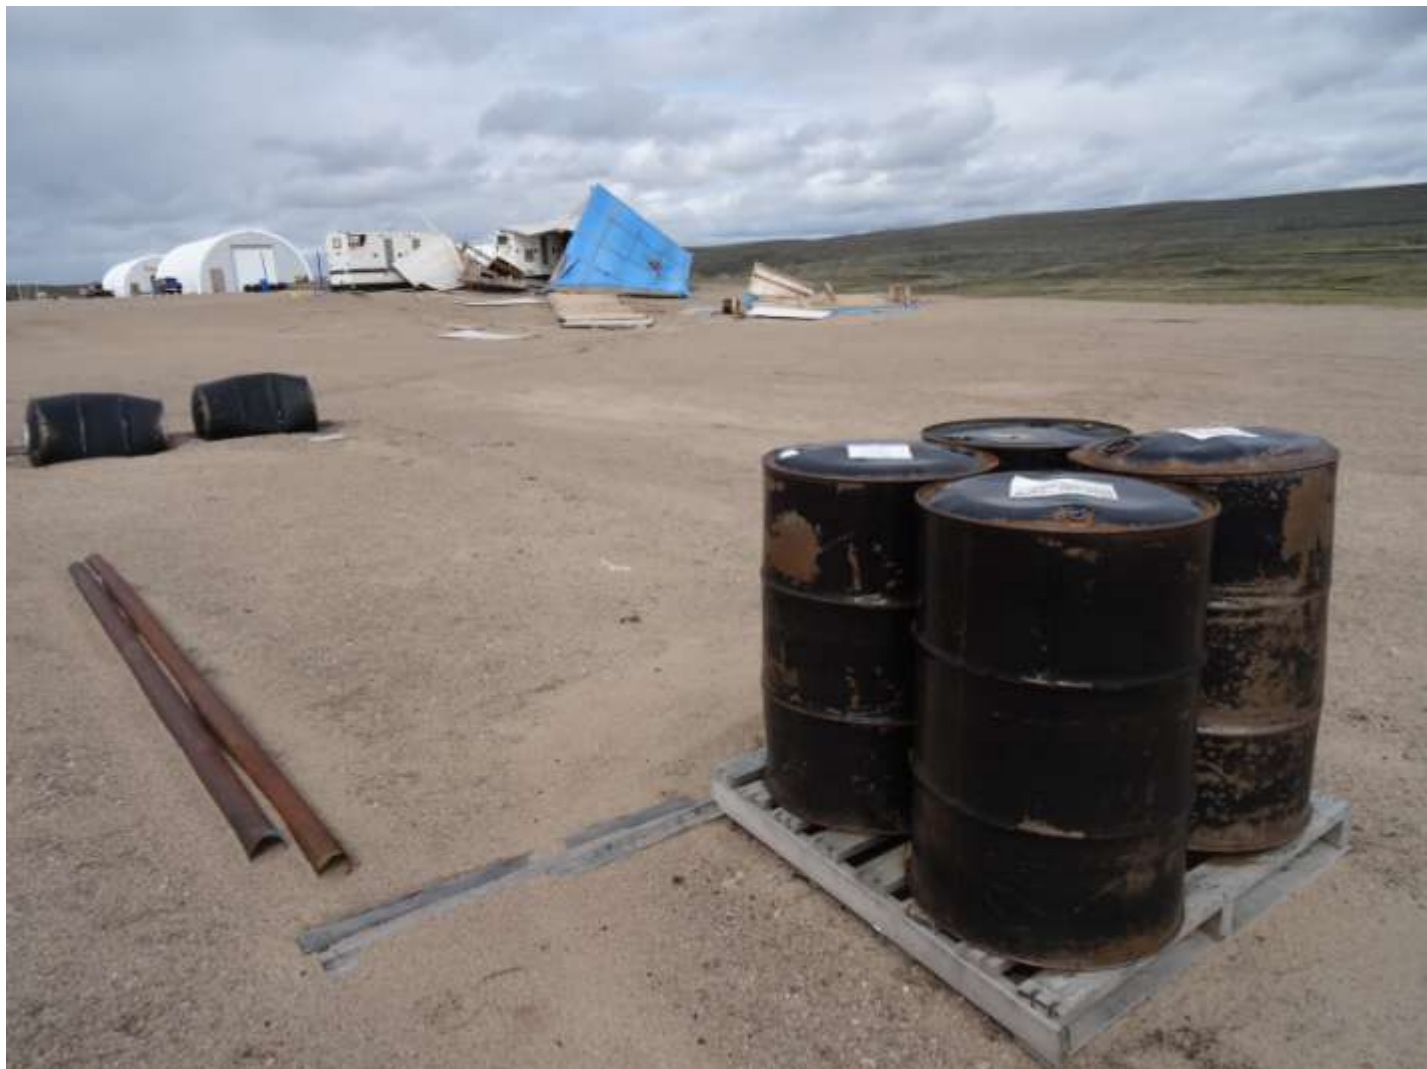
Figure 20. Full diesel barrels at the airstrip.

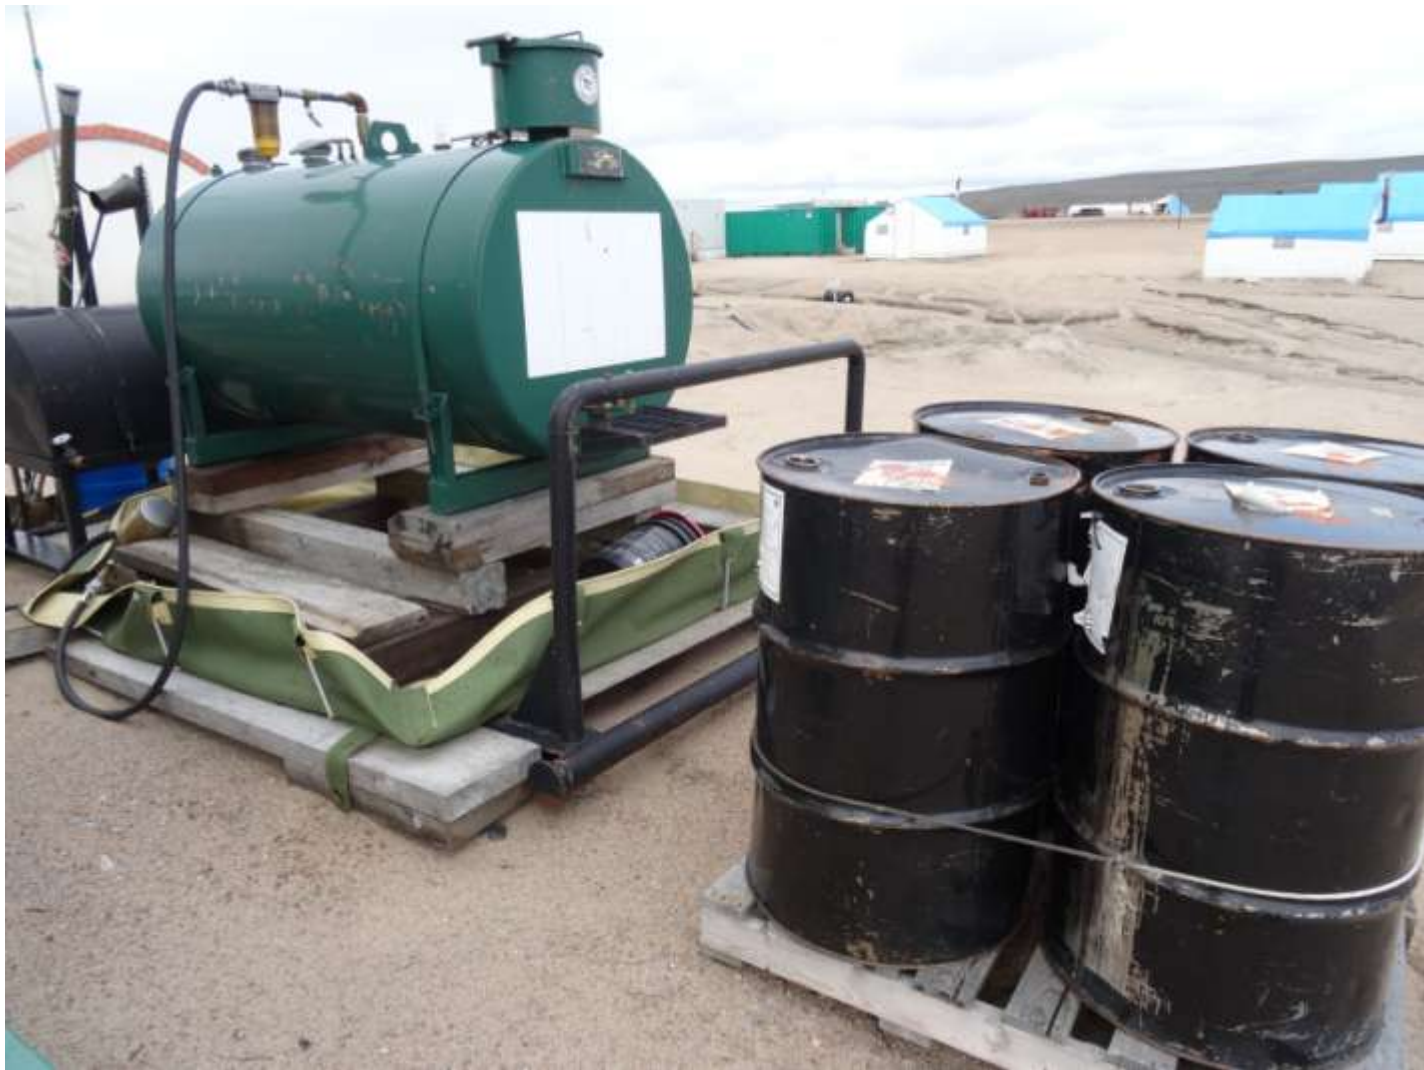
Figure 21. Barrels out of containment at the incinerator.

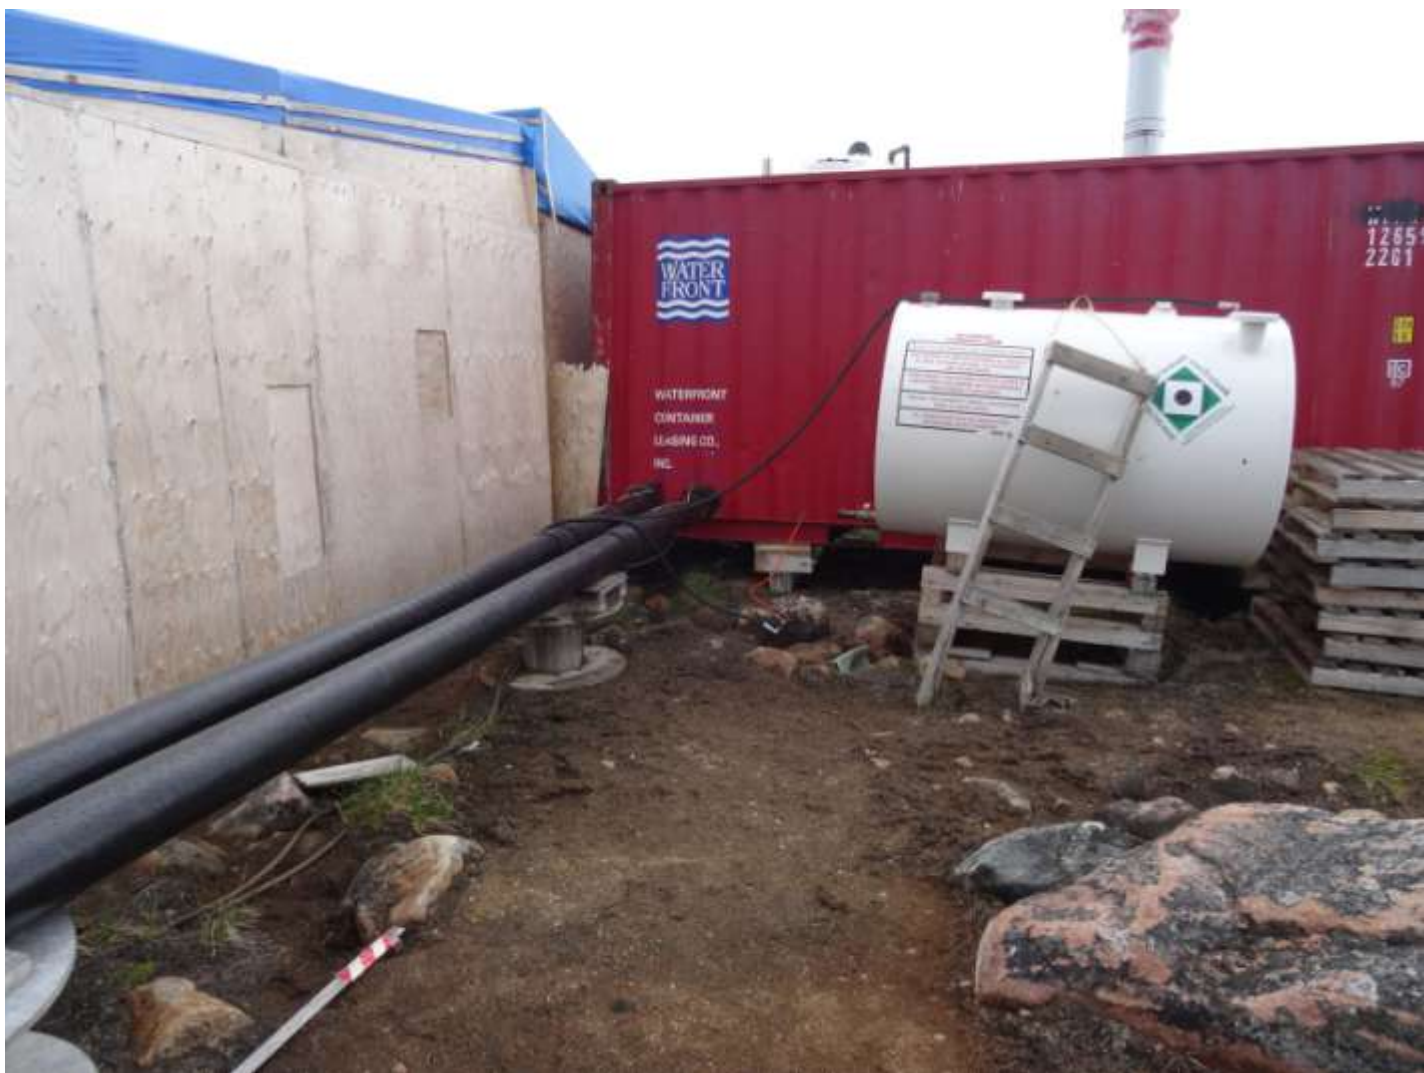
Figure 22. While tank may be double-walled, the hoses and valves are not. Secondary containment is required.

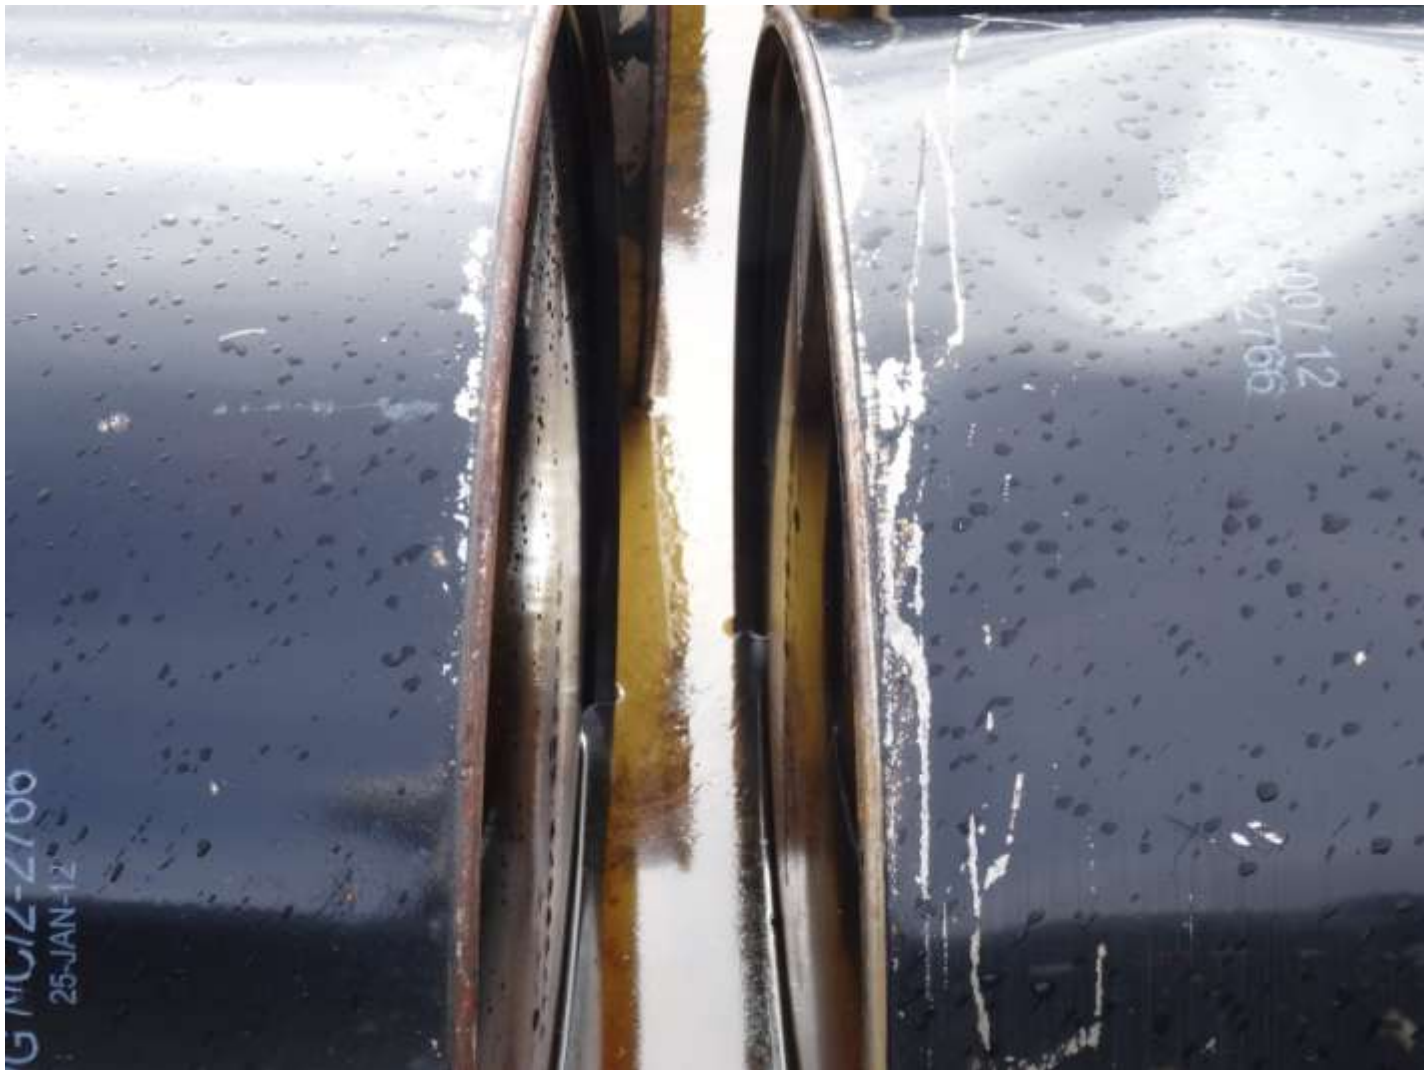
Figure 23. Contaminated water in Three-Bluffs berm 2.

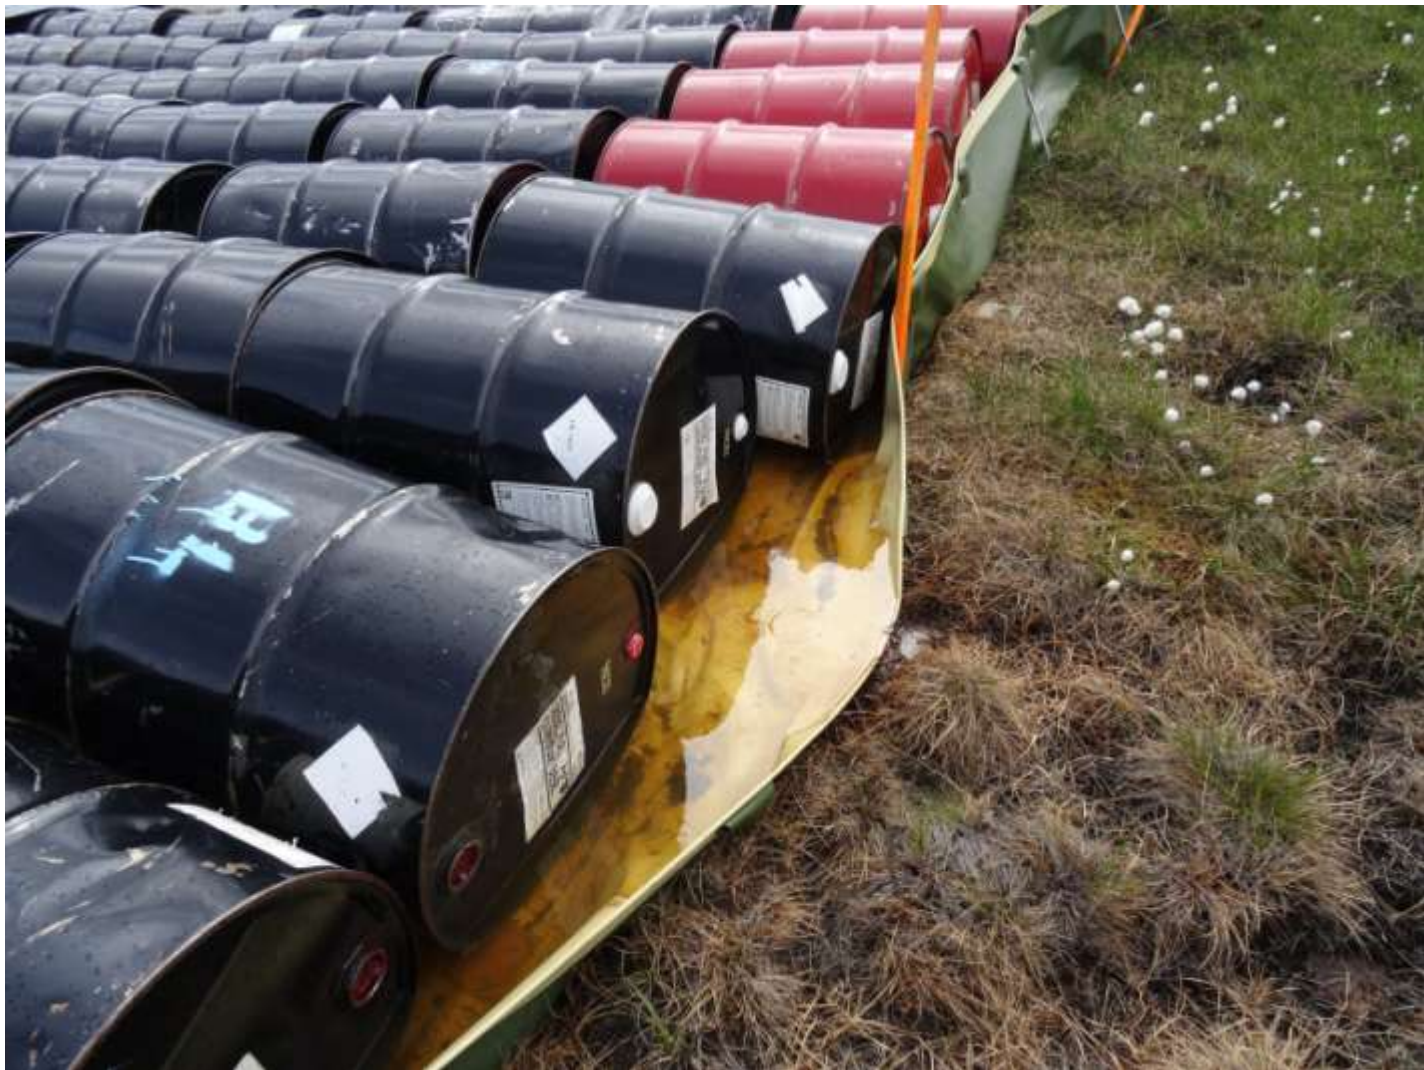
Figure 24. Collapsed side of Three Bluffs berm 2, leaking contaminated water.

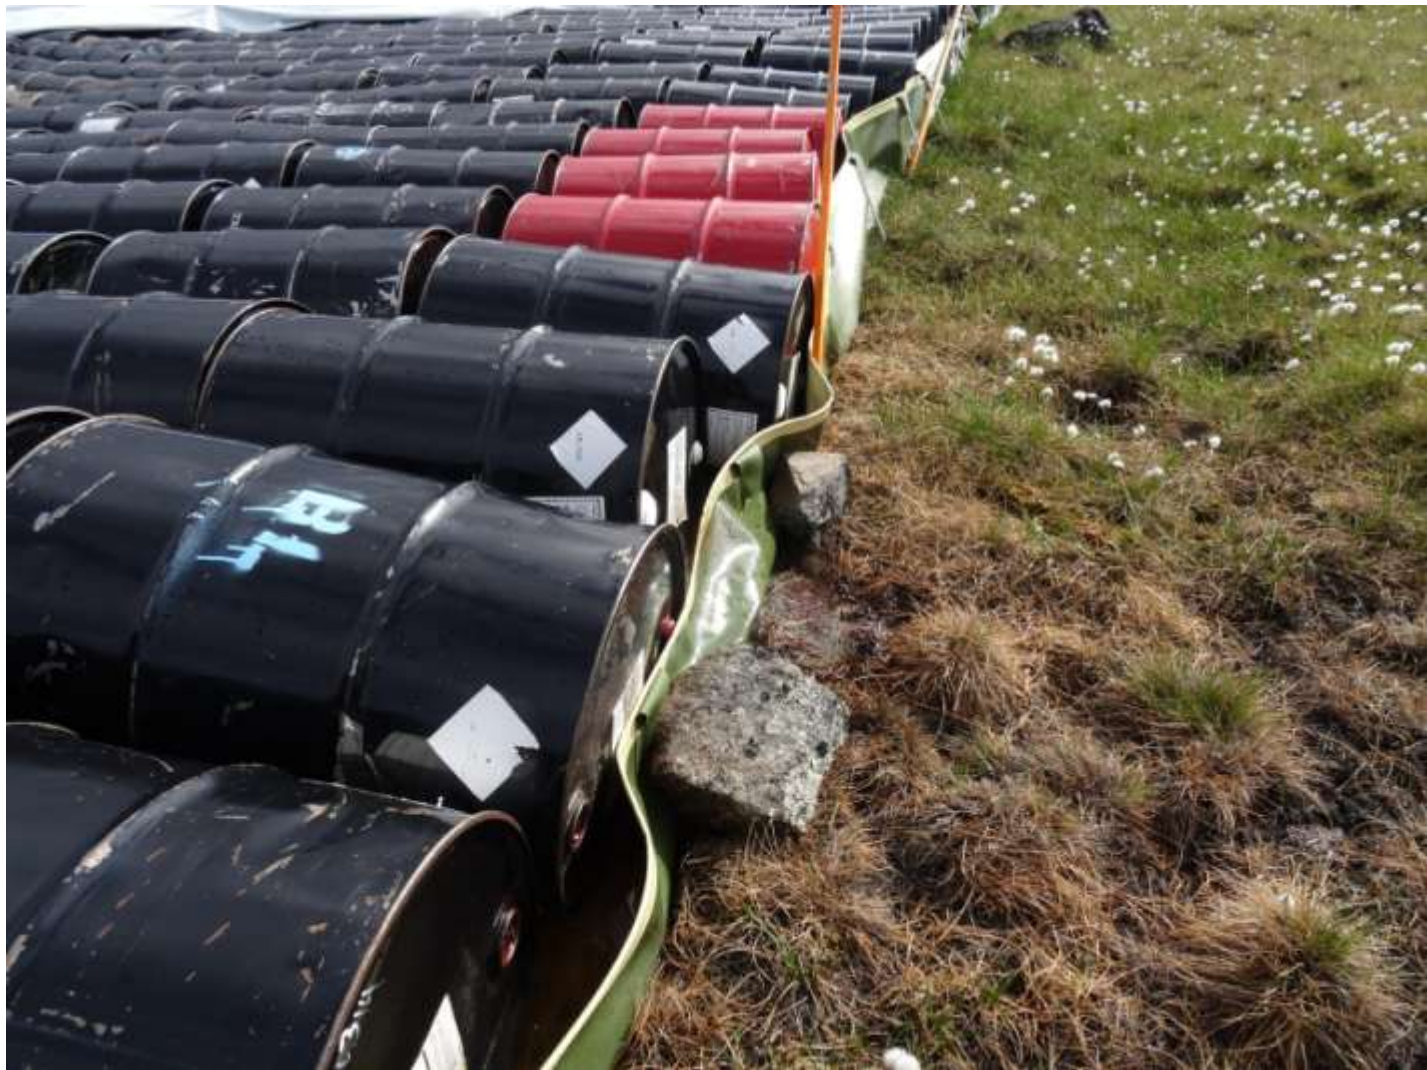
Figure 25. I propped up the side for a temporary fix. More precipitation will cause further overflow of contaminated water.

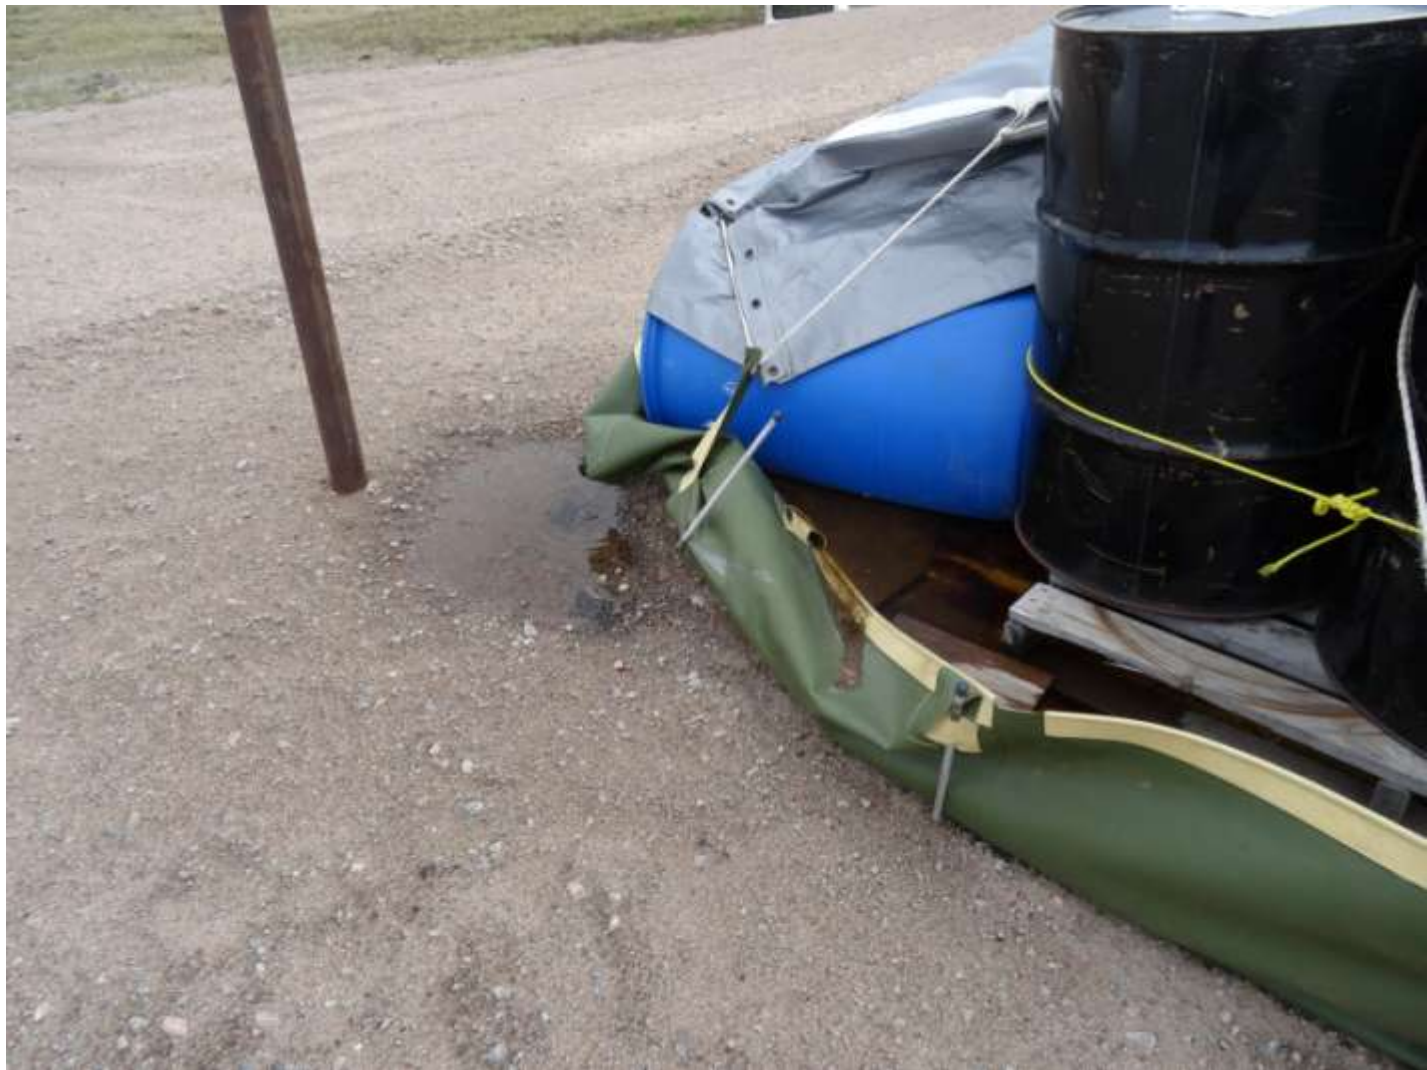
Figure 26. Hayes Camp berm; corner dripping. No obvious contamination at this time.

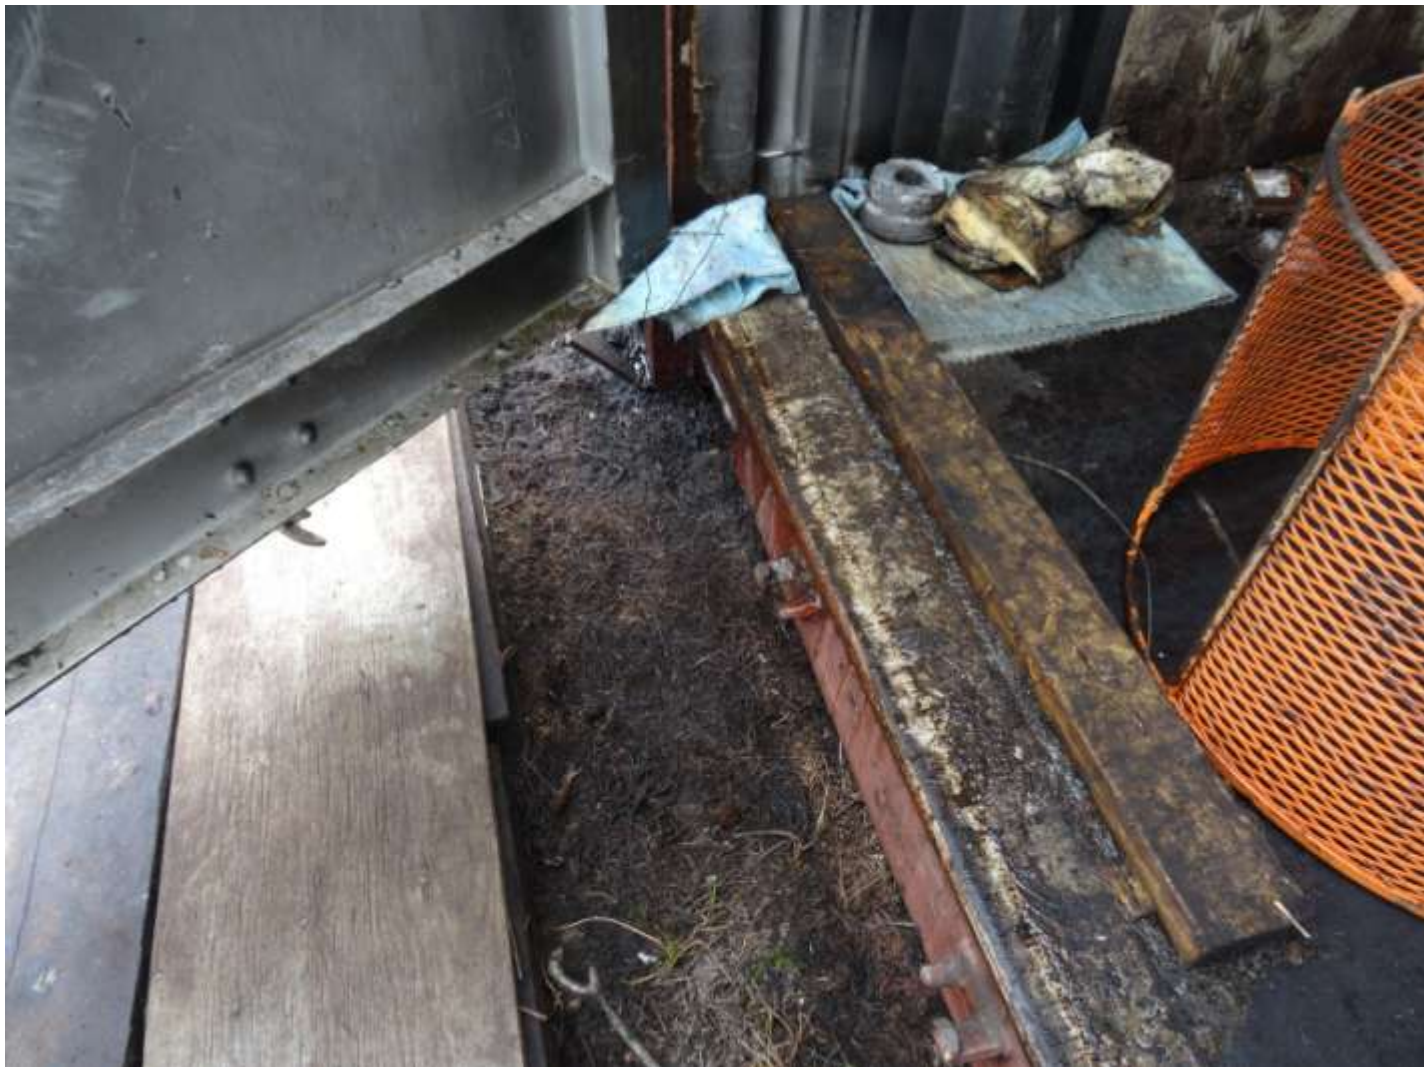
Figure 27. Sea-can leaking oil-contaminated water; there is water coming into the sea-can and flowing through.

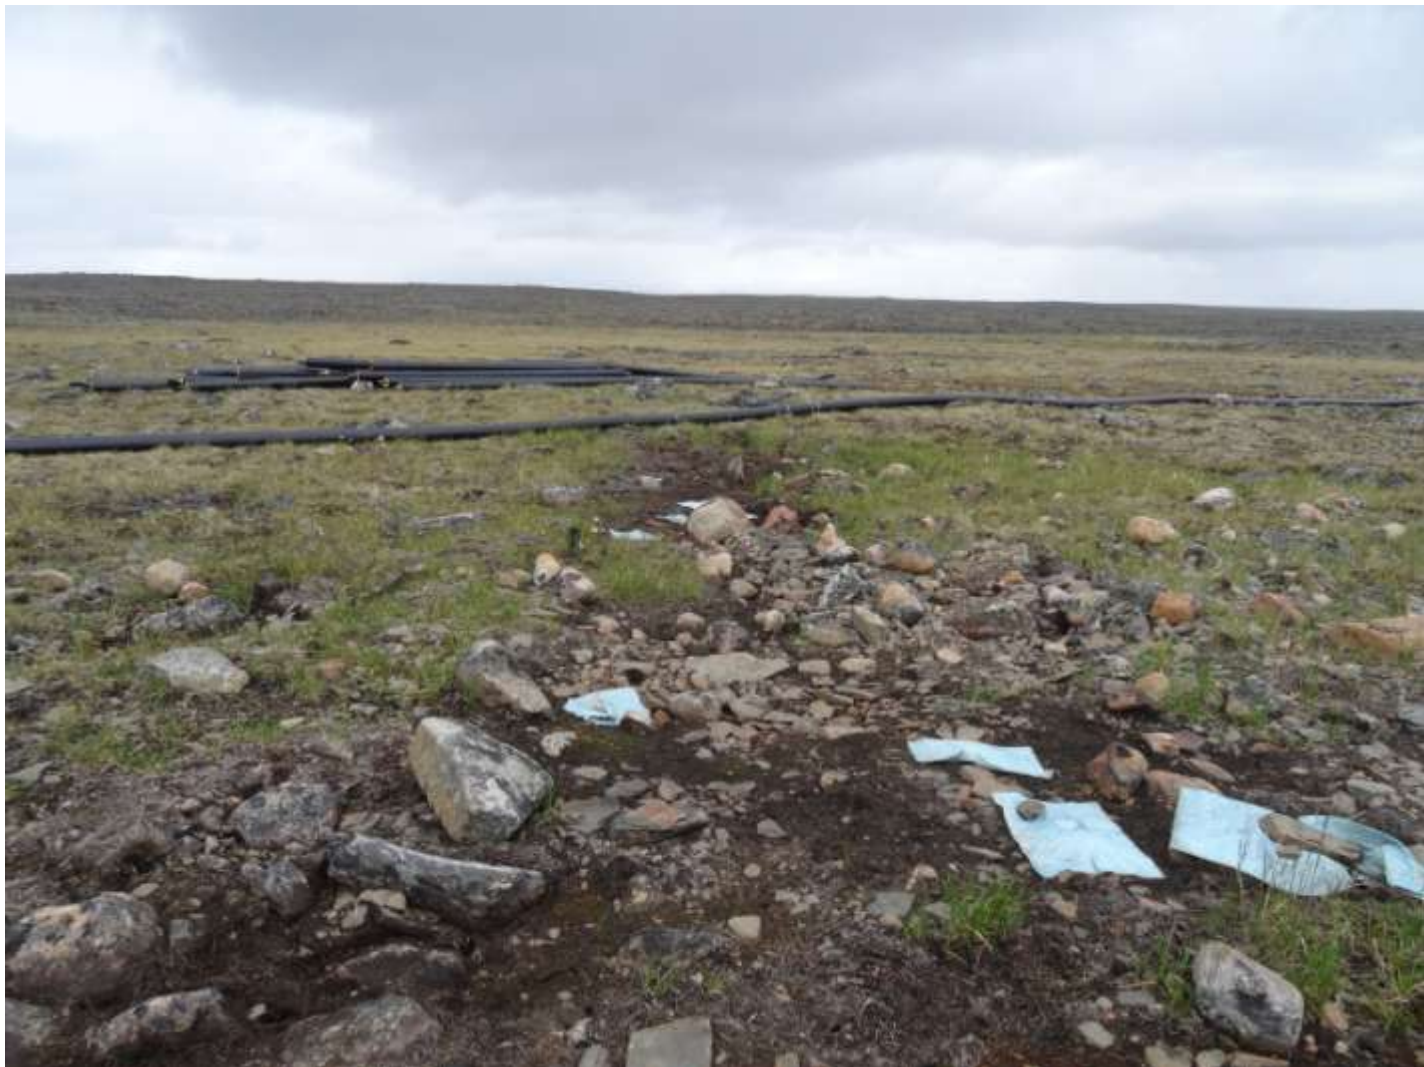
Figure 28. 2012 spill at the boiler. Spill pads are still widespread and holes have not been backfilled.

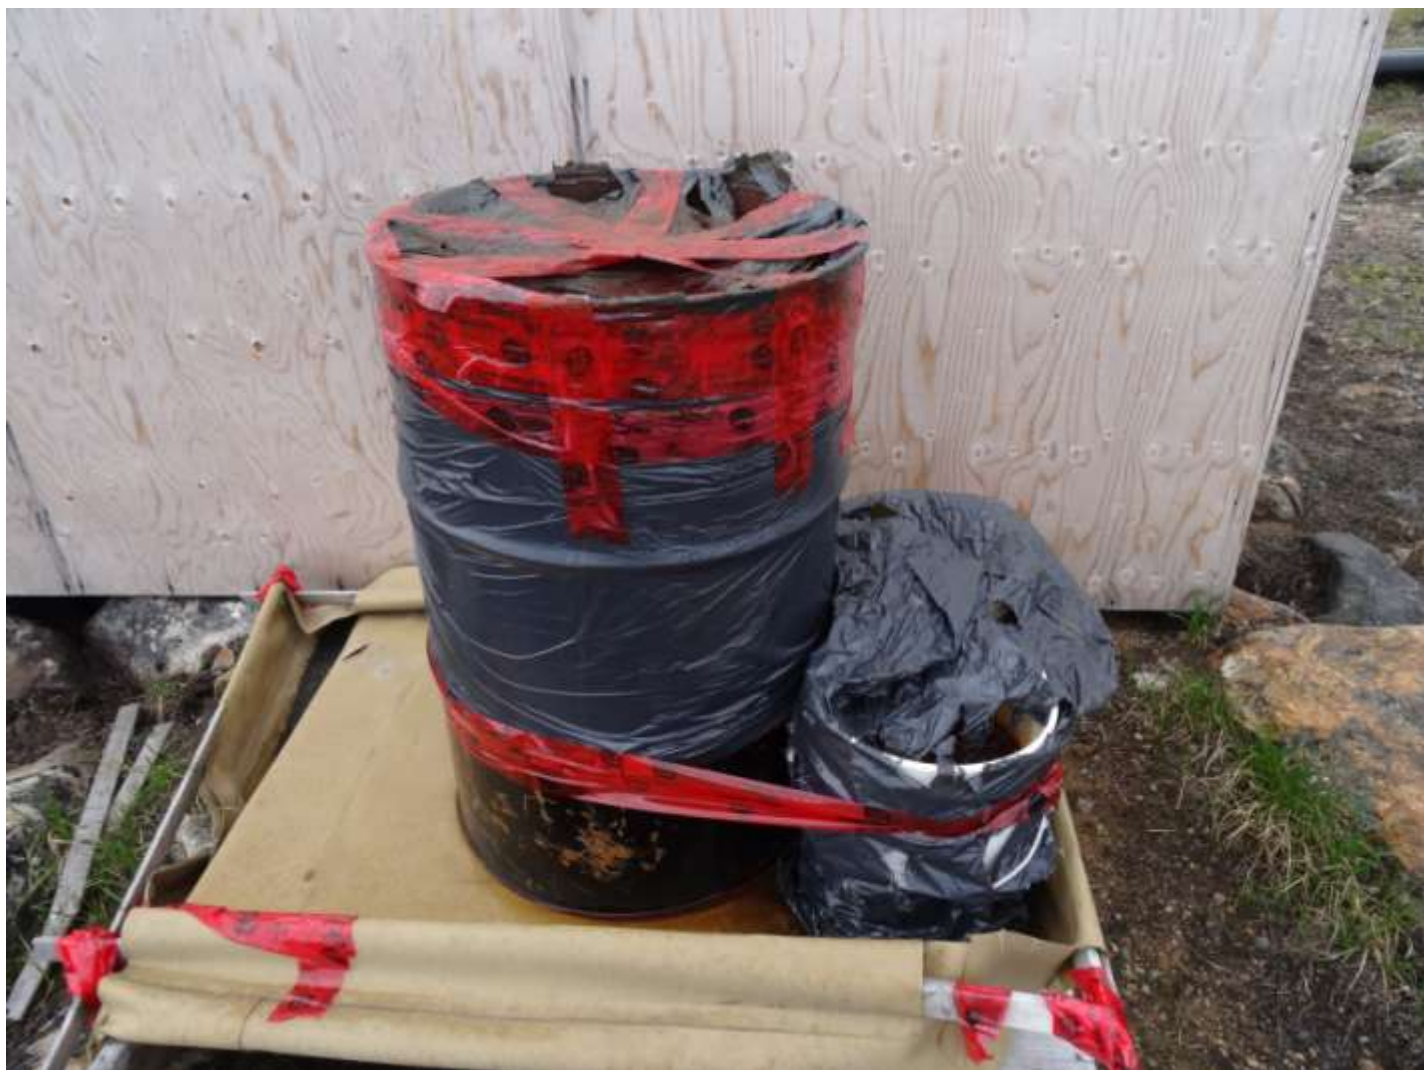
Figure 29. Covered drums of assumedly contaminated material at the boiler. Berm is destroyed, and barrel contents are exposed.
