WATER LICENCE / CROWN LAND INSPECTION FORM

| 2BE-CRA1520 | | | |
| 05/07/2016 | | Eva Paul | |

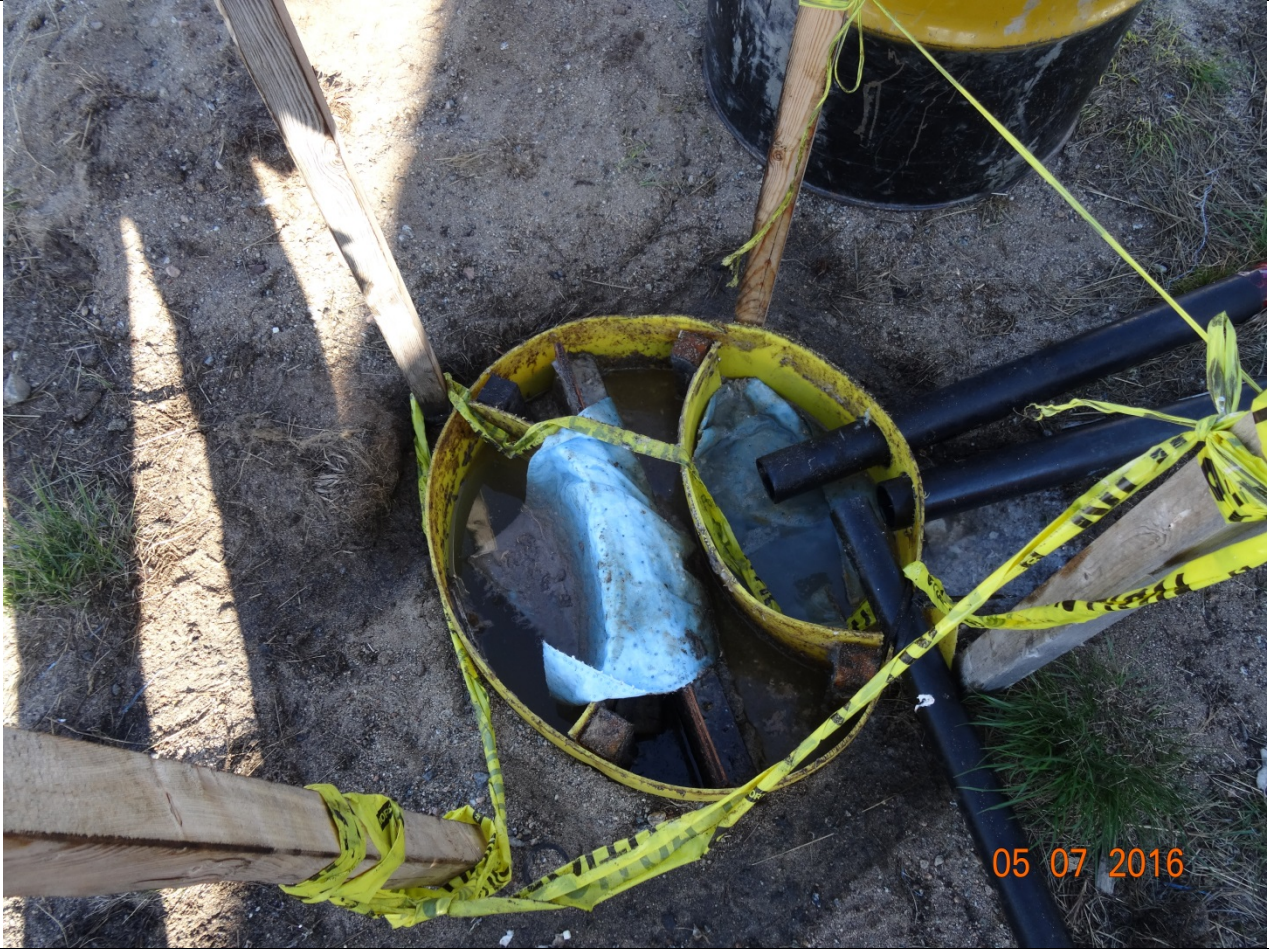
| Date | Camera | Inspector | Authorization |
|---|---|---|---|
| Photo Log # 1 | | Location (NAD 83 DD MM SS.SS) | |

Description: Grease trap at Bullion Camp shows signs of overflowing.

1. Monitor grease trap at Bullion and address deficiencies as required.
2. Ensure dust from RAB drills is not blown into nearby water bodies.
3. Protect the vegetated areas around Hayes Camp to preserve existing vegetation, particularly through the gully between camp and the helicopter area.
4. Implement measures to mitigate the sediment deposition south of camp (eg: by diversion or and dissipation of the flow to areas that are still vegetated or that don't flow directly into the lake). Evaluate the efficacy of the measures and adapt as necessary.
5. Provide to the inspector coordinates of all drill activities for 2015. Provide the 2016 coordinates with the annual report as required.

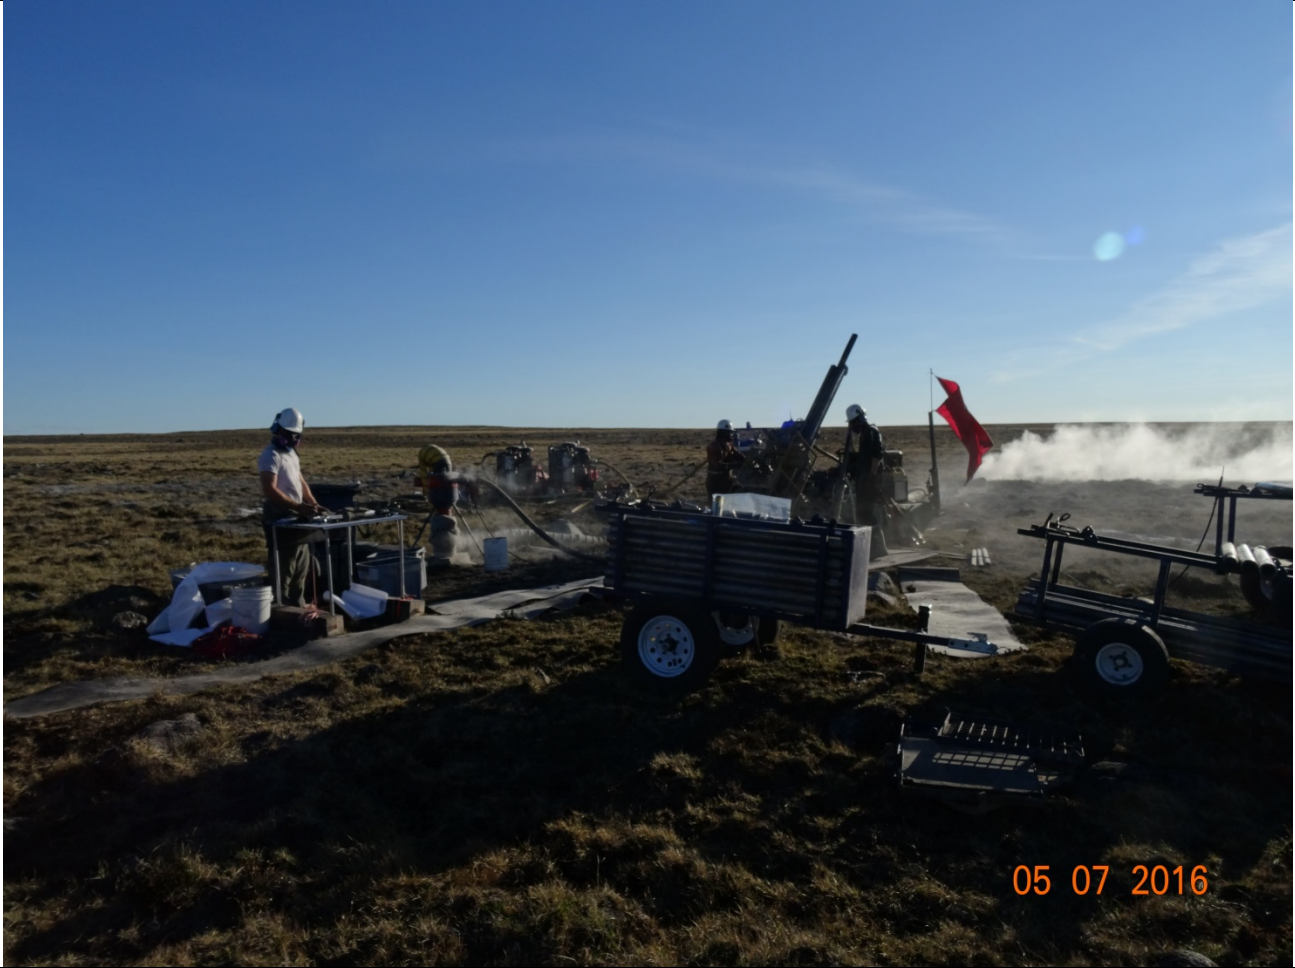
| Photo Log # 2 | Location (NAD 83 DD MM SS.SS) |

Description: Active RAB setup at hole 35. Chemicals/oils all in containment.

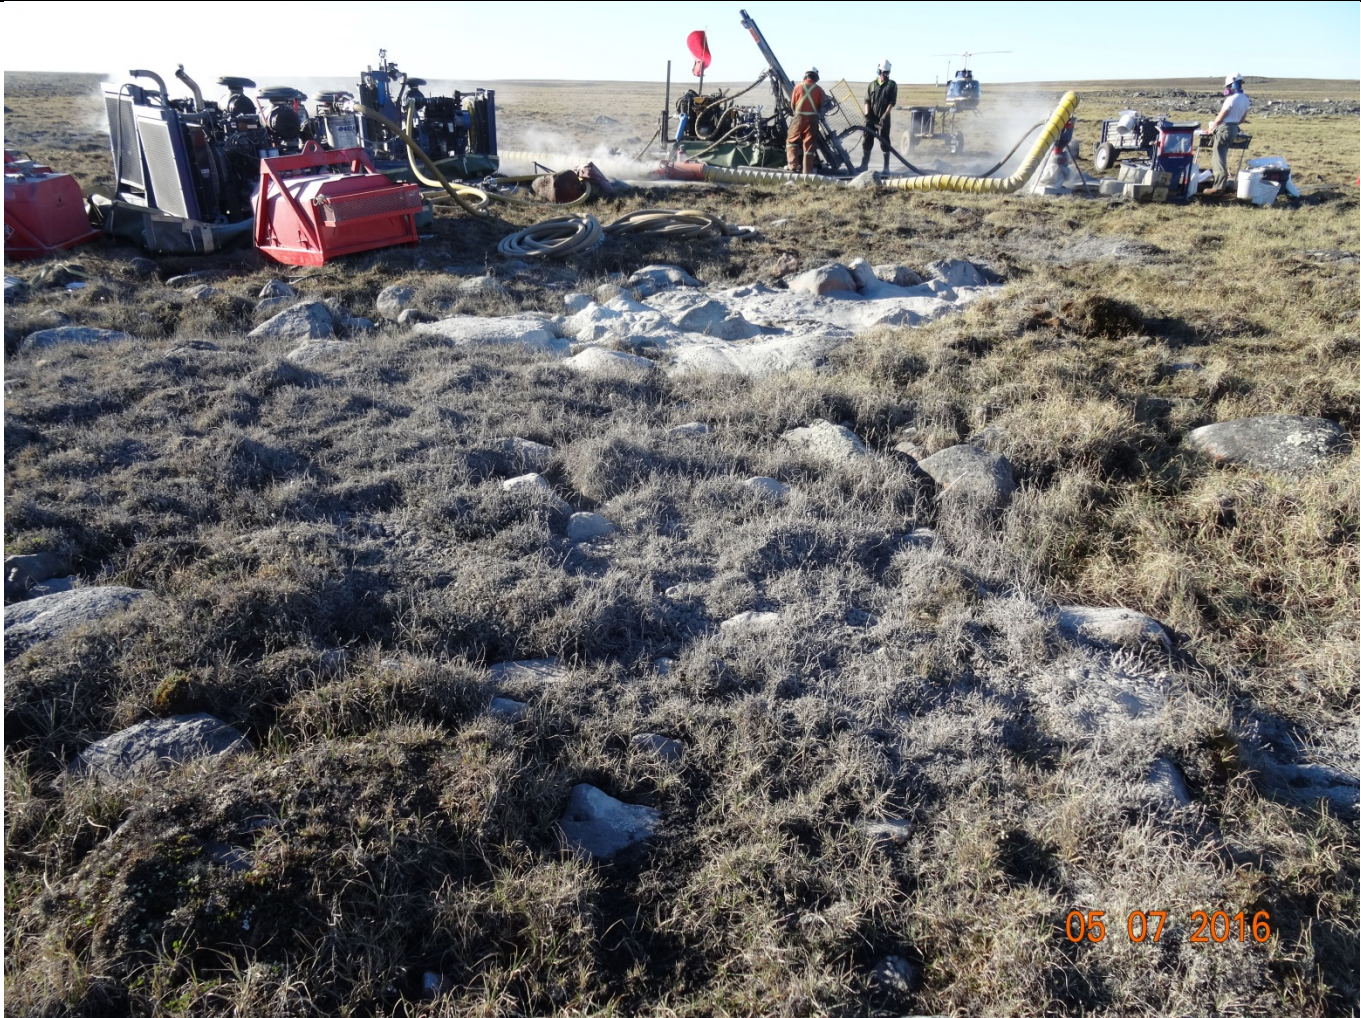
Photo Log # 3

Description: Dry cuttings left on tundra, similar to process with wet diamond-drill cuttings.

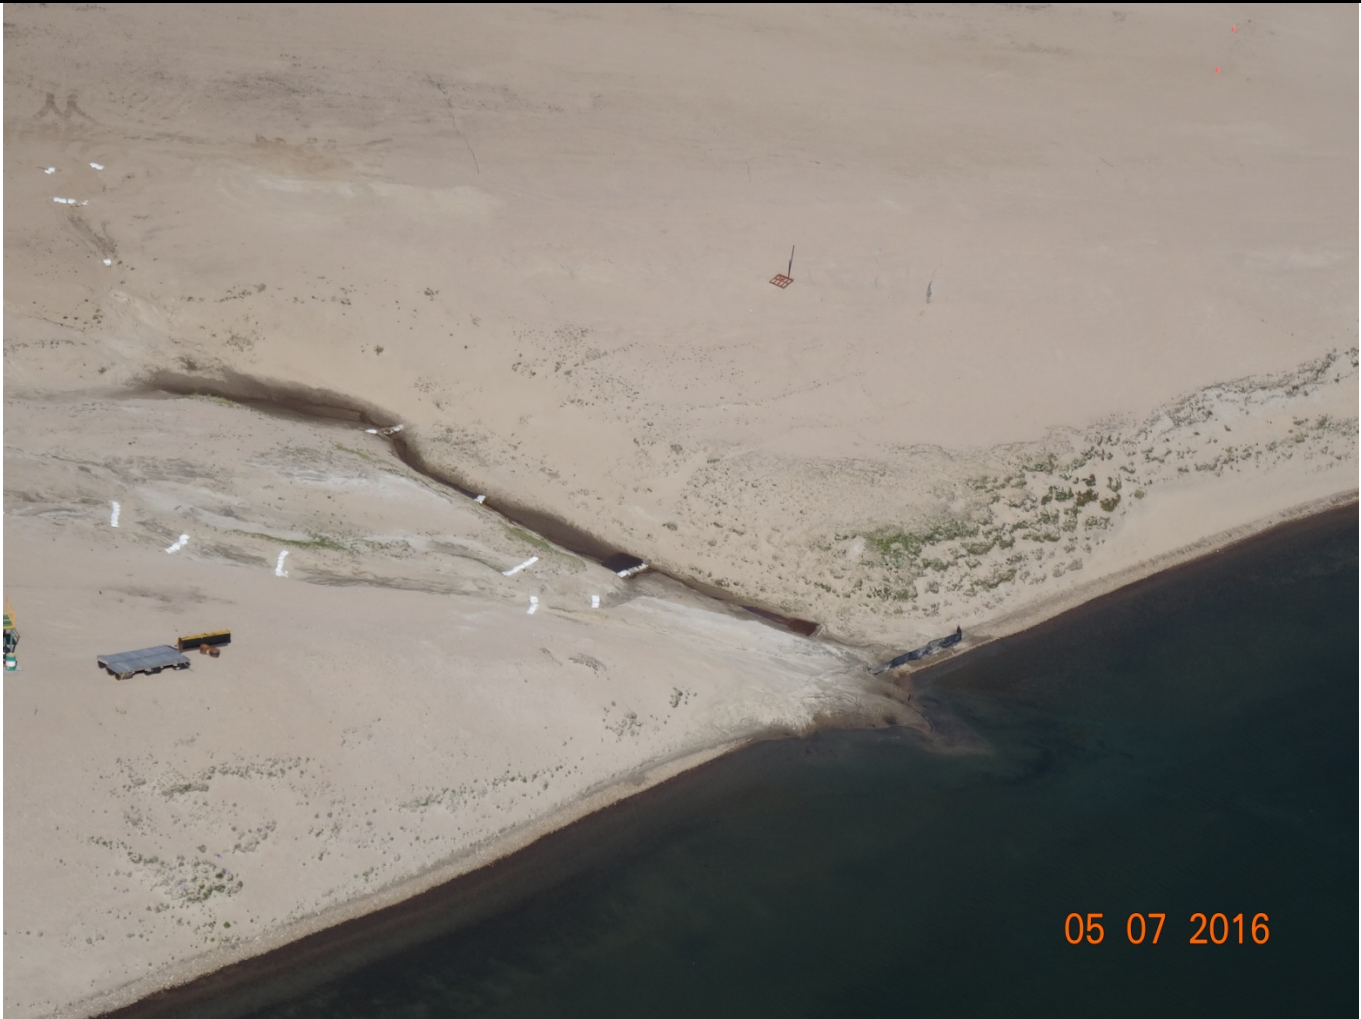
Photo Log # 4

Water Licence:
Part C Item 6. Erosion to the bank of the lake to the south of the camp.
Part C Item 7. Measures undertaken to control erosion are not effective, resulting in sediment deposition to the lake.
Part E Item 2. Camp activities have impacted surface drainage, increasing flow of sediment into the lake.
Part J Item 4. Provide coordinates for all wastes (including cuttings from RAB drill).

Description: Erosion stream seen from the air.

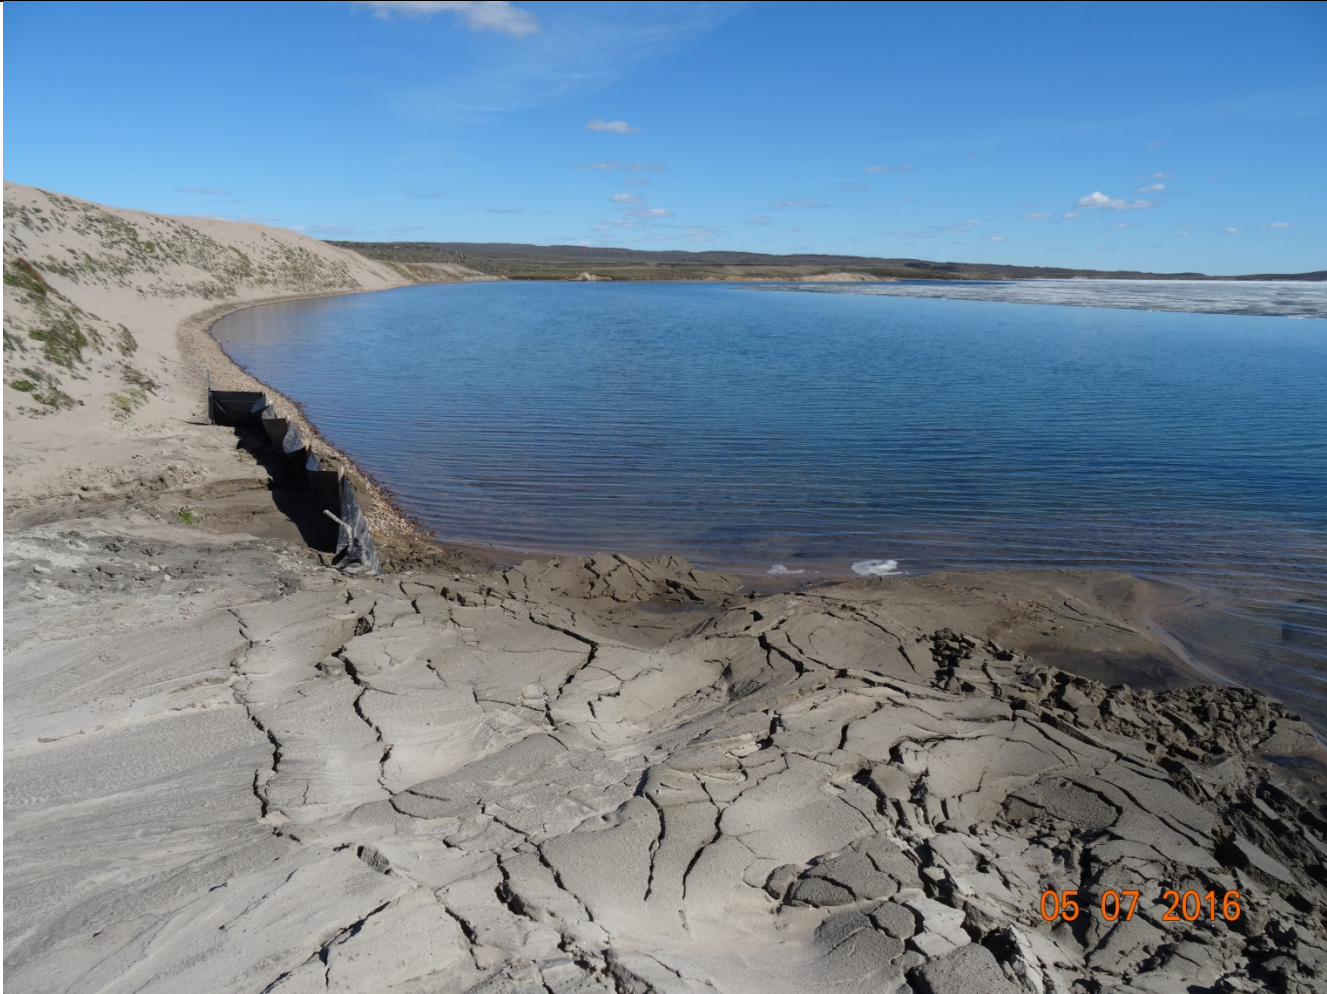
Photo Log # 5

Description: Esker sand deposited in lake, as seen from the ground.

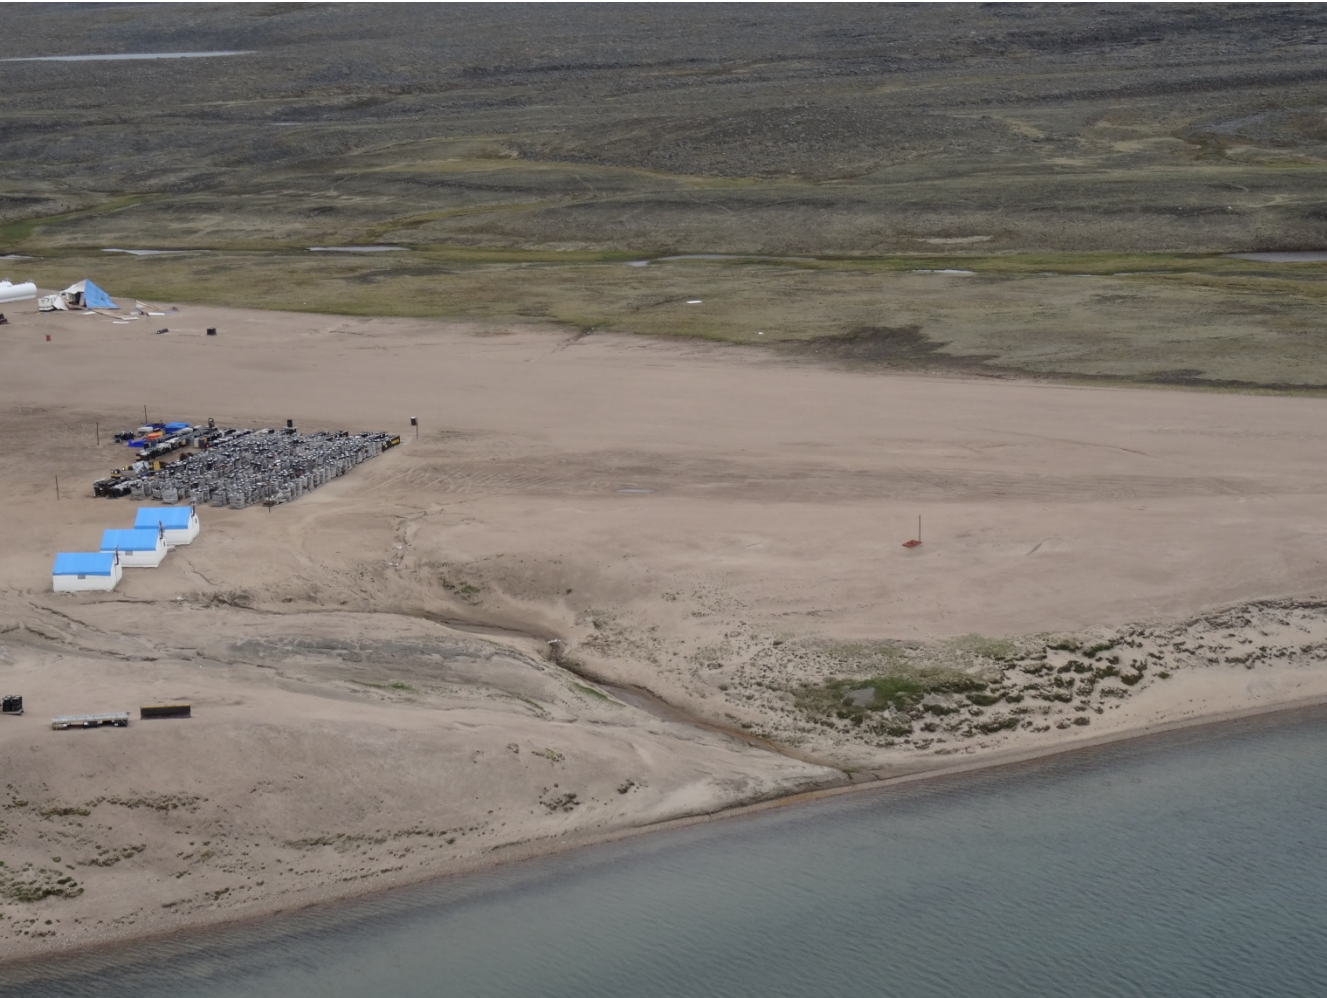
Photo Log # 6

Description: Erosion channel as seen in 2014.
