WATER LICENCE INSPECTION FORM

| North Country Gold/Auryn Resources | | Bryan Atkinson | |
| 2BE-CRA1520 | | Exploration Manager | |
| 29 July 2018 | | Baba Pedersen | |

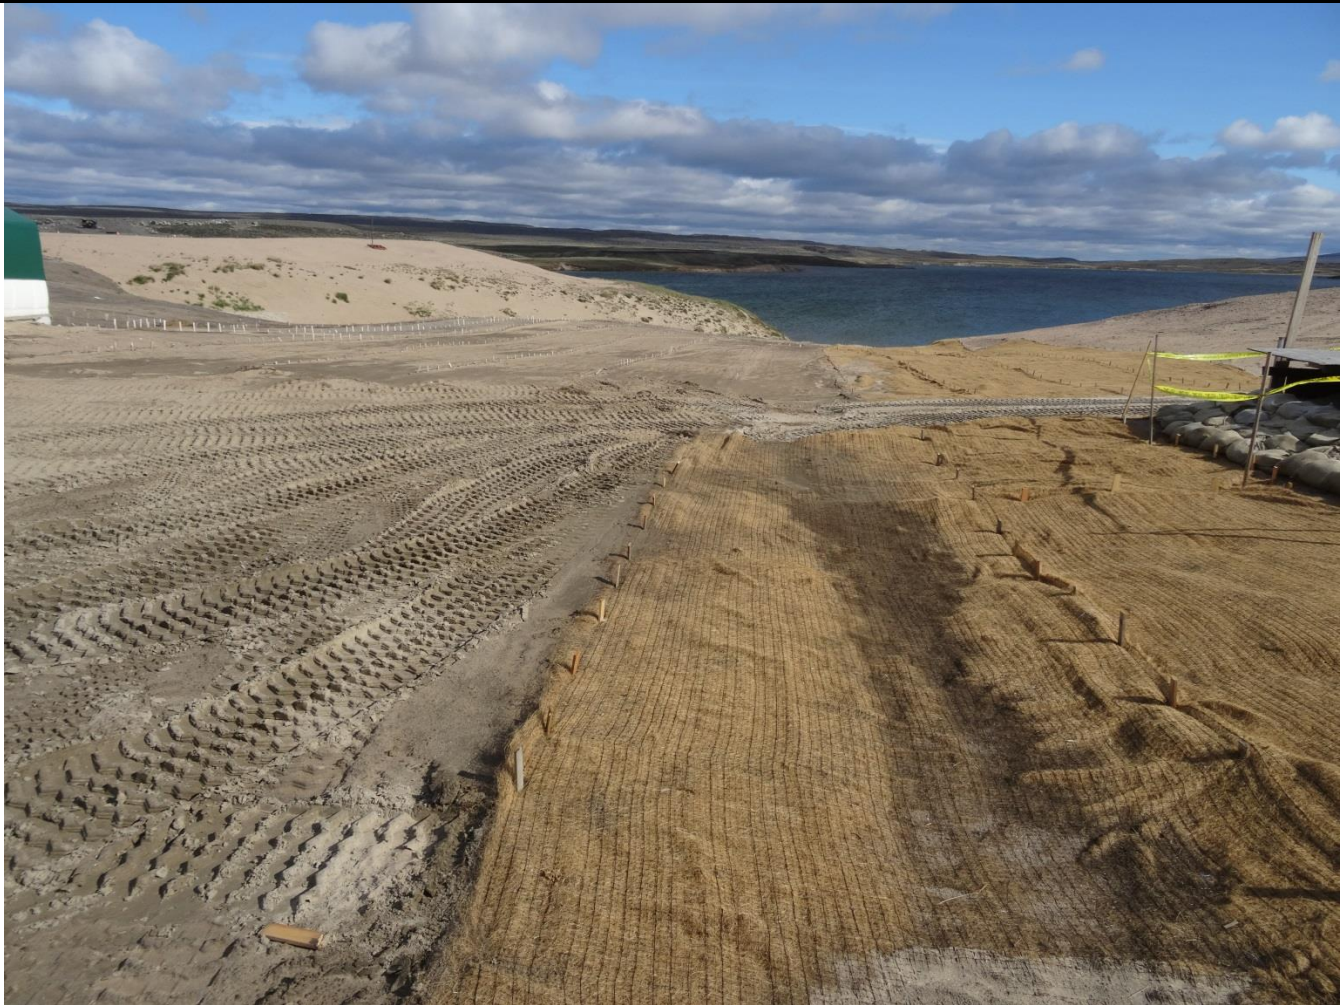
Photo 7

Description: Coconut Matting installed for Erosion Control as per Eva Paul's Direction from last Inspection – also visible in Photo #2

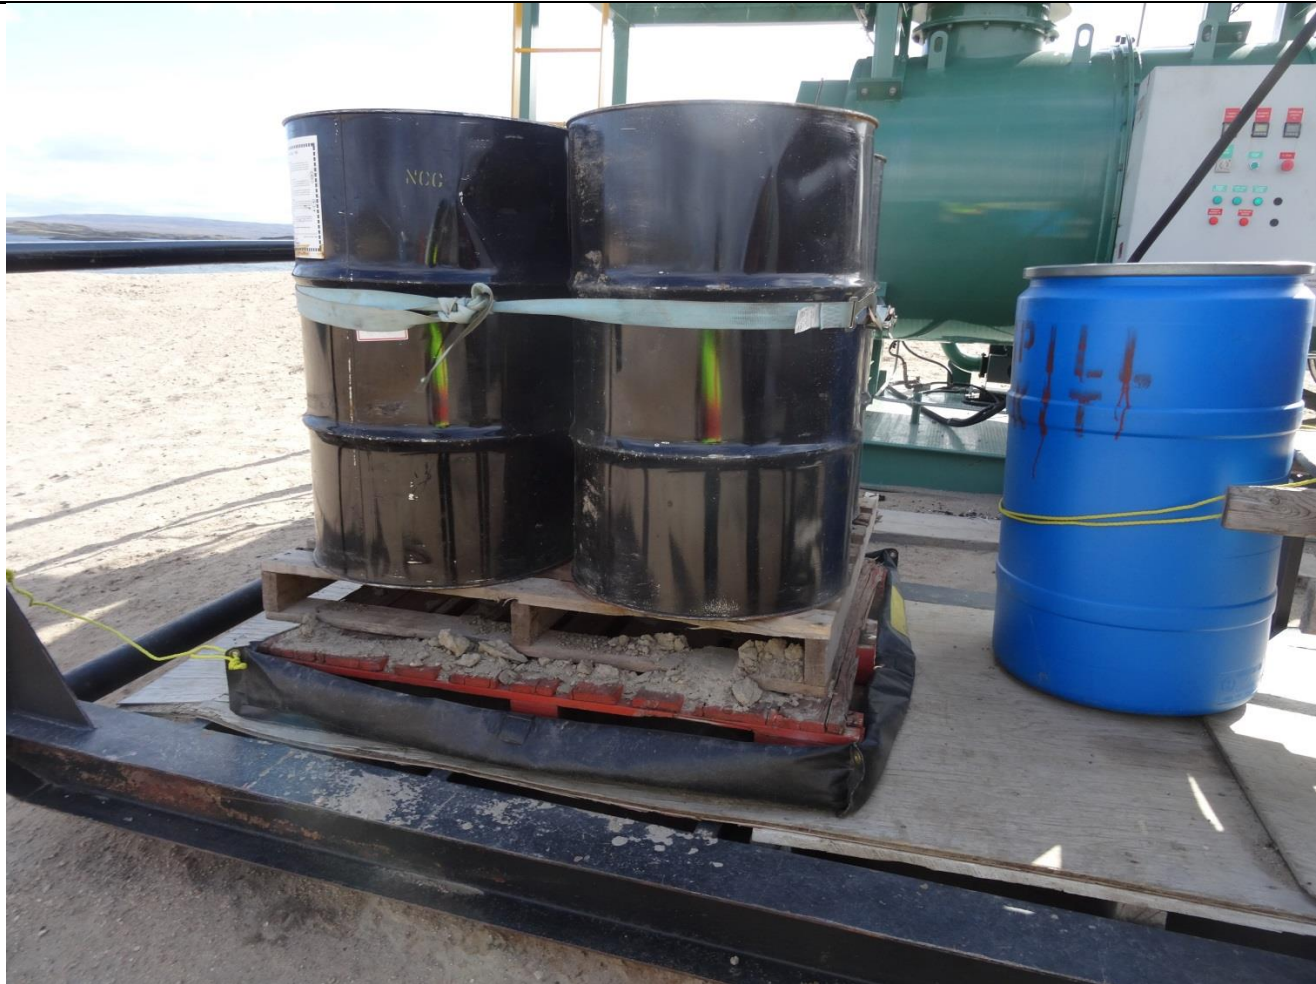
Photo 8

Description: Fuel Drums for Incinerator – Needs Larger Secondary Containment

| 1. Very Nice Secondary Containment on all Individual Drums, Thank you very much. 2. Thank you for Installing the Grease Trap as per a previous Inspection request. 3. Thank you for Installing the Coconut Matting for Erosion Control as per previous Inspection request. 4. The Secondary Containment under the 4 Drums used for the Incinerator MUST be changed to a larger one so it completely encloses the bottom, send photos to the Inspector once complete to verify this 5. The Waste Drum Berm #2 Secondary Containment MUST be repaired, send photos to the Inspector once complete to verify this. 6. It was mutually agreed that the reclamation of the old Quarry is a Long-Term Reclamation Project, the Proponent will fill in the low spots and channel the drainage to its original location. The Proponent is to Update the Progress of this Reclamation in each Annual Report. 7. All was well at the RAB Drill Site, I have no concerns. 8. All was well at the Diamond Drill Site, I have no concerns. | | | |

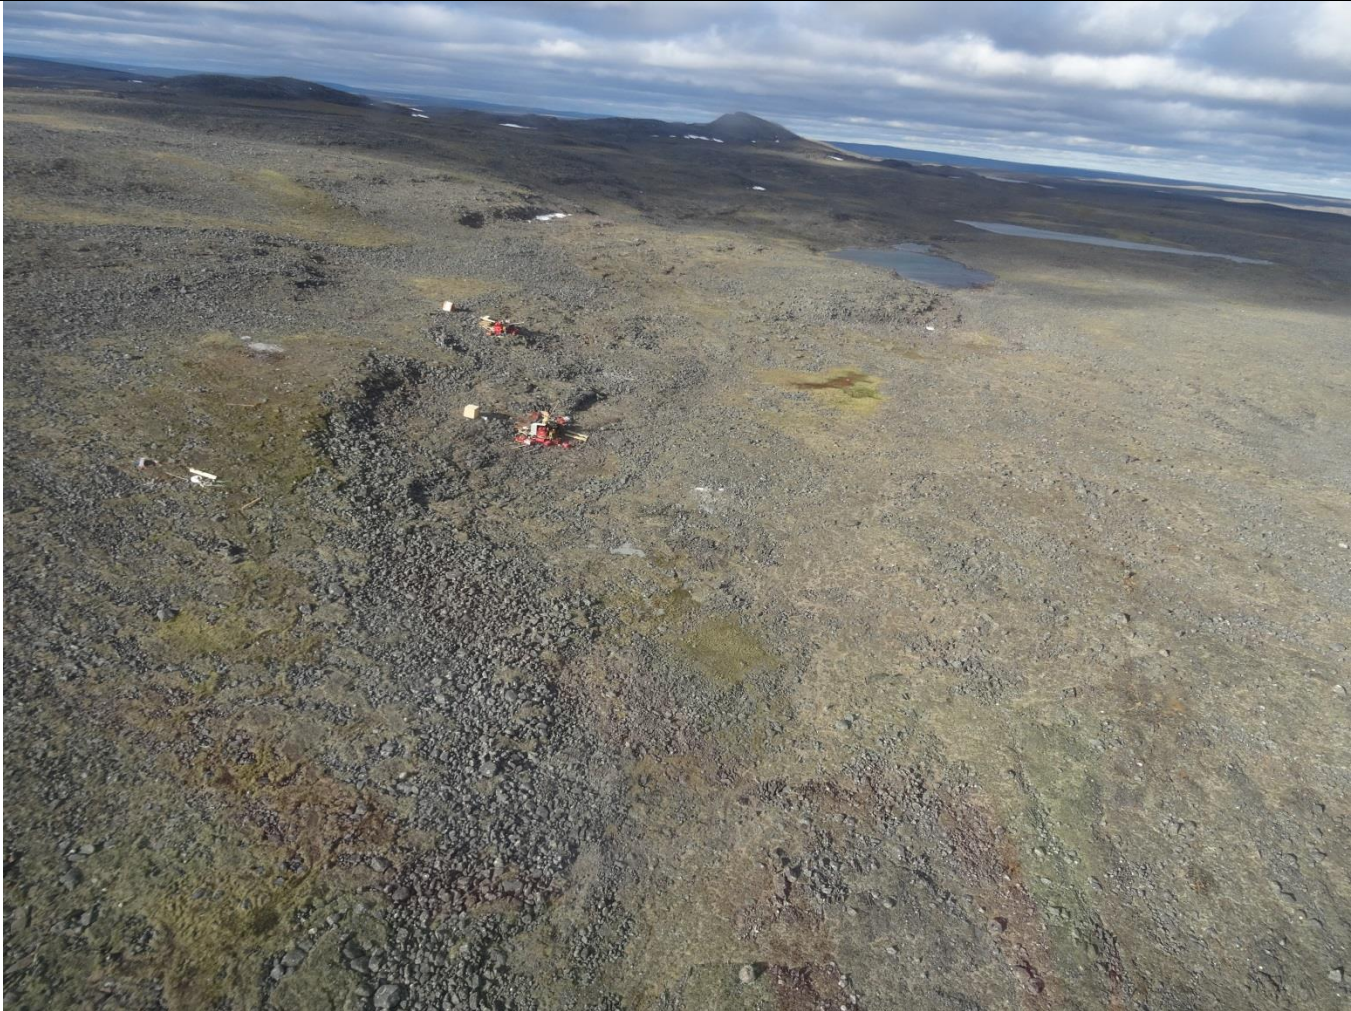
Photo 17

Description: Aerial View of 2 Diamond Drill Rigs side-by-side with Water Source shown in the top right

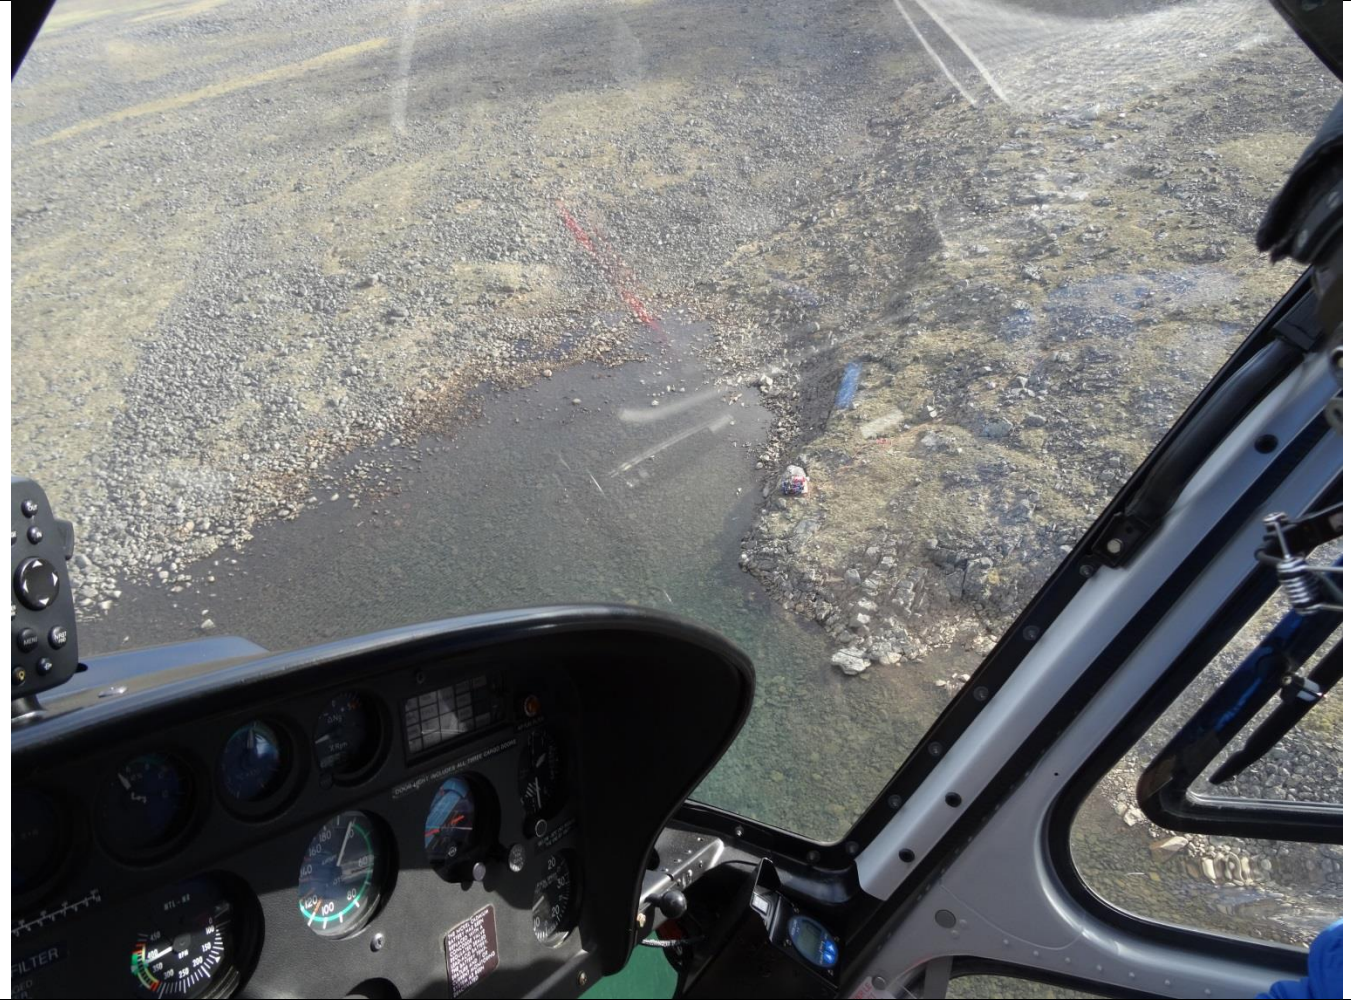
Photo 18

Description: Aerial View of Water Pump at Source
