## **Committee Bay Project**

## ***Annual Report***

***2022***

North Country Gold Corp.  
January 2023

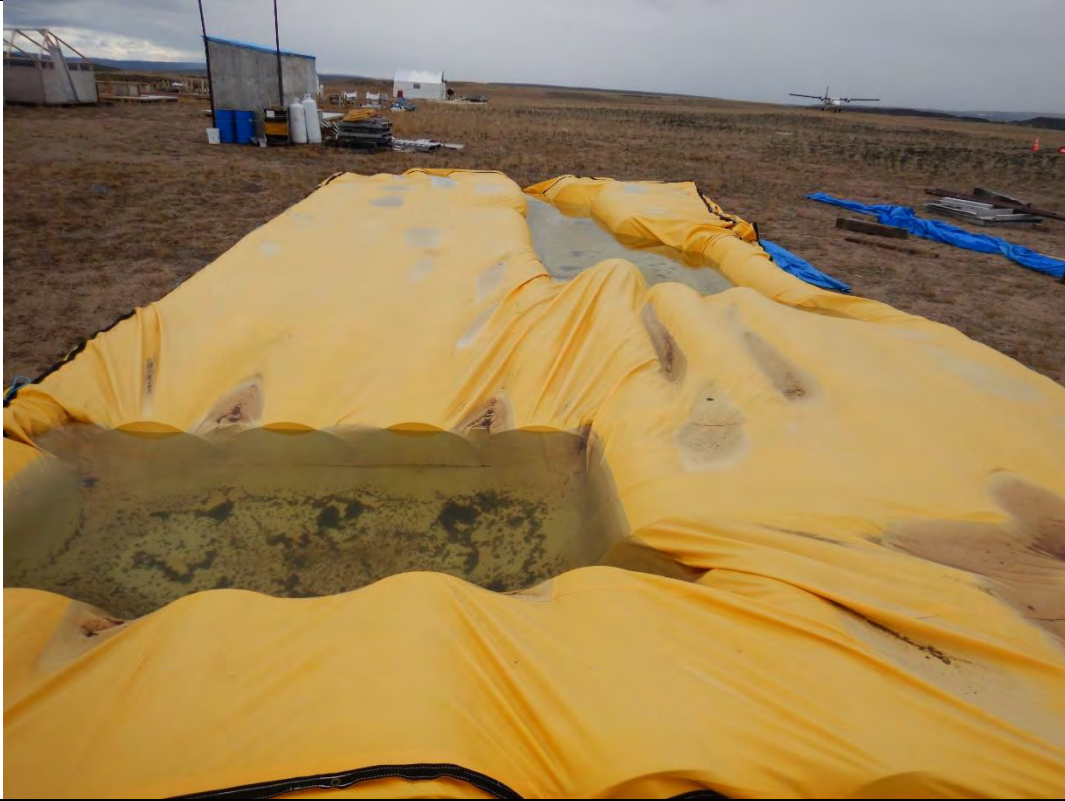
| Date | Camera | Inspector | Authorization |
|---|---|---|---|
| Photo 2 | | | |

1. The main fuel cache secondary containment appeared to be full of water. See photos 1 and 2 for photos of containment berms full of water.
2. While on site at Crater Camp it did not appear that any of the tent heating fuel tanks have any covers installed, the secondary containment in place had significant water pooling. See photos 3 and 4 for tent heating fuel tanks.
3. it was noted that there is no berm surrounding the grey water sump, It does not appear that the sumps are constructed in a way to prevent melt water and/or rain water from flooding the sump . See photo 5 for the sump.
4. During the inspection the majority of secondary containment was either full with rainwater, damaged and had no secondary containment covers. See photos 3-9 for fuel storage mentioned.

| Date | Camera | Inspector | Authorization |
|---|---|---|---|
| Description: pooling water on top of containment. | | | |

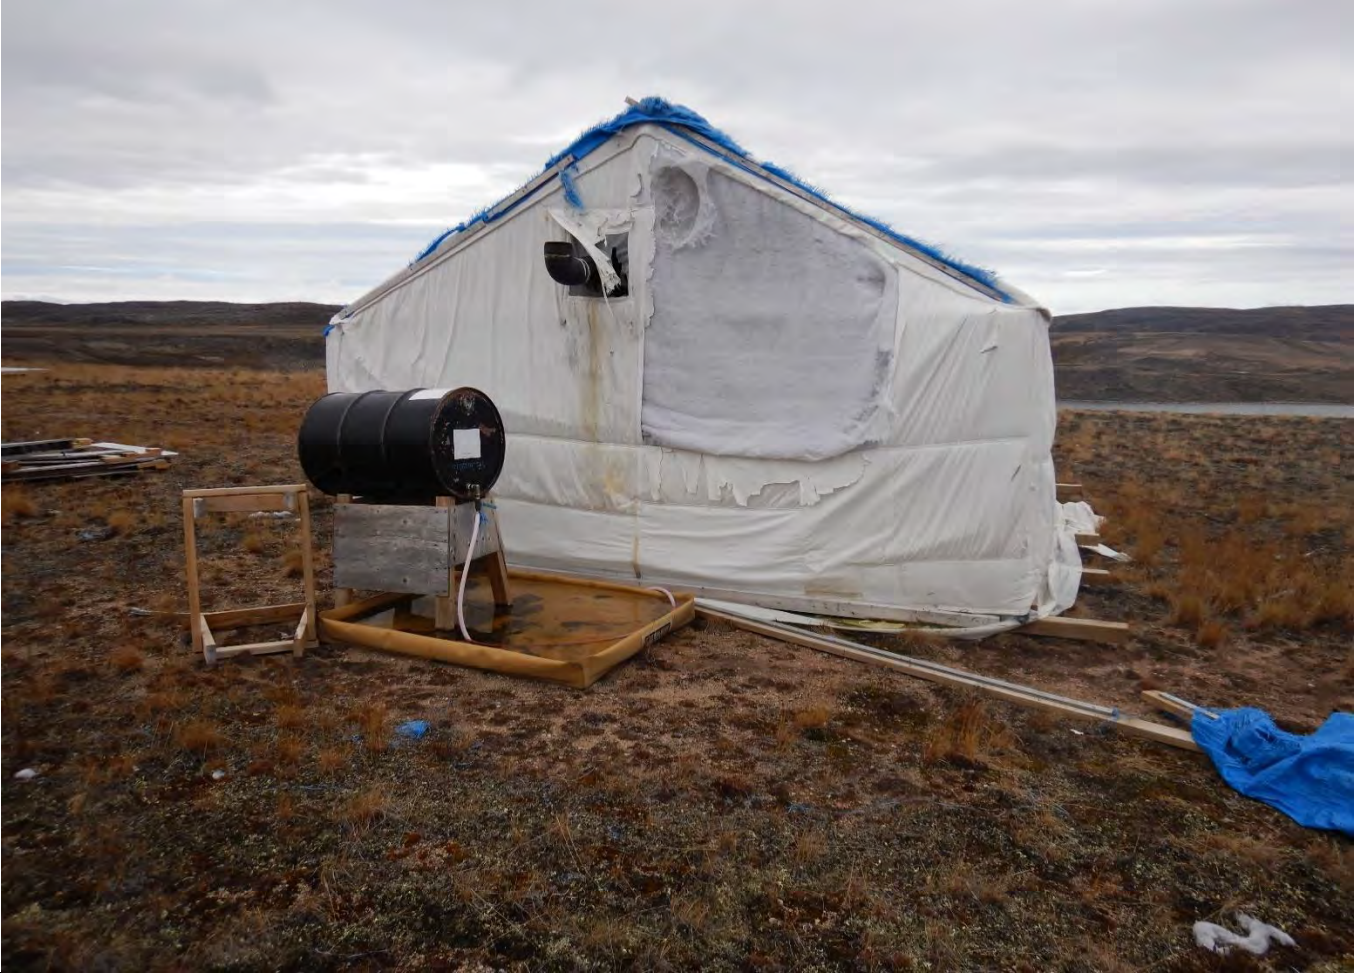
| Date | Camera | Inspector | Authorization |
|---|---|---|---|
| Photo 3 | | | |

| Date | Camera | Inspector | Authorization |
|---|---|---|---|
| Description: heating stove tank without required covering. | | | |

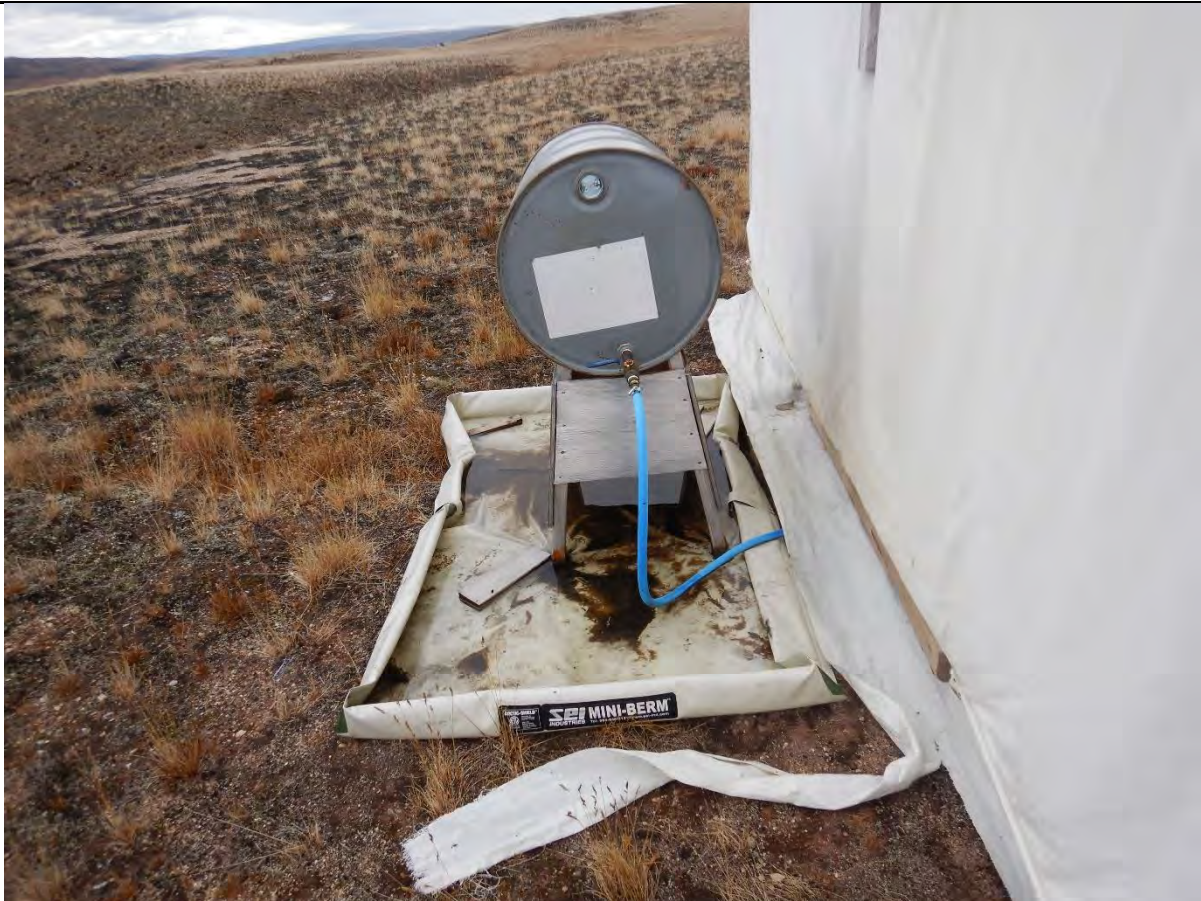
| Date | Camera | Inspector | Authorization |
|---|---|---|---|
| Photo 4 | | | |

| Date | Camera | Inspector | Authorization |
|---|---|---|---|
| Description: heating stove tank without required covering and damaged secondary containment. | | | |

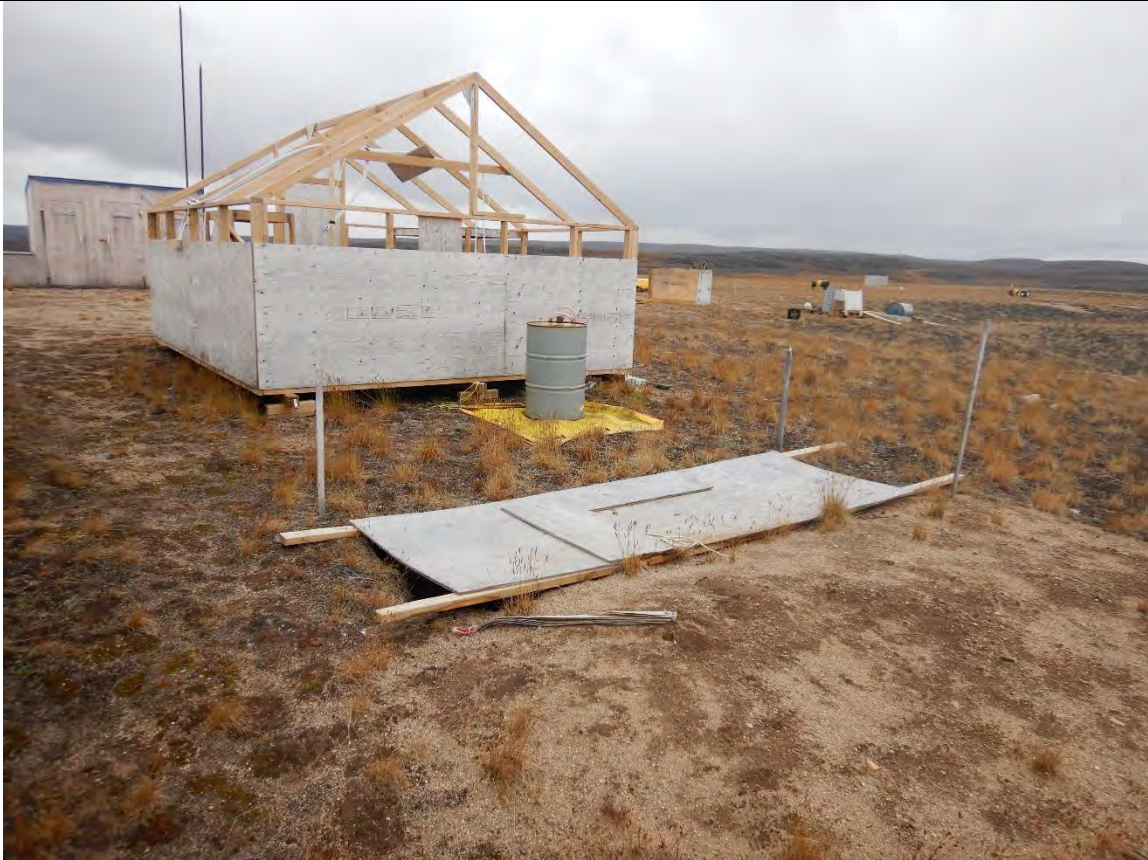
| Date | Camera | Inspector | Authorization |
|---|---|---|---|
| Photo 5 | | | |

| Date | Camera | Inspector | Authorization |
|---|---|---|---|
| Description: partially covered sump and damaged secondary containment. | | | |

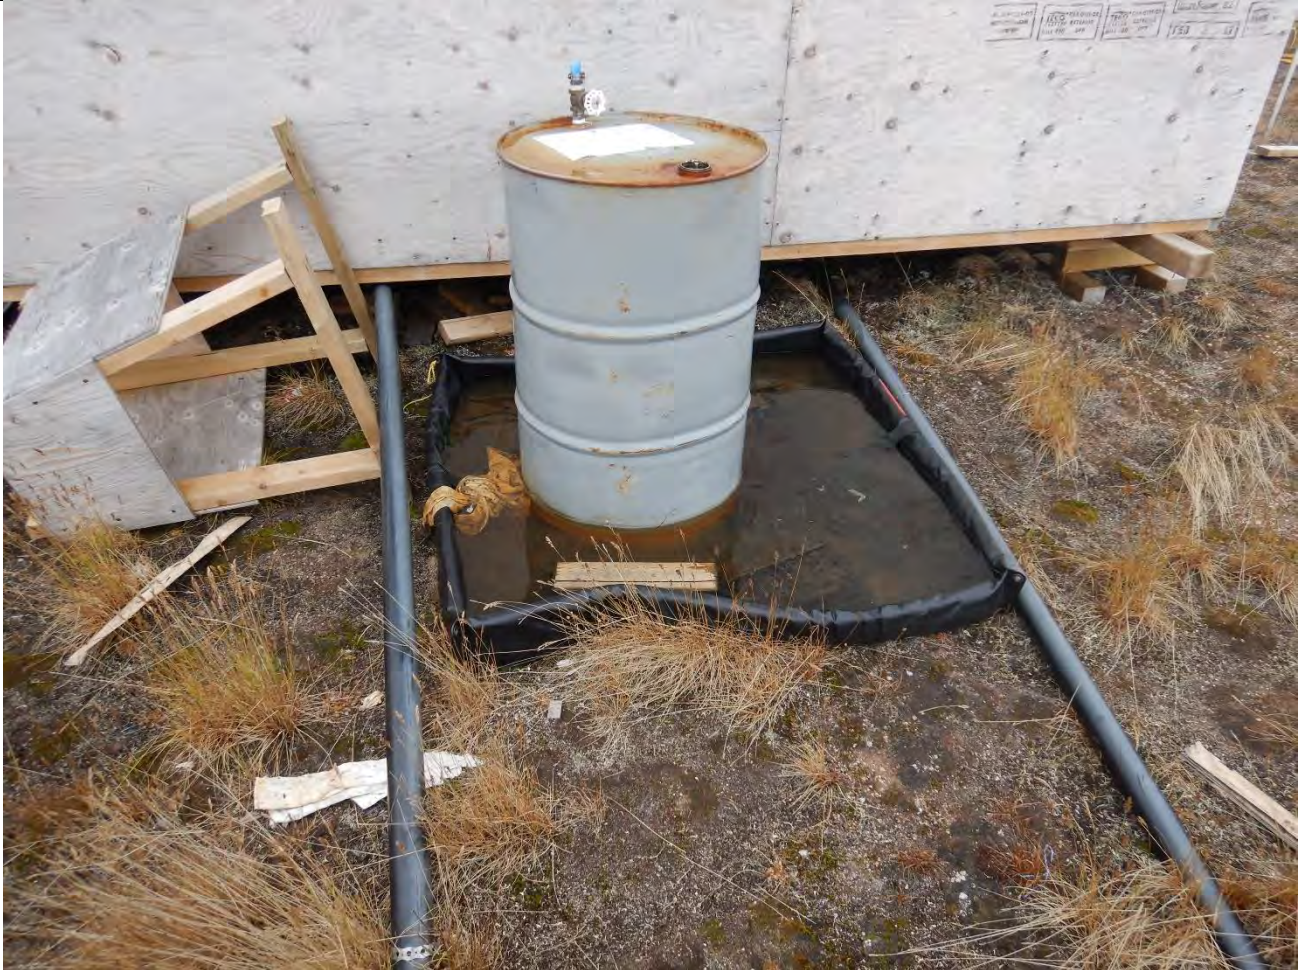
Photo 6

Description: secondary containment full of water.

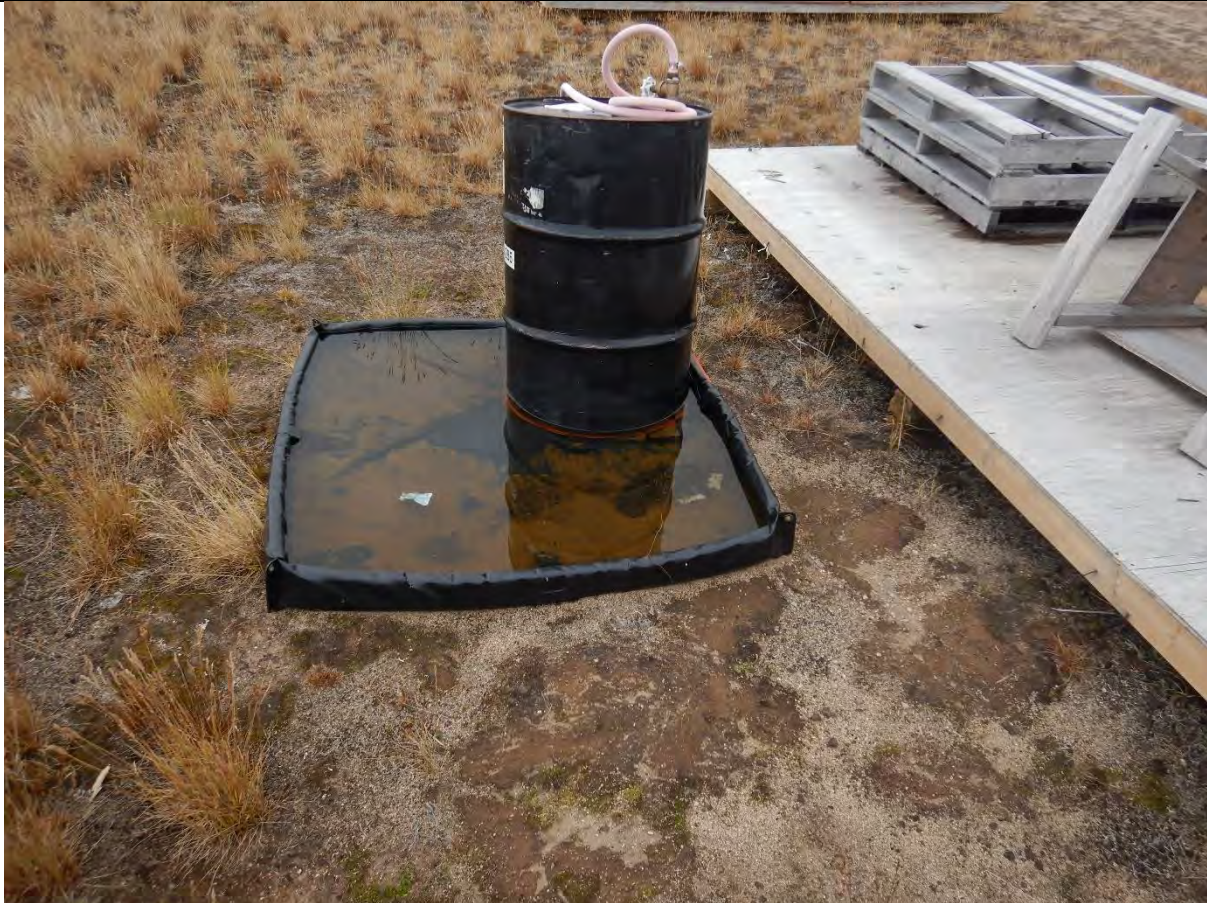
Photo 7

Description: secondary containment full of water.

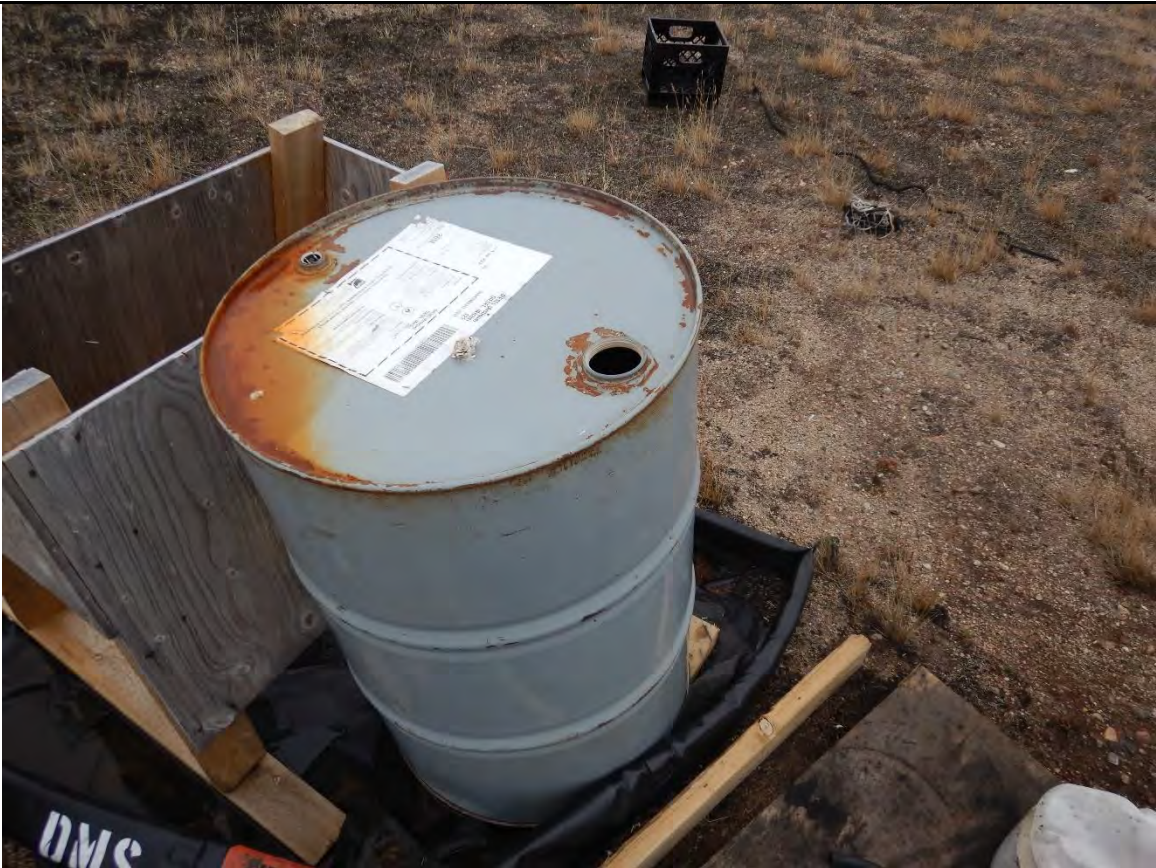
Photo 8

Description: wood within the containment pushing down the containment wall.

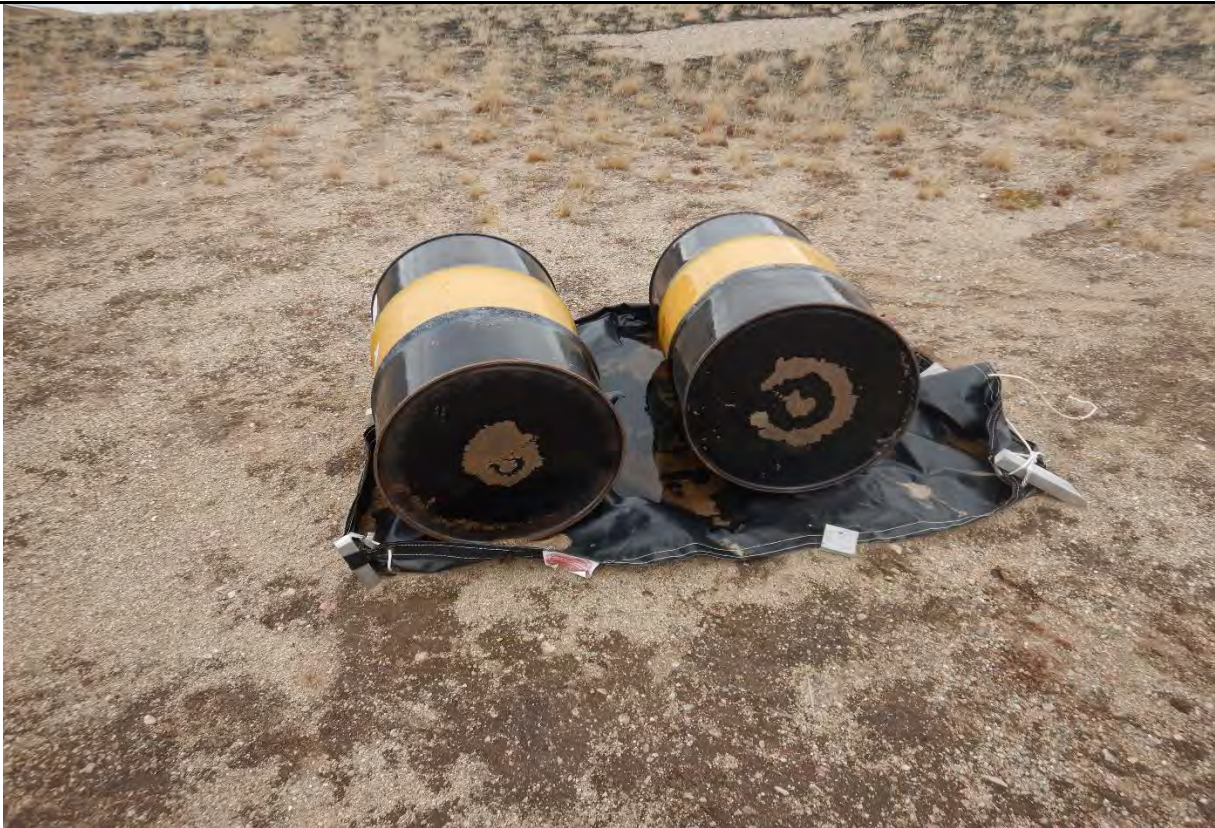
Photo 9

Description: damaged containment.

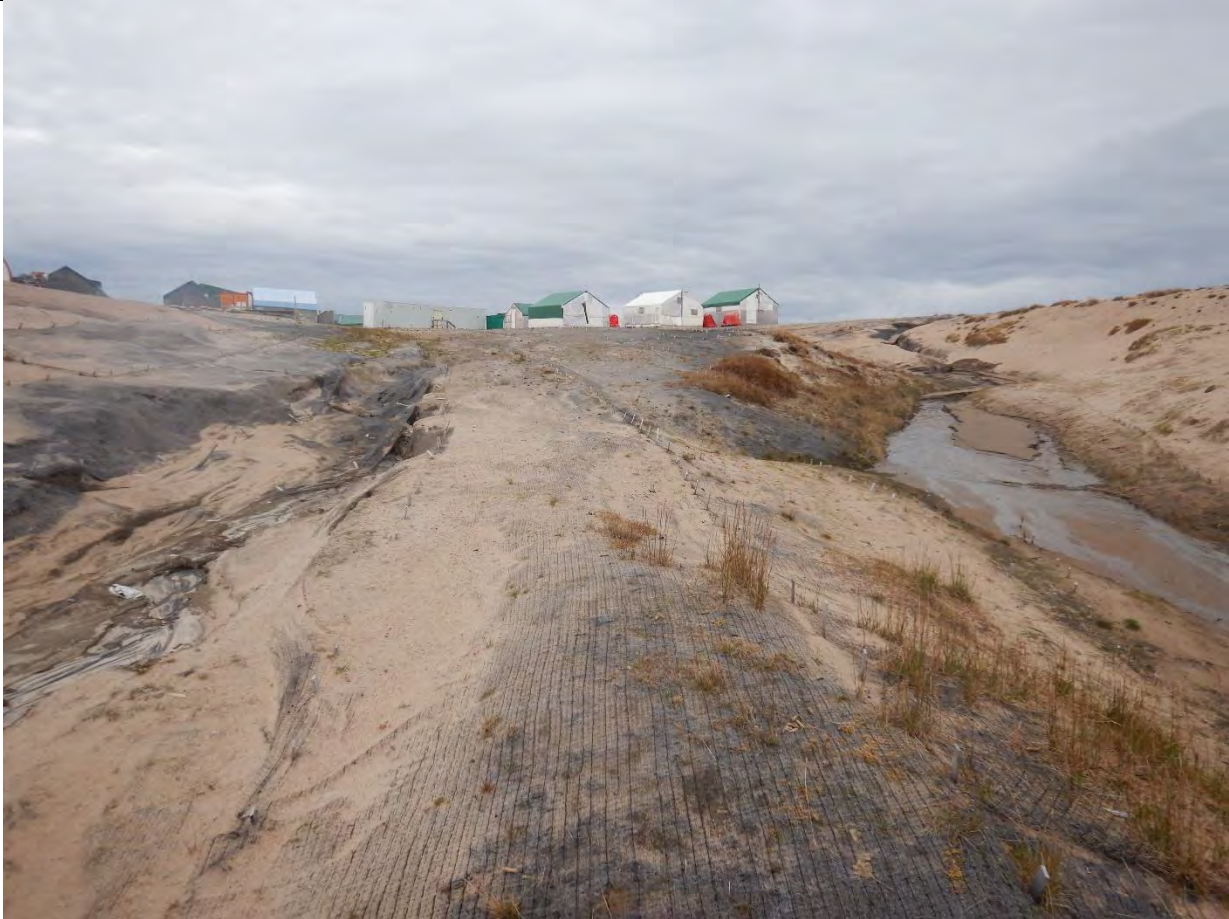
Photo 10

1. While on site there was significant erosion near the sump, the licensee appears to be using fabric to slow the erosion. See photo 10 for the erosion noted.
2. There was approximately 12 barrels outside of containment near the wind sock and drill core storage, See photo 11 for the fuel outside of containment.

Description: erosion near sump.

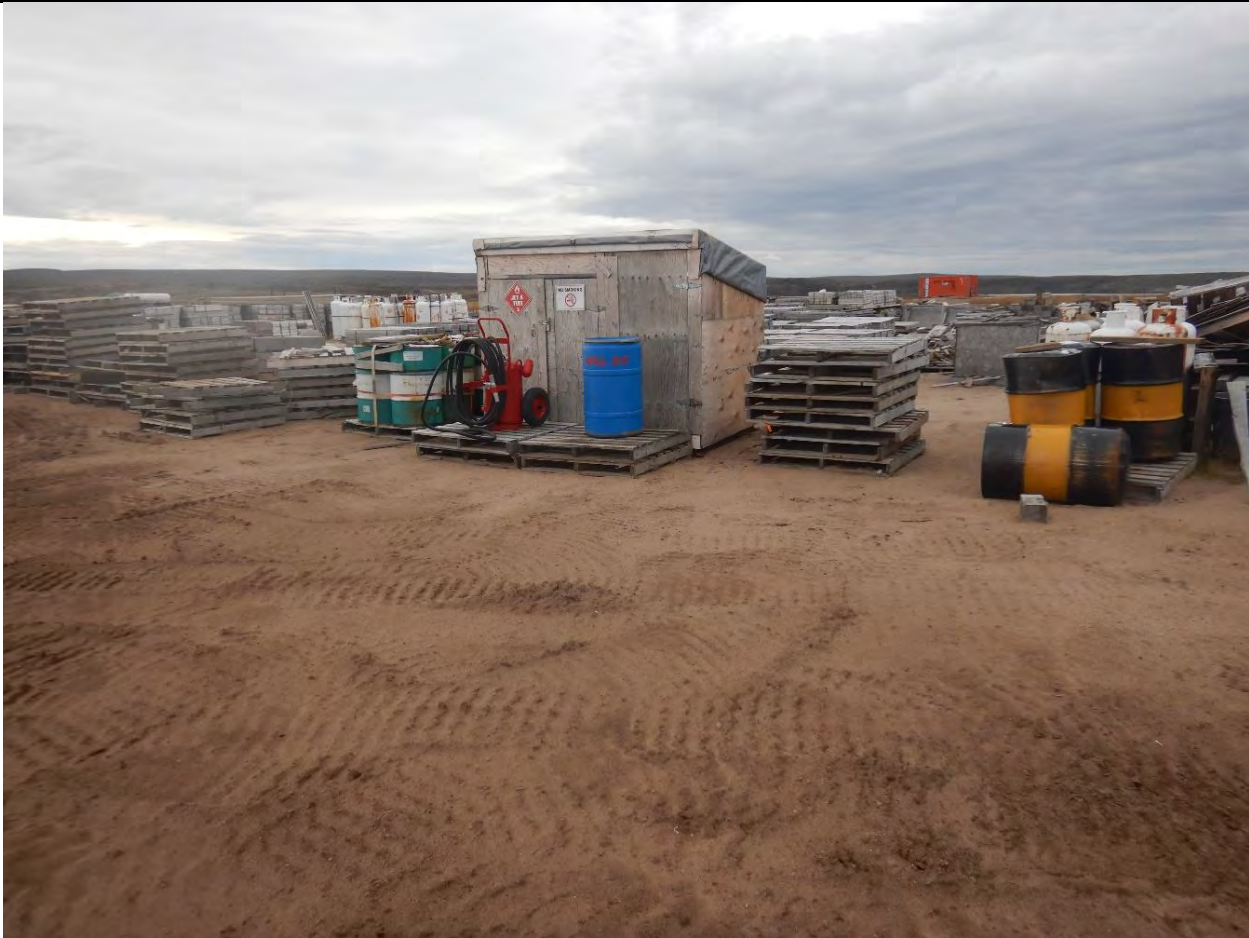
Photo 11

Description: 12 barrels outside of containment.

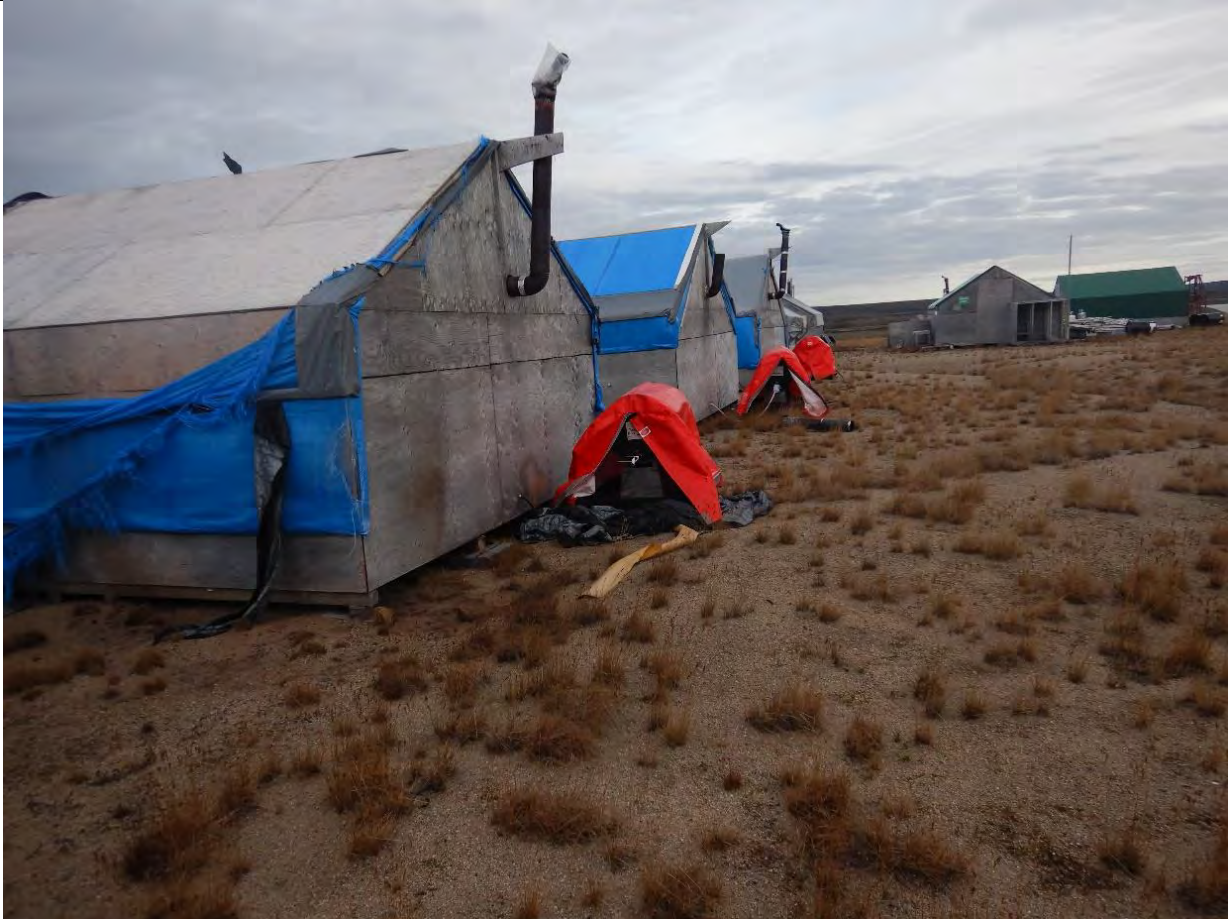
Photo 12

1. while on site some tent heating fuel tanks covers installed were not operating as intended. See photos 12 for the covers referred to.
2. There was approximately 9 barrels outside of containment within this camp, see photos 13 and 14 for the fuel outside of containment.
3. While on site it appeared that the grey water sump and the outhouse sump appeared to be less than 31m away from pooling water. See photo 15 for the photos of the sump.
4. It was noted that there is no berm surrounding the grey water sump. It does not appear that the sumps are constructed in a way to prevent melt water and/or rain water from flooding the sump. See photo 15 for the sump.

Description: tank covers open.

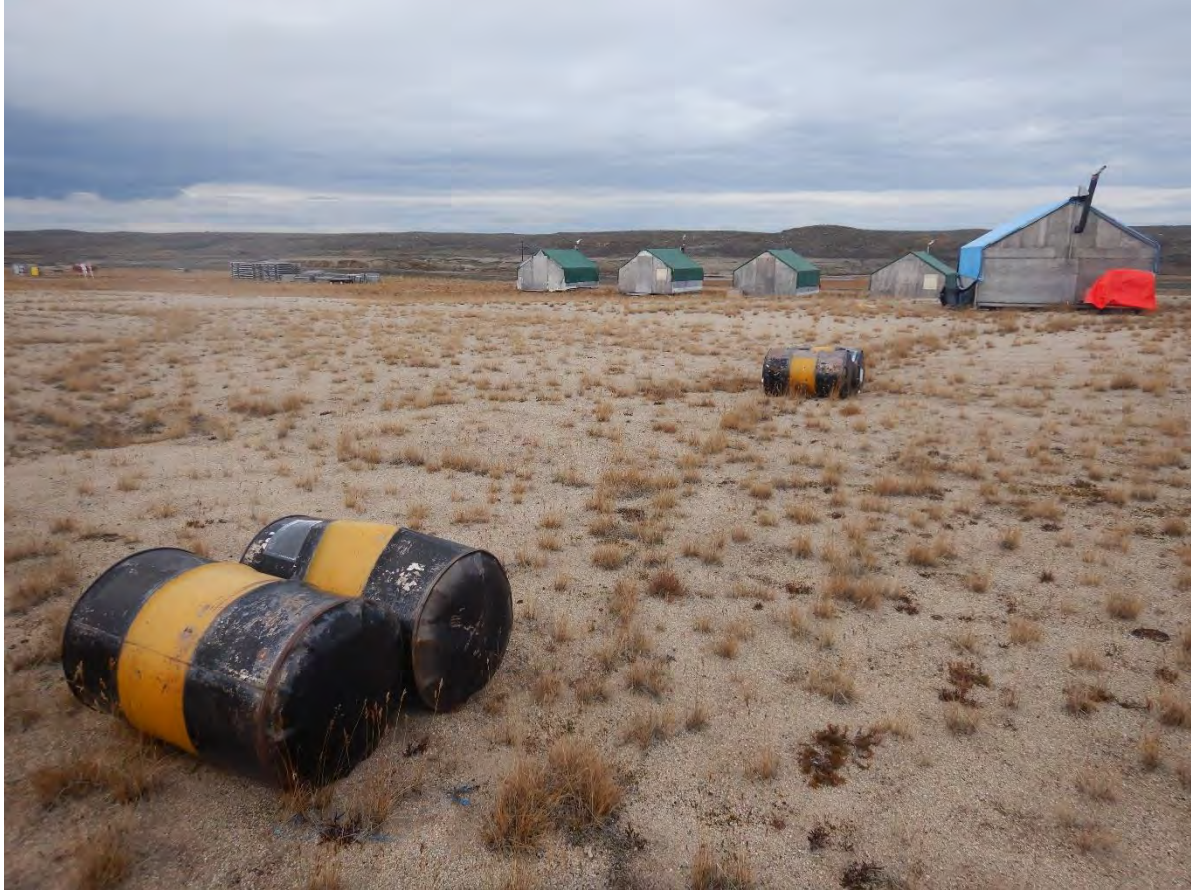
Photo 13

Description: barrels outside of containment.

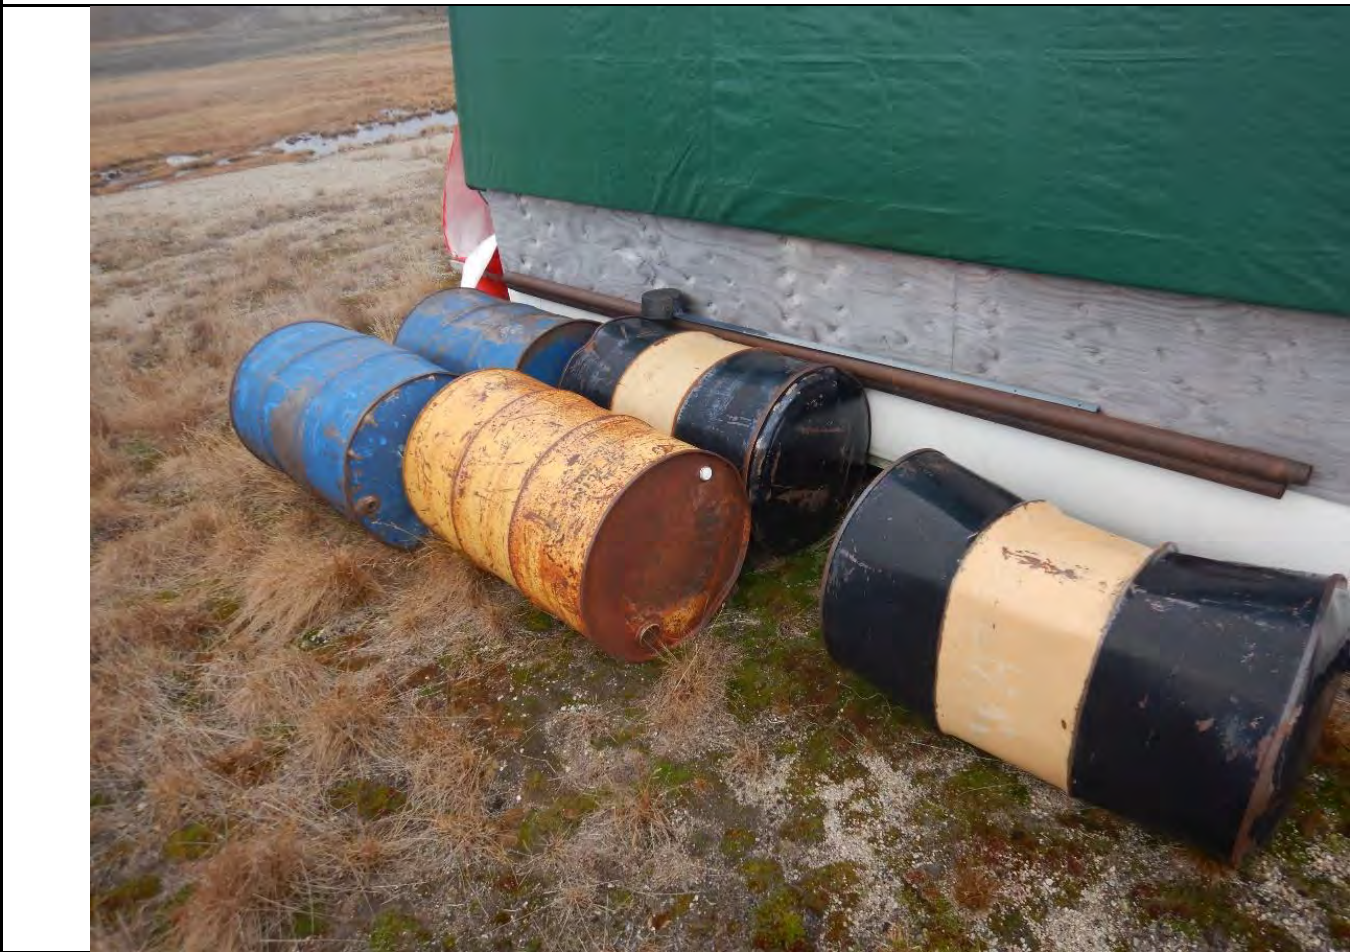
Photo 14

Description: barrels outside of containment.

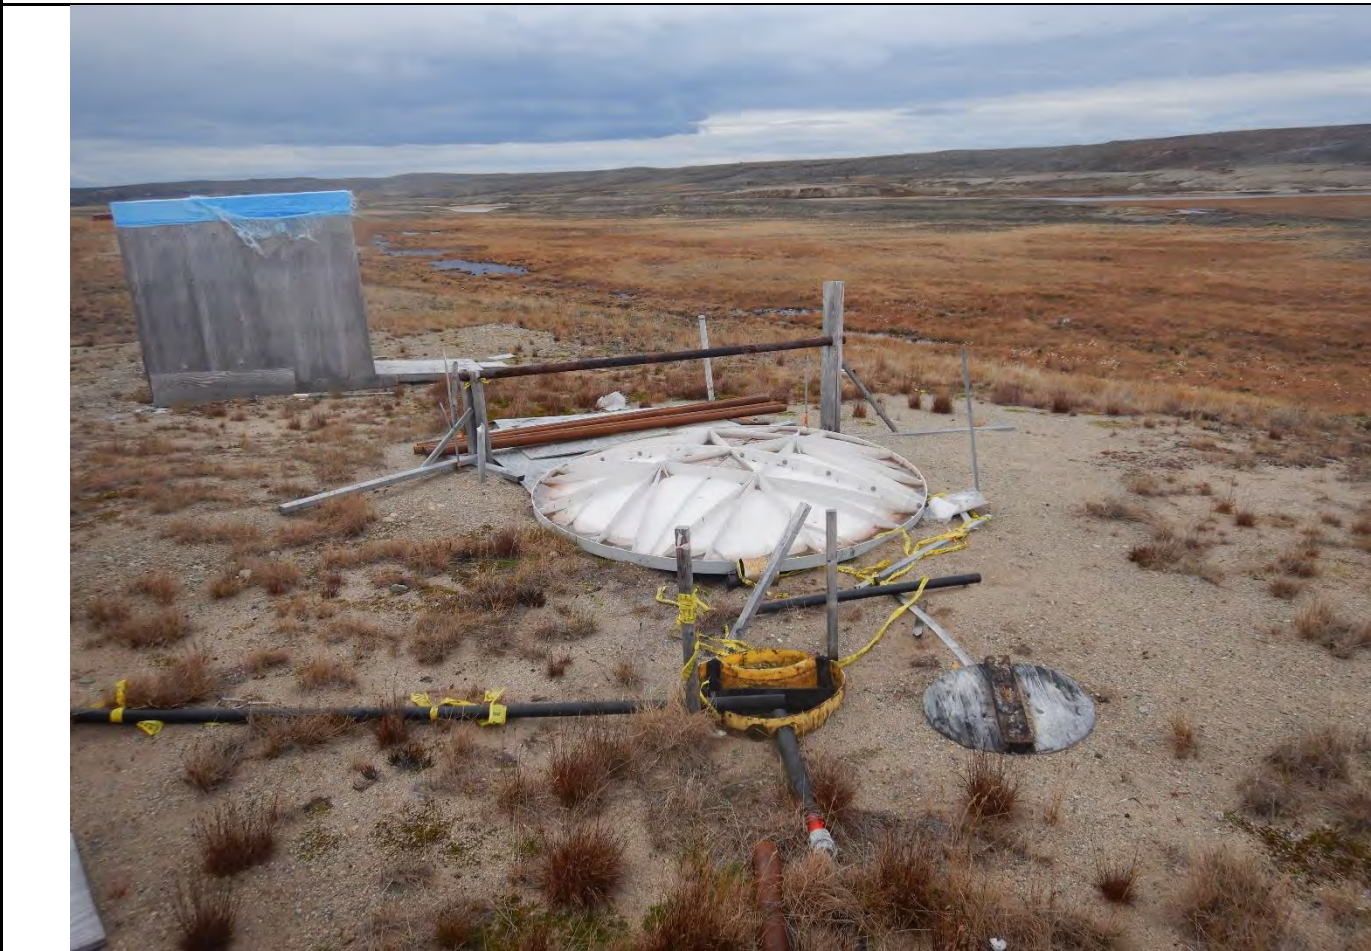
Photo 15

Description: sump without berms to prevent flooding.
