APPENDIX 7

Inspection Report

2014 Water Licence Inspection Report and correspondence

WATER LICENCE INSPECTION FORM

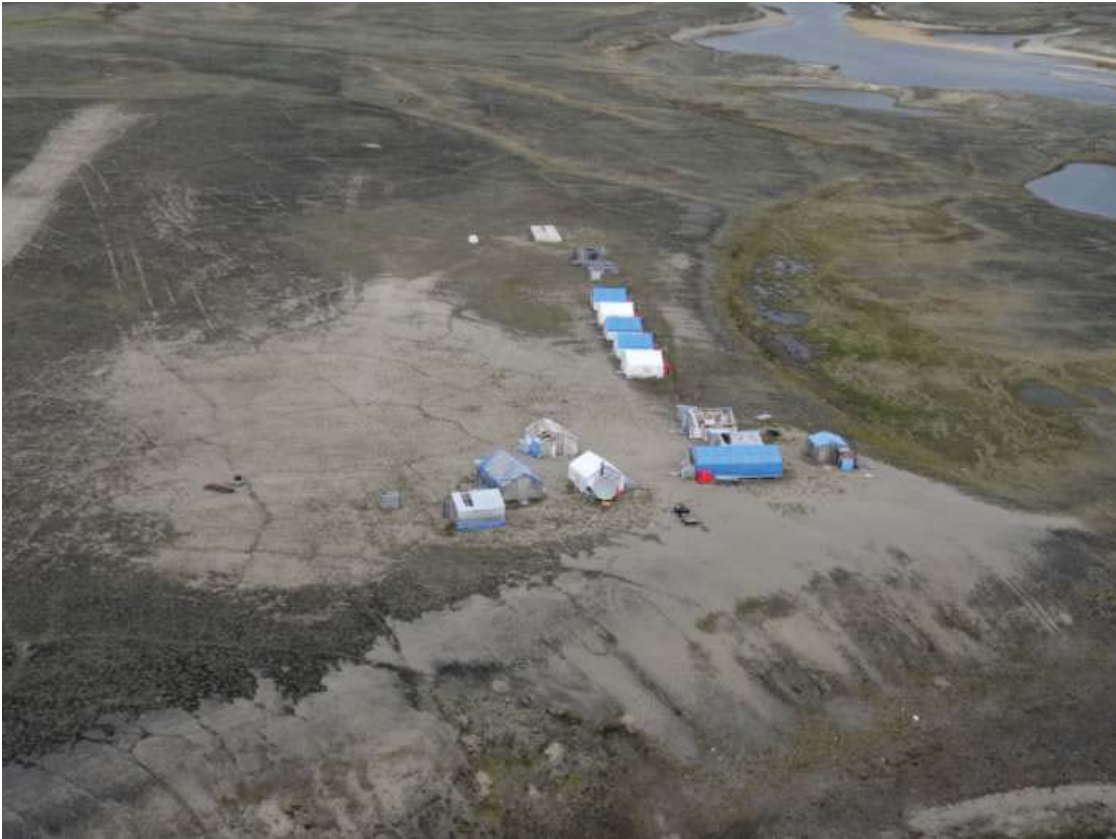
Figure 1. Bullion Camp. Berm is intact. Some tents are torn.

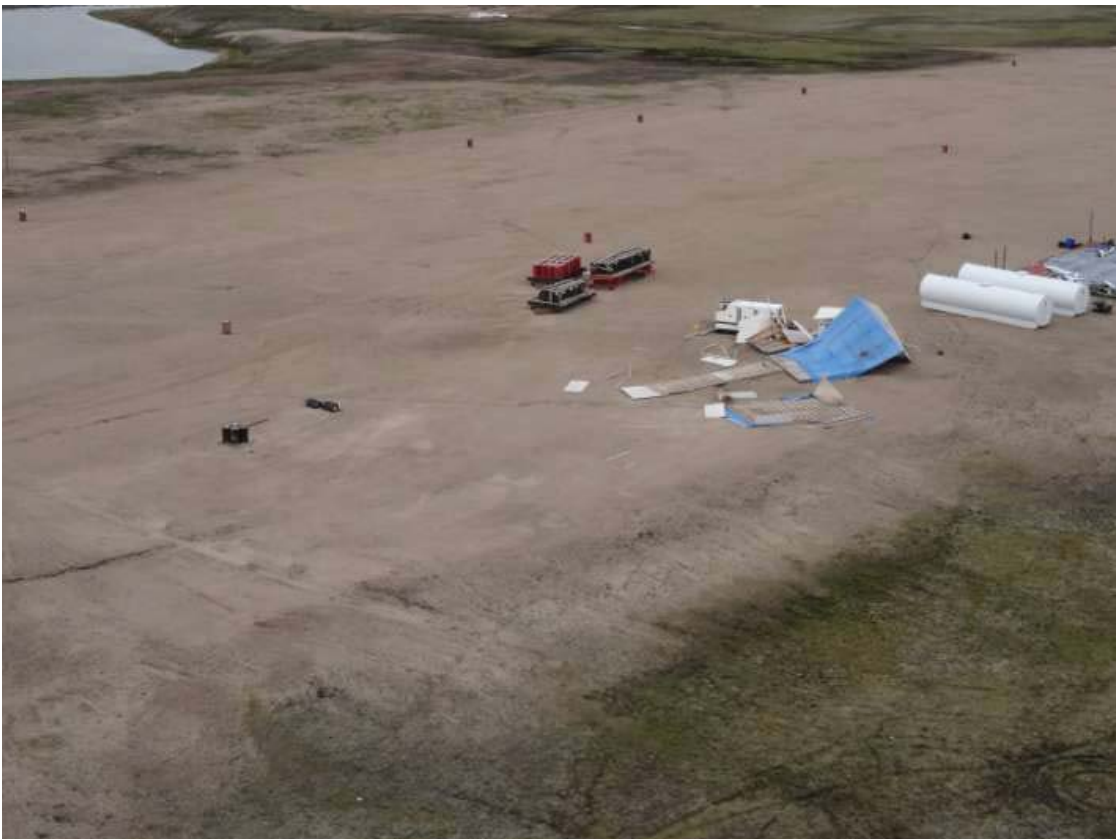
Figure 2. Lay-down at Hayes Camp. Building demolished.

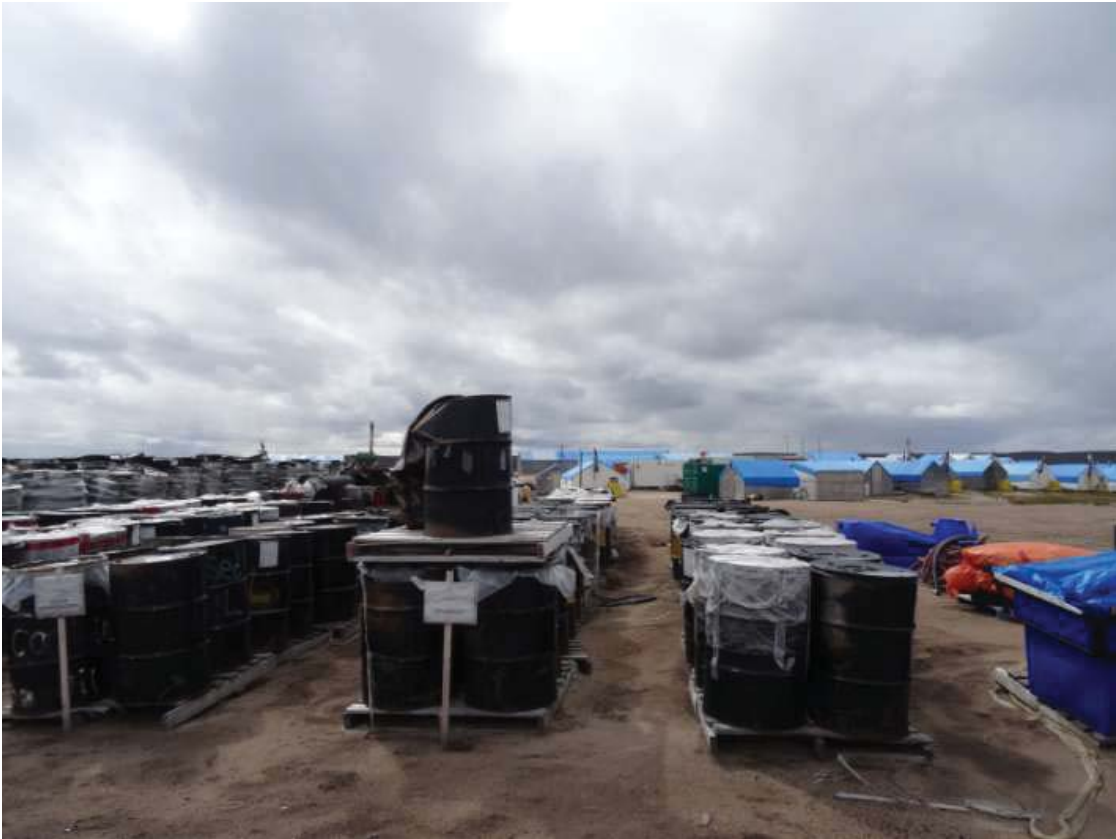
Figure 3. Waste area at Hayes. Garbage barrels.

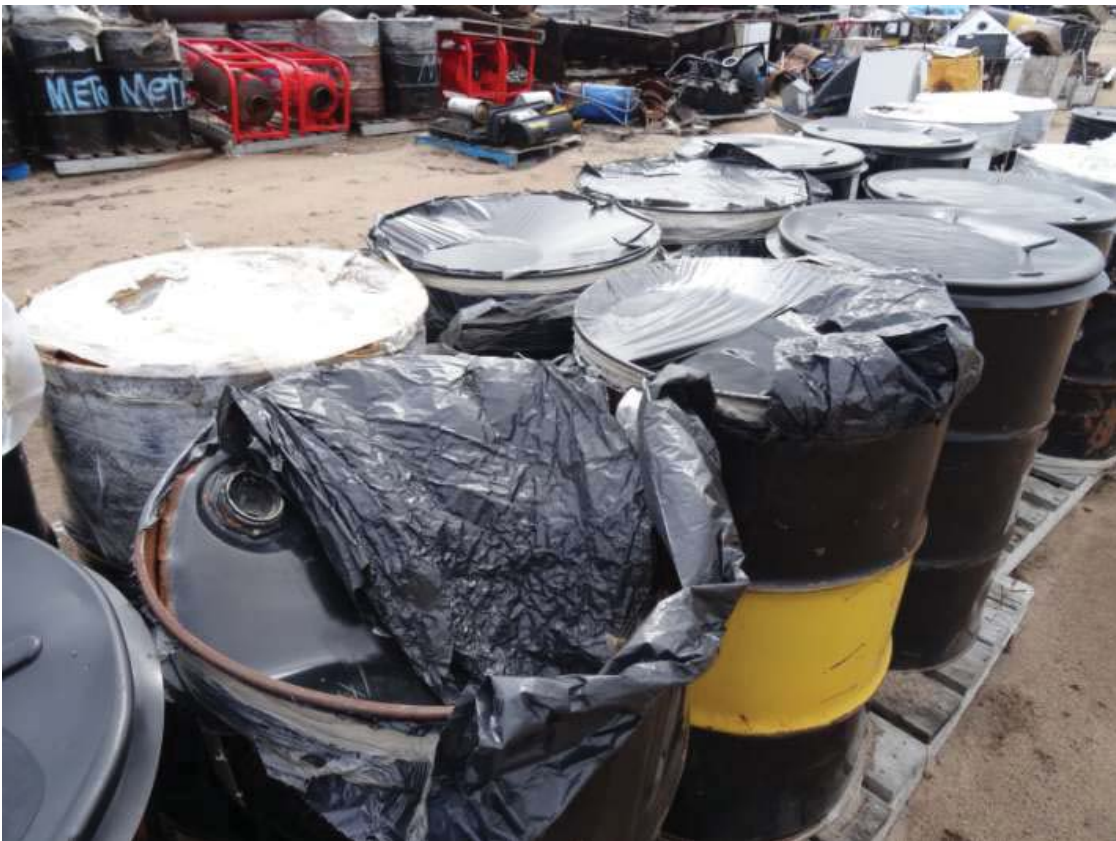
Figure 4. Barrels are no longer sealed.

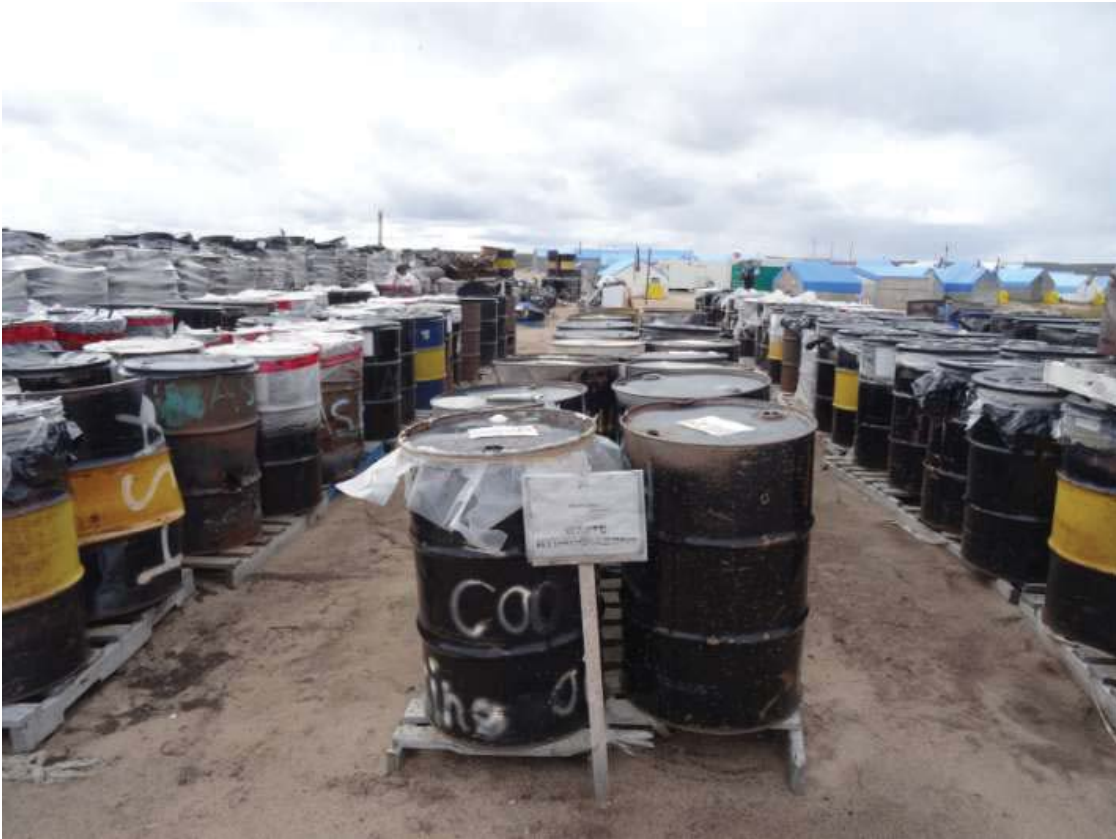
Figure 5. Waste Hydrocarbons should have been removed from site.

1. All hazardous waste and kitchen waste are to be backhauled by October 31, 2014.			
2. A spill report is to be filed with the Spill Line with respect to the contaminated water spilling from the berm at Three Bluffs.

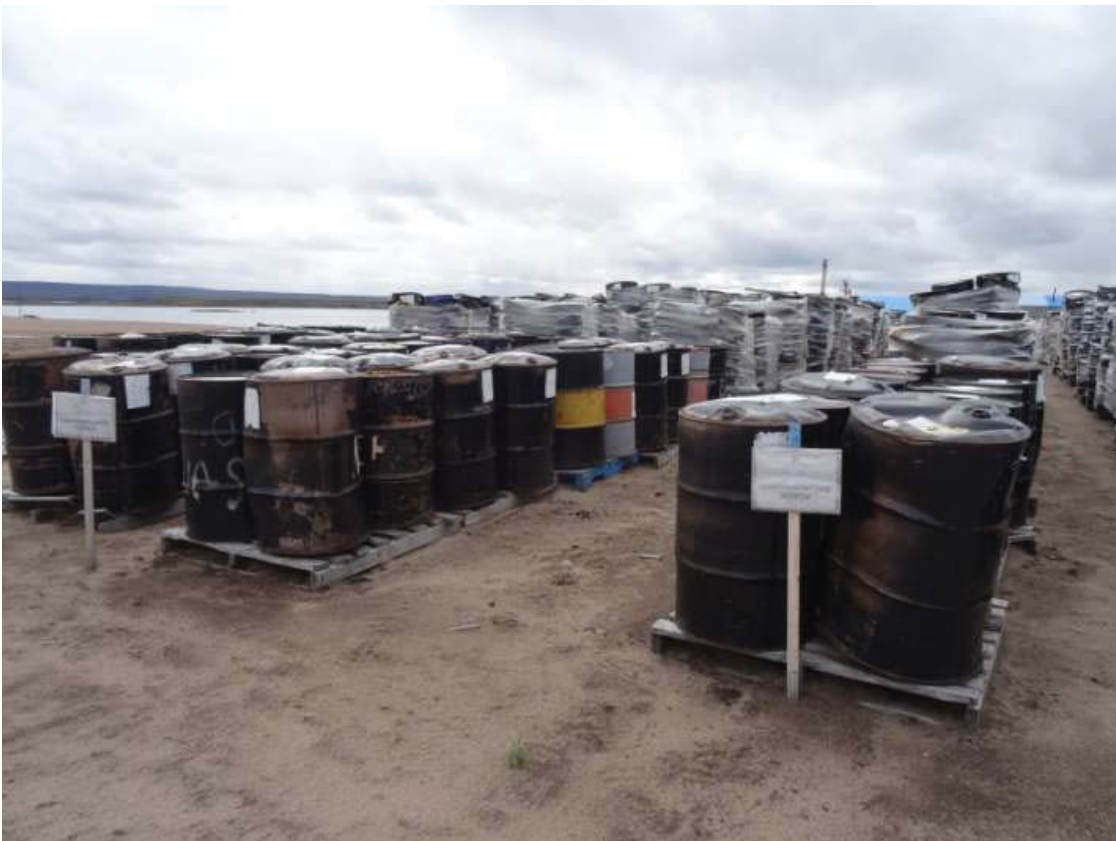
Figure 6. Contaminated water should be removed from site.

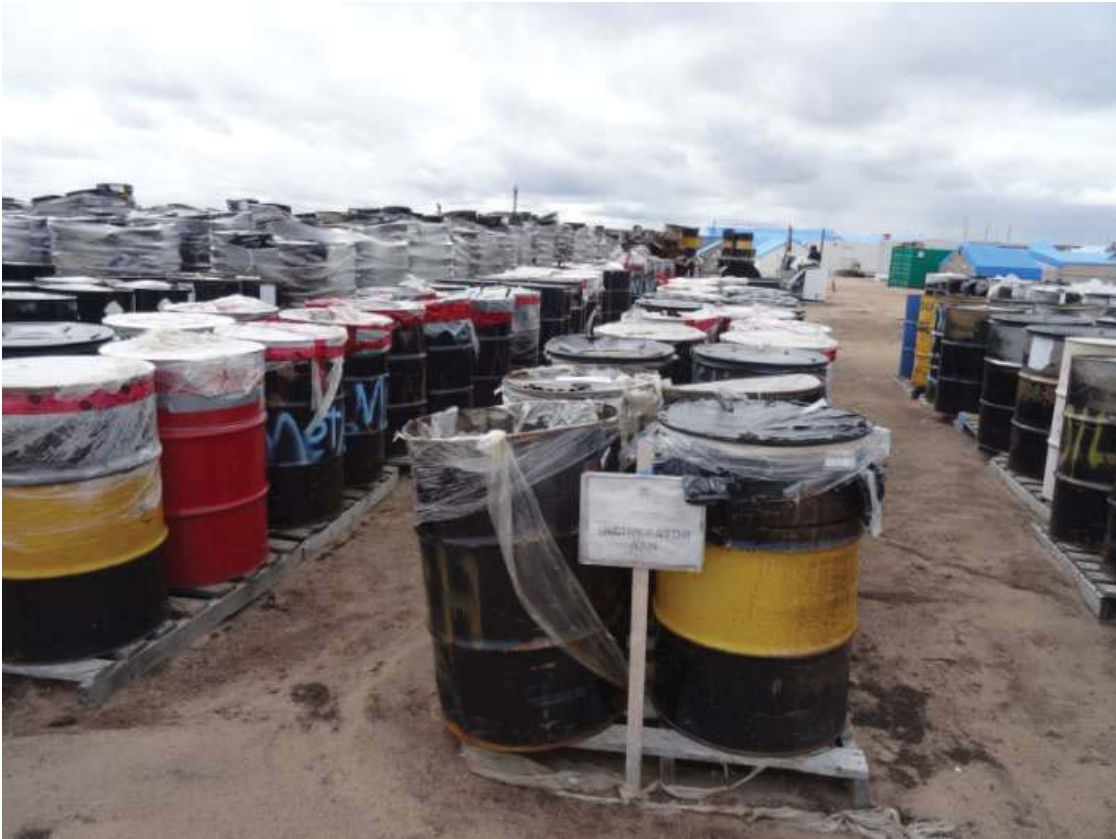
Figure 7. Incinerator Ash should be removed from site.

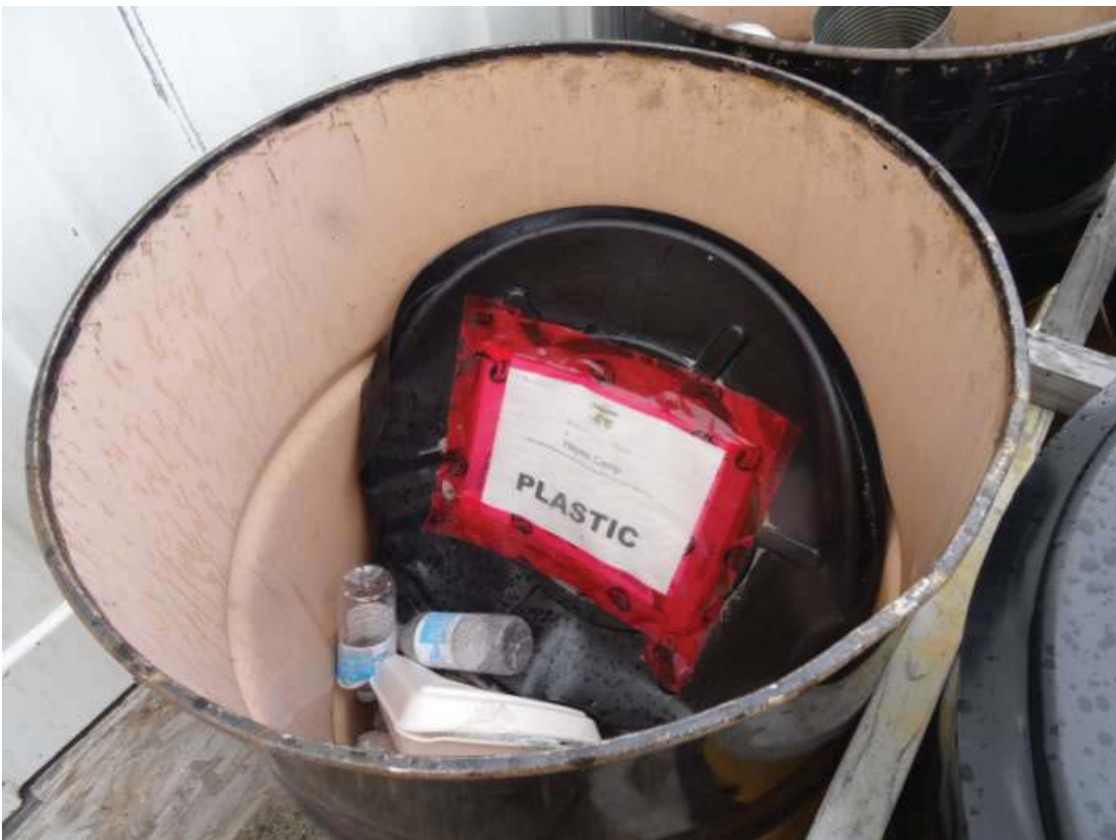
Figure 8. Garbages within the camp were not emptied.

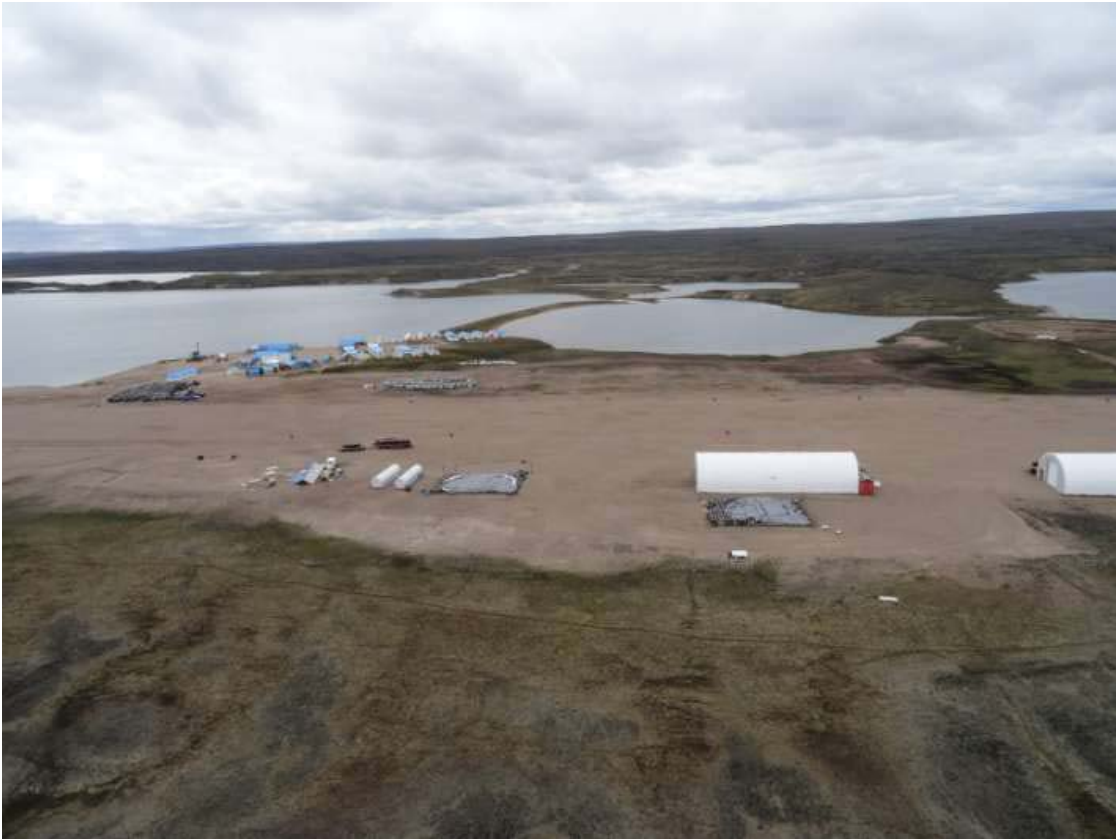
Figure 9. Aerial view of Hayes berms.

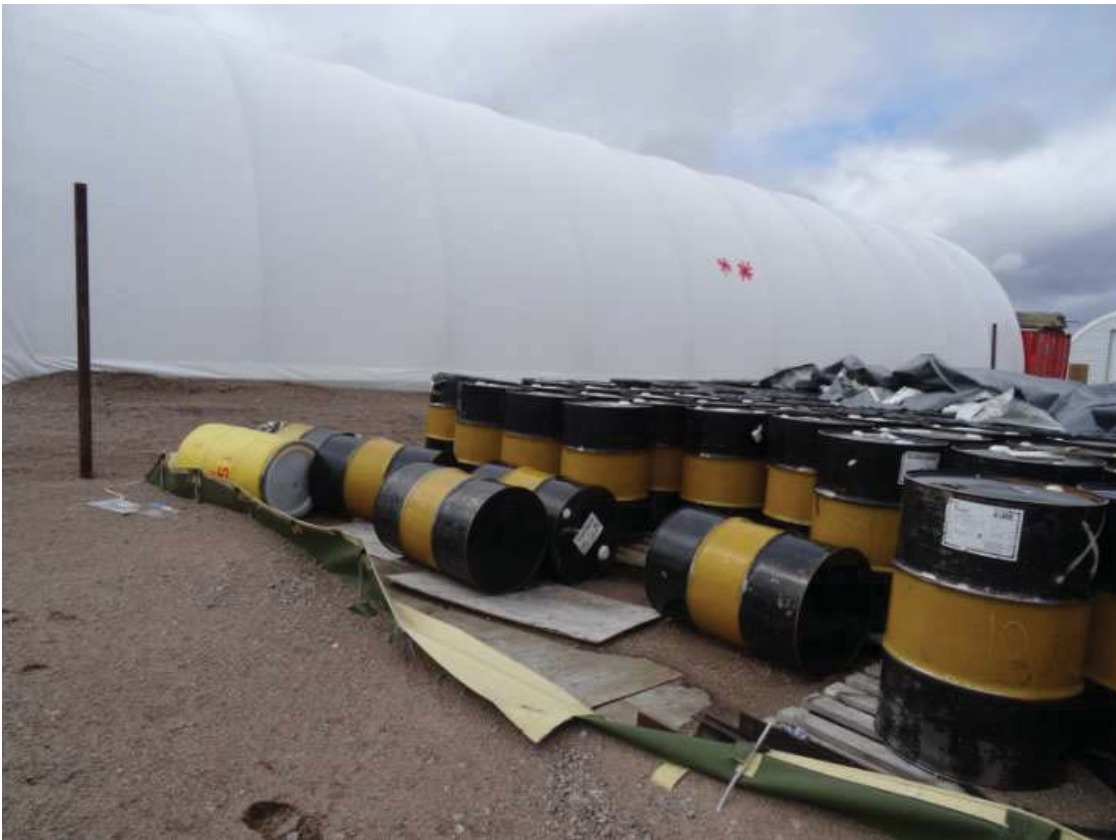
Figure 10. Hayes berm collapsed.

3. All water accumulated in fuel berms (including small berms for individual tanks) is to be treated and pumped out of the berms. Berms are to be repaired or replaced in order to provide secondary containment. Berms are to be covered to prevent filling with water or snow. This is to be carried out by August 15, 2014.

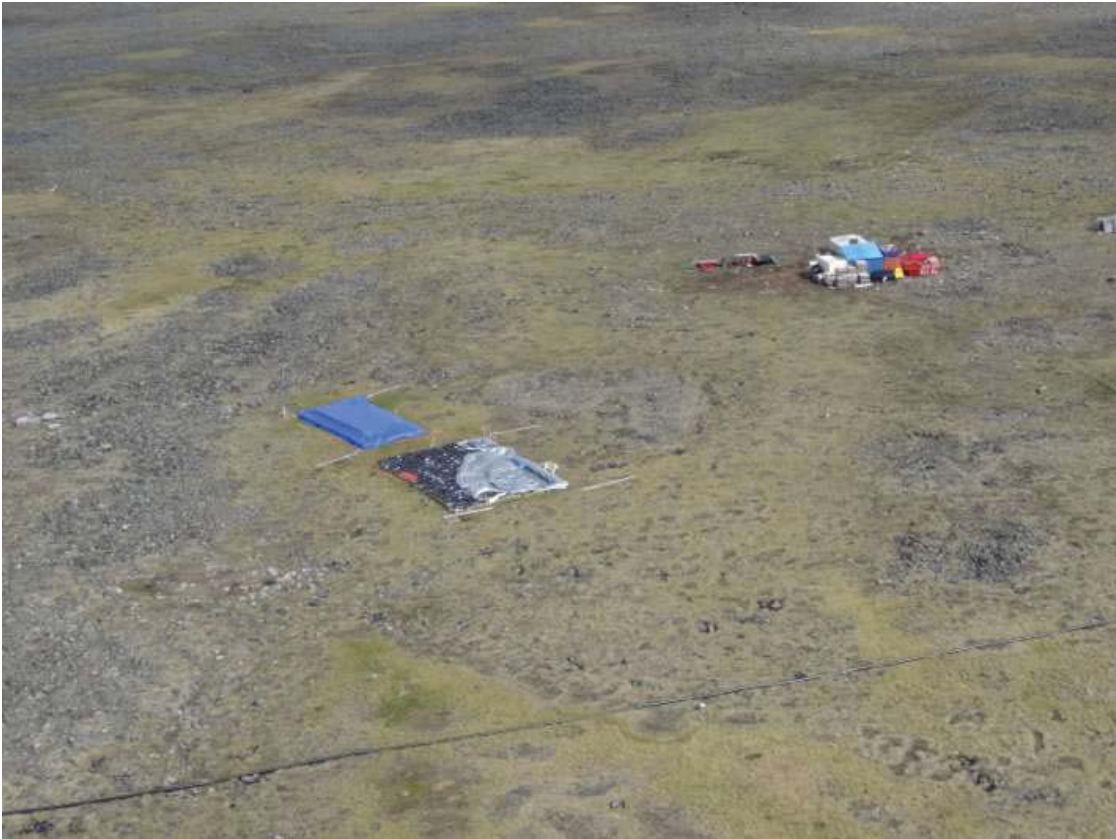
Figure 11. Berms at Three Bluffs.

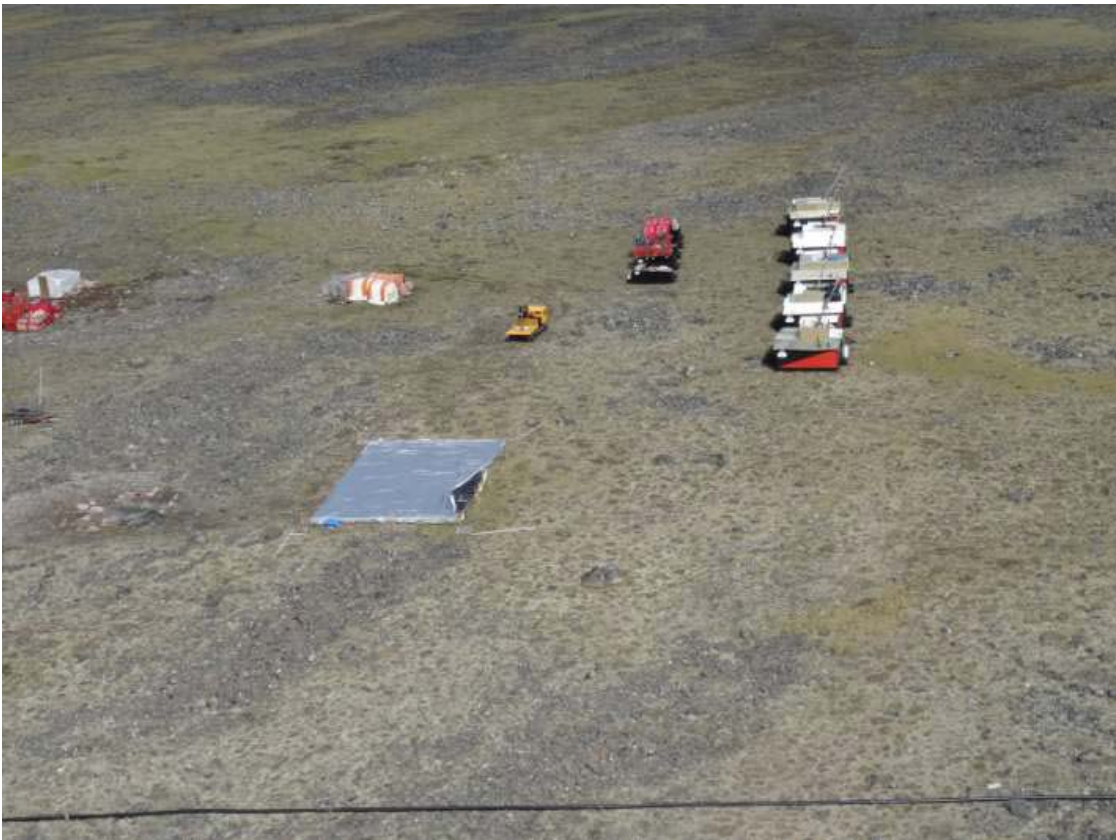
Figure 12. Third berm at Three Bluffs.

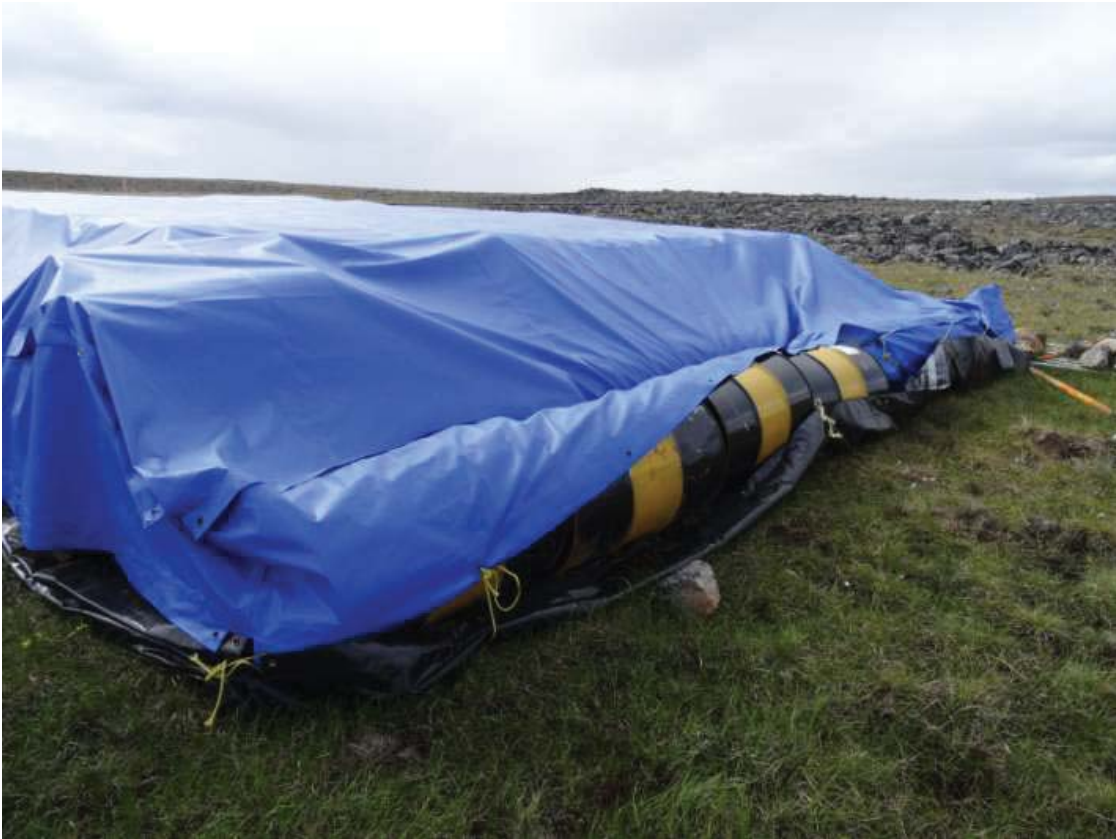
Figure 13. Three Bluffs berm 1.

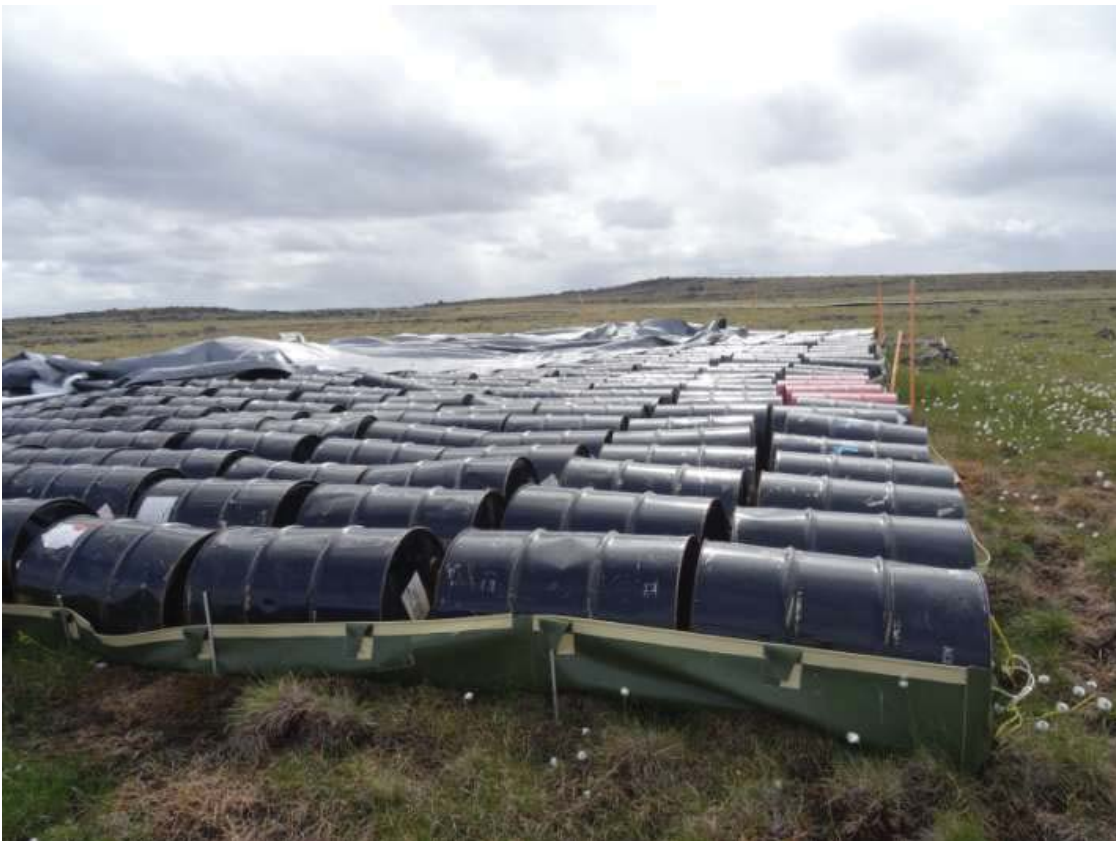
Figure 14. Three Bluffs berm 2.

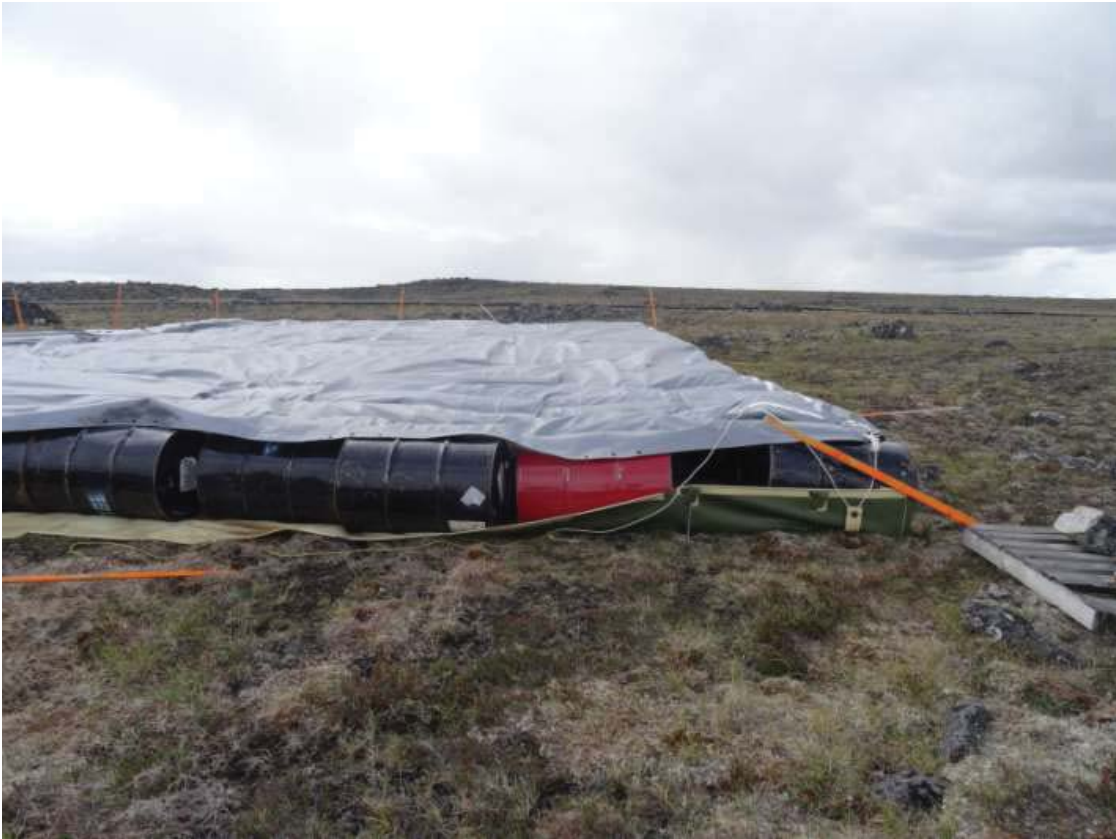
Figure 15. Three Bluffs berm 3.

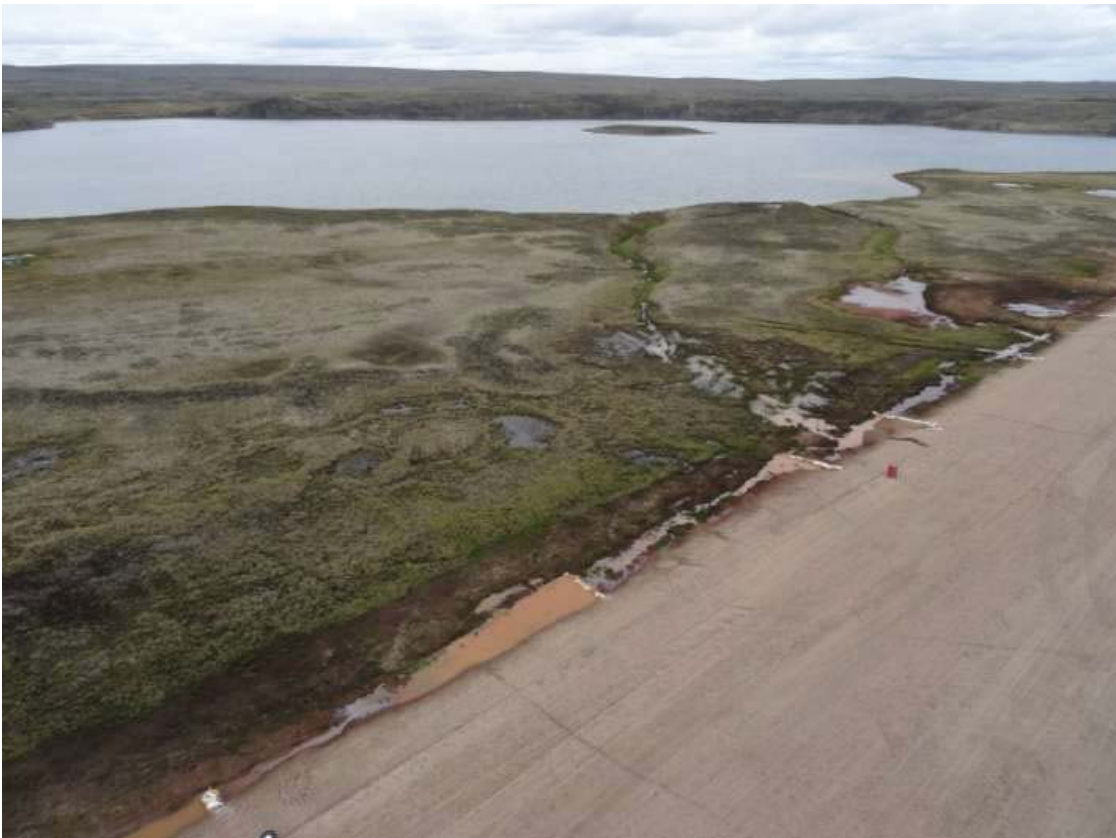
Figure 16. Pooling/ponding on the side of the airstrip; sediment evident in water flowing down-slope.

5. Erosion control measures throughout the site are to be improved by August 15, 2014, in order to prevent sediment deposition in the lake.			
6. All fuel that is not waste to be backhauled is to be located into covered secondary containment by August 15, 2014.

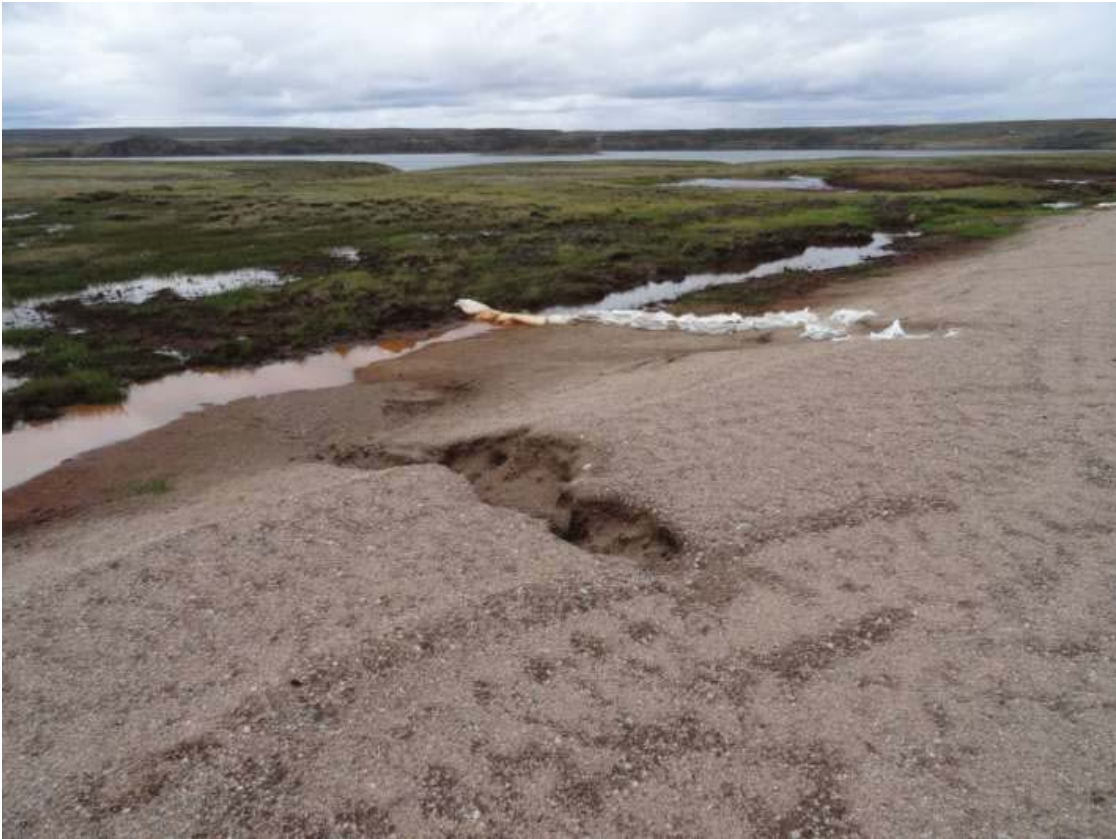
Figure 17. Permafrost degradation leading to deterioration of airstrip and sediment in the water.

4. A geotechnical inspection by a qualified engineer is to be carried out of the airstrip. The geotechnical inspection report is to be submitted to the Board with the 2014 Annual Report, along with a covering letter from the Licensee outlining an implementation plan with timelines to respond to the Engineer's recommendations.

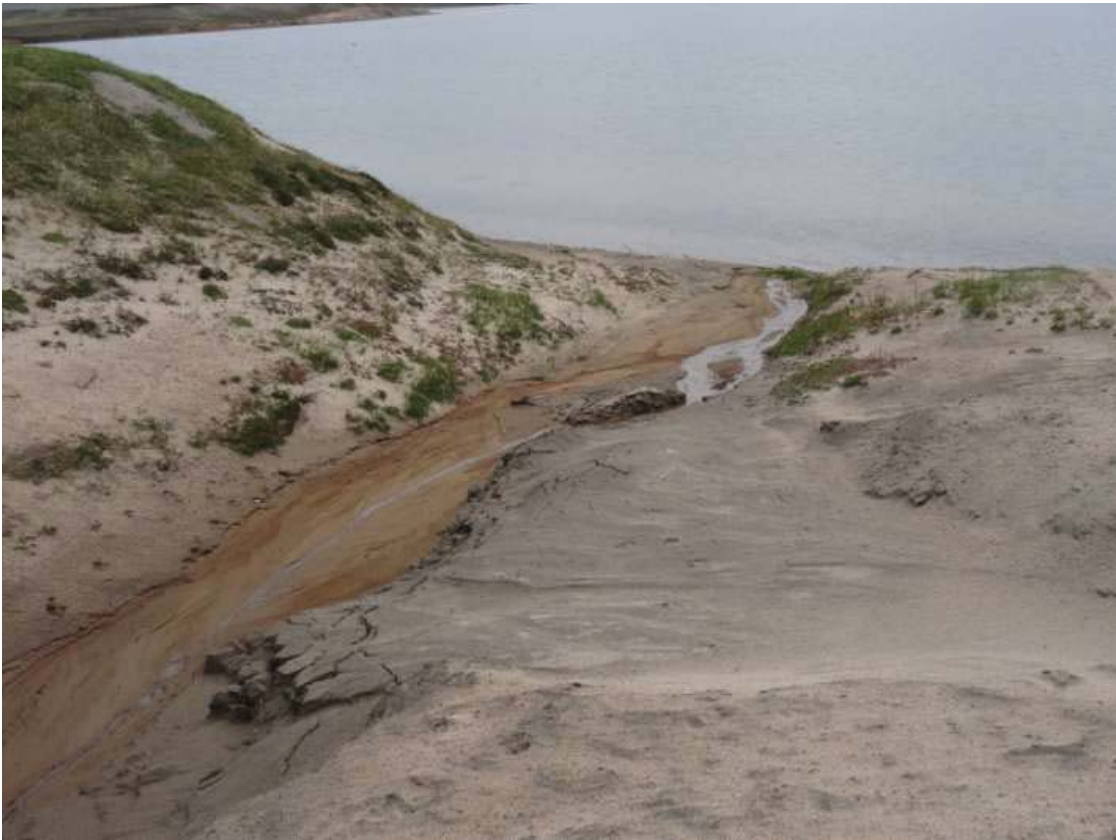
Figure 18. Camp drainage: original flow on left, new channel on right.

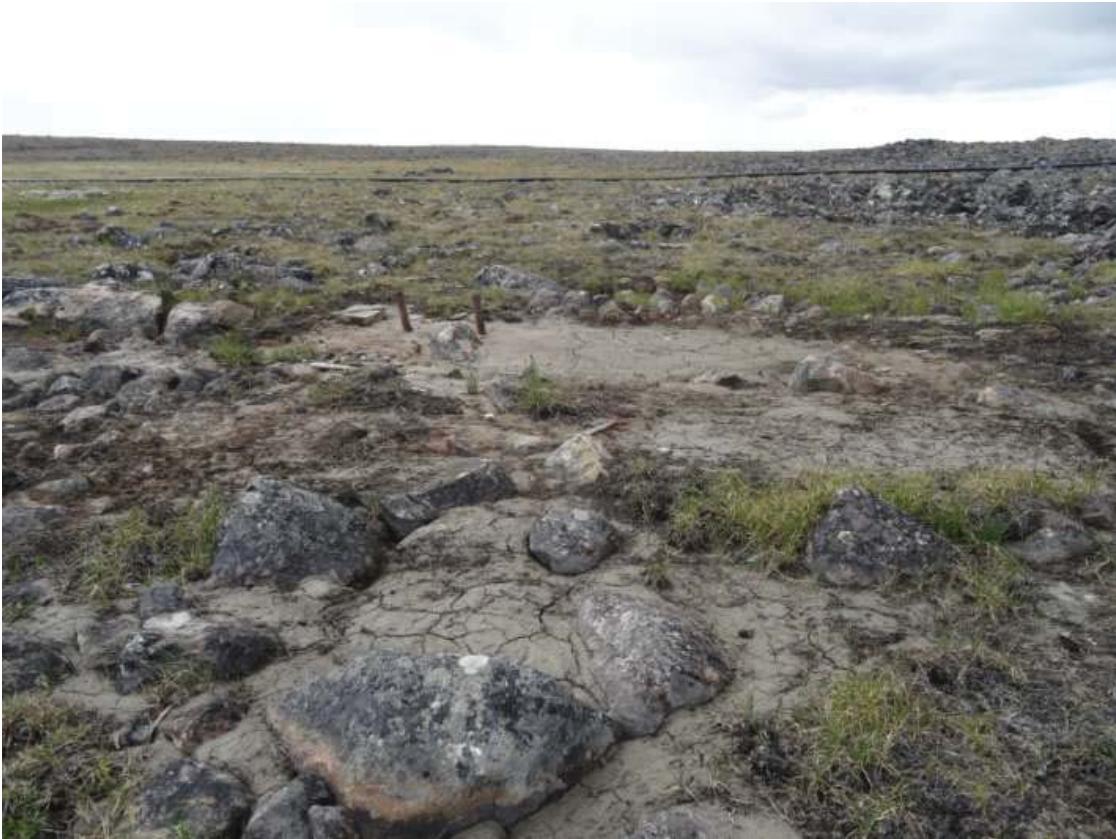
Figure 19. Drill sites require reclamation.

10. Drill sites are to be reclaimed by removing the drill casings and anchors, or cutting and capping them. This work is to be carried in the Licensee's next snow-free period of activity.

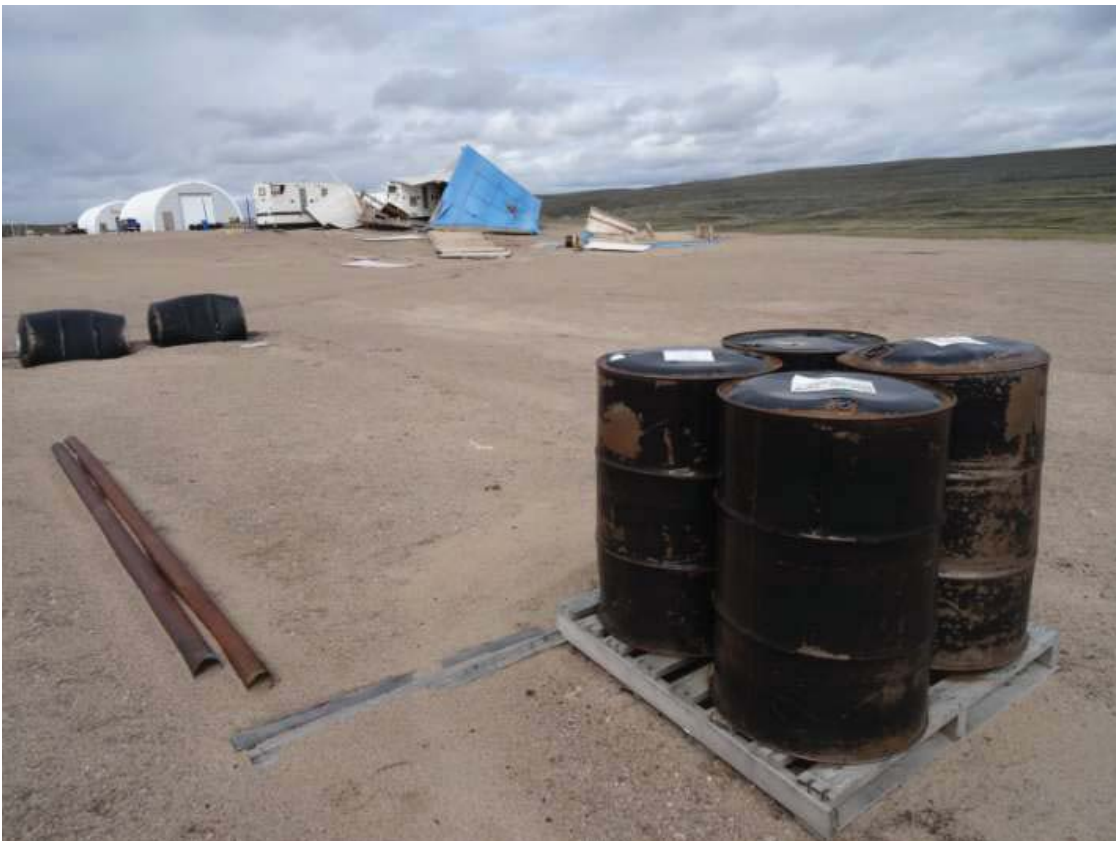
Figure 20. Full diesel barrels at the airstrip.

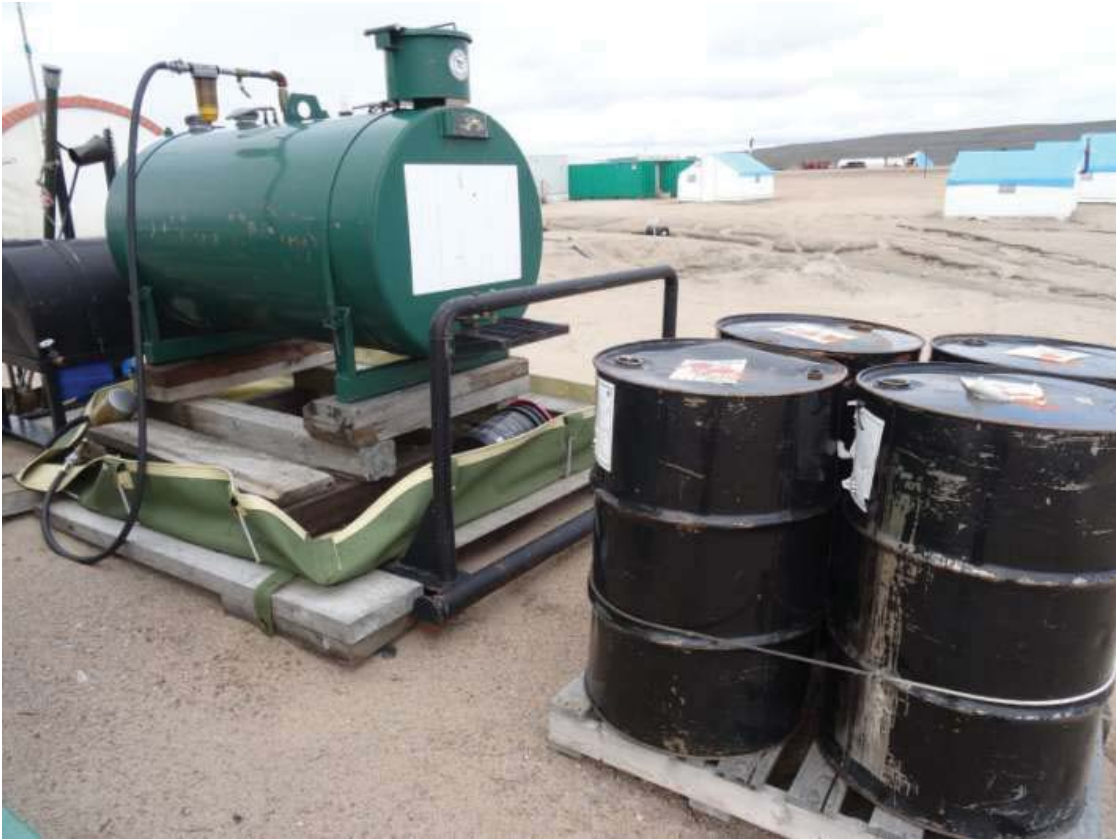
Figure 21. Barrels out of containment at the incinerator.

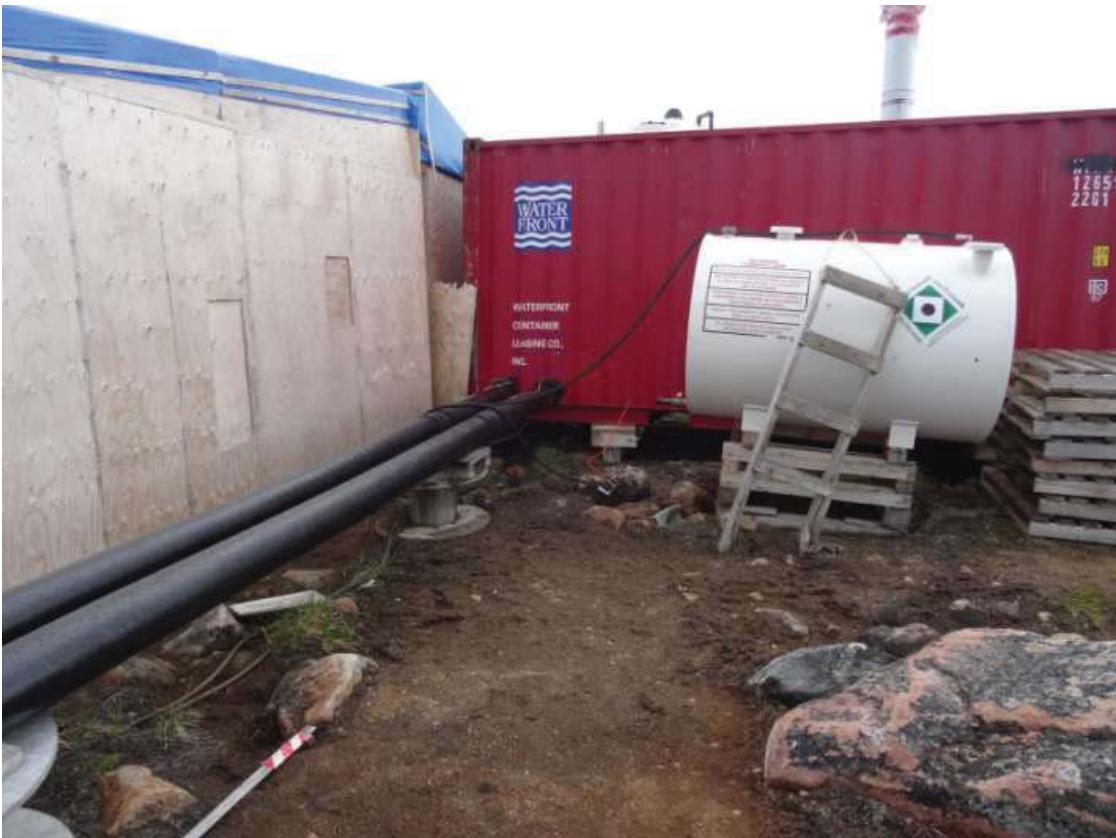
Figure 22. While tank may be double-walled, the hoses and valves are not. Secondary containment is required.

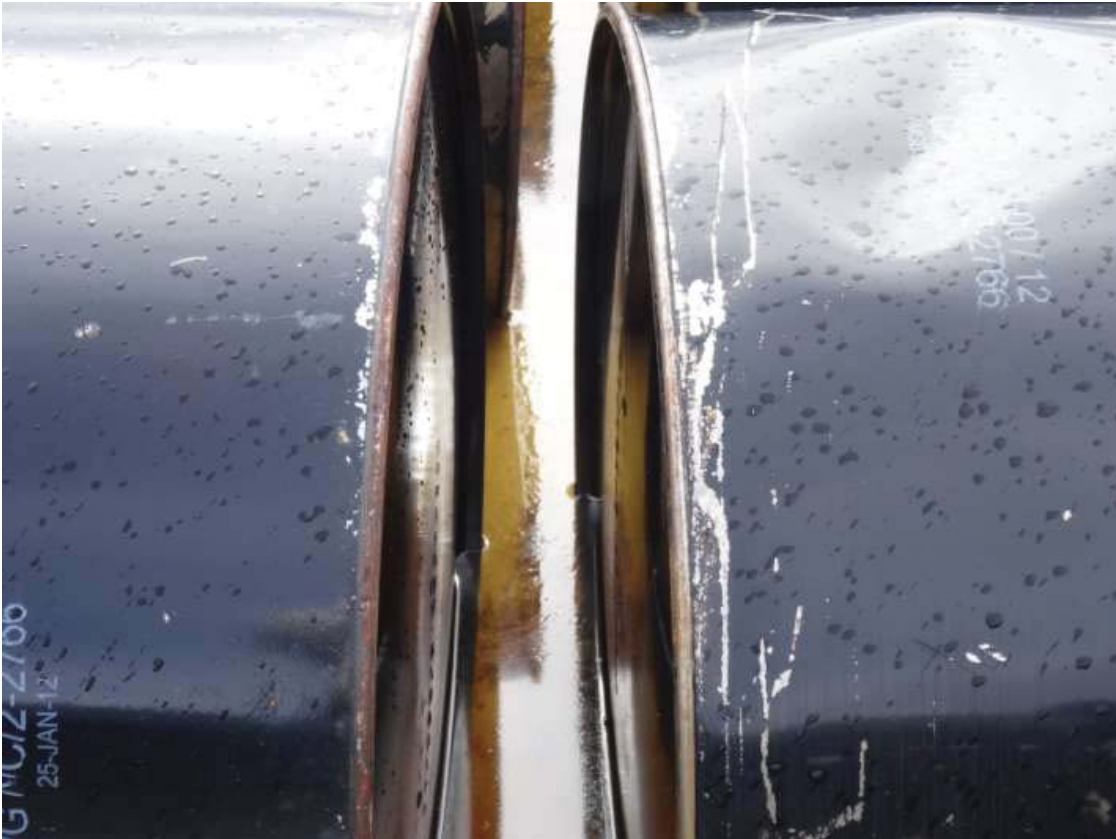
Figure 23. Contaminated water in Three-Bluffs berm 2.

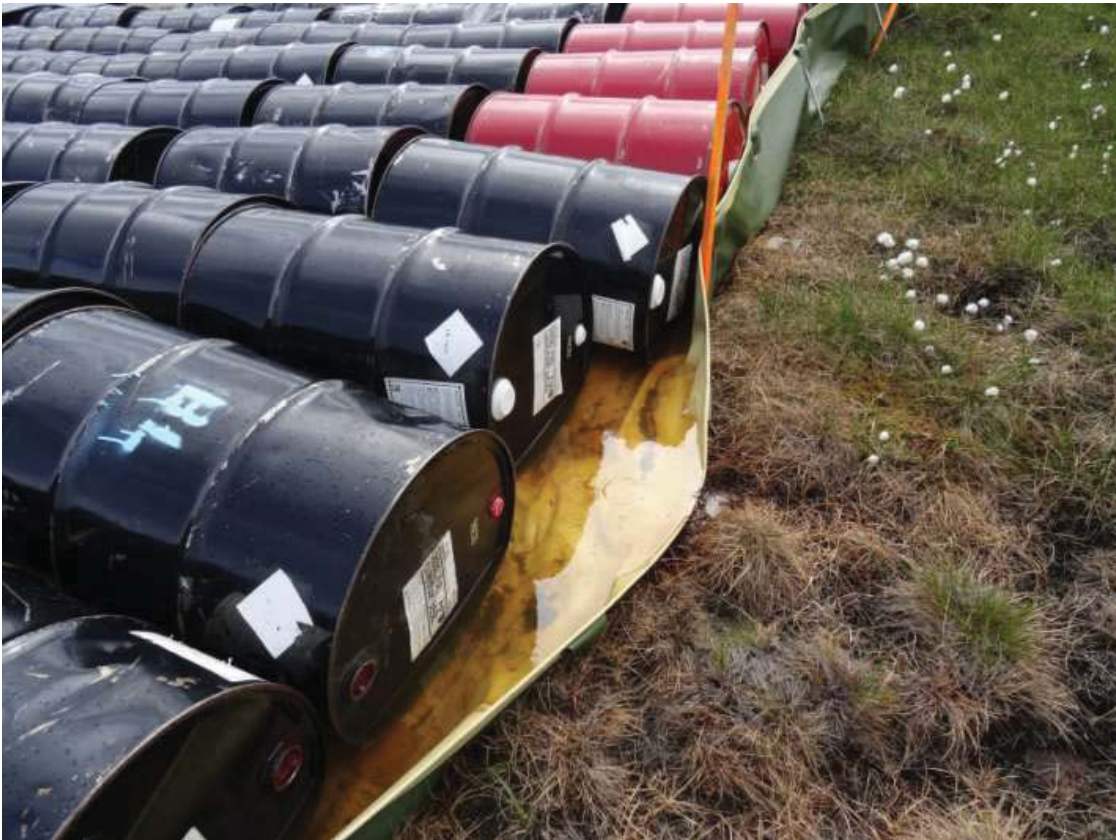
Figure 24. Collapsed side of Three Bluffs berm 2, leaking contaminated water.
