APPENDIX 7

Inspection Report

2014 Water Licence Inspection Report and correspondence

WATER LICENCE INSPECTION FORM

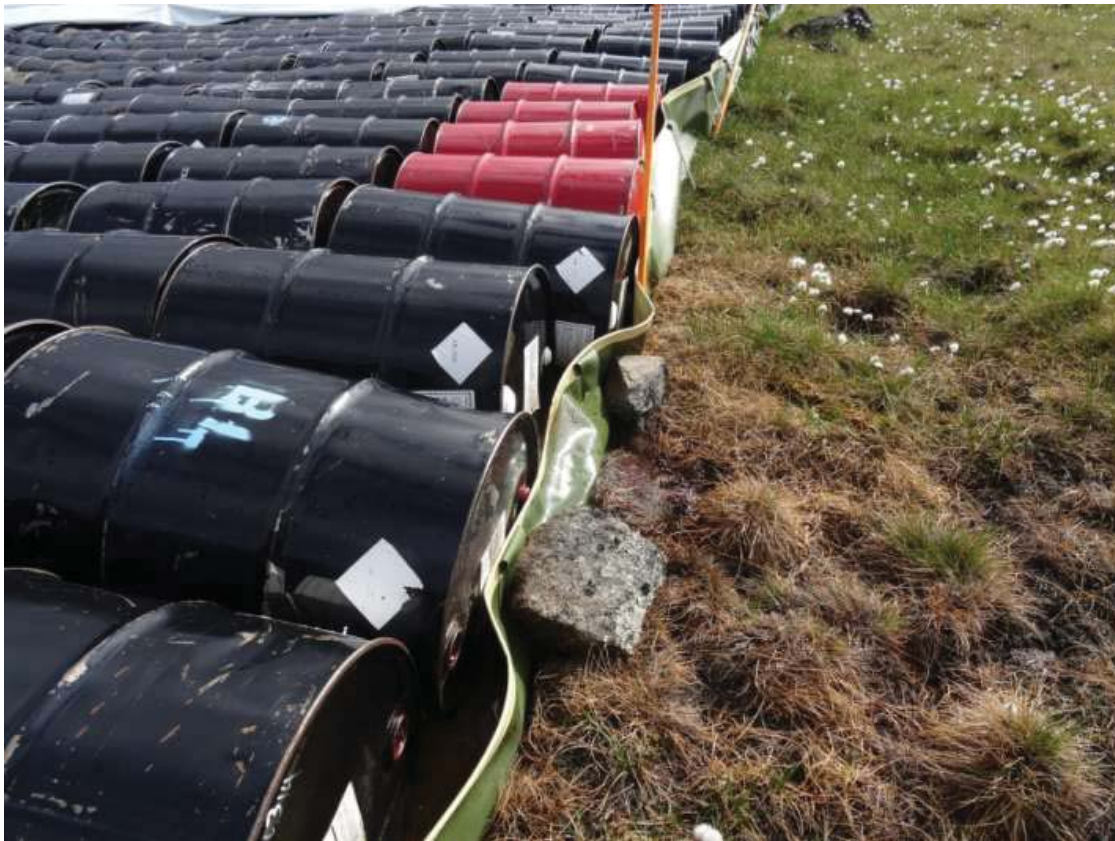
Figure 25. I propped up the side for a temporary fix. More precipitation will cause further overflow of contaminated water.

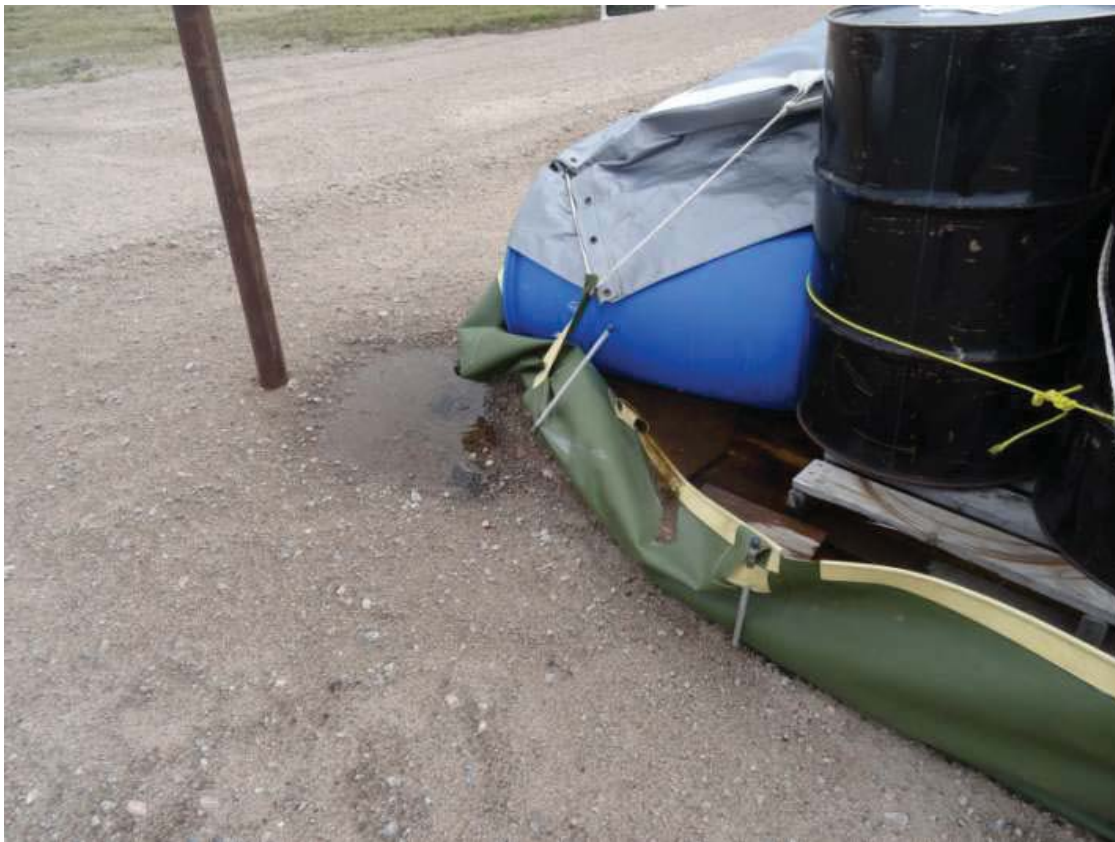
Figure 26. Hayes Camp berm; corner dripping. No obvious contamination at this time.

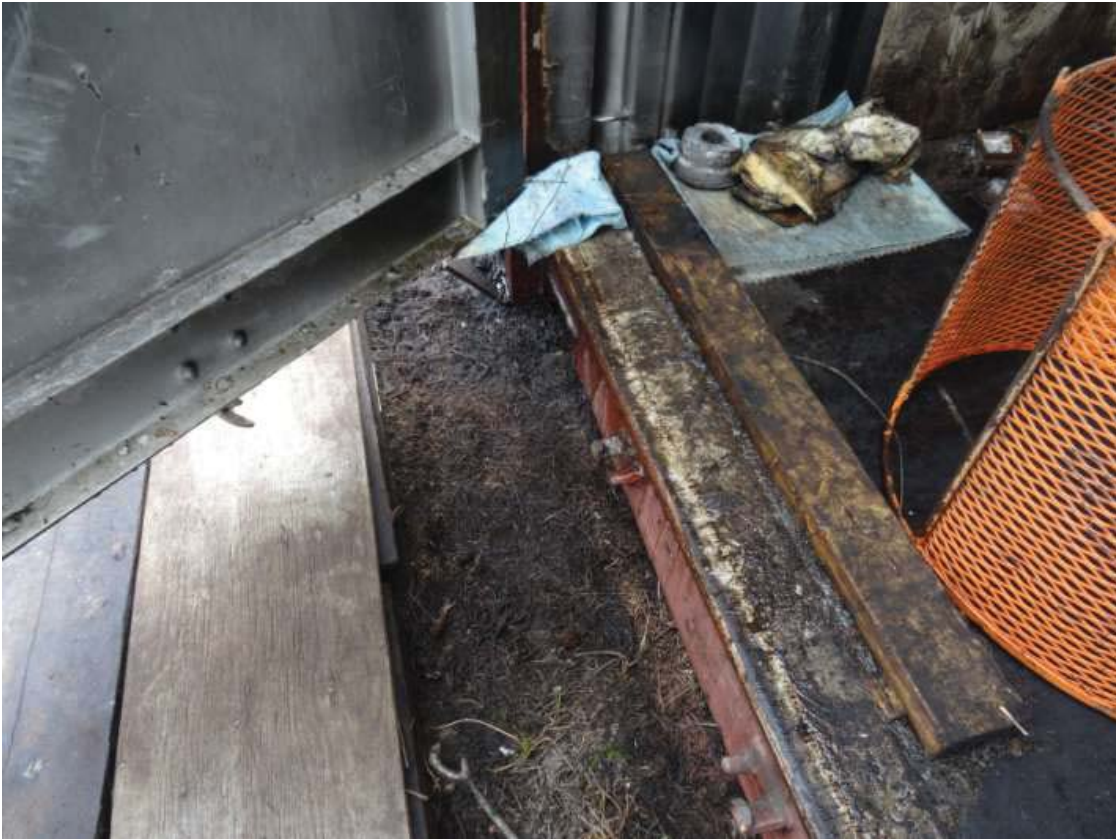
any water in the filters over winter must have the filters replaced prior to use. The red sea-can containing drill greases and oils is discharging oil-contaminated water out the door. Without adequate monitoring, those spills that occur are not addressed promptly and there is a failure to implement the spill plan. Remediation of the spill that occurred in 2012 near the boiler at the drill area has not been completed; spill pads are still spread around the area. Excavated areas should be backfilled to prevent water accumulation and permafrost degradation. In addition, all issues identified in the 2013 LUP inspection are to be addressed as committed to in the 2013 annual report.

Figure 27. Sea-can leaking oil-contaminated water; there is water coming into the sea-can and flowing through.

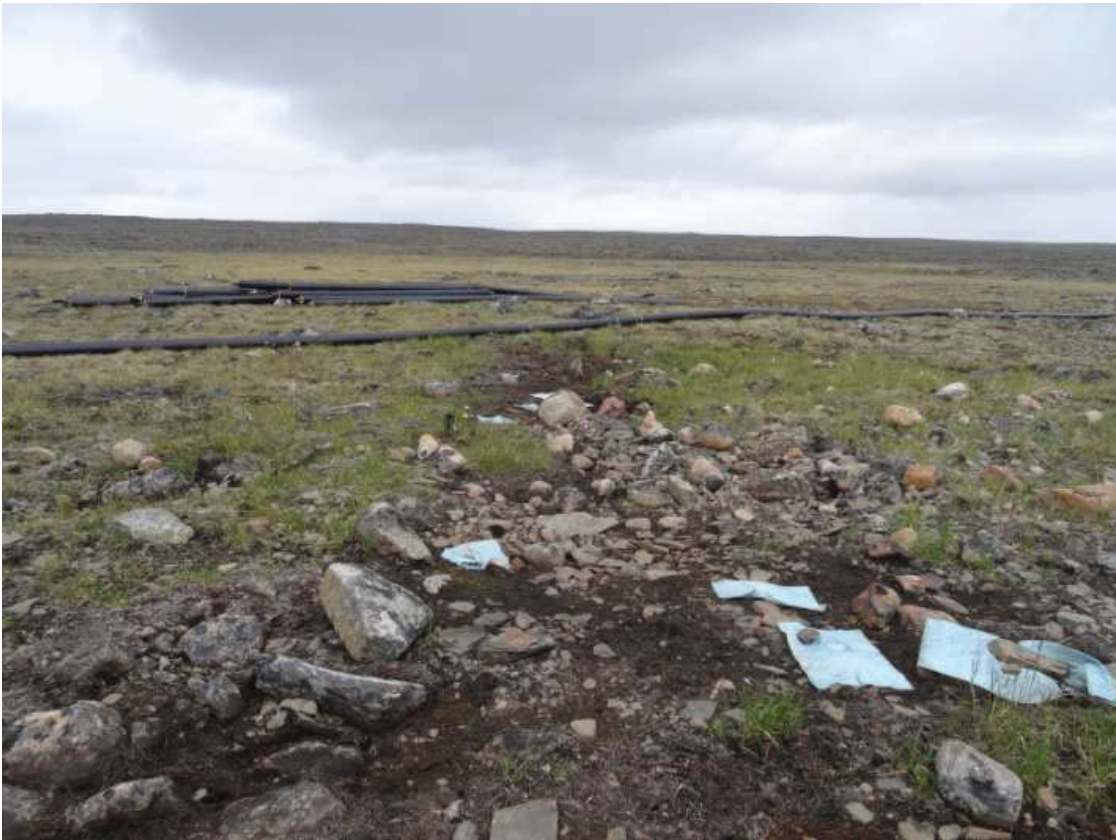
Figure 28. 2012 spill at the boiler. Spill pads are still widespread and holes have not been backfilled.

7. Contaminated soil from fuel and oil spills is to be removed, and holes immediately backfilled; this includes the 2012 spill. This is to be completed by August 15, 2014.

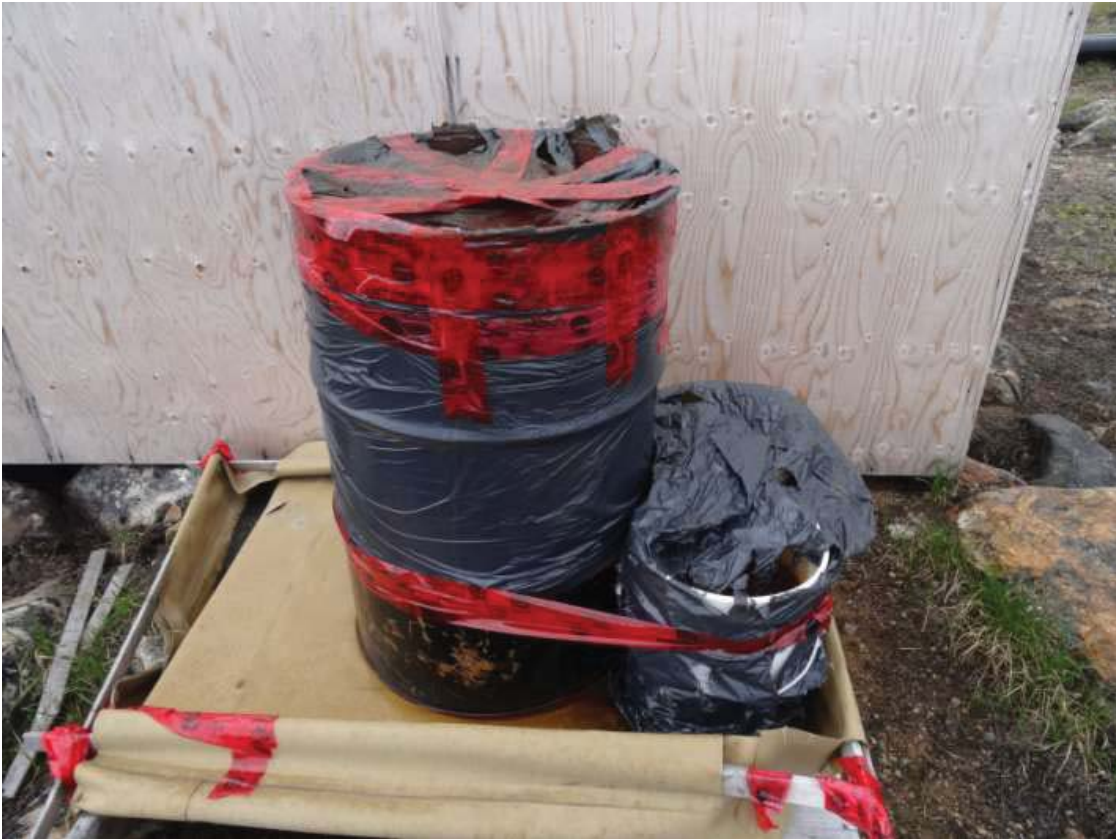
Figure 29. Covered drums of assumedly contaminated material at the boiler. Berm is destroyed, and barrel contents are exposed.

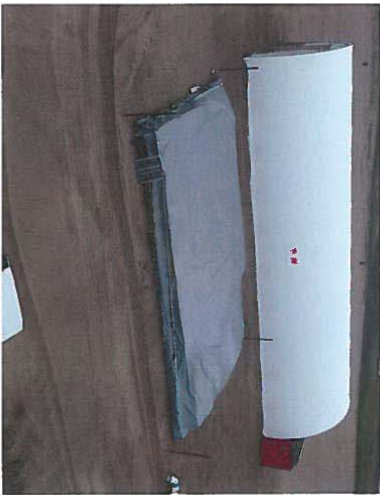
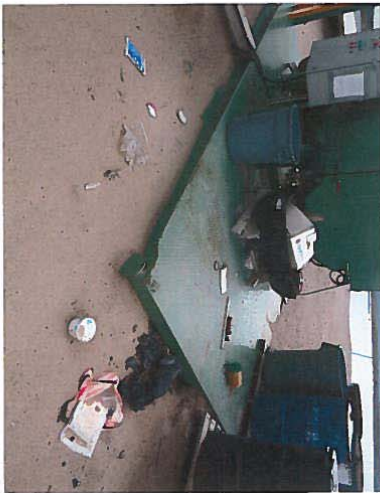
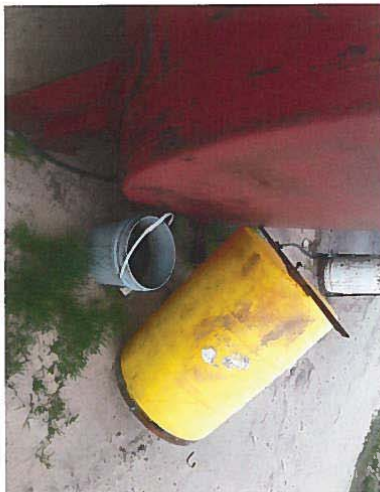
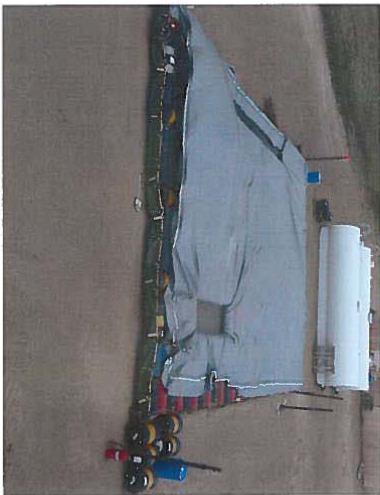
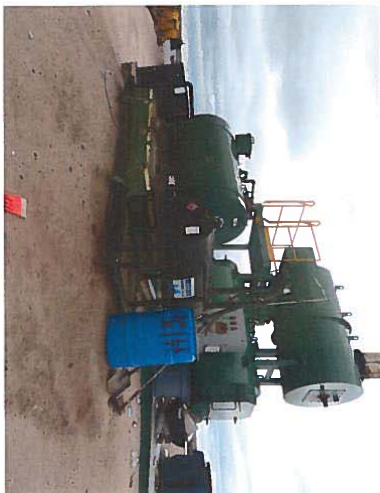
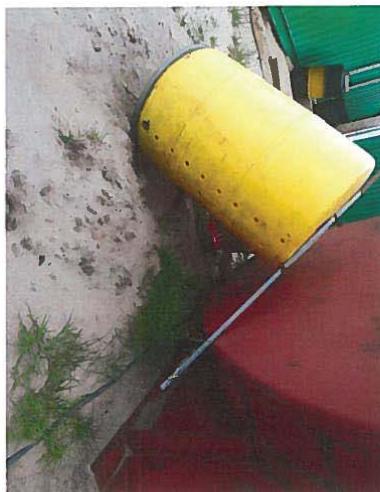
(4) N 7009 C0018

As per photo sheet #1 of the Hayes Camp, there was some garbage found around the Incinerator that needs to be cleaned up and disposed of, the valve on the large red tank is unsecure and needs to be covered or locked, and the secondary containment on 1 of the 2 fuel caches needs attending to as water has accumulated on top causing other areas to be exposed. The covered secondary containment for individual drums behind each structure is very nice thank you.

The above deficiencies need to be fixed and “before” and “after” photos shall be provided to me to show compliance. These sites will be Inspected again in 2014 to ensure compliance.

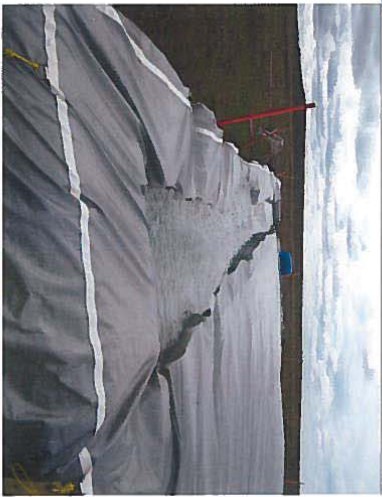
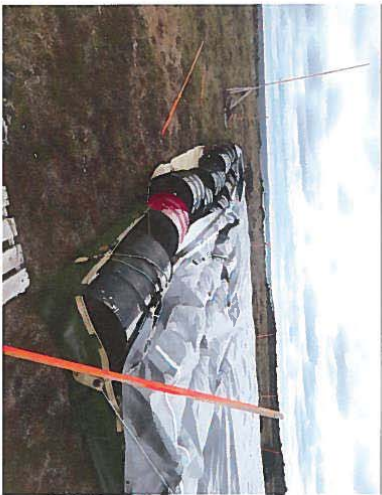
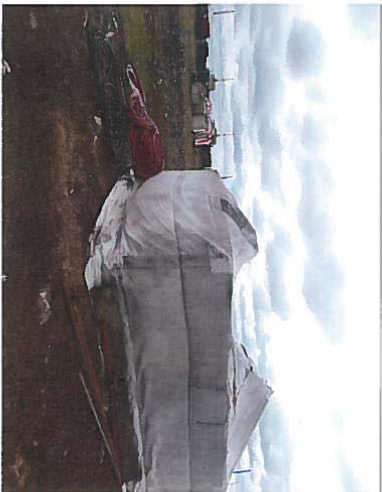
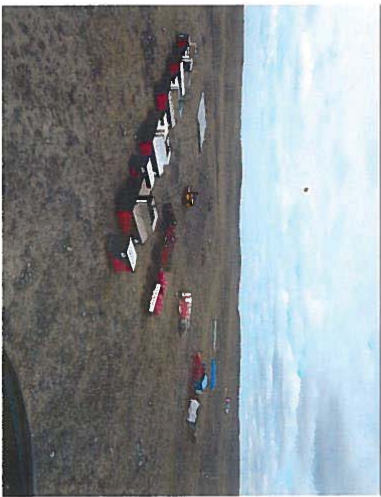
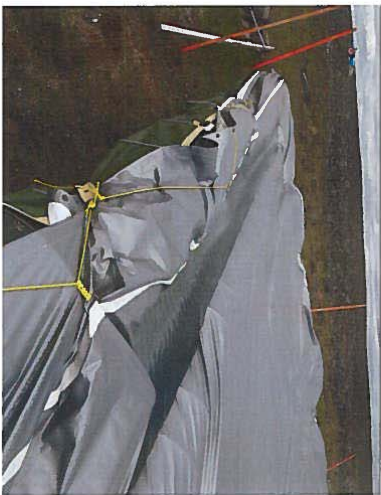
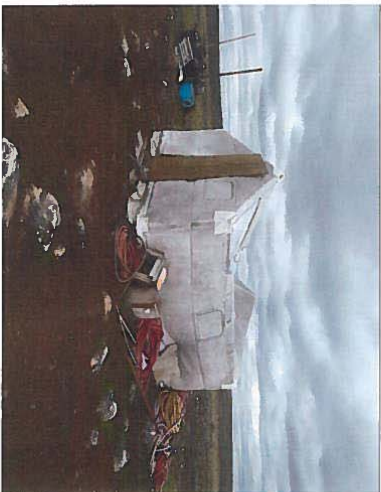
(#2) N8009C0018

As per photo sheet #2 of the Drill Laydown area and Fuel Cache, 1 Tent Frame is weather damaged and needs repairing and 1 Fuel Cache has a large pool of standing water that needs to be drained off and the other Fuel Cache has had part of the cover blown off and a section of the containment wall has collapsed from the support strings coming off.

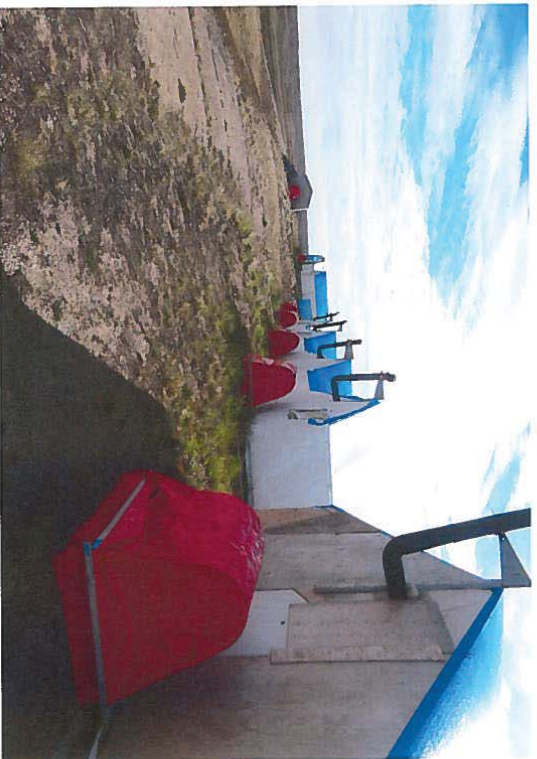
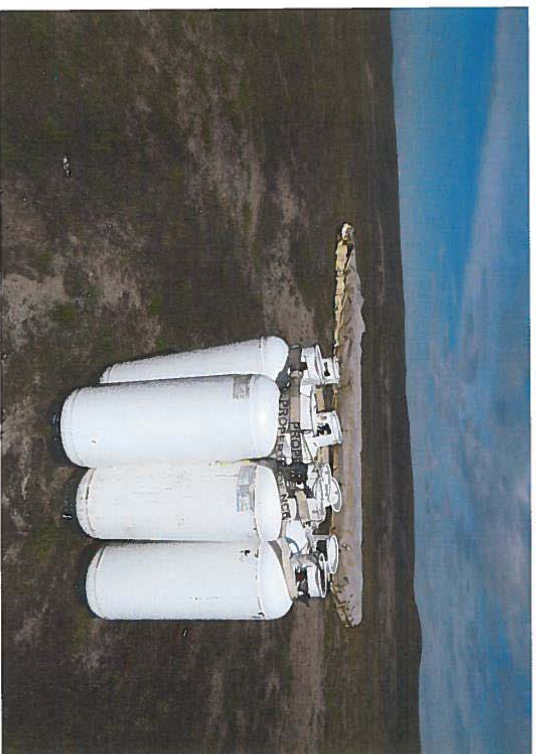
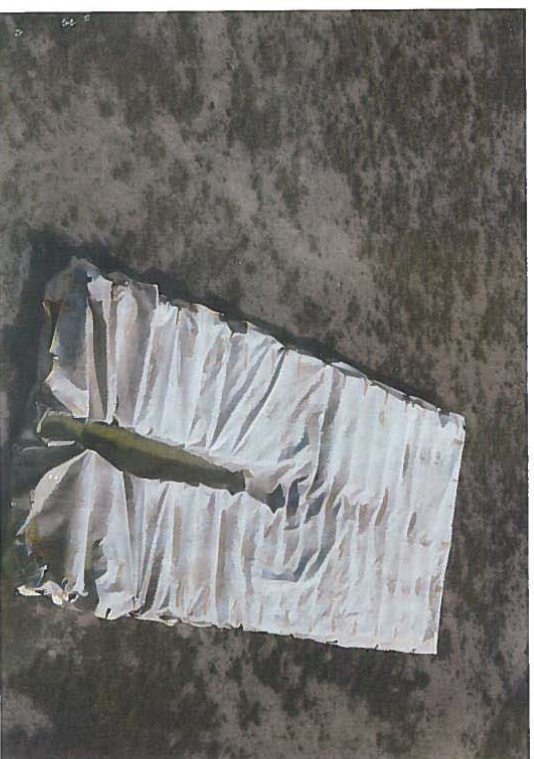
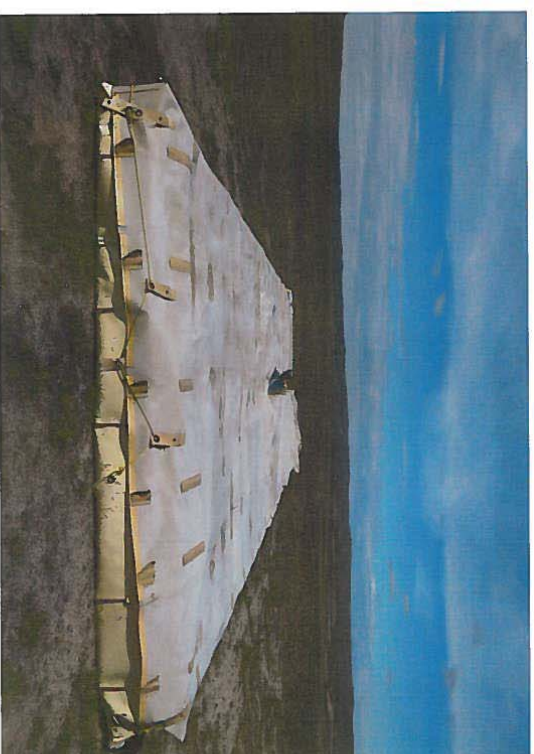
(E1)

As per photo sheet #1, all fuel stored on site is in Covered Secondary Containment, thank you very much for this. That is how we require all Secondary Containment that is unattended for more than 24 hours at a time.

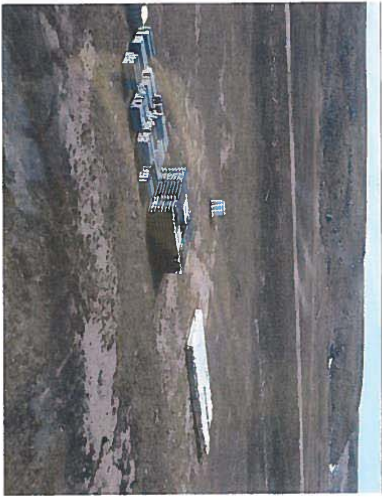
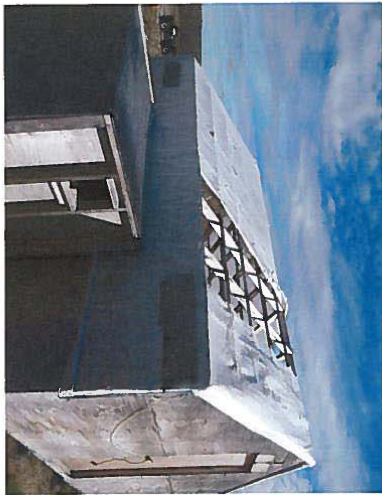
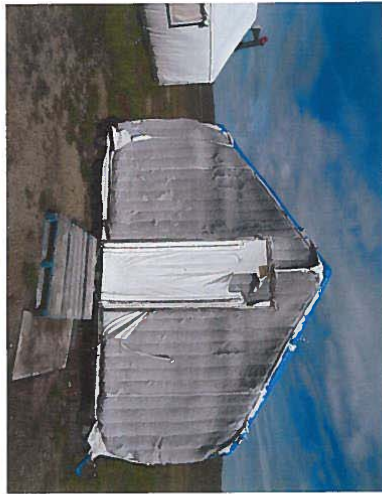
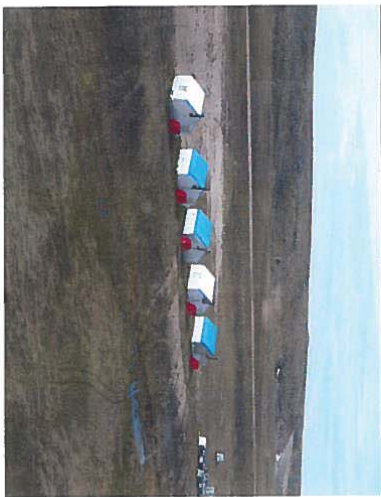
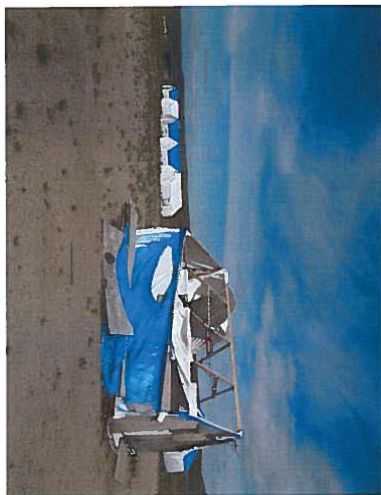
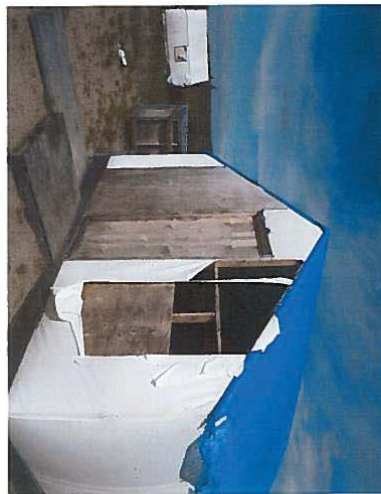
#27 N 2004 C0019

As per photo sheet #2, at least 6 structures in the camp have sustained extensive weather damage. These must all be repaired and all structures must be secure. You shall provide me with “before” and “after” photos of your repairs to ensure compliance.
