## Appendix 7 - 2018 AANDC Land Use and Water Licence Inspection

WATER LICENCE INSPECTION FORM

Licensee		Licensee Representative	
North Country Gold/Auryn Resources		Bryan Atkinson	
Licence No. / Expiry		Representative's Title	
2BE-CRA1520		Exploration Manager	
Land / Other Authorizations		Land / Other Authorizations	
LUP N2014C0005		Lease 56J/11-1-2	
Date of Inspection		Inspector	
29 July 2018		Baba Pedersen	
Activities Inspected			
<input checked="" type="checkbox"/> Camp	<input checked="" type="checkbox"/> Drilling	<input type="checkbox"/> Mining	<input type="checkbox"/> Construction
<input type="checkbox"/> Roads/Hauling	<input type="checkbox"/> Other:	<input type="checkbox"/> Other:	<input checked="" type="checkbox"/> Reclamation
		<input checked="" type="checkbox"/> Fuel Storage

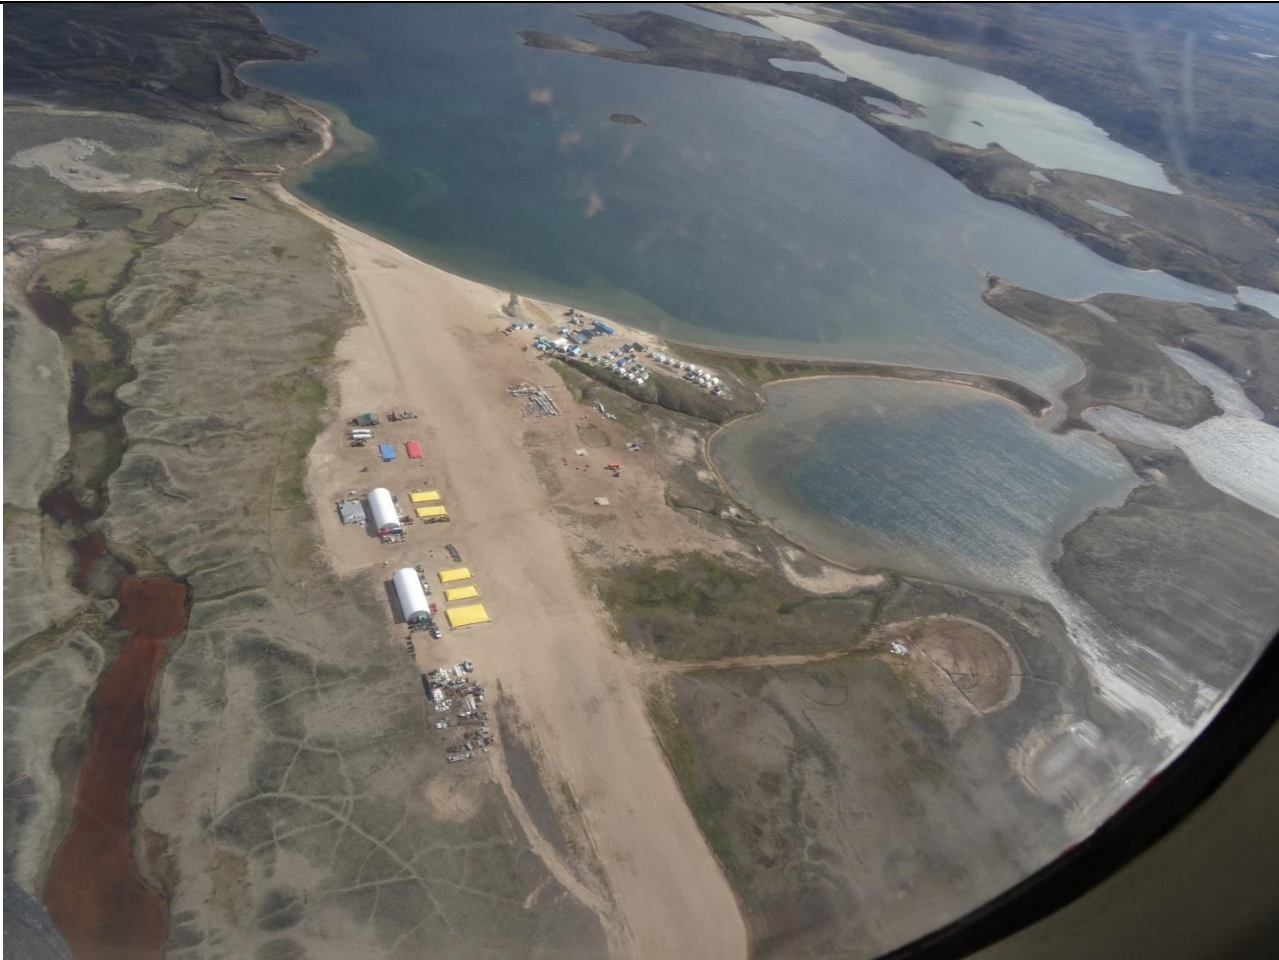
Photo 1

Description: Aerial View #1 of Hayes Camp

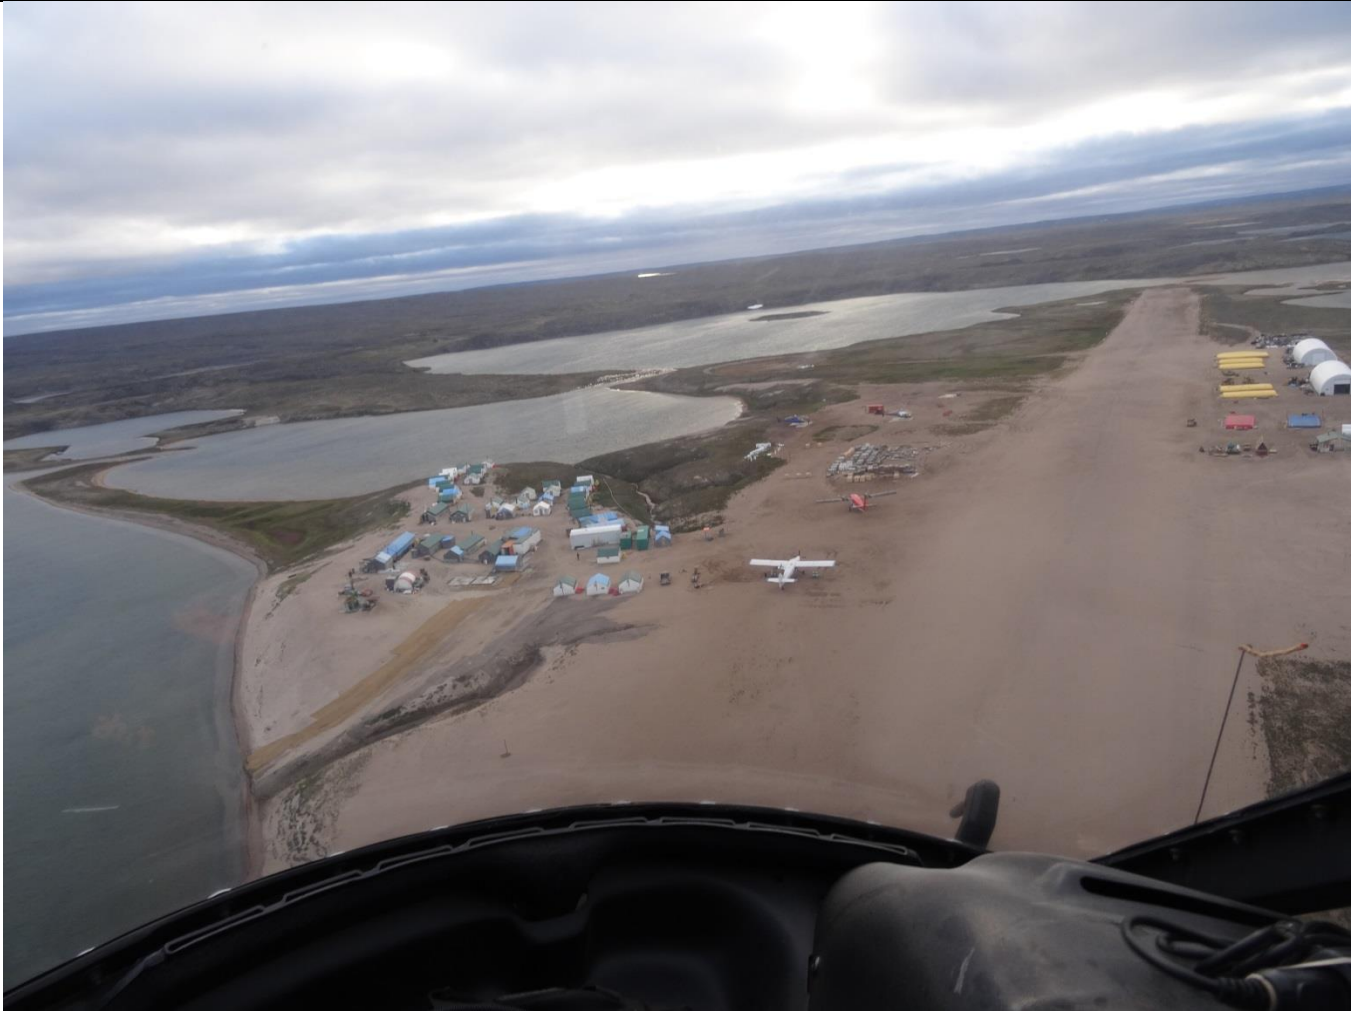
Photo 2

Description: Aerial View #2 of Hayes Camp

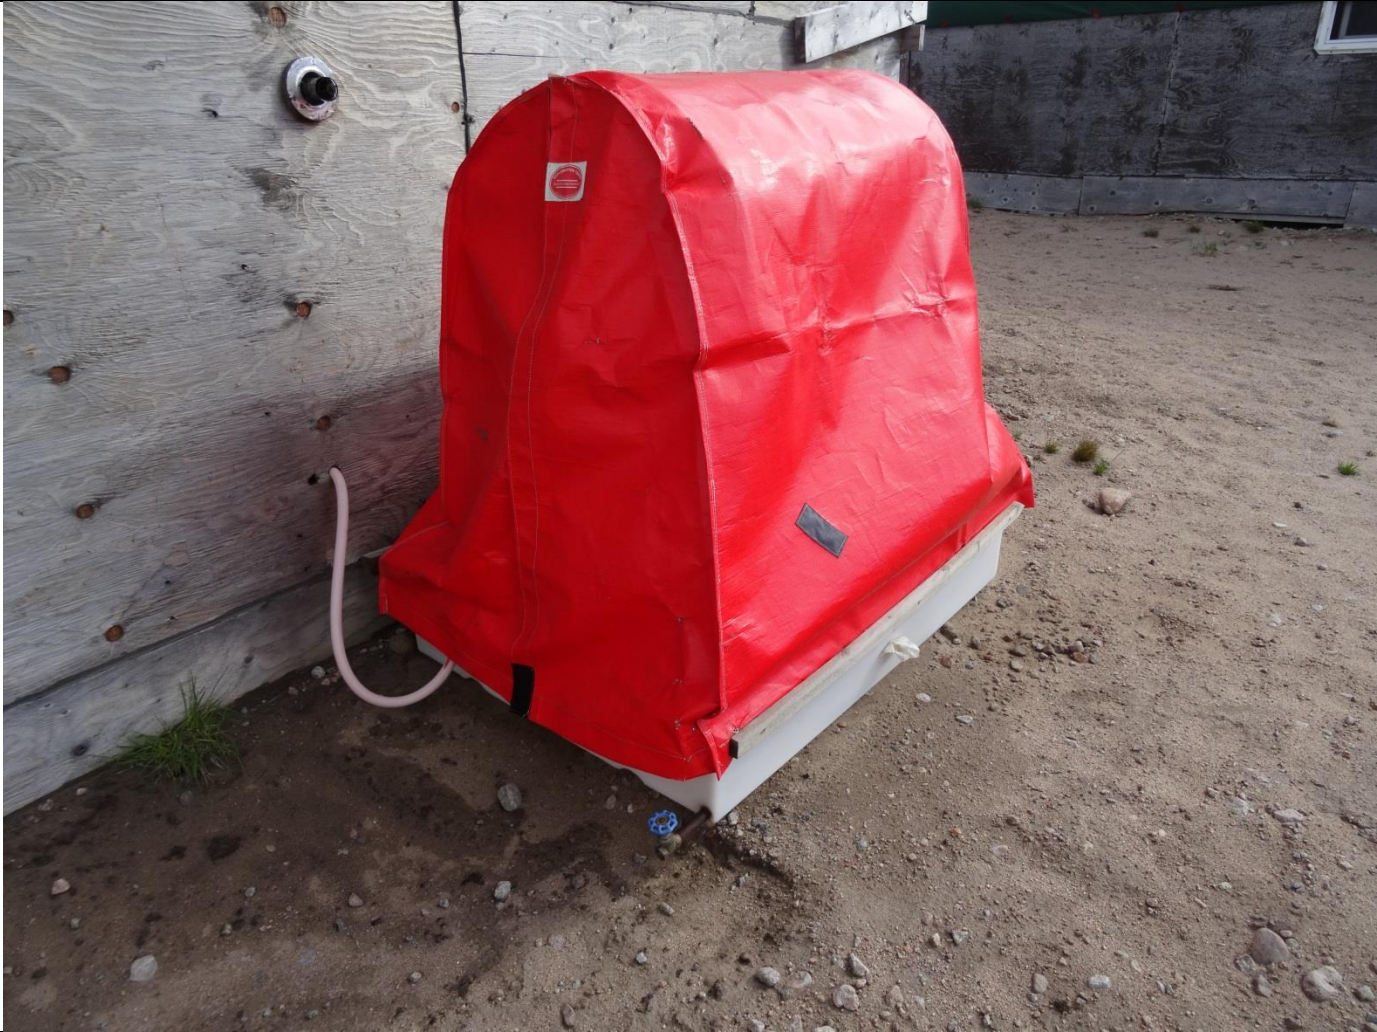
Photo 3

Description: Type 1 of Secondary Containment on Individual Drums behind each Cabin – VERY NICE!

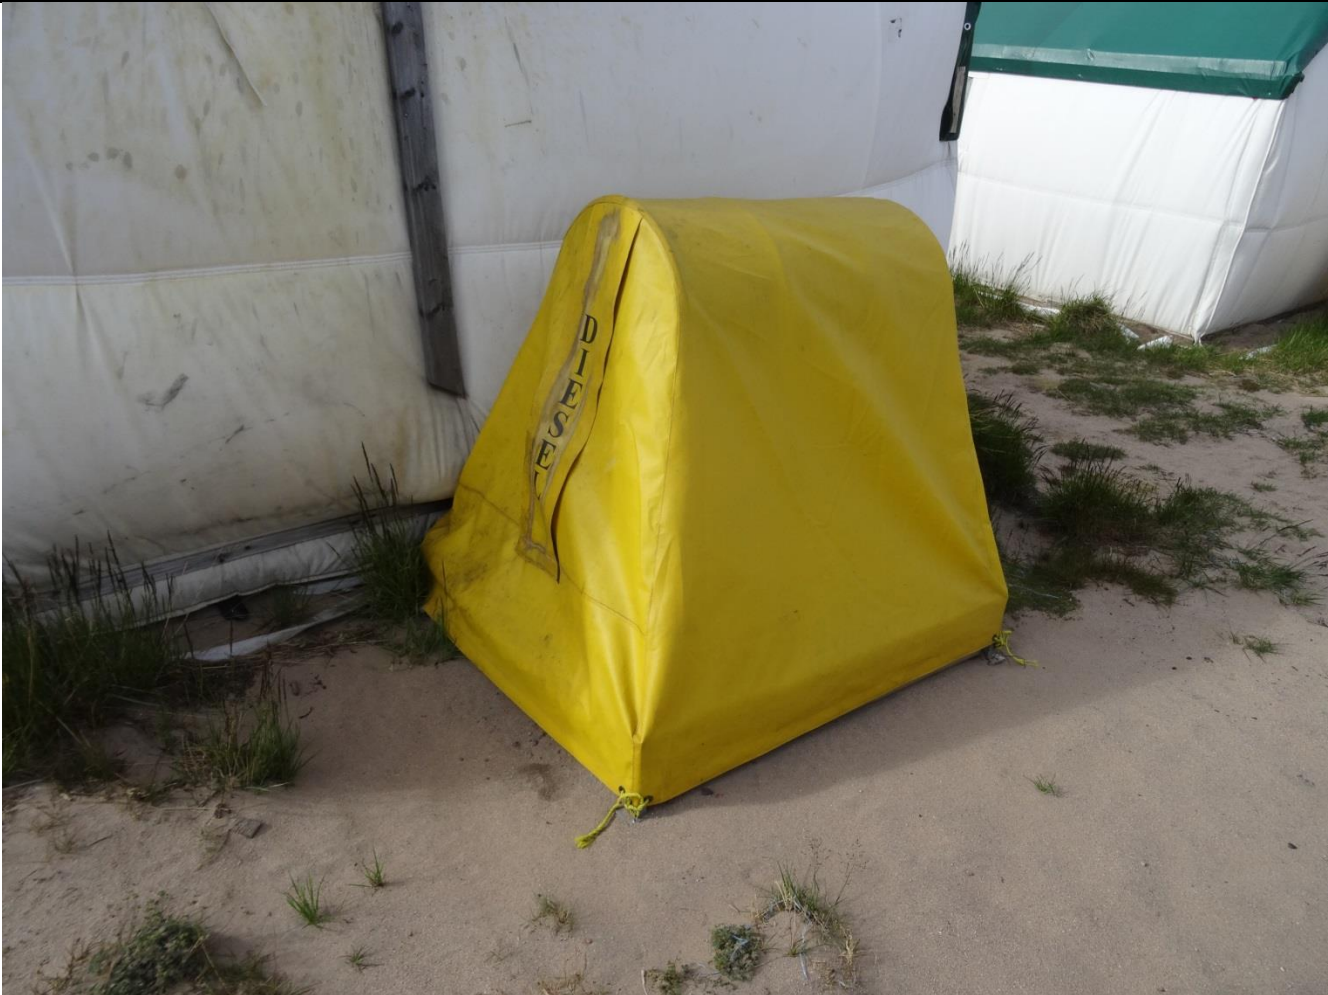
Photo 4

Description: Type 2 of Secondary Containment on Individual Drums behind each Cabin – VERY NICE!

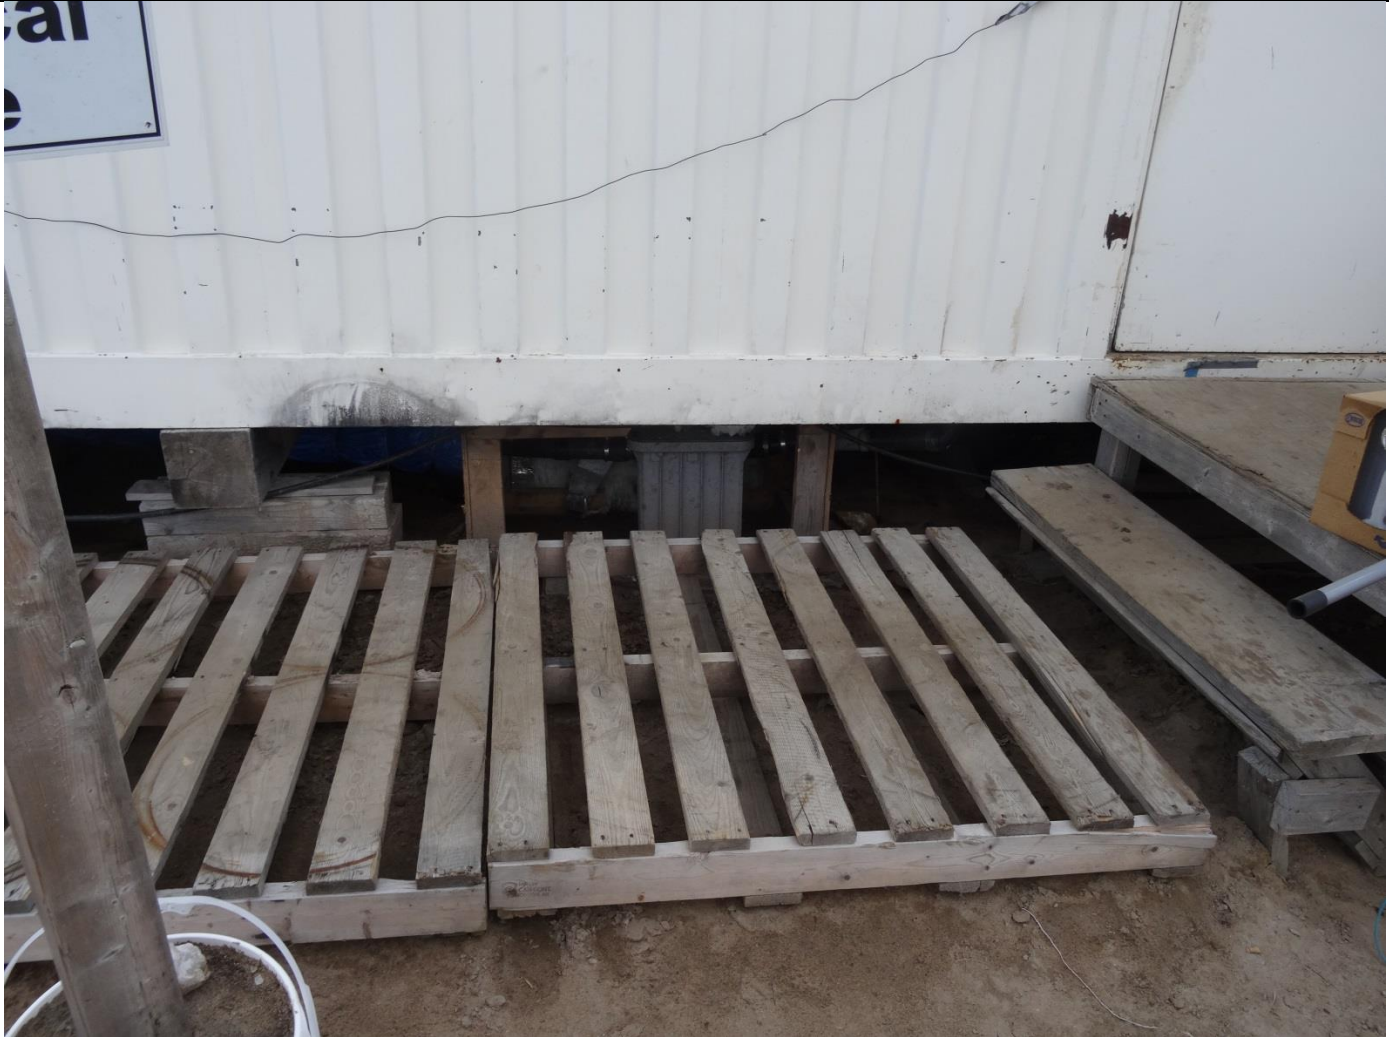
Photo 5

Description: Kitchen Grease Trap installed as per Inspector Eva Paul's direction from last Inspection – Thank You

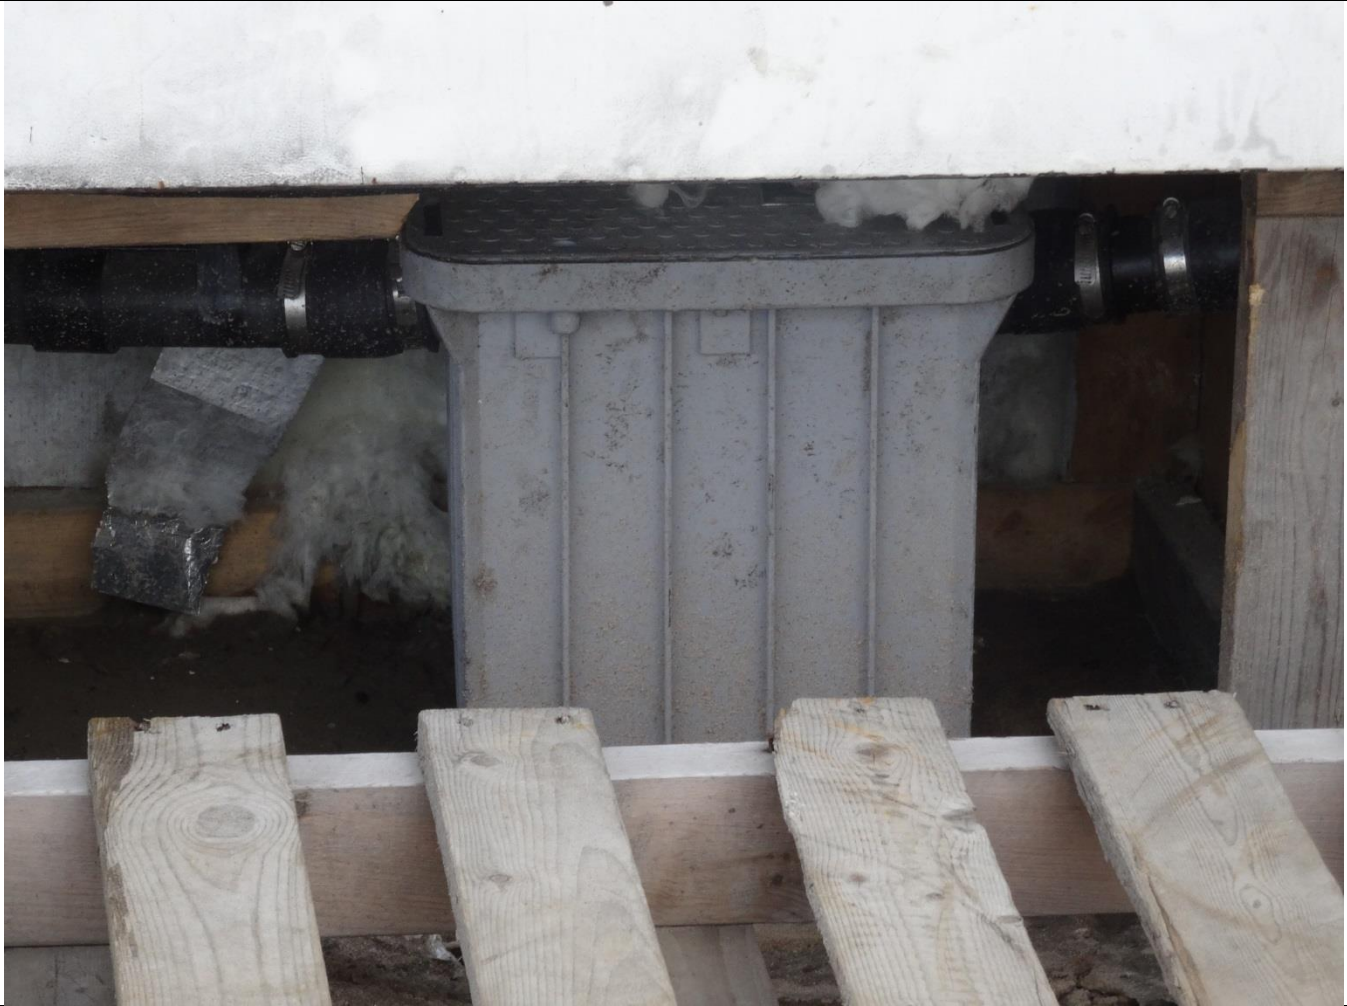
Photo 6

Description: Close-up of Kitchen Grease Trap installed as per Inspector Eva Paul's direction from last Inspection – Thank You

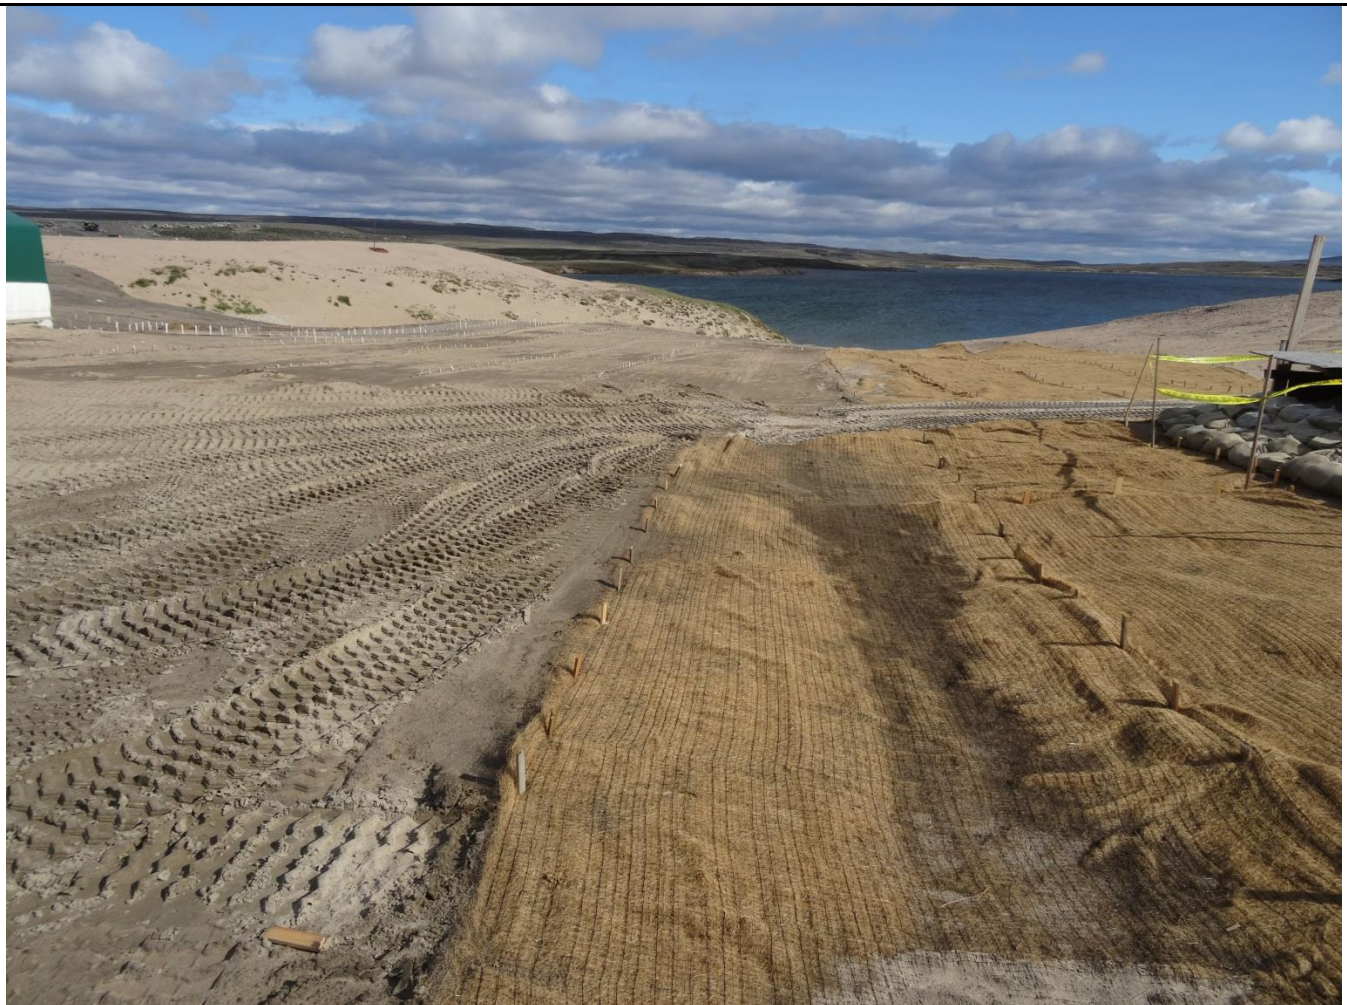
Photo 7

Description: Coconut Matting installed for Erosion Control as per Eva Paul’s Direction from last Inspection – also visible in Photo #2

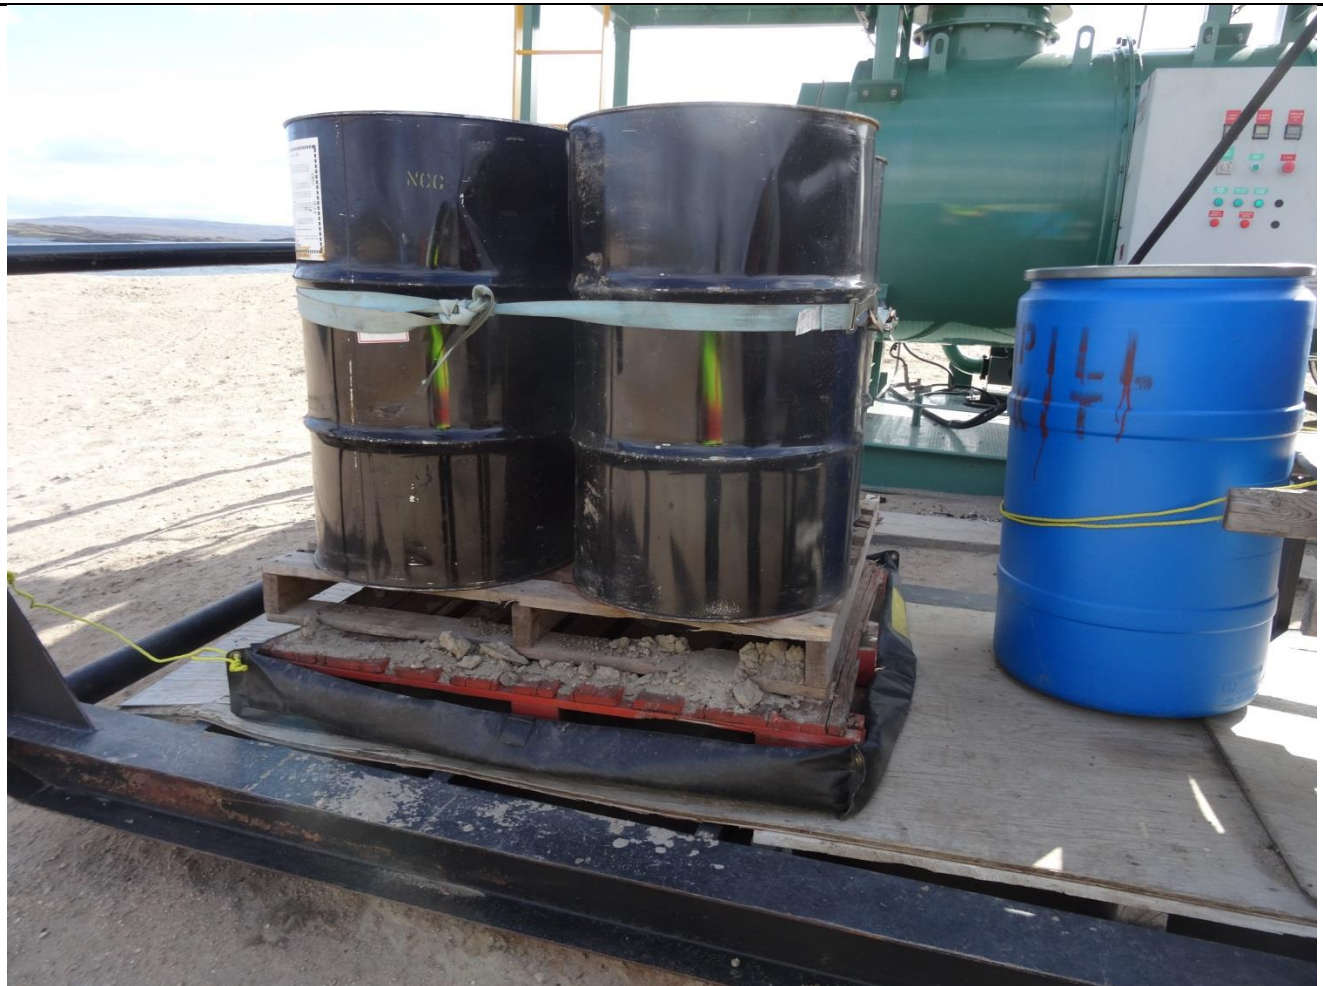
Photo 8

Description: Fuel Drums for Incinerator – Needs Larger Secondary Containment

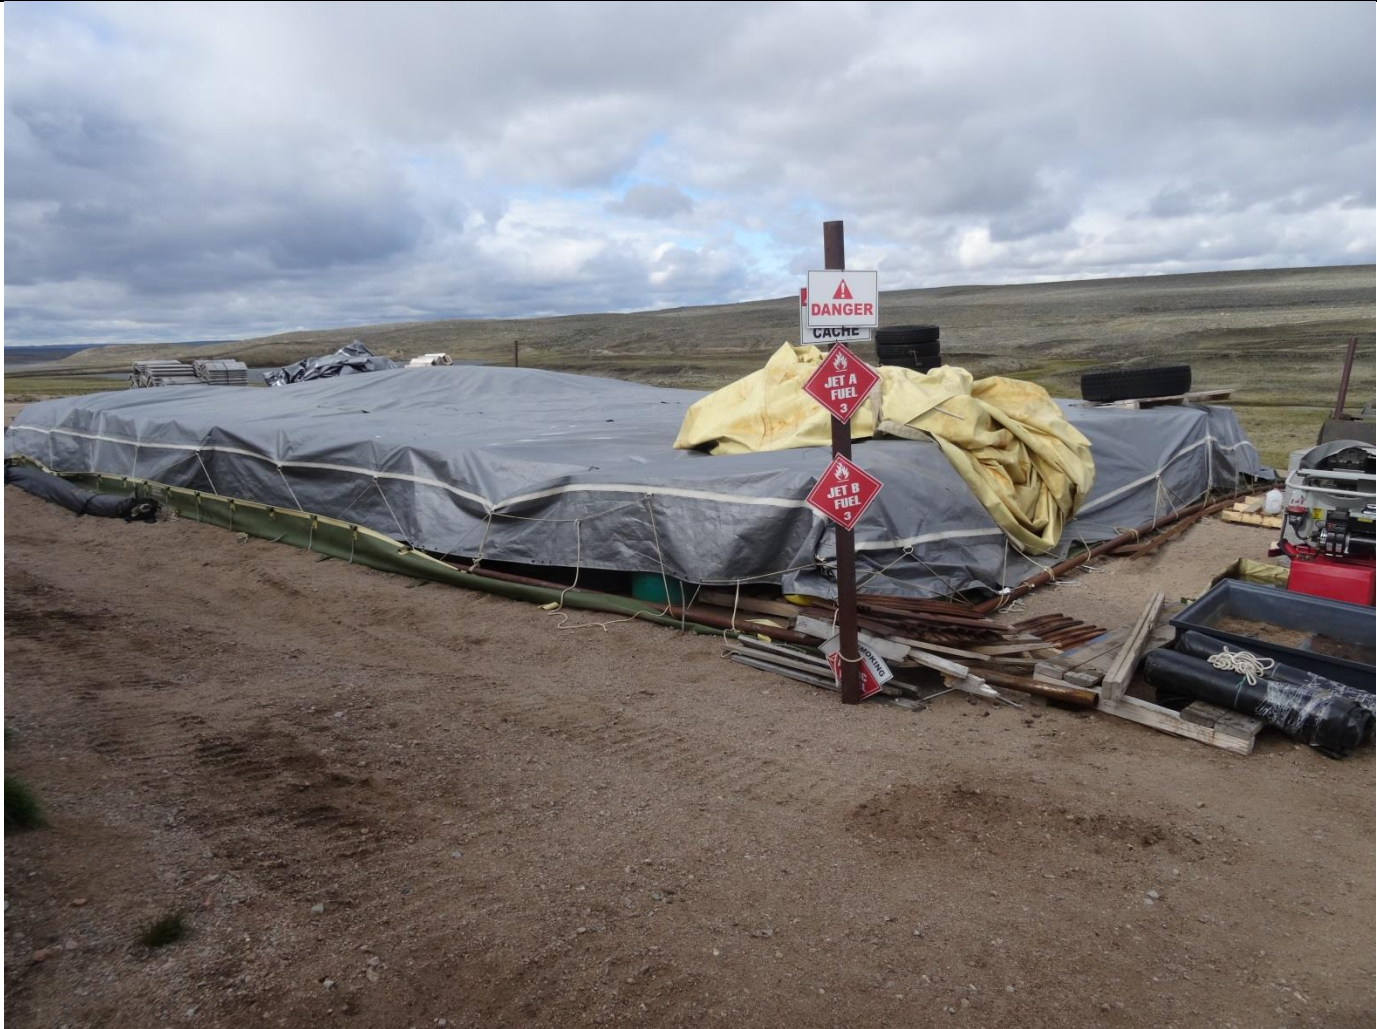
Photo 9

Description: Waste Berm #2 – Needs Repairs on Secondary Containment

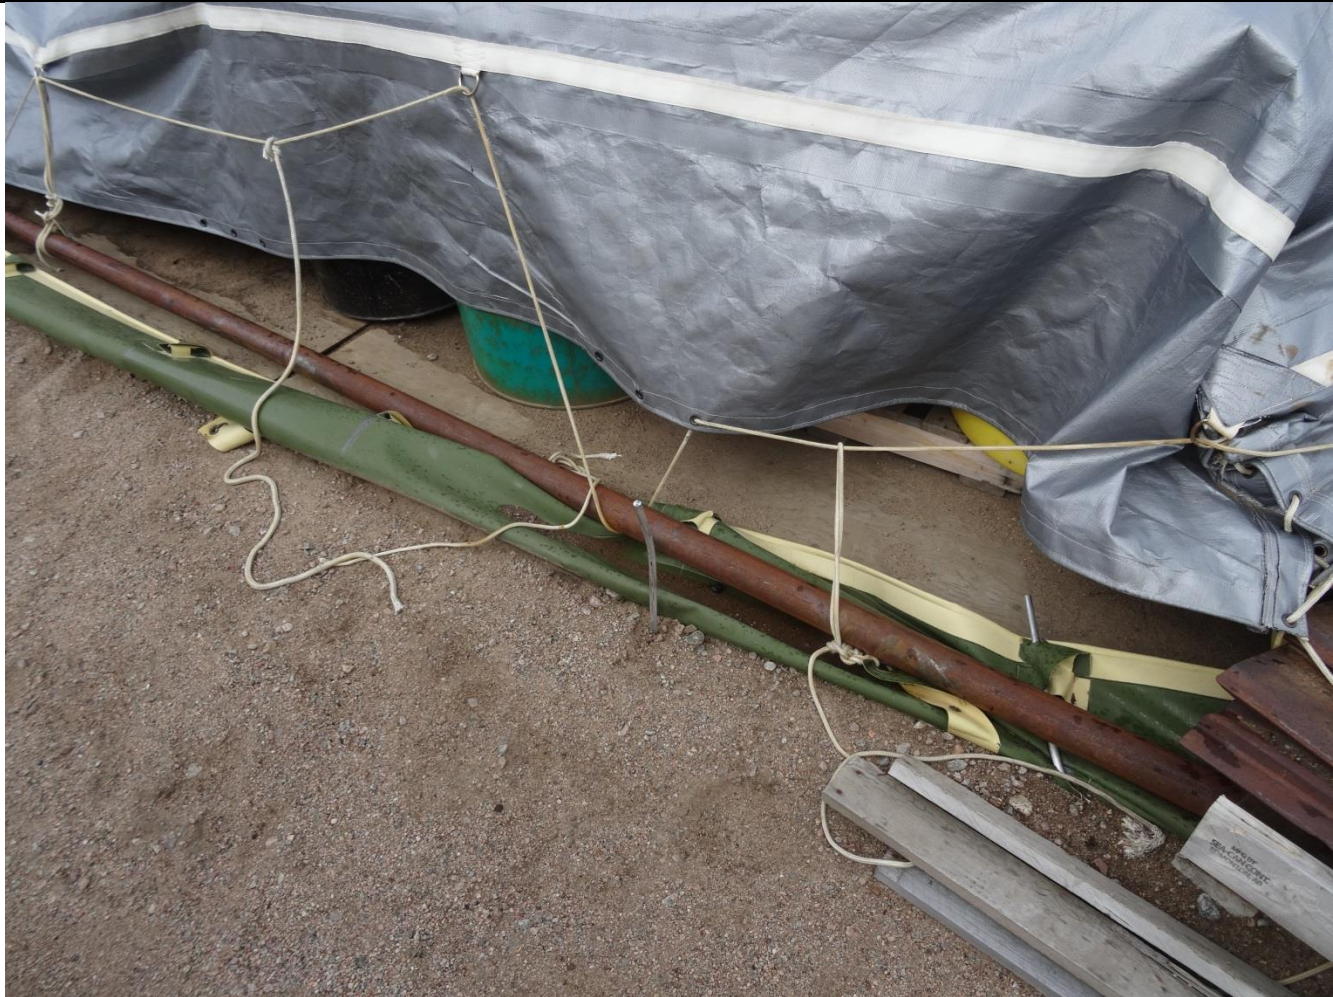
Photo 10

Description: Waste Berm #2 – Needs Repairs on Secondary Containment

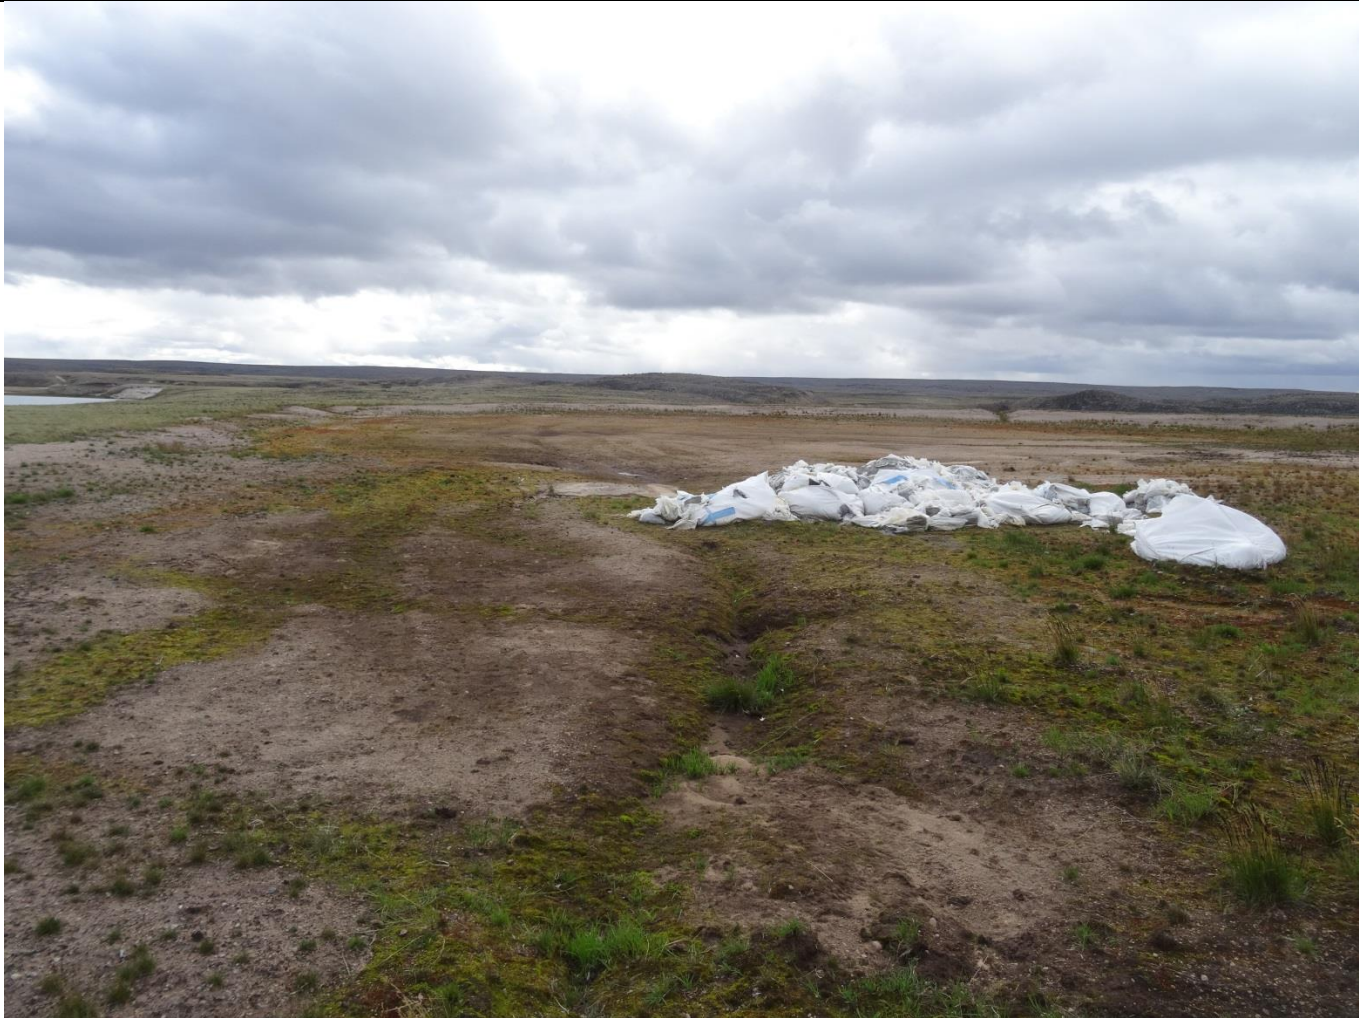
Photo 11

Description: Old Quarry Area to be added to Long Term Reclamation Plan

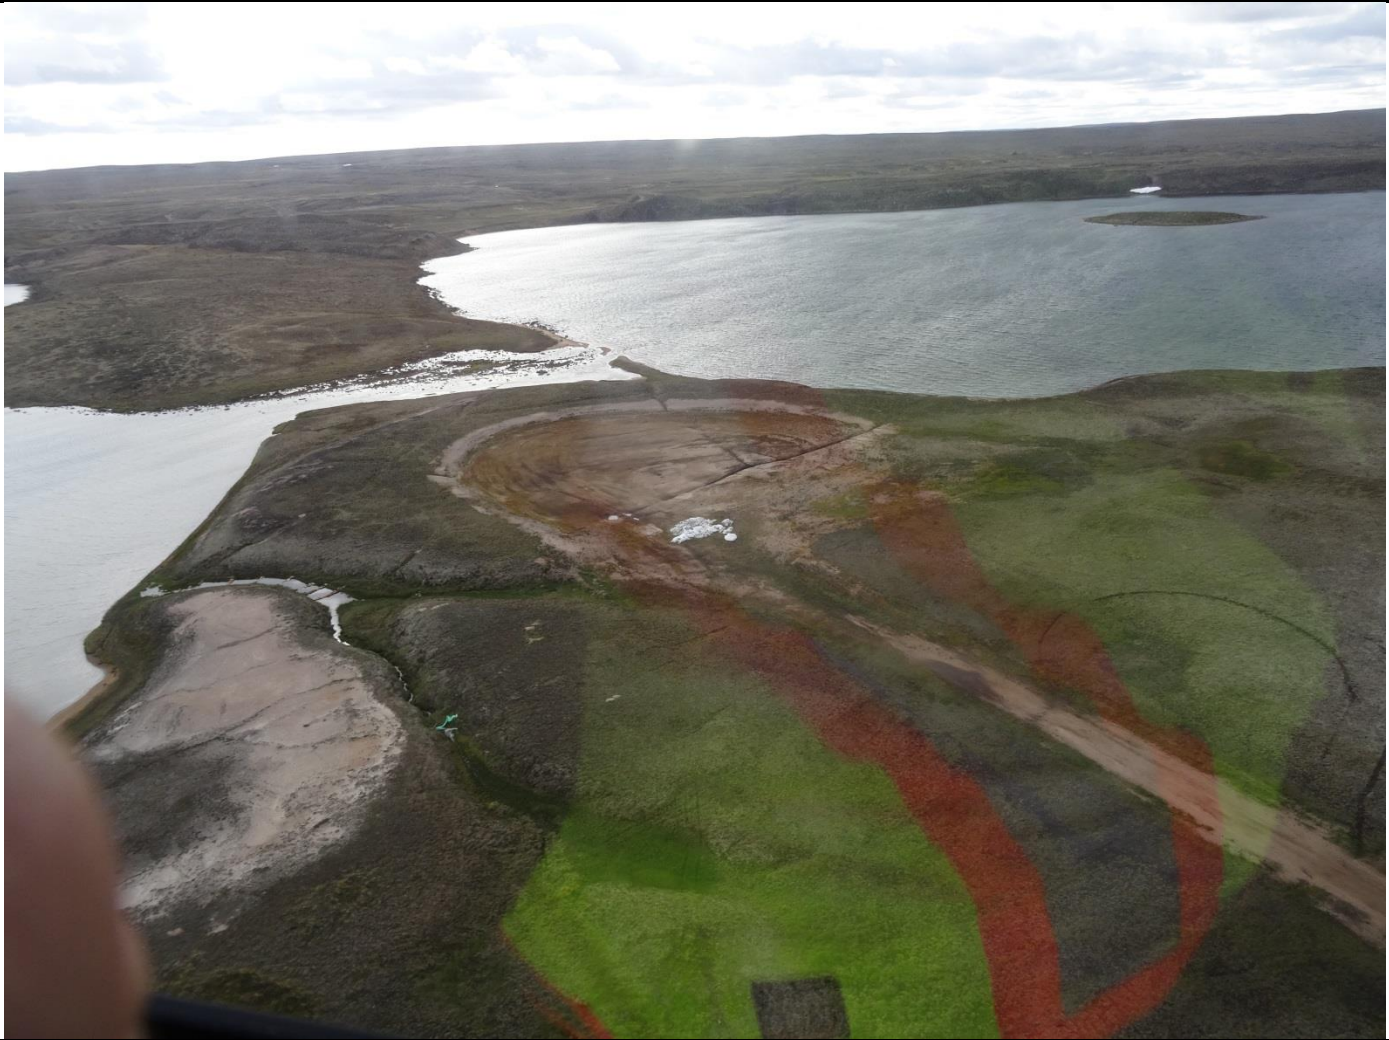
Photo 12

Description: Old Quarry Area to be added to Long Term Reclamation Plan – Aerial View

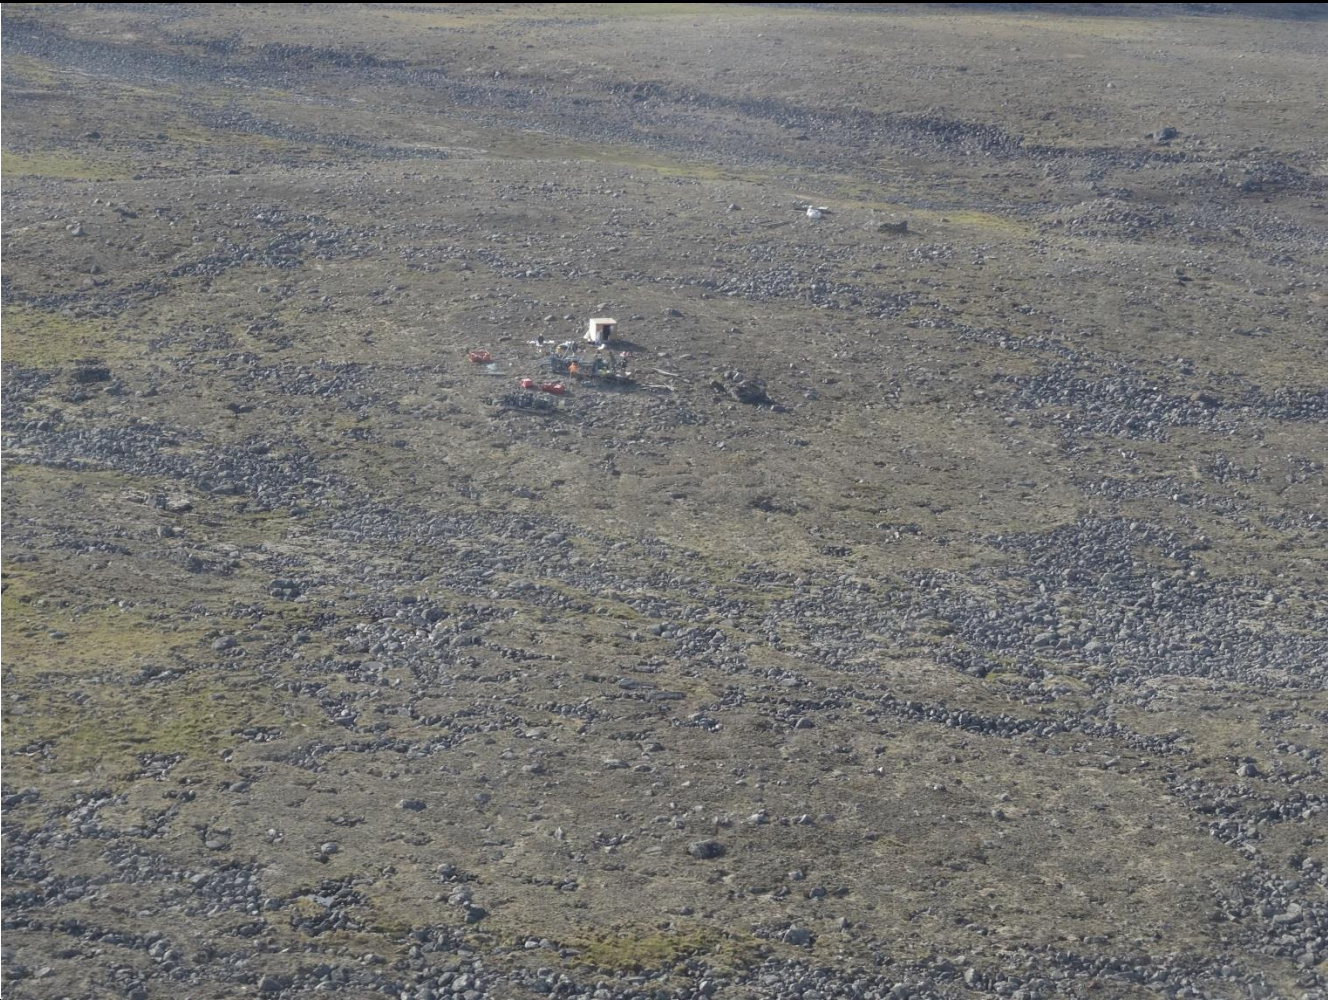
Photo 13

Description: Aerial View of RAB Drill Site

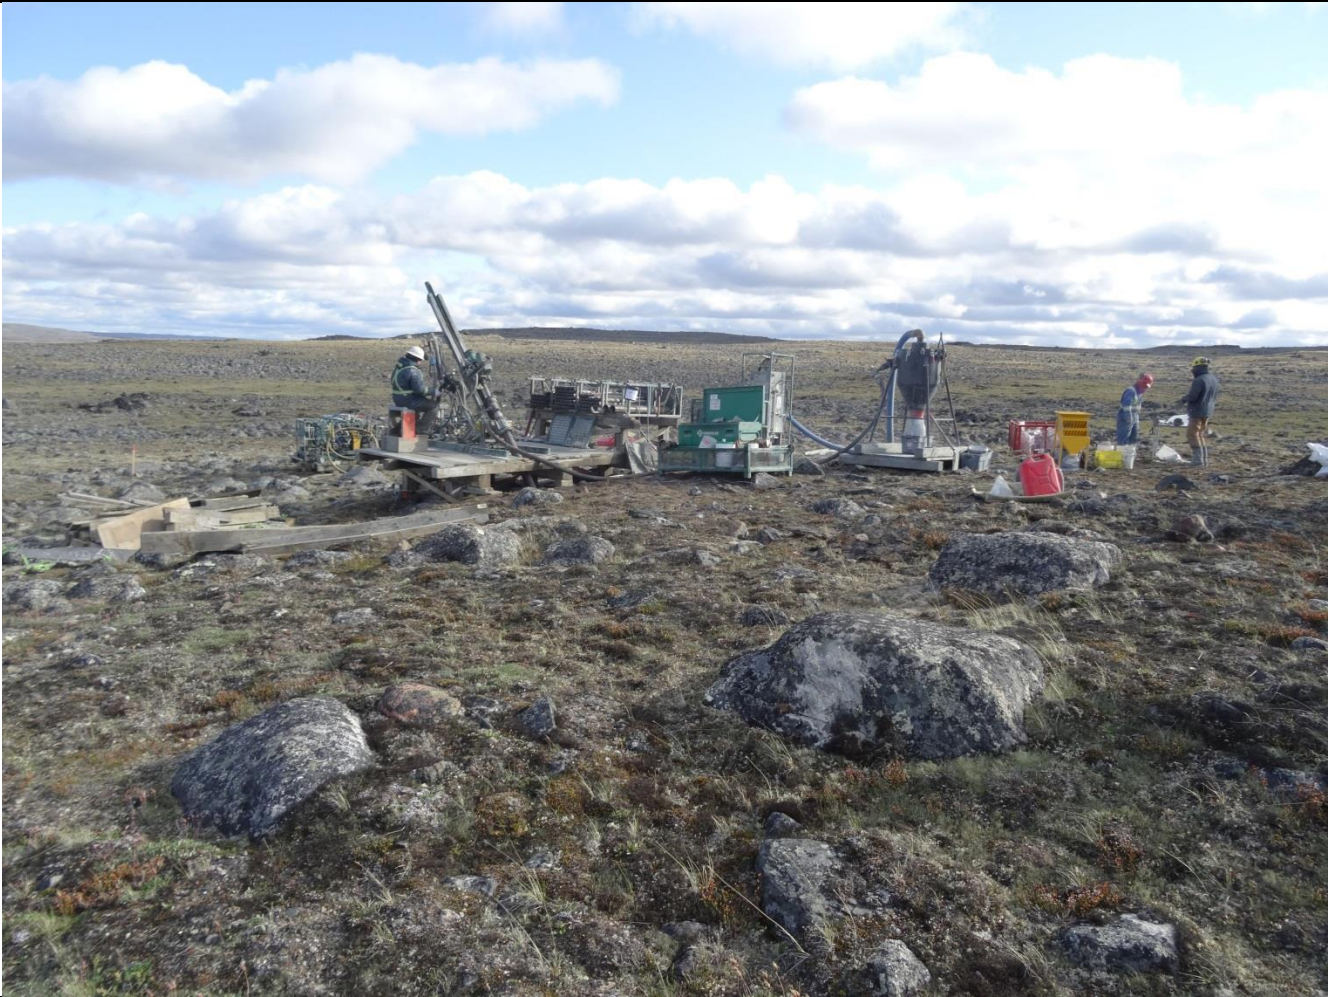
Photo 14

Description: RAB Drill Site showing compact Foot Print

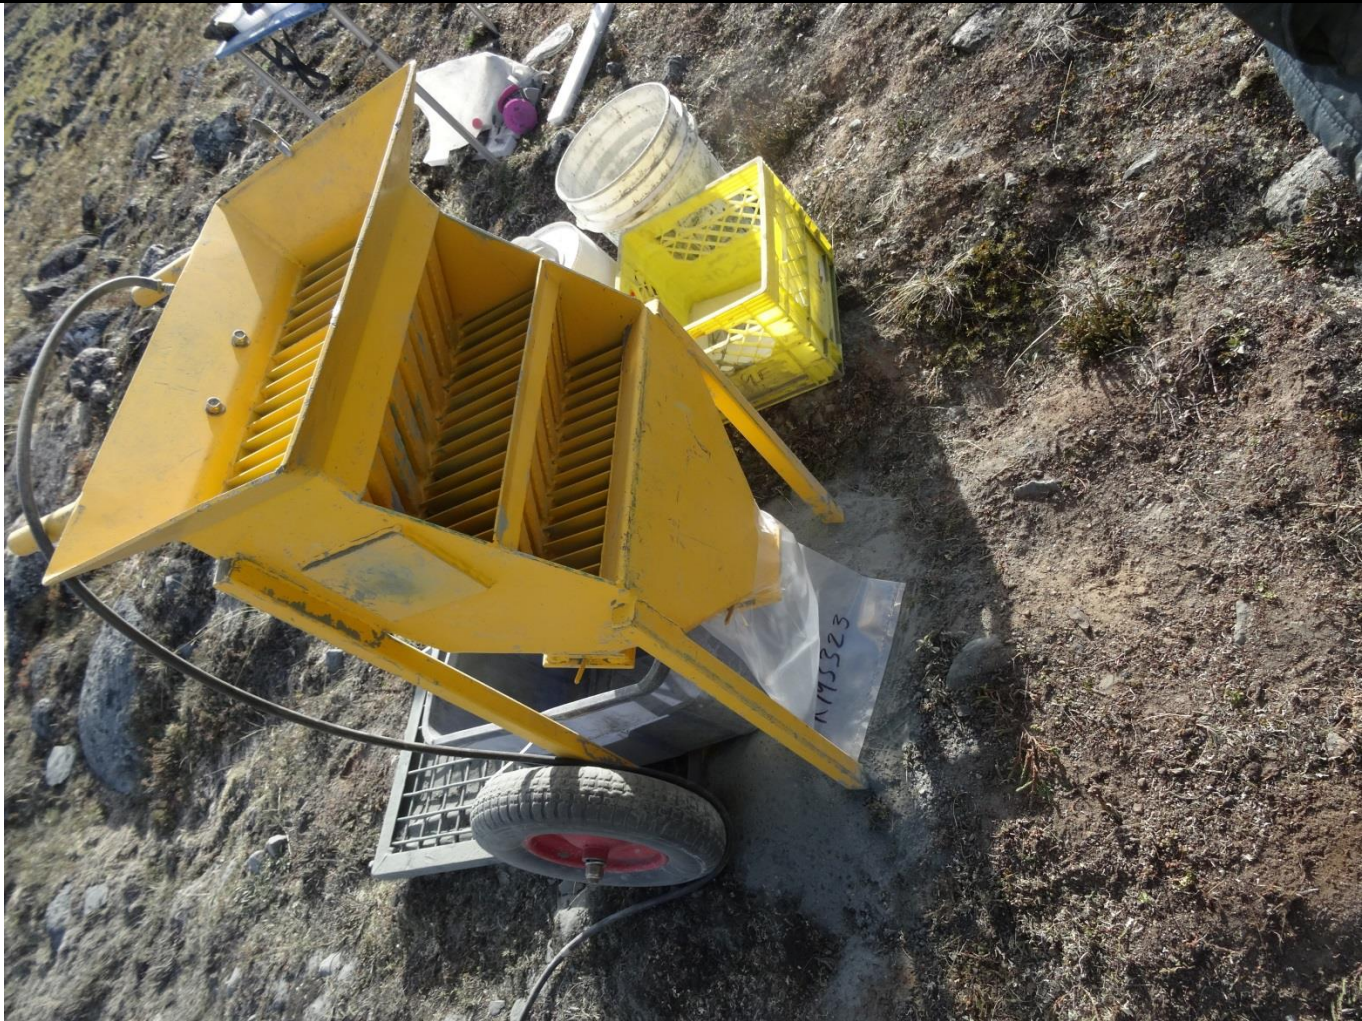
Photo 15

Description: RAB Drills produce Dust (not Core) which is poured through this Sifter into Bags

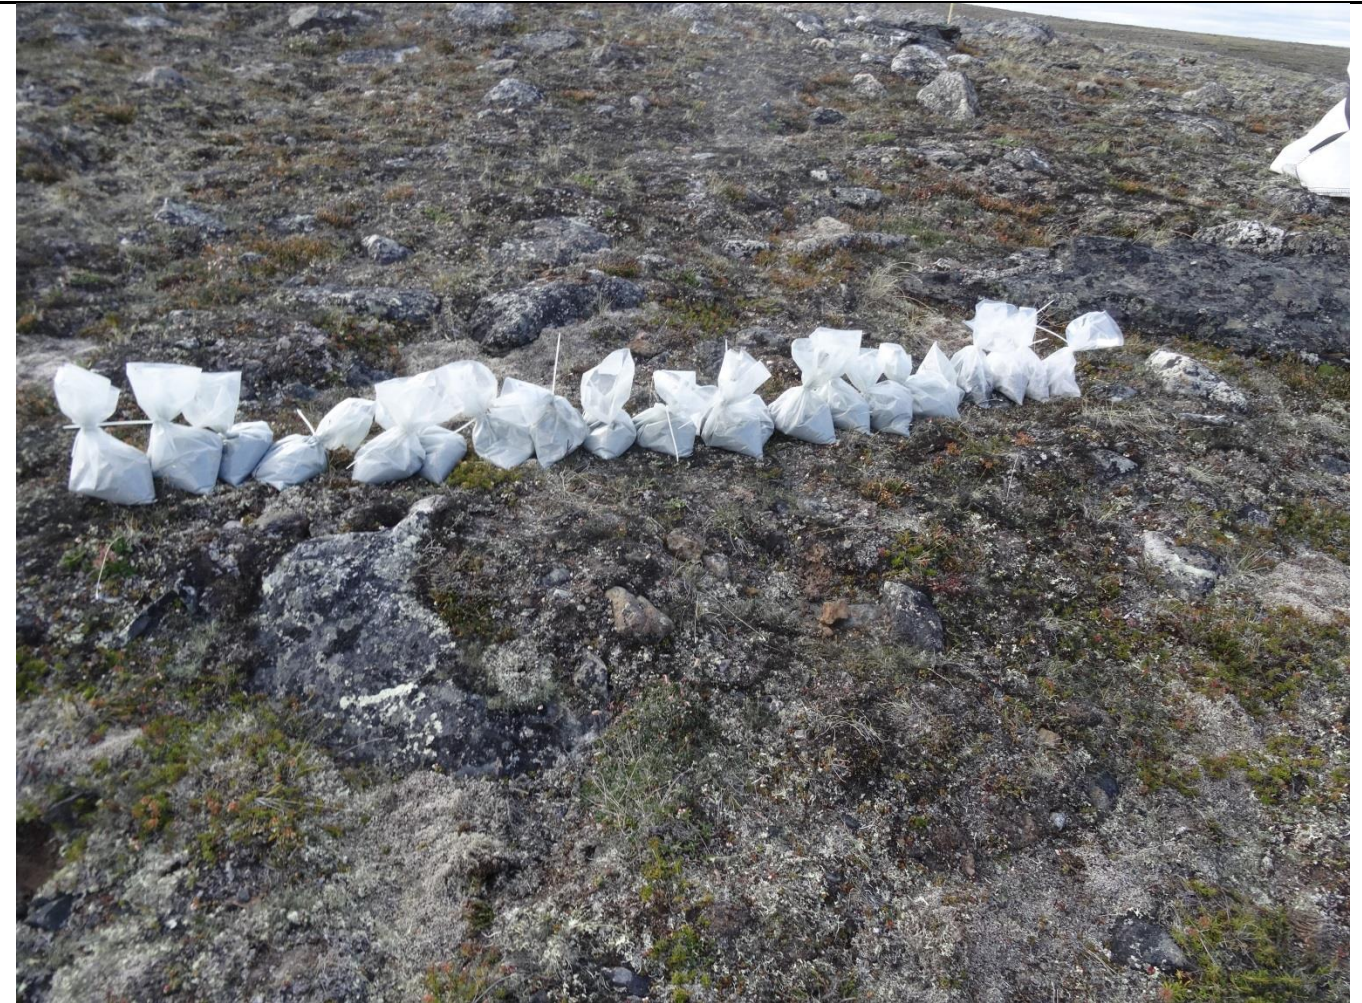
Photo 16

Description: These Bags of Powder are what is produced by the RAB Drill Process
