## Appendix 7 - 2018 AANDC Land Use and Water Licence Inspection

WATER LICENCE INSPECTION FORM

Licensee		Licensee Representative	
North Country Gold/Auryn Resources		Bryan Atkinson	
Licence No. / Expiry		Representative's Title	
2BE-CRA1520		Exploration Manager	
Land / Other Authorizations		Land / Other Authorizations	
LUP N2014C0005		Lease 56J/11-1-2	
Date of Inspection		Inspector	
29 July 2018		Baba Pedersen	
Activities Inspected			
<input checked="" type="checkbox"/> Camp	<input checked="" type="checkbox"/> Drilling	<input type="checkbox"/> Mining	<input type="checkbox"/> Construction
<input type="checkbox"/> Roads/Hauling	<input type="checkbox"/> Other:	<input type="checkbox"/> Other:	<input checked="" type="checkbox"/> Reclamation
		<input checked="" type="checkbox"/> Fuel Storage

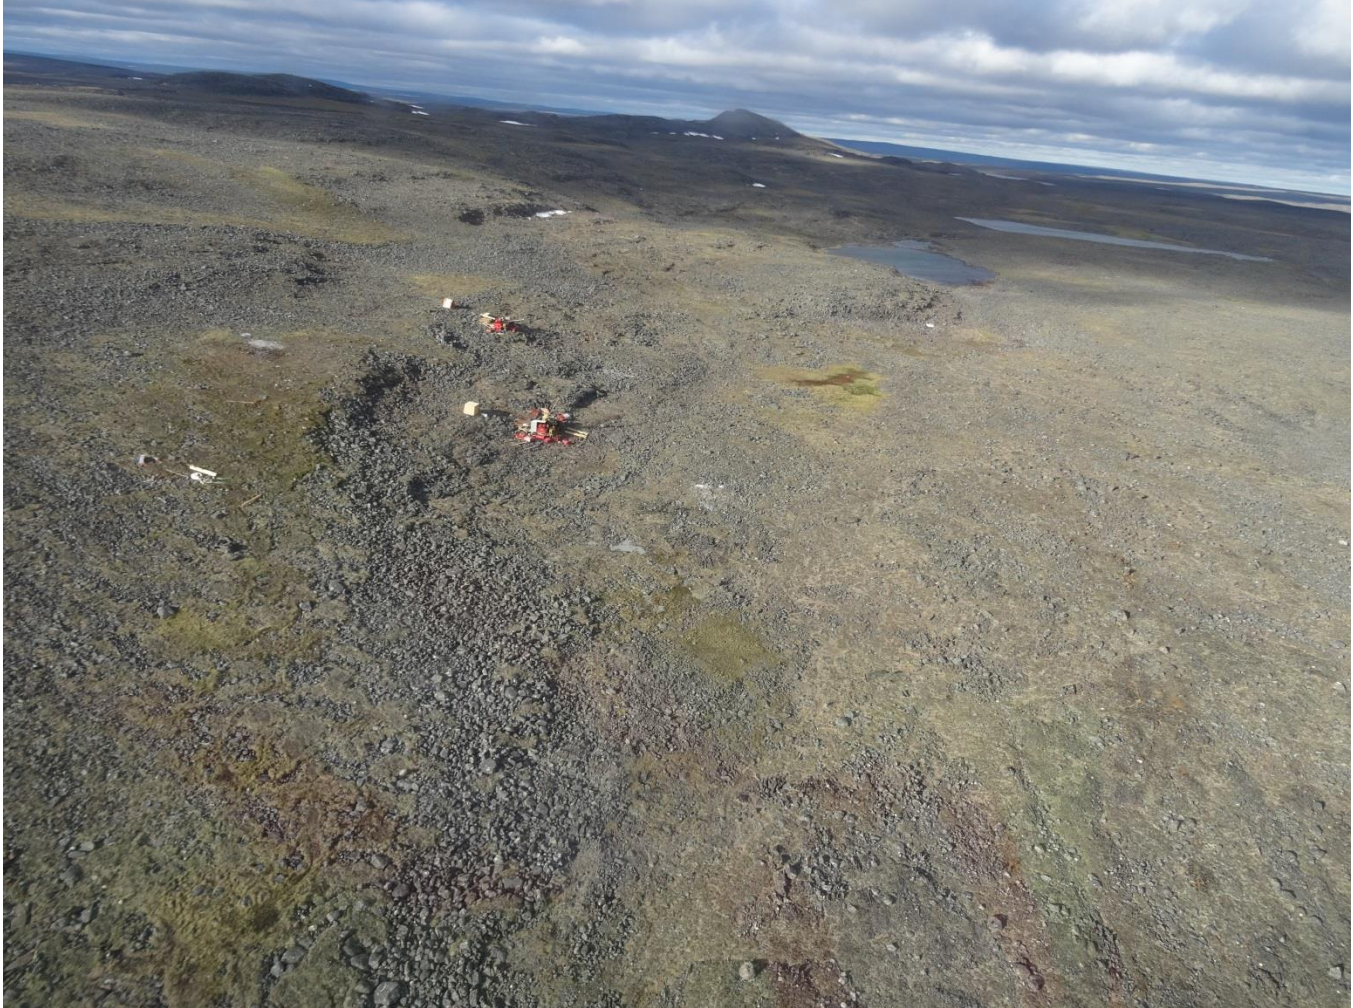
Photo 17

Description: Aerial View of 2 Diamond Drill Rigs side-by-side with Water Source shown in the top right

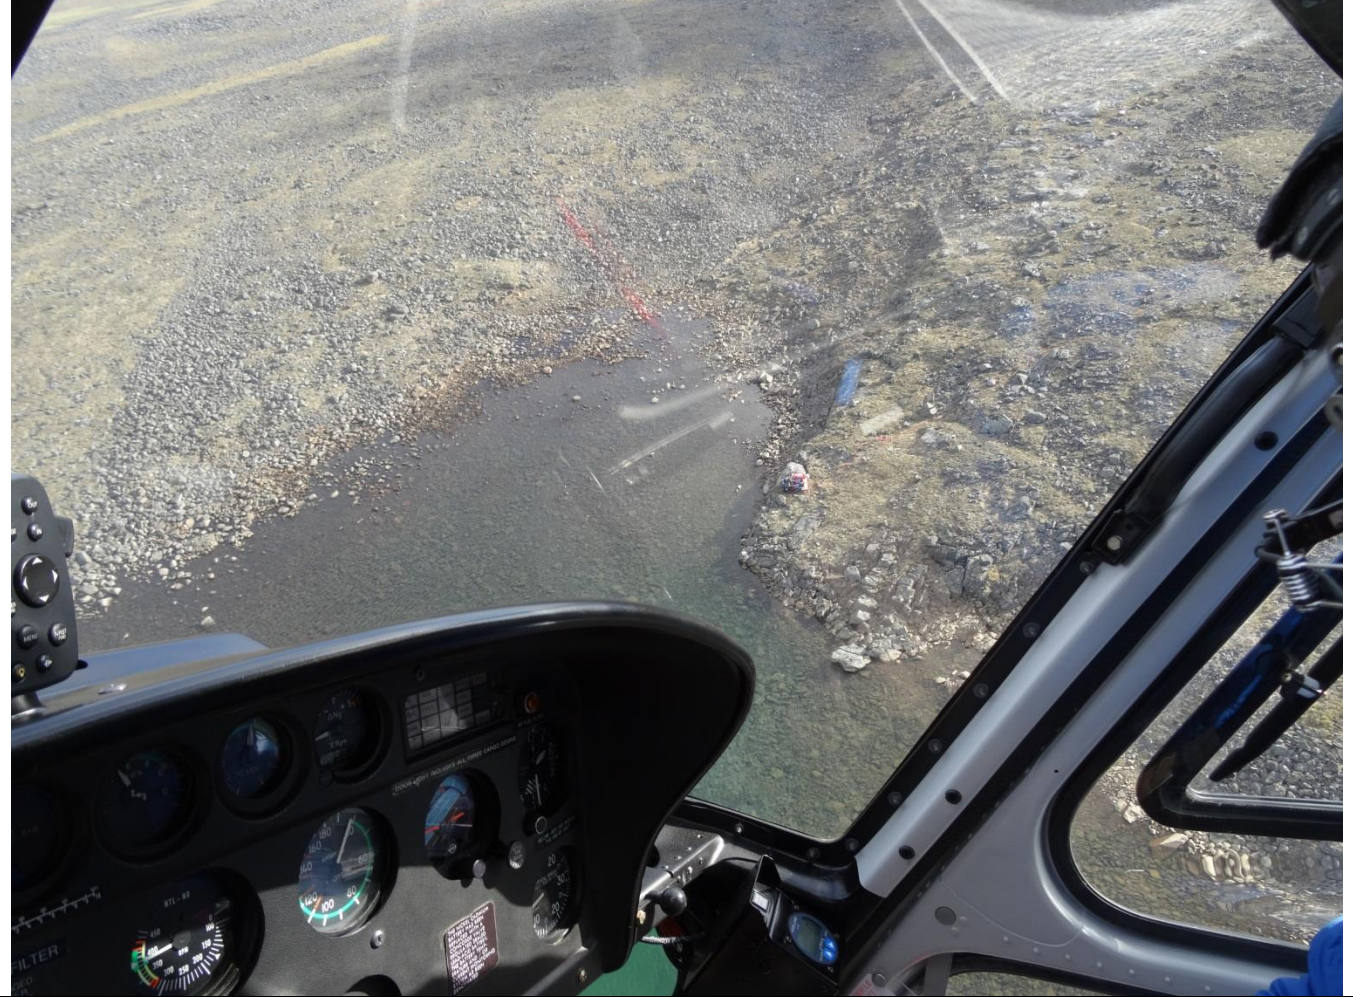
Photo 18

Description: Aerial View of Water Pump at Source

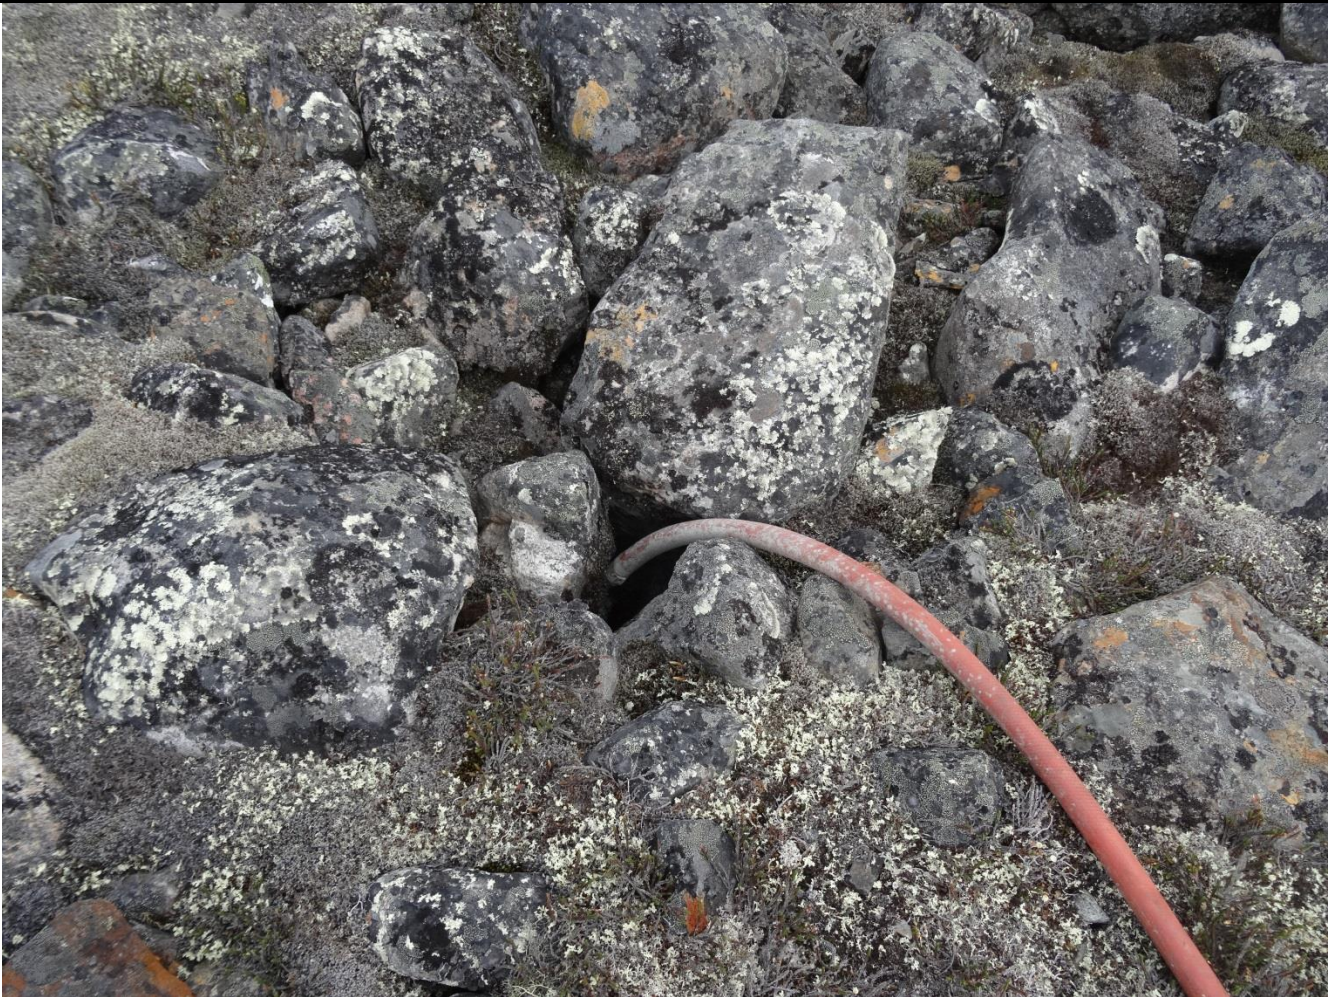
Photo 19

Description: Close-up of Sump in Natural Depression in Rock Pile

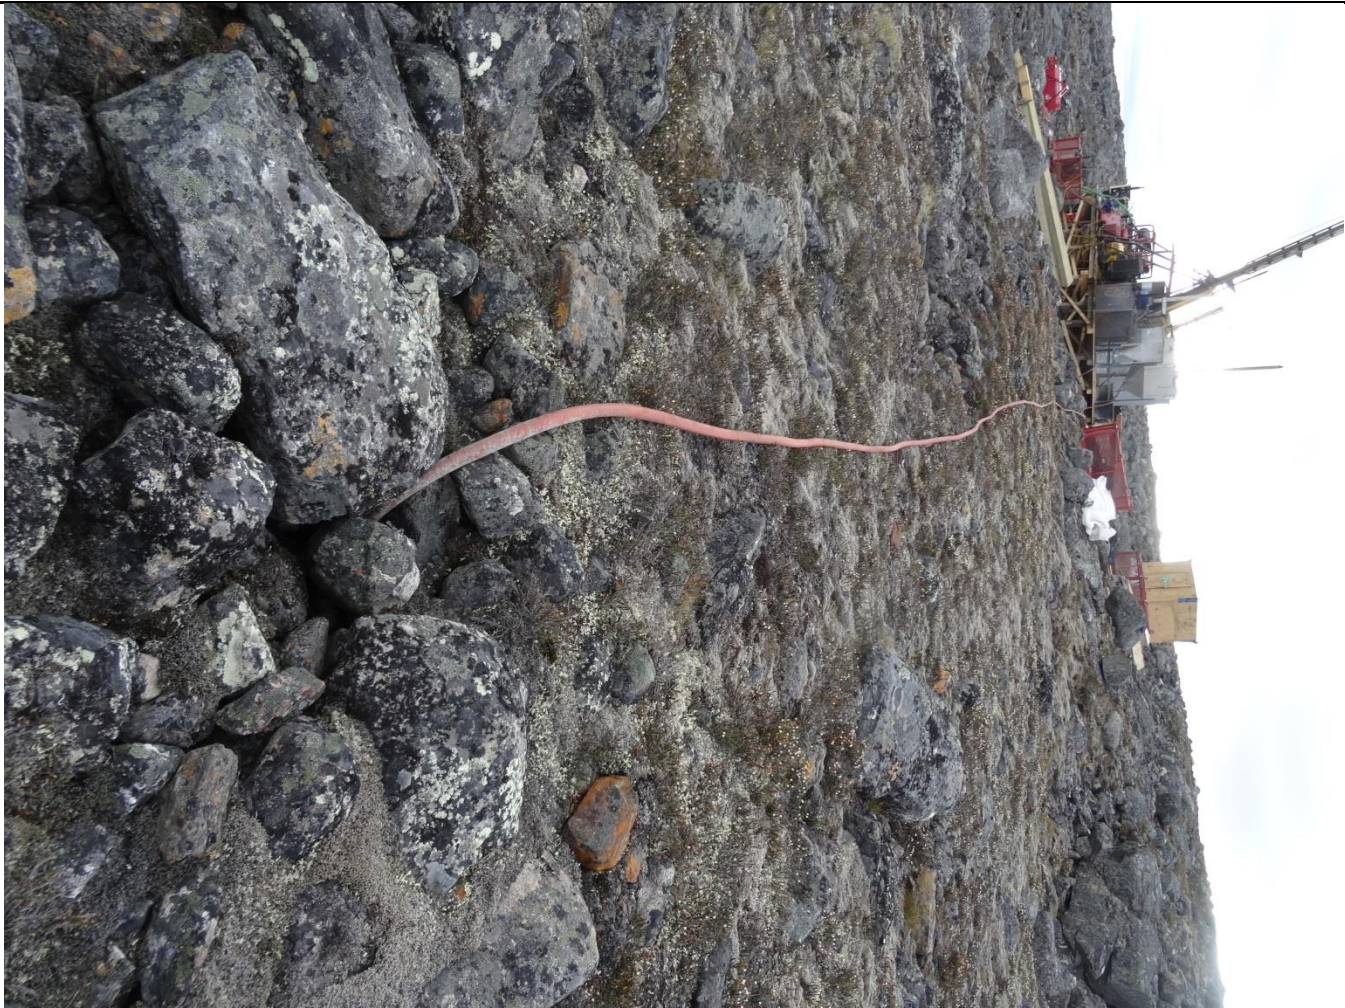
Photo 20

Description: Sump Line from Diamond Drill Rig in background
