WATER LICENCE INSPECTION FORM

Licensee	Licensee Representative
North Country Gold Corp	NA
Licence No. / Expiry	Representative's Title
2BE-CRA	NA
Land / Other Authorizations	Land / Other Authorizations
	--
Date of Inspection	Inspector
September 5,2021	Jonathan MESHER
Activities Inspected	
<input type="checkbox"/> Camp	<input type="checkbox"/> Drilling
<input checked="" type="checkbox"/> Roads/Hauling	<input checked="" type="checkbox"/> Mining
	<input type="checkbox"/> Construction
	<input type="checkbox"/> Other:
	<input type="checkbox"/> Reclamation
	<input type="checkbox"/> Fuel Storage

On September 5, 2021 I Jonathan Mesher A Resource Management Officer of CIRNAC conducted a Water licence inspection at Hayes Camp N66 39’30” W91 32’11”, Bullion Camp N66 23’39” W93 06’55” and Crater Camp N67 22’19” W88 51’24” to ensure compliance with the terms and conditions of the licence 2BE-CRA1520.

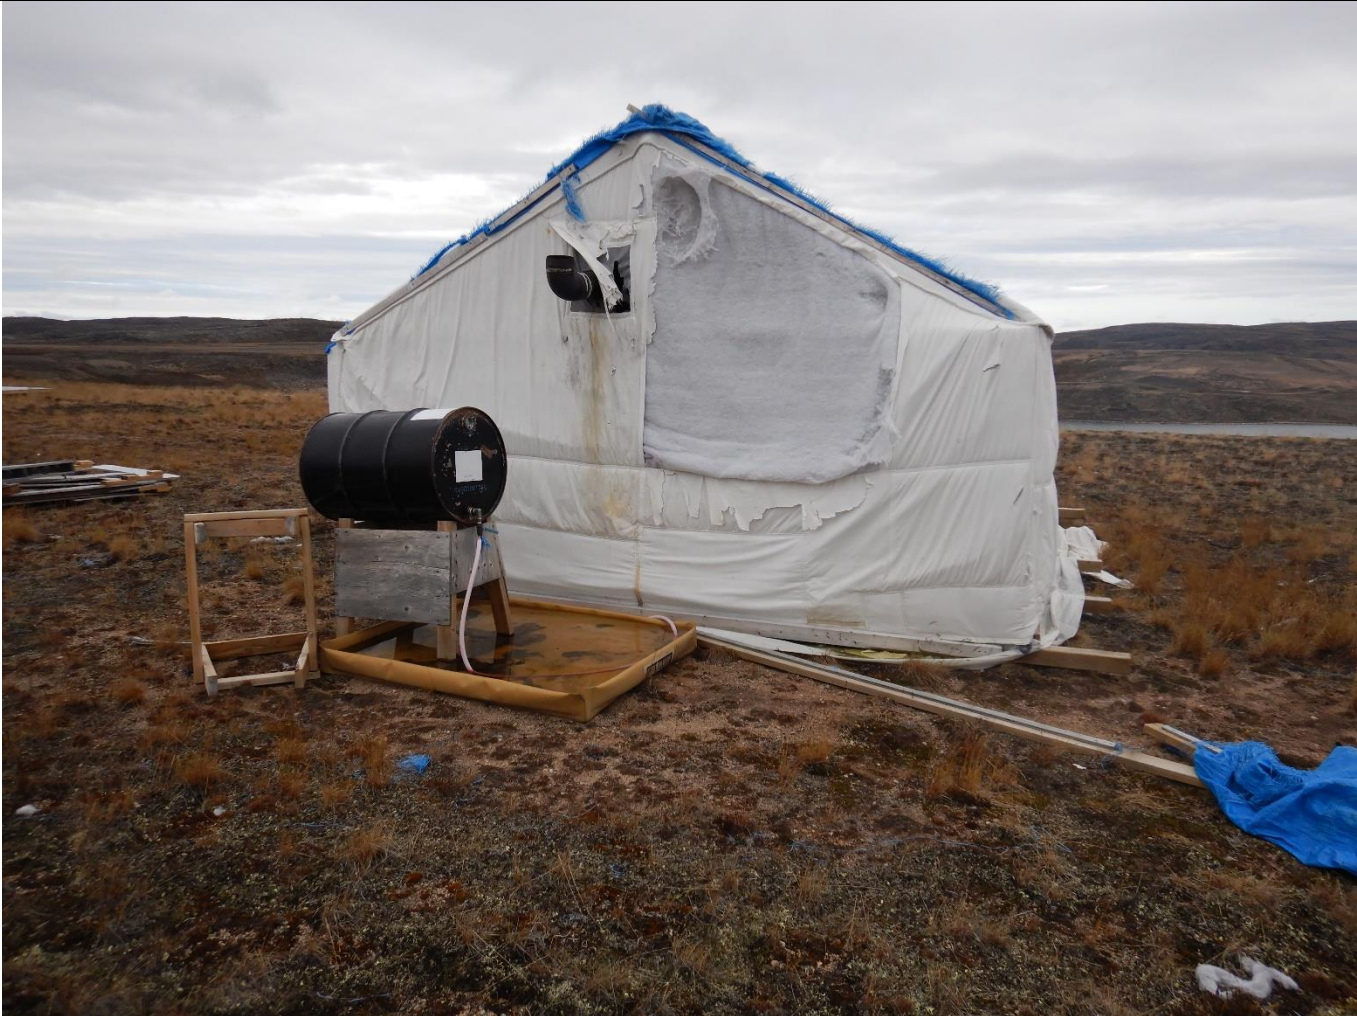
Photo 3

- The main fuel cache secondary containment appeared to be full of water. See photos 1 and 2 for photos of containment berms full of water.
- Section 6.2 of Fuel Management Plan states that “Drums, stands and trays will be covered with heavy-duty Exploration Tents1 (or equivalent) supply drum covers to prevent accumulations of rain of snow.”, while on site at Crater Camp it did not appear that any of the tent heating fuel tanks have any covers installed. See photos 3 and 4 for tent heating fuel tanks.

- Section 7 of the Fuel management plan states “NCGC will store all drummed fuel, oils and hydraulic fluids within secondary containment (SEI Industries2 ‘Insta-berms’, Exploration Tents3 berms/trays or equivalent designs). Secondary containment will be capable of holding 110 percent of the volume of the largest fuel reservoir housed within.”, during the inspection the majority of secondary containment was either full with rainwater, damaged and had no secondary containment covers. See photos 3-9 for fuel storage mentioned.

Description: heating stove tank without required covering.

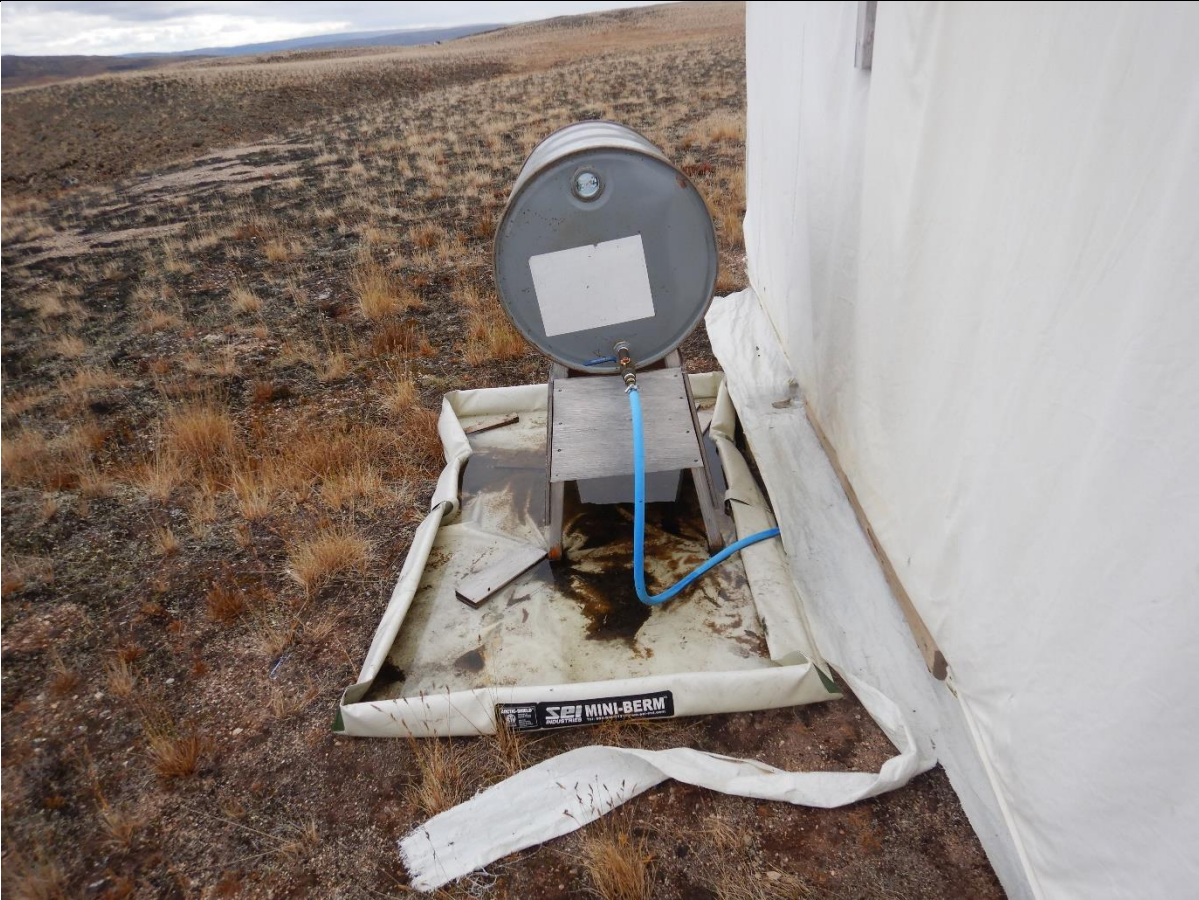
Photo 4

Description: heating stove tank without required covering and damaged secondary containment.

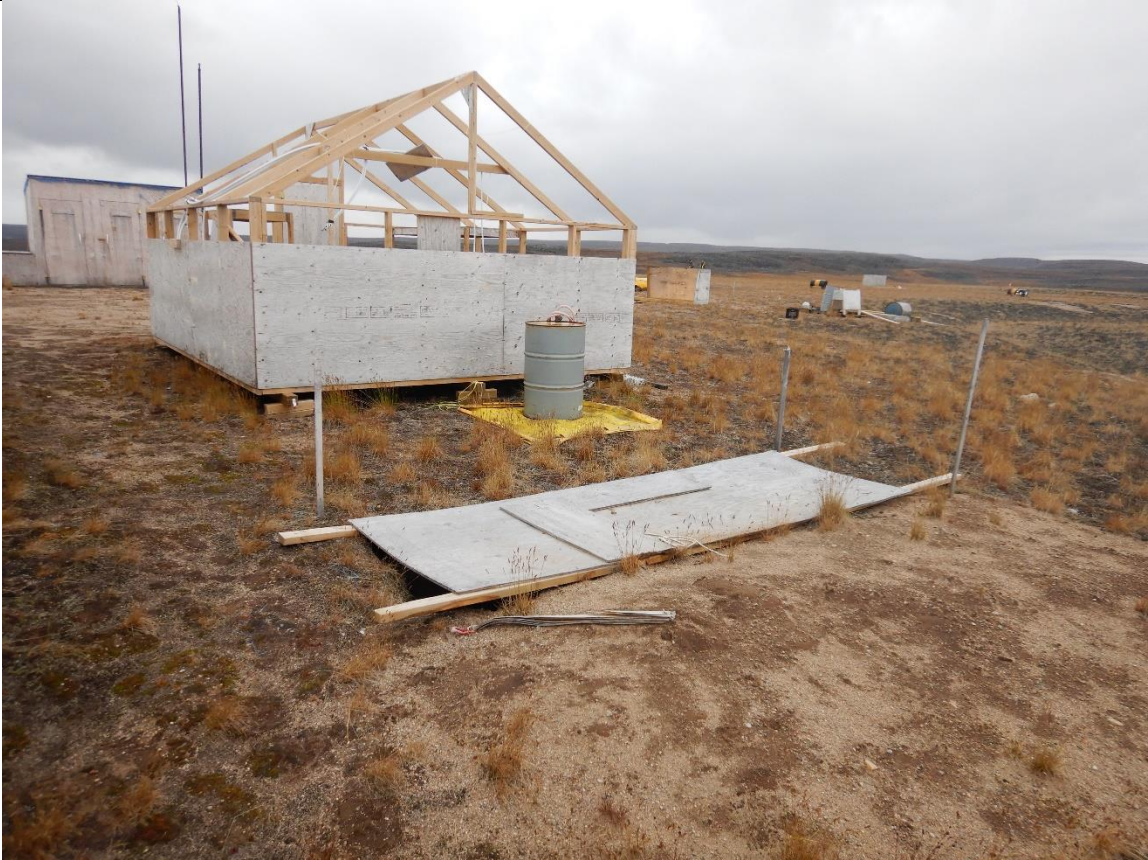
Photo 5

- Part E, item 13 of the licence 2BE-CRA1520 states that “The Licensee shall ensure that all containment and runoff control structures are constructed and maintained to prevent escape of Wastes to the surface or groundwater systems.”, it was noted that there is no berm surrounding the grey water sump. It does not appear that the sumps are constructed in a way to prevent melt water and/or rain water from flooding the sump. See photo 5 for the sump.

Description: partially covered sump and damaged secondary containment.

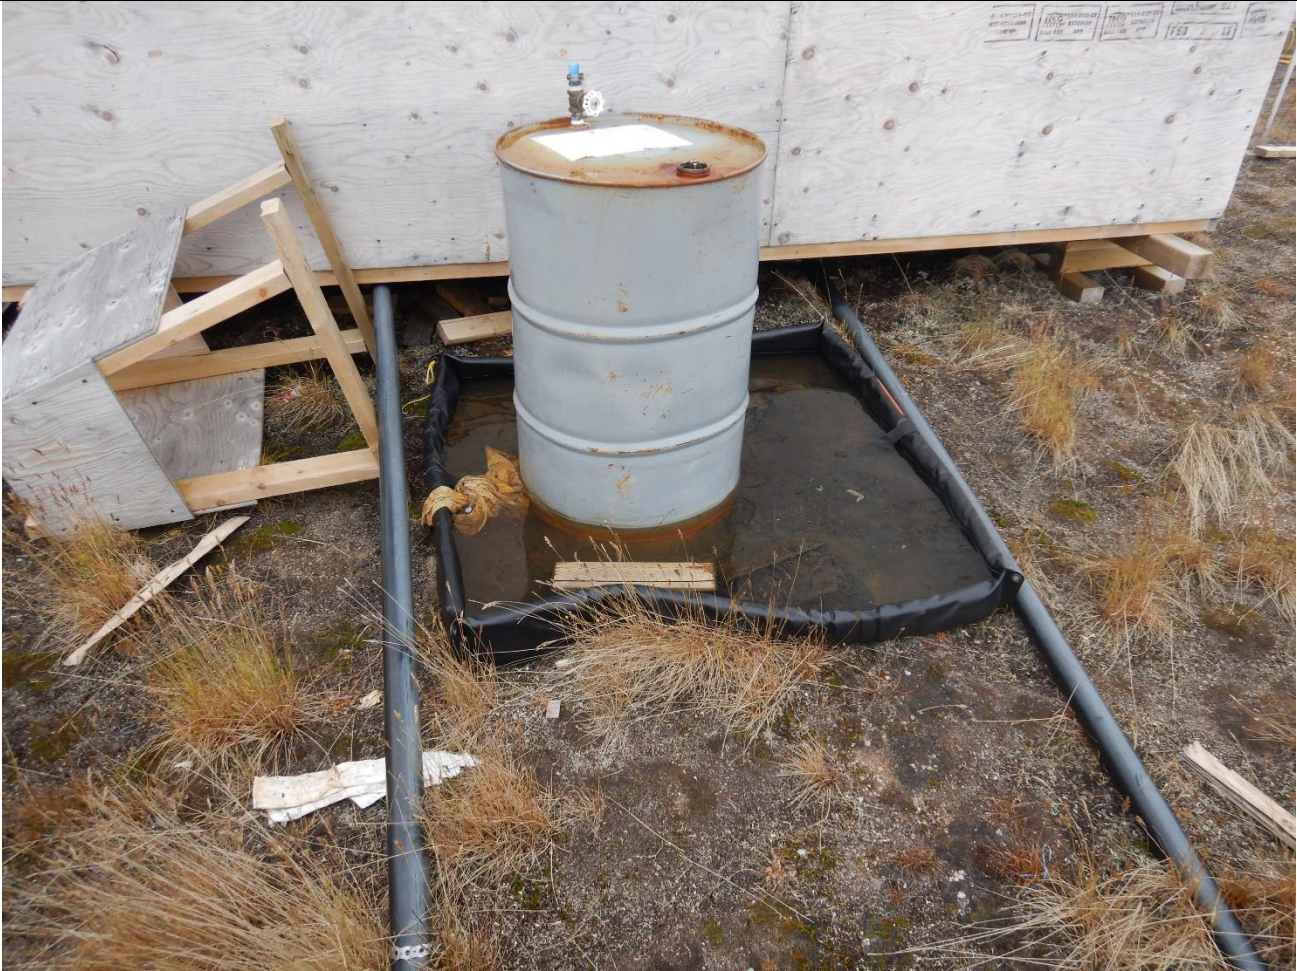
Photo 6

Description: secondary containment full of water.

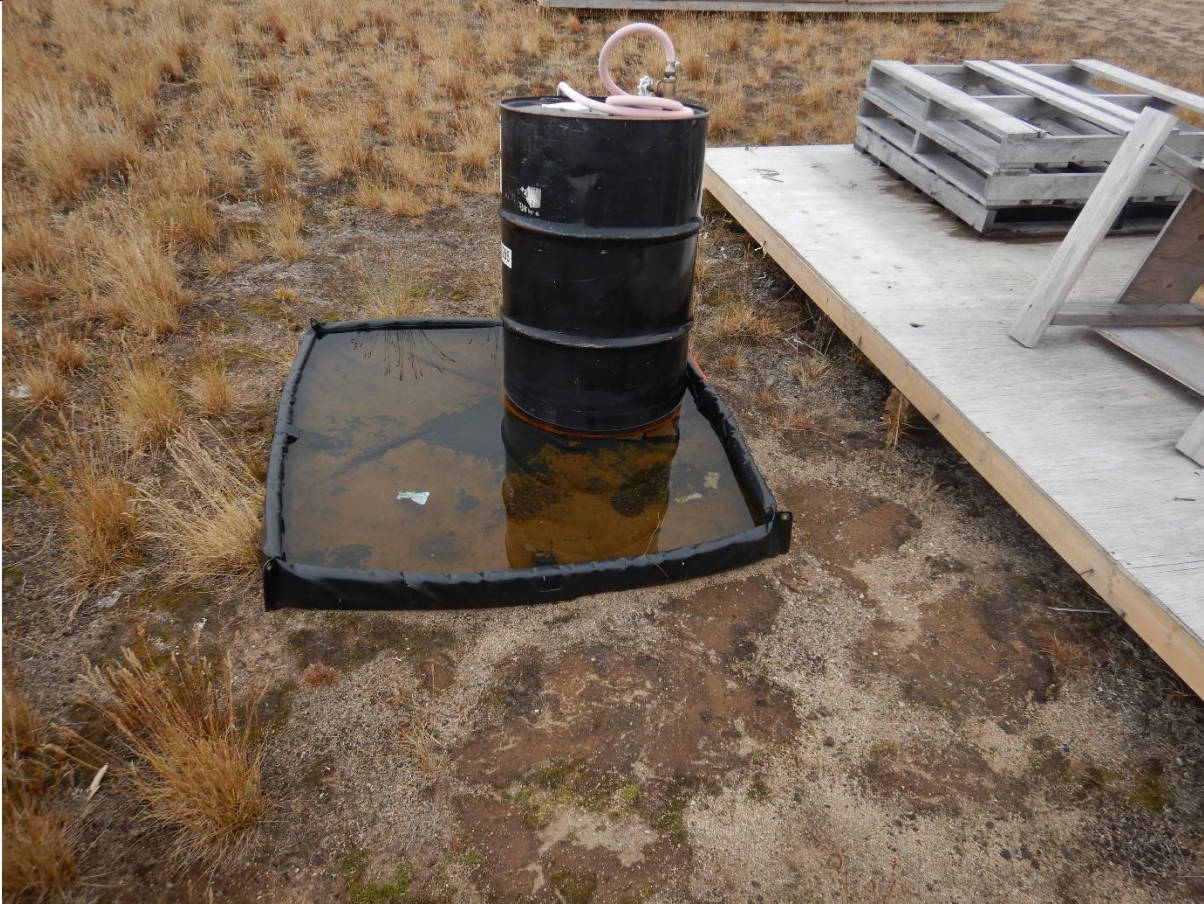
Photo 7

Description: secondary containment full of water.

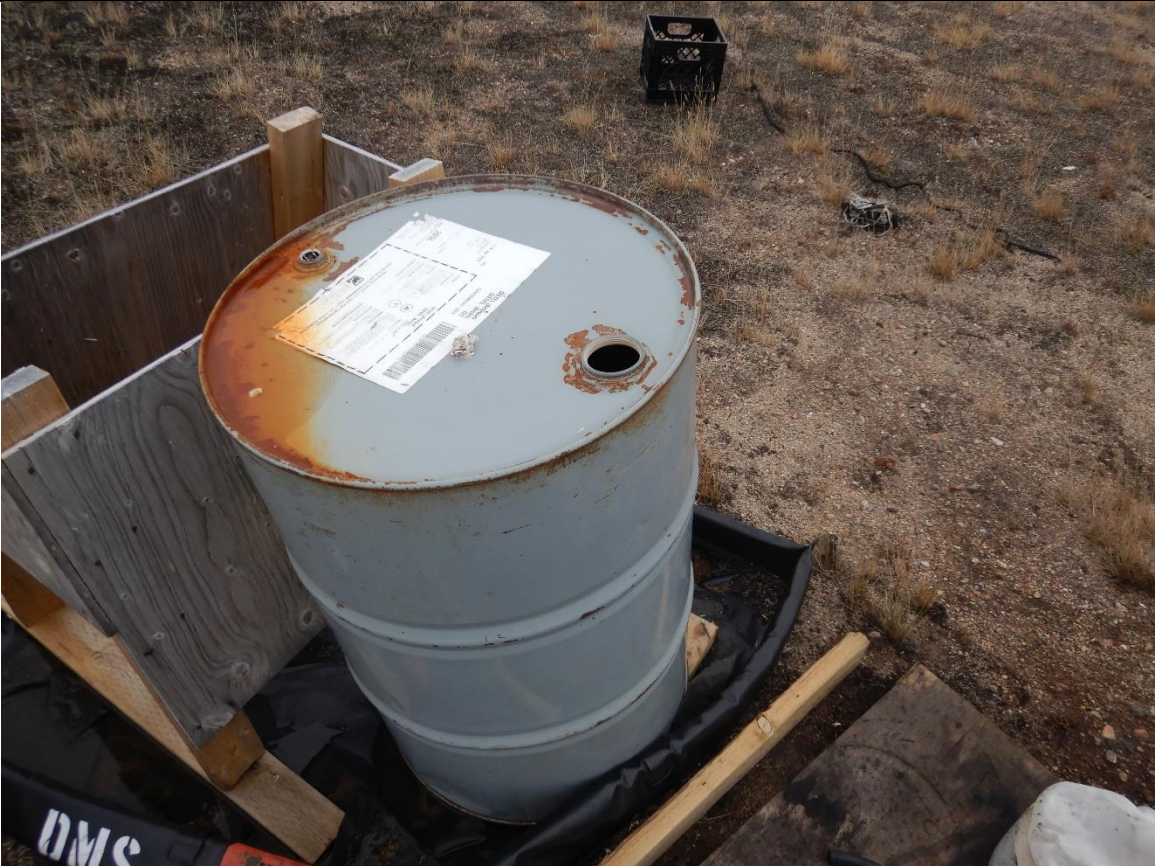
Photo 8

Description: wood within the containment pushing down the containment wall.

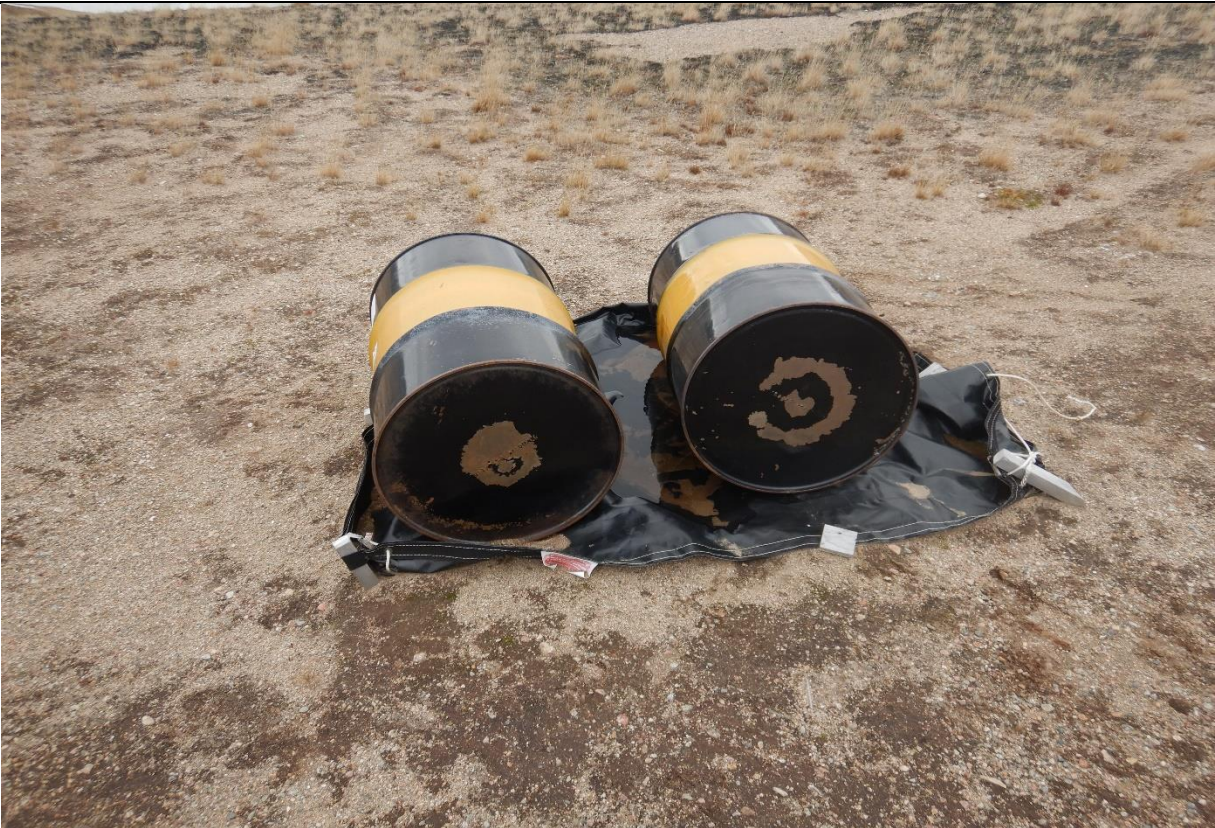
Photo 9

Description: damaged containment.

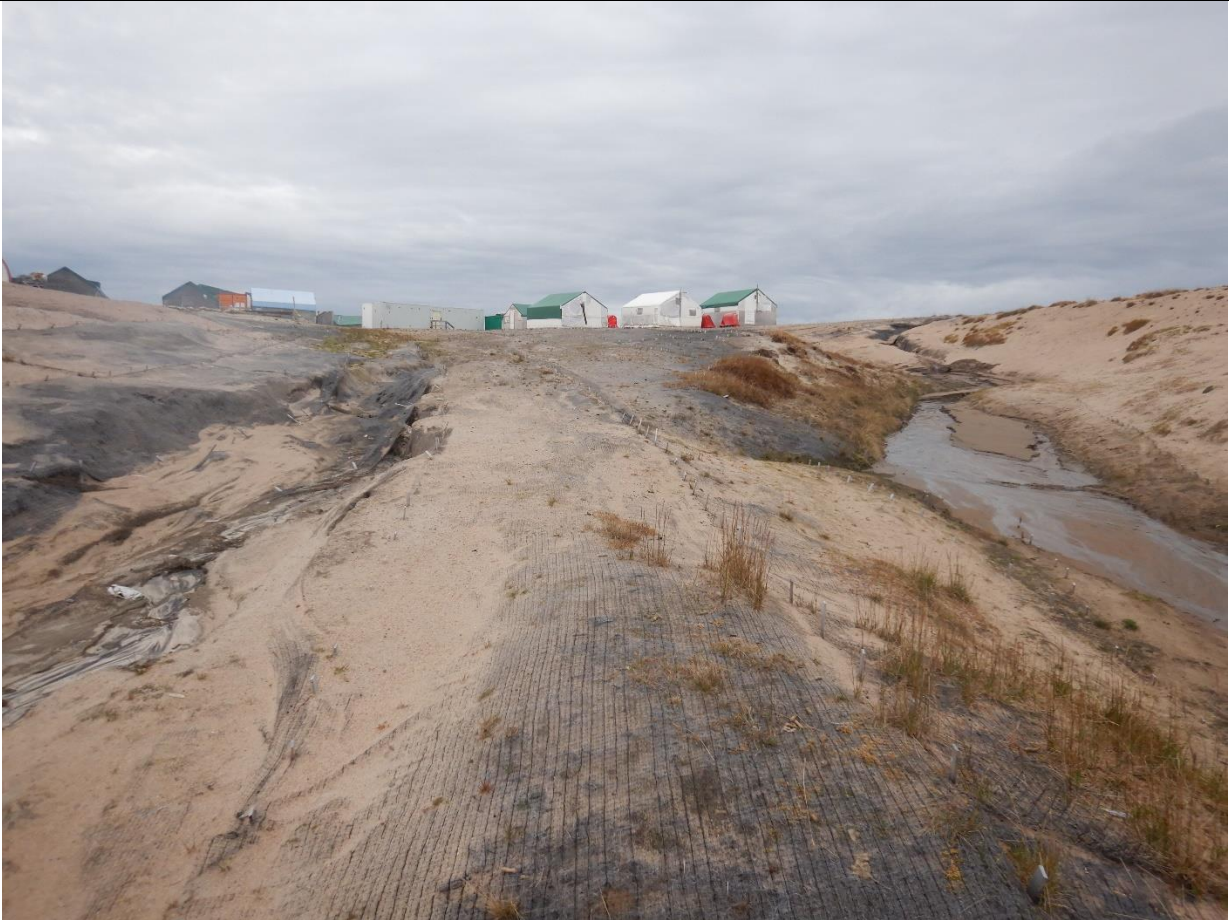
1. Part C, item 6 states, “The Licensee shall not cause erosion to the banks of any body of Water and shall provide necessary controls to prevent such erosion” and Part C item 7 states, “Sediment and erosion control measures shall be implemented prior to and maintained during the undertaking to prevent entry of sediment into Water.”. While on site there was significant erosion near the sump, the licensee appears to be using fabric to slow the erosion. See photo 10 for the erosion noted.

Description: erosion near sump.

Section 2	<input type="checkbox"/> Comments	<input type="checkbox"/> Non-Compliance with Act or Licence	<input checked="" type="checkbox"/> Action Required
<p>The following is a list of action required, the licensee is to provide a plan by November 25, 2021to rectify the concerns noted in this section, once the concerns are remediated the licensee is to provide photos with a brief report detailing what work has been done.</p> <div><div>1. The licensee is to ensure all fuel is stored in covered, secondary containment.</div><div>2. The licensee is to ensure the sumps are constructed in a way to prevent the waste from spreading to the surrounding waters.</div><div>3. The licensee is to ensure all sumps are located a minimum of 31m from any water.</div><div>4. The licensee is to remediate the erosion noted in comment B1 at Haynes Camp.</div></div>			
Inspector's Name			
Jonathan MESHER			
Signature

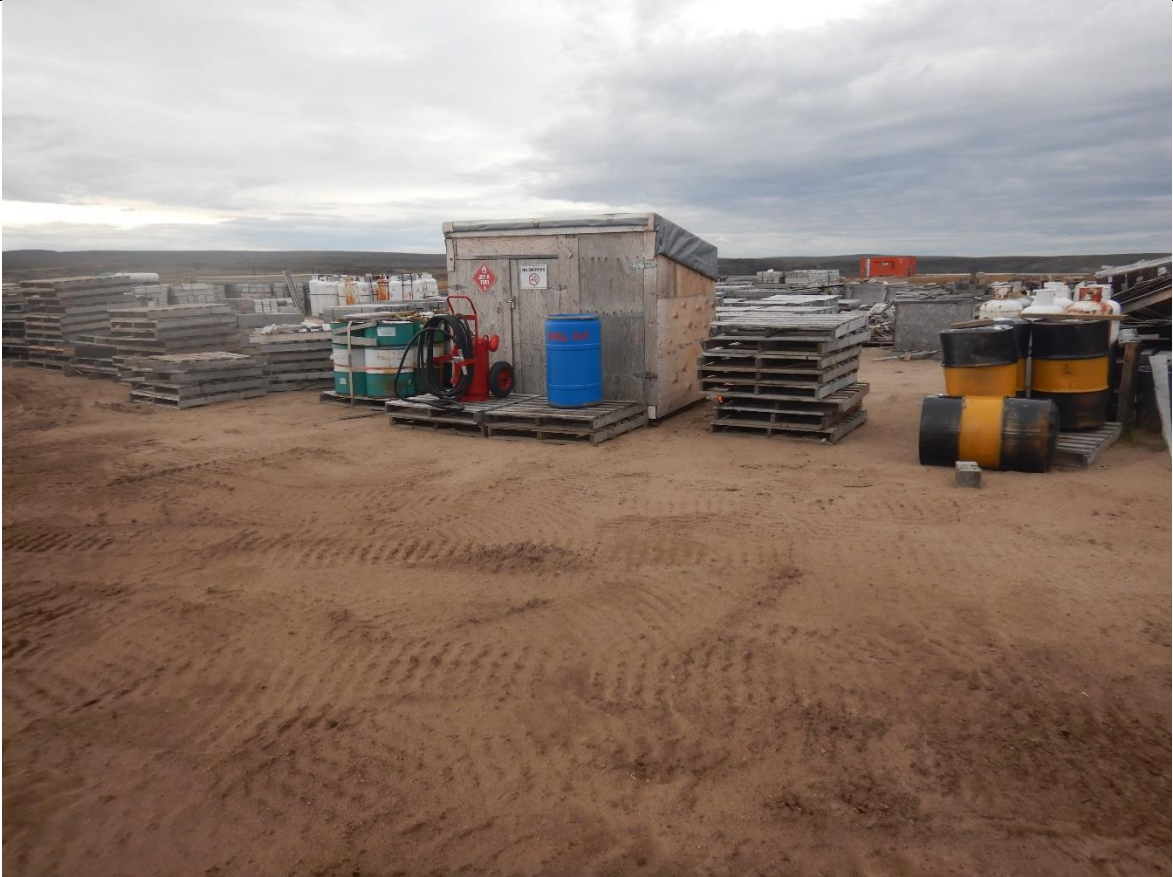
2. There was approximately 12 barrels outside of containment near the wind sock and drill core storage. Section 7 of the Fuel management plan states “NCGC will store all drummed fuel, oils and hydraulic fluids within secondary containment (SEI Industries2 ‘Insta-berms’, Exploration Tents3 berms/trays or equivalent designs). Secondary containment will be capable of holding 110 percent of the volume of the largest fuel reservoir housed within.” See photo 11 for the fuel outside of containment.

Description: 12 barrels outside of containment.
