Hayes Camp Airstrip Geotechnical Inspection Report

RE: Inspection Report follow up – Hayes Camp airstrip geotechnical report

2014 Geotechnical Inspection Three Bluffs Gold Project, Nunavut

SRK Consulting (Canada) Inc.
1CN023.001
November 2014

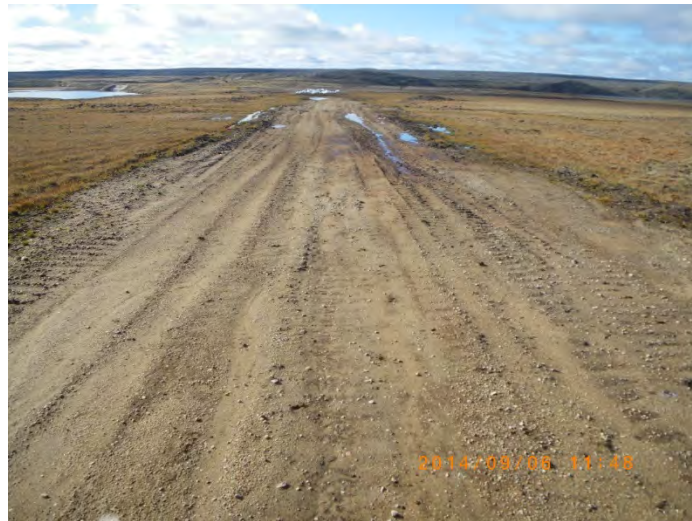
Access Road to Borrow Area #1

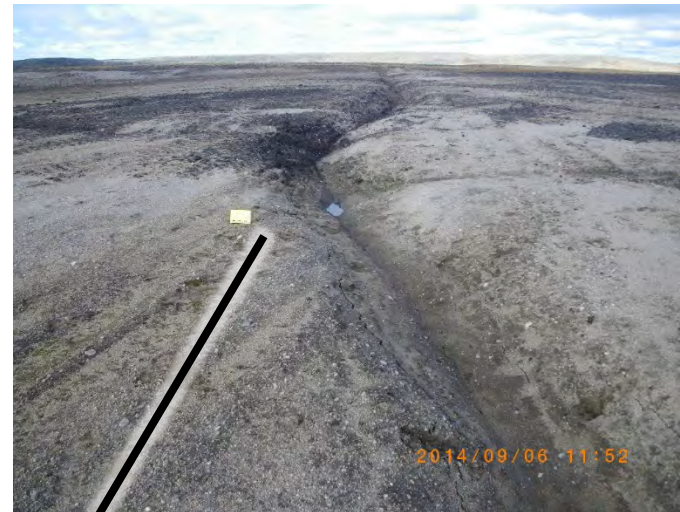
During the 2014 inspection no further melting of the ice wedge within the Borrow Area was observed, suggesting steady state conditions had developed and the Borrow Area #1 Access Road showed no signs of additional thermal erosion. The gully to the ravine remains blocked with fill so there is no natural drainage of this area. The sandbag dykes installed in the ravine have trapped sediment and are causing surface water runoff to flow over these erosion control structures (Figure 3).

Melted ice wedge shows signs that steady state conditions may have developed

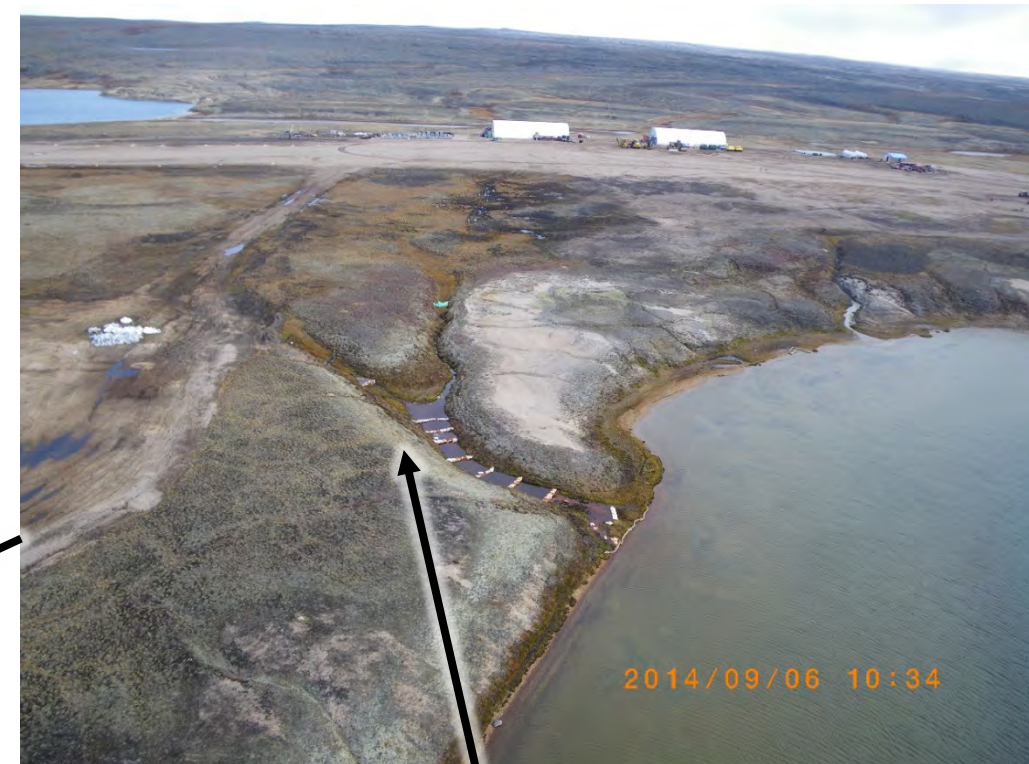
Aerial view of Gully south of Borrow Area #1

- Re-establish the outlet to permit surface water runoff to drain naturally from Borrow Area #1 into the gully and into Sandspit Lake.

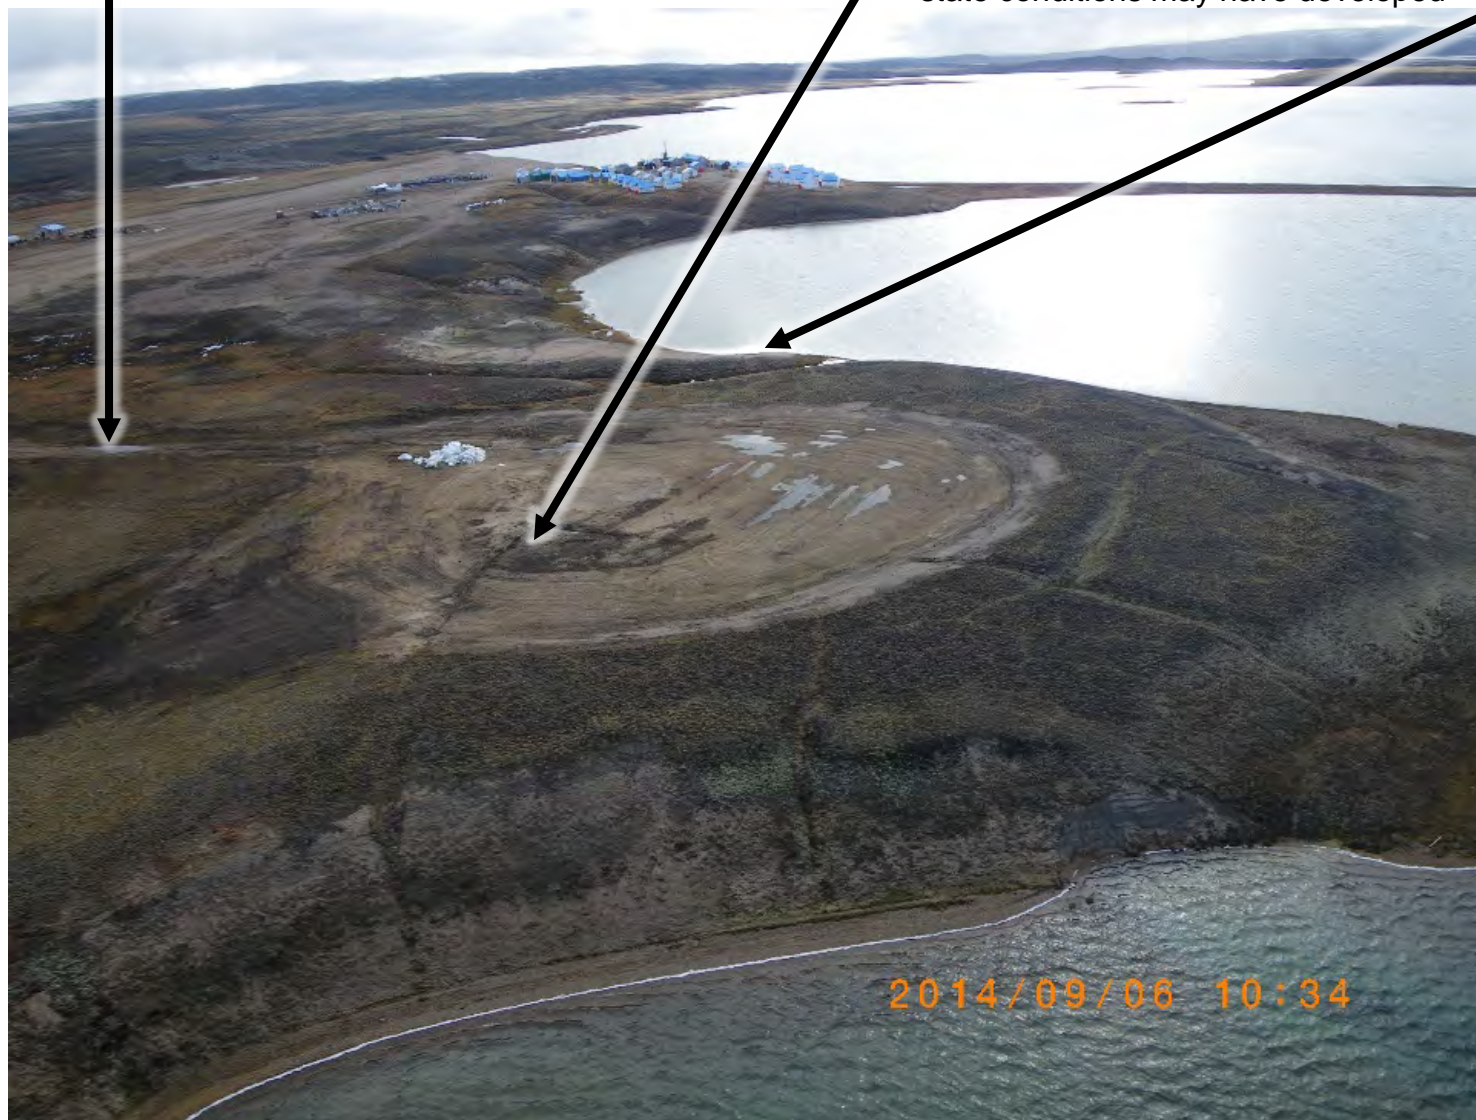
Borrow Area #1 is located to the west of the Three Bluffs Airstrip. Granular fill, consisting of sand with trace silts and clays has been excavated from this borrow source for construction of the Hayes Camp Surface Infrastructure and the Three Bluffs Airstrip. Excavation practices resulted in a large bowl shaped depression that permitted ponding water and exposed an ice wedge which runs through the centre of the borrow area. Water from the melting exposed ice wedge was allowed to naturally drain from the borrow area into the gully located to the south of the borrow area. Sandbag filter dykes and silt fencing was constructed within and at the outlet of the gully to prevent suspended sediments from entering Sandspit Lake. The trapped silt has never been removed from behind the filter dykes and the silt fencing prior to freeze-up, so these sediment management structures are not functioning as intended.

Aerial View of Borrow Area #1

- The sediment retained by the sandbag filter dykes should be removed to ensure that they remain functional. To improve future functionality of this system, a series of additional silt fencing should be installed upstream of the sandbag filter dykes.

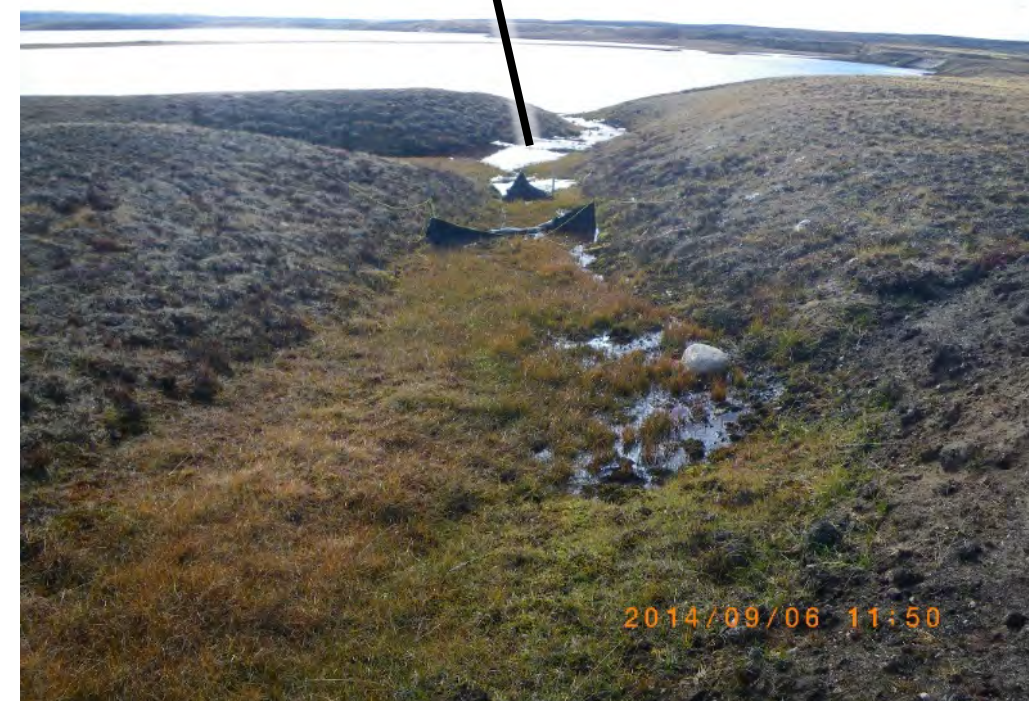
Looking down the Gully from Borrow Area #1

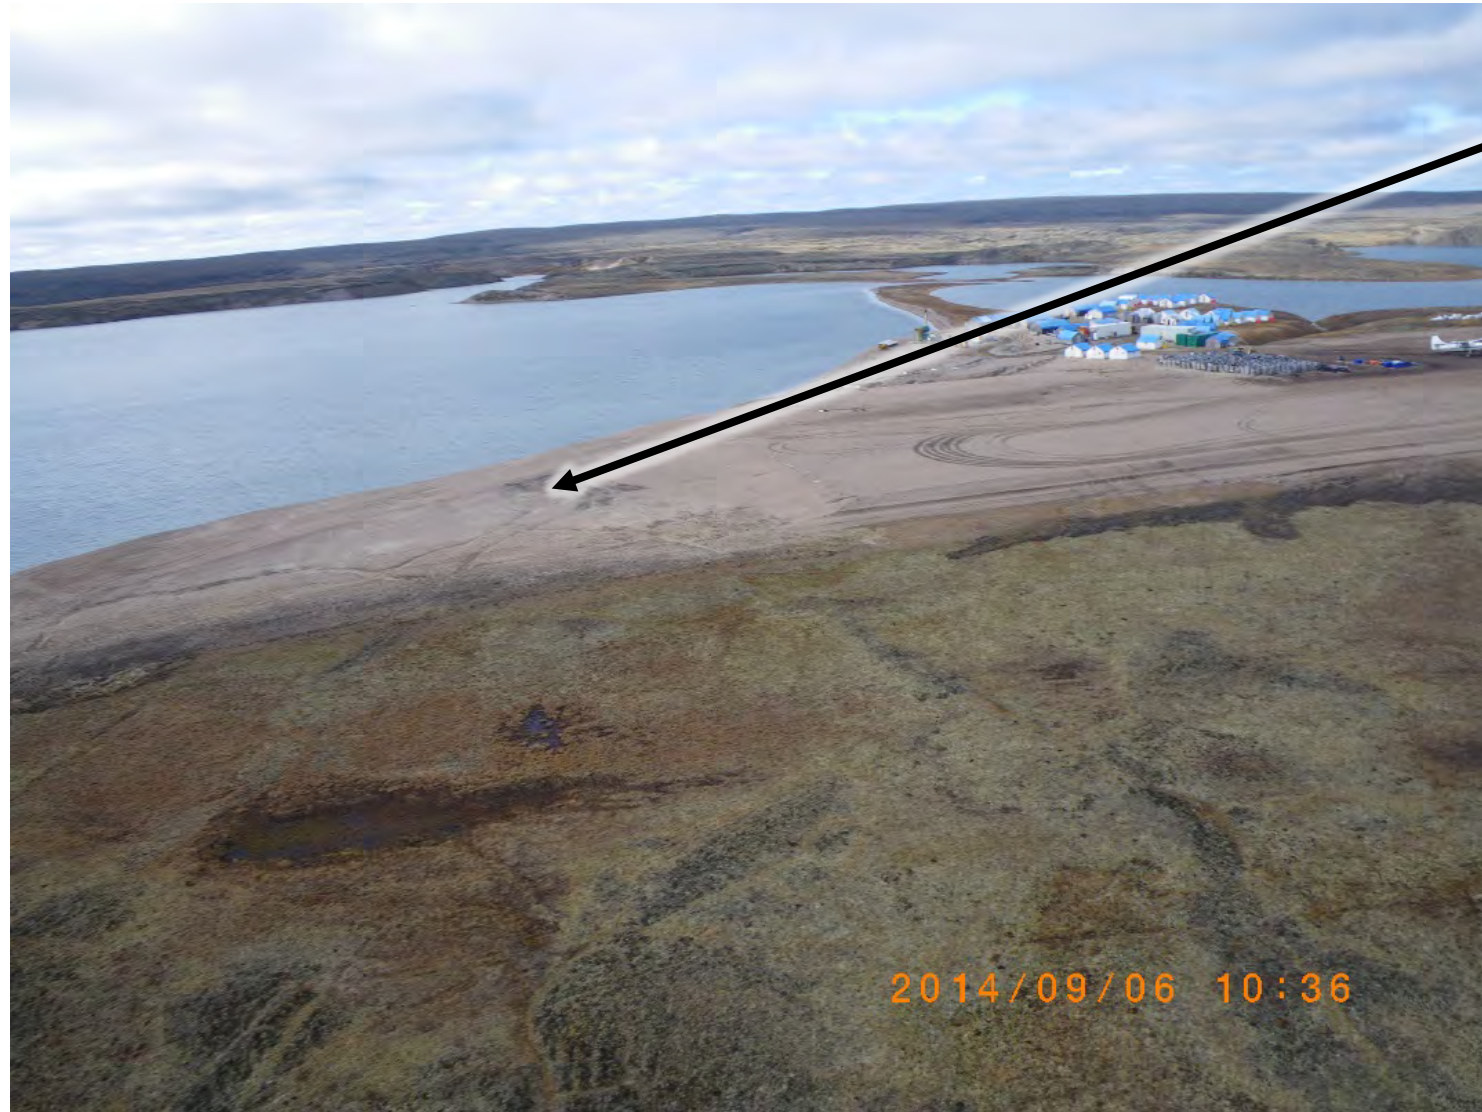
Aerial view of Borrow Area #2 looking west.

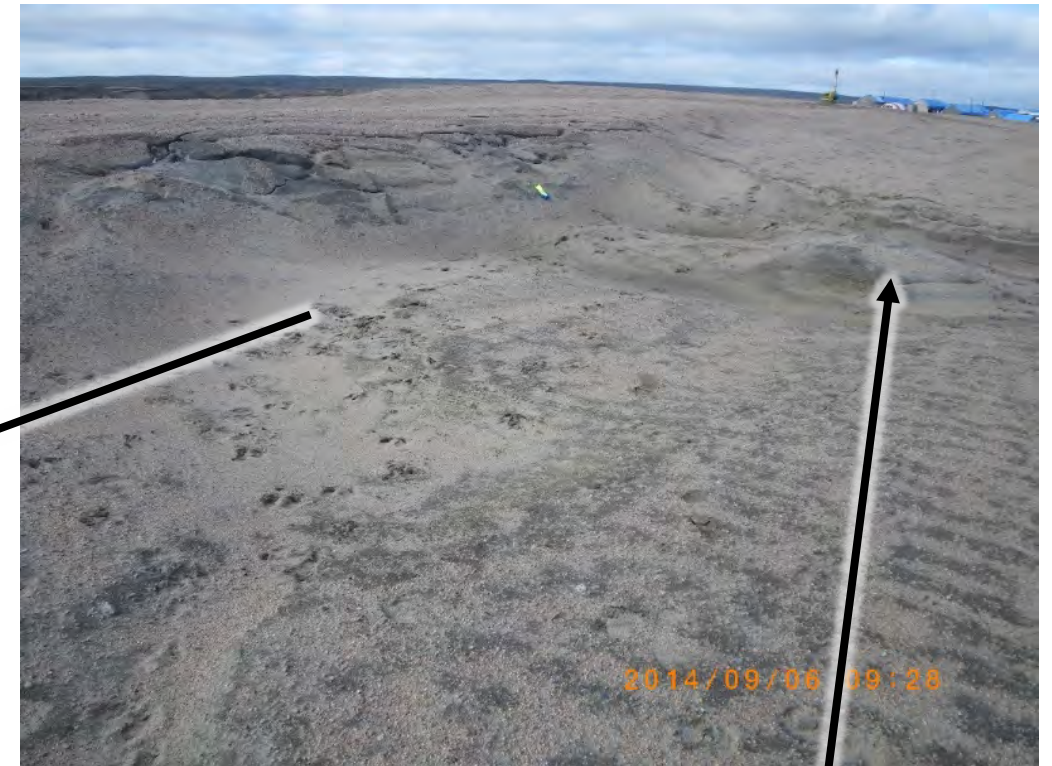
Borrow Area #2 is located south of Hayes Camp at the south end of the Three Bluffs Airstrip. This material consists of sand with trace silts and clays, and was used in the construction of the Three Bluffs Airstrip early in the summer of 2011. By mid-summer of 2011, this borrow area was abandoned and regraded. This borrow is in an ice-rich area as evidenced by the presence of frost-wedge polygons. Since its decommissioning there have been signs of ice melting due to the exposure caused by the removal of the tundra vegetation and excavation activities causing ponded water. During the 2014 inspection, there were clear signs of surface settlement as a result of ground ice melting (Figure 4). These areas result in local ponding which further exacerbates the thermal erosion.

Large depressions at the north end of Borrow Area #2

- Bring in fill material, sourced from regarding the Three Bluffs Airstrip to fill in the depressions. The fill should be placed in 0.3 m thick lifts and compacted with the 10 T drum compactor. The finished grade should be contoured to promote surface water runoff towards the east, away from the Twin Otter Airstrip.

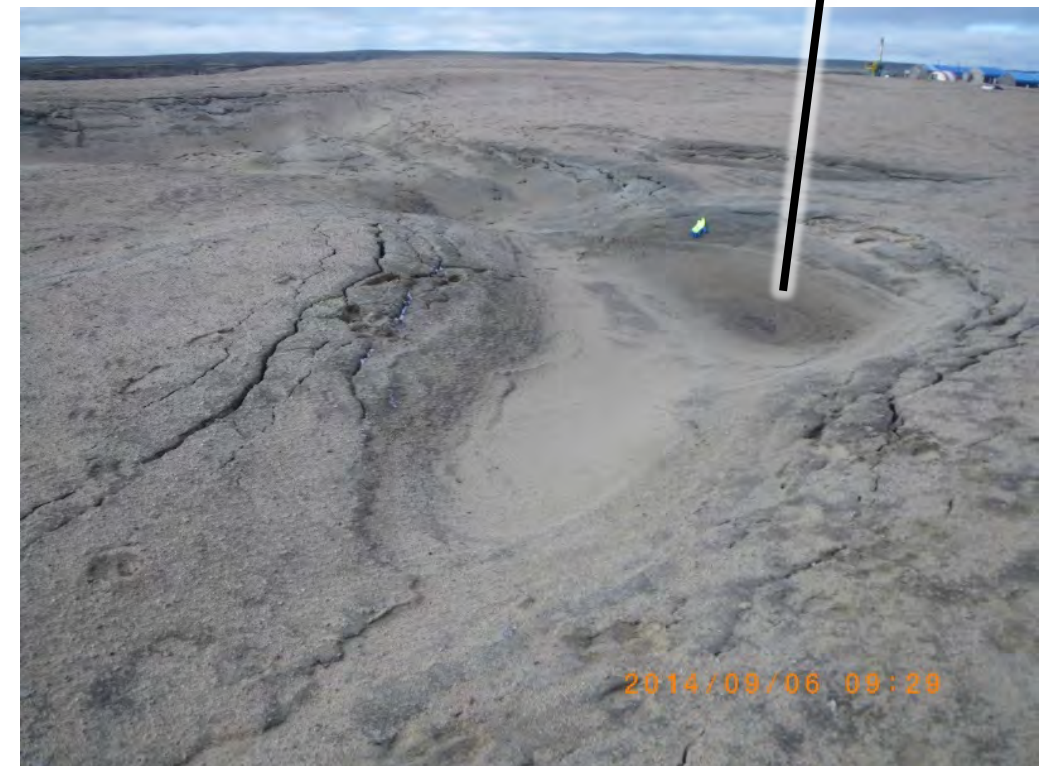
Large depressions in Borrow Area #2 as a result of permafrost degradation due to the removal of tundra vegetation and excavation activities

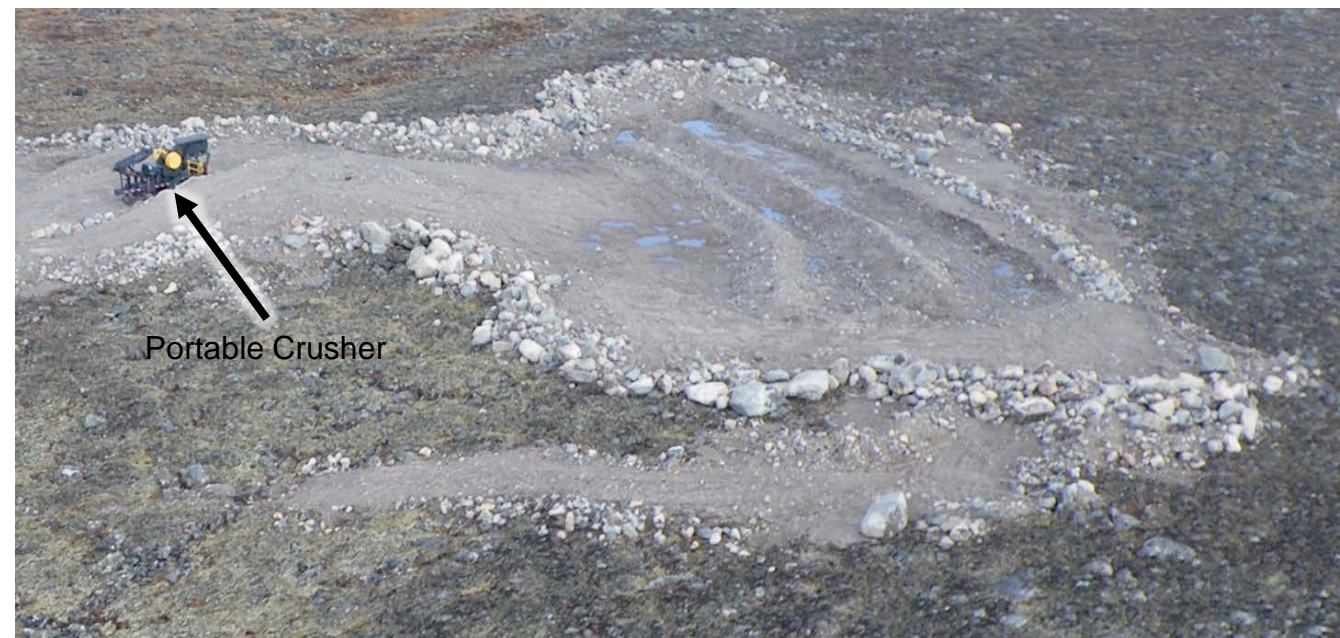
Portable Crusher

Borrow Area #3 and Crusher

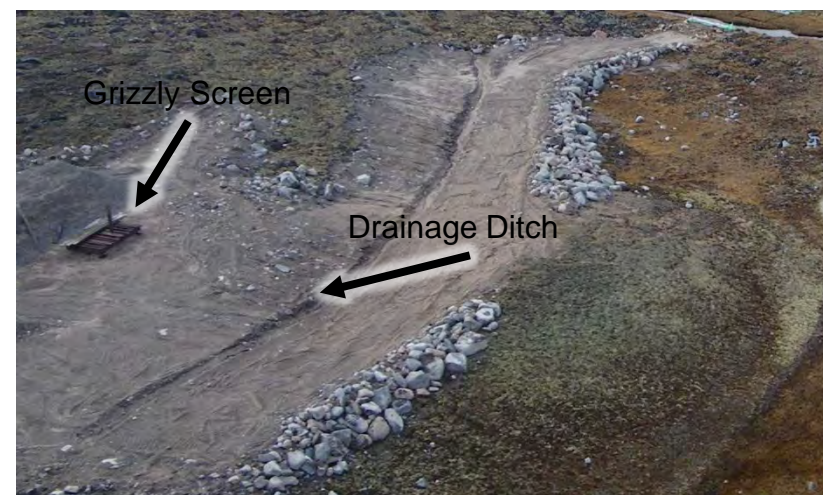
During SRK's 2012 site inspection, small erosion channels across the access road were observed. The silt fences were still in place along with the additional sandbag dykes to prevent any sediment transport to the stream. The 2014 geotechnical inspection did not reveal any change in conditions within Borrow Area #3 (Figure 5).

Condition of access road and drainage ditch to Borrow Area #3

- Maintain silt fencing and sandbag filter dykes, on either side of the stream, to prevent any sediment transport into the stream.

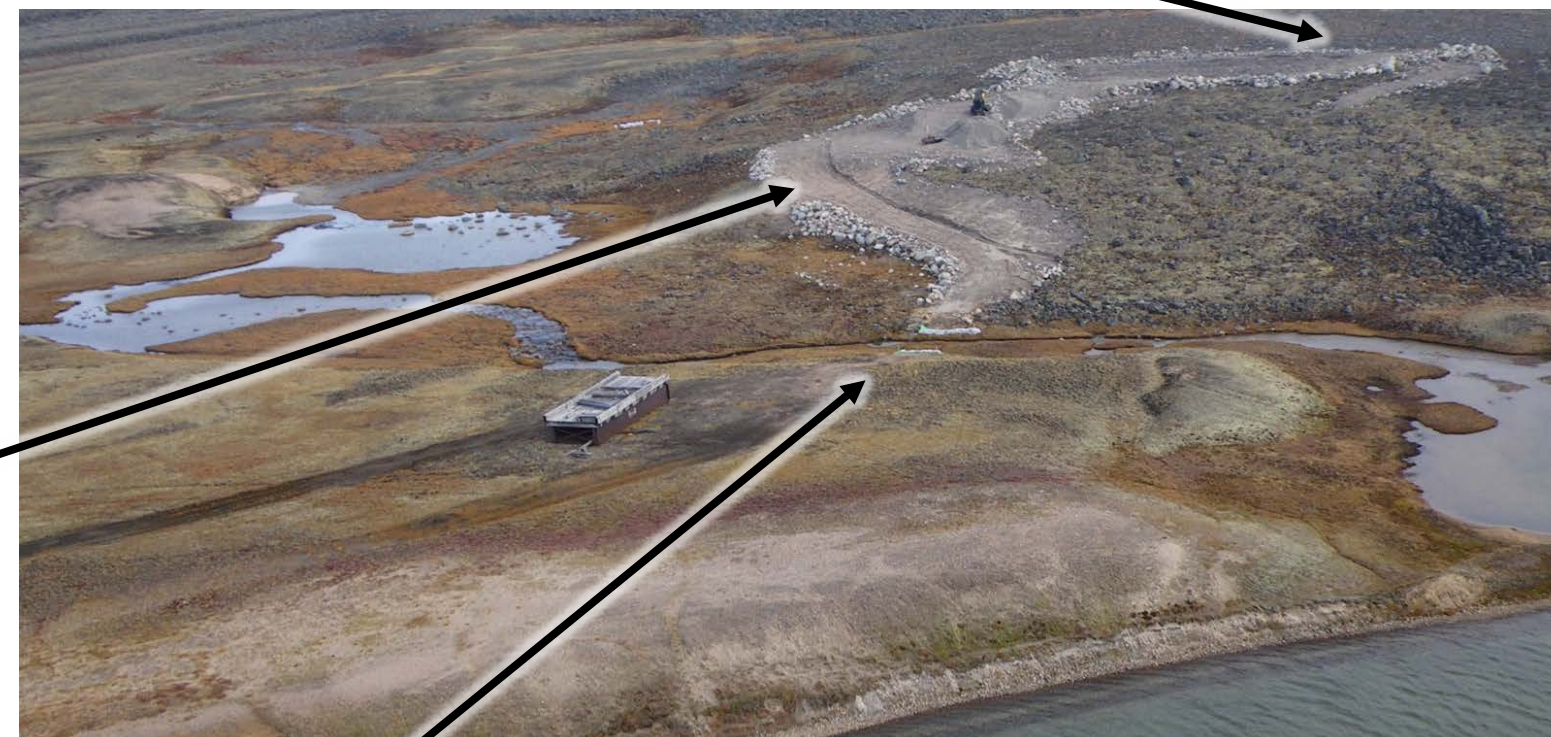
Aerial view of Borrow Area #3 looking east

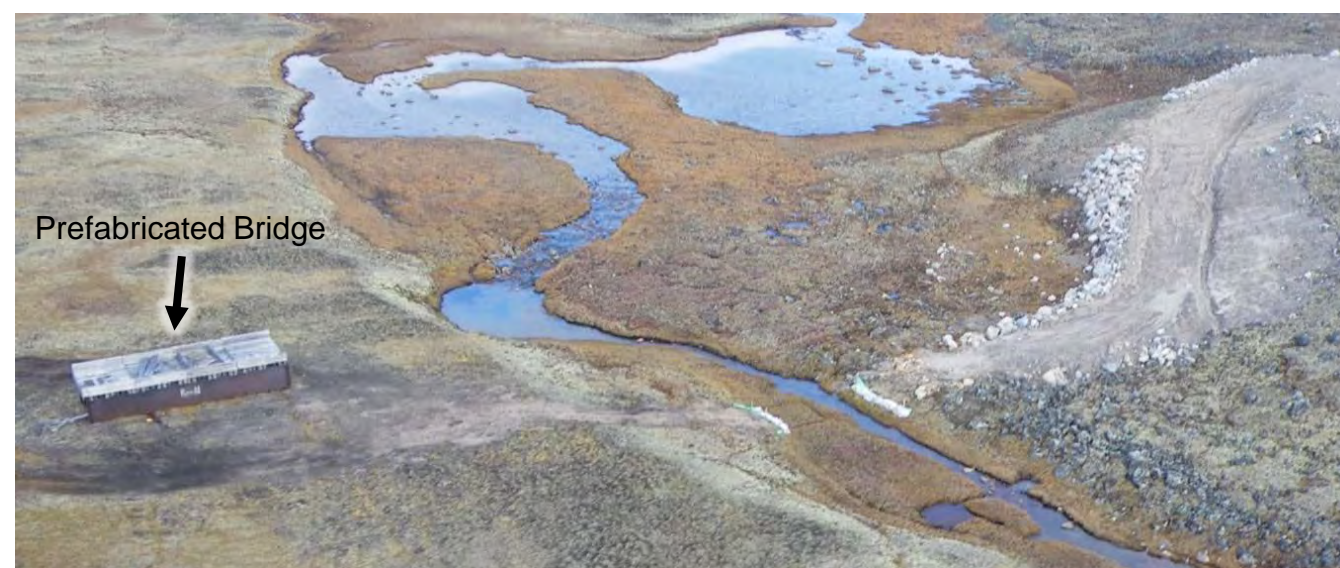
Stream crossing and Access Road to Borrow Area #3

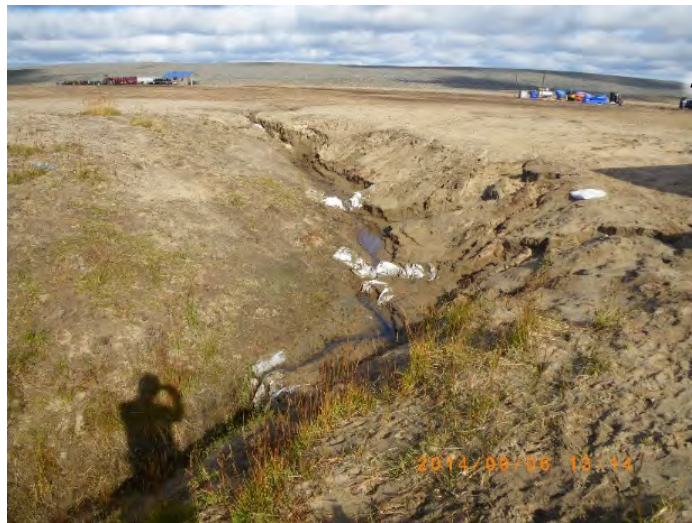
Surface water drainage from the Three Bluffs Airstrip east of Hayes Camp into a natural gully east of Hayes Camp

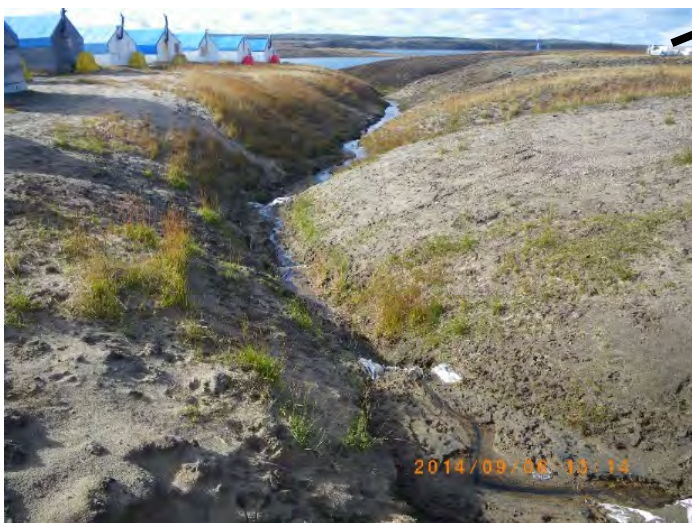
The large natural gully to the east of the camp area shows minor changes when compared to the 2012 site inspection. The sandbag filter dykes are full of trapped sediments so that surface water runoff passes over the filter dykes.

Natural gully along the east side of Hayes Camp. Surface water runoff flowing over the top of these sandbag filter dykes due to the retained sediments

- The sediment retained by the sandbag filter dykes should be removed to ensure that they remain functional. To improve future functionality of this system, a series of additional silt fencing should be installed upstream of the sandbag filter dykes.

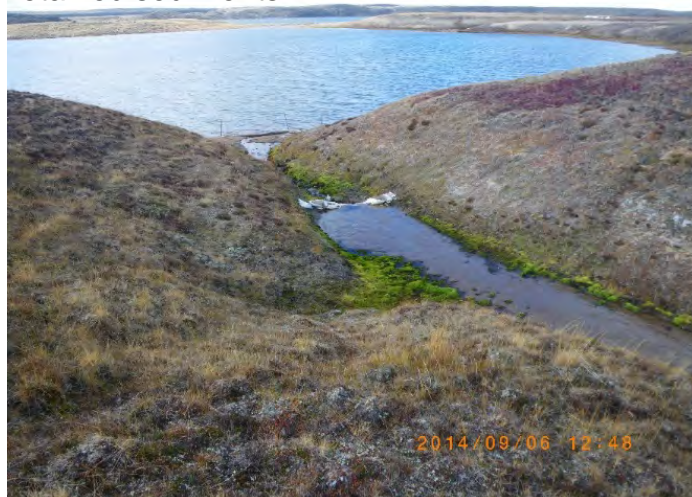
The sediment control structure at the outlet of the natural gully along the east side of Hayes Camp into Sandspit Lake

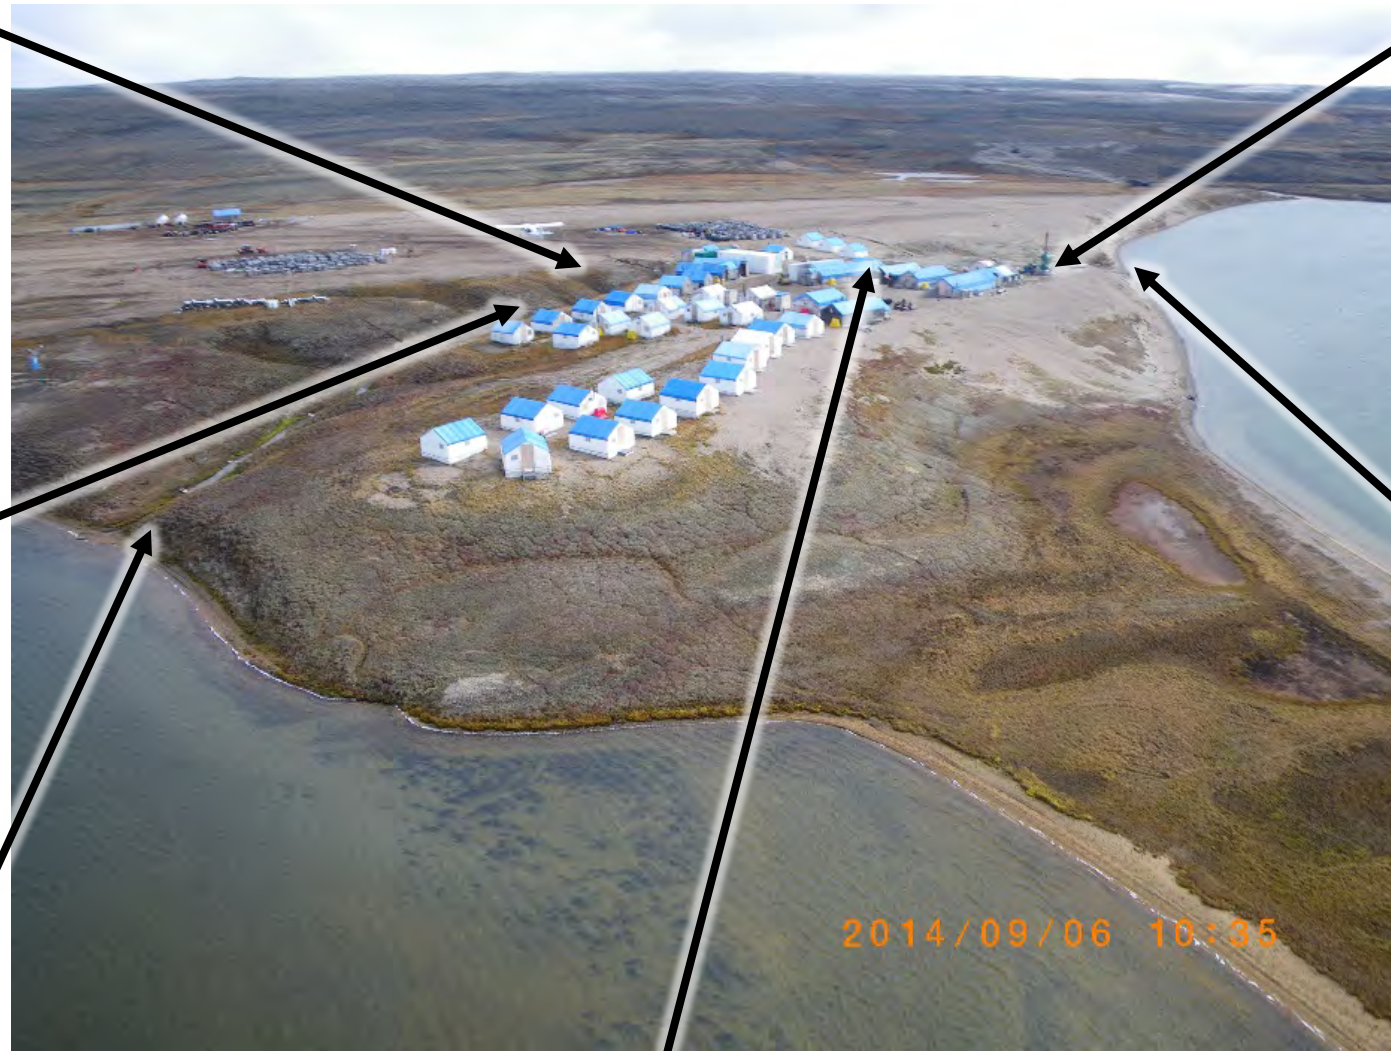
Aerial View of Hayes Camp looking southeast

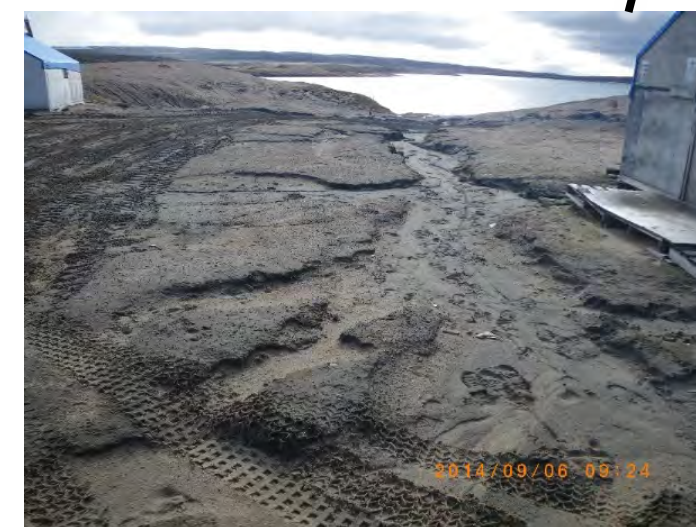
Surface water runoff at the south end of Hayes Camp

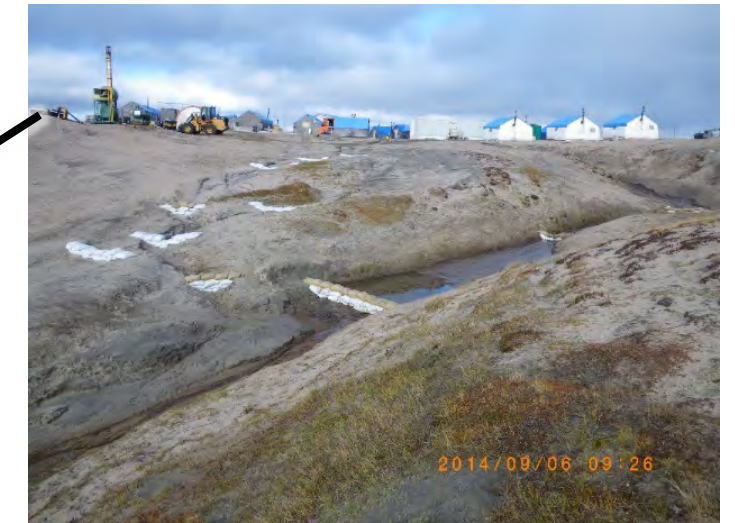
During the 2012 site inspection, some sandbag filter dykes had been placed across one of the large gullies, at the south end of the camp. The 2014 geotechnical inspection saw additional sandbag filter dykes placed within both gullies to slow the velocity of surface water runoff and to trap the transported sediments.

New sandbag filter dykes within the natural gullies at the south end of Hayes Camp

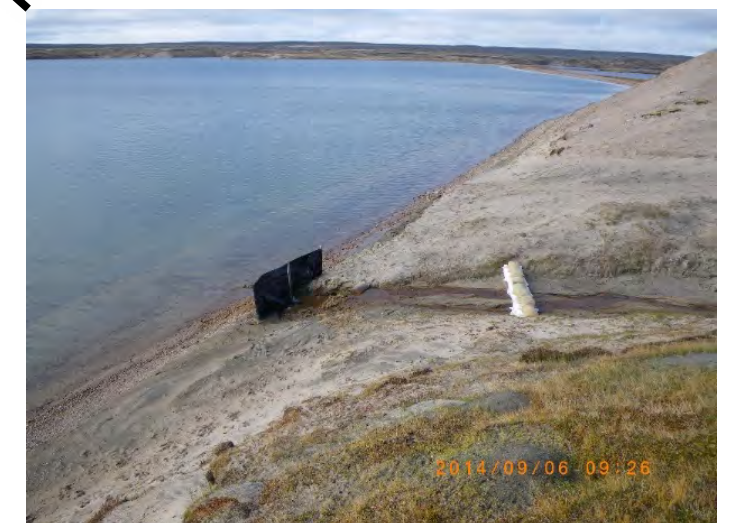
The newly installed sediment control structure at the outlet of the natural gully at the south end of Hayes Camp

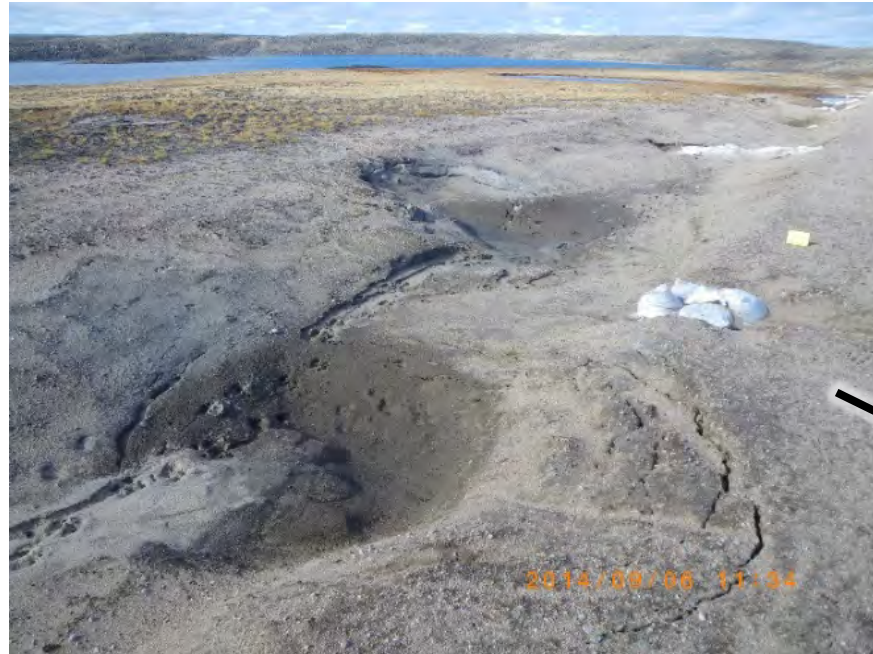
Permafrost degradation due to ponded water within the drainage ditch along the west side of the Three Bluffs Airstrip

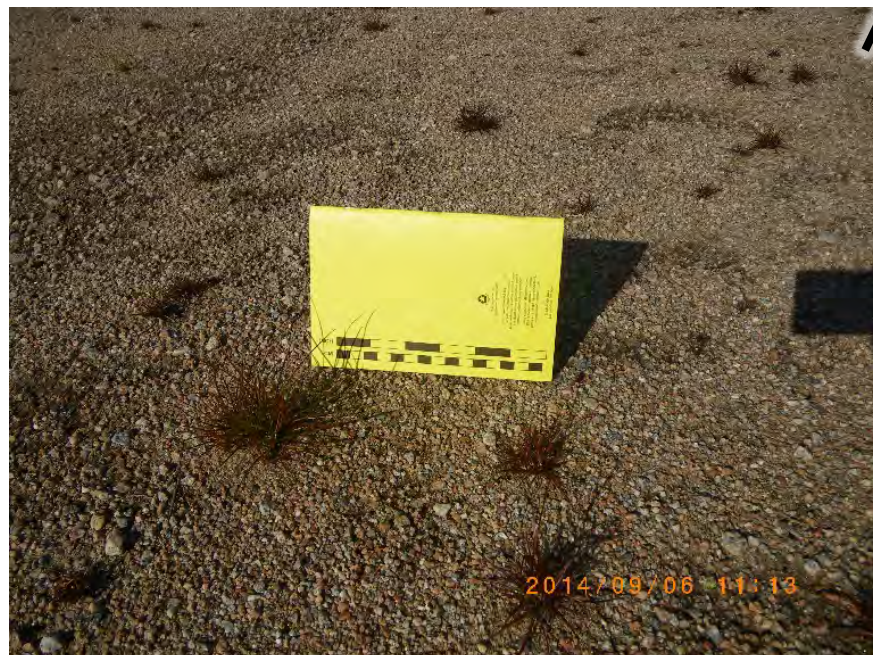
Natural revegetation along the Airstrip surface

- Allow the north end of the airstrip to continue to revegetate naturally.
- Remove the degraded sandbag filter dykes installed within the drainage ditches along either side of the airstrip and replace them with silt fencing.

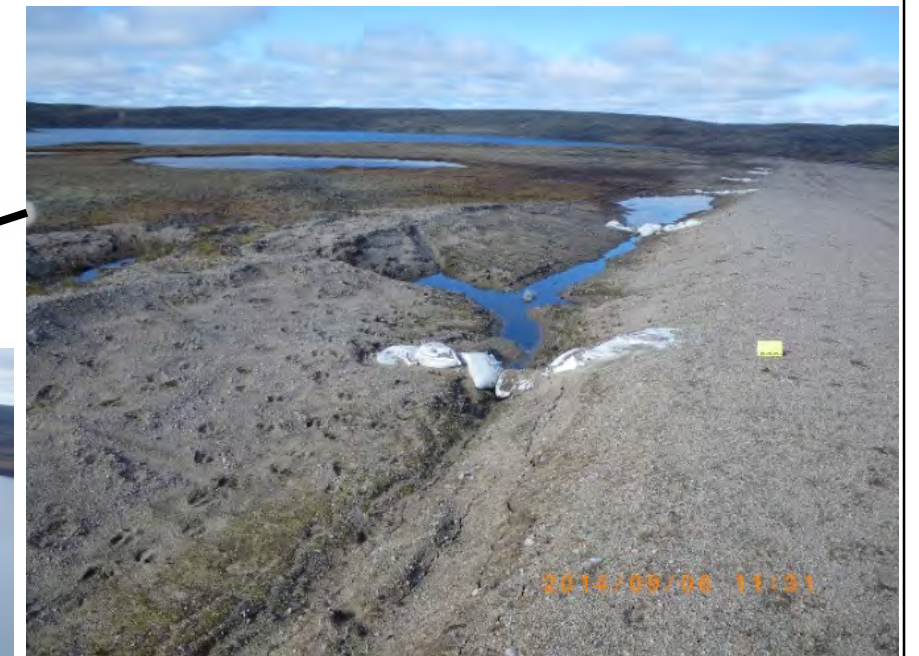
Permafrost degradation due to ponded water within the drainage ditch along the west side of the Three Bluffs Airstrip

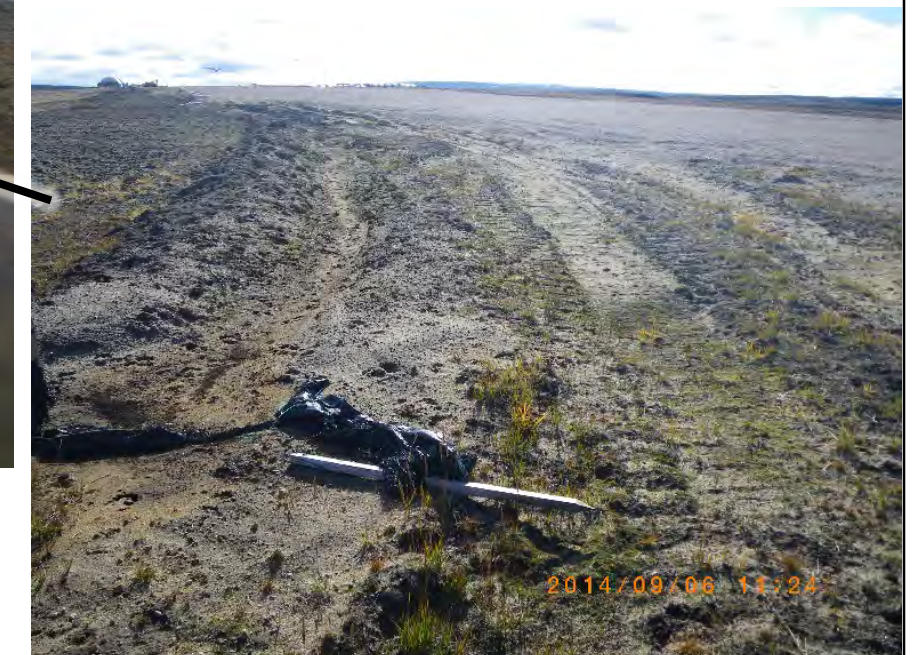
Natural revegetation at the north end of Three Bluffs Airstrip

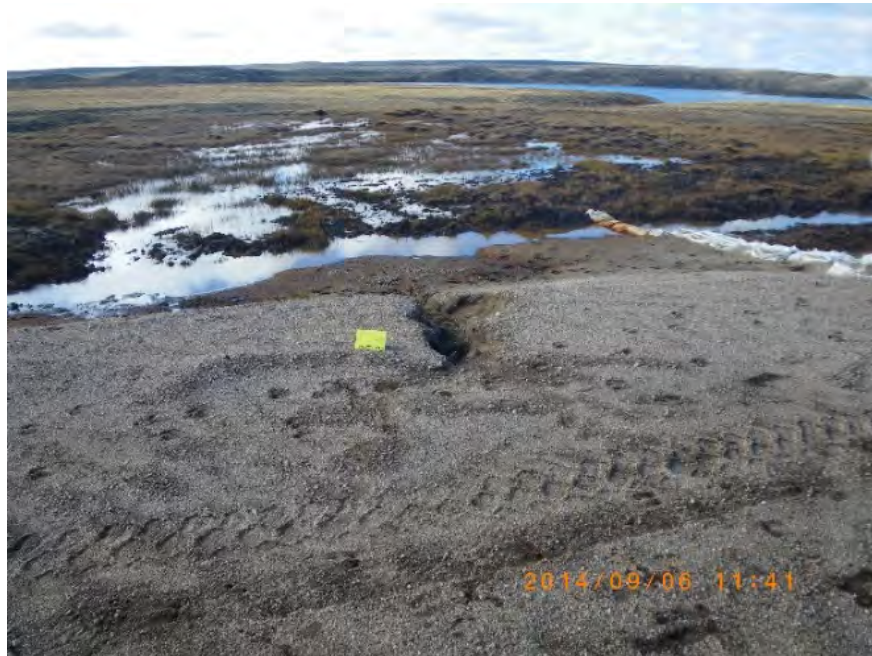
Erosion channel at the edge of the runway

- Regrade the edges of the airstrip to allow for a gentle transition from the airstrip to the drainage ditches. Establish a crown along the center line of the airstrip to reduce the volume of the surface water runoff forming erosion channels.

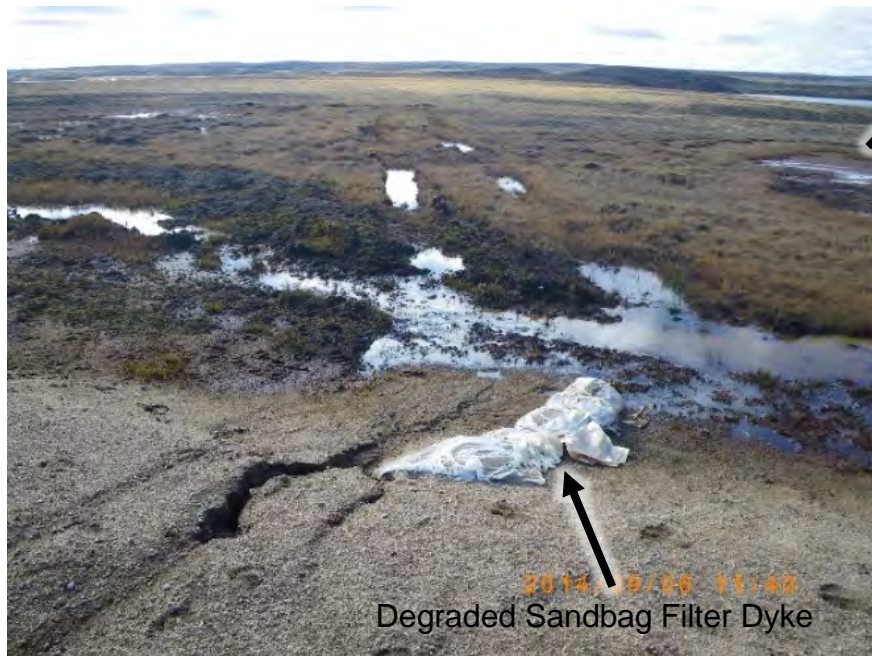
Erosion channel at the edge of the runway and permafrost degradation from a tracked vehicle in the background

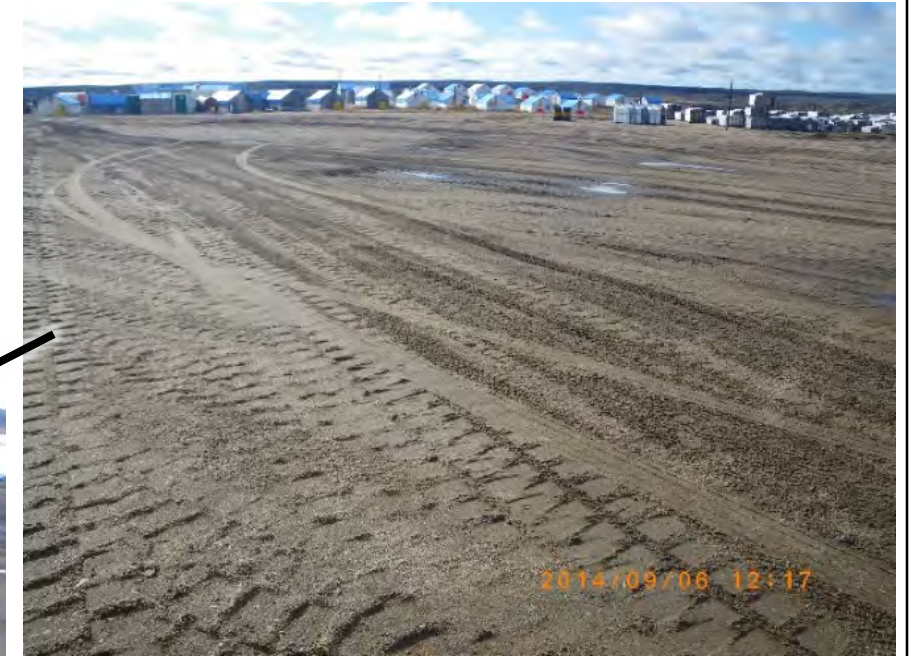
General condition of the runway by the apron

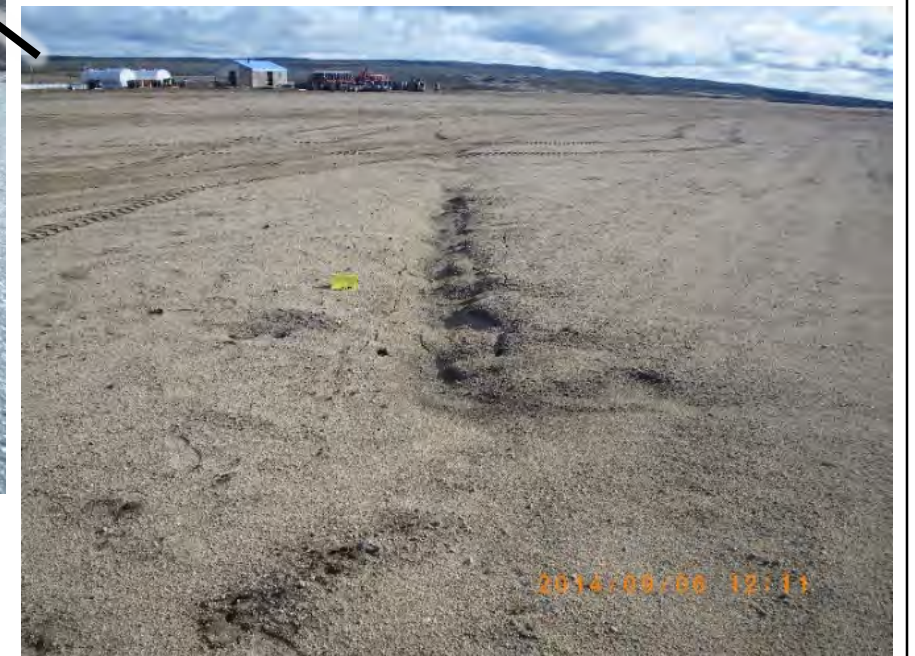
During the 2014 geotechnical inspection the sinkholes and depressions, caused by the melting ice wedges along the airstrip shows signs of stabilization, suggesting they are starting to reach equilibrium with the changed ground conditions. The north end of the airstrip shows signs of natural revegetation. There is still significant erosion of the fill along the edges of the airstrip and the sandbag filter dykes installed in 2011 have decayed, and the trapped sediment is causing surface water runoff to bypass these erosion control structures.

No further melting of the ice wedge suggests steady state conditions have developed

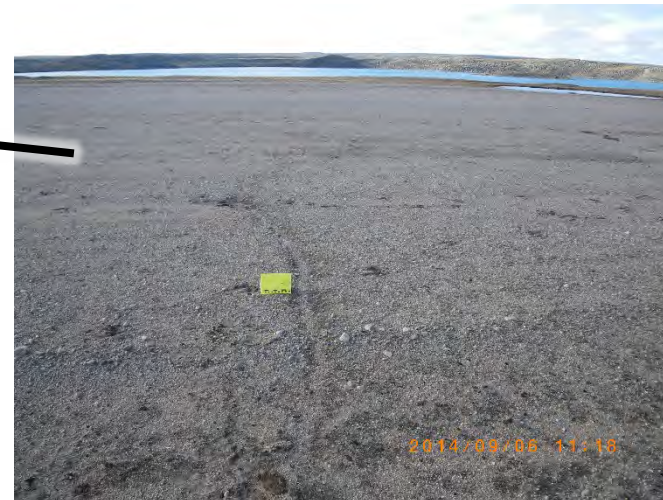
No further melting of the ice wedge suggests steady state conditions have developed

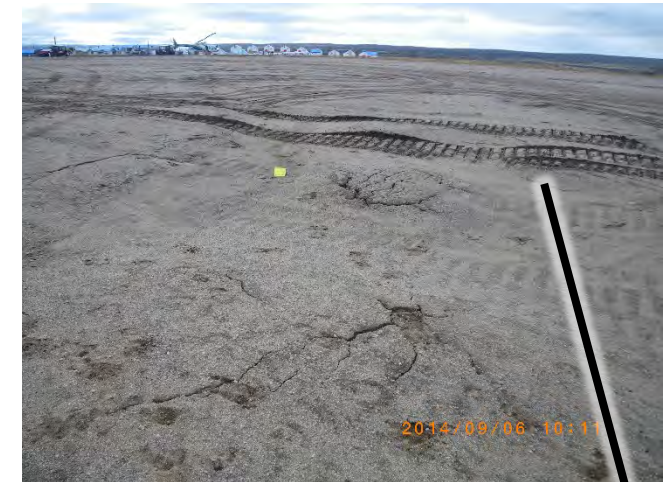
During construction activities in 2011, an apron located along the east side of the airstrip was constructed. This open area shows significant thermal erosion due to the ponding of water.

Permafrost degradation within the apron due to ponded water

- Backfill and compact the apron to prevent the ponding of water. The backfill material is to be sourced from regarding the edges of the airstrip and should be placed in 0.3 m thick lifts and compacted with the 10 T drum compactor. When completing the final grading, grade the apron so that surface water runoff is shed away from the airstrip.

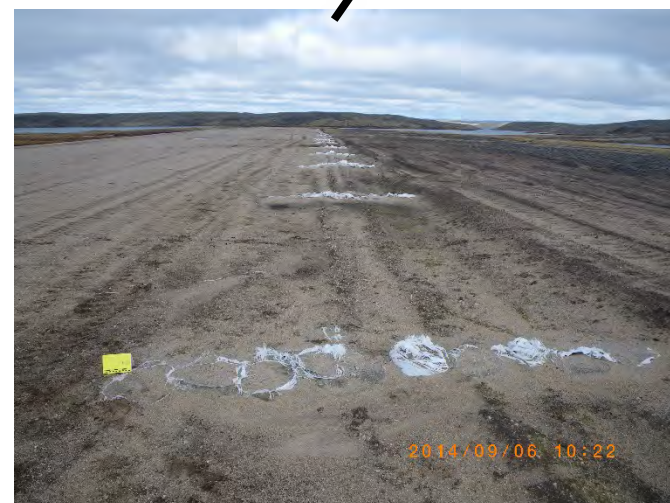
The sandbag dykes have decayed and are non-functional

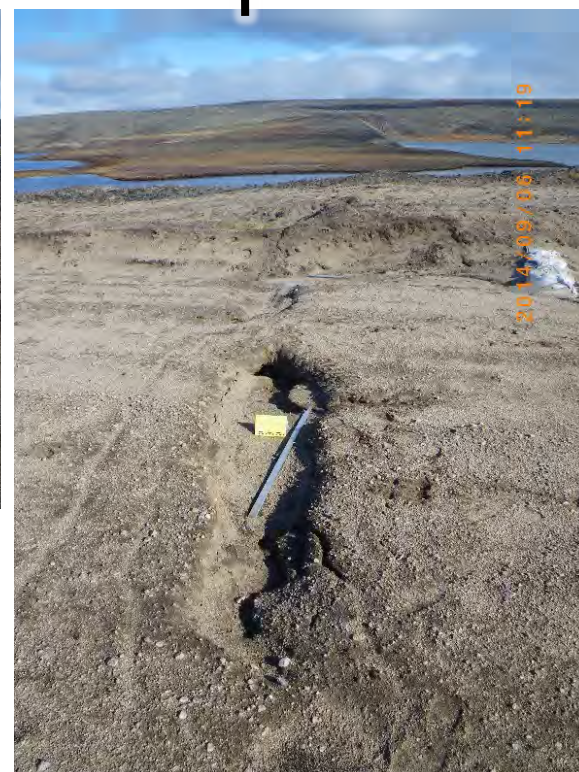
Erosion channel and piping at the crest of the runway

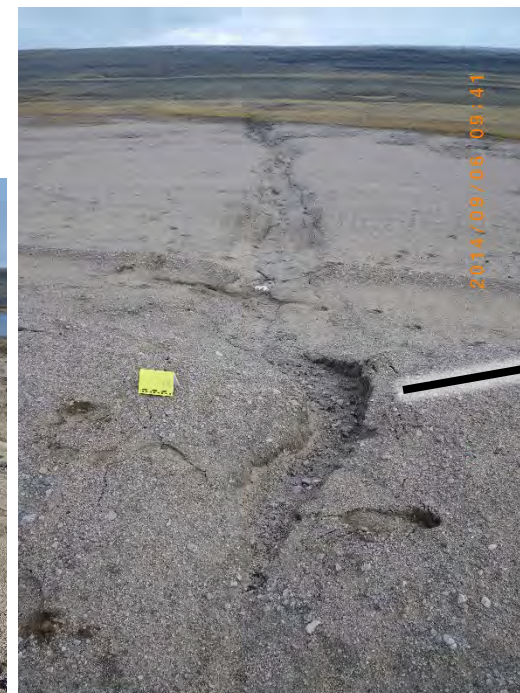
To the south of the apron and along the east side of the Three Bluffs Airstrip, is an exposed area where the natural vegetation has been removed during construction activities. Ice wedges have been exposed and melted ice is causing the overlaying soil to settle. These permafrost degradation features have started to show signs of stabilization suggesting they are starting to reach equilibrium with the changed ground conditions when comparing photographs taken during the 2012 site inspection (Figure 7).

Erosion channel connected to a melted ice wedge

- Backfill and compact the depressions and troughs caused by the melted ice wedges within the exposed area south of the apron and along the east side of the airstrip. The backfill material is to be sourced from regarding the edges of the airstrip and should be placed in 0.3 m thick lifts and compacted with the 10 T drum compactor. When completing the final grading, ensure the surface water runoff is towards the east away from the airstrip.
