## **Committee Bay Project**

## ***Annual Report***

# **2014**

North Country Gold Corp.  
December 2014

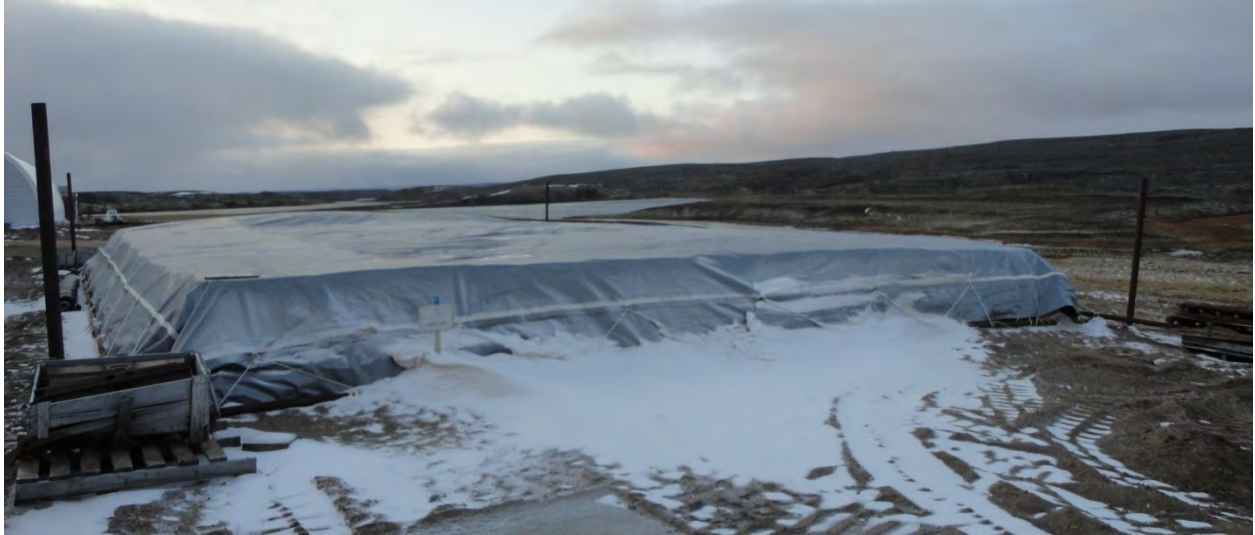
Figure 8 - Waste Oil / Fuel Berm on eastern side of Quonset 1 (Hayes Camp) with cover repaired and reinstalled. This is fuel berm shown in 2014 Inspection report Figure 10. Drill steel and scrap metal Caterpillar track pads have been used to provide additional anchor points to hold cover on in high winds.

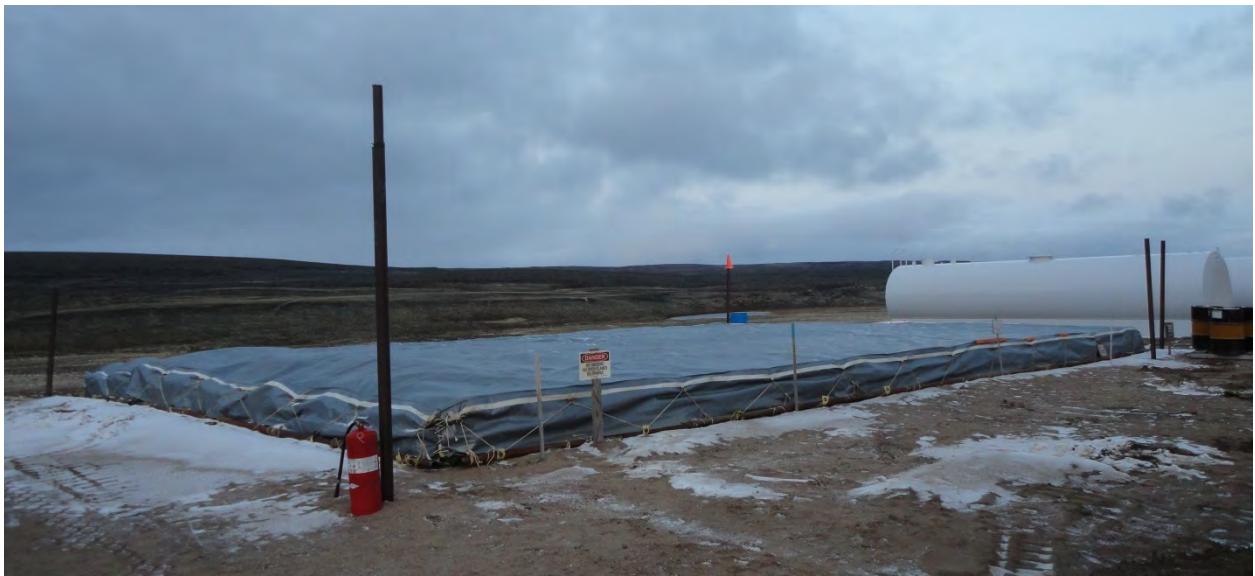
Figure 9 – P50/Jet Fuel cache located between generator and Quonset #1. Drill steel connected along all sides and used for additional anchoring of berm cover. This is fuel berm shown in 2014 Inspection report Figure 26.

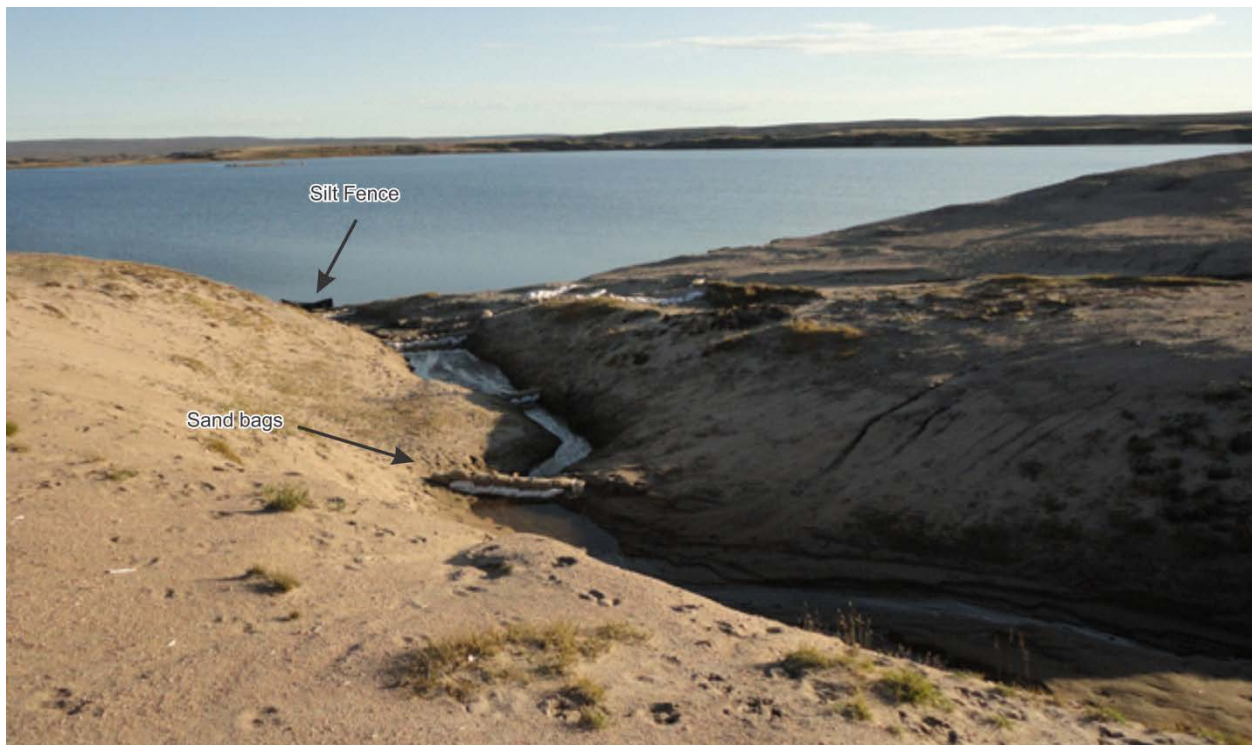
Figure 10 – Erosion control measures implemented (view southwest)

- Filling new erosion ruts with sandbags to prevent further erosion
- Creating sand bag dams on steep slopes to reduce the velocity of moving water and prevent further erosion. Dams were constructed using permeable burlap sand bag to minimize ponding of water.
- Silt fences were installed on gentle slopes to collect sediment and prevent entry into Sandspit Lake.

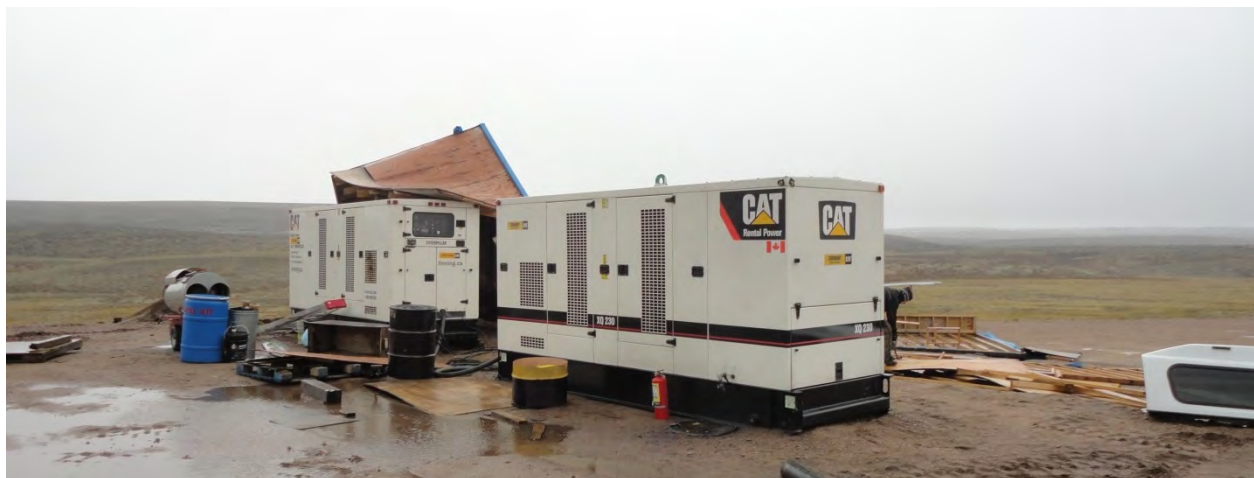
Figure 12 – Demolished Power Generation Shack

The power generation shack housing the Hayes Camp generators that was destroyed during the strong wind was removed, salvaged and a new shack constructed. All garbage and debris from the damaged shack was removed.

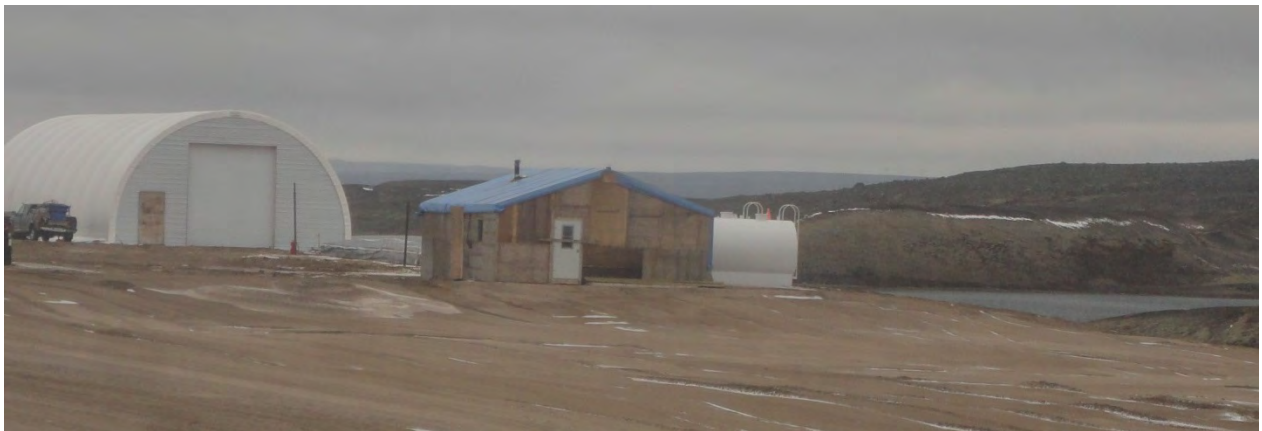
Figure 14 – Rebuilt Generator shack. All debris from damaged shack removed. (Same view as 2014 Inspection Report Figure 20)

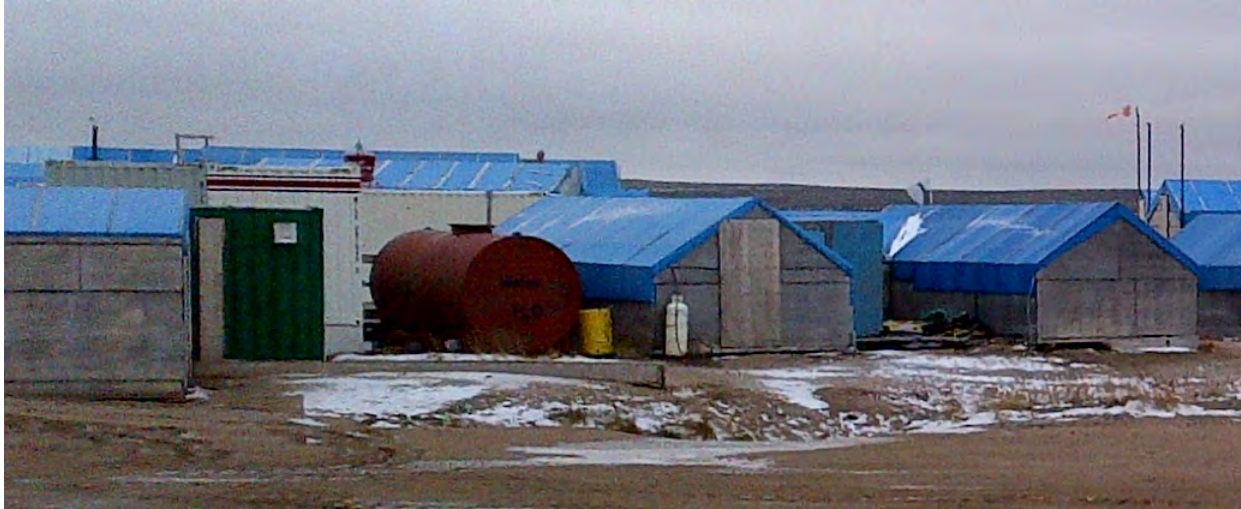
Figure 15 – Red tank used to store water at Hayes camp during summer months.

The large red tank at Hayes Camp is used as a summer camp water storage tank. This tank was labelled “Water” and “H<sub>2</sub>O” to prevent any confusion.

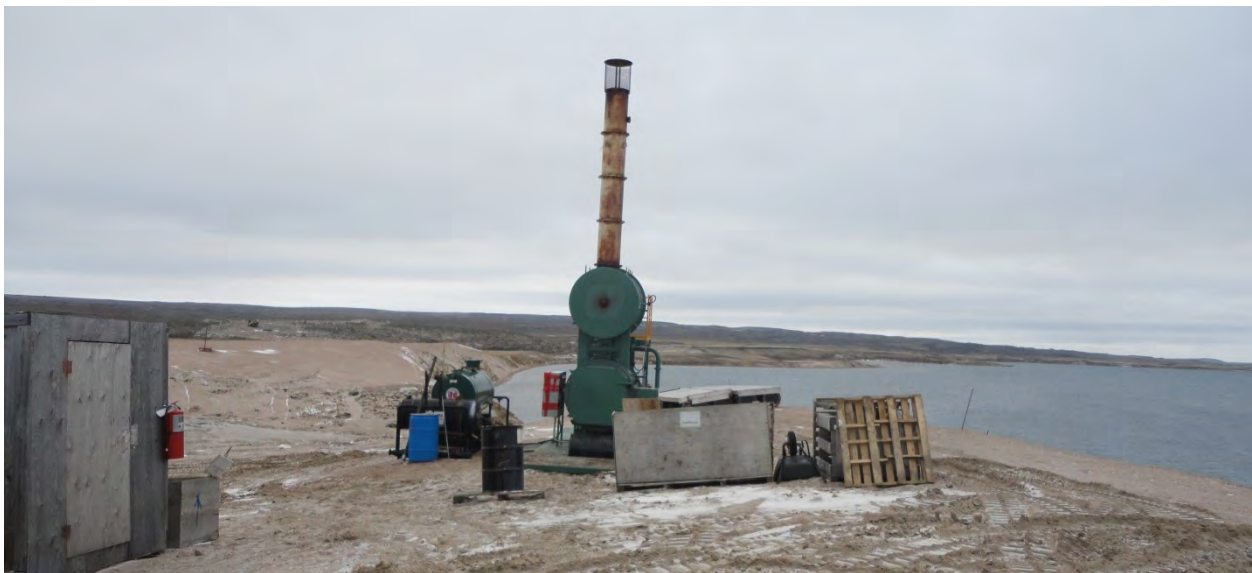
Figure 16 – Hayes Camp incinerator. Garbage was sorted and removed. Note: black drum is empty and was stored prior to departure.

All garbage around the incinerator was cleaned up. Garbage and recycling bins at Hayes camp were sealed and secured in Quonset #2.

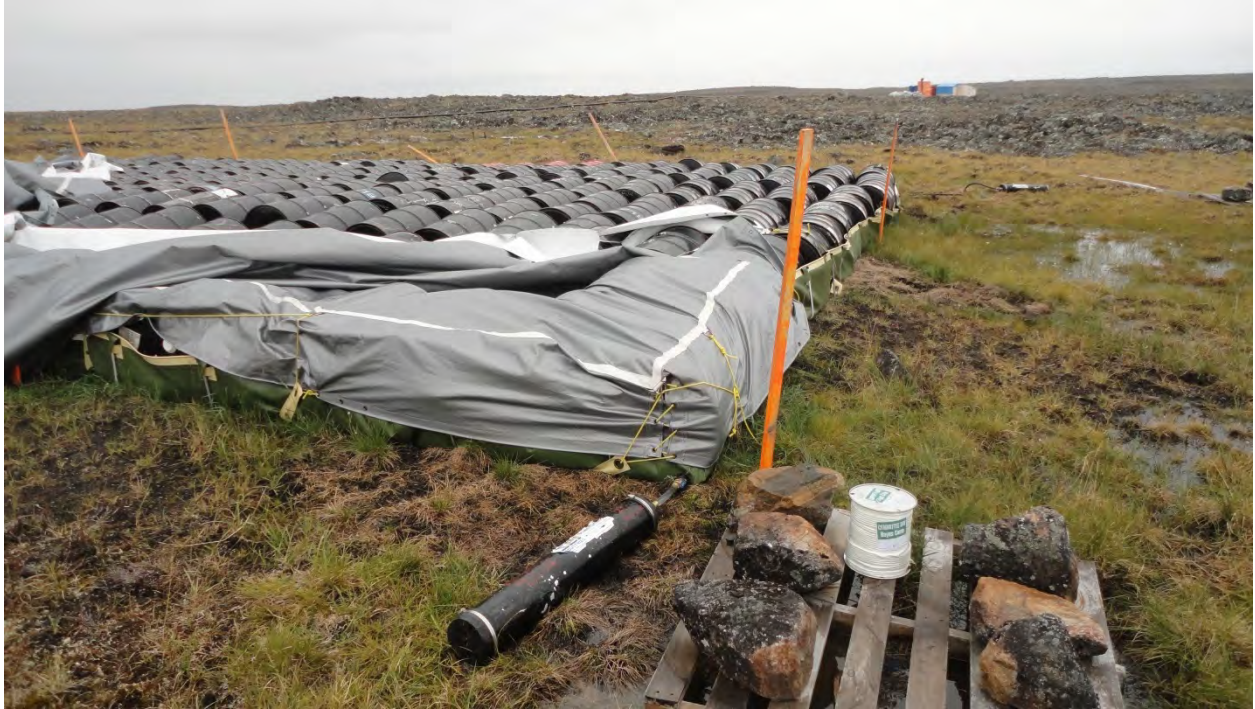
Figure 18 – Two 'Rain Drain' filters attached to Berm 2 (2014 Inspection Report Figure 24) to treat hydrocarbon contaminated water

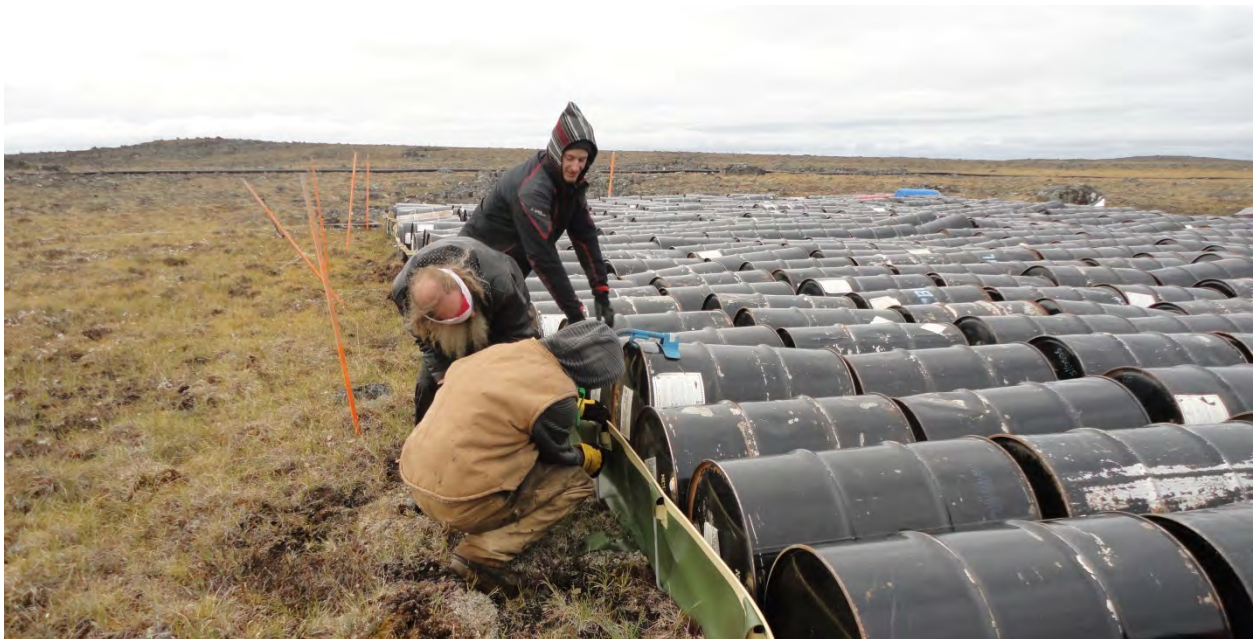
Figure 20 – Replacing damaged support brackets on berm 3 at Three Bluffs.

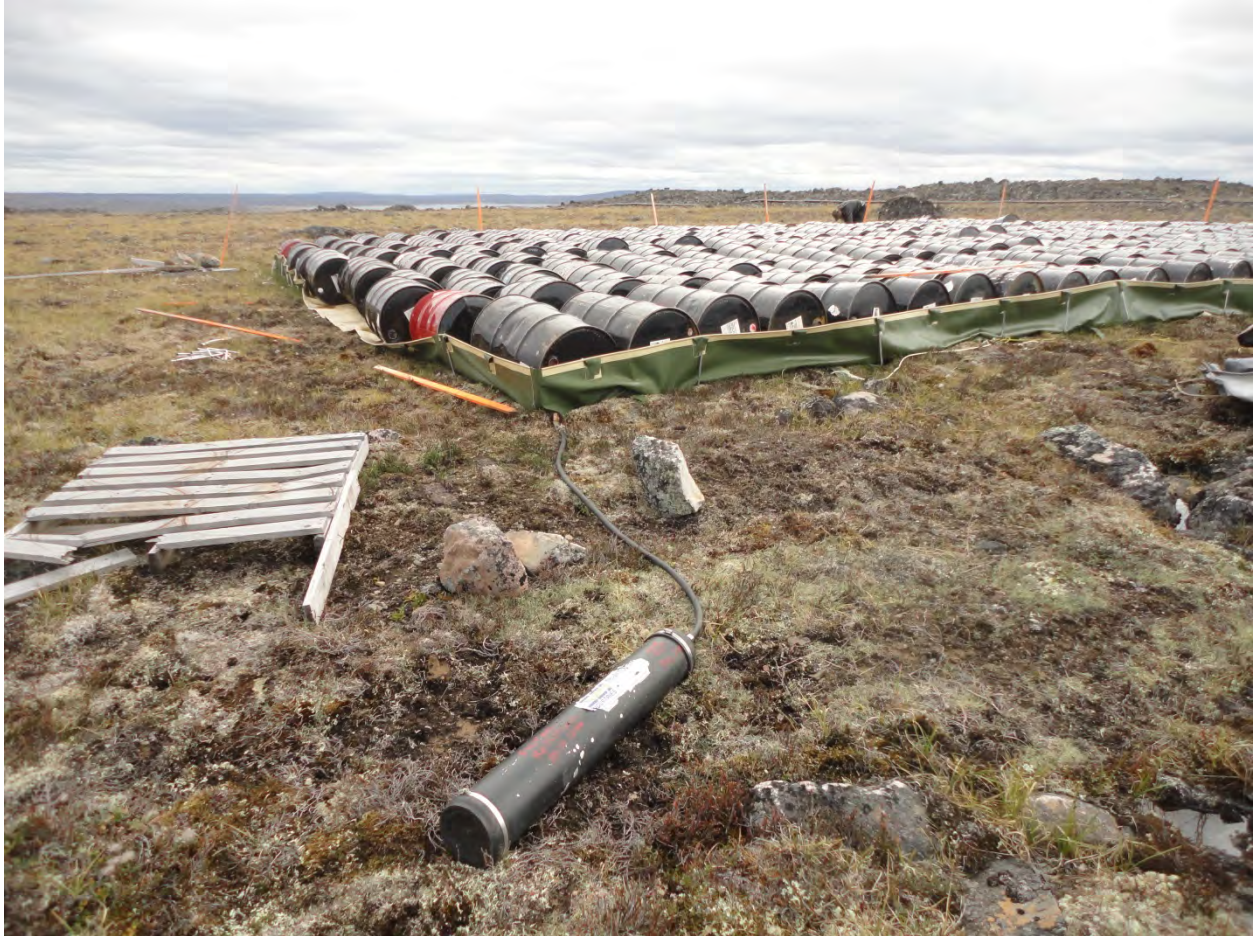
Figure 21 – Fuel berm 3 at Three Bluffs. The row of fuel drums on the far left was repositioned and additional wall support brackets added to ensure berm stability.

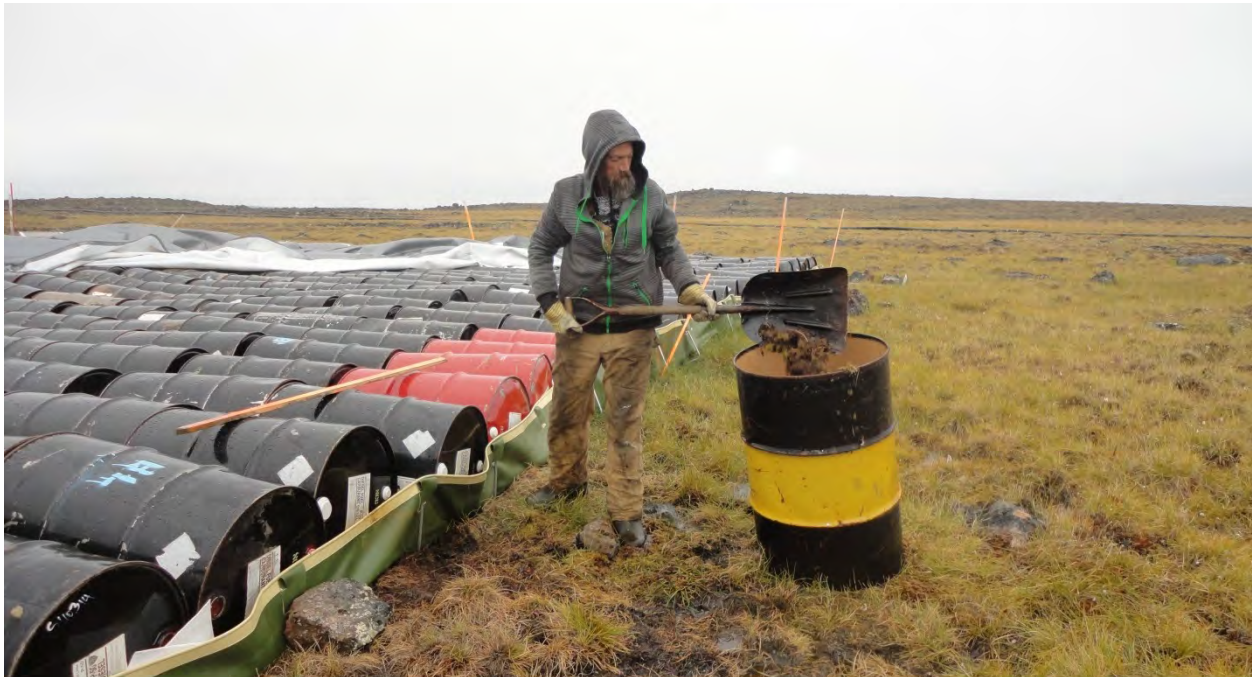
Figure 25 – Contaminated soil being removed from hydrocarbon spill which occurred as a result of Berm 2 overflowing.

Upon arrival at site the fuel spill was dealt with as a high priority item. Contaminated water within the berm was drained and treated through Rain Drain filters immediately to reduce the risk of further contamination of the tundra vegetation (See Figure 18). Absorbent matting and spill pads were used to absorb hydrocarbons from the surface where possible. Contaminated tundra was then excavated and placed in a sealed, labelled drum which was subsequently backhauled to Hayes Camp and placed within containment in Quonset #2. Holes were then backfilled using local material.

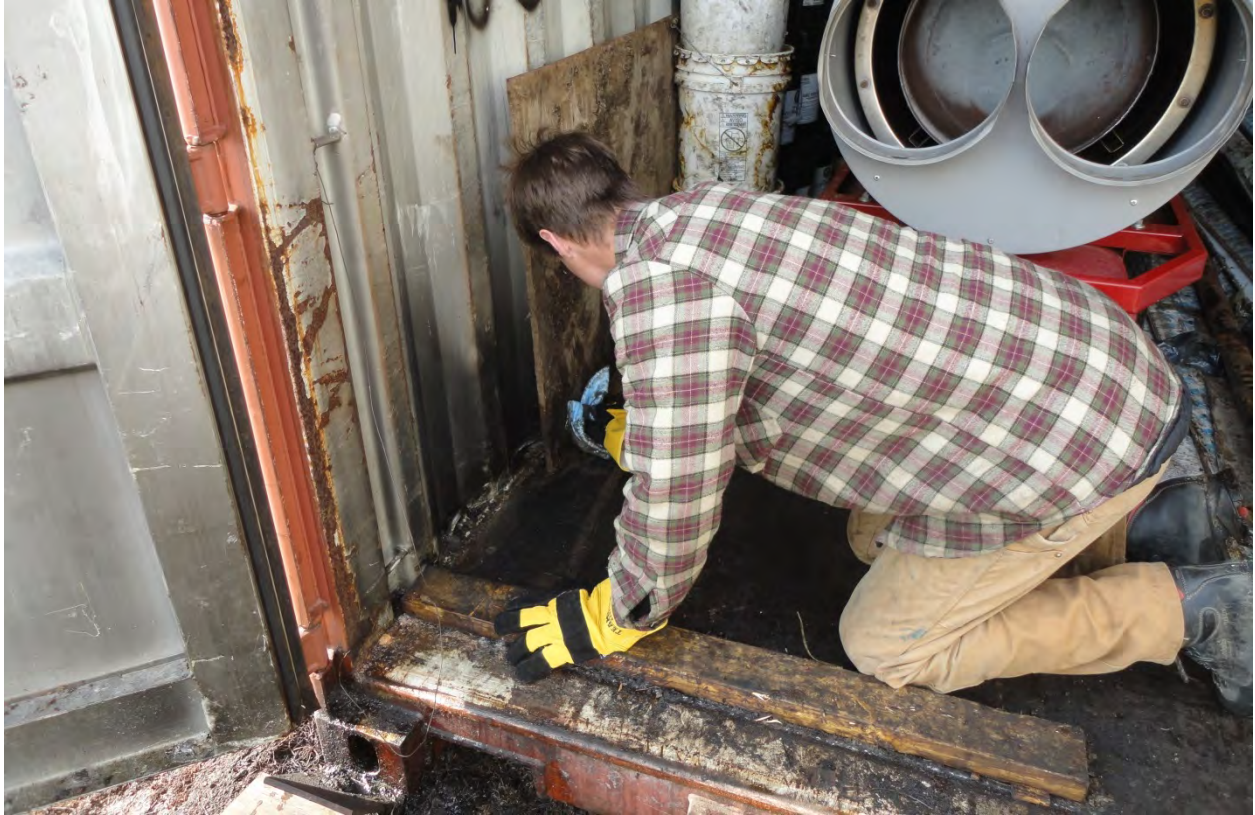
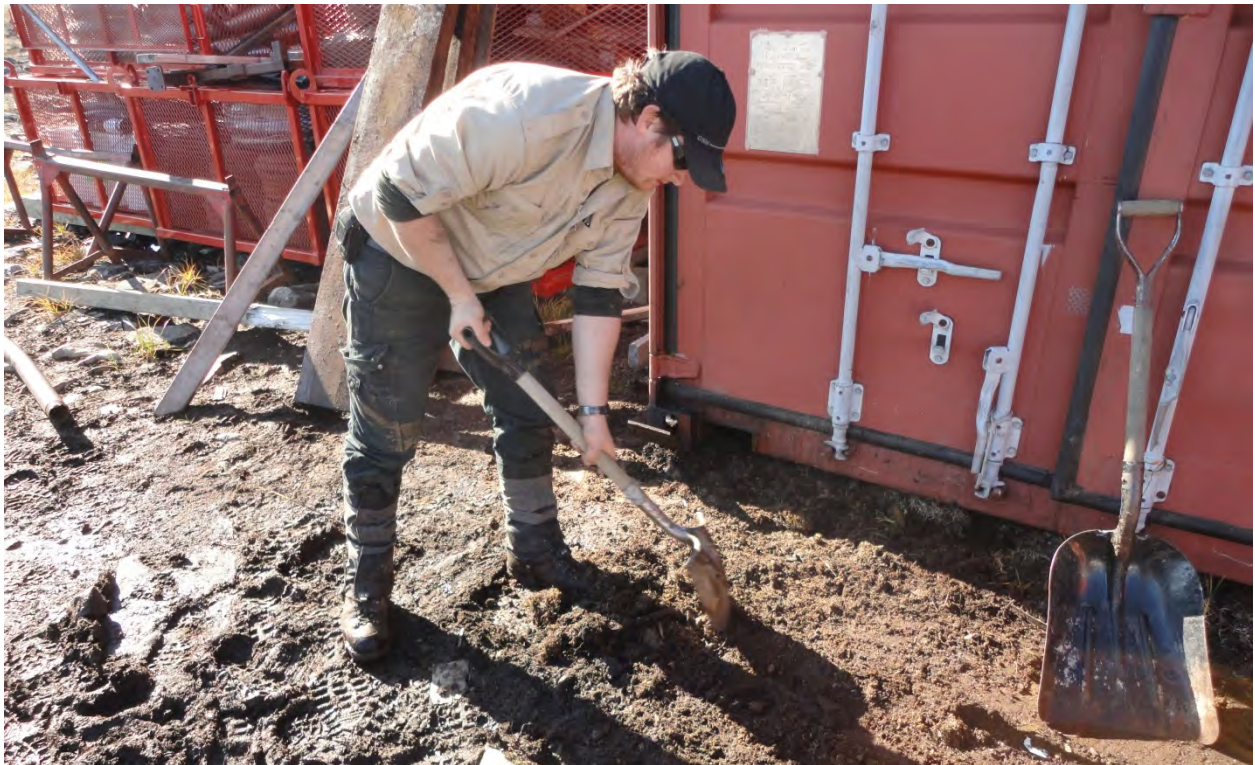
Figure 26 – Cleaning up contamination within red sea container

Figure 26 – Removing contaminated soil from door of red sea container.

The red sea container (leaking contaminated water out the door) was inspected for the source of contamination. A leaking container of biodegradable drilling additive was identified as the source of contamination and was placed inside suitable containment. Residual drilling additive was removed from the sea container floor and contaminated soil was excavated, placed in a sealed drum and transported back to Hayes Camp and stored within containment in Quonset #2.

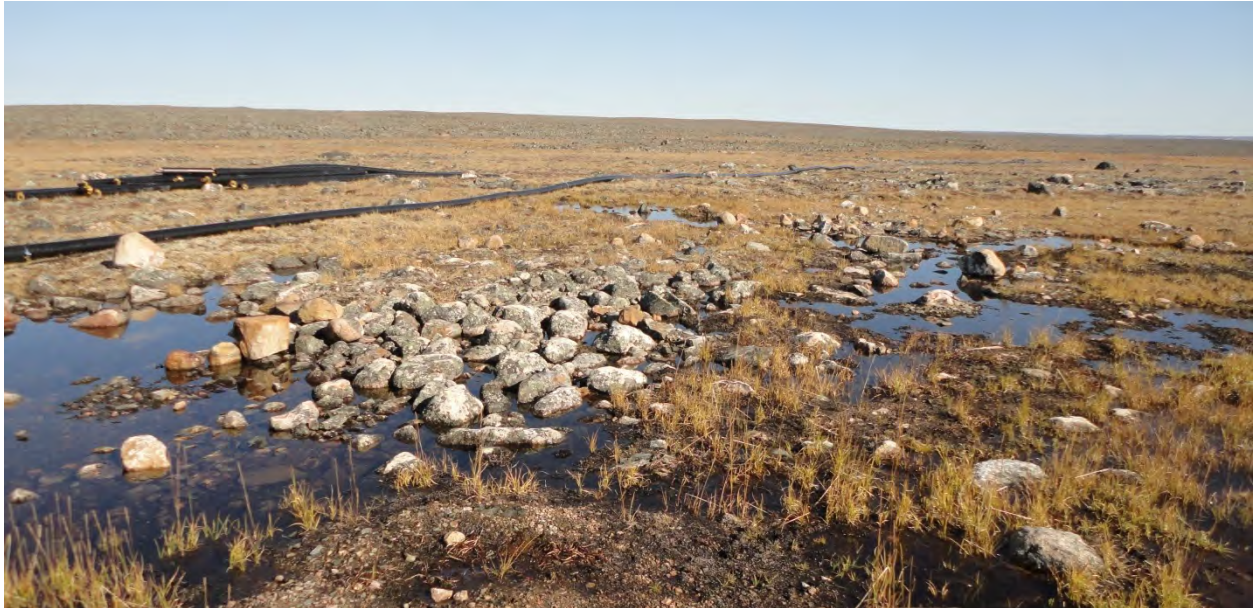
Figure 27 – Site of 2012 hydrocarbon spill. Absorbent matting was removed. Holes were backfilled to best extent possible within the natural wetland area (See 2014 Inspection Report Figure 28).

All spill pads from the site of the 2012 hydrocarbon spill were removed and transported back to Hayes camp and stored within the a sealed drum, within containment inside Quonset #2.

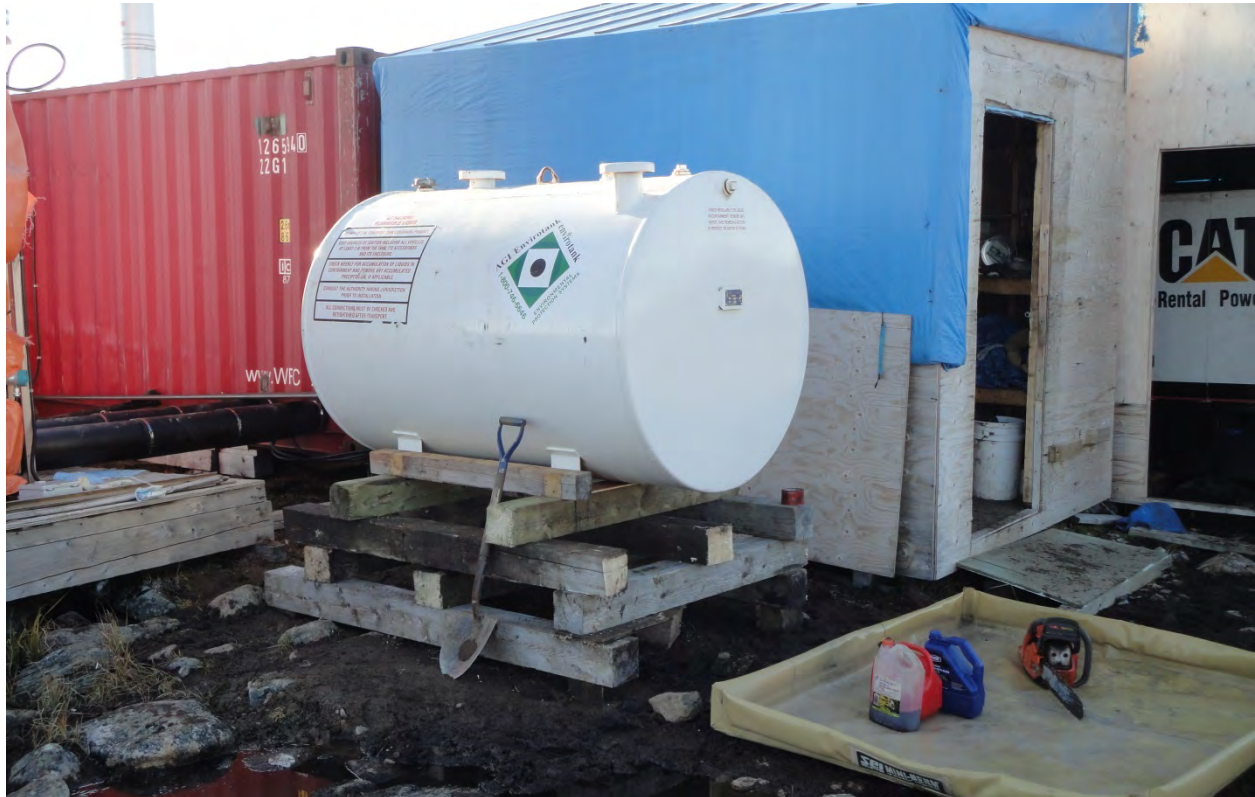
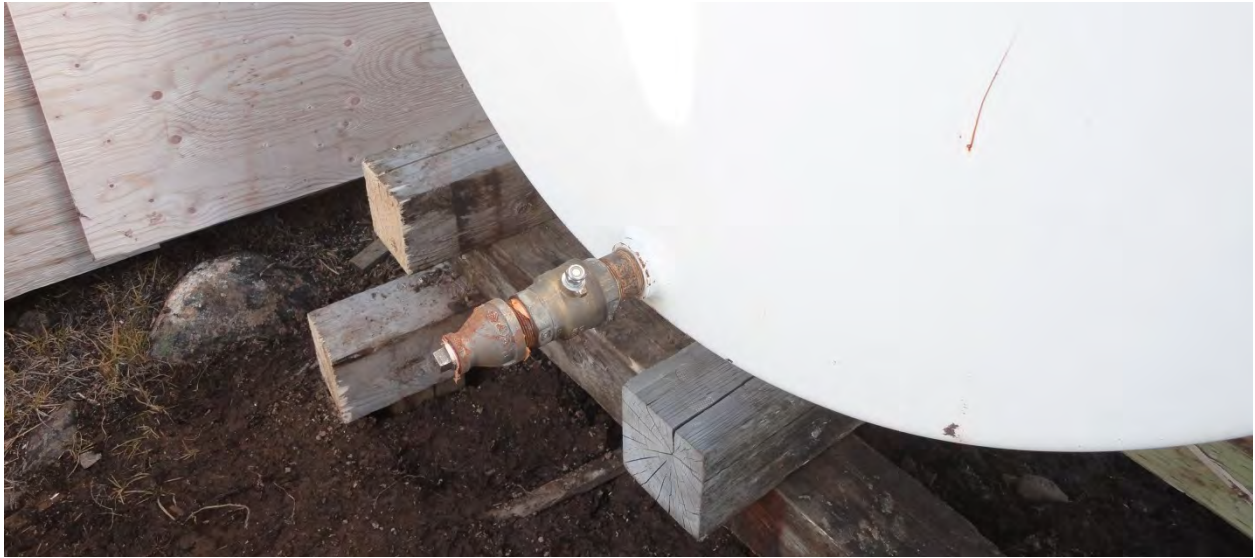
Figure 28 – Double walled fuel tank at the boiler repositioned on a solid base

Figure 29 – Fuel hoses were removed from the base of the tank, the valve handle removed and a bung installed to prevent any accidental discharge.

The double walled fuel tank at the boiler was inspected and a decision was made to relocate the tank and reconstruct a solid base for the tank. All hoses were removed from the base of the tank. The valve handle was removed and a bung installed to eliminate any risk of accidental discharge.

NCGC will install contained fuel lines that draw fuel from the top of tank prior to re-commissioning of the boiler system.

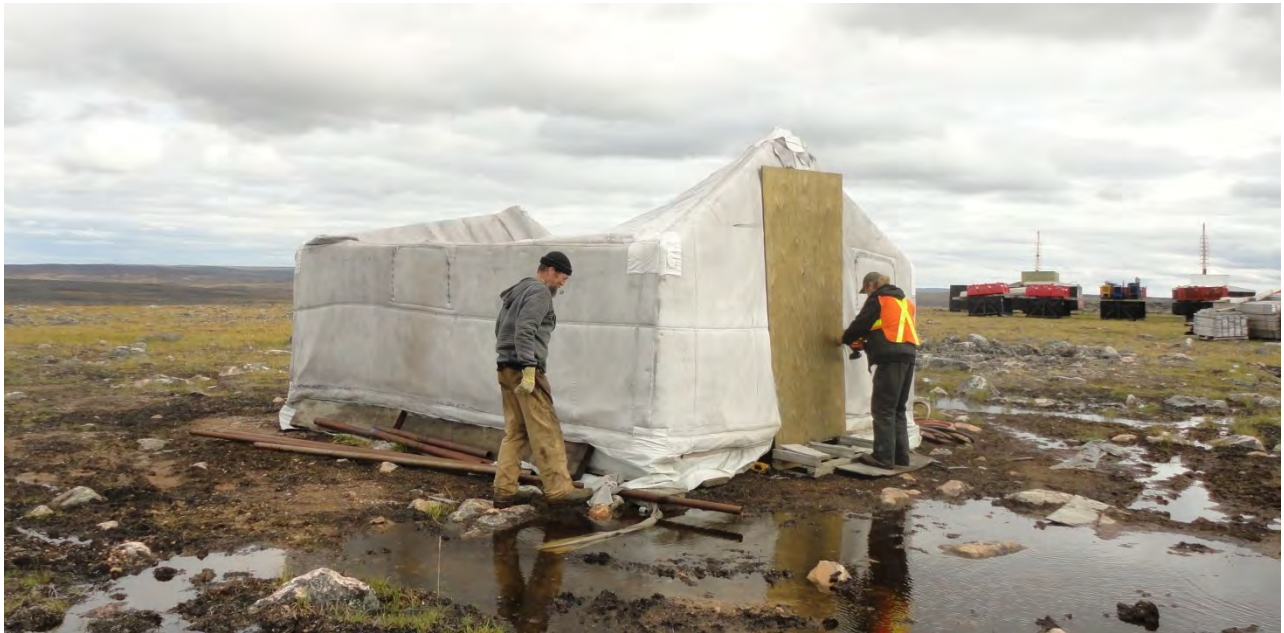
Figure 30 – Damaged storage tent at Three Bluffs drill grid.

The storage tent at the drillers' laydown at the Three Bluffs drill grid was repaired and secured for winter.

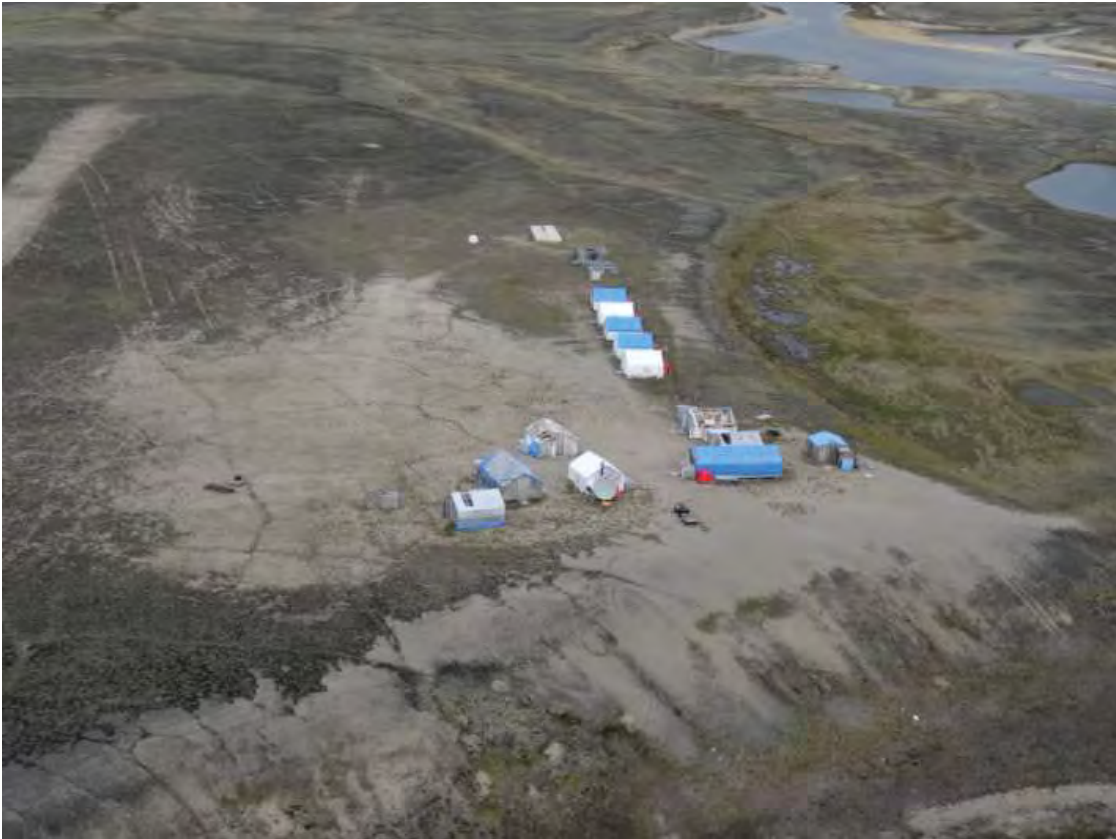
Figure 1. Bullion Camp. Berm is intact. Some tents are torn.

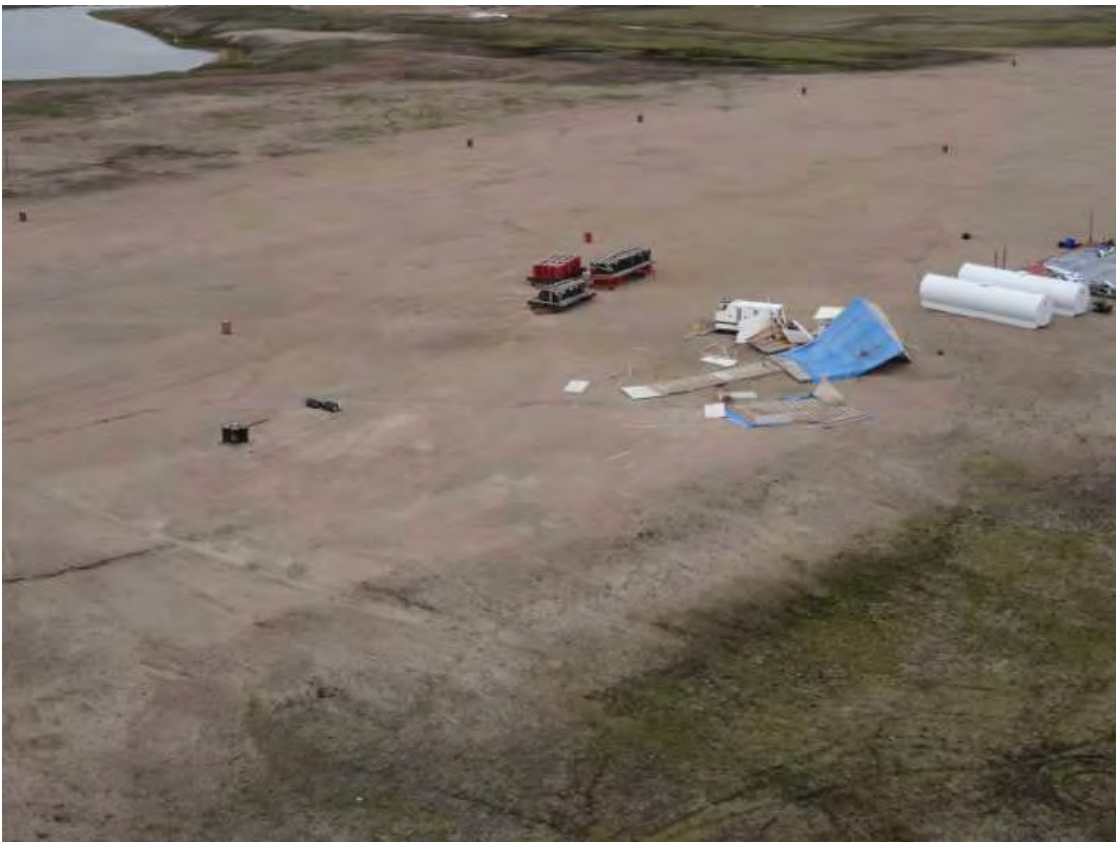
Figure 2. Lay-down at Hayes Camp. Building demolished.

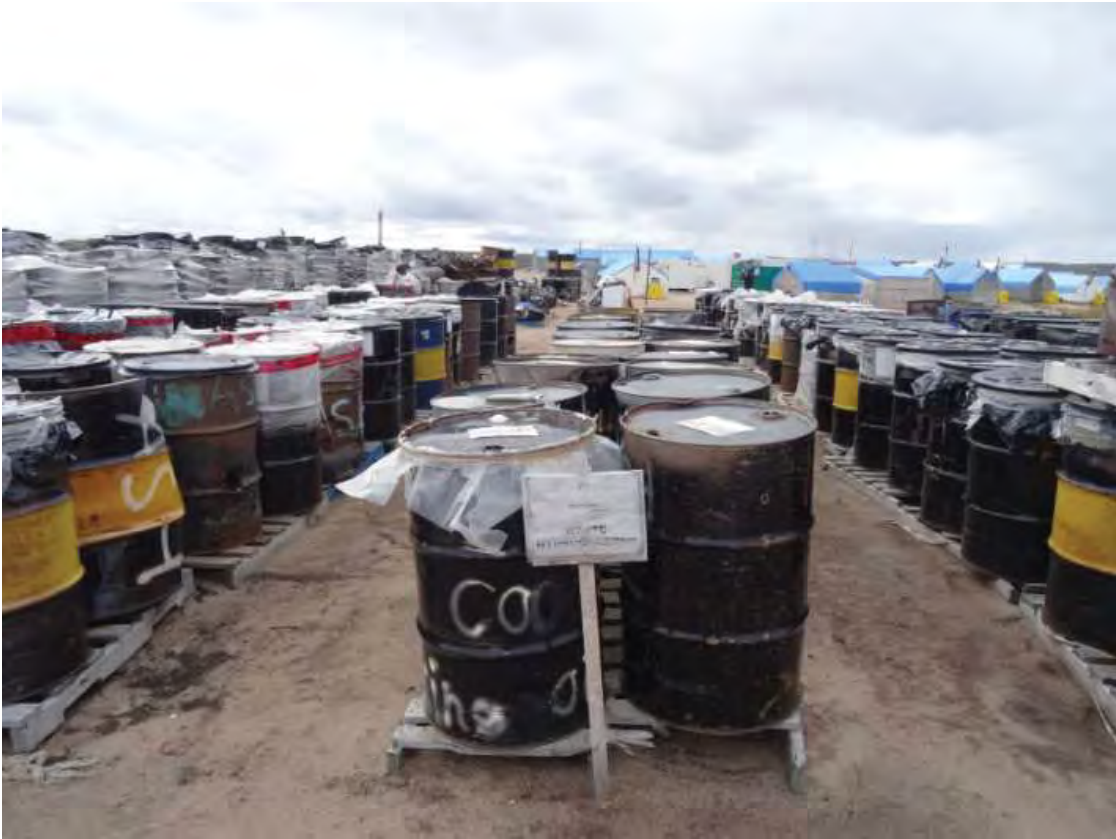
Figure 5. Waste Hydrocarbons should have been removed from site.

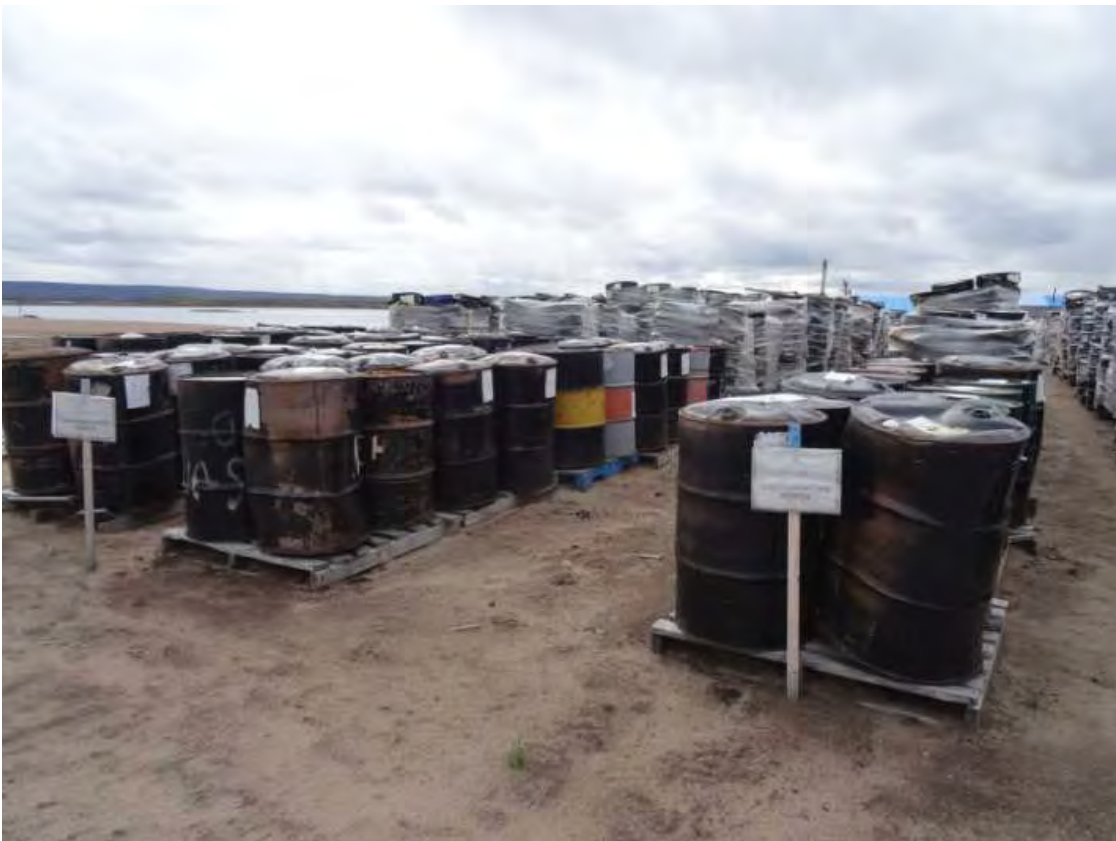
Figure 6. Contaminated water should be removed from site.

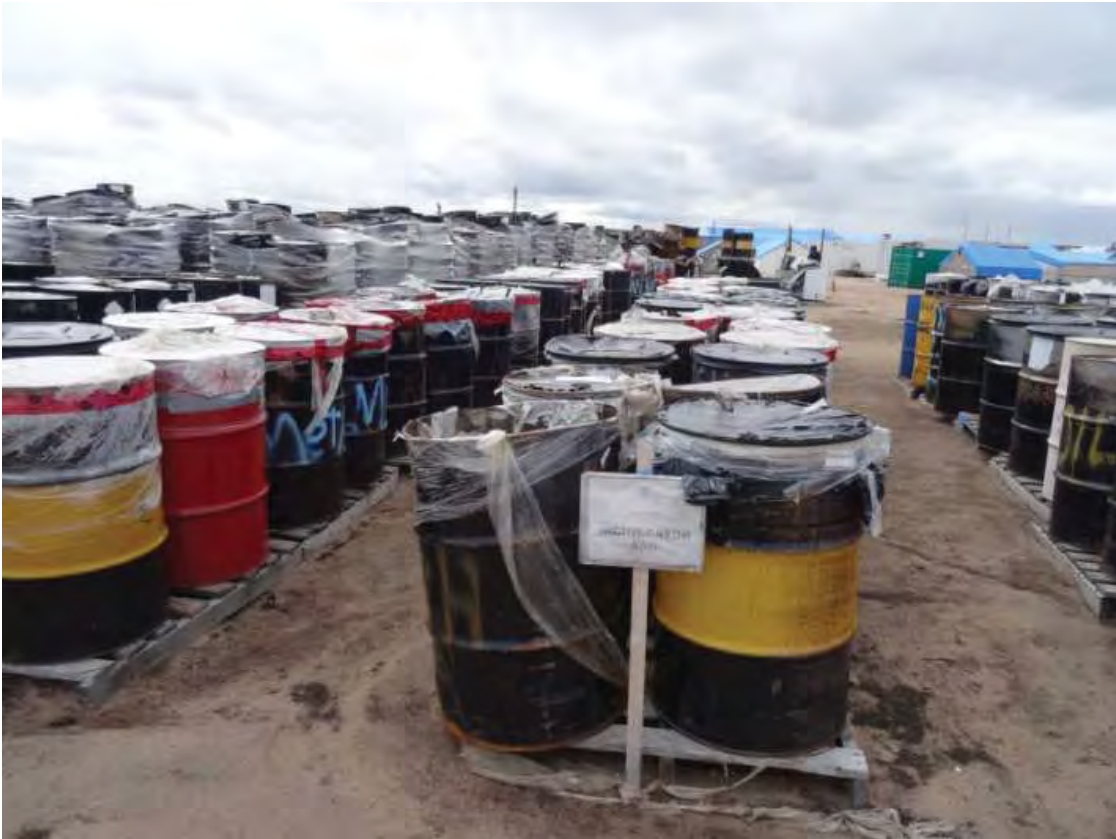
Figure 7. Incinerator Ash should be removed from site.

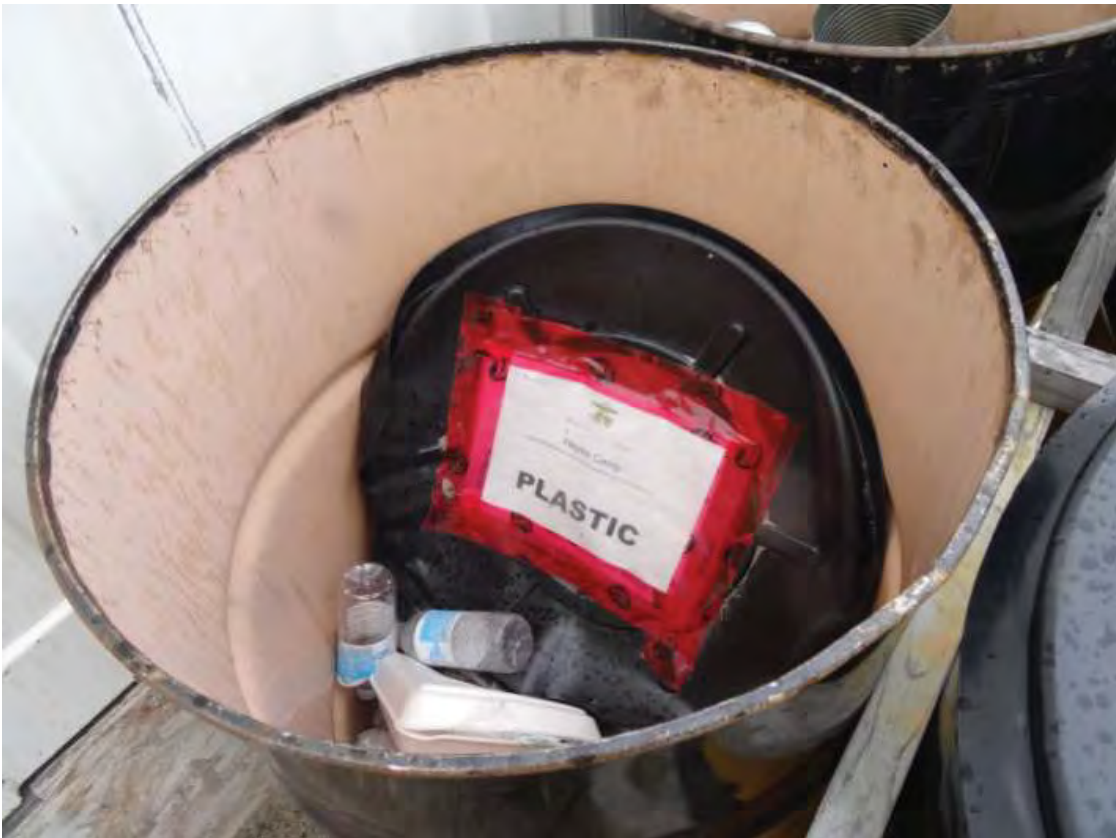
Figure 8. Garbages within the camp were not emptied.

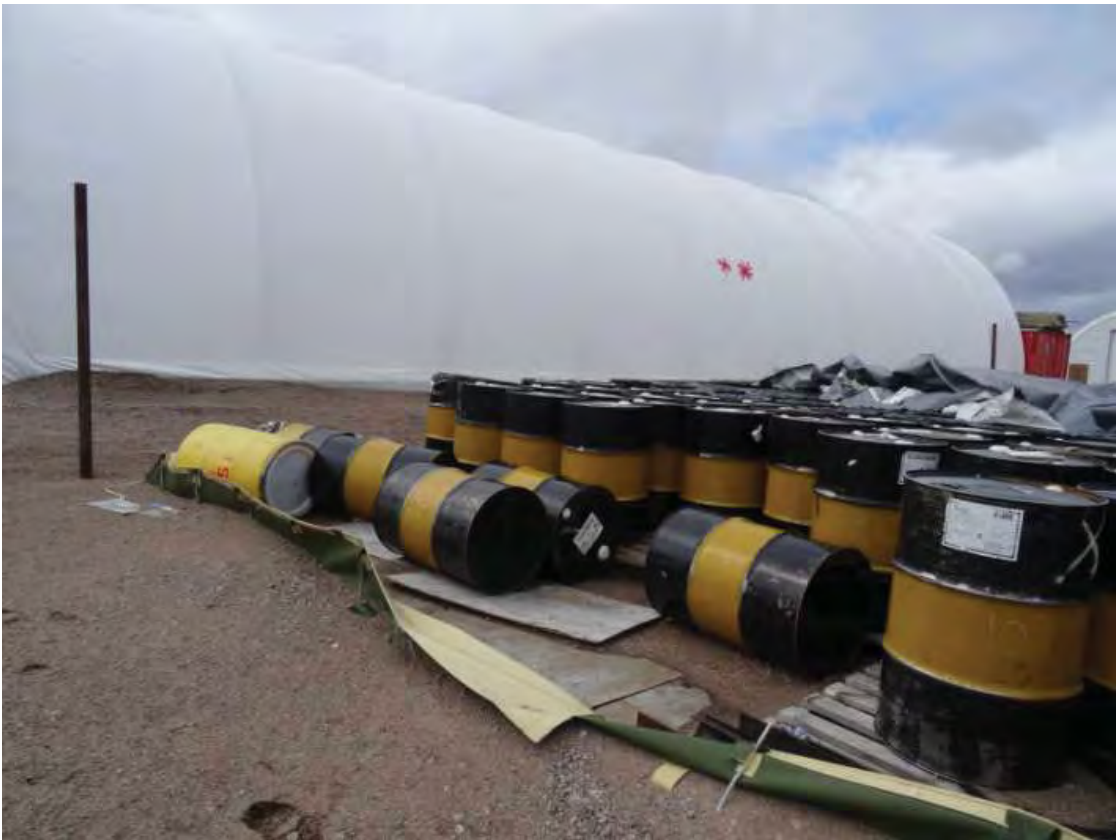
Figure 10. Hayes berm collapsed.

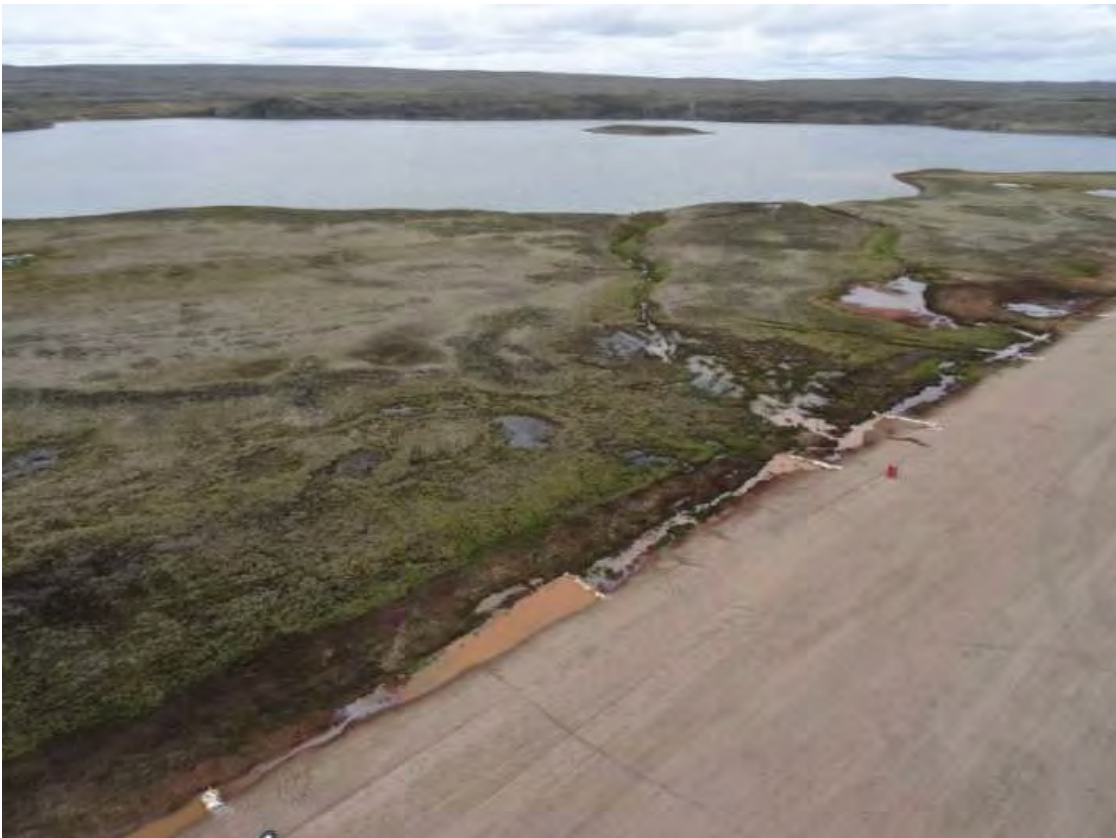
Figure 16. Pooling/ponding on the side of the airstrip; sediment evident in water flowing down-slope.
