## **Committee Bay Project**

## ***Annual Report***

# **2014**

North Country Gold Corp.  
December 2014

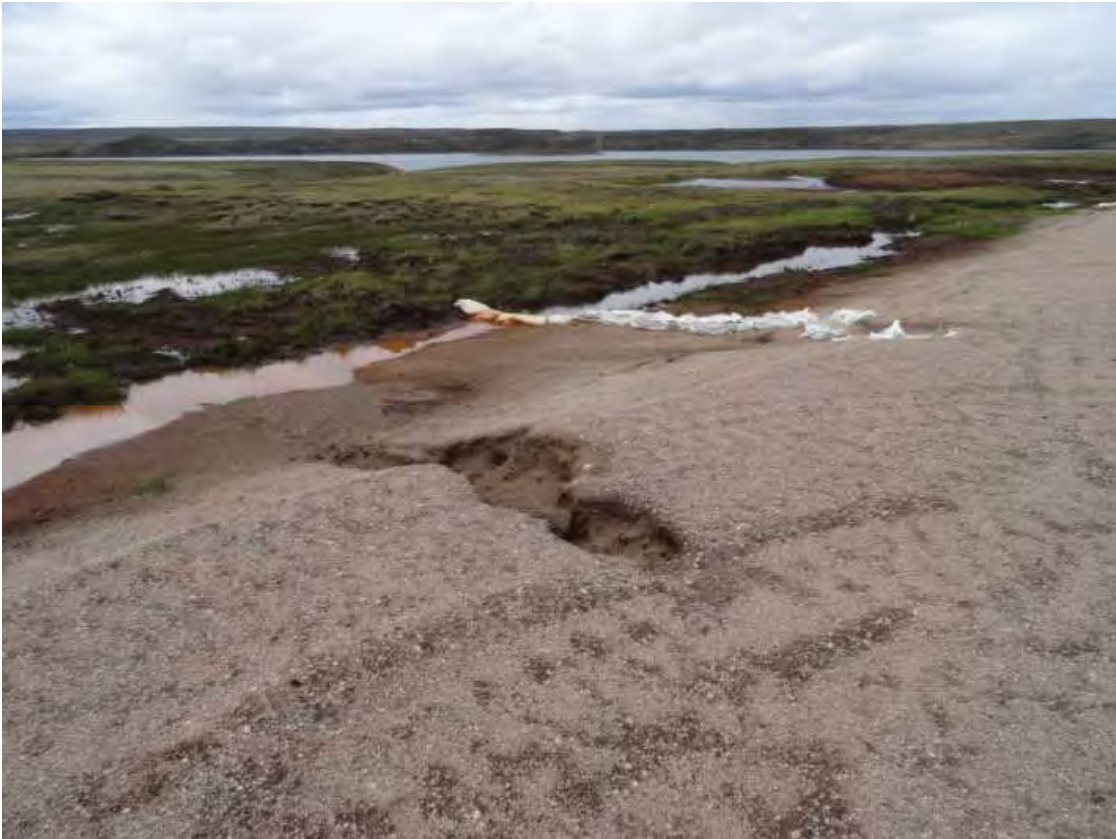
Figure 17. Permafrost degradation leading to deterioration of airstrip and sediment in the water.

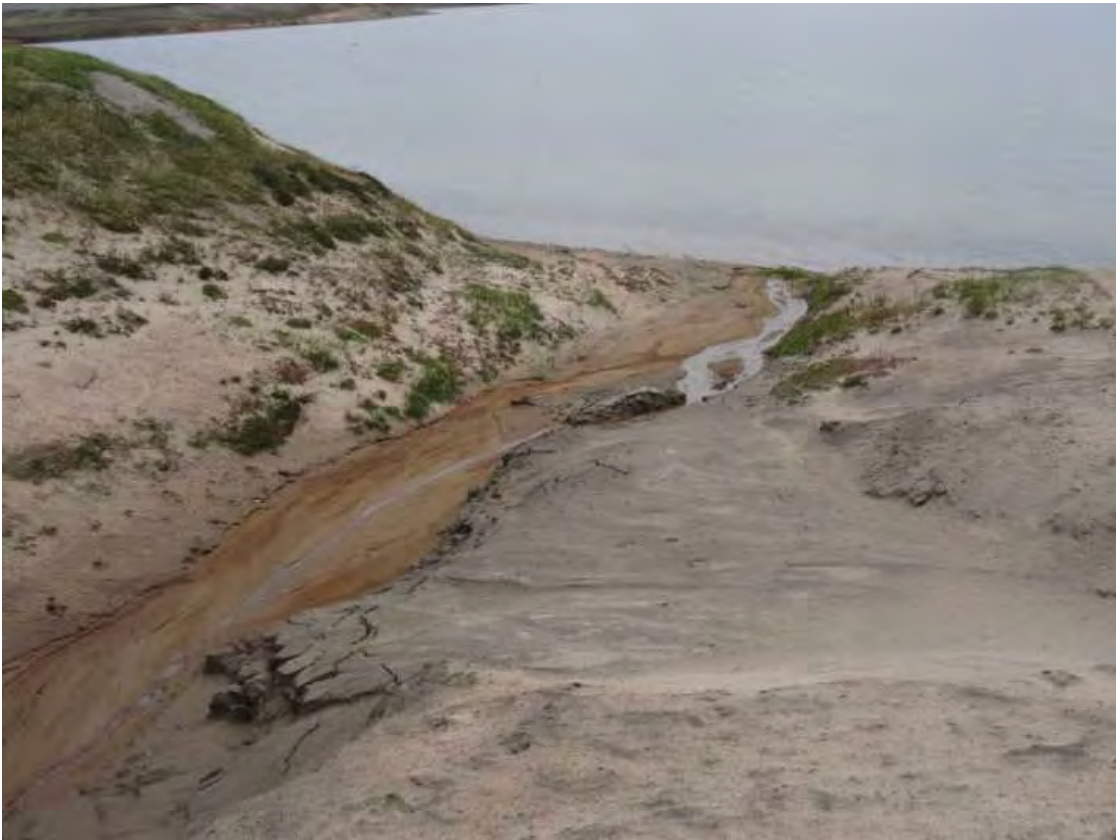
Figure 18. Camp drainage: original flow on left, new channel on right.

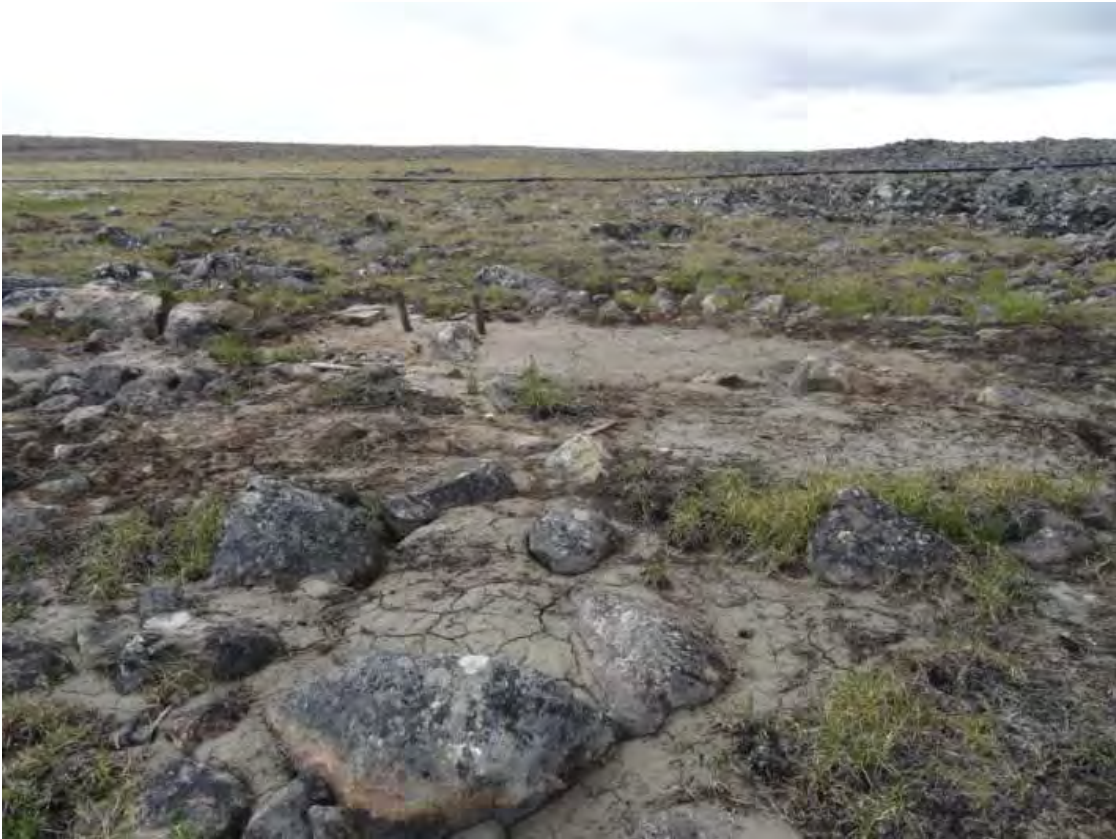
Figure 19. Drill sites require reclamation.

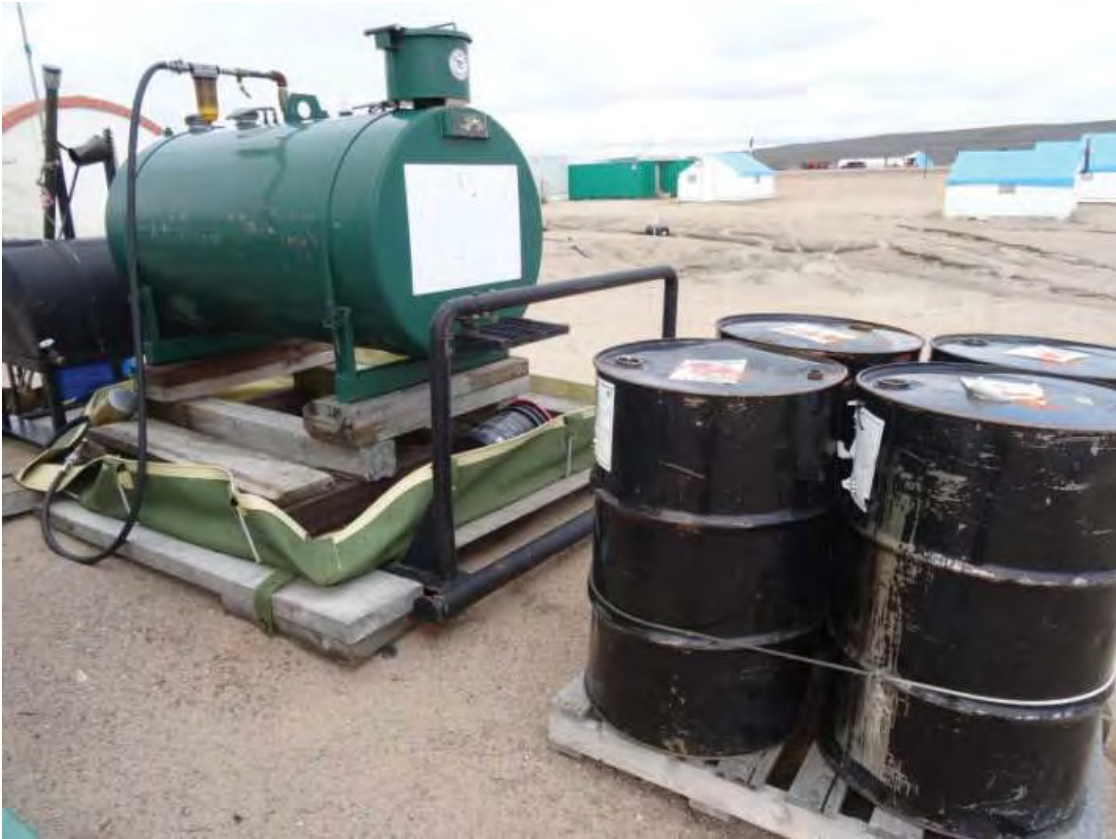
Figure 21. Barrels out of containment at the incinerator.

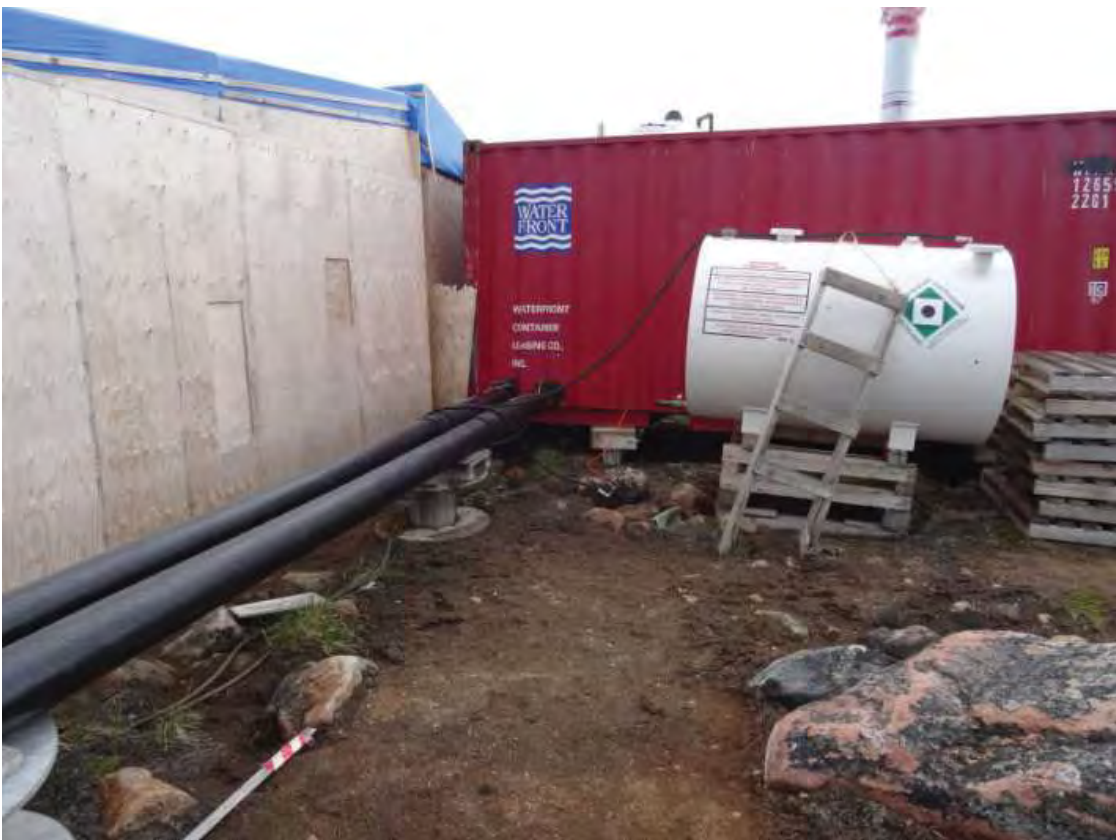
Figure 22. While tank may be double-walled, the hoses and valves are not. Secondary containment is required.

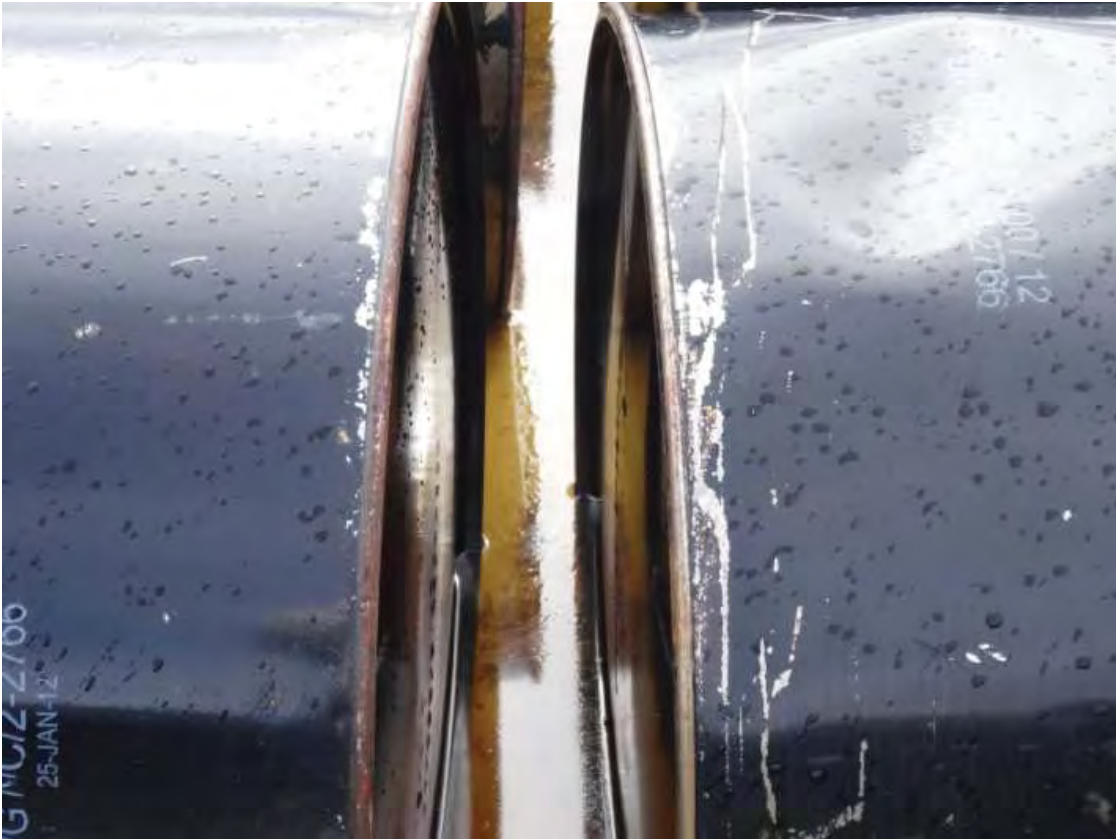
Figure 23. Contaminated water in Three-Bluffs berm 2.

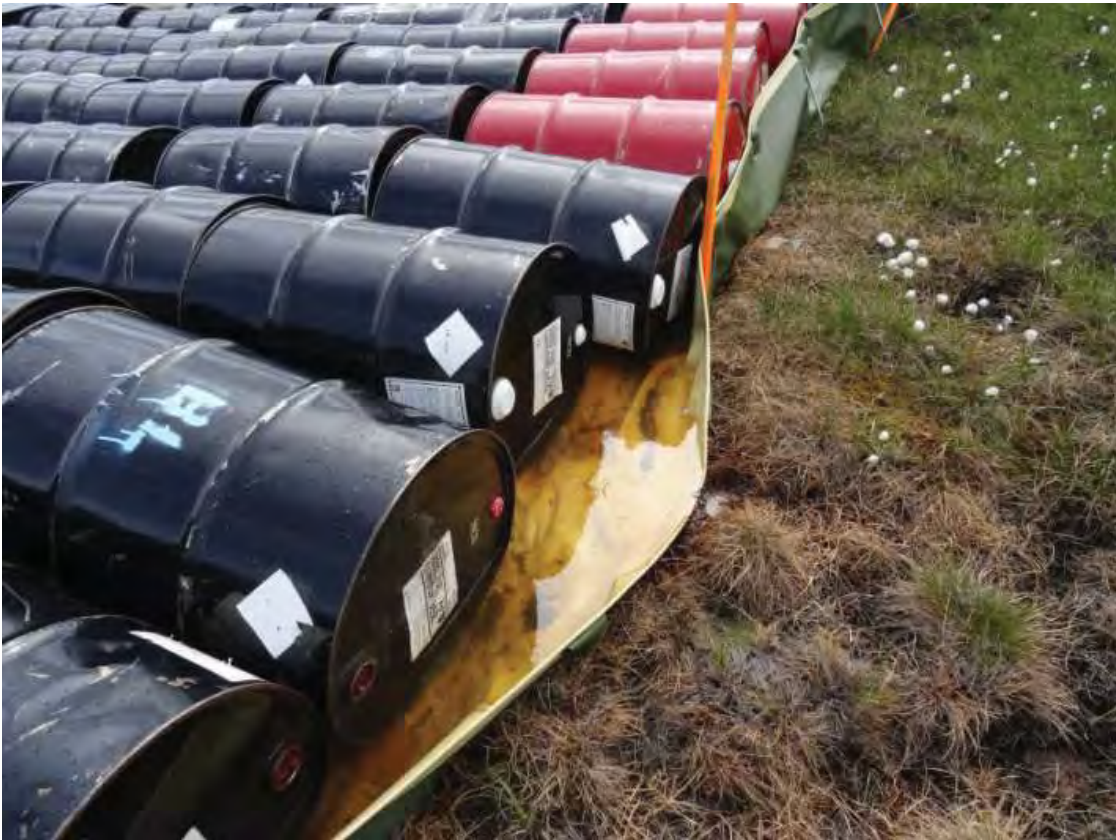
Figure 24. Collapsed side of Three Bluffs berm 2, leaking contaminated water.

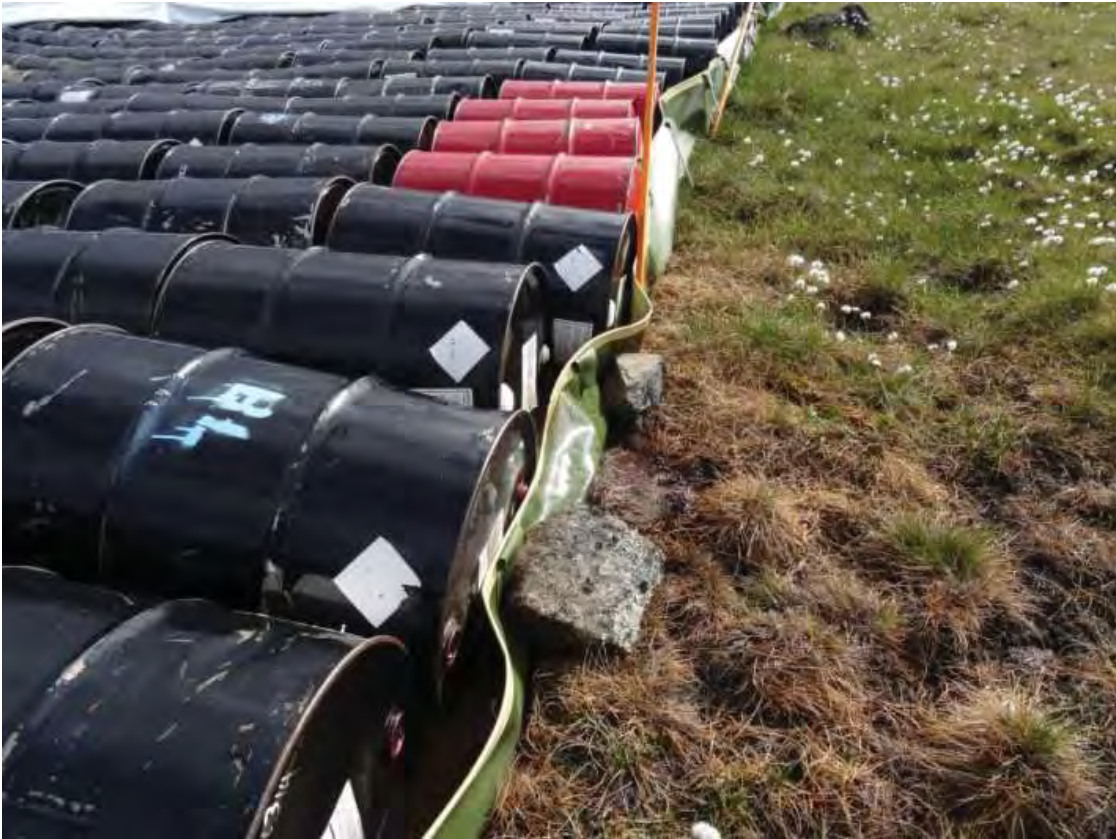
Figure 25. I propped up the side for a temporary fix. More precipitation will cause further overflow of contaminated water.

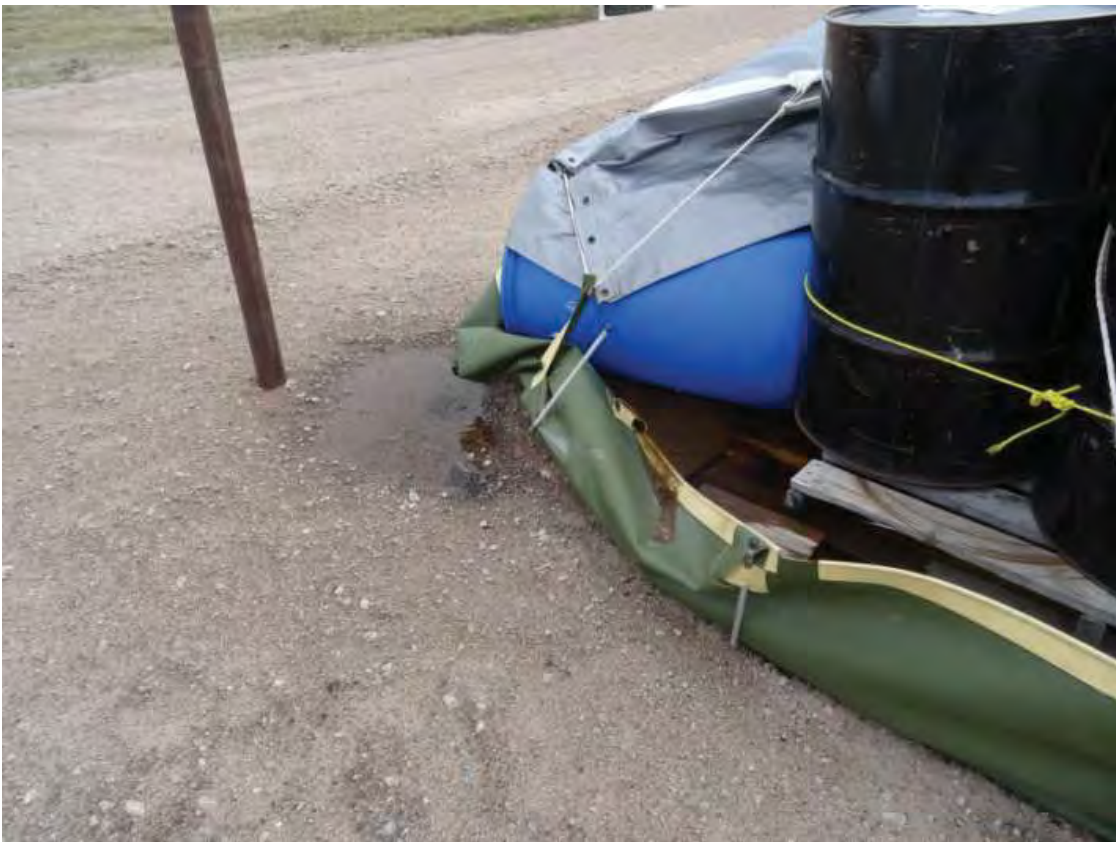
Figure 26. Hayes Camp berm; corner dripping. No obvious contamination at this time.

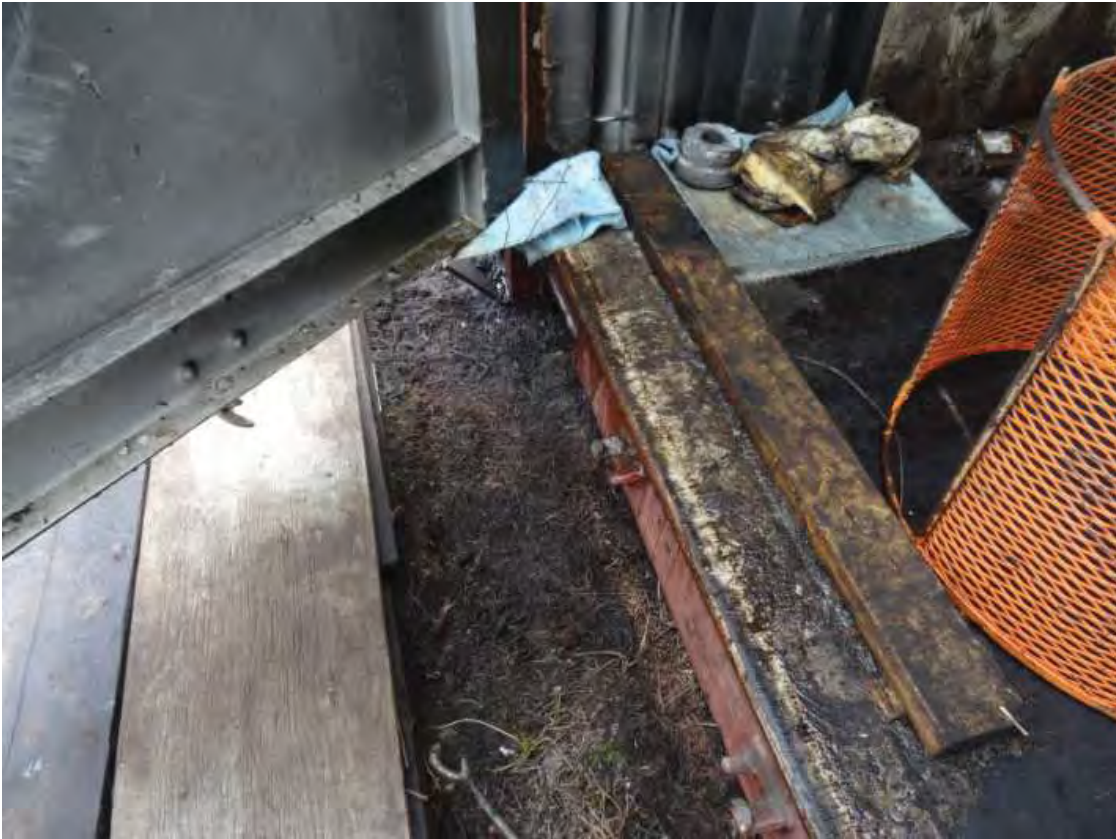
Figure 27. Sea-can leaking oil-contaminated water; there is water coming into the sea-can and flowing through.

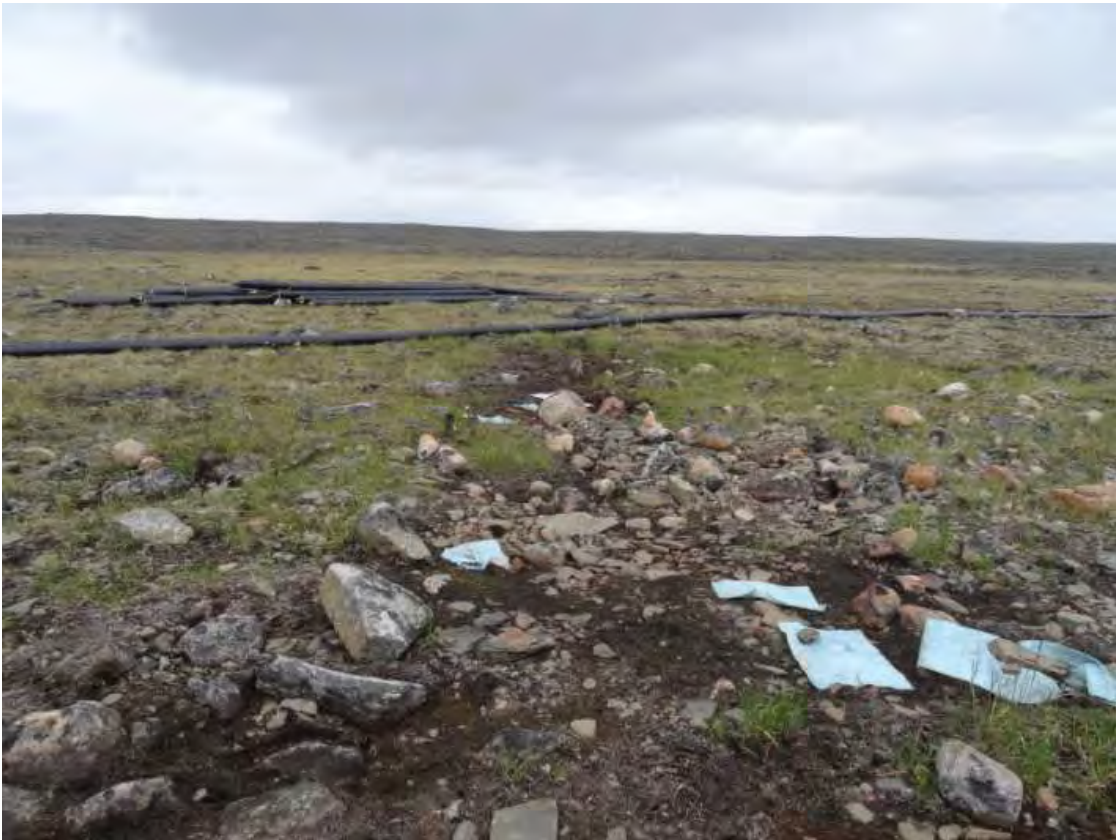
Figure 28. 2012 spill at the boiler. Spill pads are still widespread and holes have not been backfilled.

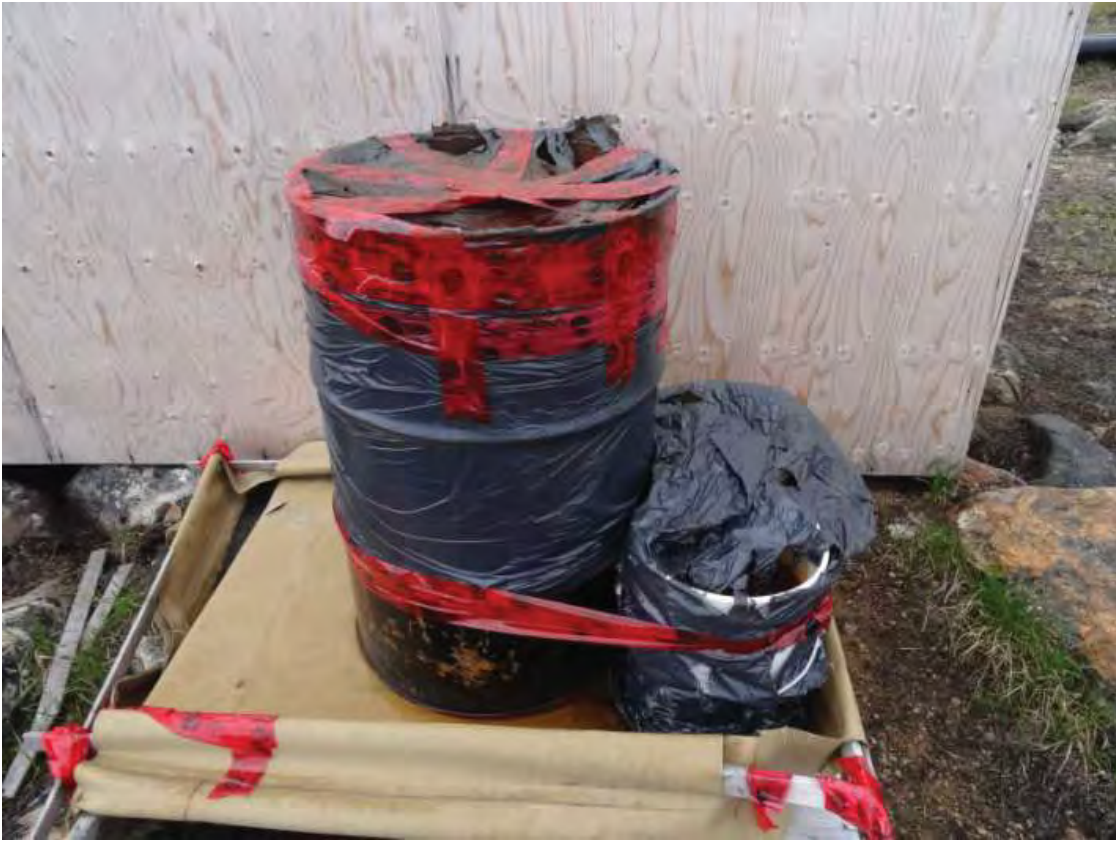
Figure 29. Covered drums of assumedly contaminated material at the boiler. Berm is destroyed, and barrel contents are exposed.
