## **REMEDIAL ACTION REPORT**

Detailing work completed to address  
*2013 Land Use Inspection Report and 2014 Water Licence Inspection Report*

### **COMMITTEE BAY PROJECT Kitikmeot Region, Nunavut Territory, Canada**

30 September 2014

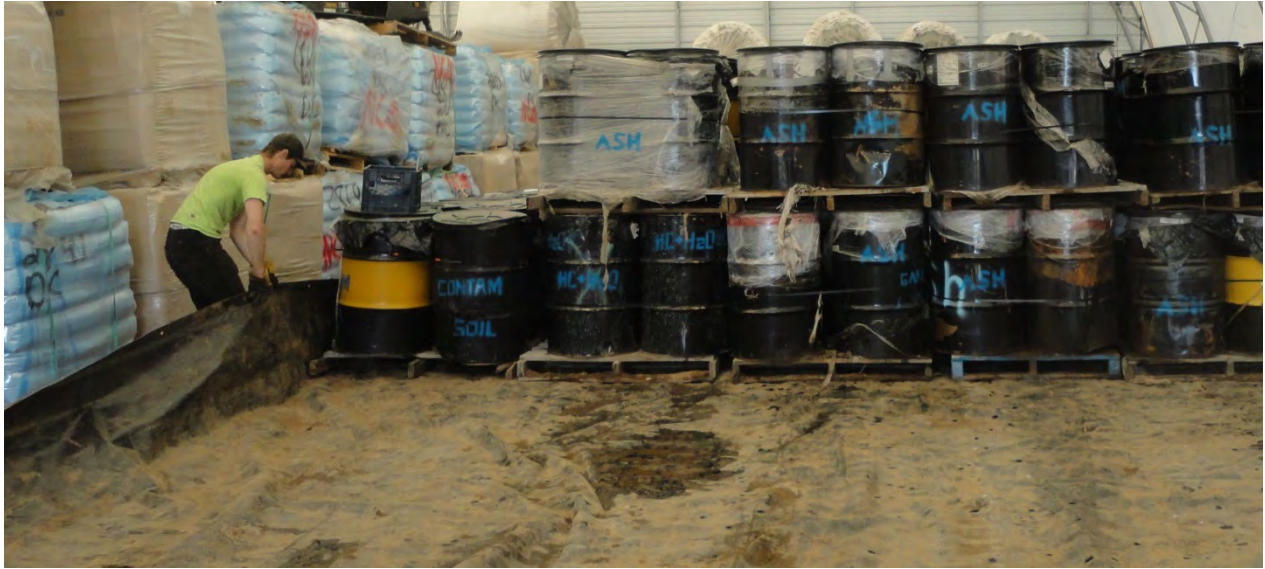
Figure 2 – Securing berm walls.

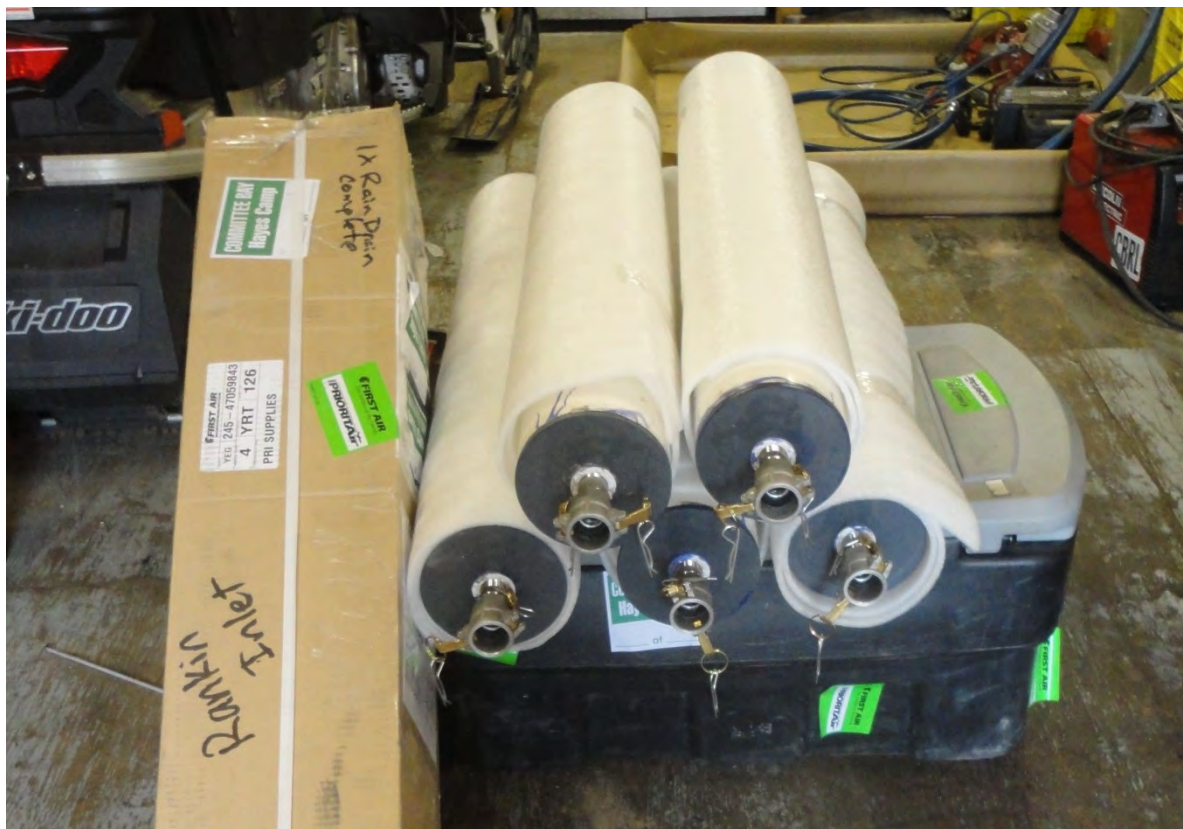
Figure 4 – New rain drain filters ready for installation

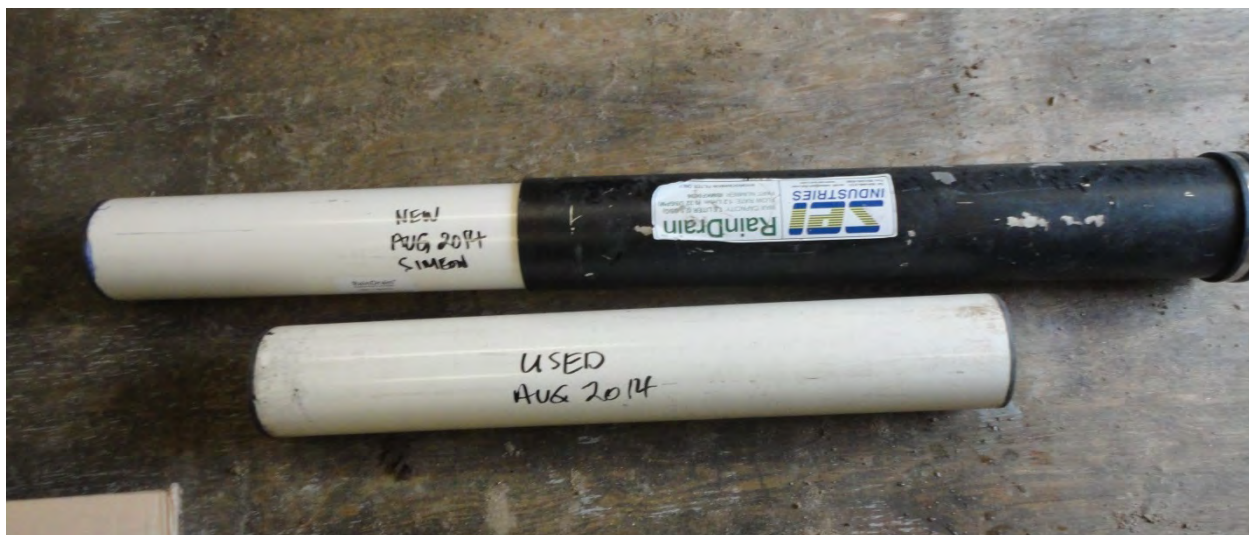
Figure 5 – Rain drain filters replaced.

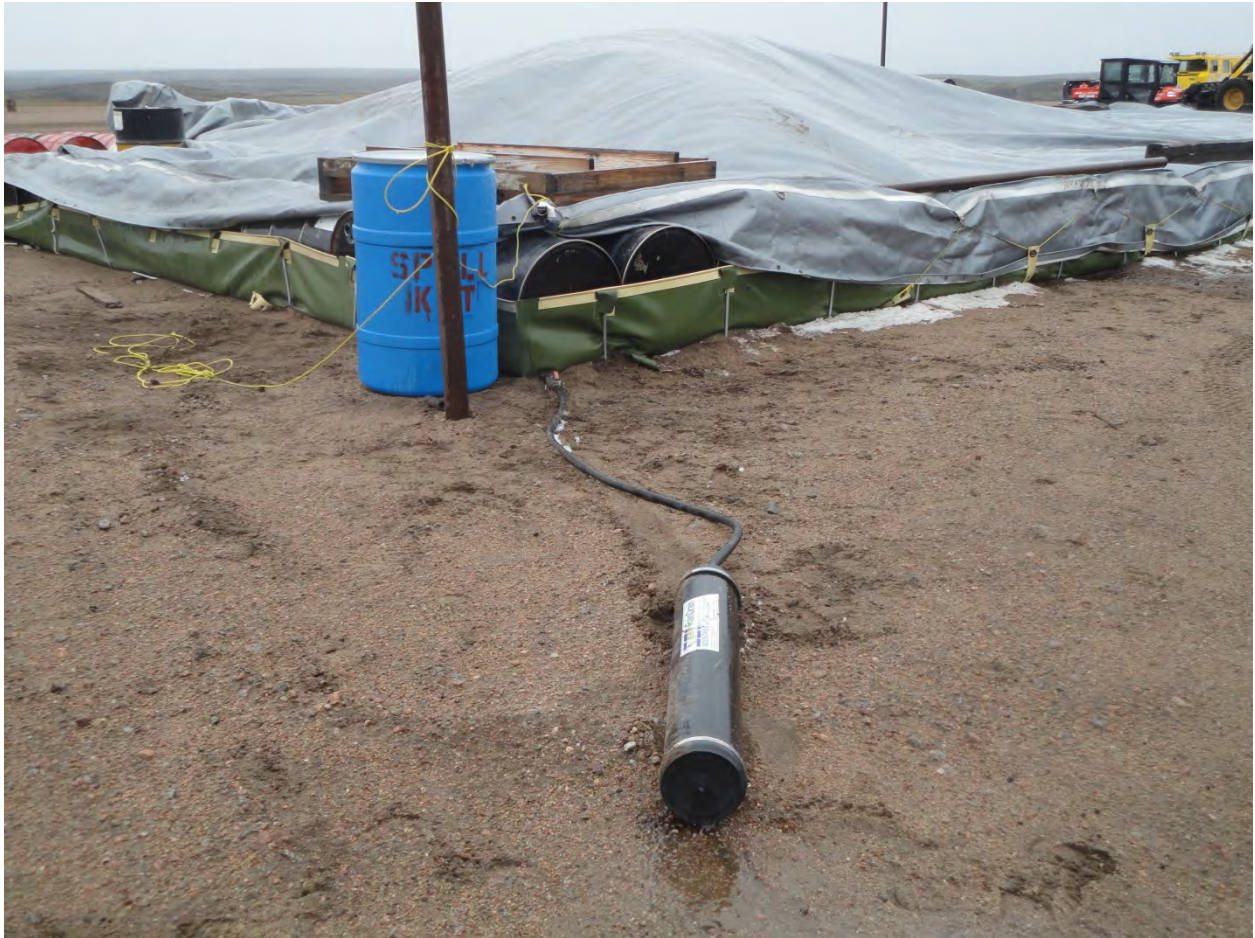
Figure 6 – Rain Drain filters attached to drain water from berm

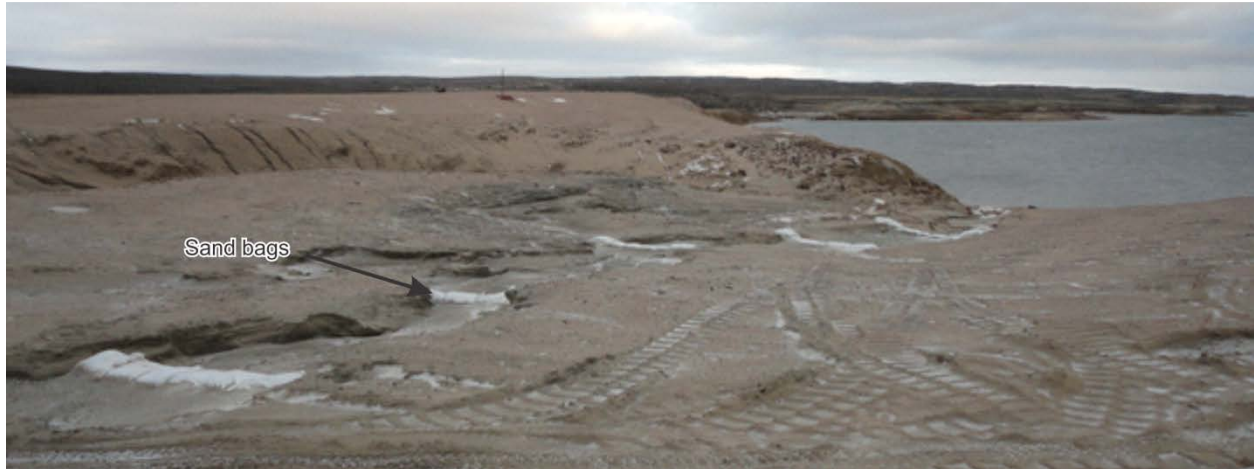
Figure 11 – Erosion control measures implemented (view southeast)

- Filling new erosion ruts with sandbags to prevent further erosion
- Creating sand bag dams on steep slopes to reduce the velocity of moving water and prevent further erosion. Dams were constructed using permeable burlap sand bag to minimize ponding of water.
- Silt fences were installed on gentle slopes to collect sediment and prevent entry into Sandspit Lake.

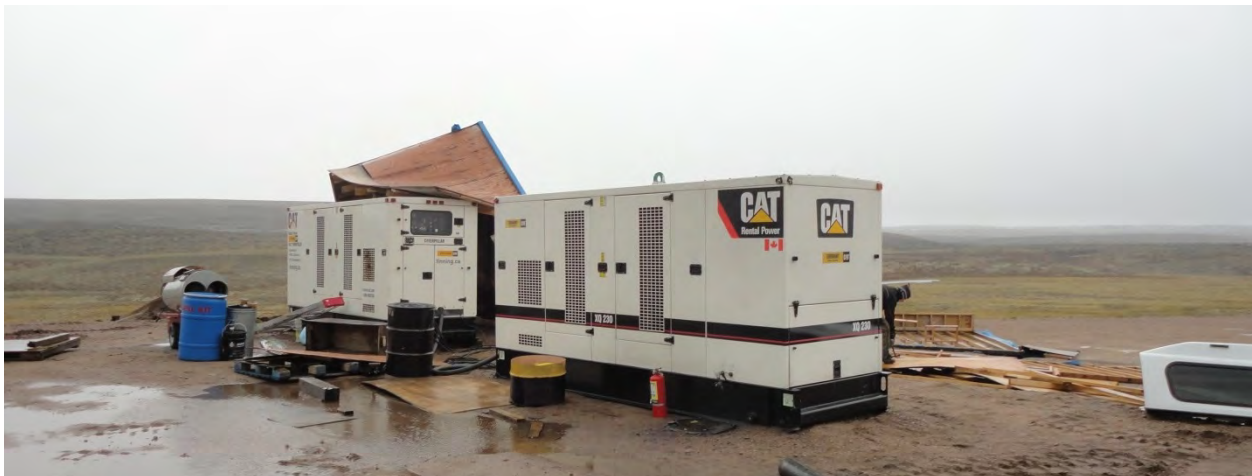
Figure 12 – Demolished Power Generation Shack

The power generation shack housing the Hayes Camp generators that was destroyed during the strong wind was removed, salvaged and a new shack constructed. All garbage and debris from the damaged shack was removed.

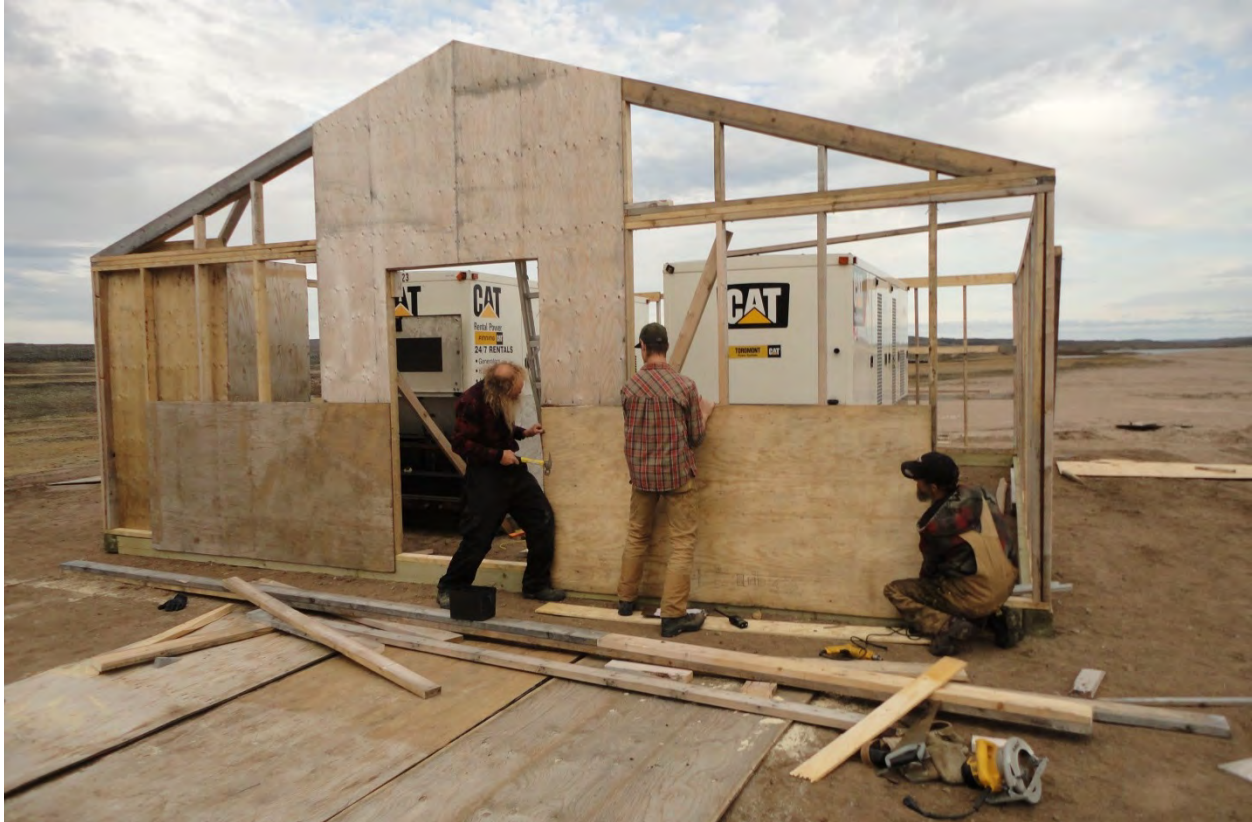
Figure 13 – NCGC staff rebuilding Generator shack. Generators repositioned enable more suitable and wind resistant construction.

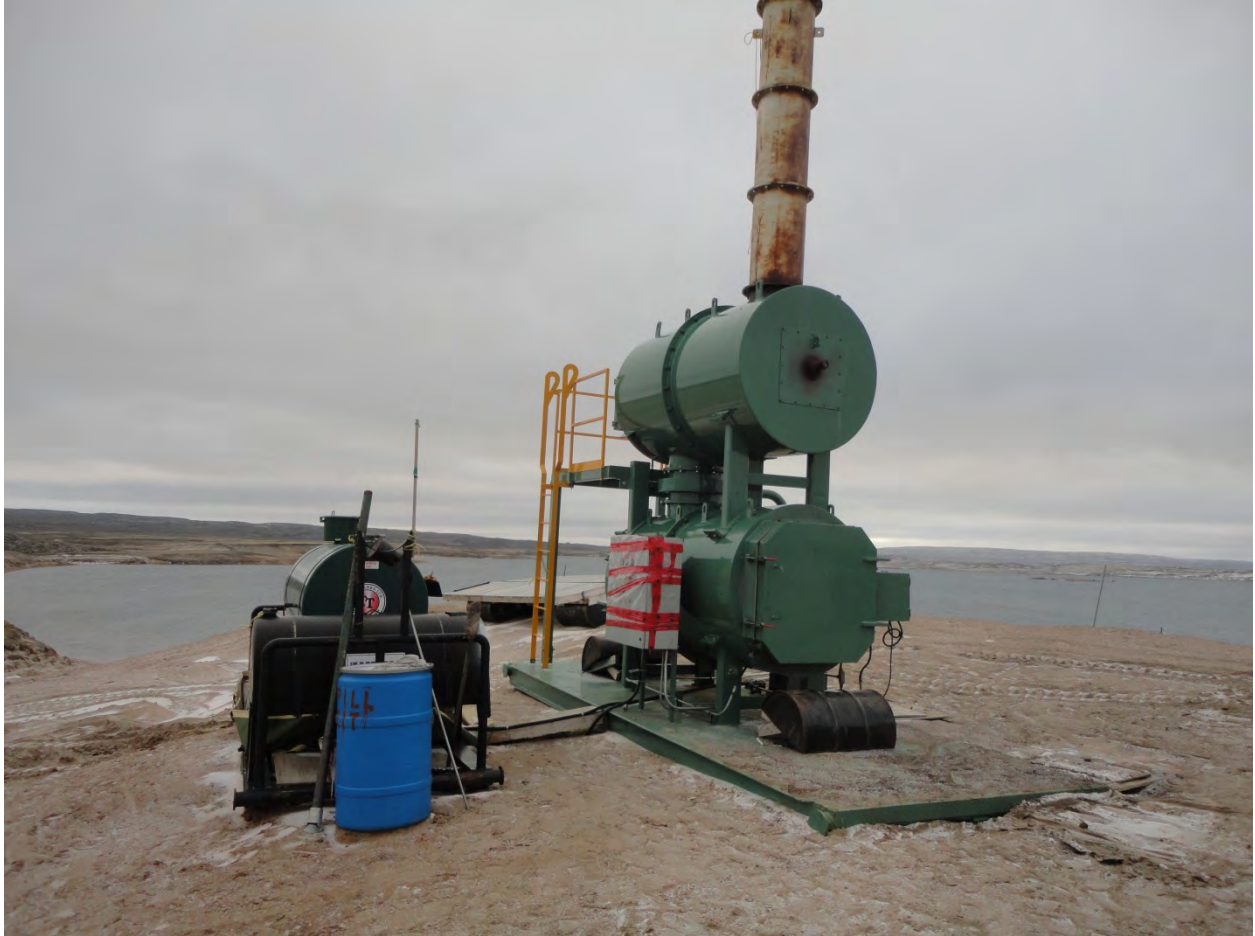
Figure 17 – Hayes camp incinerator site.

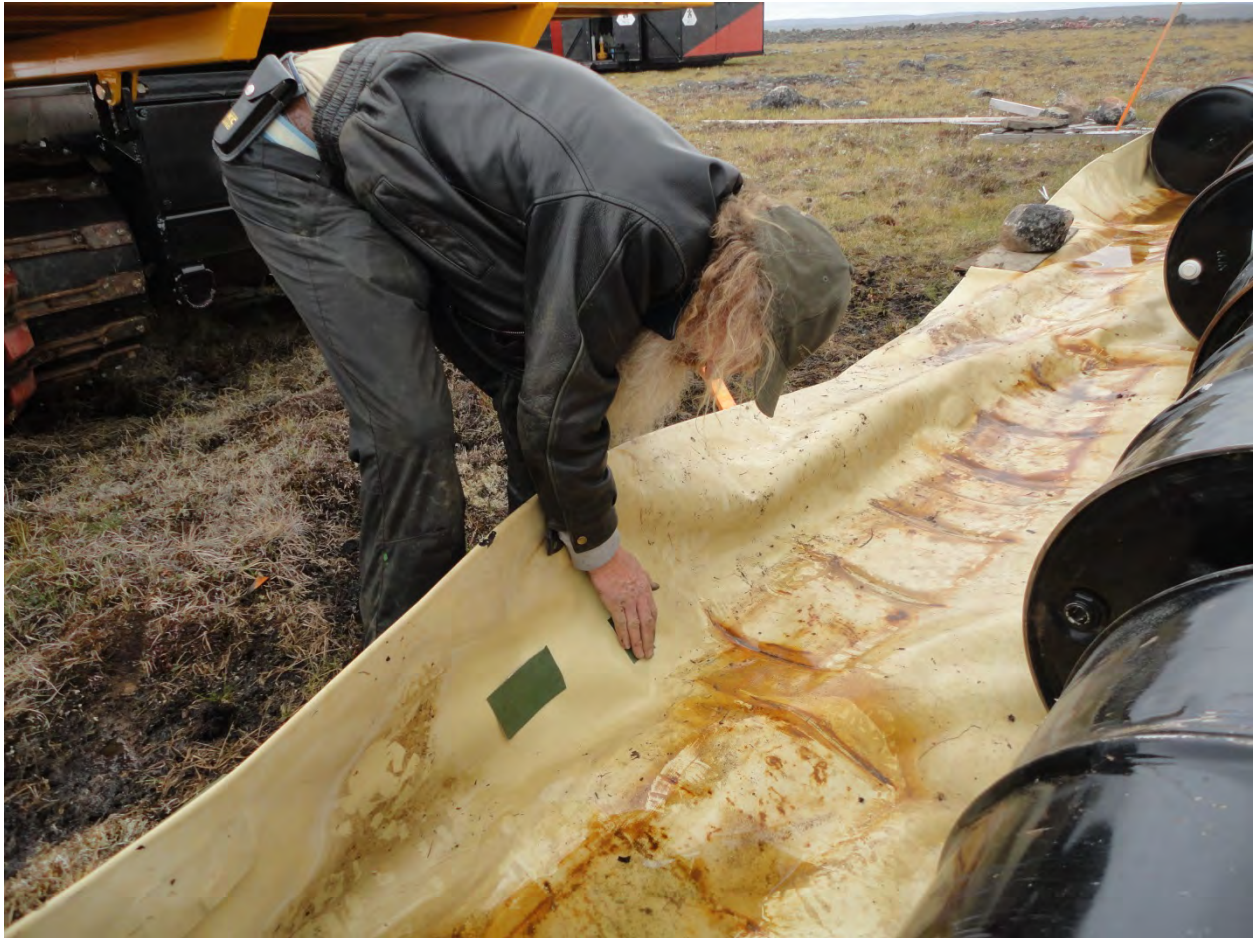
Figure 19 – Repairing damaged fuel berm

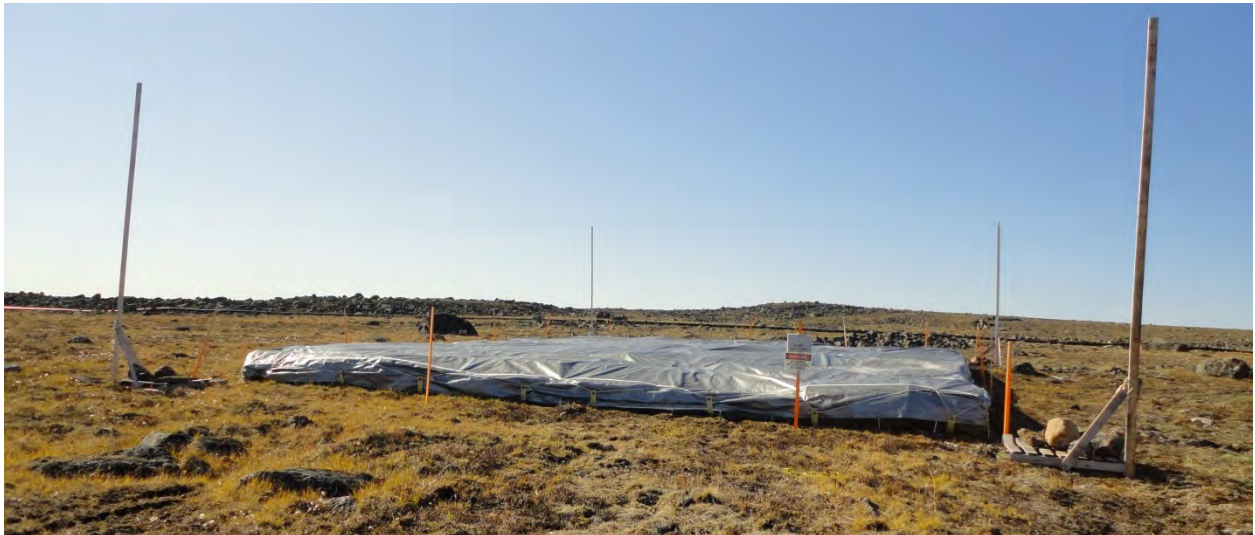
Figure 22 – Covered P50 fuel berm 3 (Three Bluffs – looking west; See 2014 Inspection report Figures 12 and 15).

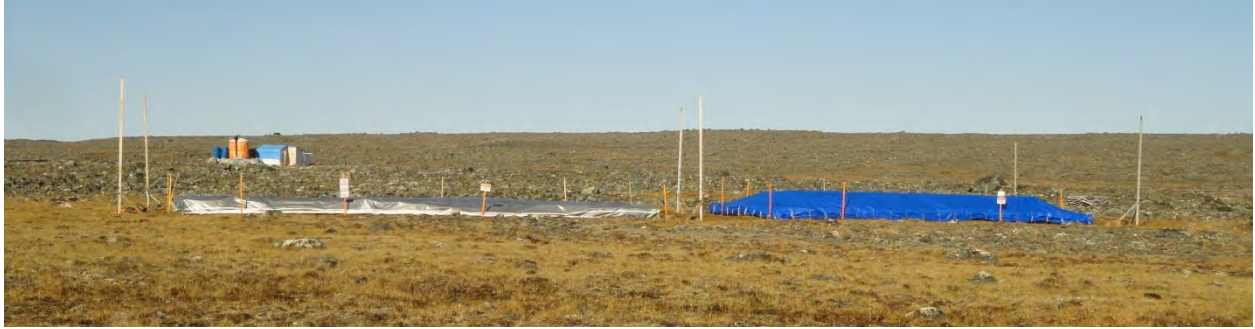
Figure 23 – Berms 1 and 2 (Three Bluffs)

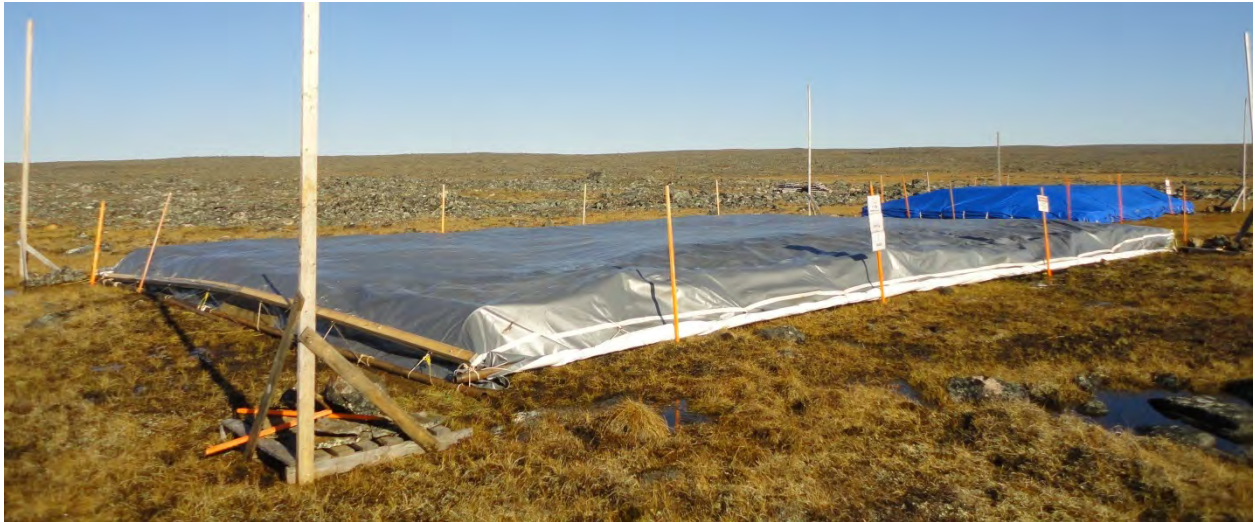
Figure 23 – Berm 2 at Three Bluffs (2014 Inspection report Figures 11, 14, 23, 24, 25).

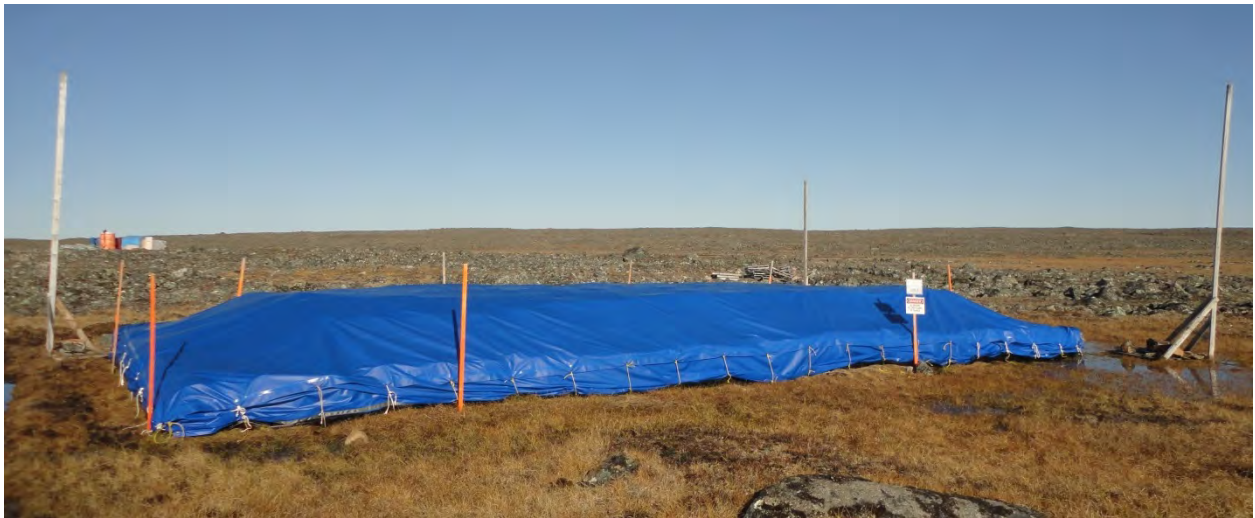
Figure 24 – Fuel Berm 1 at Three Bluffs (2014 Inspection report Figures 11 and 14)

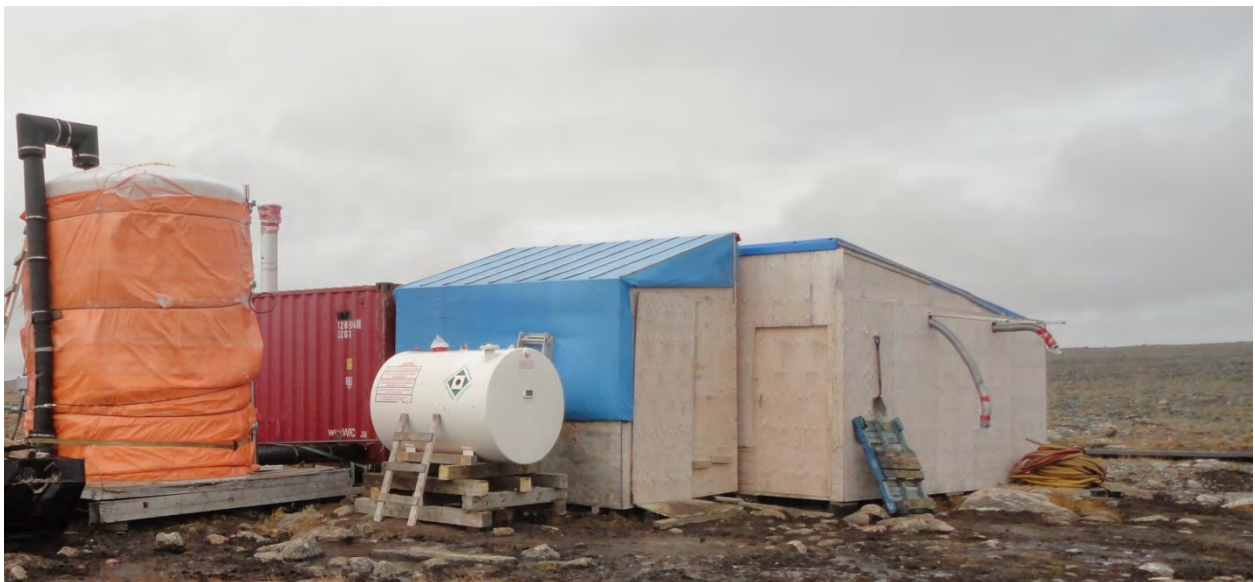
Figure 28 – Boiler site. Drums containing soil from 2012 fuel spill removed to Hayes Camp (See 2014 Inspection report Figure 29)

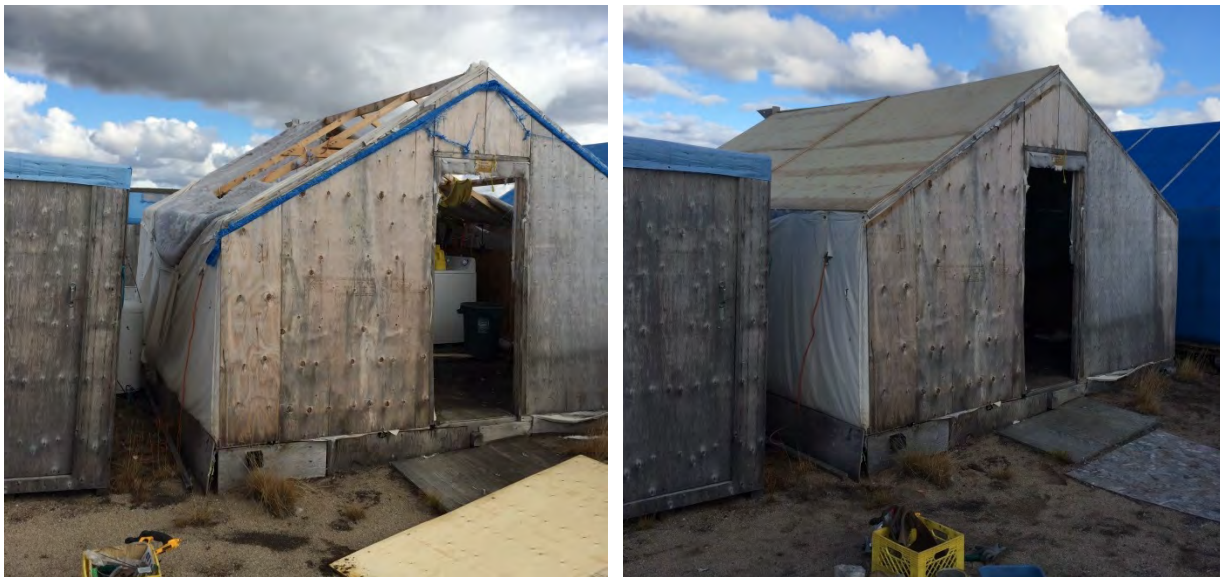
Figure 32 – Repaired roof at Bullion Camp.

NCGC completed camp maintenance at Bullion camp during the 2014 program. Damaged tents were repaired wherever possible. One tent was re-roofed. A number of canvasses were removed from the tent frames where the extent of damage was beyond repair.

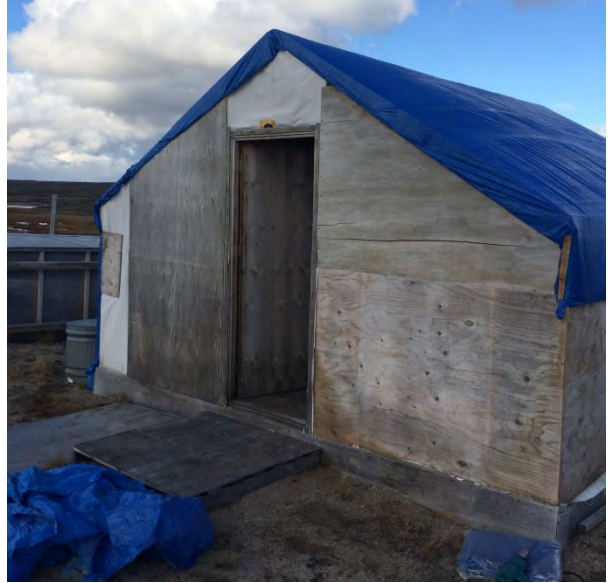
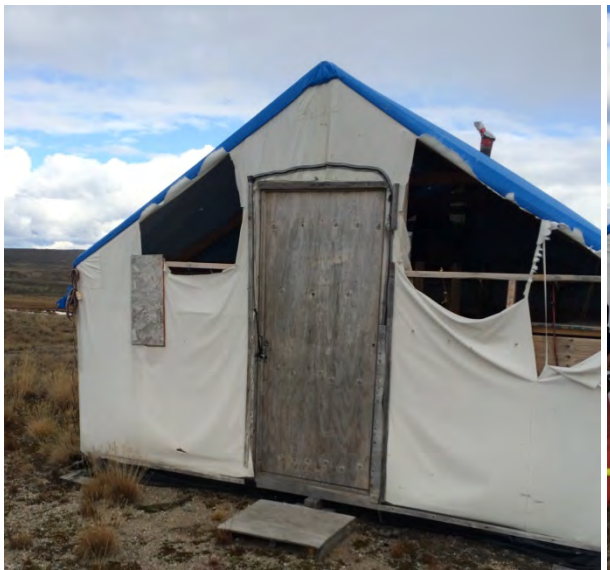
Figure 34 – Repaired tent canvas at Bullion Camp.

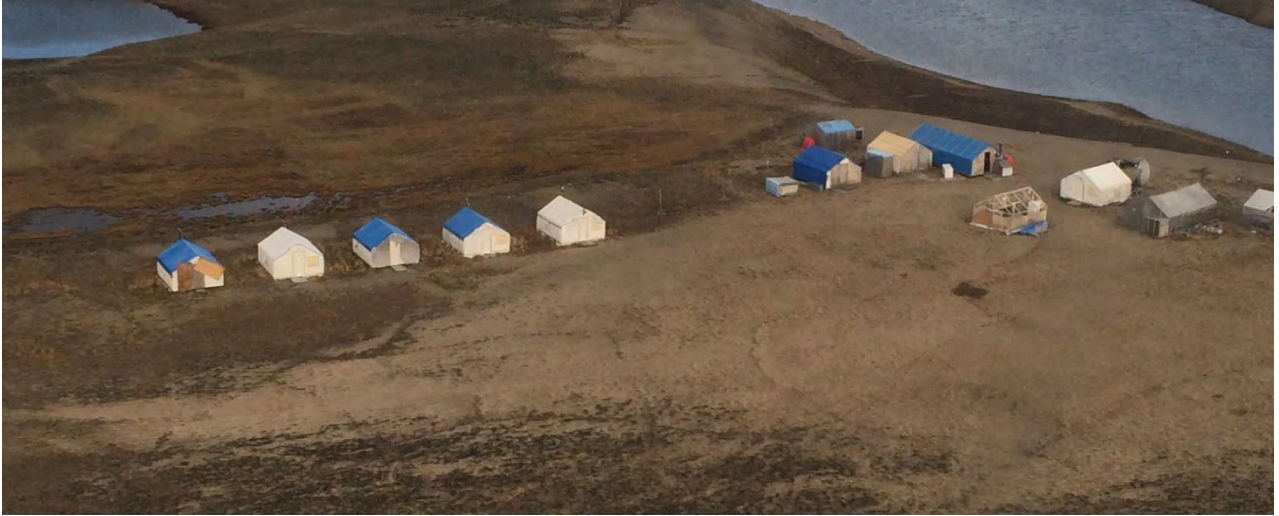
Figure 35 – Bullion Camp after maintenance.

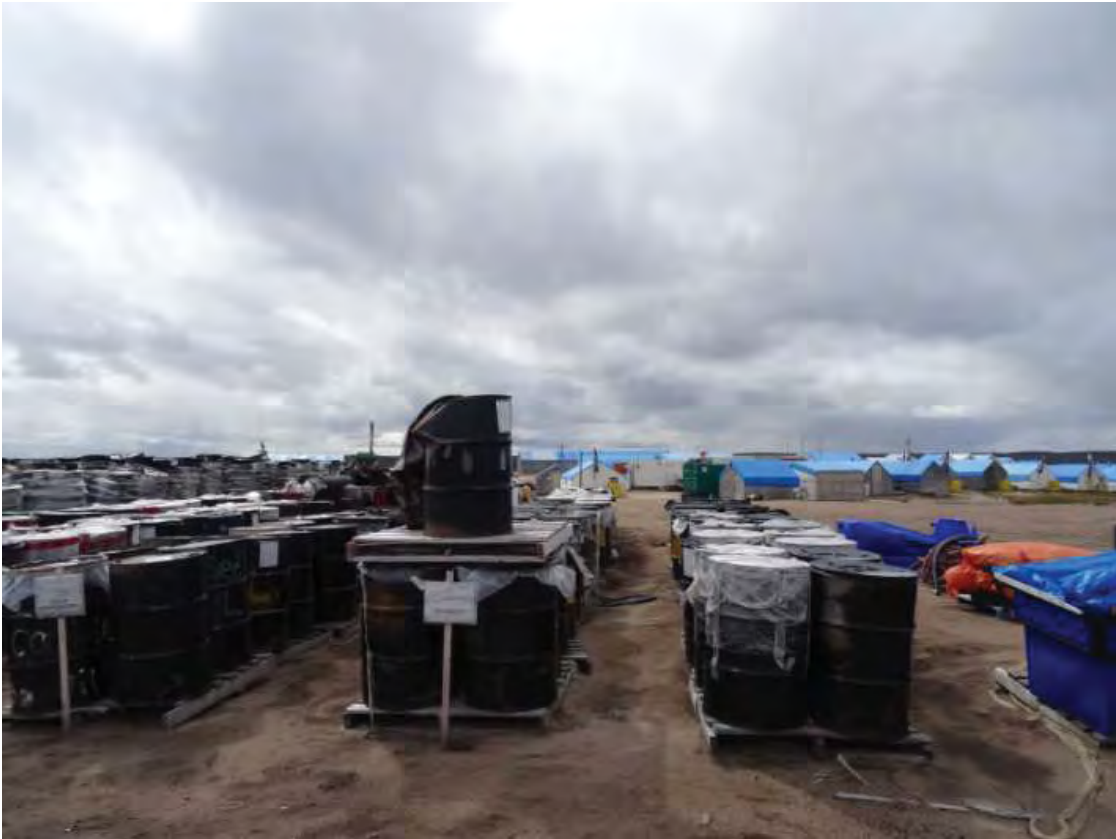
Figure 3. Waste area at Hayes. Garbage barrels.

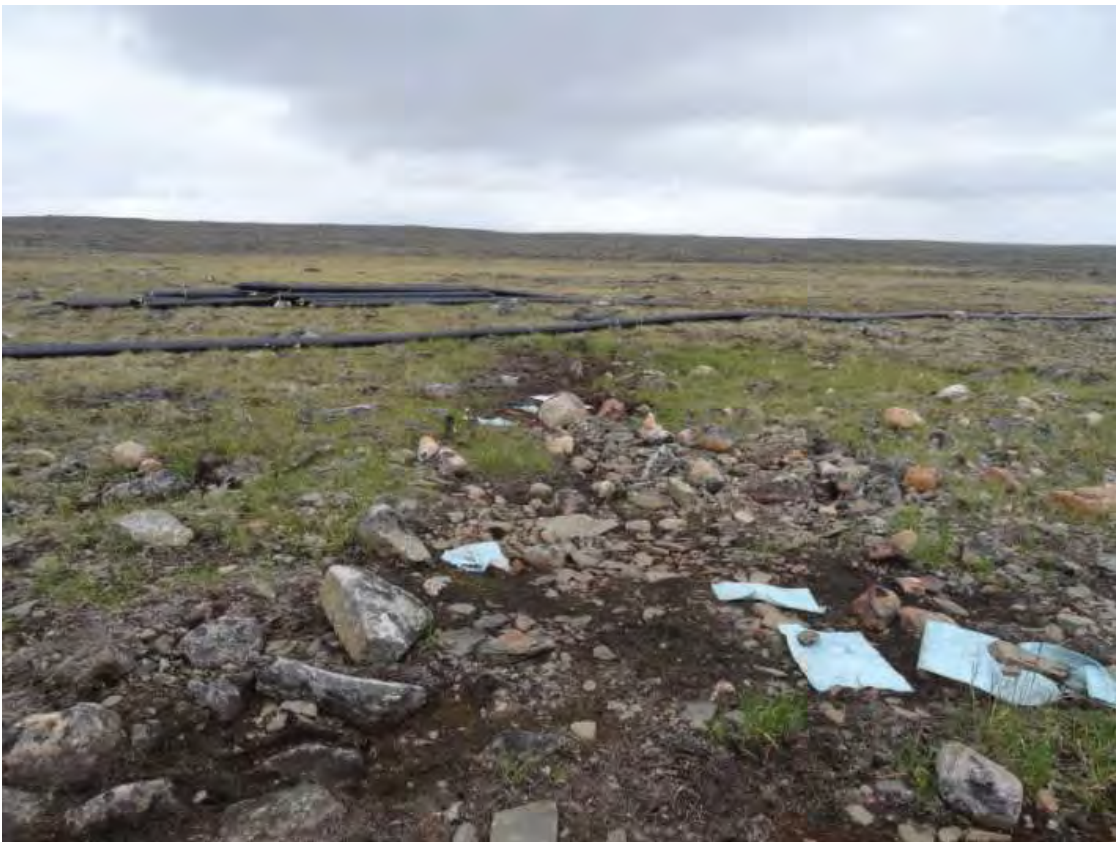
Figure 28. 2012 spill at the boiler. Spill pads are still widespread and holes have not been backfilled.

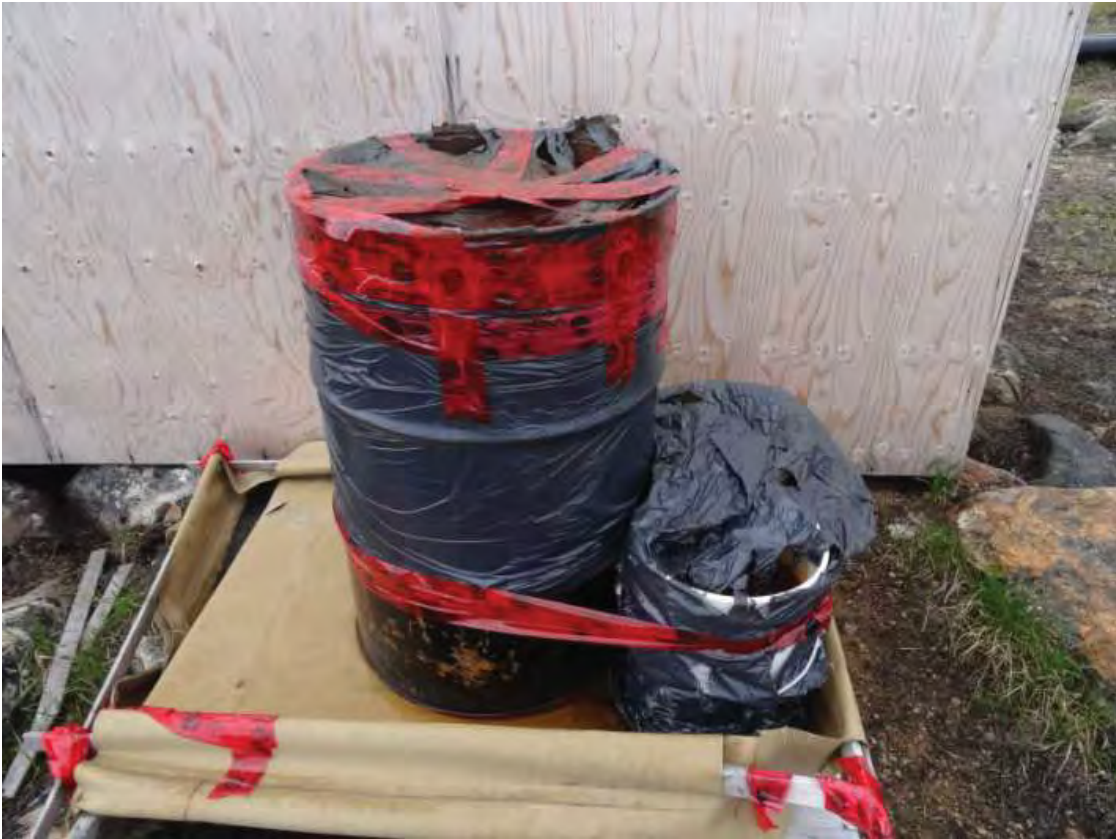
Figure 29. Covered drums of assumedly contaminated material at the boiler. Berm is destroyed, and barrel contents are exposed.
