RE: NWB Licence No. 2BE-CYG0406

## WATER USE INSPECTION FORM

Date: July 15 2012	Licensee Rep. (Name/Title): N/A
Licensee: Burnstone Ventures	Licence No.: 2BE-CYG0406

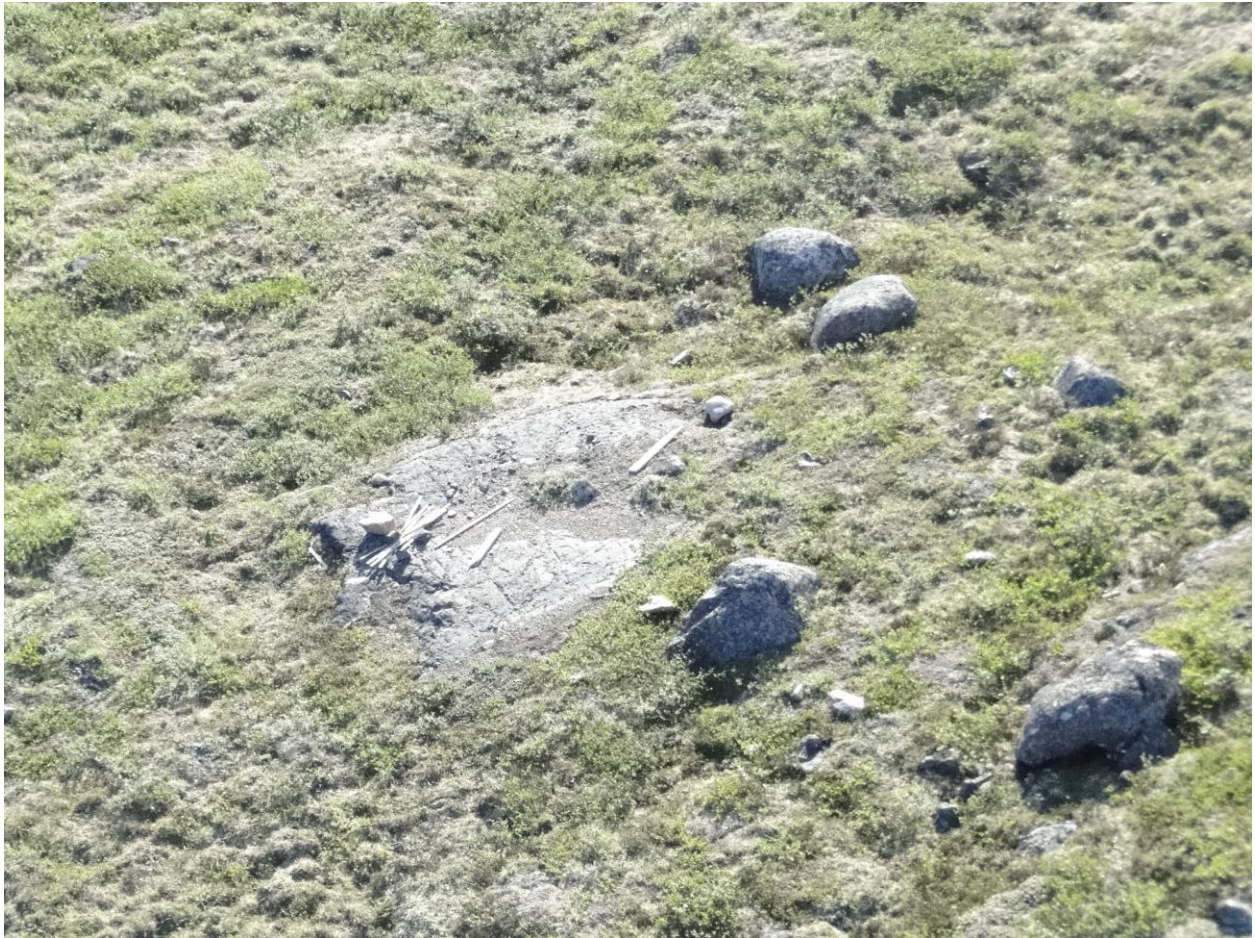
Some wooden debris present at camp location: N67 36 36.0 W110 45 05.0

**Figure 1. Wooden debris found at N67 36 36.0 W110 45 05.0**

- Licencee is to contact the inspector (undersigned) by September 7, 2012 to discuss a date when the debris and barrels will be removed.

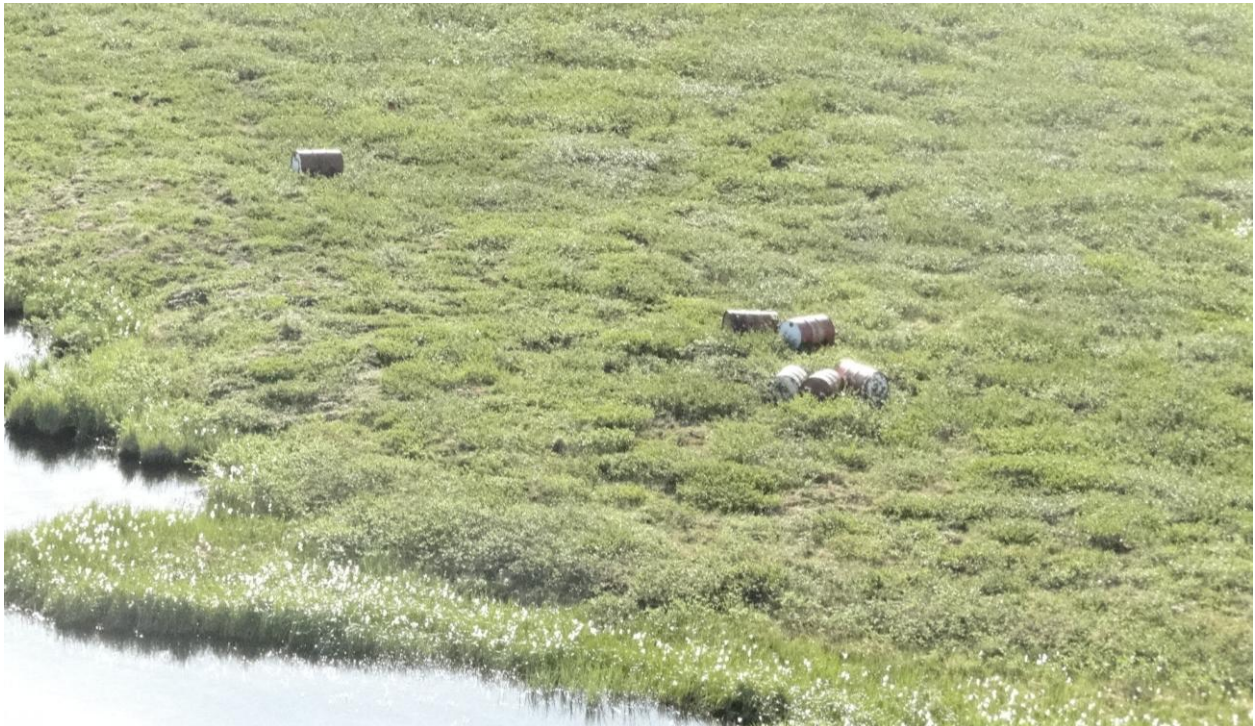
8 old drums, empty, at the location marked in the file as the fuel cache for this project:

N67 39 42.9 W110 50 20.2

Barrels should have been backhauled at the conclusion of the project.

**Figure 2. Barrels seen at N67 39 42.9 W110 50 20.2. Two other barrels present, along the shore.**
