RE: NWB Licence No. 2BE-CYG0406

## WATER USE INSPECTION FORM

| Date: July 15 2012 | Licensee Rep. (Name/Title): N/A |
| Licensee: Burnstone Ventures | Licence No.: 2BE-CYG0406 |

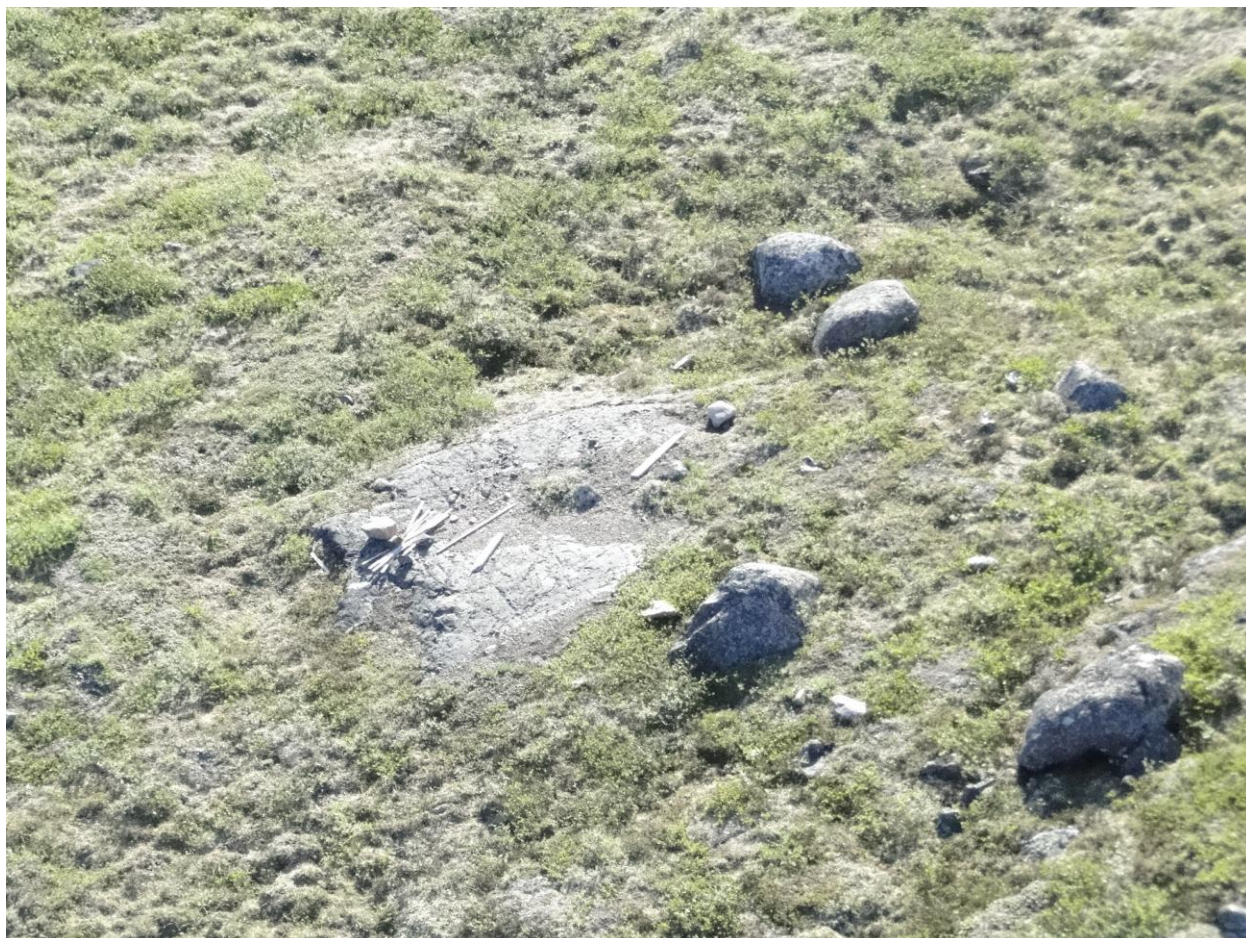
Some wooden debris present at camp location: N67 36 36.0 W110 45 05.0  
8 old drums, empty, at the location marked in the file as the fuel cache for this project:  
N67 39 42.9 W110 50 20.2

**Figure 1. Wooden debris found at N67 36 36.0 W110 45 05.0**

- Licencee is to contact the inspector (undersigned) by September 7, 2012 to discuss a date when the debris and barrels will be removed.

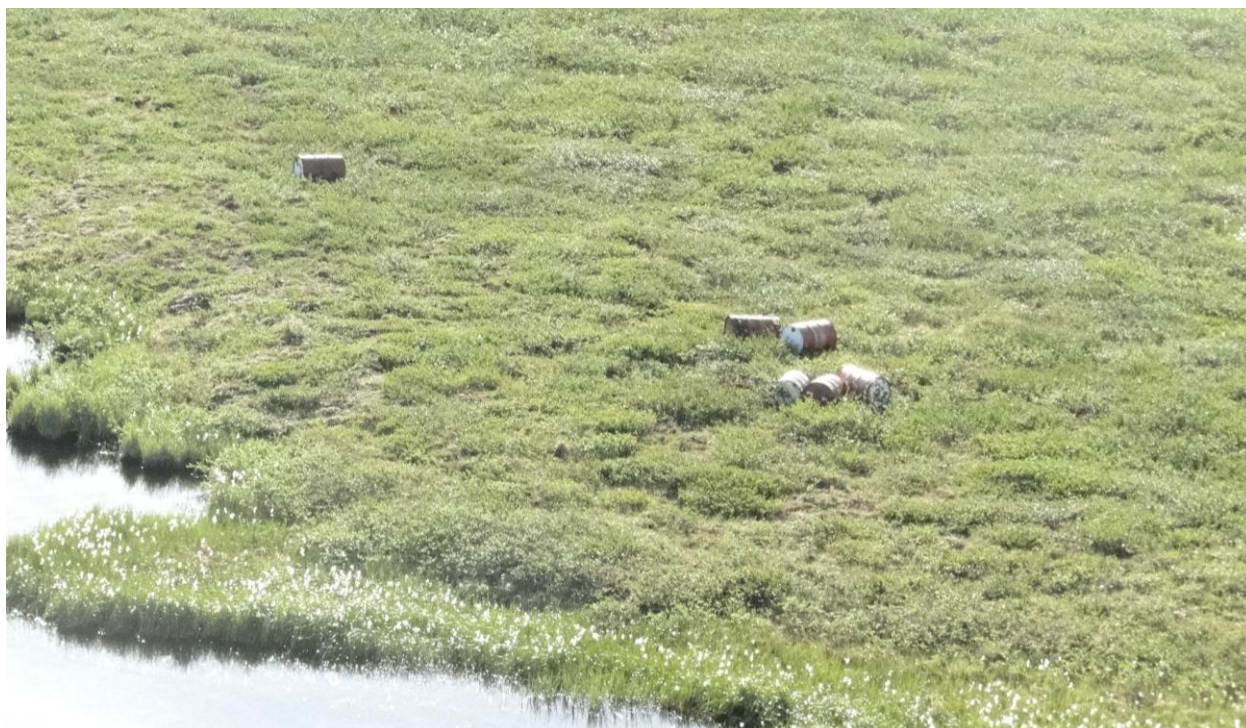
Barrels should have been backhauled at the conclusion of the project.

**Figure 2. Barrels seen at N67 39 42.9 W110 50 20.2. Two other barrels present, along the shore.**
