RE: NWB Licence No. 2BE-DBY1014, LUP N2005C0028

WATER LICENCE/LUP INSPECTION FORM

Date: August 10 2012	Licensee Rep. (Name/Title): N/A		
Licensee: Bluestone Resources / Teck Resources Ltd.		Licence No.: 2BE-DBY1014	LUP: N2005C0028

STELLAR CAMP

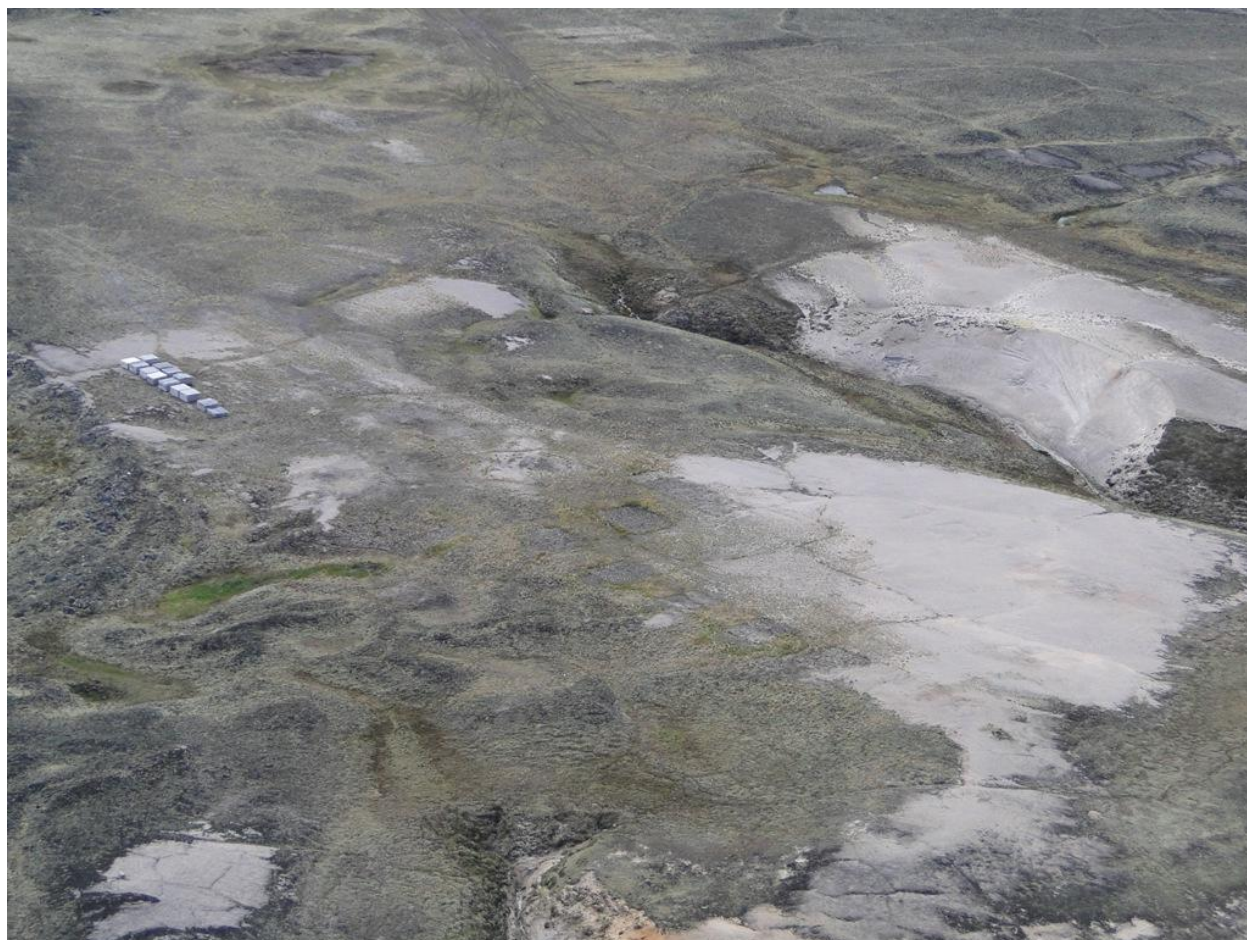
Camp has been removed. Dead vegetation remains where tent pads were placed. Latrine pit was not sufficiently backfilled. Sump is also still visible.

Figure 1. Stellar Camp Site. Tent outlines are visible in the vegetation. Excavations by the airstrip are visible at the top centre of photo.

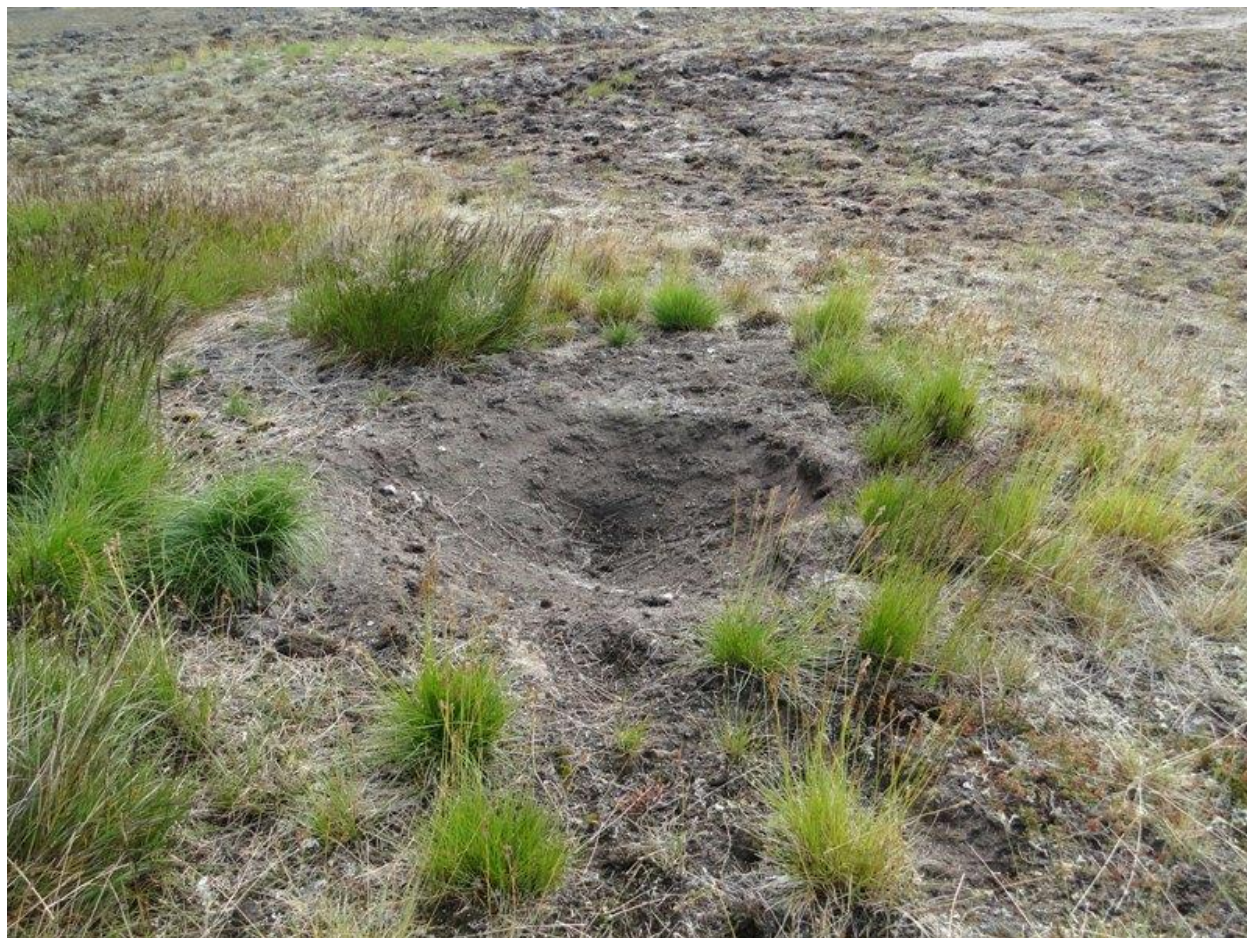
Item 4. Failure to backfill and restore sumps to the pre-existing contours of the land.

Figure 2. Sump or latrine pit - one of several holes to be backfilled and re-contoured.

- Barrels are to be collected from the creek.
- A thorough cleaning of the site is to be conducted to remove all the small bits of garbage and debris that remain. Nails and metal waste from burned buildings are to also be collected.
- Sump and latrine pit to be properly backfilled and re-contoured to prevent permafrost degradation.
- Hydrocarbon contaminated soil to be removed and backhauled as hazardous waste.
- Excavations at the airstrip to be backfilled and re-contoured to prevent permafrost degradation.
- Site cleanup is to be done during the snow-free period in 2013. A report is to be submitted to the Inspector by July 31 2013 with photos to show that the work is done.

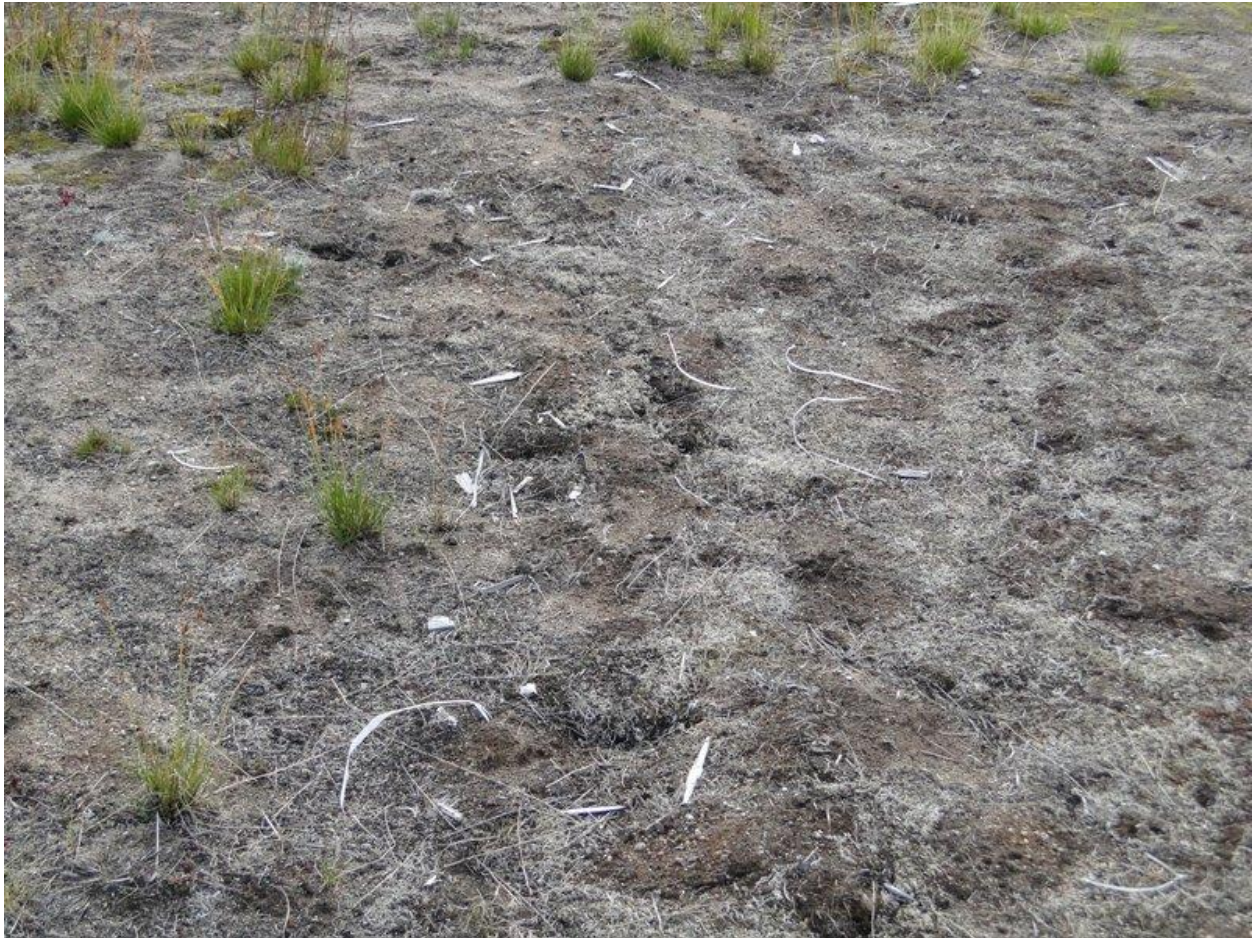
While large waste has been removed from the site, a thorough clean-up was not done. Small pieces of garbage litter the site: bits of plastic, shredded tarp material, burned remains of structures etc. There also remain 3 barrels in the creek which runs off the end of the runway. I was not able to check whether they are full or empty. A more thorough cleaning will be required before the licence or permit can be closed. Structures in camp were burned in place, leaving ashes, nails, hinges and other debris.

Figure 3. Small bits of garbage litter the campsite.

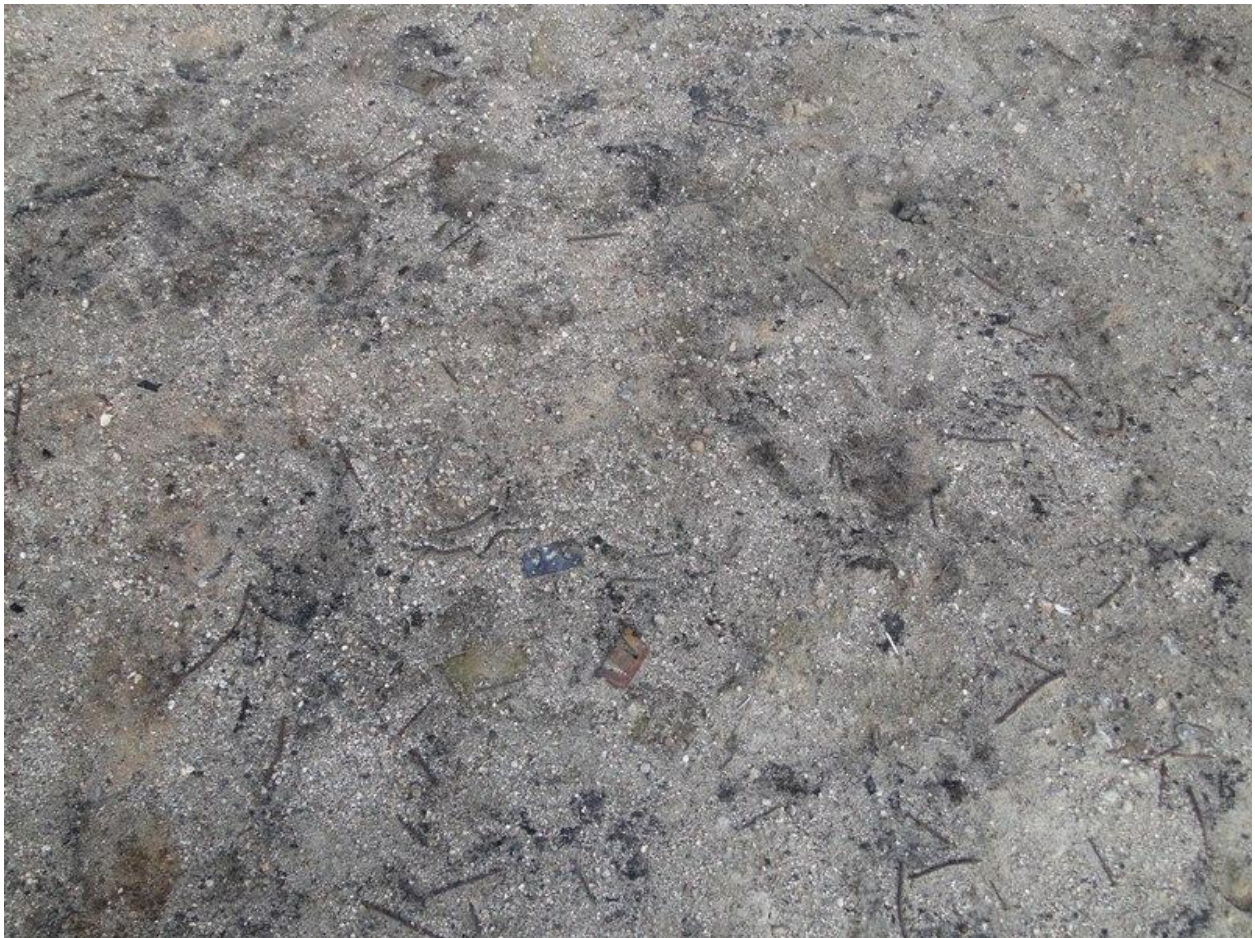
Item 5. Failure to remove barrels and waste. Burning of structures rather than removal is also contrary to this section.

Figure 4. Ashes, nails, hinges etc. where structures were burned without authorization.

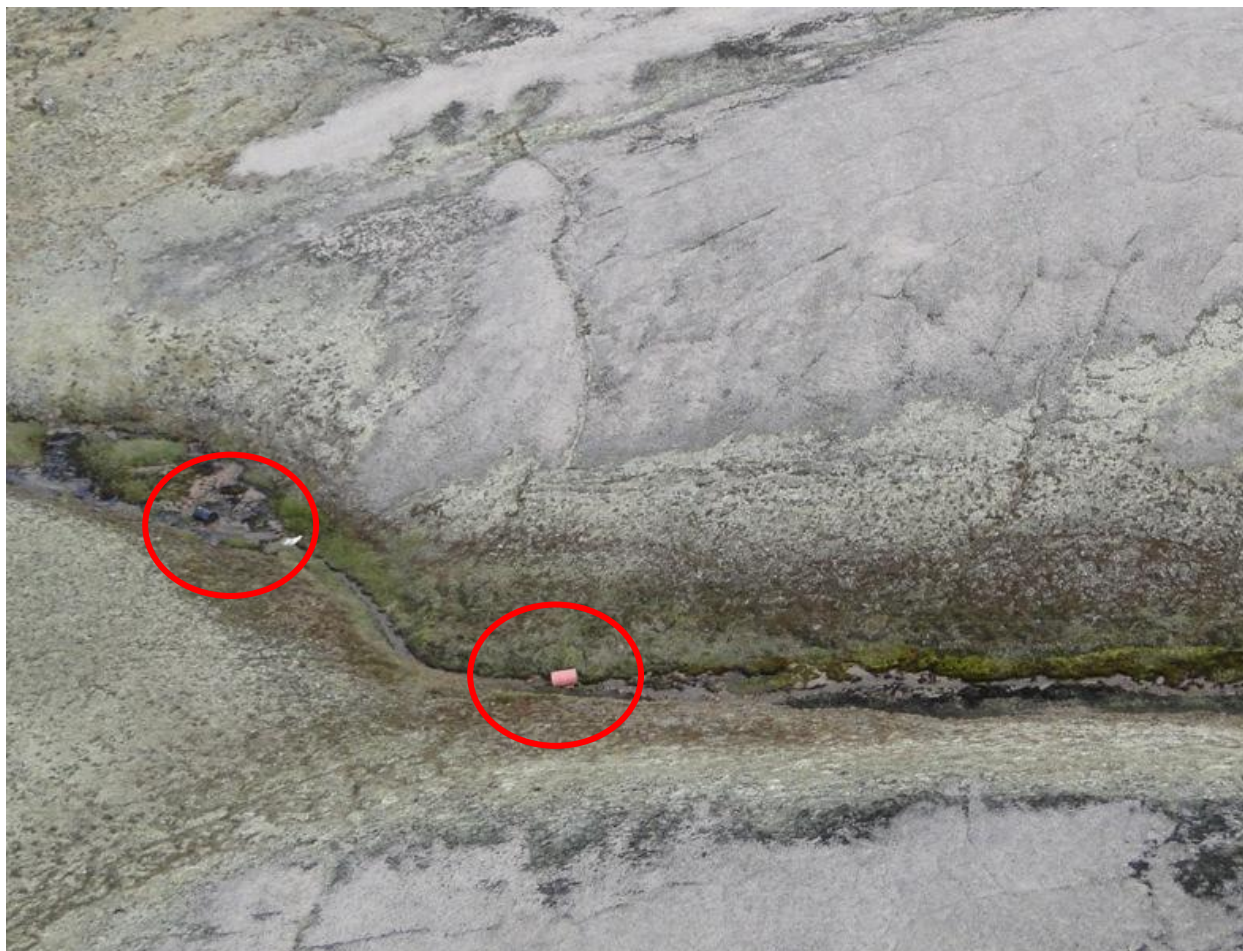
Figure 5. Two of three barrels visible in the creek at the end of the airstrip. The third barrel is outside the scope of this photo.

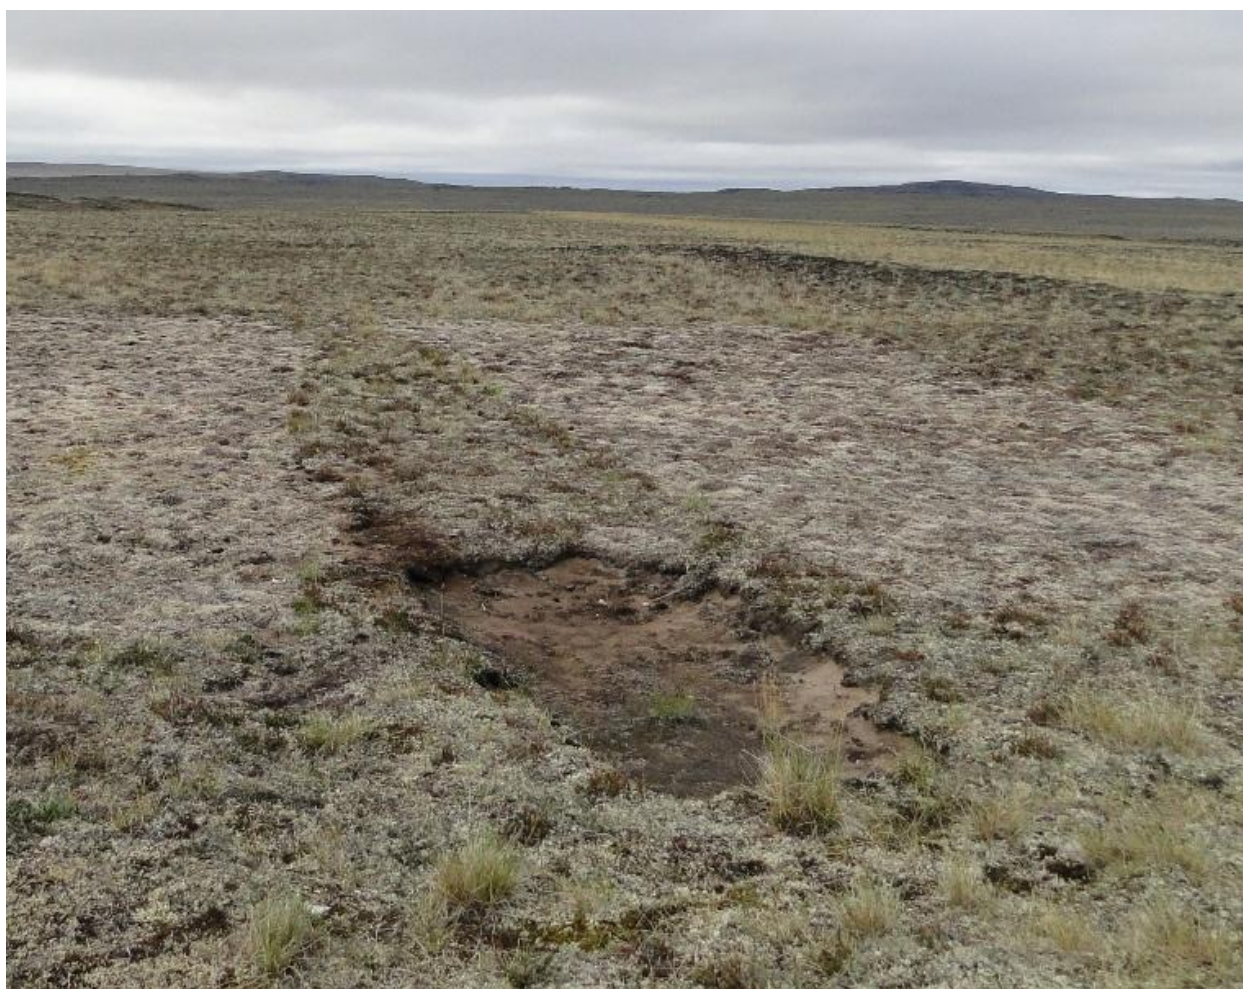
Comments: Where the barrels were stored at the airstrip, there is evidence of a spill that was partially cleaned up. Some soil was removed, but staining remains. The hole was not backfilled. Another similar but larger hole was excavated at one point, and again not filled in.

Figure 6. Excavation between the two fuel berms; approx 1m x 3m.

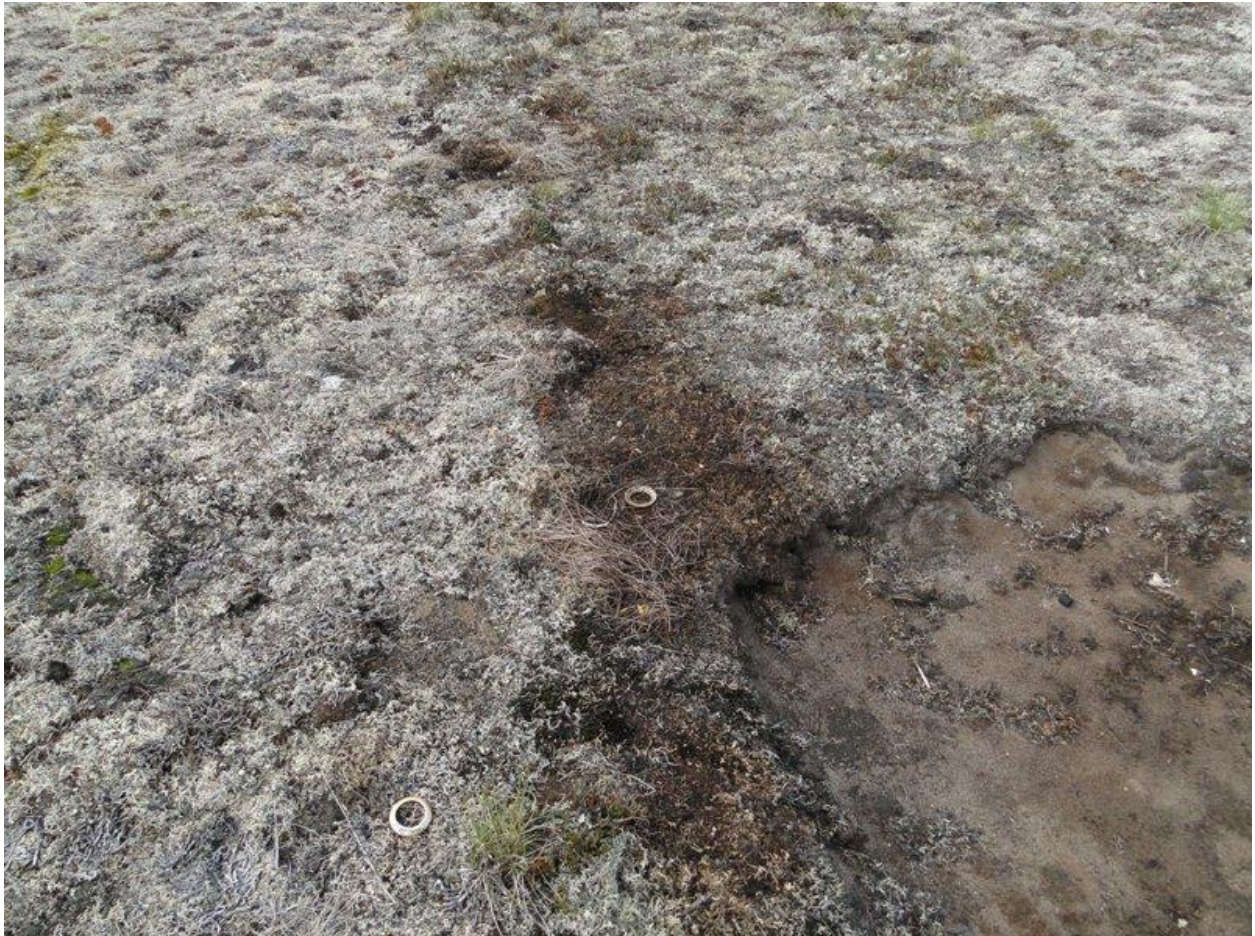
Item 9. Failure to reclaim hydrocarbon-contaminated areas.

Figure 7. Hydrocarbon staining still visible, and excavation was not backfilled.

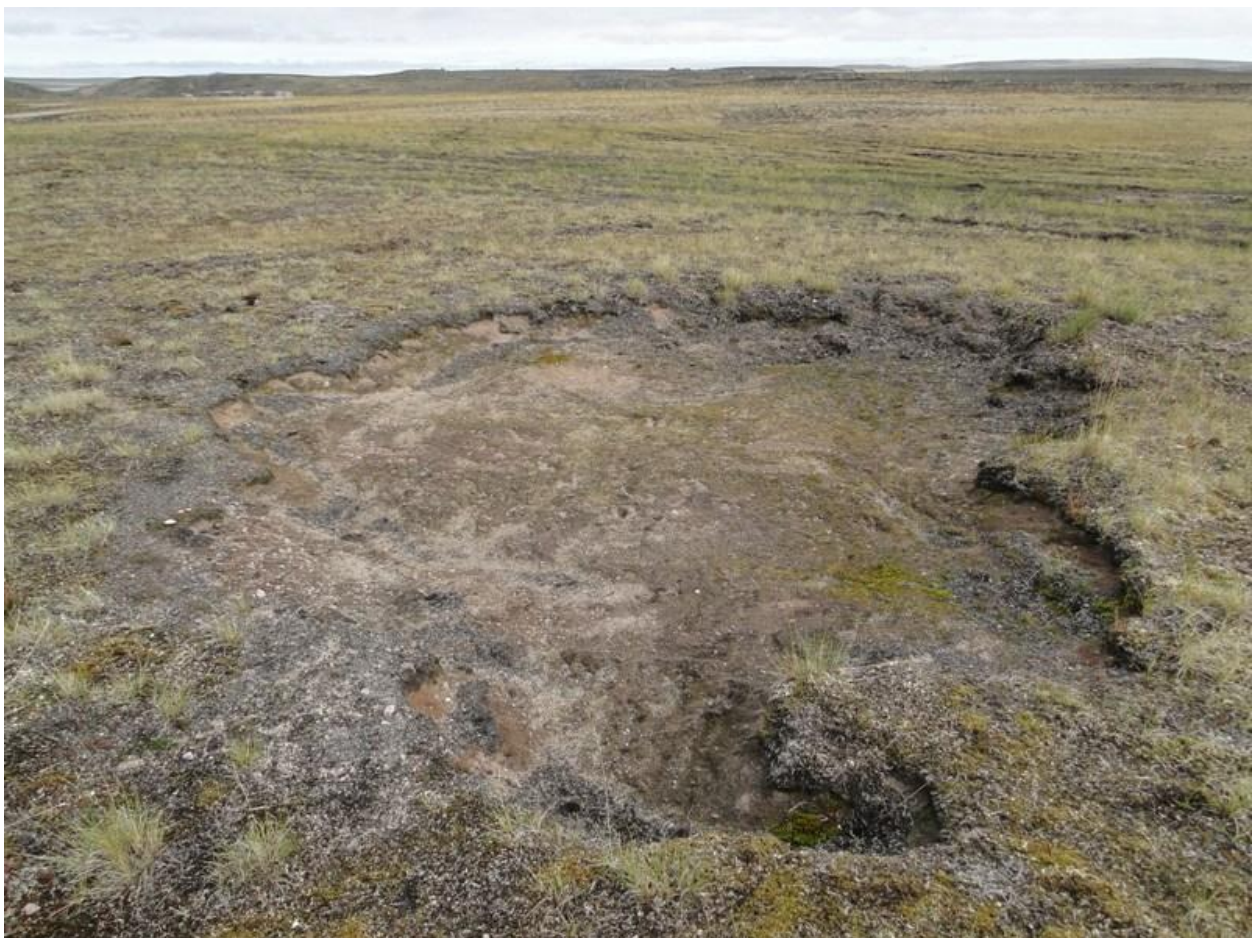
Figure 8. Older excavation, also not backfilled. Approximately 4m x 6m.

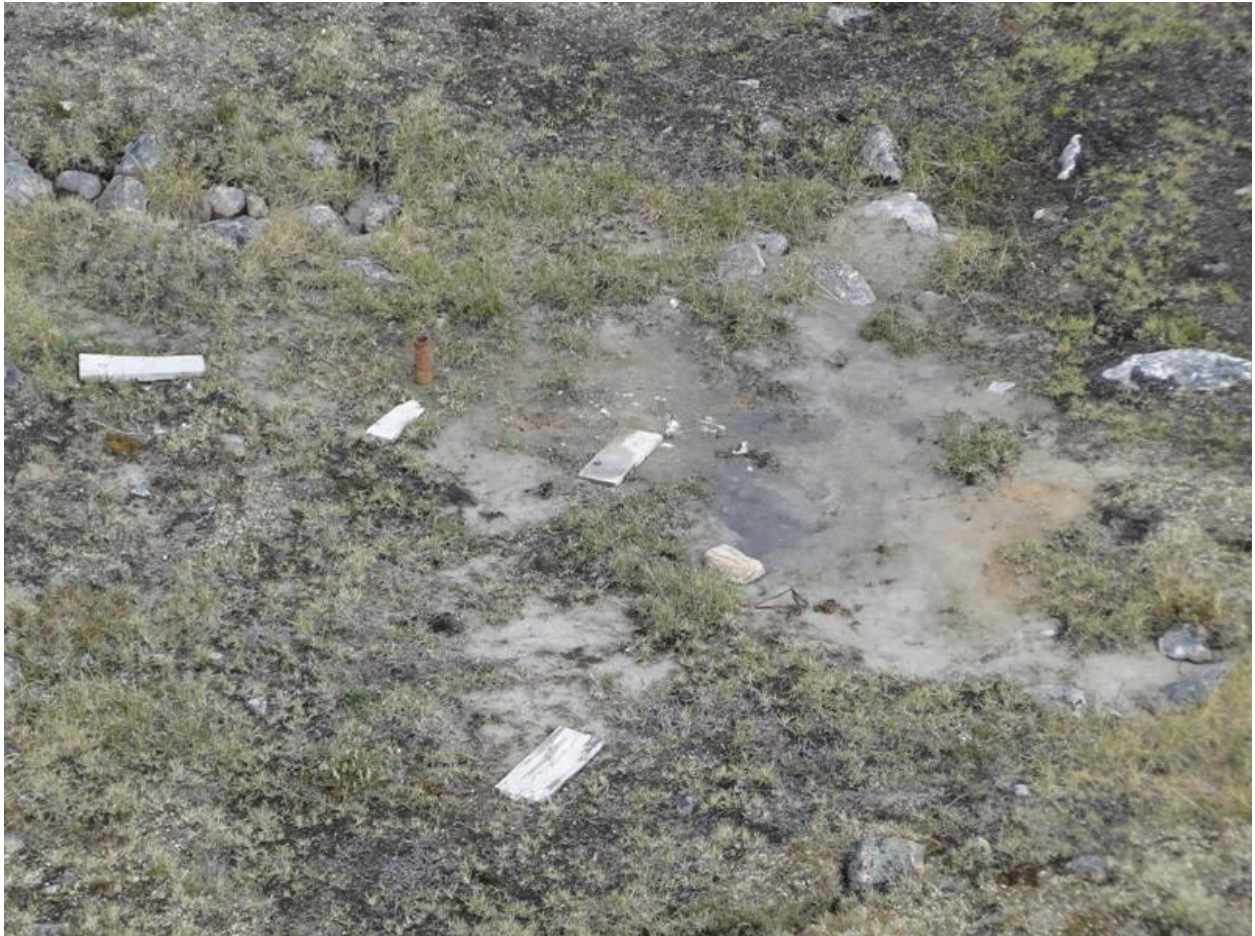
Drill sites: DR-07-30 and DR-07-31 were inspected. Progressive reclamation was not done; debris remains at the sites, and the drill casings also remain.

Item 10. Failure to reclaim drill holes and disturbed areas.

Figure 9. Drill hole with incomplete cleanup. N67°14'38.5" W92°59'04.8". Debris left on site and casings/collars not removed as per the licence. Also apparent that cuttings were not directed to a sump; rather they were left to accumulate beneath the drill.

- Drill holes are to be reclaimed as per Section I item 10 of the licence.
