WATER LICENCE and LUP INSPECTION FORM

Licensee		Licensee Representative	
Teck Resources Ltd.		Karen Weir	
Licence No. / Expiry		Representative's Title	
2BE-DBY1014			
Land / Other Authorizations		Land / Other Authorizations	
N2005C0028			
Date of Inspection		Inspector	
21/07/2015		Eva Paul	
Activities Inspected			
<input checked="" type="checkbox"/> Camp	<input checked="" type="checkbox"/> Drilling	<input type="checkbox"/> Mining	<input type="checkbox"/> Construction
<input type="checkbox"/> Roads/Hauling	<input type="checkbox"/> Other:	<input type="checkbox"/> Other:	<input checked="" type="checkbox"/> Reclamation
<input type="checkbox"/> Fuel Storage

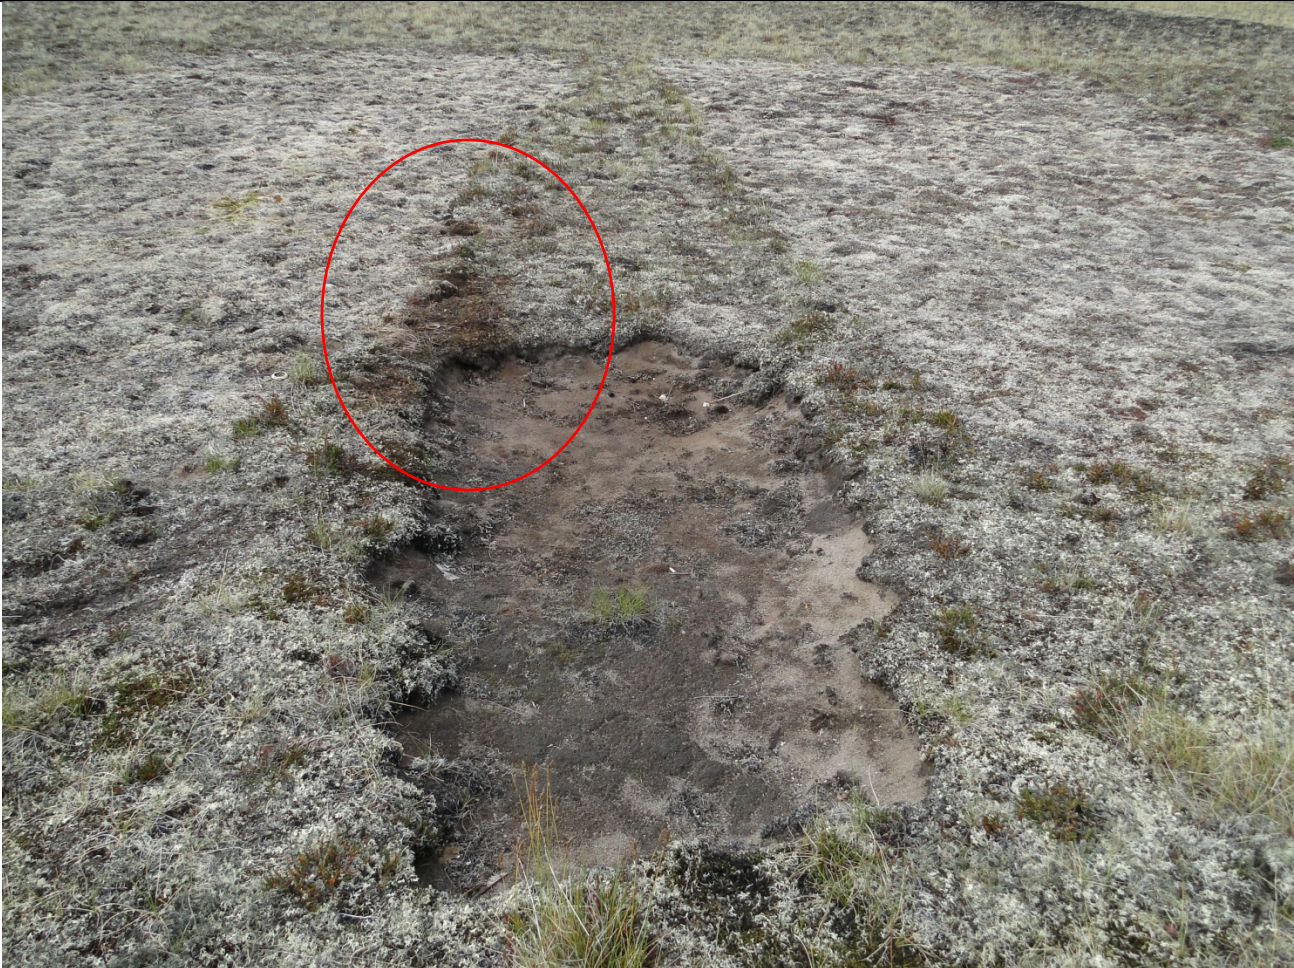
Photo Log # 2	Location (NAD 83 DD MM SS.SS)	
Photo DSC07850 (10/08/2012)	N	W

Description: Small excavation as seen in 2012. Hydrocarbon staining noted at the end of the hole; Teck was directed to excavate any remaining contaminated soil and backfill the hole.

20. Failure to backfill and restore sumps.			
SECTION 3	<input type="checkbox"/> Comments	<input type="checkbox"/> Non-Compliance with Act or Licence	<input checked="" type="checkbox"/> Action Required
<div>1. Verify whether any contamination remains at the small excavation, and complete the backfilling of excavations as was required by 2012 inspection. Clean fill is to be used. Please provide a report with photos, to the Inspector, upon completion of the restoration.</div>

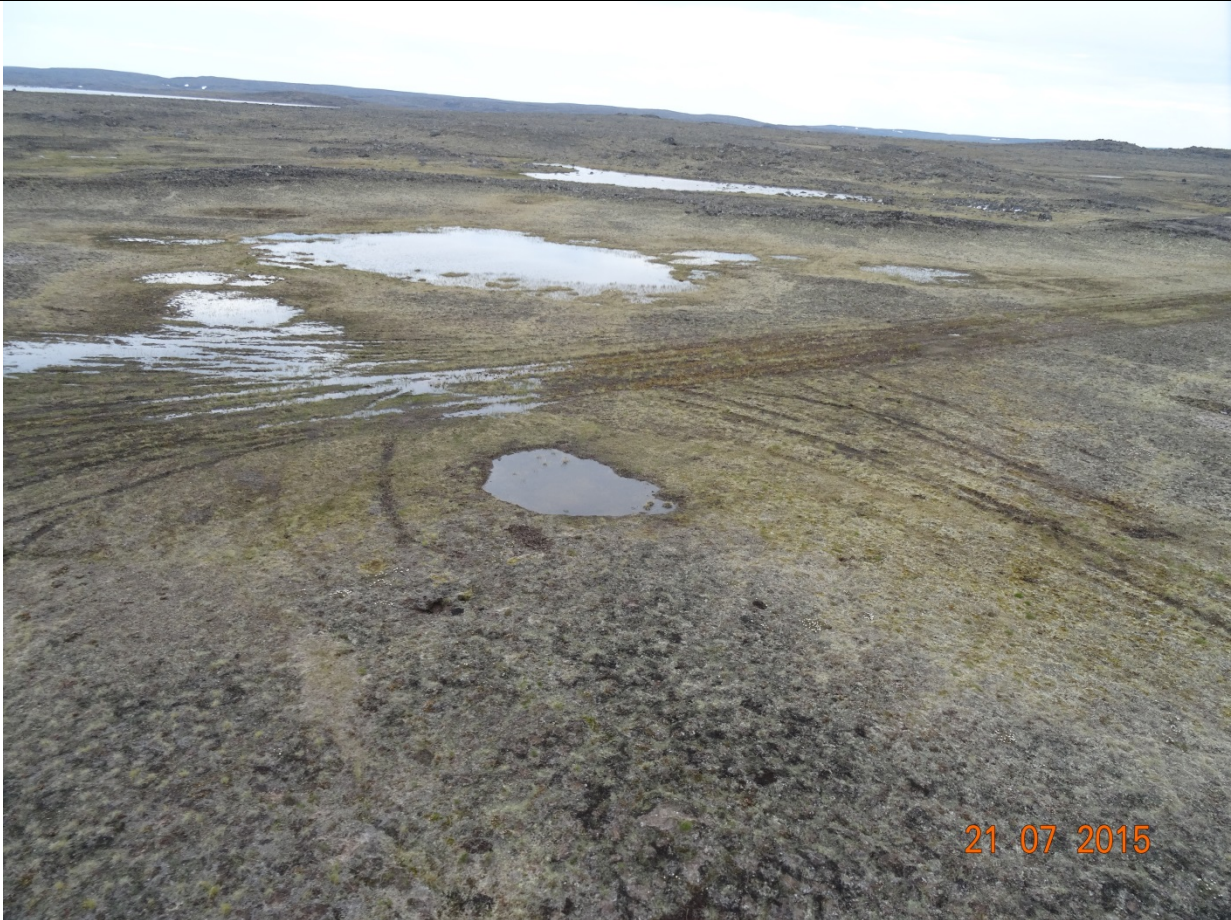
Photo Log # 3

Description: Large excavation (in foreground), now filled with water, as seen in 2015.

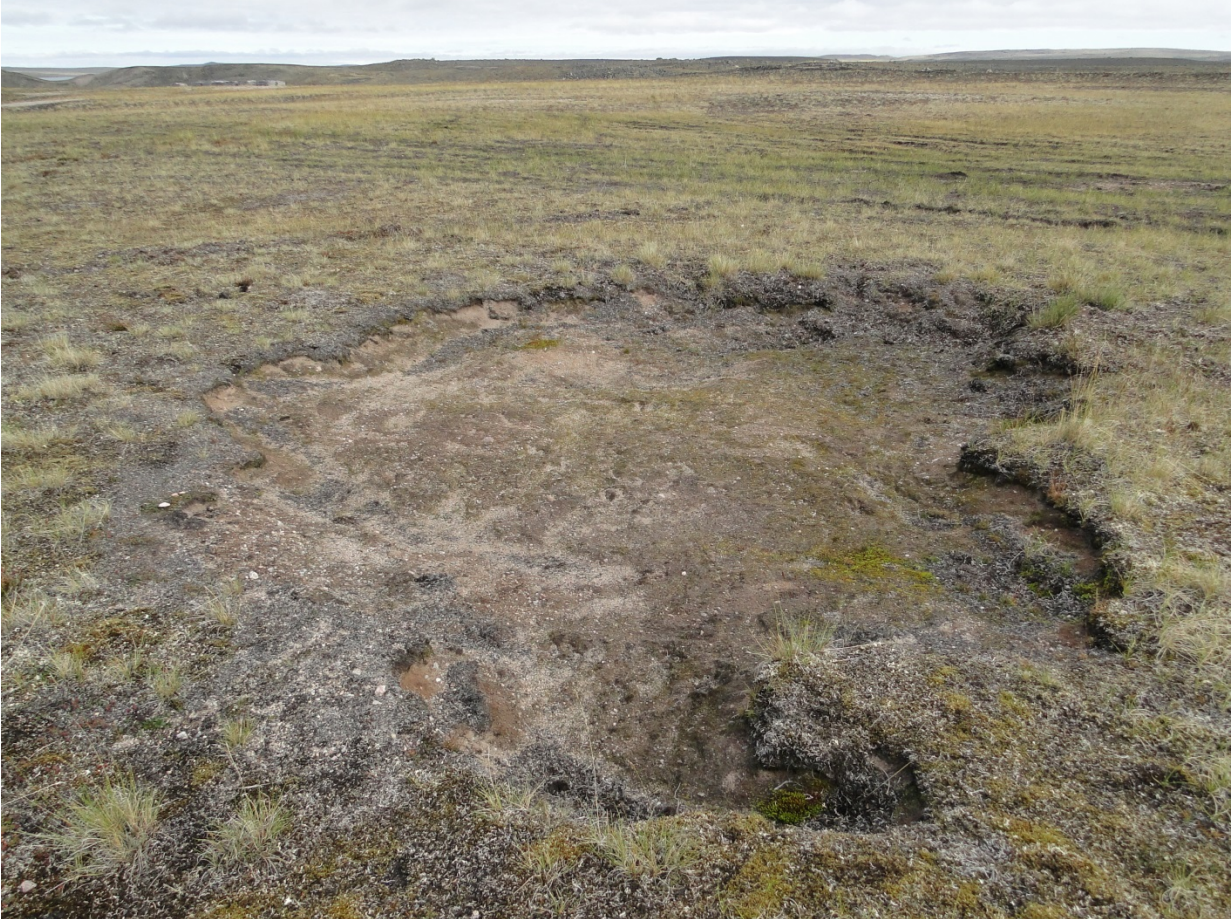
Photo Log # 4

Description: Large excavation as seen in 2012. Teck was directed at that time to backfill the hole to prevent ponding and permafrost degradation.
