WATER LICENCE INSPECTION FORM

Licensee		Licensee Representative	
Adamera Minerals Corp.		Zoe Pratt- Offsite Representative	
Licence No. / Expiry		Representative's Title	
2BE-DUB0812		GIS Technician	
Land / Other Authorizations		Land / Other Authorizations	
		N2008C0030	
		Inspector	
		WRO C. Wilson	
Activities Inspected			
<input type="checkbox"/> Camp	<input checked="" type="checkbox"/> Drilling	<input type="checkbox"/> Mining	<input type="checkbox"/> Construction
<input type="checkbox"/> Roads/Hauling	<input type="checkbox"/> Other: Water Discharge		<input checked="" type="checkbox"/> Reclamation
			<input type="checkbox"/> Fuel Storage
			<input checked="" type="checkbox"/> Other:

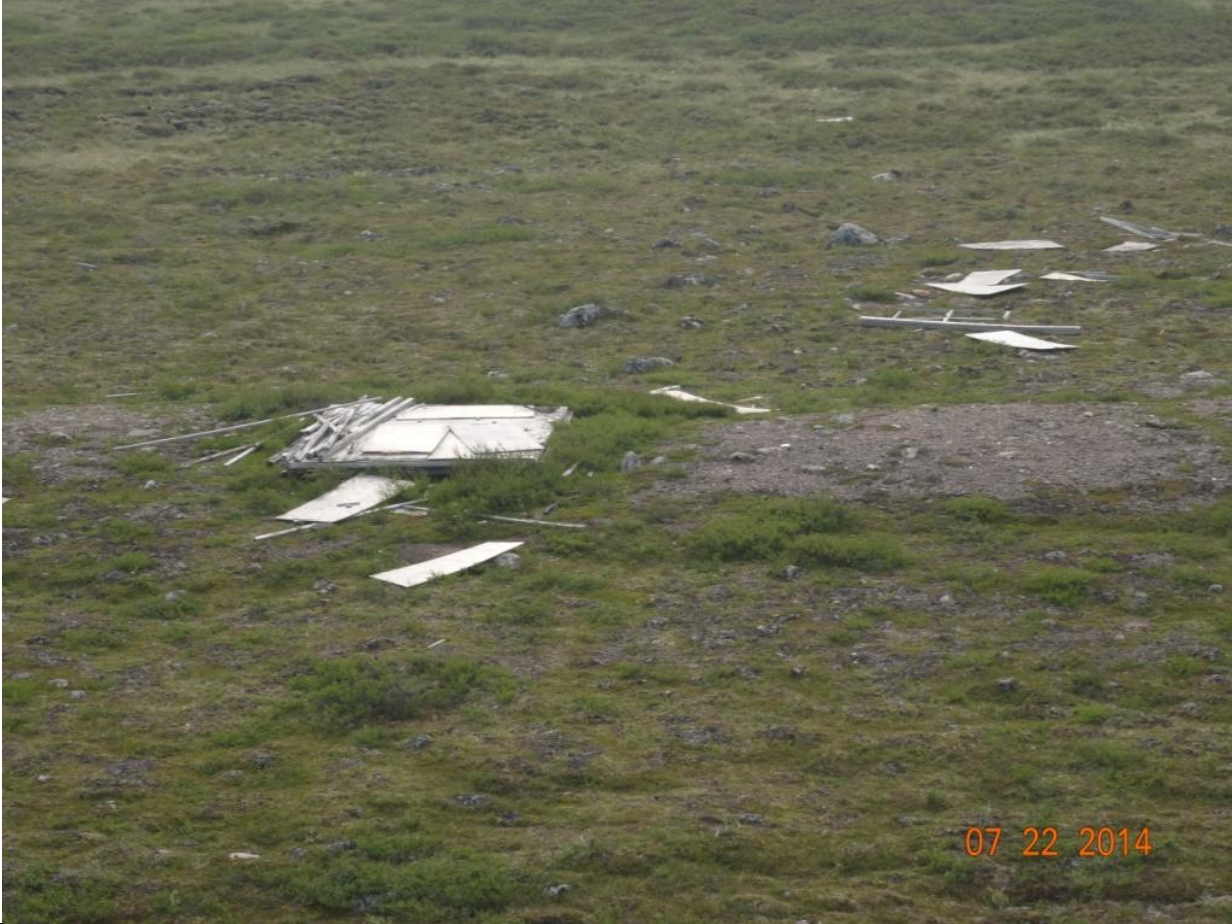
Locations name:	Lat/Long (DD.MM.SS.SS, NAD83)
PHOTO 1	N62° 25' 34.83", W 101° 21' 30.91"

Description:
Wood and wind blown debris

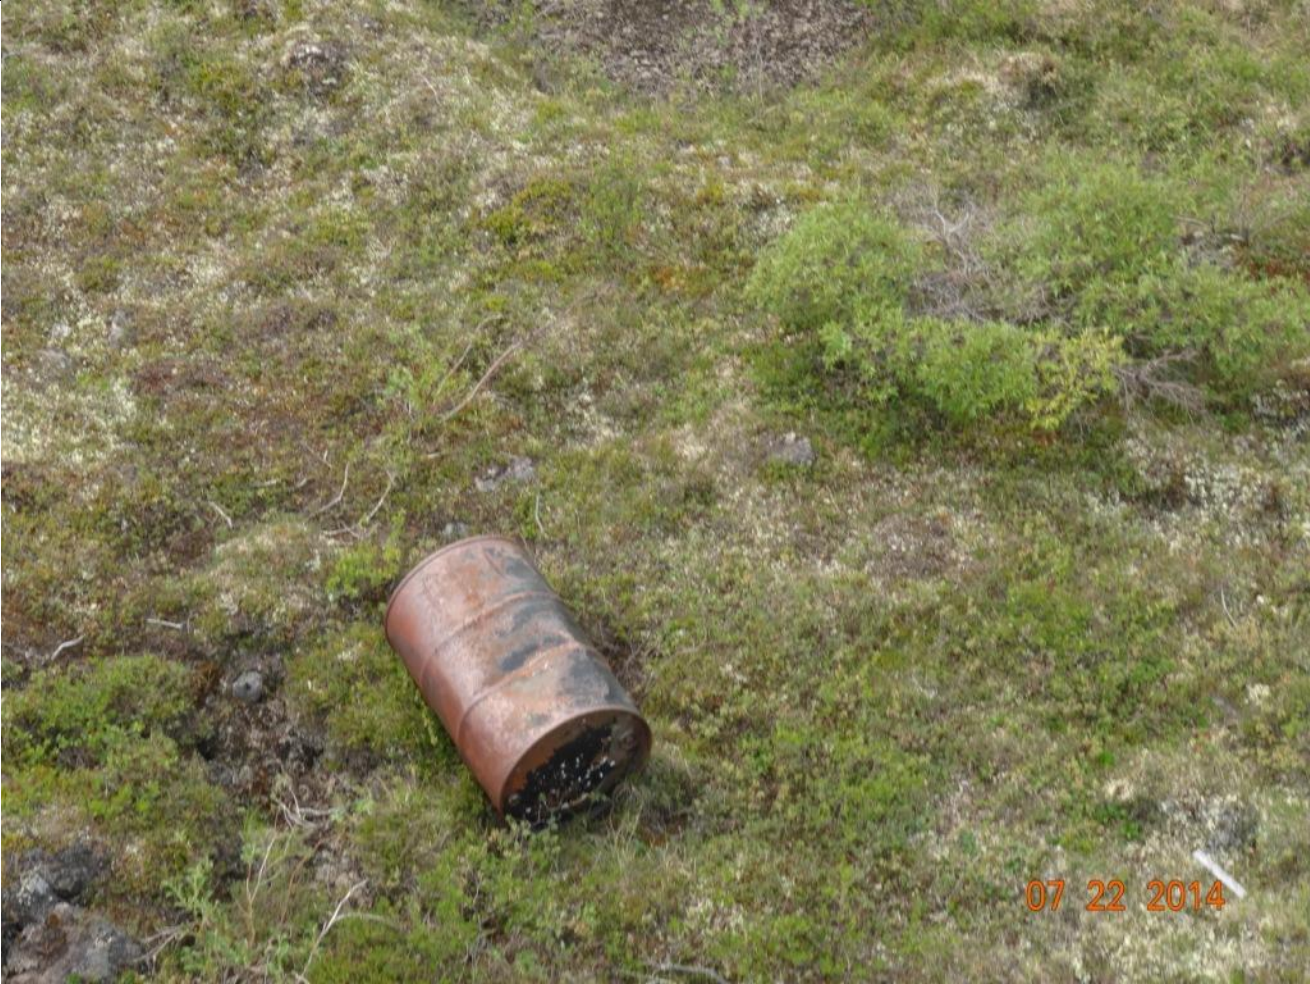
Locations name:	Lat/Long (DD.MM.SS.SS, NAD83)
PHOTO 2	N62° 32' 30.796", W 100° 44' 44.249"

Description:
Drum
