# Water Licence Inspection Report

| <b>Water Licence 2BE-FER2227</b> | <b>Project Geologist</b> |
| <b>August 14, 2023</b> | <b>RMO Kyle Amsel</b> |

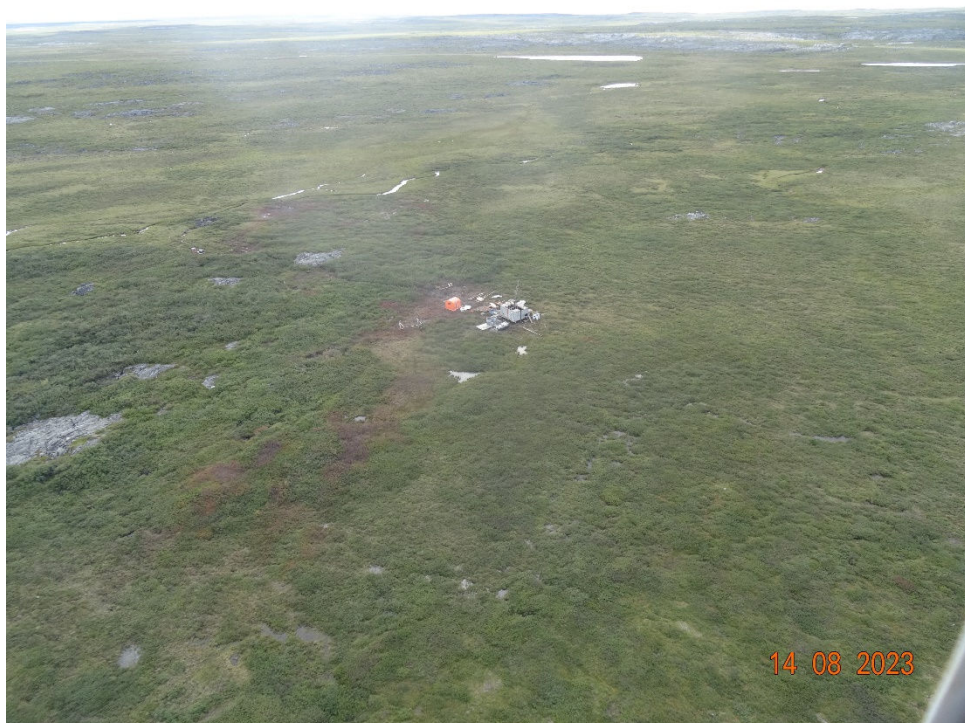
| Photo No. | Lat/Long (DD.MM.SS.SS, NAD83) |
|---|---|
| Photo 1 | N62° 52' 29.6" W96° 57' 34.9" |

- a) Drilling in the area is mostly conducted with lighter fly drills. (Photo 1) One larger sled drill is used by the project but not moved during summer months.

Drill 4 at hole FL23-527B.

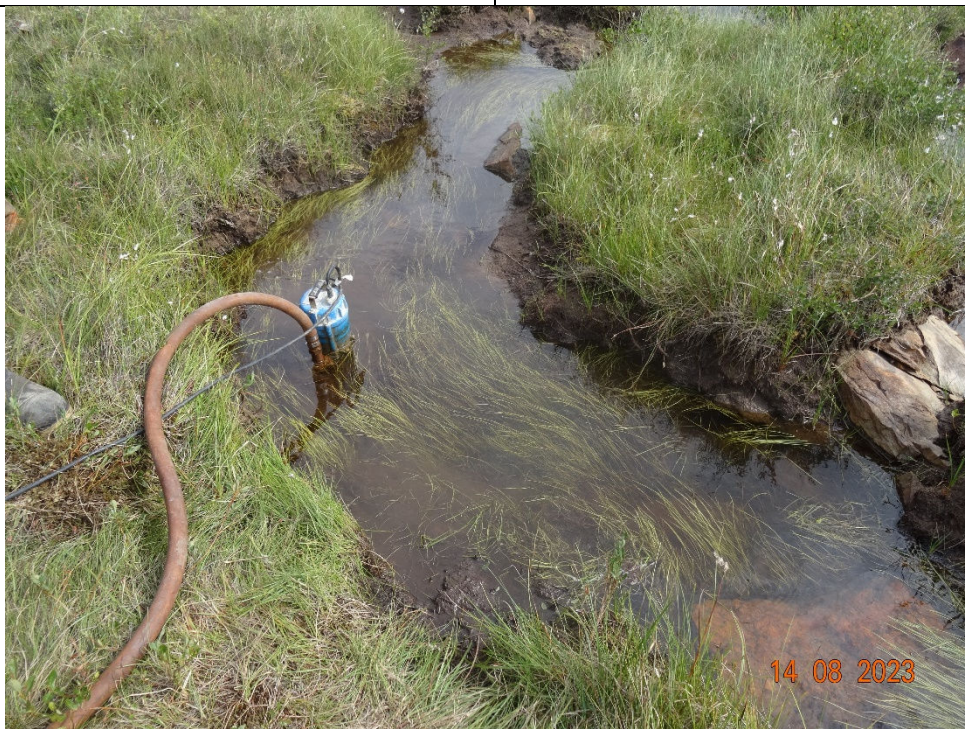
| Photo No. | Lat/Long (DD.MM.SS.SS, NAD83) |
|---|---|
| Photo 2 | N62° 52' 22.6" W96° 57' 37.3" |

- c) Drill 4 was inspected at 62° 52' 26.6"N 96° 57' 40.19"W drilling hole FL23-527B.
  - i) The area chosen is over 31m from fresh water.
  - ii) Water intake is located at 62° 52' 22.84"N 96° 57' 37.51"W (Photo 2). As part of the water pumping a generator setup is placed outside of 31m from the small stream and an electric pump is placed in the stream. A screen is part of the pump meeting requirements under Part C Item 6.

Water intake at drill 4.

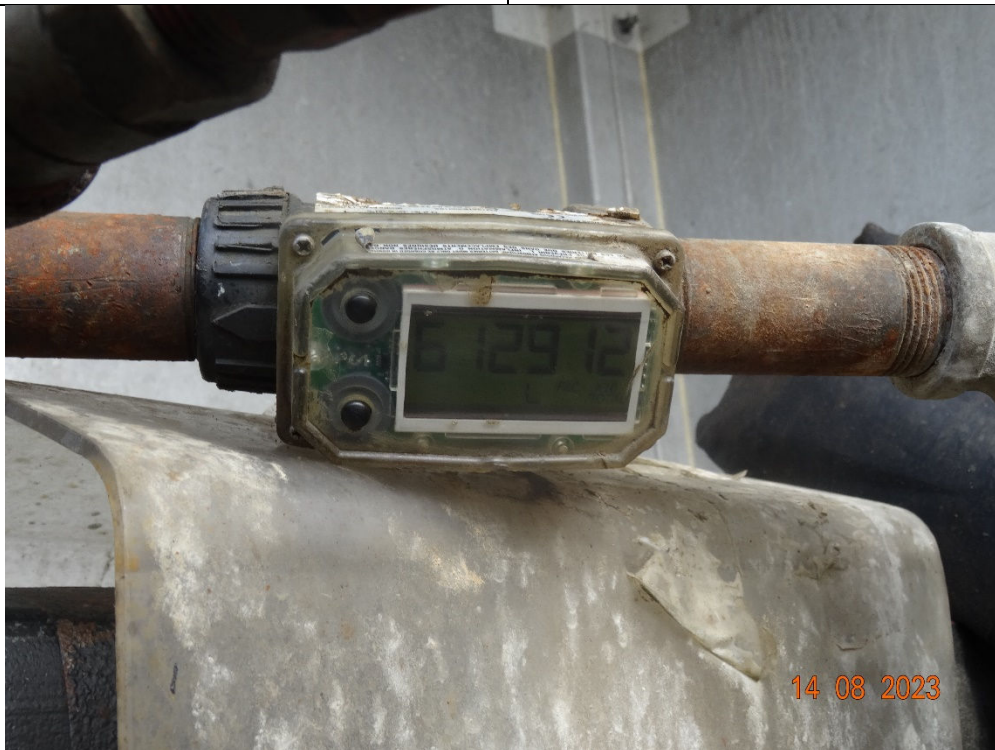
Photo 3

- iii) Water is continuously being pumped to the drill and metered as required under Part B Item 4 of the Licence (Photo 3). This was noted as a concern in the 2022 Inspection and the Inspector considers this matter addressed. Excess water not being used for the drill was discharged at 62° 52' 27.64"N 96° 57' 40.34"W.

Water meter of drill 4.

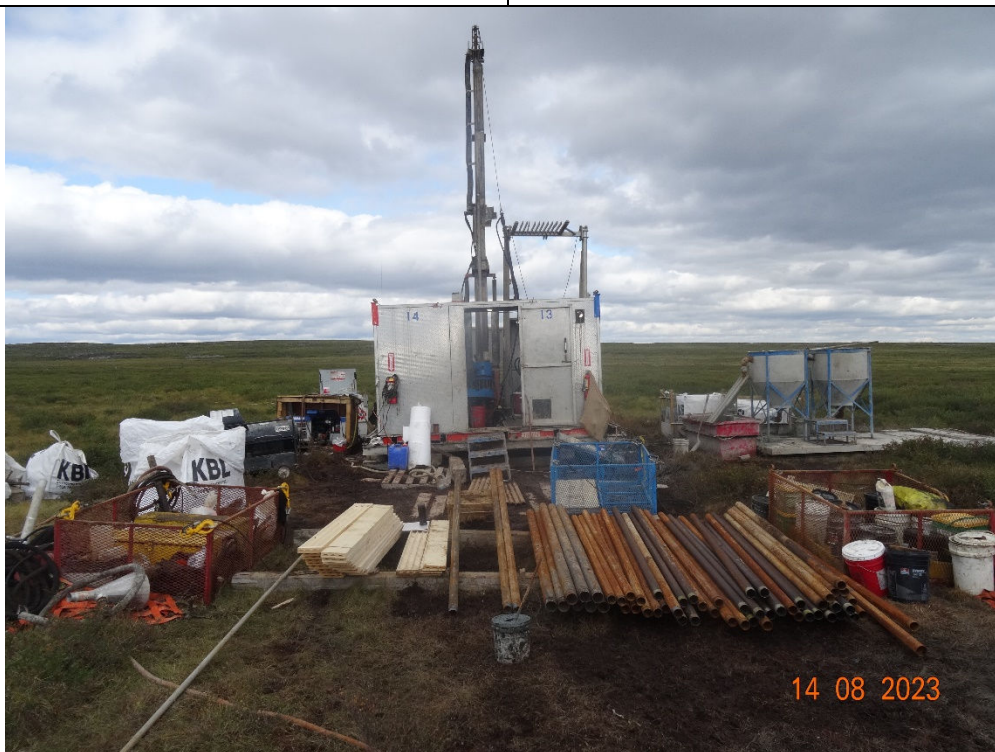
Photo 4

- iv) Water from the drill pipe containing cuttings is recovered and piped into two settling tanks (Photo 4). Cutting is settled out and the water is re-circulated into the bore hole. Cuttings is flown in quartex bags and disposed off in a sump at camp.

Overview of drill 4. Drill rod in forefront. Cutting settling tanks on right. Fuel storage on left of drill.

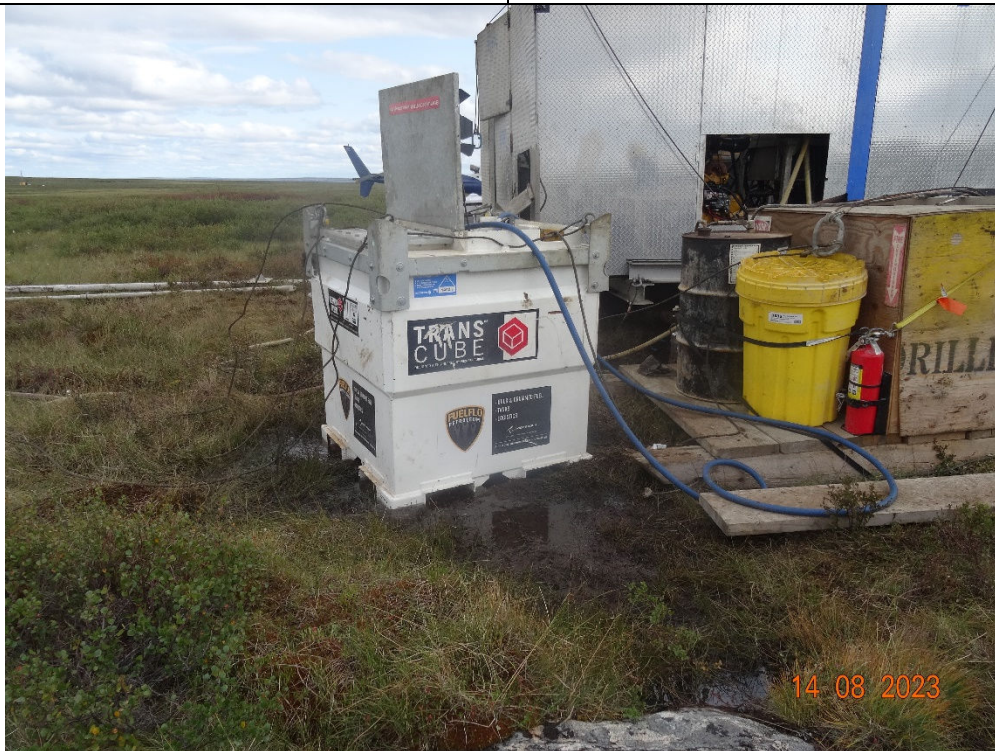
Photo 5

- v) Fuel is stored in a double walled fuel cube which transfers fuel to a drum used as functional fuel tank for drill (Photo 5).

Fuel storage at drill. Fuel is flown in using double walled cube. Fuel is transferred to drum on right which is functional fuel tank of drill.

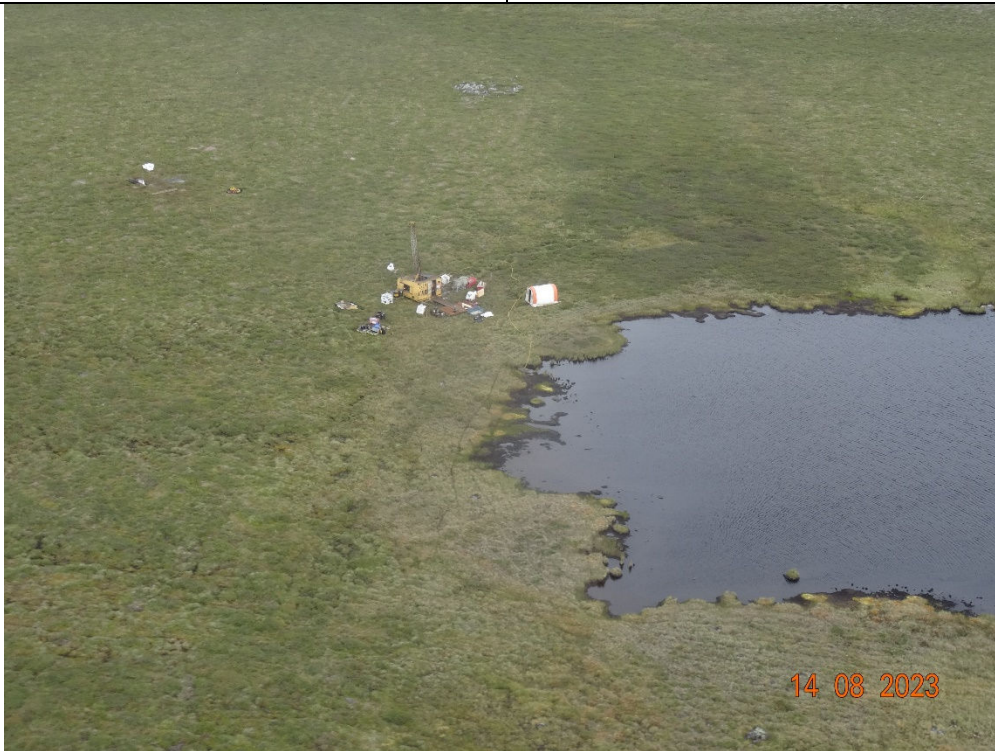
Photo 7

- f) Several other drill locations were inspected from the air (Photo 7 & 8)
- 2) Drill collars
  - a) Under Part I item 10 & 11 of the Licence, the Licensee will either remove or cut off drill casings upon completion of drilling or may leave them in the field for no longer than two years if signalled or signed appropriately.

Drill Inspected.

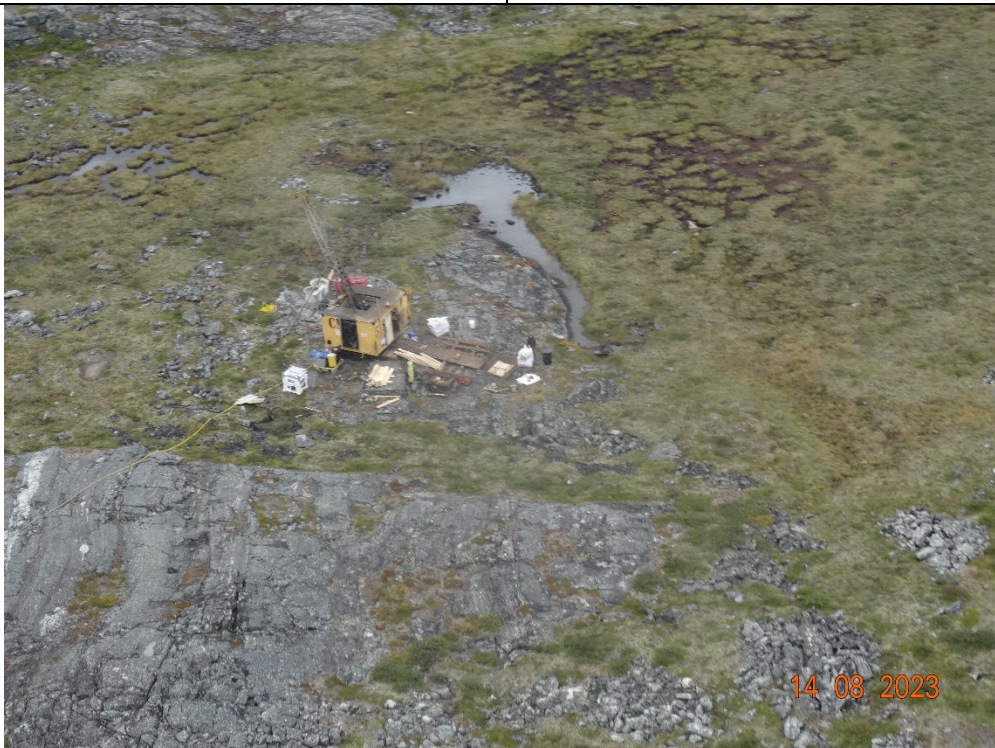
Photo 8

Drill inspected.

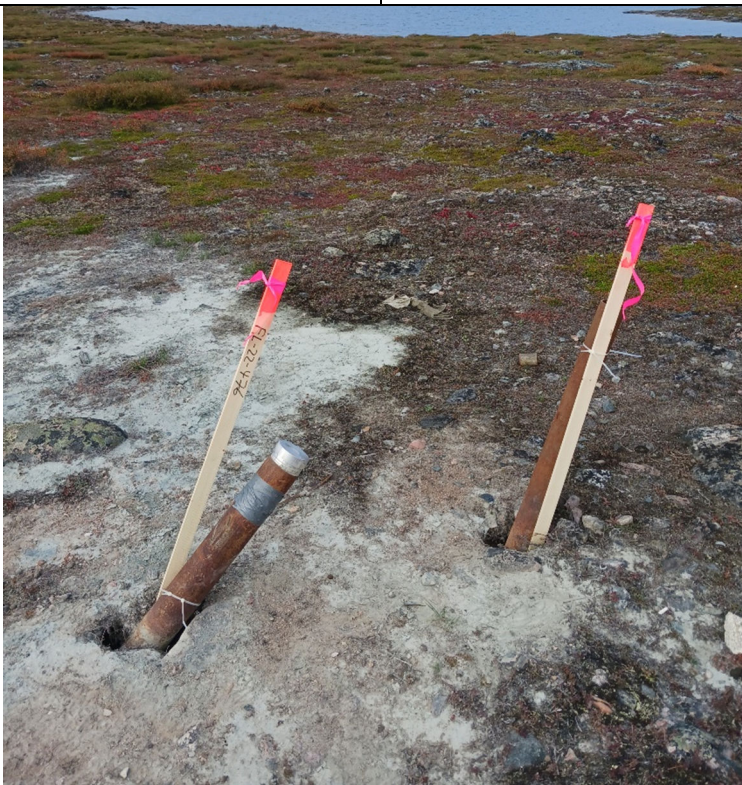
Photo 9

- b) On inspection several drill collars were observed that were not being drilled and had not been signed or removed/cut off. This is not compliant with Part I Item 10 & 11 of the Licence.

- c) On September 3, 2023 the Representative advised that collars for the majority of drill holes have either been cut or signalled. This was noted as a concern in the 2022 Inspection and the Inspector considers this matter addressed. Photos were provided as evidence (Photo 9 & 10).

Appropriate signalling installed at drill collars for hole FL22-476. Provided by representative.

- Present to the Inspector no later than March 31, 2024 a written plan for the removal, remediation and/or disposal of the drilling laydown located at 62° 52' 12.3"N 96° 55' 24.2"W. This plan will include a planned timetable.
- Endeavor to continue removal or cutting off of drill collars in the field.

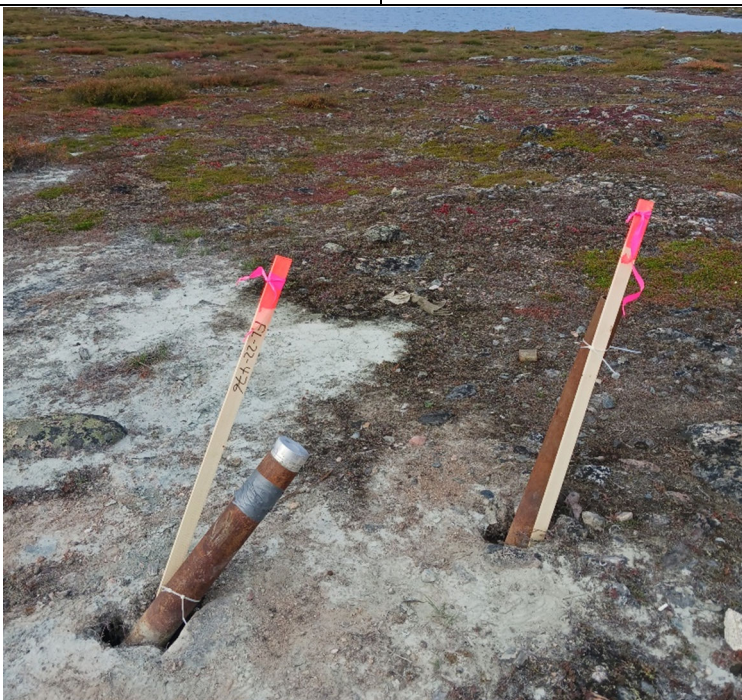
Photo 10

Appropriate signalling installed at drill collars for hole FL22-485. Provided by representative.

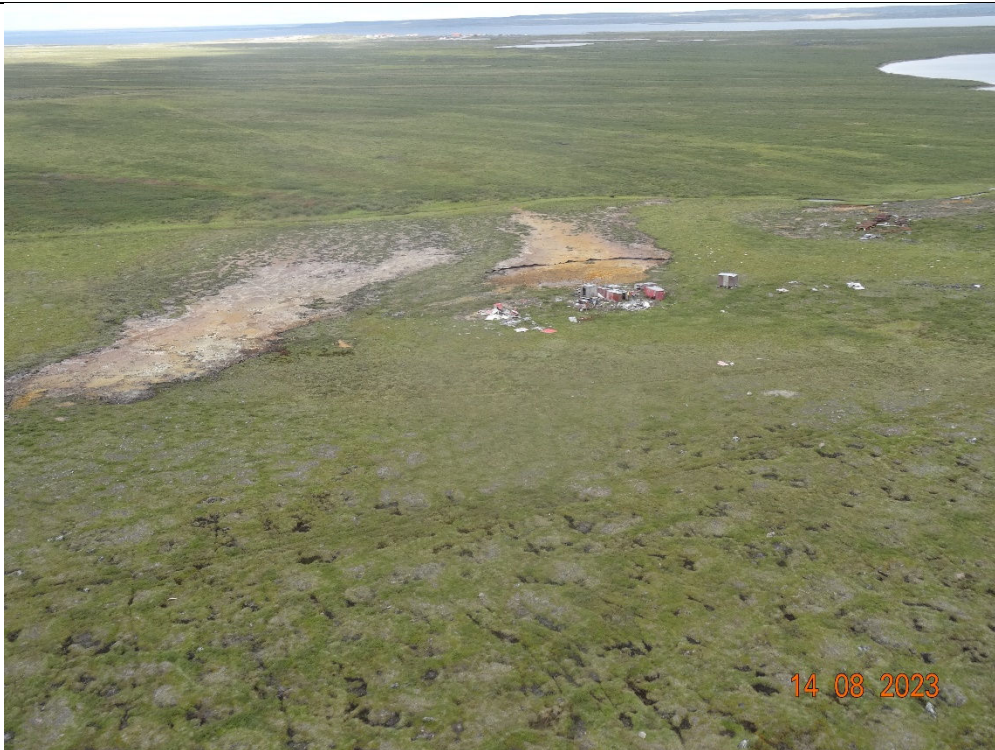
Photo 11

- 3) Drill Laydown at 62° 52' 12.3"N 96° 55' 24.2"W (Photo 11)
  - a) The concerning material related to the 2022 Inspection report have been removed from the area.

- b) No plan for the removal of the buildings, structures and material has been presented to the inspector.
- 4) Historic Bulk Sample Location
  - a) At the time of inspection, the area was dry with no standing water.

Old drill laydown aerial view.

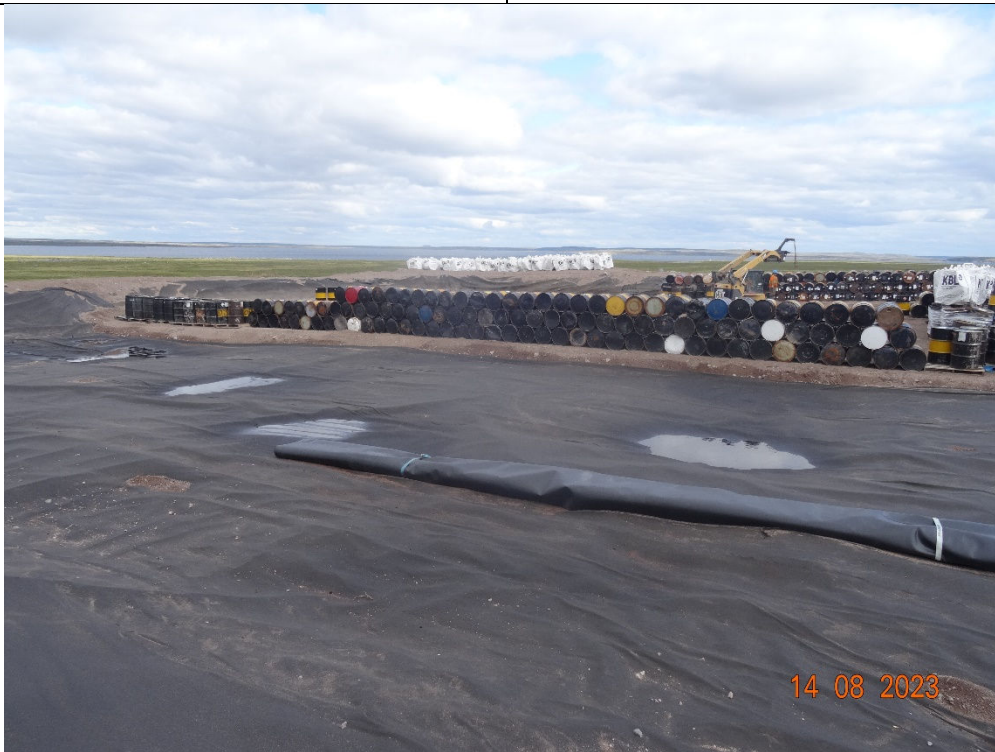
Photo 12

- b) No new acid drainage was evident.
  - c) Silt curtains installed in the area appear kept and maintained.
- 5) Fuel Containment Area (FCA)
  - a) The FCA was rebuilt since last inspection. (Photo 12). No rips in the liner are present and the facility appears significantly improved since last inspection.

- b) At the time of the Inspection no water was present in the facility.
  - c) The licensee sought to discharge water from the facility prior to inspection and took water samples which were outside limits set in Part D Item 12. This water was placed in drums to allow for transportation to a facility authorized to receive wastes.

Newly refurbished Fuel Containment Berm.

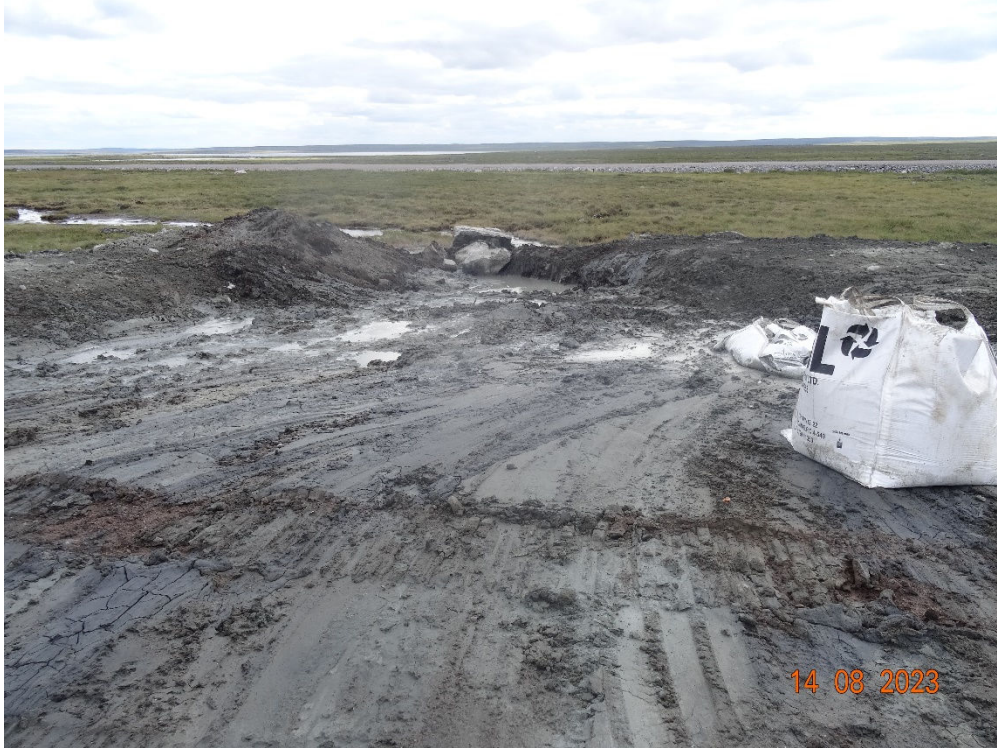
Photo 13

- 6) Cuttings sump
  - a) The sump noted at 62° 53' 37.5"N 96° 54' 38.9"W is the only sump used by the project. Cuttings from all drills and materials from the core shack are deposited in the sump. (Photo 13)

- b) Since the 2022 Inspection the sump has reduced capacity due to additional deposition of cuttings into it. There is flow of cuttings apparent from the rear of the sump.

- c) The Inspector is concerned with the sump in it's current condition as the amount of cuttings being deposited is exceeding it's capacity and further deposition may cause off site impacts.

Drill cuttings sump.

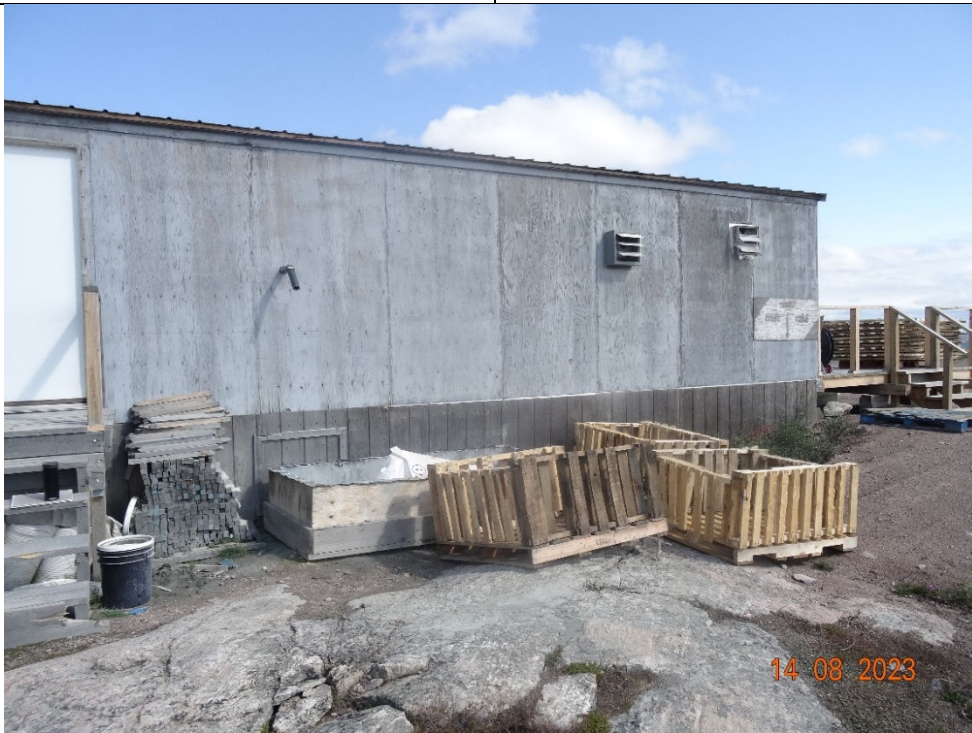
Photo 14

- 8) Camp Site
  - a) Core shack cuttings are now dumped directly into quartex bags, and the area is no longer is covered in cuttings. This was noted as a concern in the 2022 Inspection and the Inspector considers this matter addressed. (Photo 14)

Core shack area. Core cuttings are now handled differently that previous inspection and area is now clean of cuttings.
