# STARFIELD RESOURCES INC.

## **SITE ACTIVITY REPORT - FALL 2009**

This letter is to provide you with an account of the site activities at Ferguson Lake camp during the fall visit to conduct clean up activities including the treatment and discharge of water from the lined earthen berm, secondary containment structure.

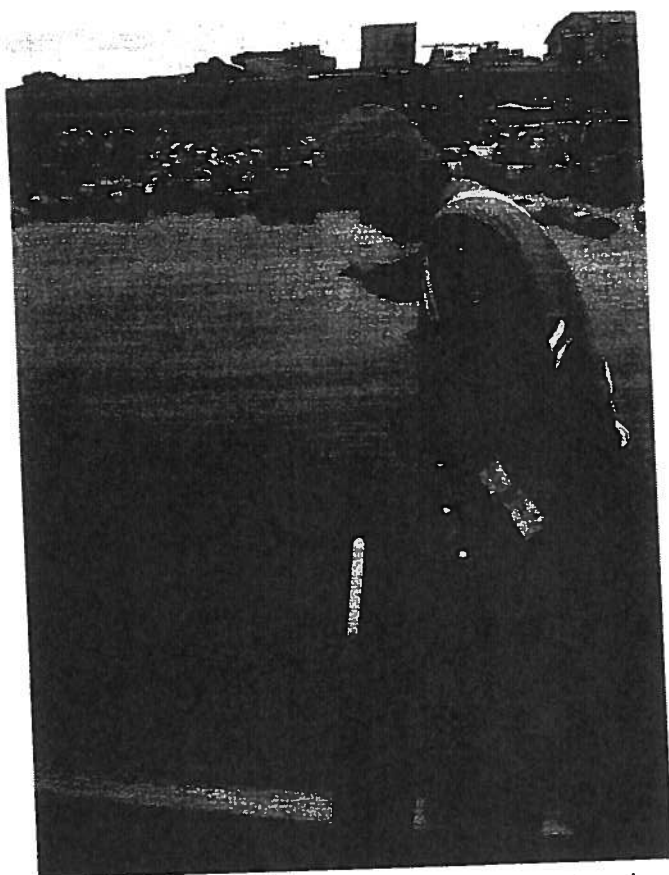
Water samples were collected within the lined earthen berm.

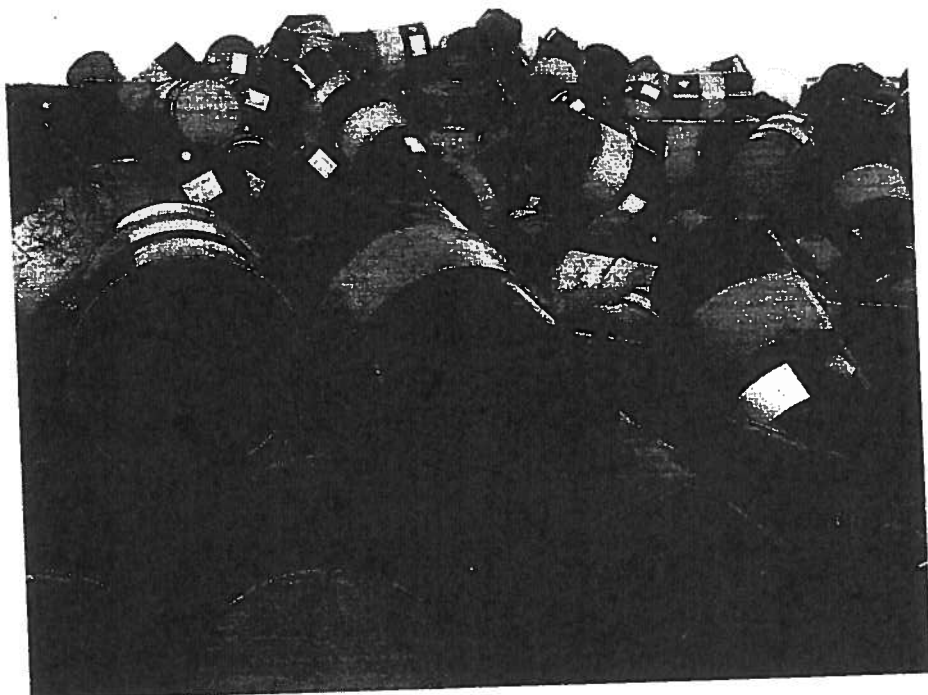
Empty fuel drums before.

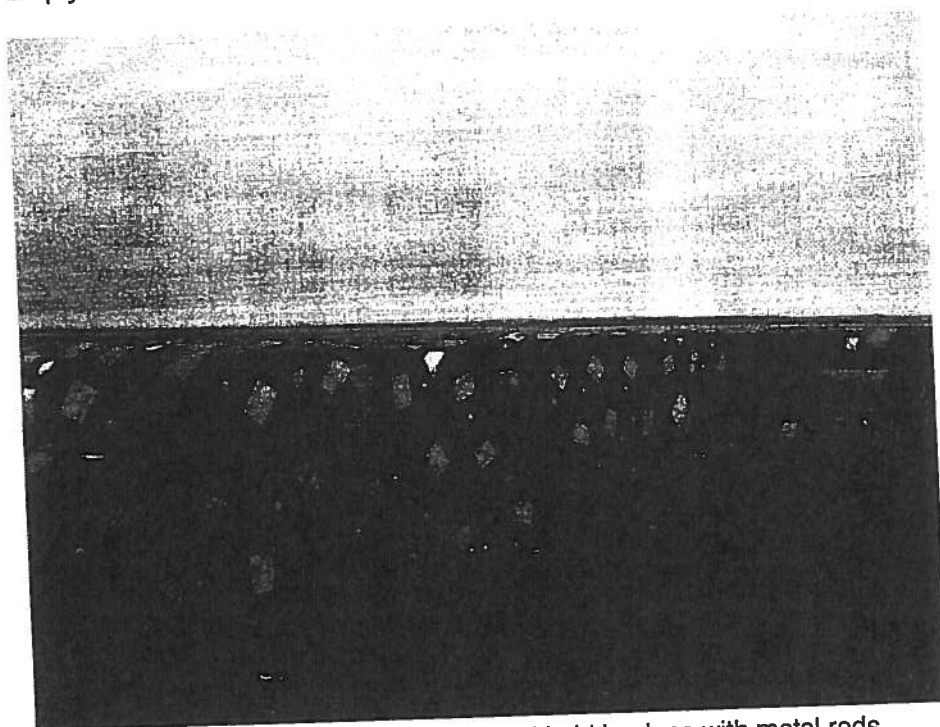
Empty fuel drums were stacked neatly and held in place with metal rods.

The empty drums were re-stacked in to neat rows and held in place with metal posts. In April 2009, two sleds were loaded with crushed drums for backhaul to Arviat to be shipped south on the barge. The sleds broke however, and the crushed drums were dumped by the contractor. There were over 1400 crushed drums. Approximately half of these drums have been stacked within secondary containment for storage until they can be back-hauled from site. The remaining crushed drums will be stacked within secondary containment in the spring when Starfield returns to continue clean up efforts.

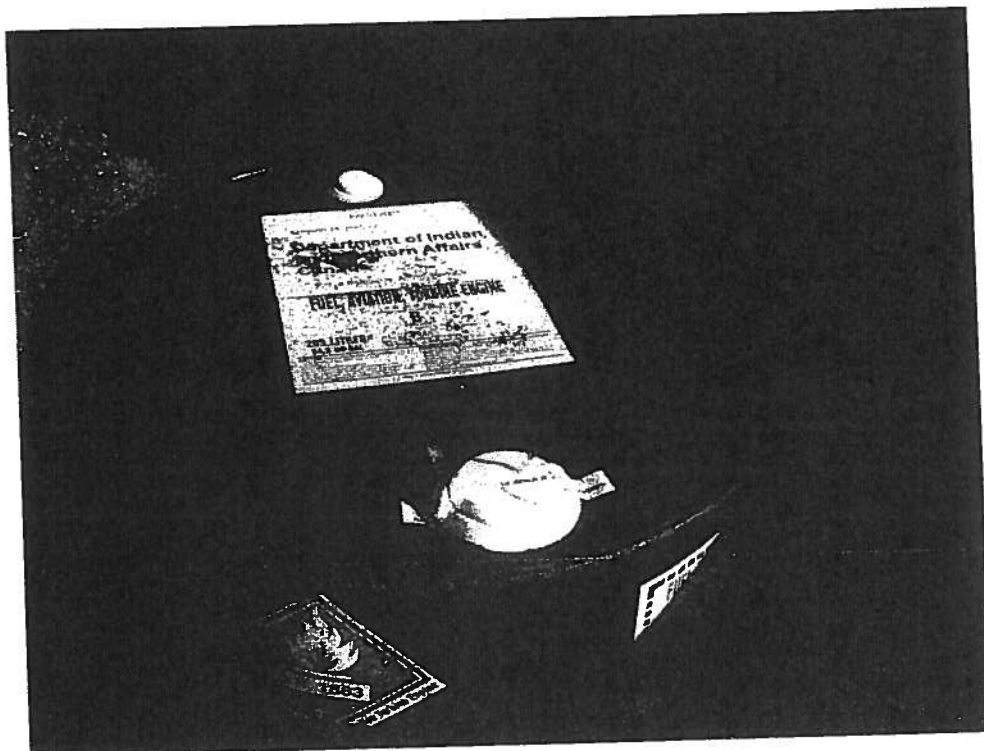
Fuel left on airstrip.

Drums of fuel were scattered in the water within the berm. These drums were stacked in neat rows with bungs in the 3:00 and 9:00 position within the berm toward the entrance ramp. Drummed fuel on site was taken to the berm, including the fuel left on the airstrip by INAC, and stacked in the rows.
