**WATER LICENCE INSPECTION FORM**☒ Original
☐ Follow-Up Report

Licensee	Licensee Representative/ Title
Canadian North Resources Inc.	Trevor Boyd, Project Geologist
Licence No. / Expiry	Project
2BE-FER2227/March 1, 2027	Ferguson Lake Project
Land Authorization No. / Expiry	Location
KIA Lease	N62° 53' 35.5" W96° 54' 19.1"
Date of Inspection	Inspector
October 13-14, 2022	WRO K. Amsel
Activities Inspected	
<input checked="" type="checkbox"/> Camp <input checked="" type="checkbox"/> Drilling <input type="checkbox"/> Mining <input type="checkbox"/> Construction <input type="checkbox"/> Reclamation <input checked="" type="checkbox"/> Fuel Storage <input type="checkbox"/> Roads/Hauling <input type="checkbox"/> Other: <input type="checkbox"/> Other:

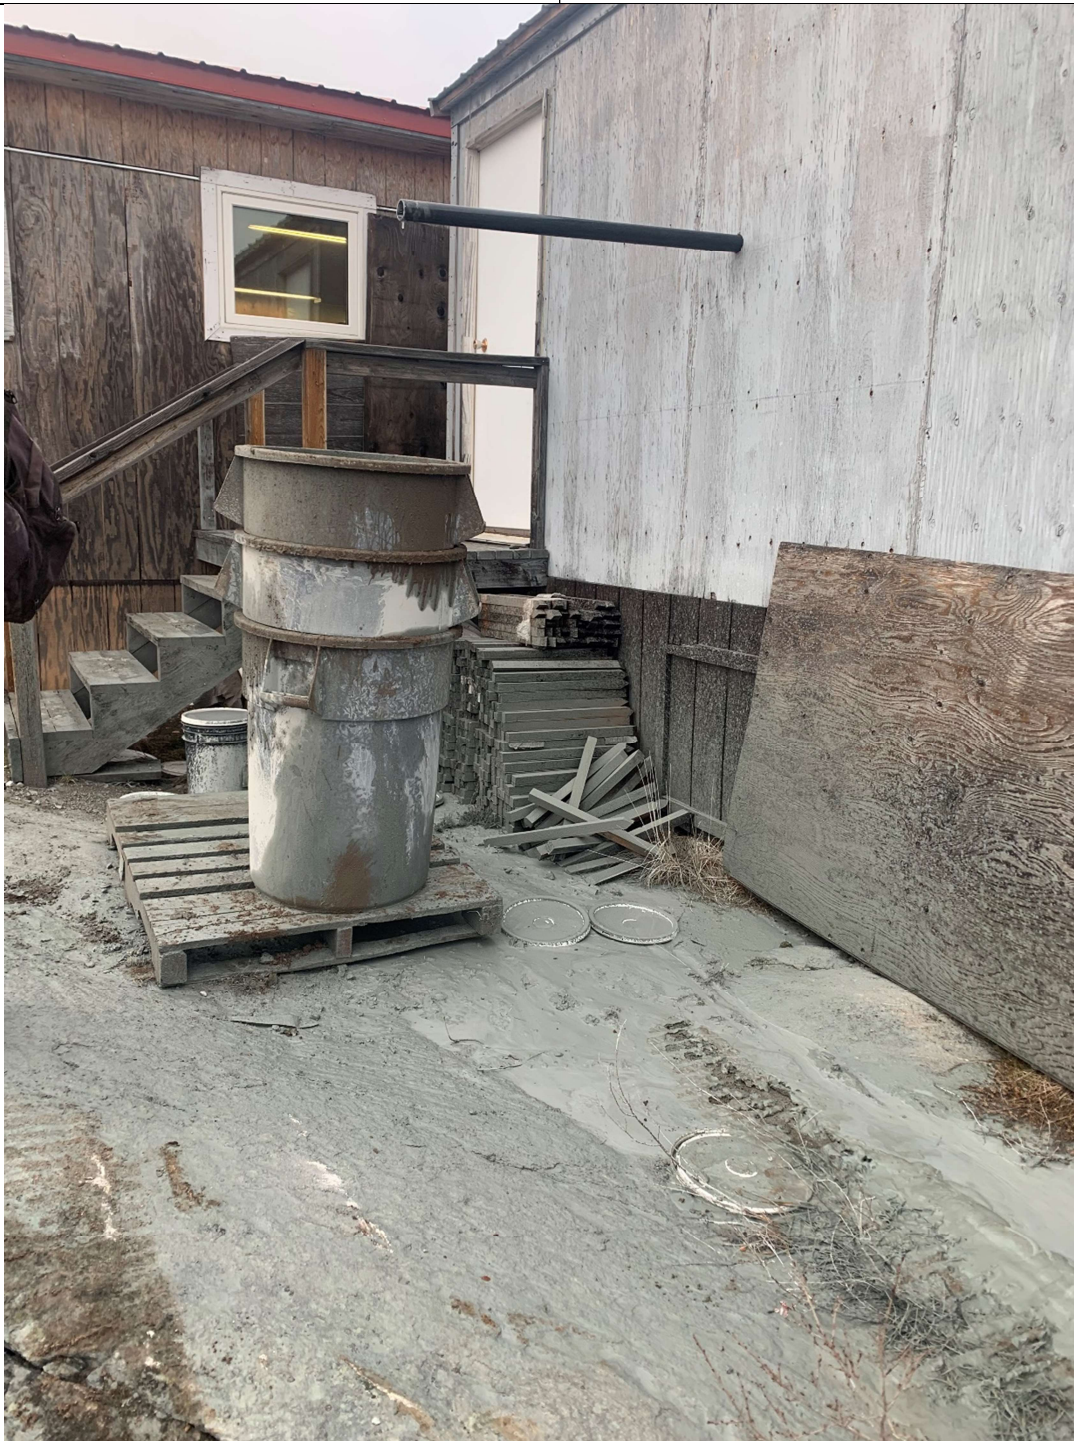
Waste from Core Cutting saws outside core shack.

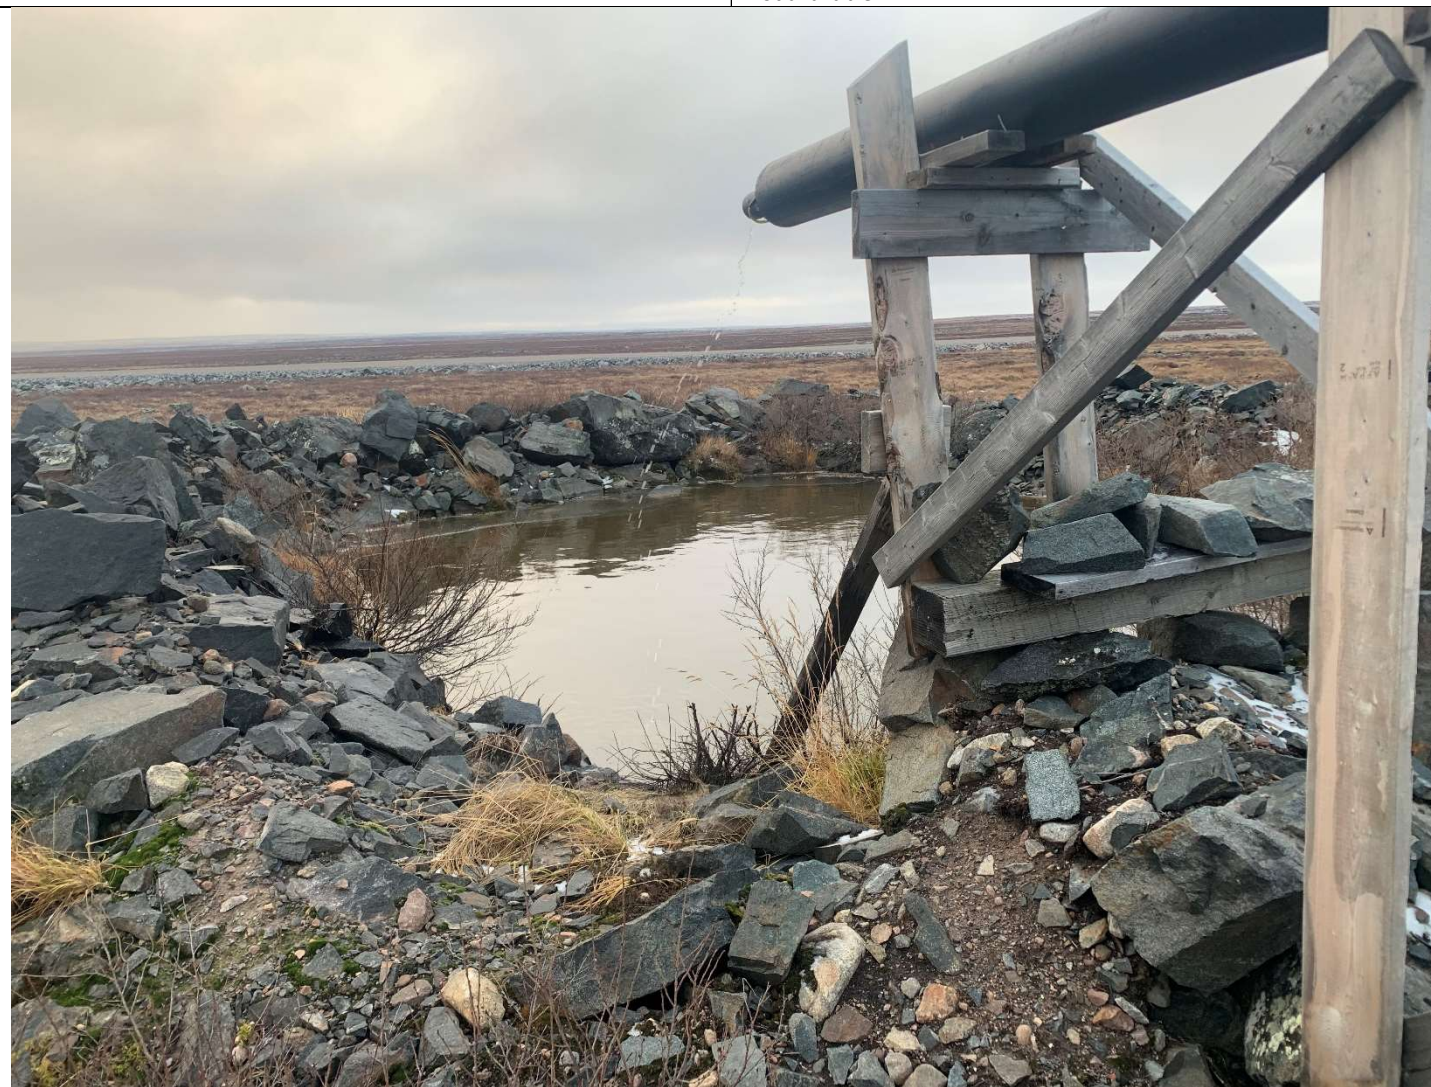
2

Grey water sump

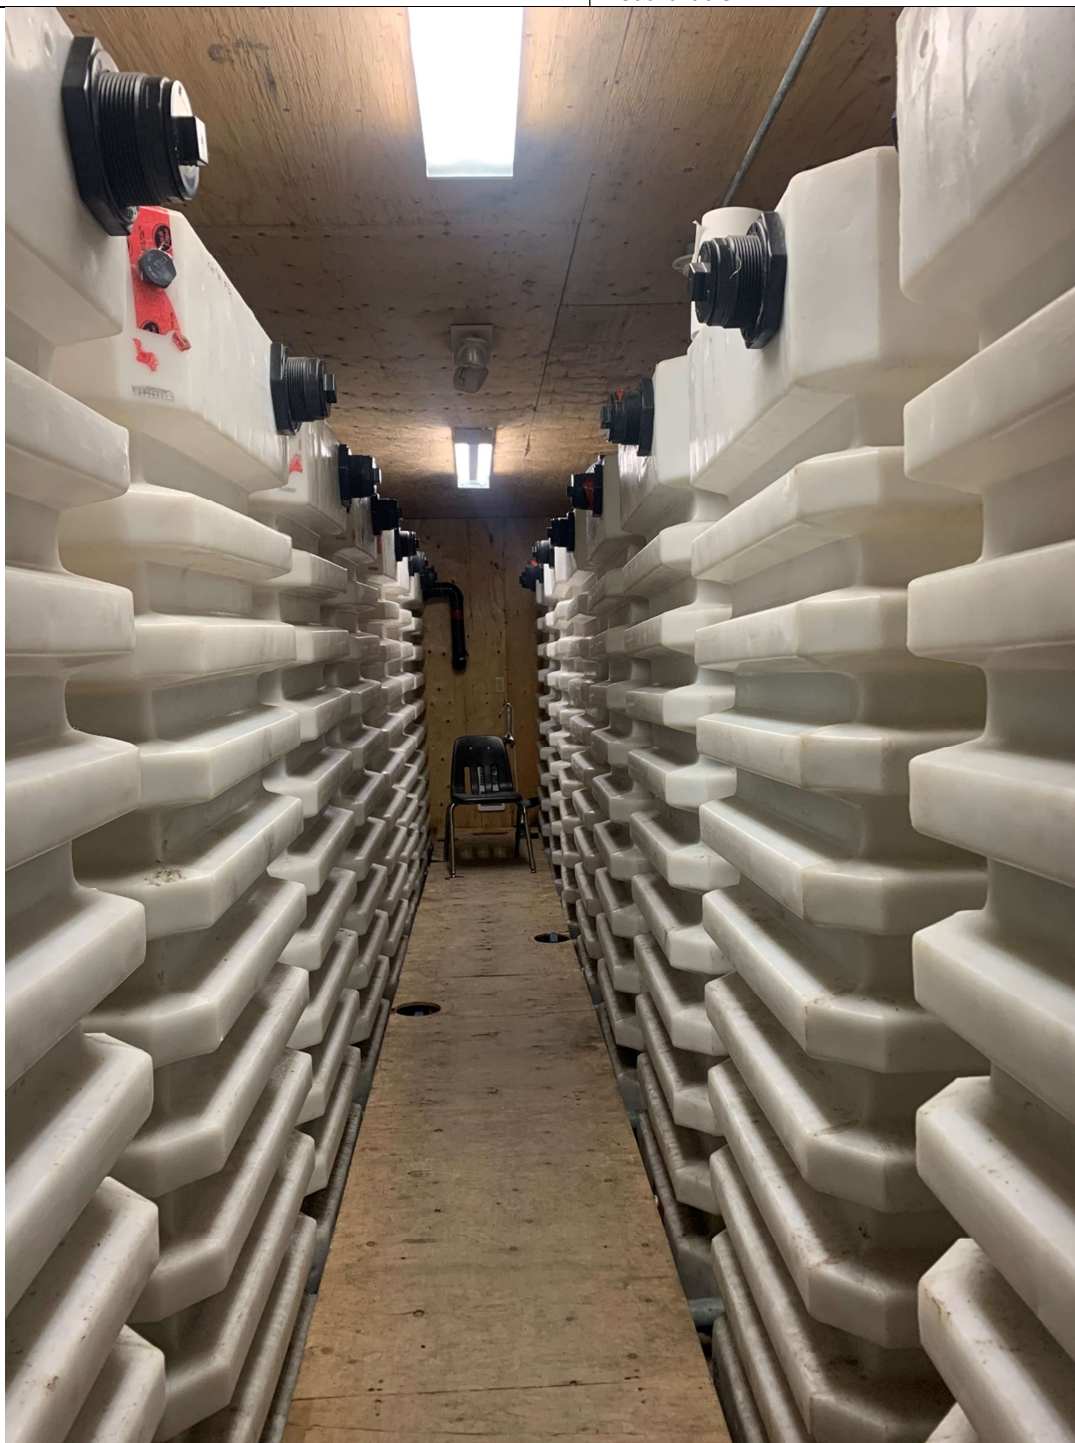
3

the camp by conveyance line. During the winter months fresh water is pumped into two holding tanks on a sled and is hauled up to the camp then transferred into the storage tanks. These tanks have a maximum capacity of 24m³ (photo 3), water is metered as consumed from these tanks in accordance with Part B item 4. This method is found to be satisfactory to the Inspector. Water use is recorded daily as required by Part J item 1. Water use records are posted and available for review.(photo 4)

Freshwater storage inside main camp

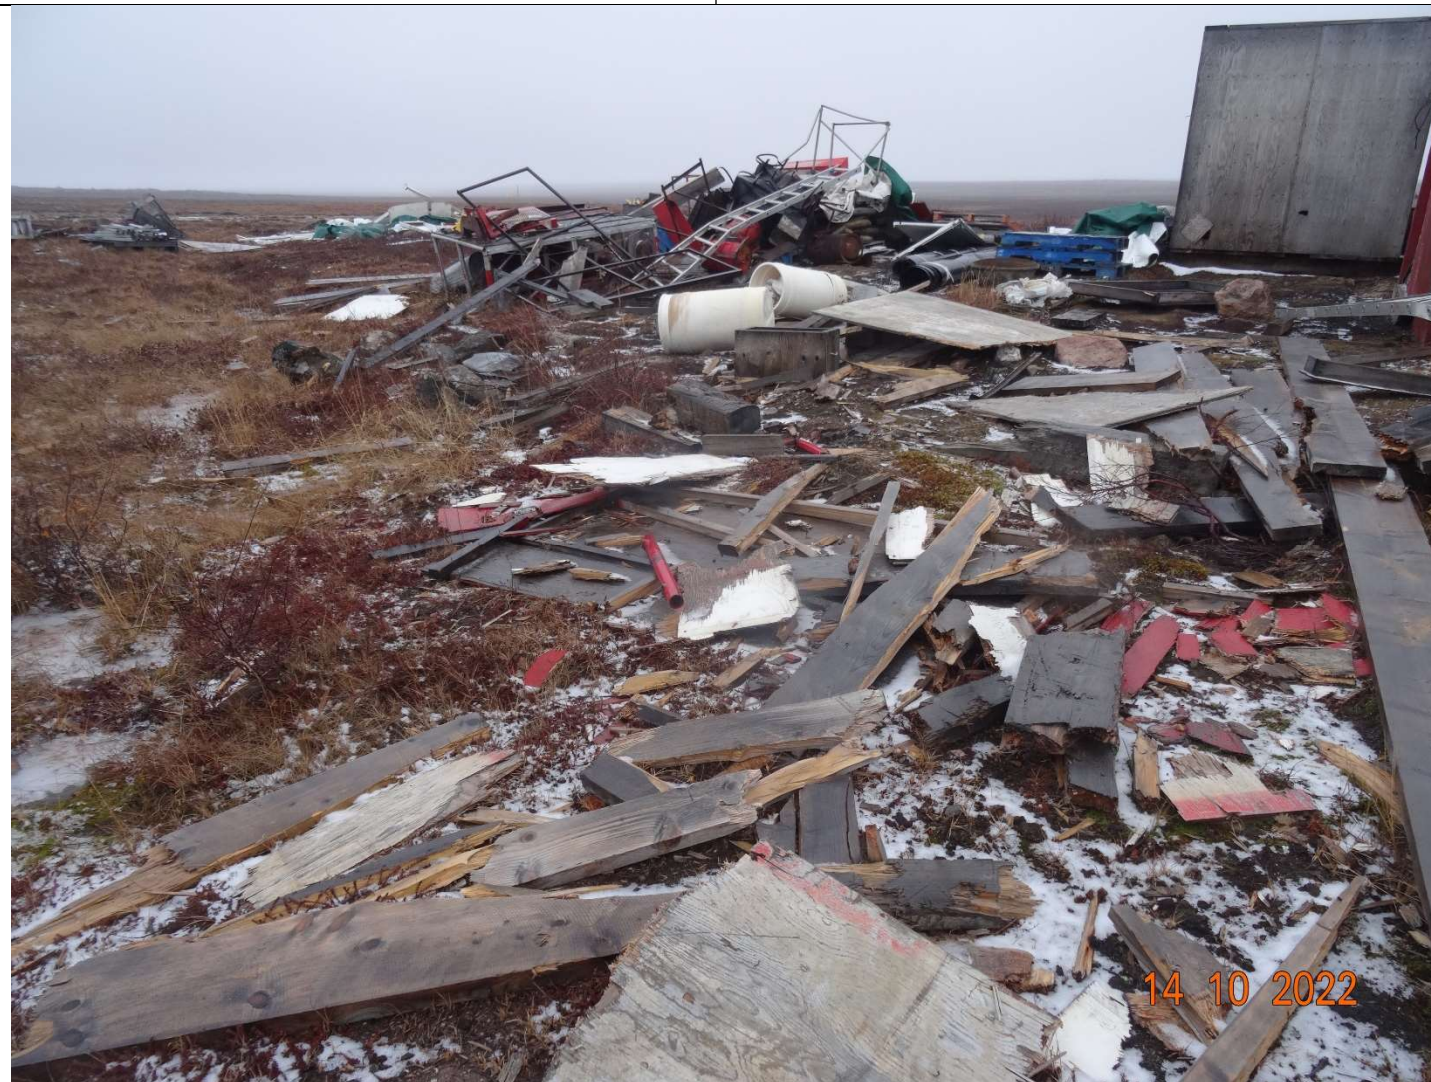
6

- a. This site is located at N62° 52' 12.3" W96° 55' 24.2". The site is unkept and majority of the structure are in poor condition. The representative has removed some of the materials (e.g.: drilling equipment, structures and hazardous waste) and relocated them to camp. The Licensee is reminded that progressive reclamation of any components that are no longer required is required as prescribed in Part I item 3. (photo 6). A detailed plan for reclamation should be contemplated before the term of the next inspection.
- b. In 2020 a spill was observed at N62° 52' 9.768" W96° 55' 29" of a number unknown materials (e.g.: drilling grease, calcium chloride, soaps and hazardous waste) when a bear entered the structures. All of the materials of concern have been removed from the site and returned to the camp for disposal. The spill site has not been reclaimed and is still observed on the ground.

Drill Laydown.

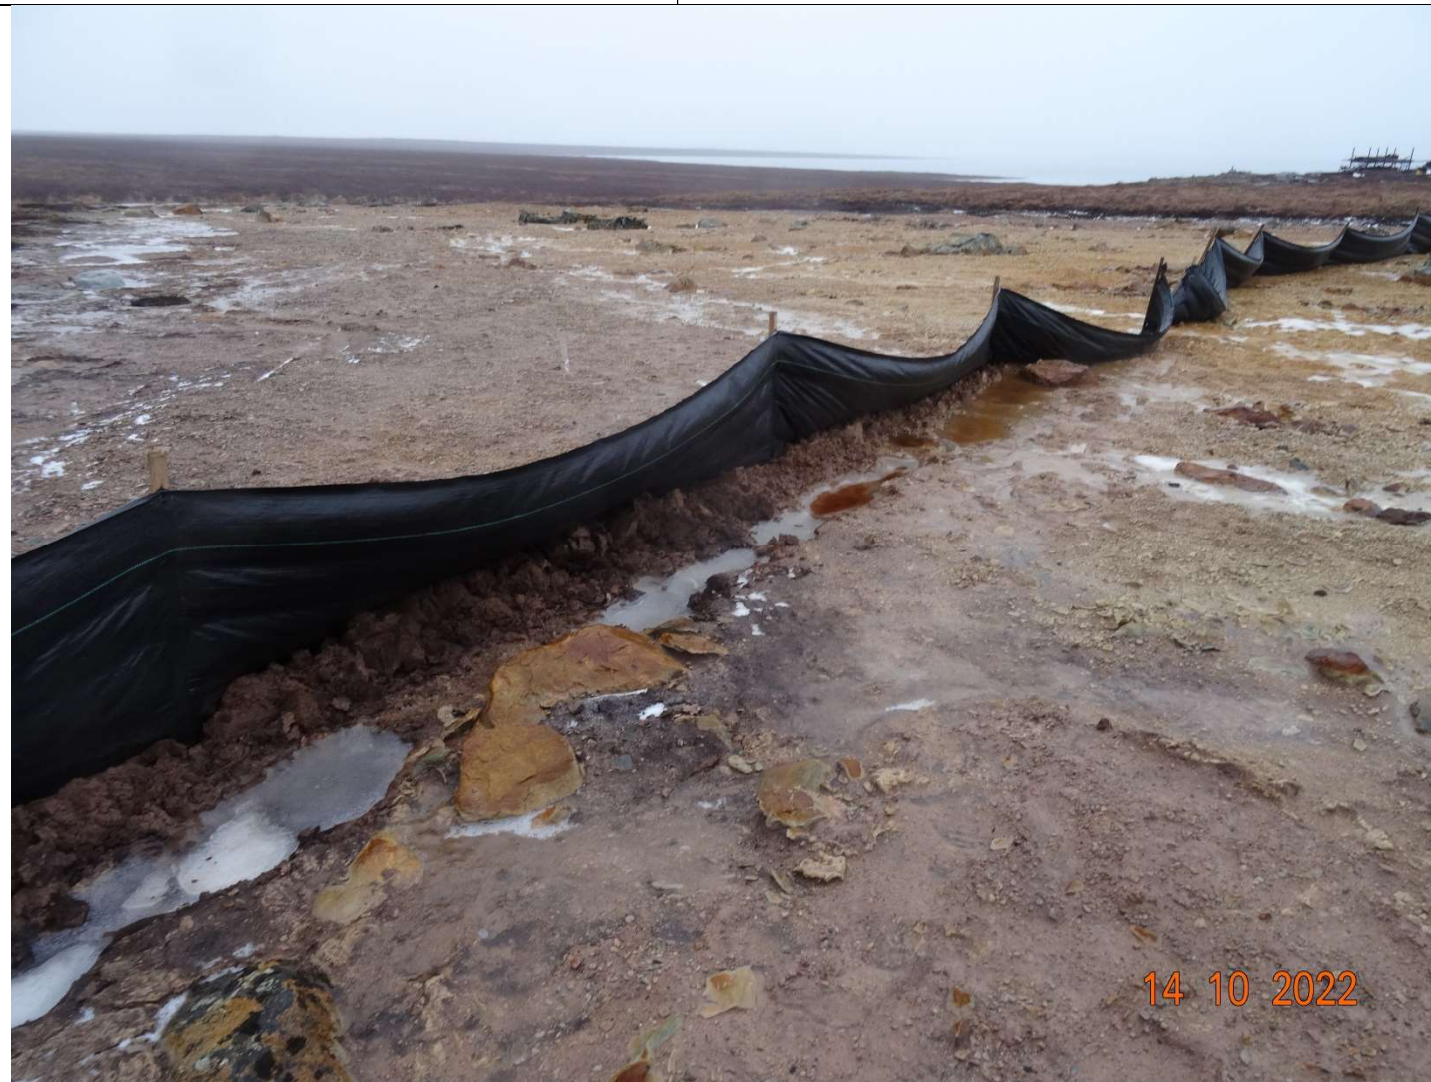
7

- a. An area of concern in relation to acid rock drainage was noted in the 2020 and 2021 inspection report. This area is at a historic bulk sample site. The representative indicated that measure have been taken to prevent further weathering of the rock including monitoring of the run off water, capping of the location and installation of a silt curtain (photo 7).
- b. Field measurements for pH collected in nearby pooled water indicated a pH level of 3-4. Additional measurements collected at the nearby creek (above and below the area of concern) indicated a pH of 5. The representative indicated that baseline samples are available for review and would provide that information to the Inspector upon request.

Silt curtain installed near historic bulk sample.

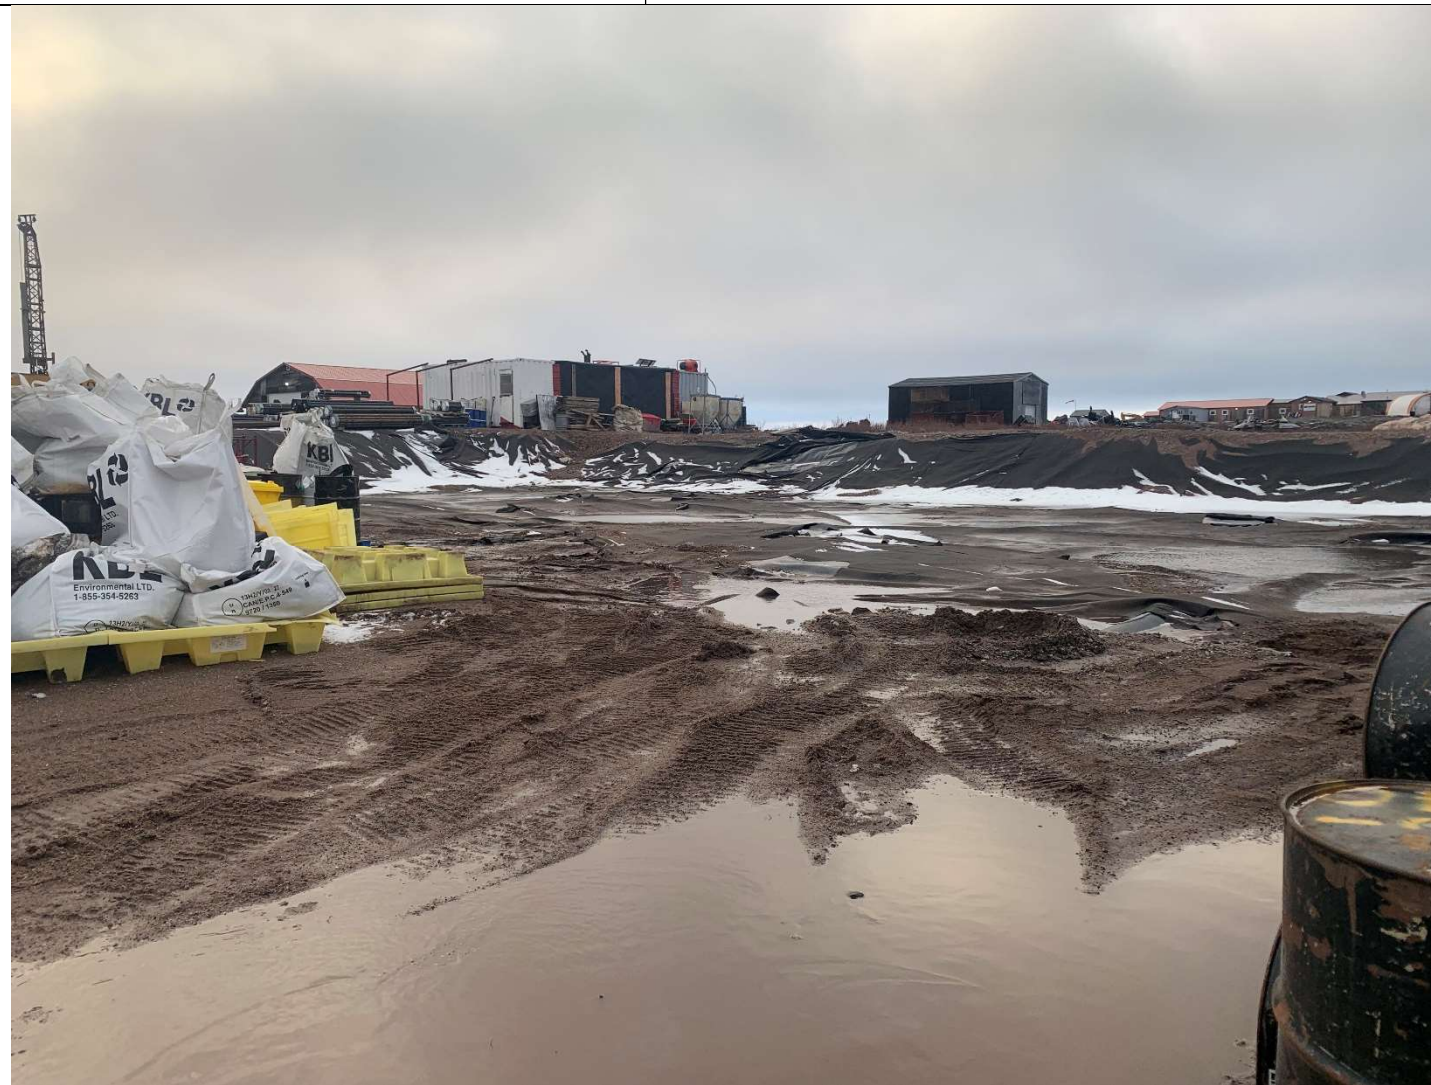
8

- a. The FCA is secondary containment berm is located at N62° 53' 31.3" W96° 54' 03.0" and is used to store hazardous waste and fuel.
- b. The HDPE liner is damaged in several locations (photo 8). The Licensee indicated that improvements would be made to the FCA during 2023.
- c. No water will be discharged from the FCA in 2022.

Fuel Containment Area, HDPE Liner exposed and torn in some locations

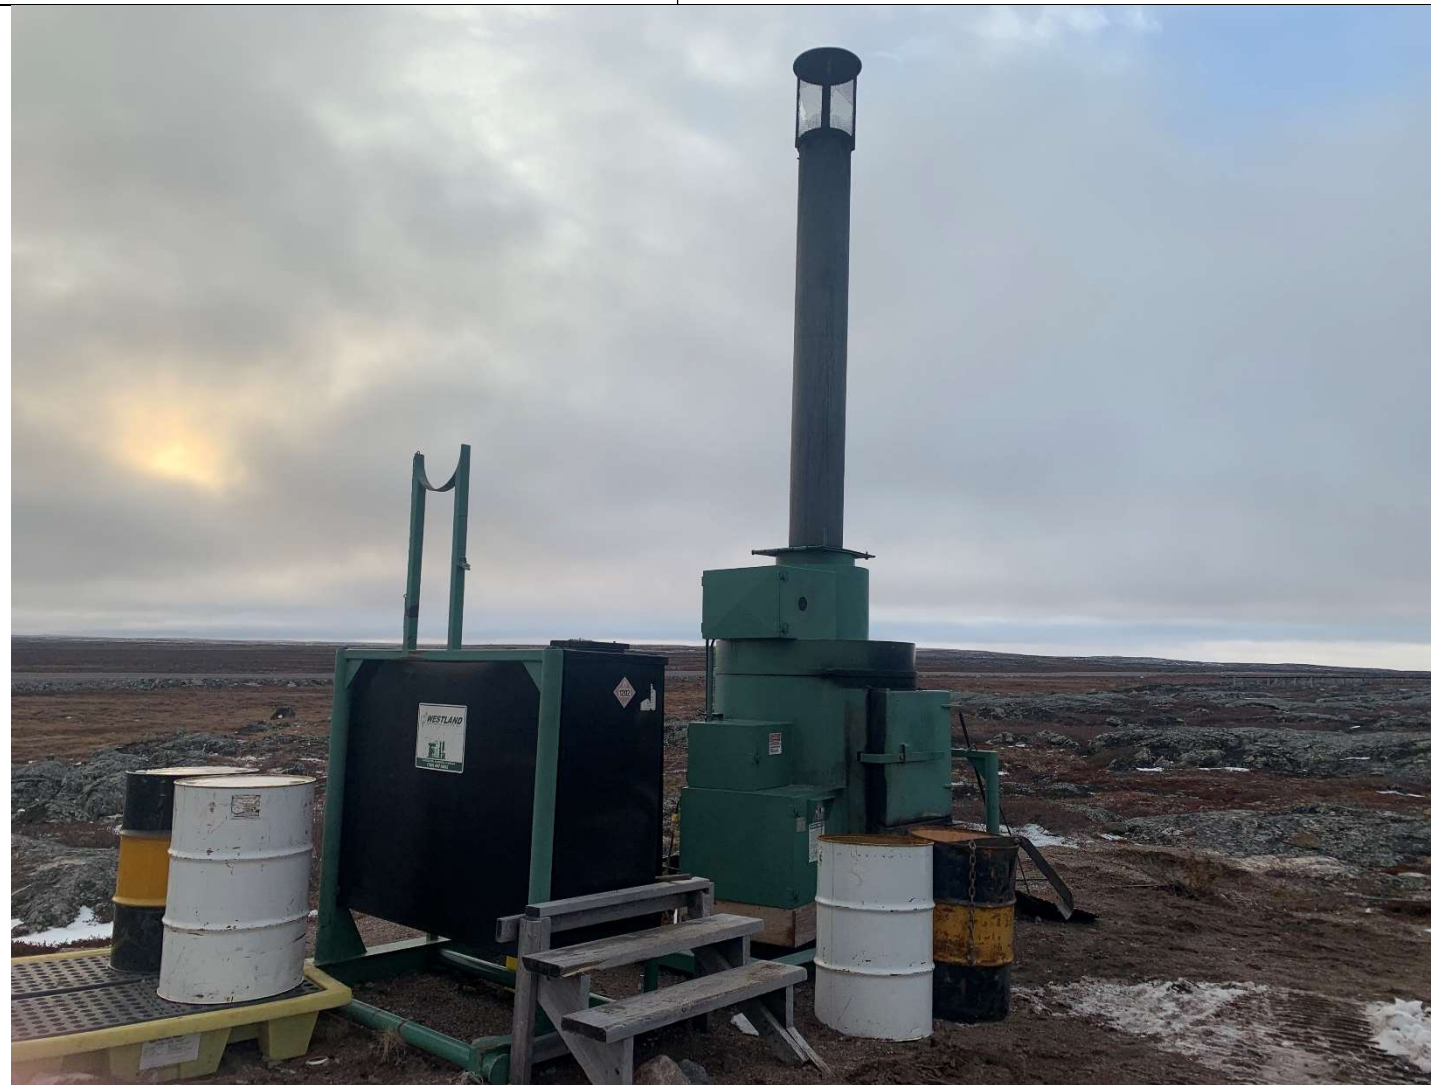
9

- a. Garbage is disposed of by incineration (photo 9) as permitted under Part D item 3.
- b. Waste will be backhauled in marine shipping containers from the camp to Baker Lake overland this winter. The waste will then be sent out for appropriate disposal on sealift in the future. The Licensee is reminded of the

Incinerator used to dispose of combustible garbage.
