WATER LICENCE INSPECTION FORM

Licensee				Licensee Representative							
Sabina Gold and S	N/A Representa	N/A Representative's Title									
2BE-GEO1520 and 2BE-GOO1520 -											
Land / Other Authorizations Land / Other Authorizations											
Date of Inspection Inspector											
17/07/2015 Eva Paul											
Activities Inspected											
☐ Roads/Hauling						☐ Construction ☐ Reclamation ☐ Fuel Storage ☐ Other:					
Conditions: A - Acceptable C - Concern U - Unacceptable NA – Not Applicable NI – Not Insp								spected			
Water Use	Condition Co	Site Conditions		Condition	Comment	Haz/Mat Manager	nent Condition	Comment			
Intake/Screen	NA	Water Manageme	nt Structures	С	1	Storage	А				
Flow Measure. Device	NA	Culverts / Bridge	!S	Α		Spills	А				
Source:	NA	Drainage		Α		Spill Plan	NI				
Water Use:	NA	Erosion / Sedime	ent	С	2						
Recirculation (y /n)	NA Mitigation Measures		ures			Administrative					
		Reclamation Act	ivities	NI		Records	Α

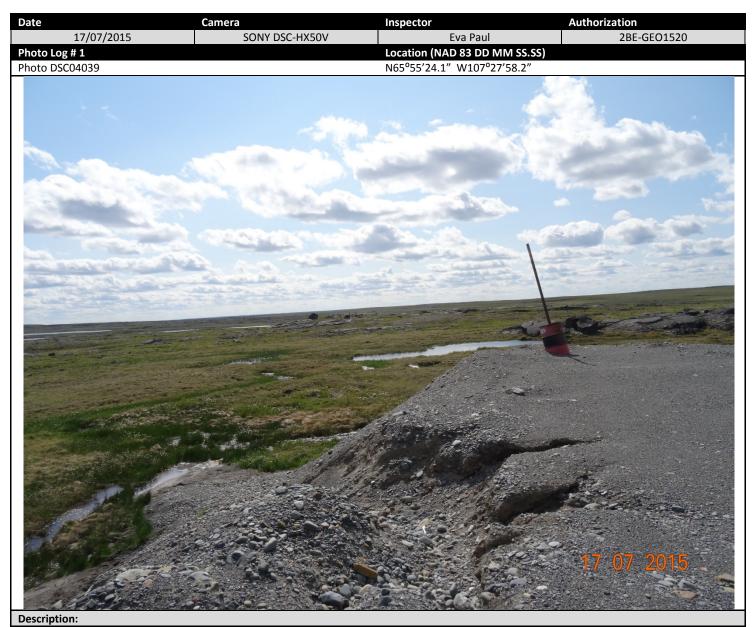
2. The fuel storage pad is showing significant erosion/slumping in some places. As this pad appears to be built in a marshy area, these slumps result in a spread of material and sediment into the wetland areas.											
SECTION 2	Comments	Non-C	☐ Non-Compliance with Act or Licence ☐ Action Required

South East side of the fuel storage pad: slumping and erosion is visible off the side, deposited into the wetland below.

1. Please ensure that r	monitoring f	requency is sufficient to	prevent bern	ns from c	vertopp	ing.					
2. Steps should be taken to repair the erosion and slumping of materials from the fuel storage pad at George Camp into the											
wetlands below. Ple	ease confirm	n with the inspector by S	eptember 30	when th	is work o	an be carried out.					
Licensee or Representative				Inspector's Name
