WATER LICENCE INSPECTION FORM

Licensee	Licensee Representative
Sabina Gold and Silver	Merle Keefe
Licence No. / Expiry	Representative's Title
2AM-BRP1831	Environmental permitting Manager
Land / Other Authorizations	Land / Other Authorizations
	--
Date of Inspection	Inspector
June 19, 2022	Jonathan MESHER
Activities Inspected	
<input checked="" type="checkbox"/> Camp	<input type="checkbox"/> Drilling
<input type="checkbox"/> Roads/Hauling	<input type="checkbox"/> Other:
<input checked="" type="checkbox"/> Mining	<input type="checkbox"/> Construction
	<input type="checkbox"/> Reclamation
	<input type="checkbox"/> Fuel Storage
	<input type="checkbox"/> Other:

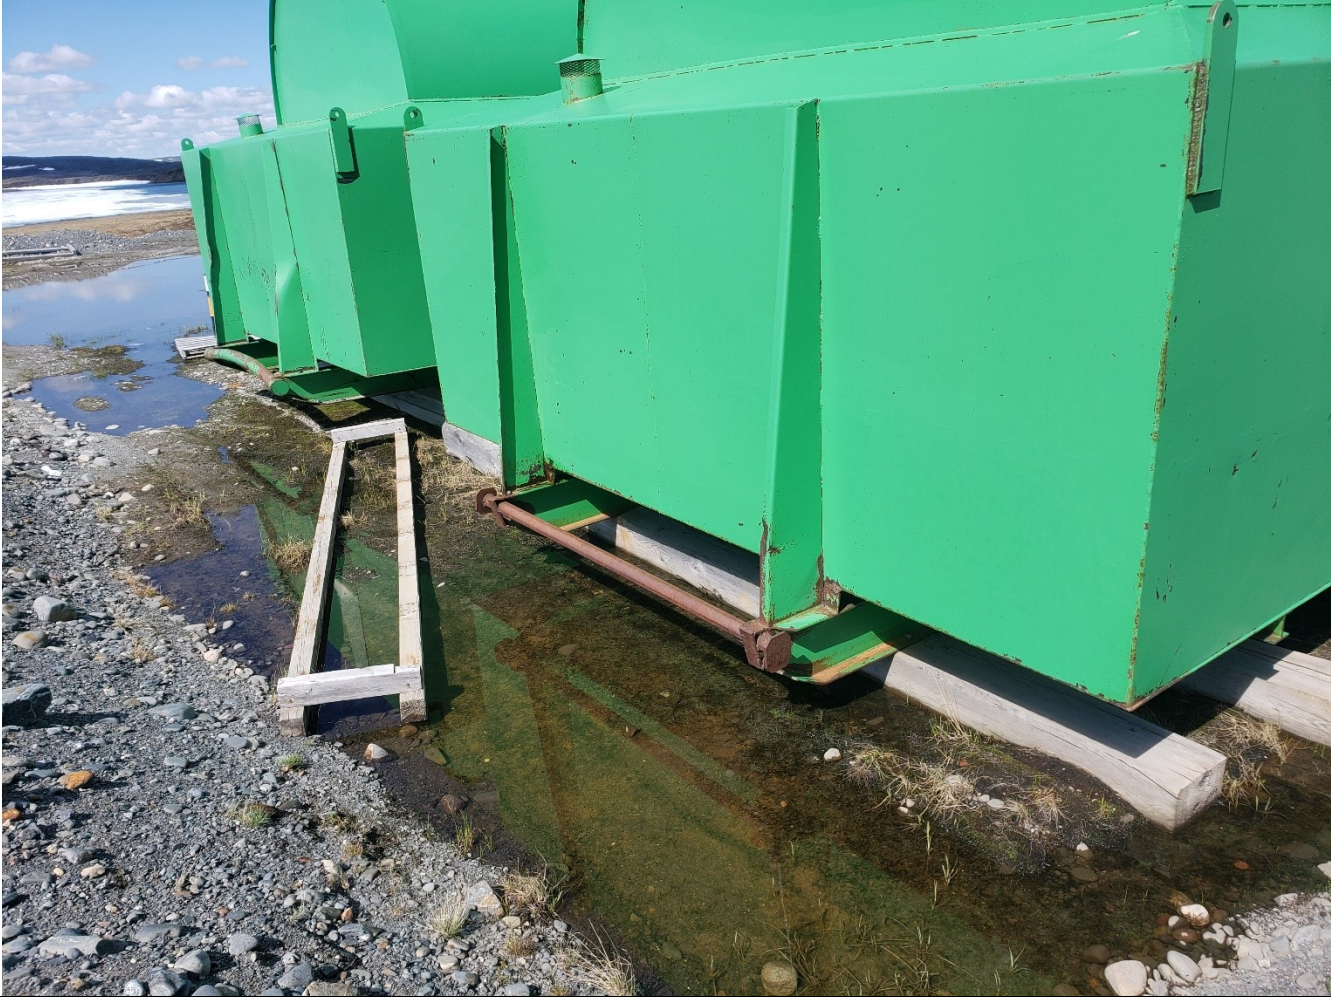
Date	Camera	Inspector	Authorization
June 19, 2022	Sony Cyber-shot	J.Mesher	2AM-BRP
Photo Log			
Photo 2

Description: Bulk fuel storage.

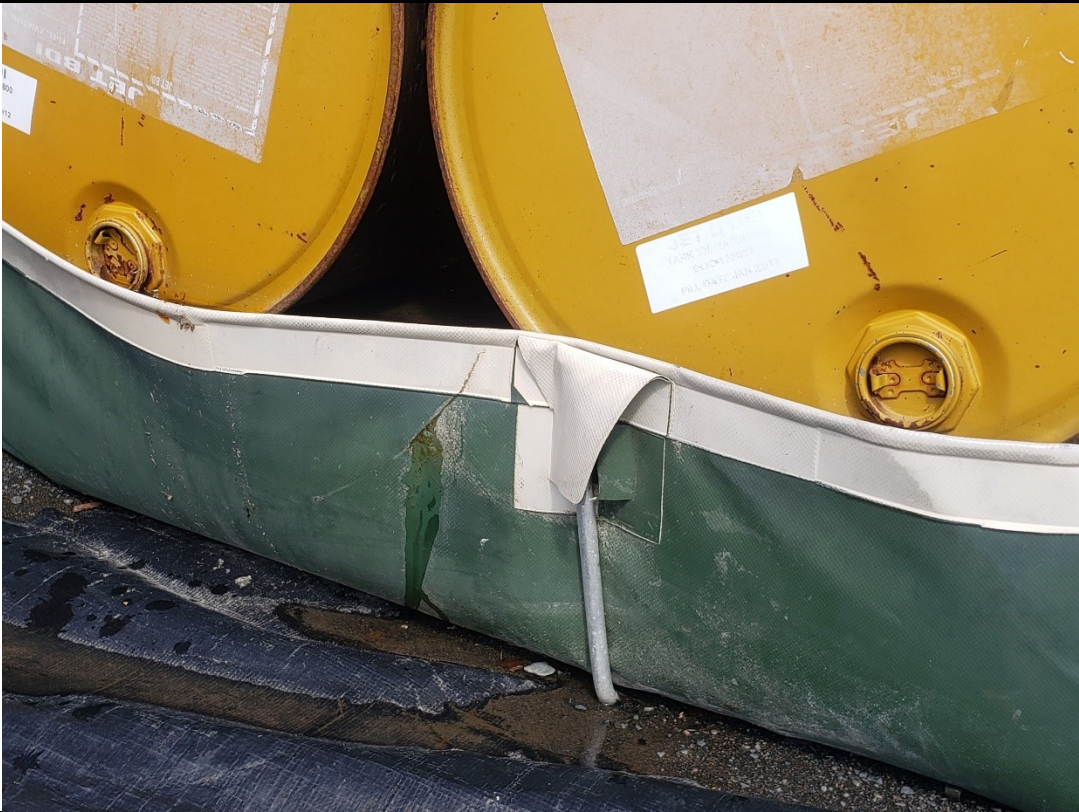
Photo 3

Description: Erosion down gradient of the “sump”

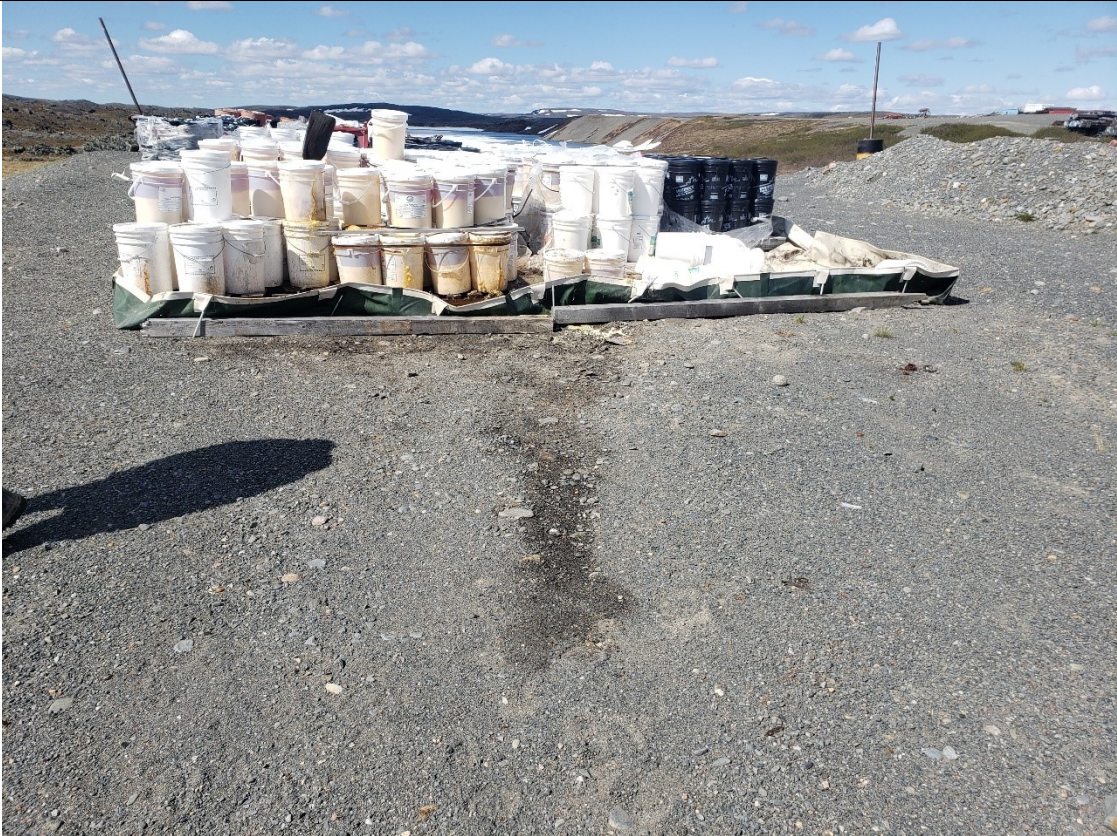
Photo 4

Description: Chemical storage with visible staining down stream.

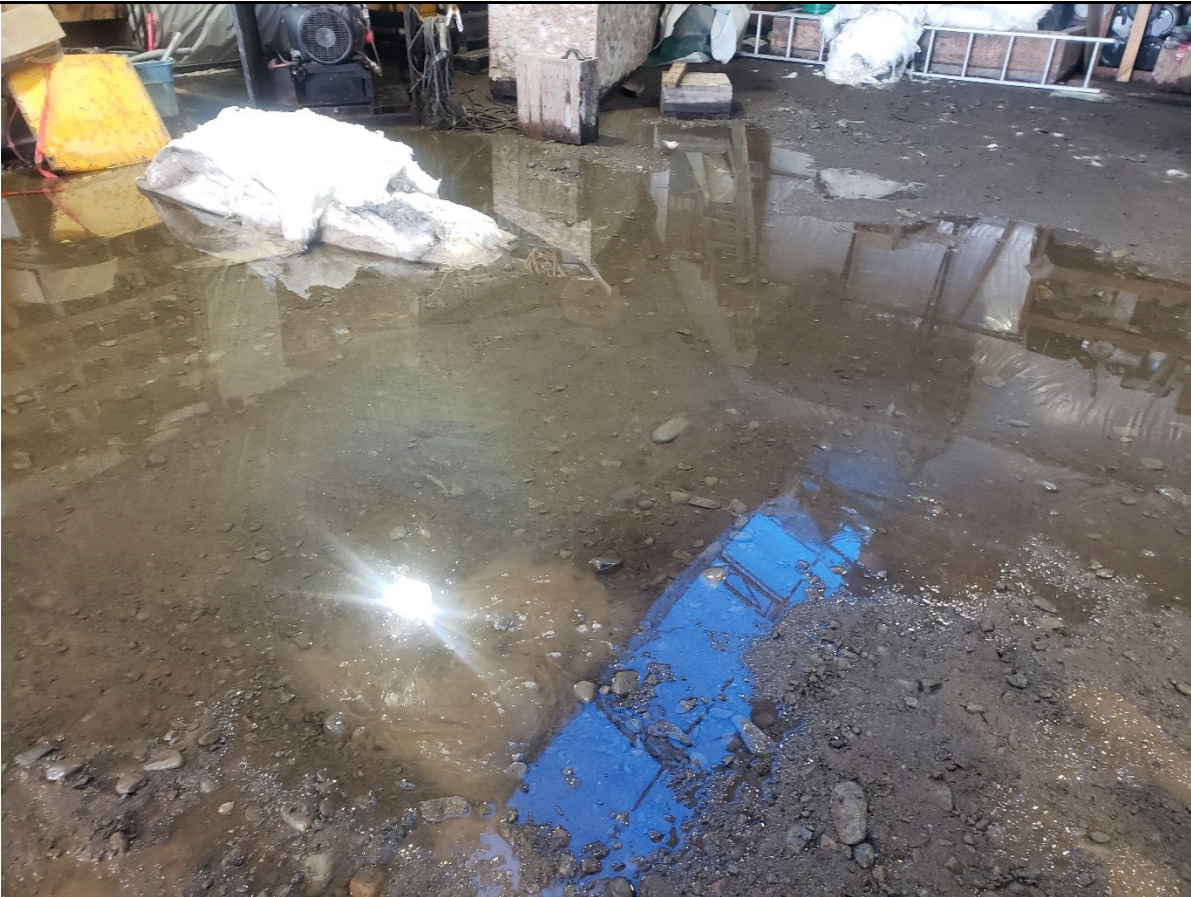
Photo 5

Description: potentially contaminated water.

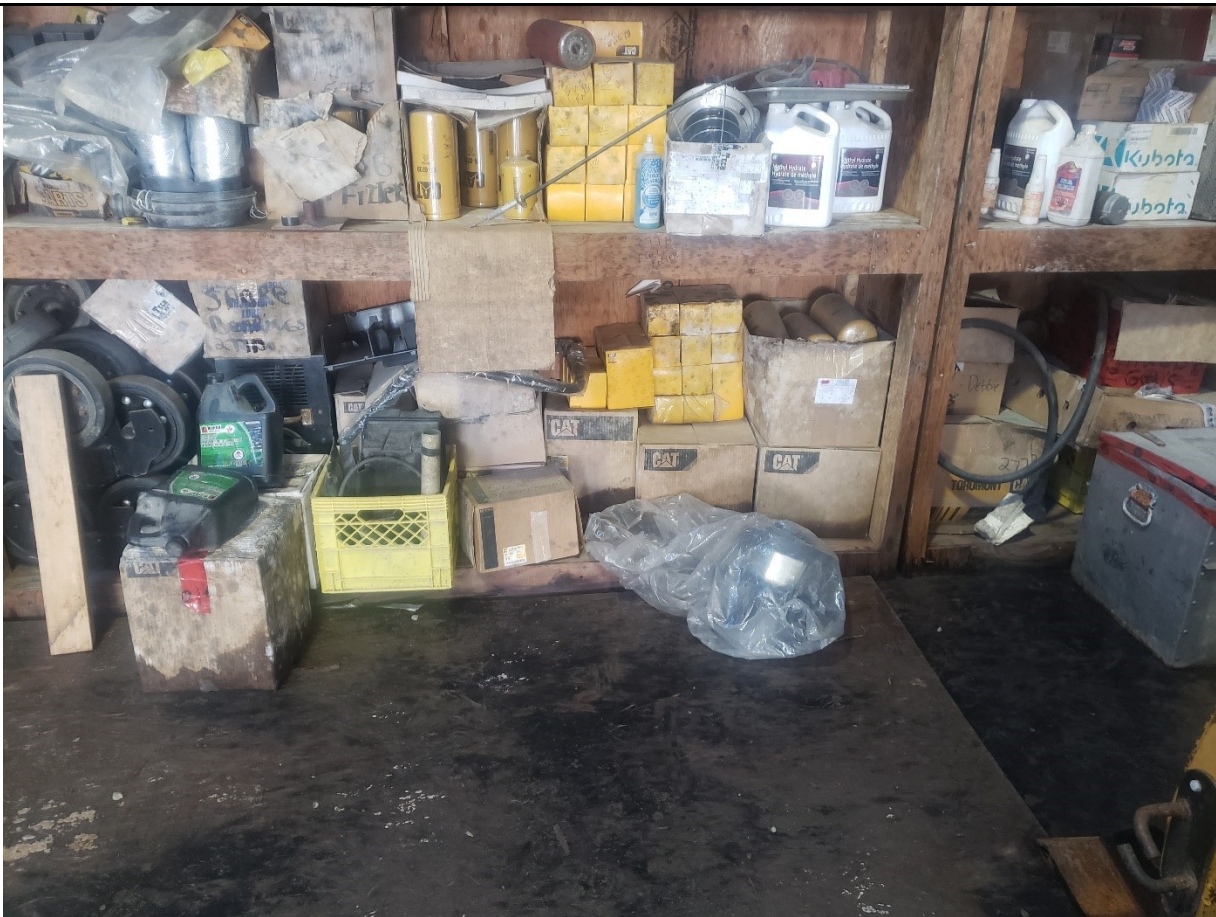
Photo 6

Description: Potential hydrocarbon staining in garage.
