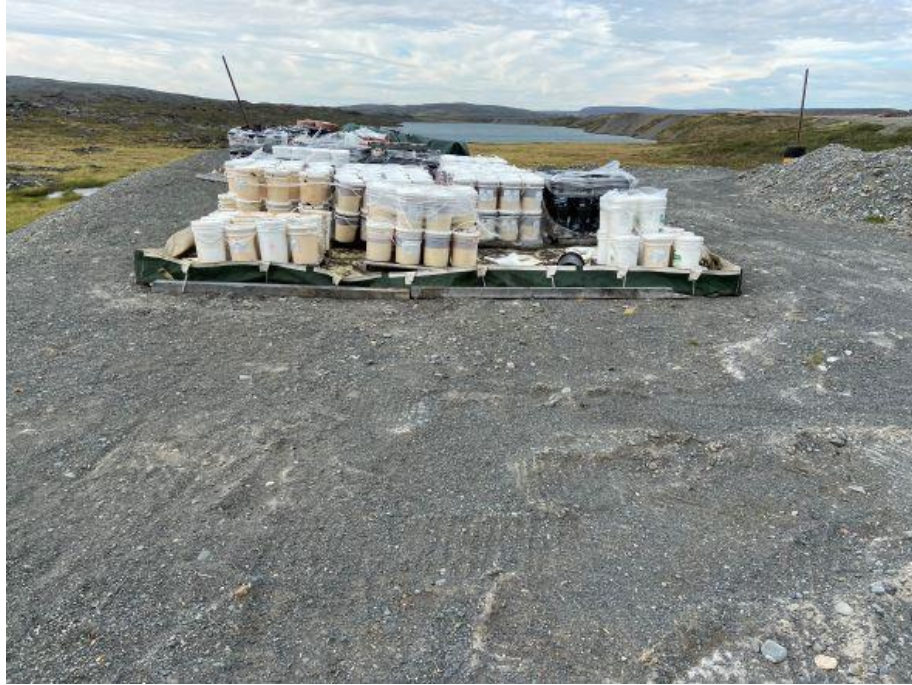
- 1) The licensee is to ensure the pop-up berm mentioned in comment b (II), is not leaking.
  - Sabina is reviewing options to relocate pails to another containment facility in 2023; for example, a lined seacan, and/or backhaul materials to an accredited waste management facility in Yellowknife. Large tarps have been used to cover instaberms (see below figures).

Figure 1. Contaminated material adjacent to berm has been remediated and material spilled material has been removed from the berm.

- 2) The licensee is to repair or replace the leaking berm and submit a pill report for the seepage.
  - Sabina repaired the liner and spilled materials scooped and/or shoveled into empty drum for backhaul to an accredited waste management facility in Yellowknife. Remediated stained material into empty drum for backhaul to an accredited waste management facility in Yellowknife (see above figures).

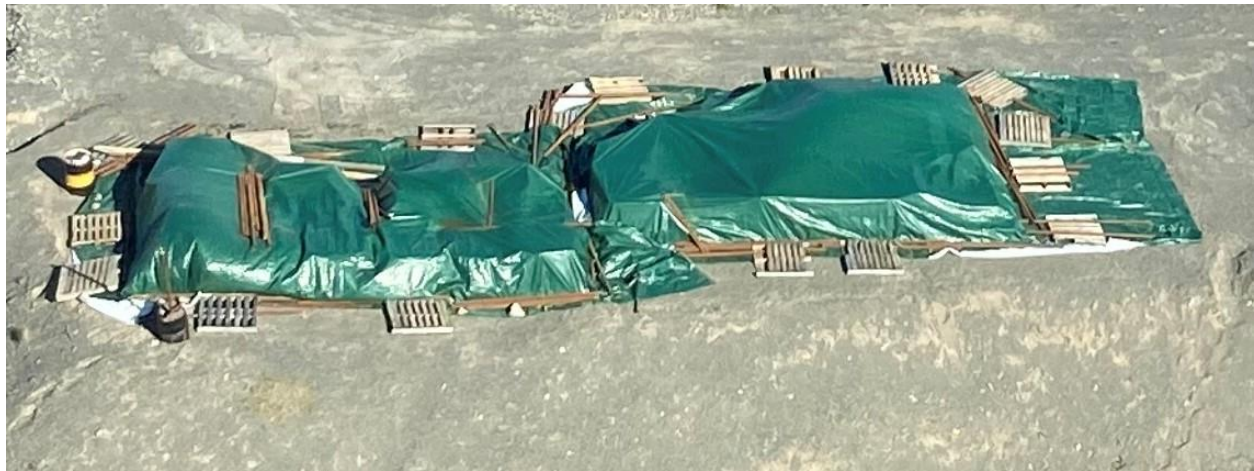
Figure 2. Pop-up berms covered completely with tarps.

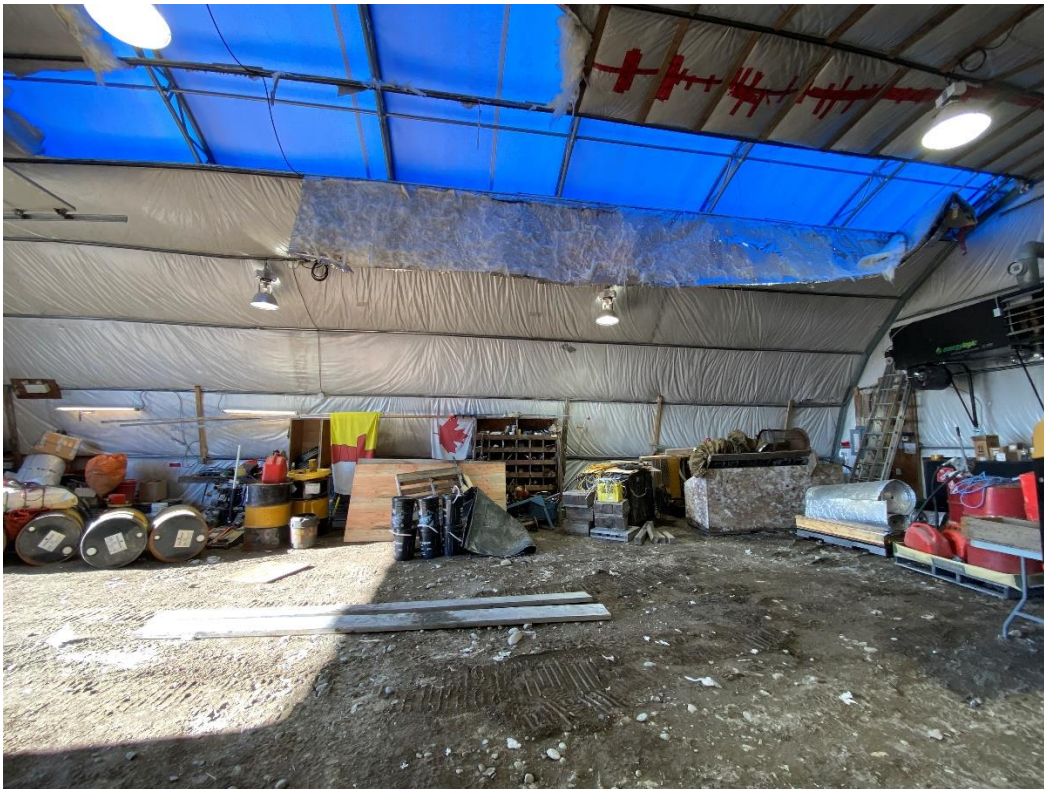
- Sabina pulled out high risk problematic insulation and have plan in place to replace all other insulation in 2023, repaired Quonset skin, ponding water evaporated (see figures). Water is likely caused by condensation build up, not from rain or other surface water (no water was seen in the Quonset after a significant rain event). Once the problematic insulation is replaced it will not store and release this condensation volume any longer.

Figure 3. Quonset after high risk insulation removed and showing no ponding water.

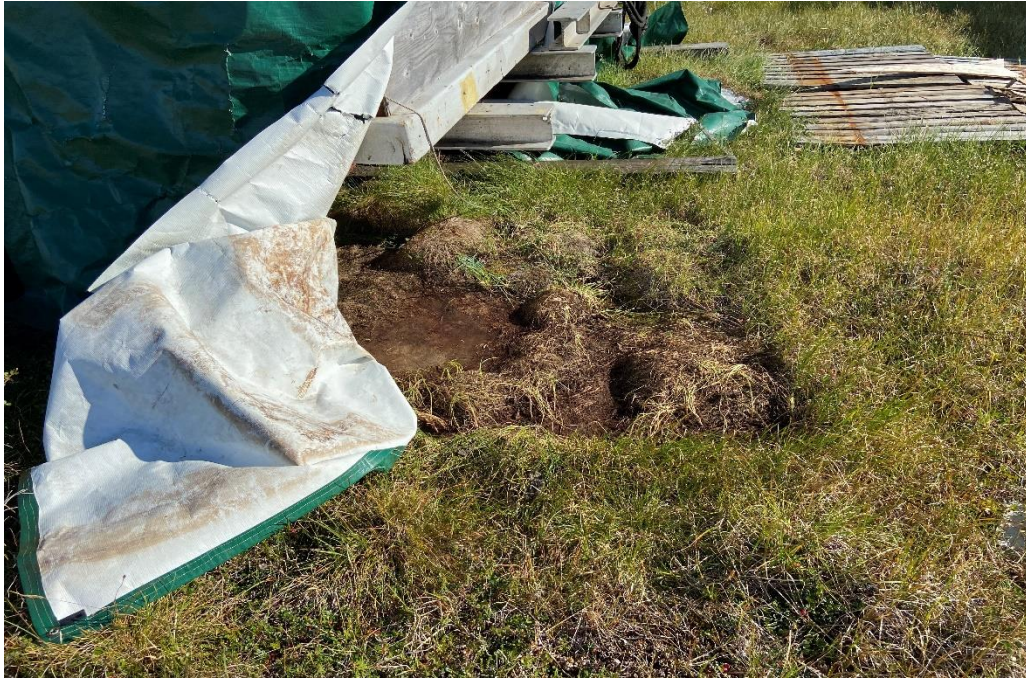
- 4) The licensee is to remediate the spill at Drill shack number 1486 and submit a spill report for this spill.
- Brown tundra under the drill shack is not caused by a spill, but instead by lack of sunlight since the shack was covered in a tarp, and that tarp has since been blown off and some green

life is returning (see figures). The inside of the drill shack was inspected for spills, but none were found. Spill matting placed inside the drill during shutdown is dry and shows no signs of spillage. The soil beneath the shack and down to approximately 10cm smells and feels like clean soil.

Figure 4. Vegetation adjacent to drill storage area.

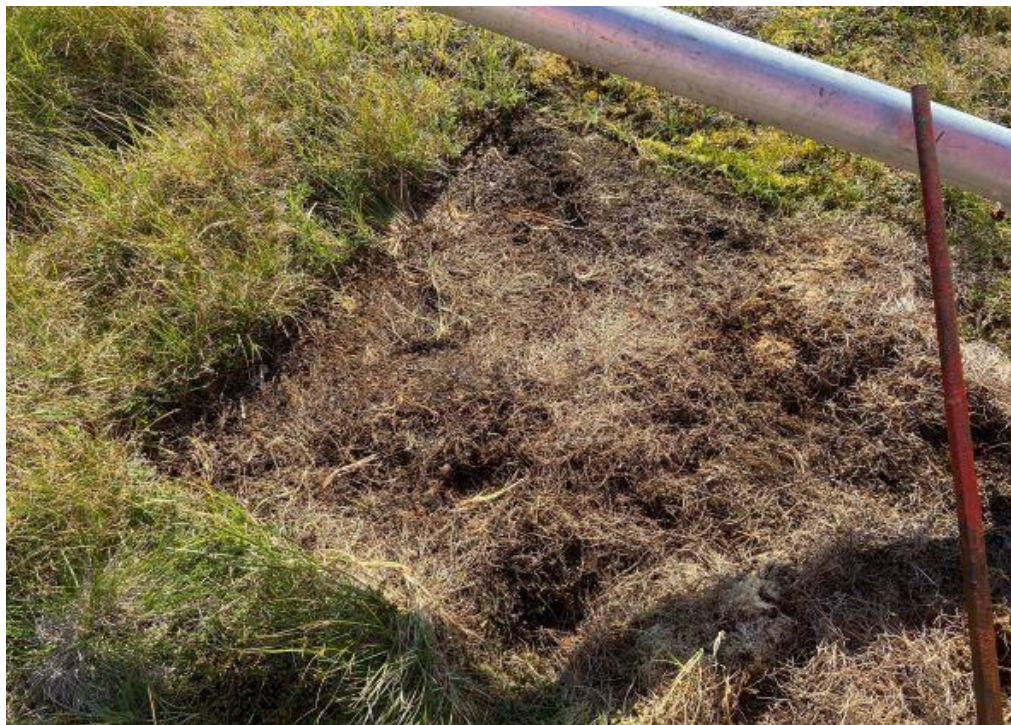
Figure 4. Vegetation adjacent to drill storage area (x2).
