PHOTOS FROM INSPECTION OF WATER LICENCE 2BE-GEO1015, JULY 7 2012

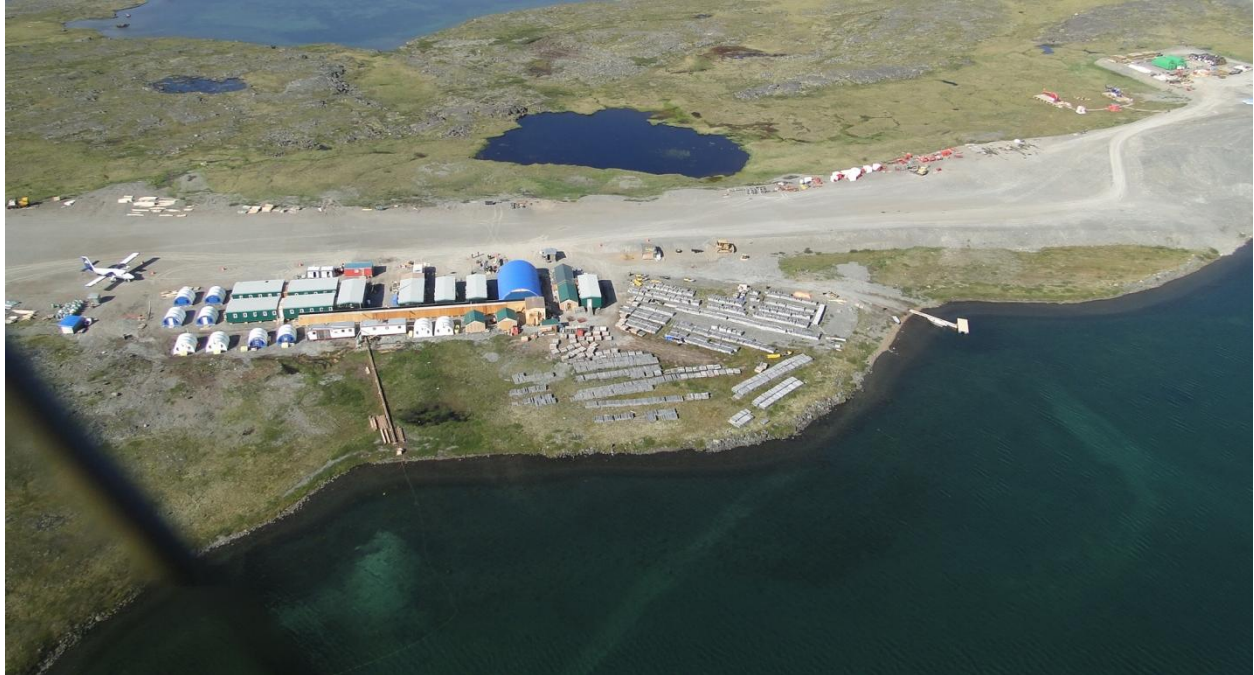
Figure 1. George Lake Camp (overview). Note dark pond near water where greywater pools. Note core stacks near water's edge

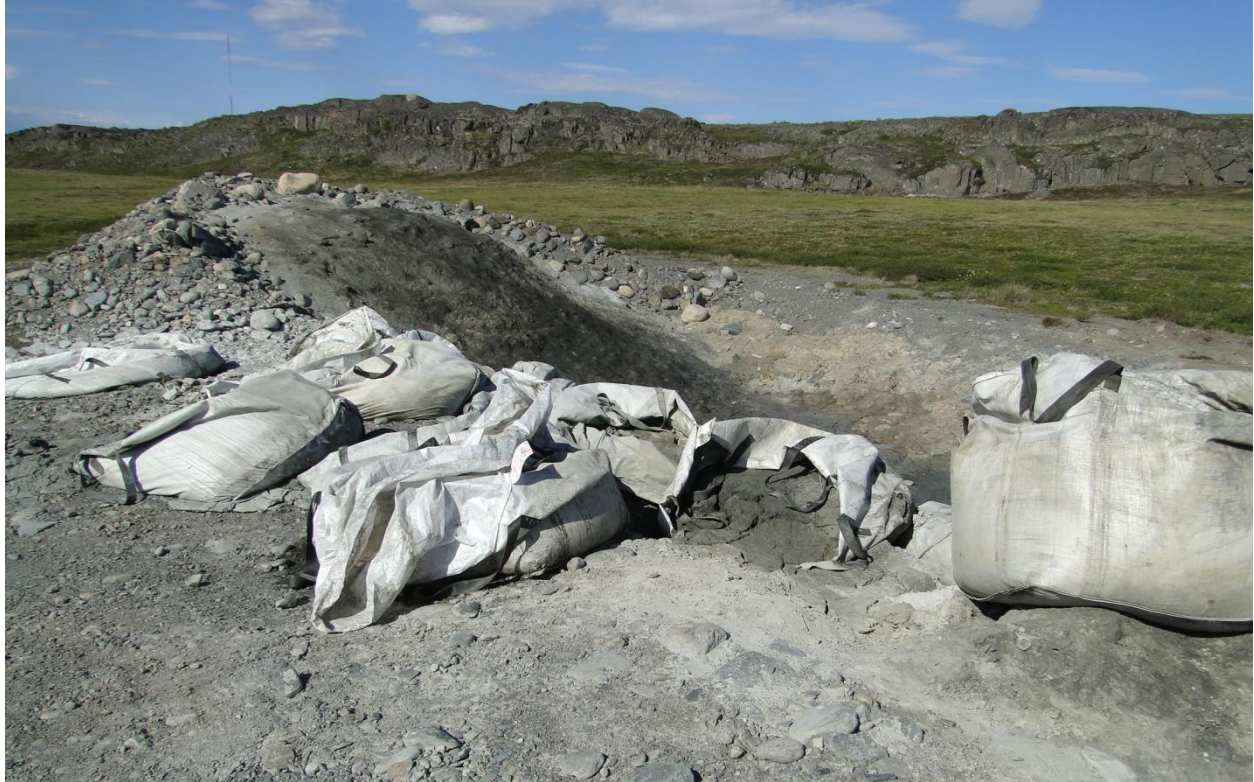
Figure 3. Trench where drill cuttings are being deposited. Reason for dark staining unknown.

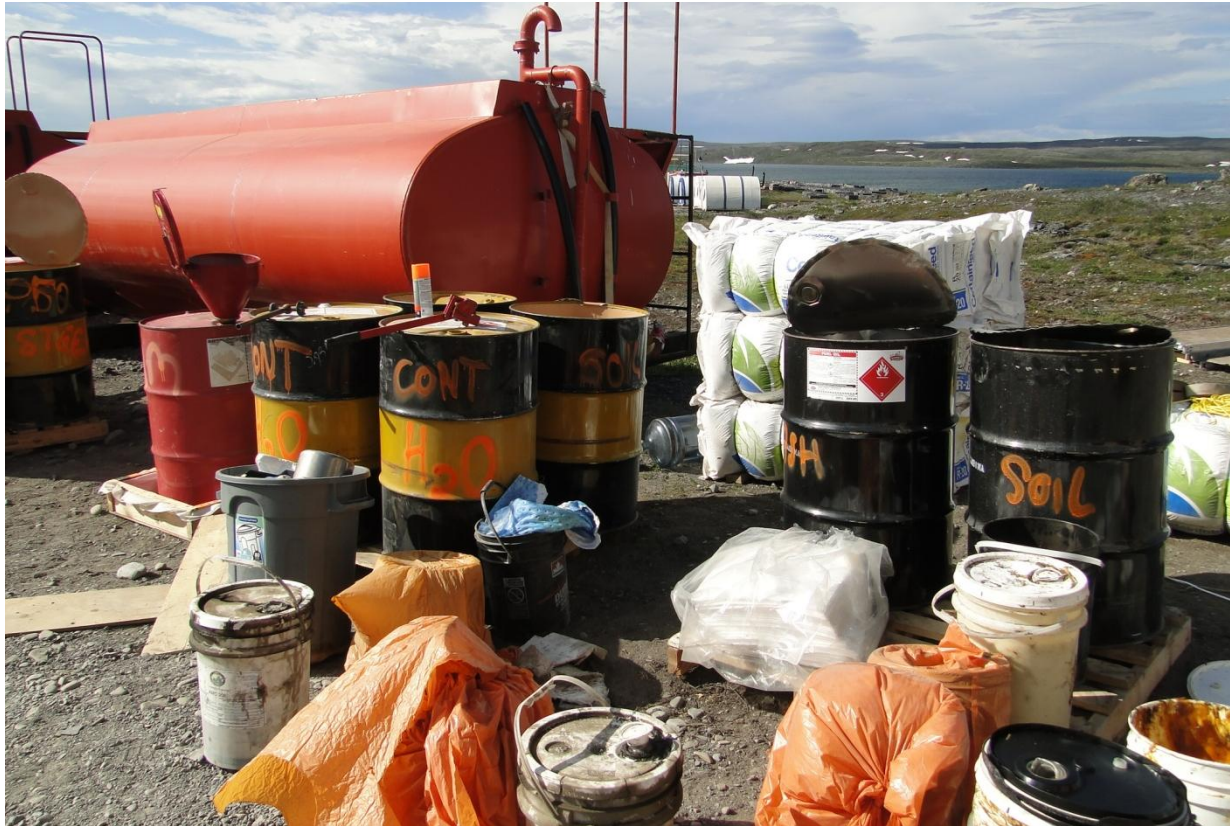
Figure 5. Waste consolidated near incinerator. Barrels marked, but not all are in containment or covered. Pails should be contained/covered as well.

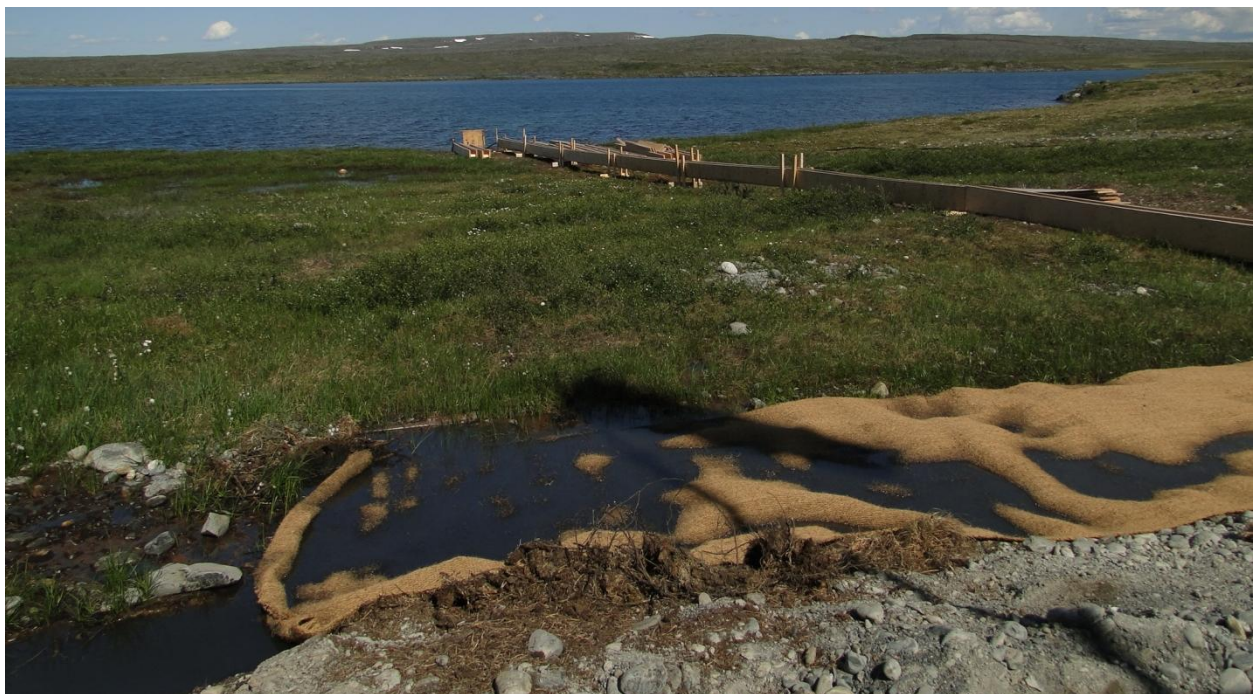
Figure 6. Greywater treatment at time of inspection. Shallow ditch, some matting, and then flowed downhill to lake.

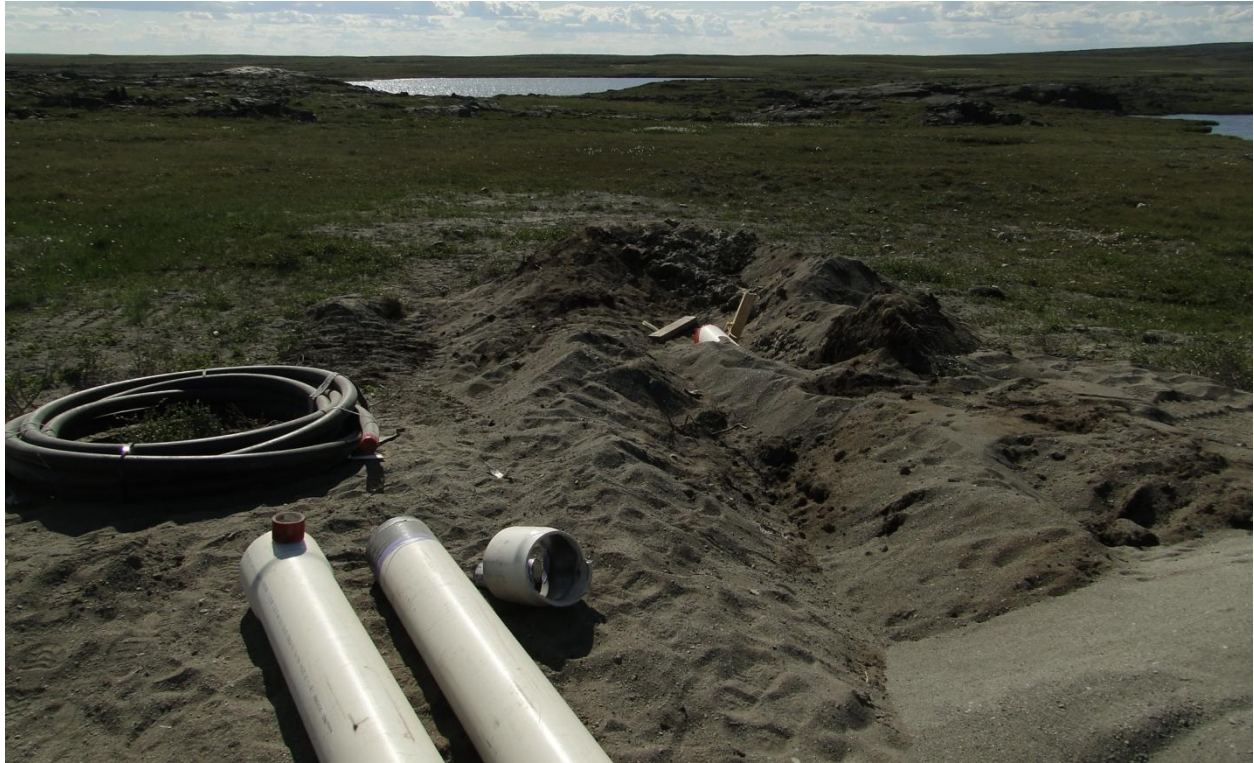
Figure 7. Greywater improvements in progress; line being installed on west side of airstrip and away from the water source.

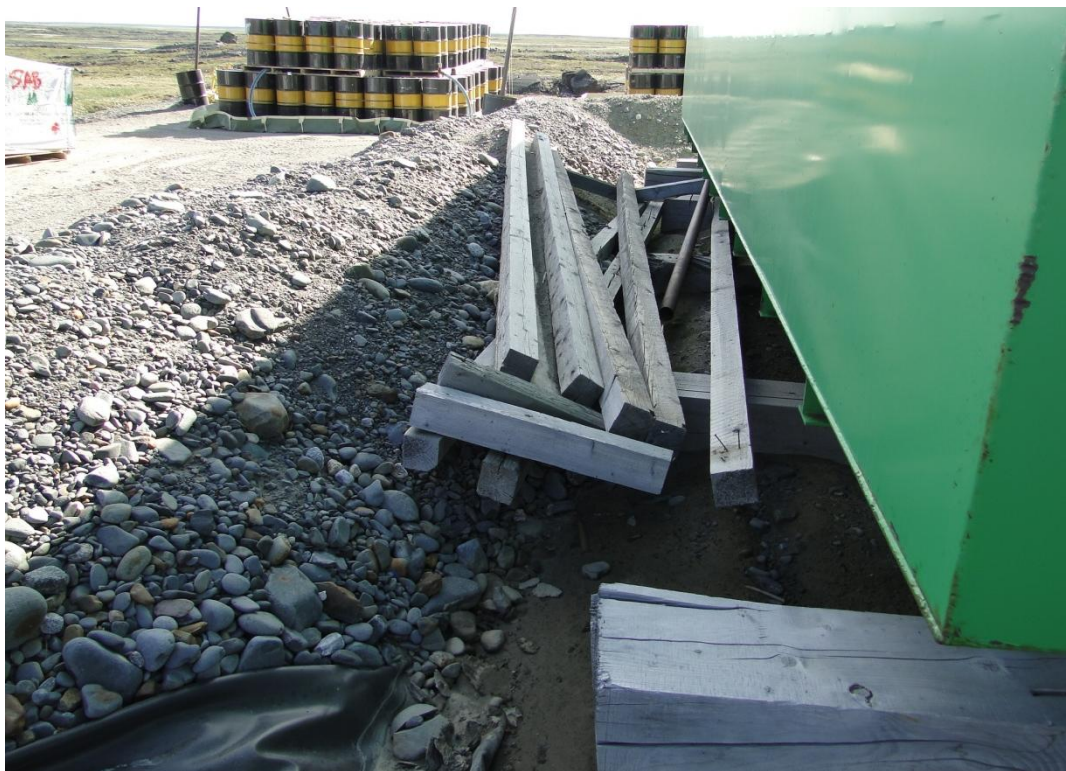
Figure 8. Berm liner exposed and boards with nails piled inside.

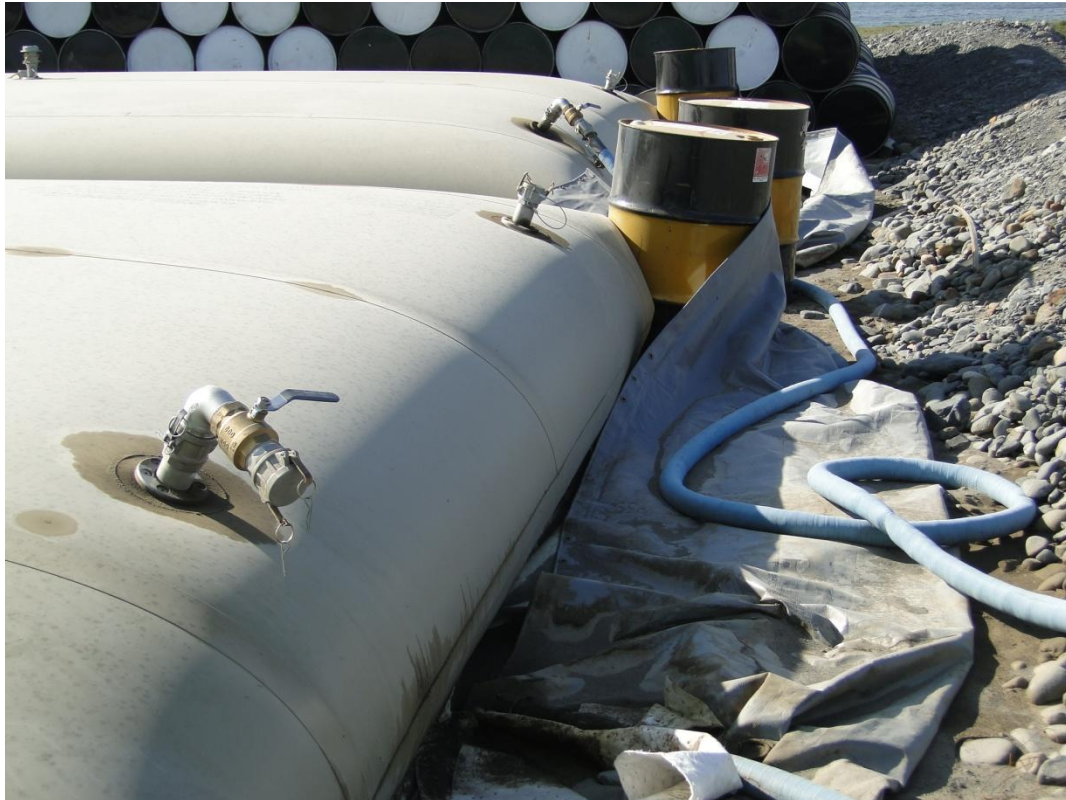
Figure 9. Fuel bladders in use within engineered berm; secondary liner stained.

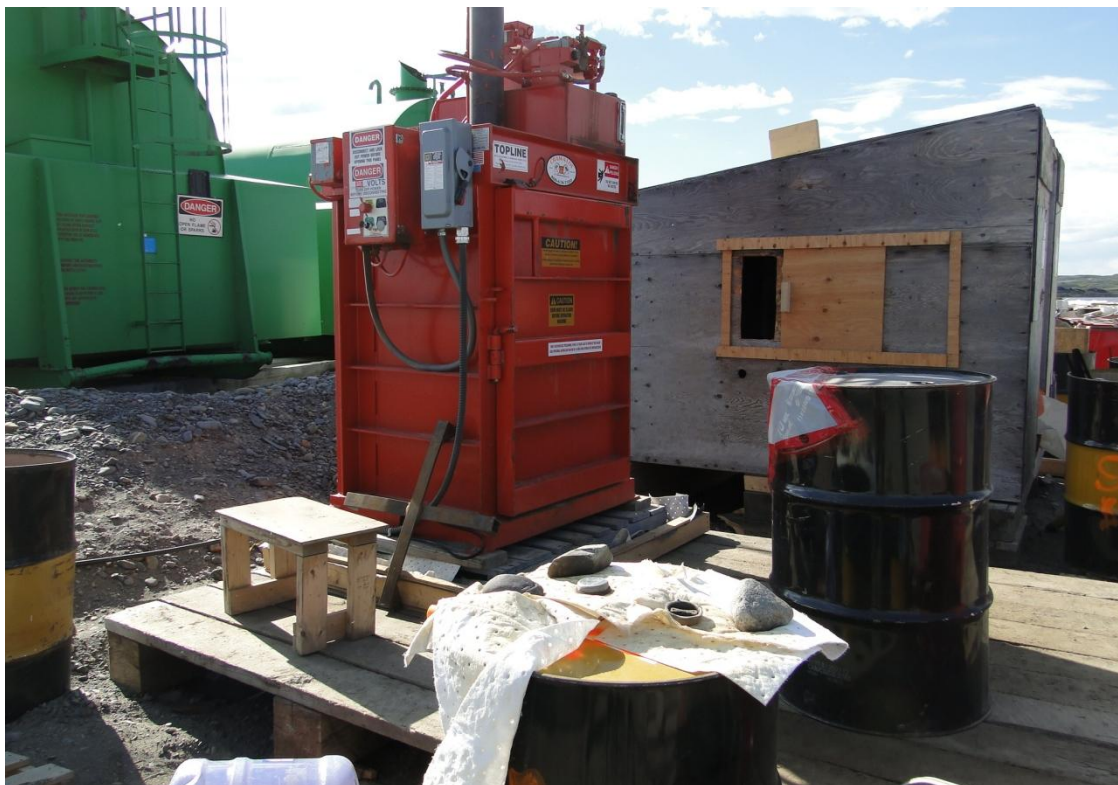
Figure 10. Drum crusher set on absorbent pads and tray; drums not over containment.

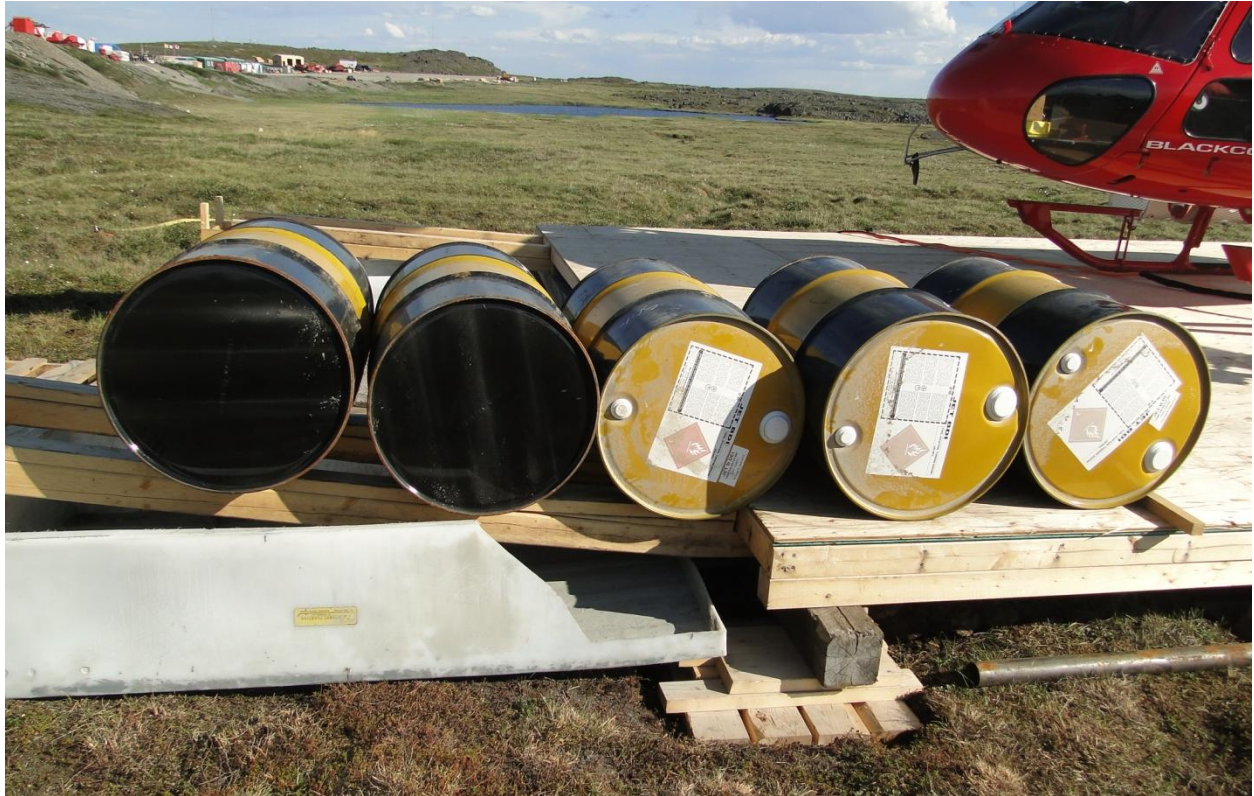
Figure 11. Secondary containment at helicopter area is insufficient.

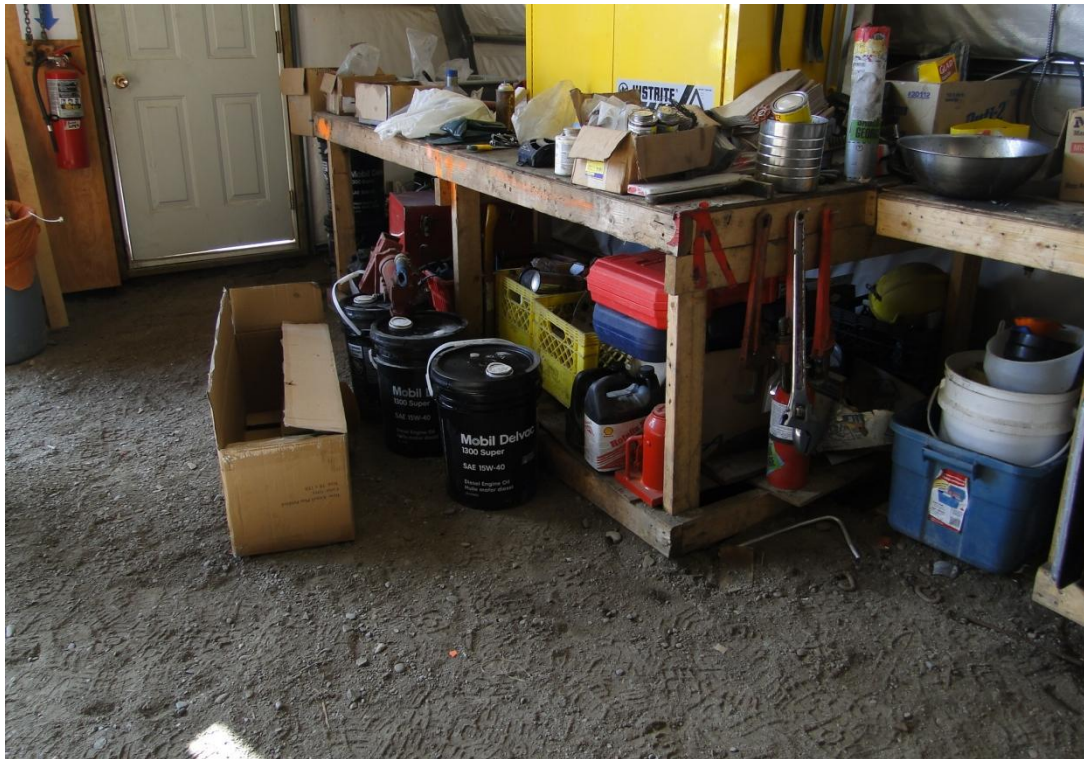
Figure 12. Oils stored within shop.
