PHOTOS FROM INSPECTION OF WATER LICENCE 2BE-GOO1015, JULY 8 2012

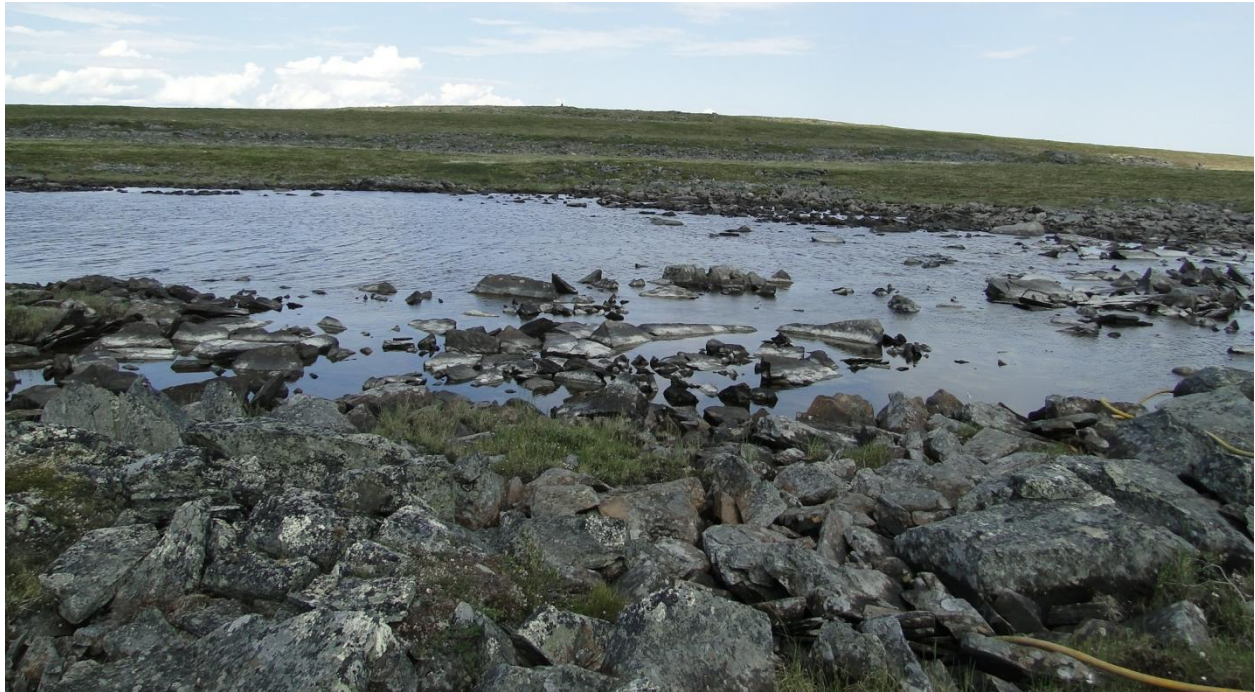
Figure 1. Shallow water body chosen for drill water showed draw-down.

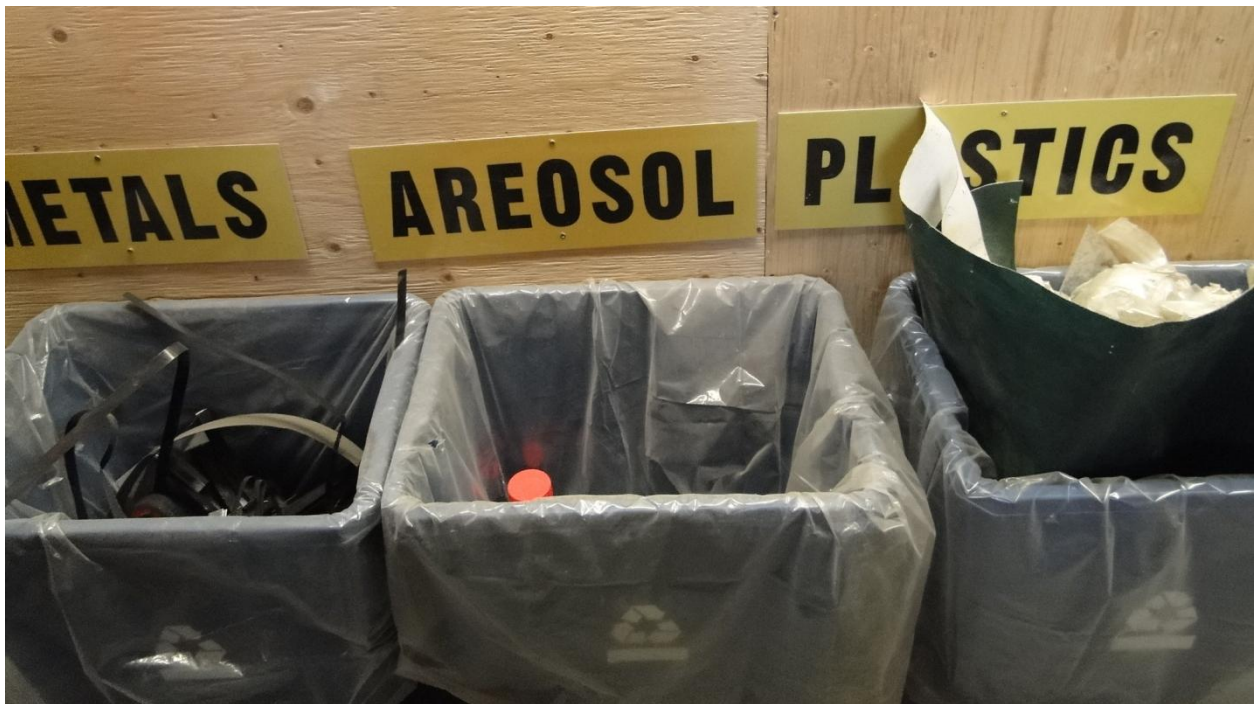
Figure 2. Waste sorting practices in place.

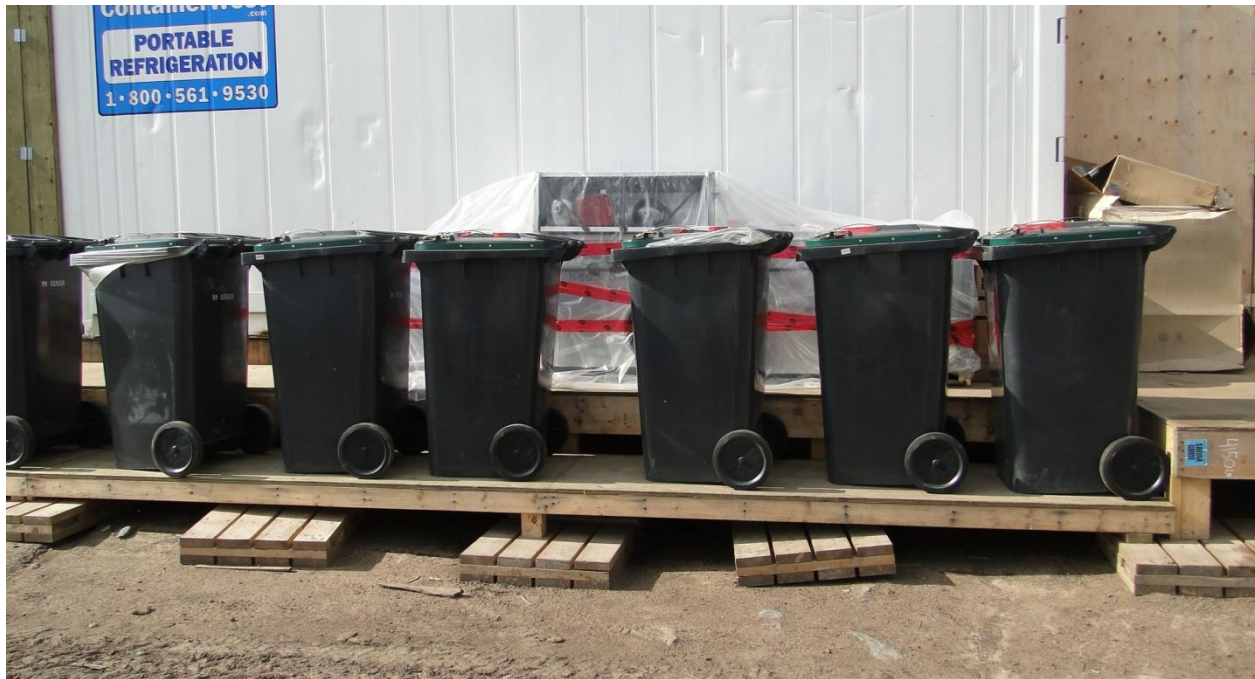
Figure 3. Bear proof containers for segregating waste.

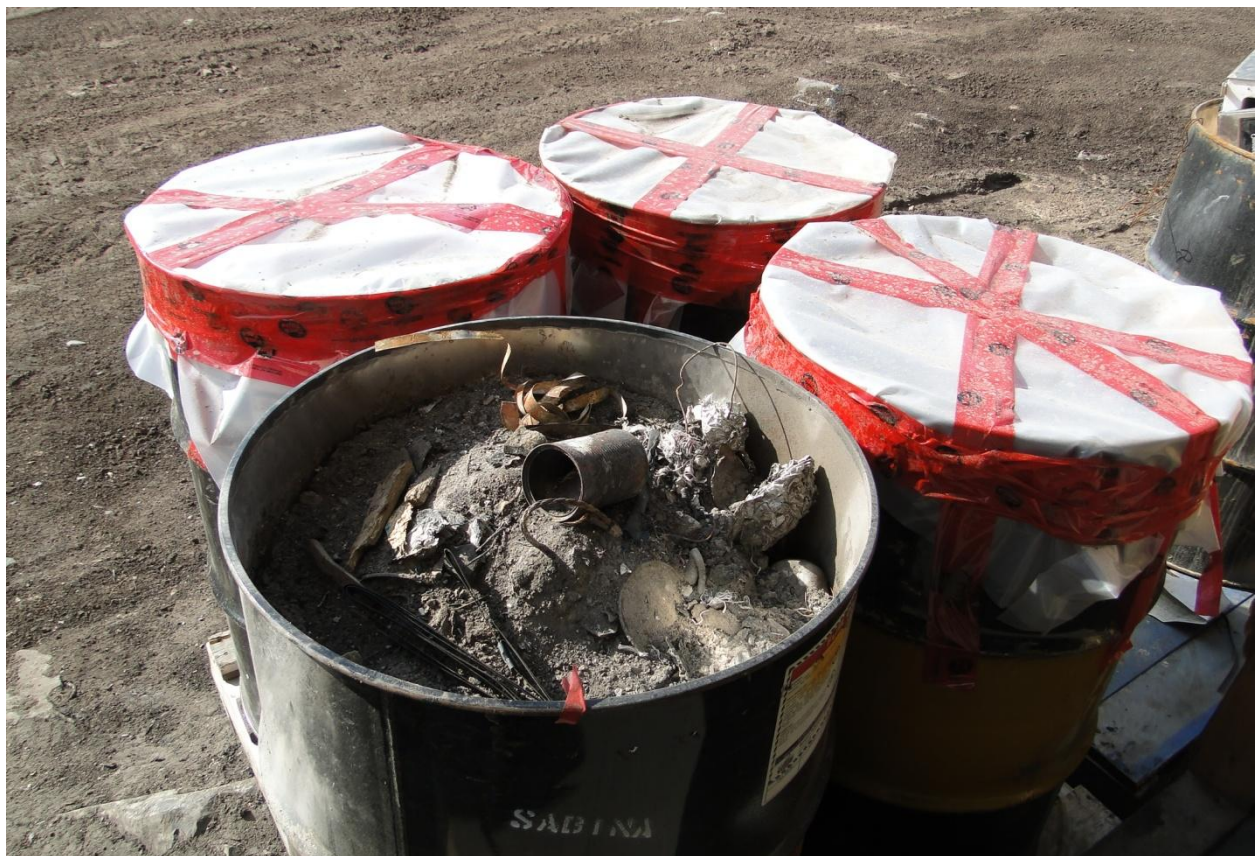
Figure 4. Metals and cable in incinerator ashes.

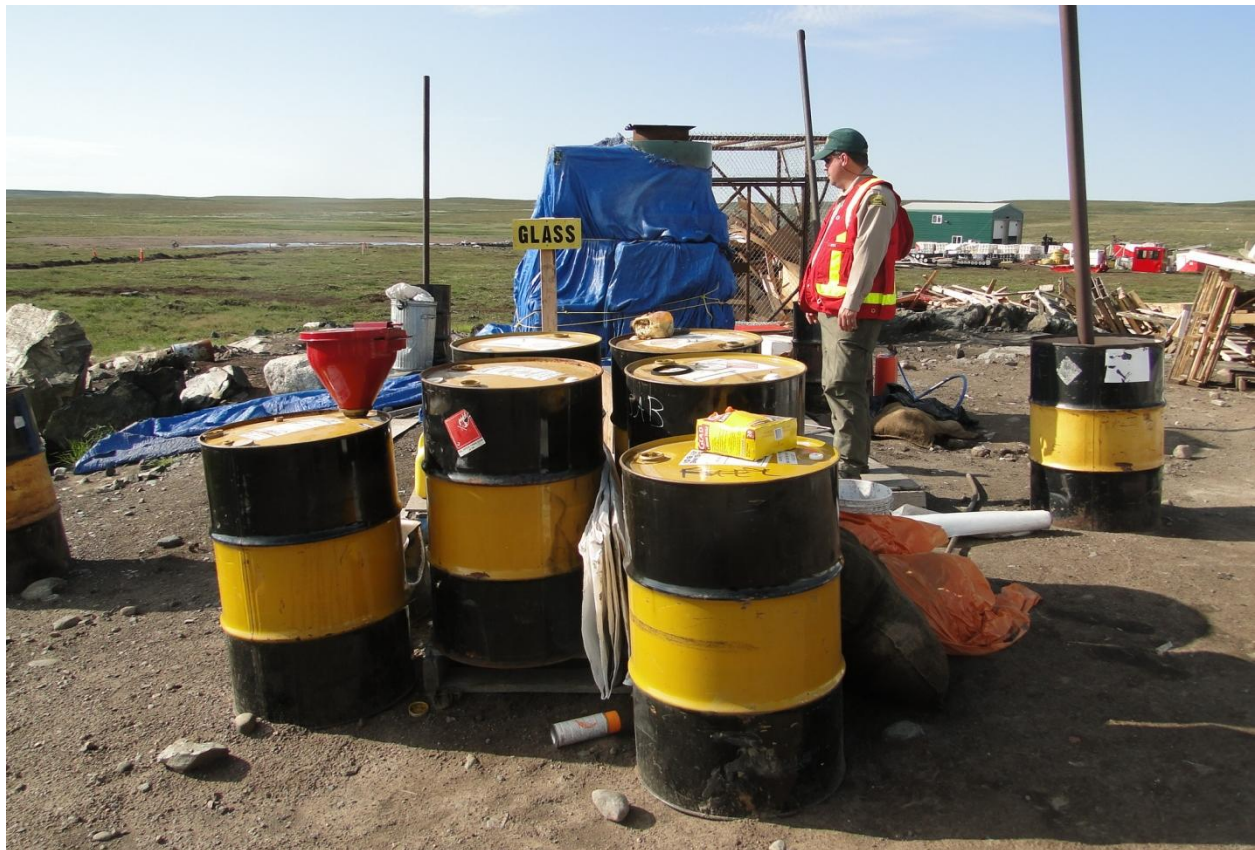
Figure 5. Waste oil barrel should have containment. Burn cage and stock of wood shown in background.

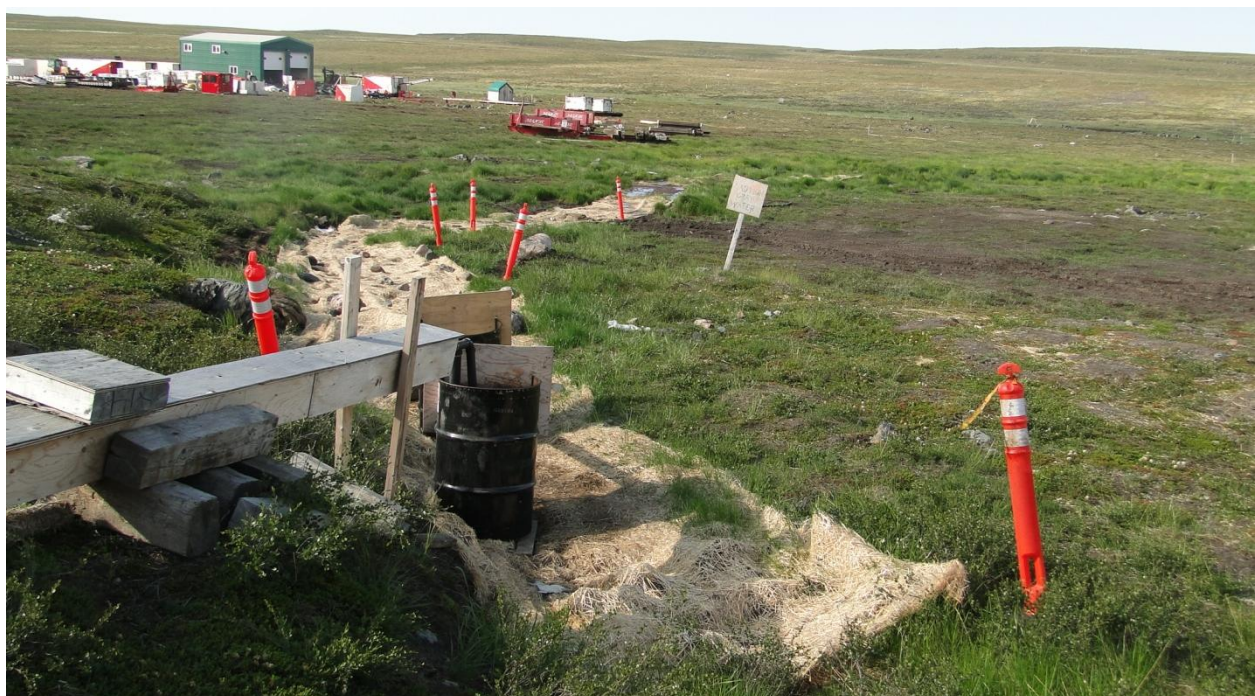
Figure 6. Grey water discharge - improvised grease traps and fibre matting to settle particles out. No defined depression to act as a sump.

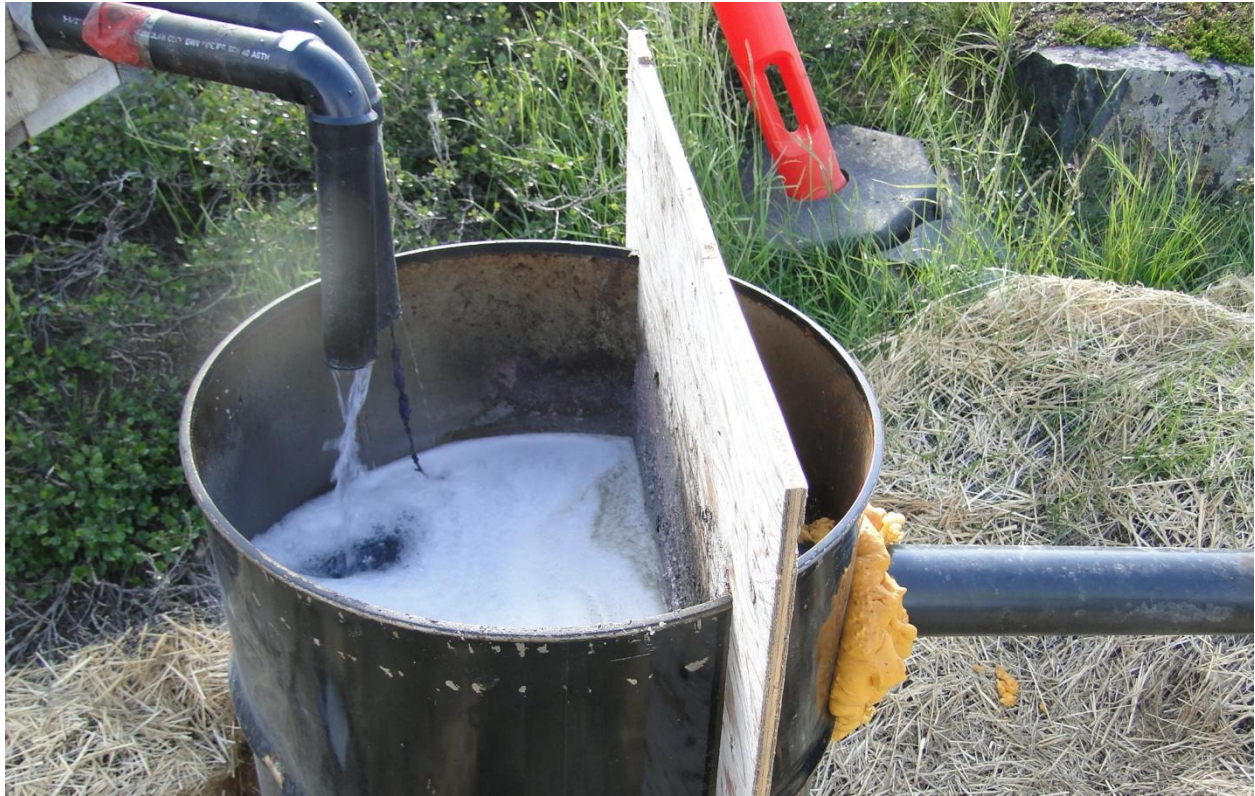
Figure 7. Improvised grease trap.

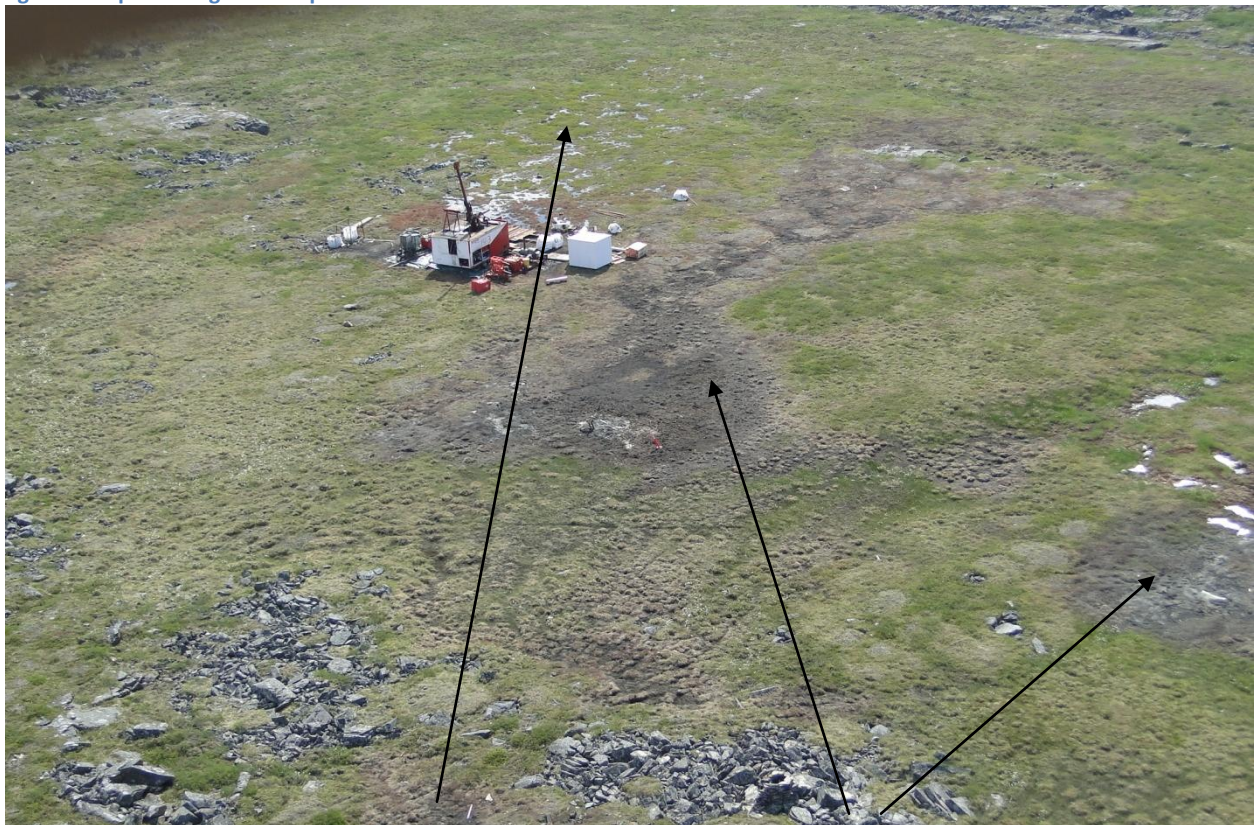
Figure 8. Drill site from overhead. Note drill water flowing over the tundra and dead vegetation from older drill sites.

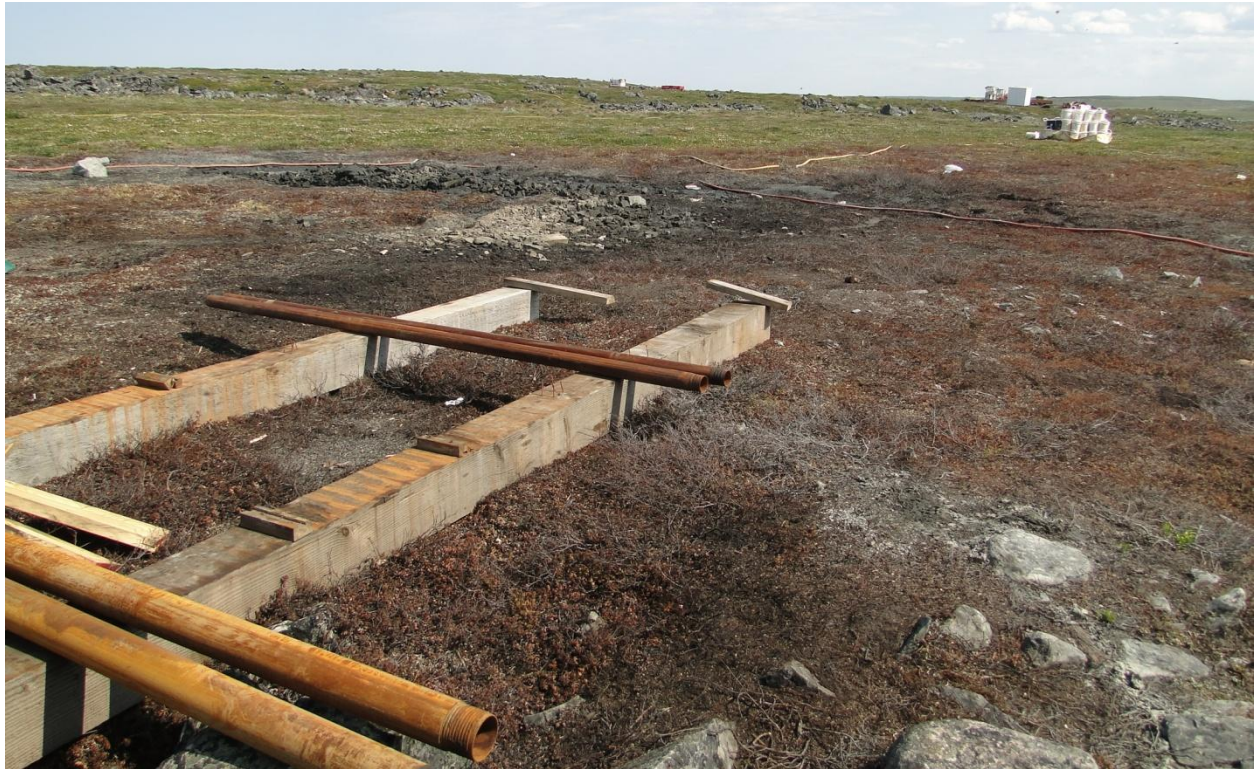
Figure 9. Reddish colour characteristic of salt-burned vegetation.

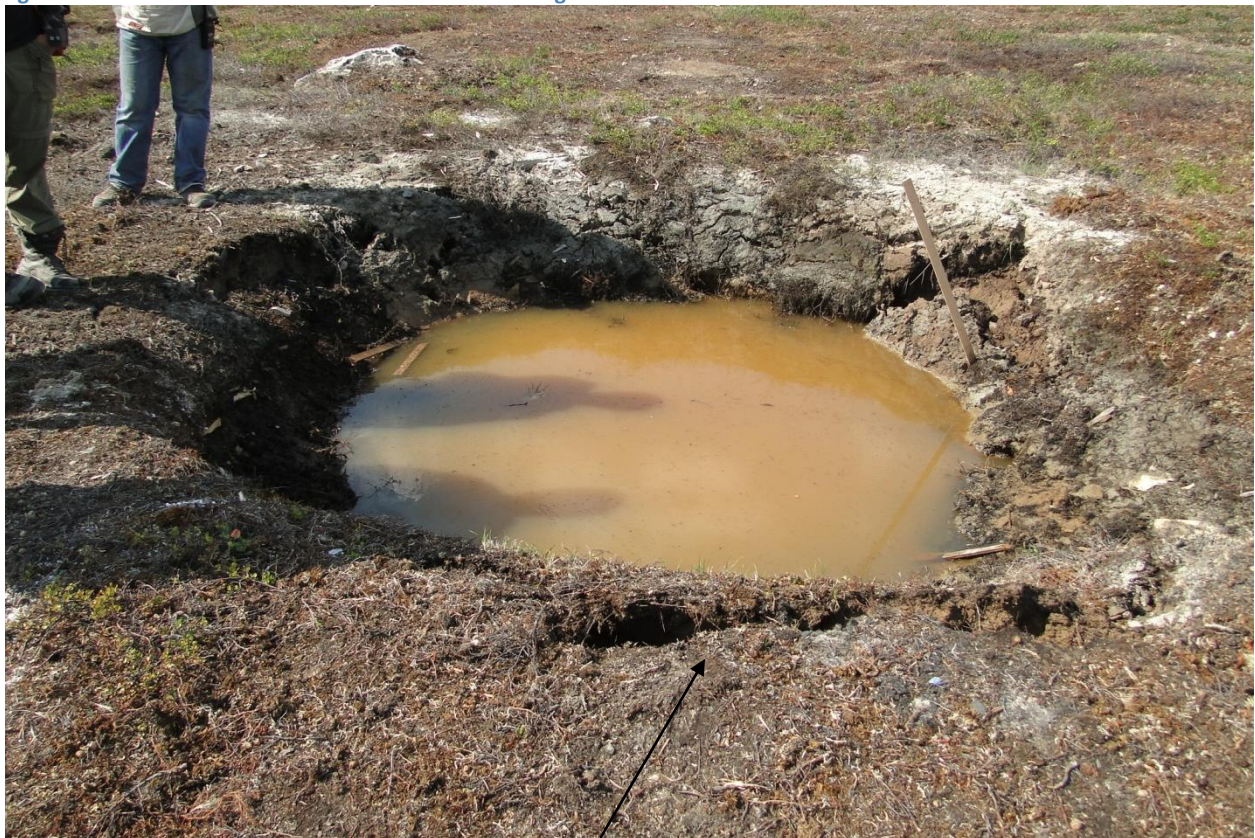
Figure 10. Thermokarst formed from old drill hole. Note slumping as the hole expands.

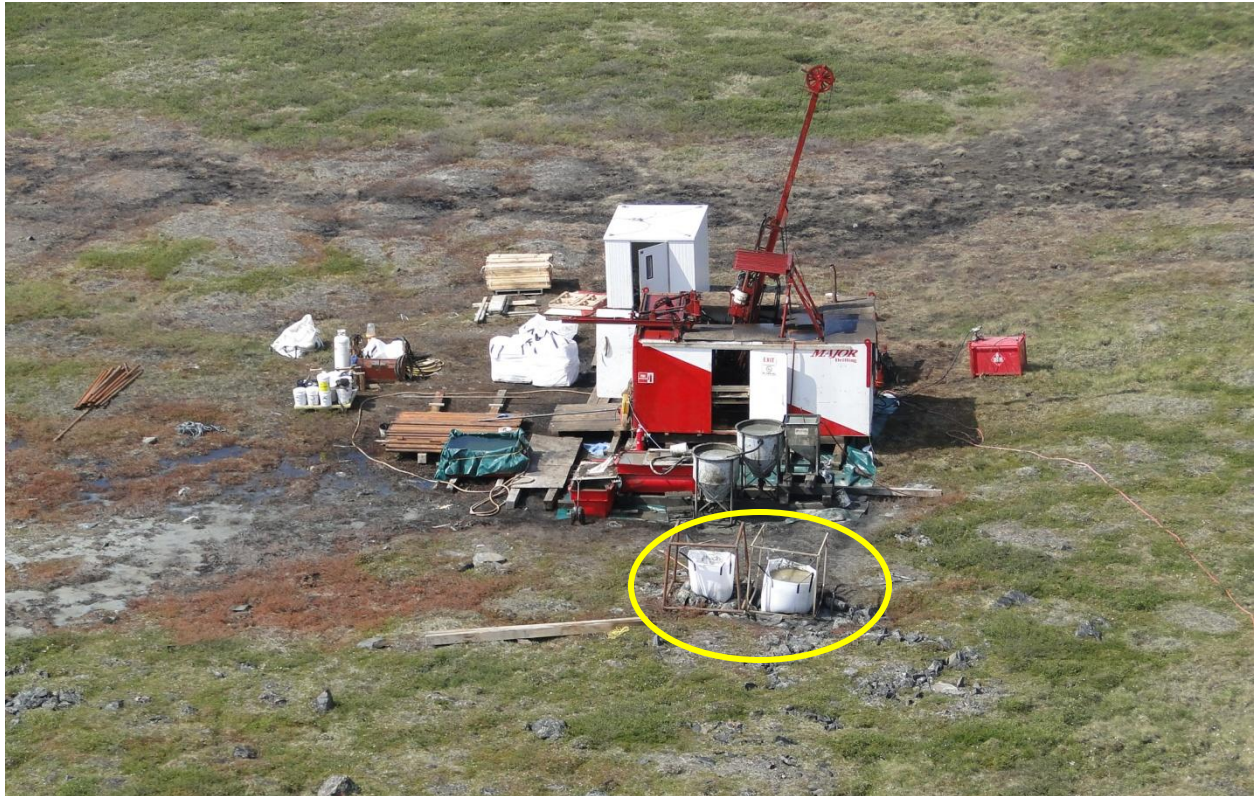
Figure 11. Current drill setup. Polydrill system and the use of mega-bags to capture cuttings are recent improvements. Mega-bags should sit in an appropriate rocky depression that will contain the water so it doesn't flow downhill.

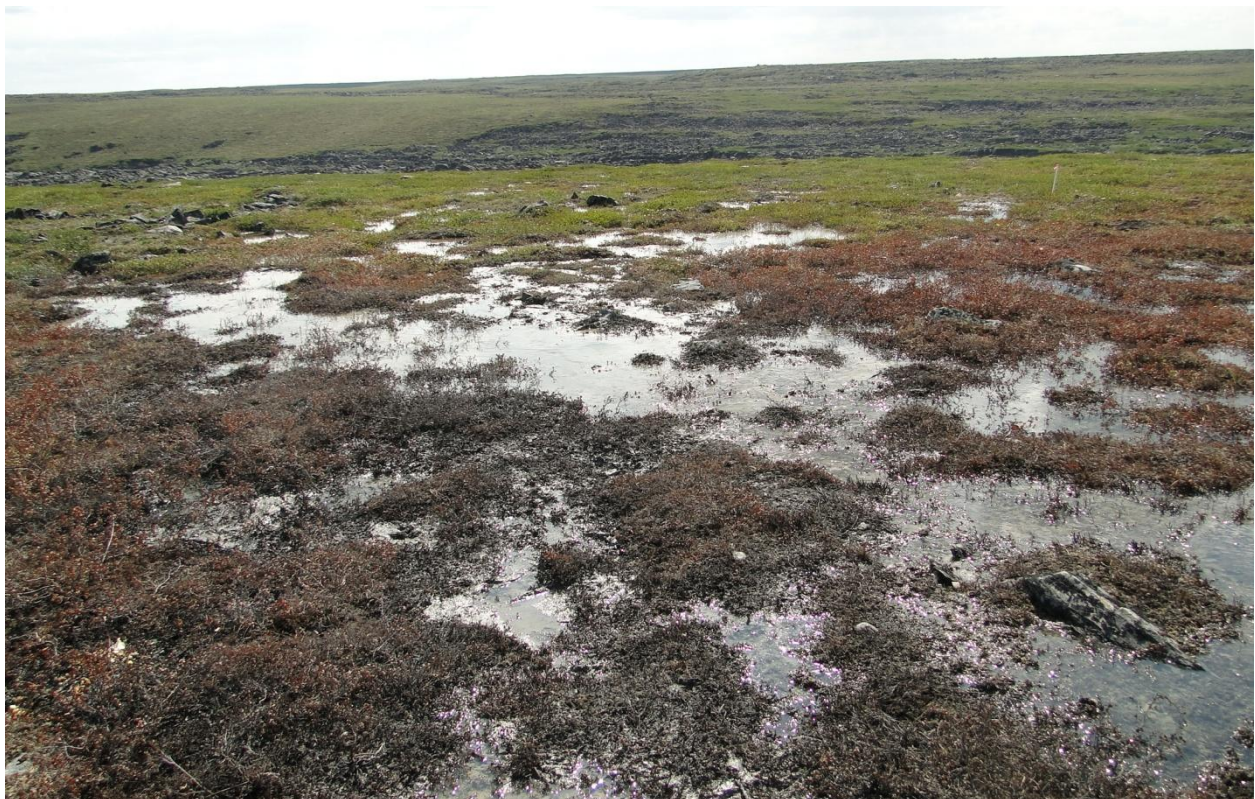
Figure 12. Drill water (may just be unused water) flowing in uncontrolled manner over the tundra.

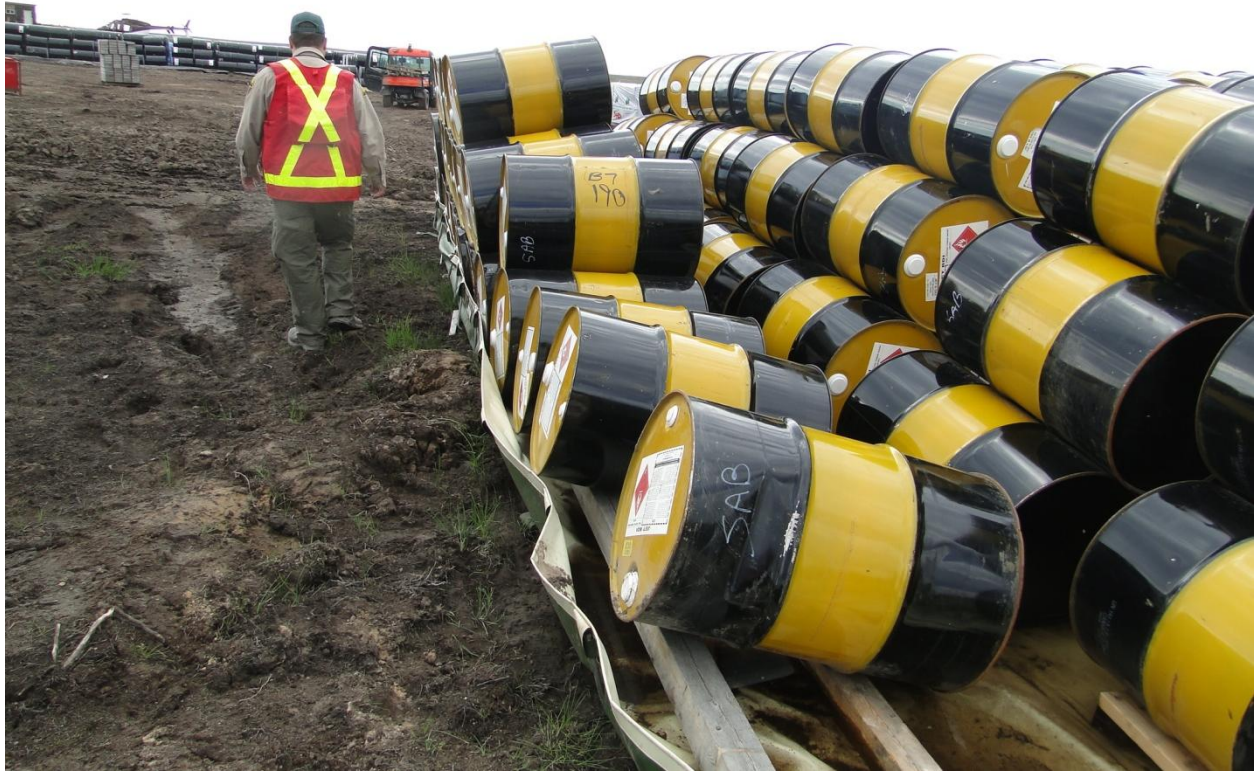
Figure 13. Piles of barrels stacked during winter shift and lean on soft ground. In this photo they lean right over the berm.

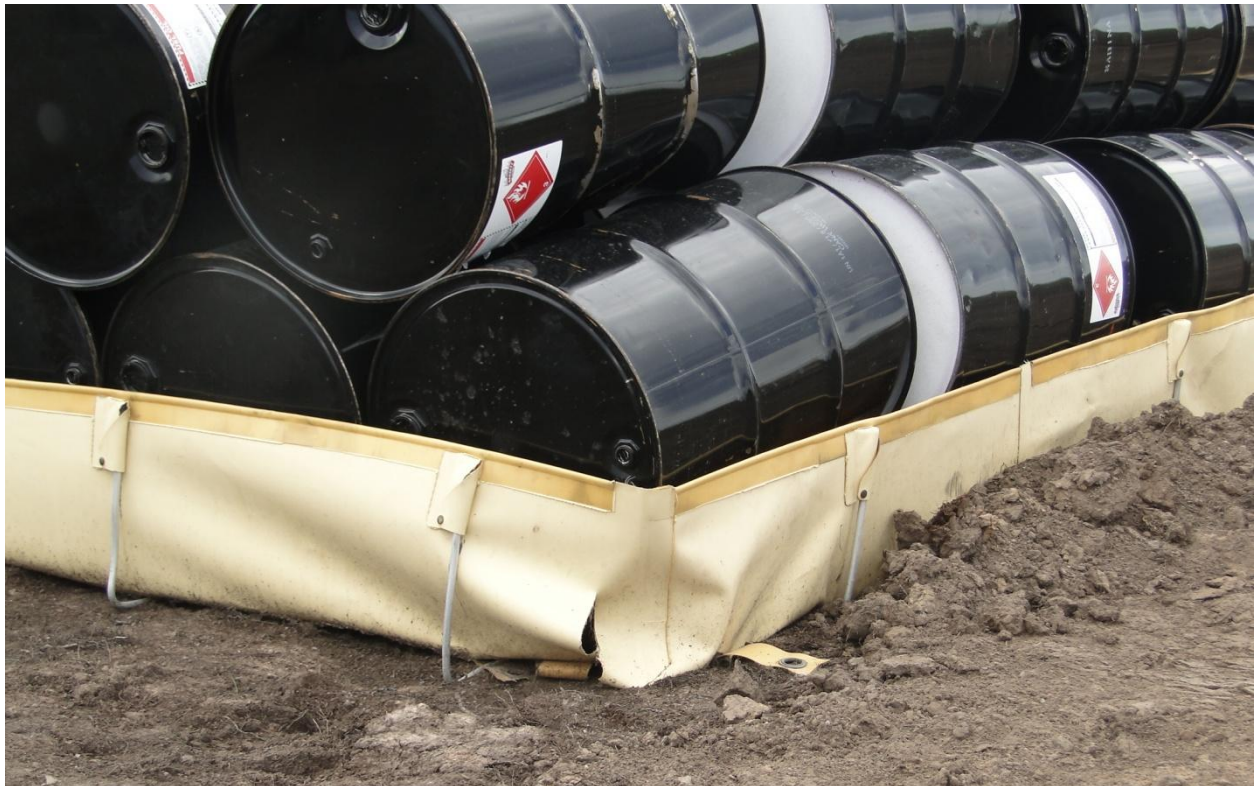
Figure 14. Torn berms.

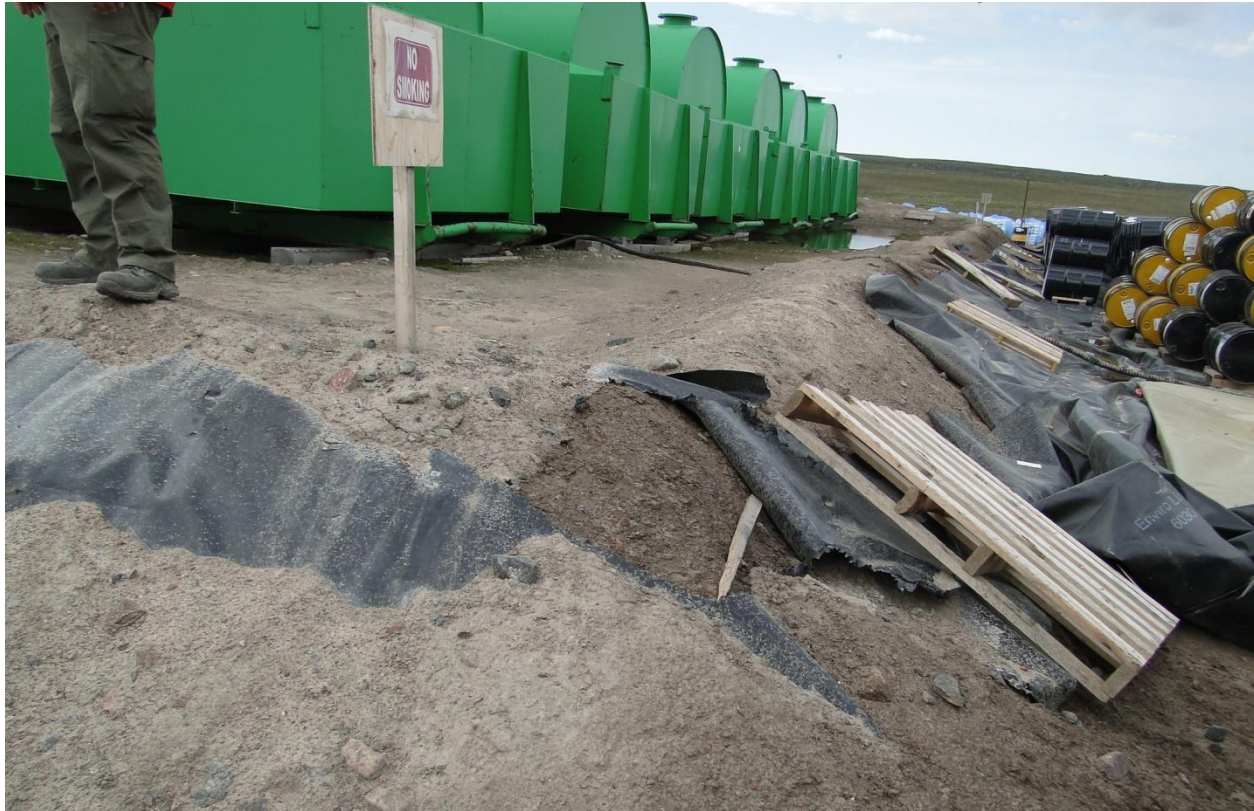
Figure 15. Torn liner for bulk fuel storage.

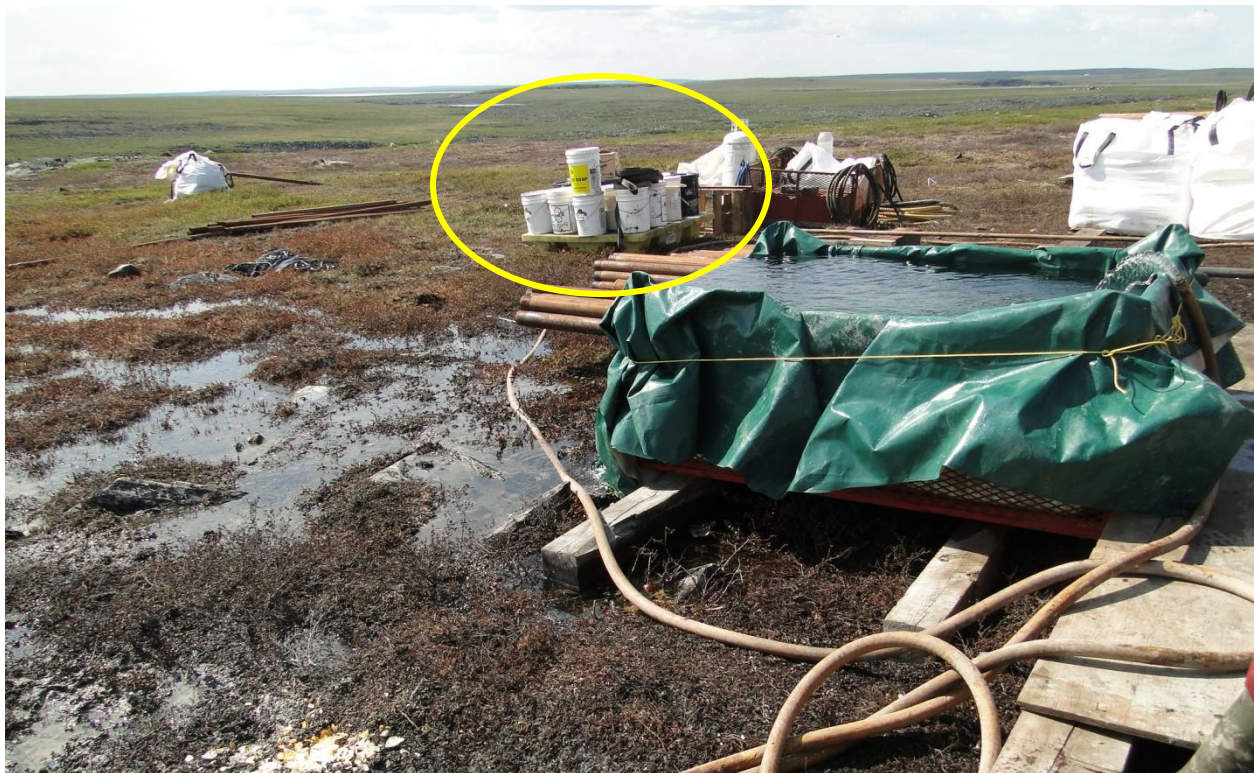
Figure 16. While technically 'on' secondary containment, the efficacy is doubtful.

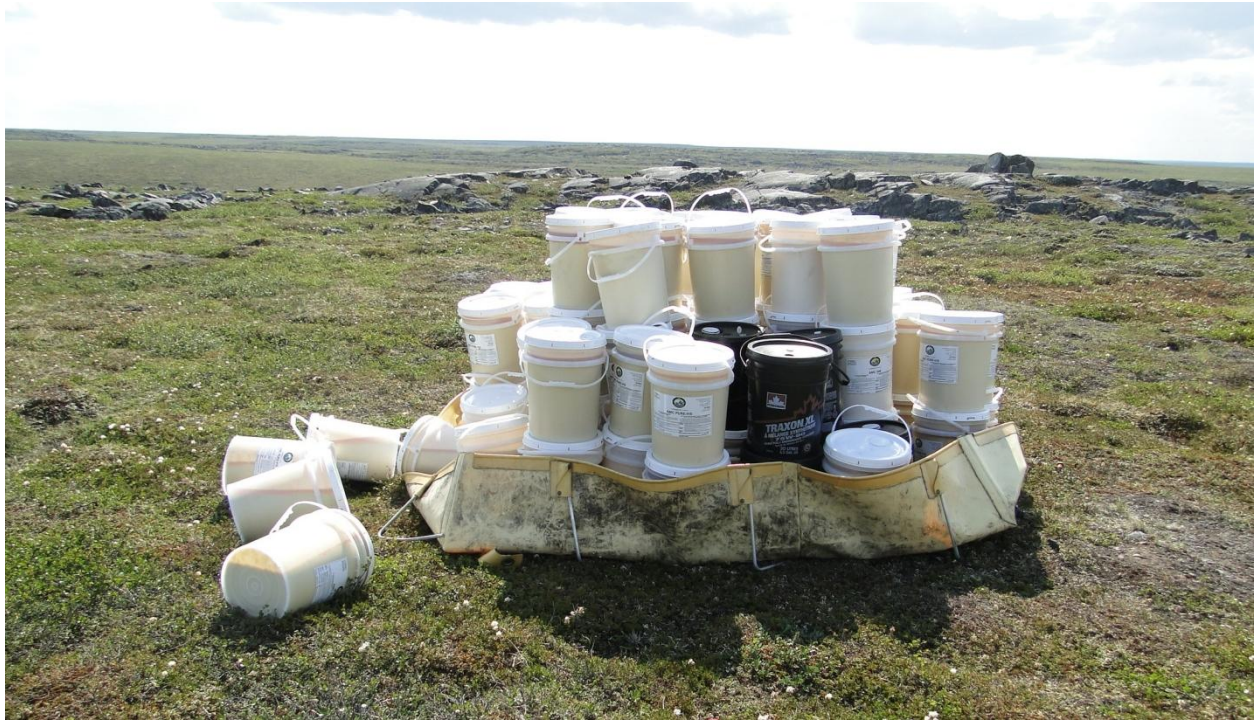
Figure 17. Pails of drill additives fallen out of collapsed containment.

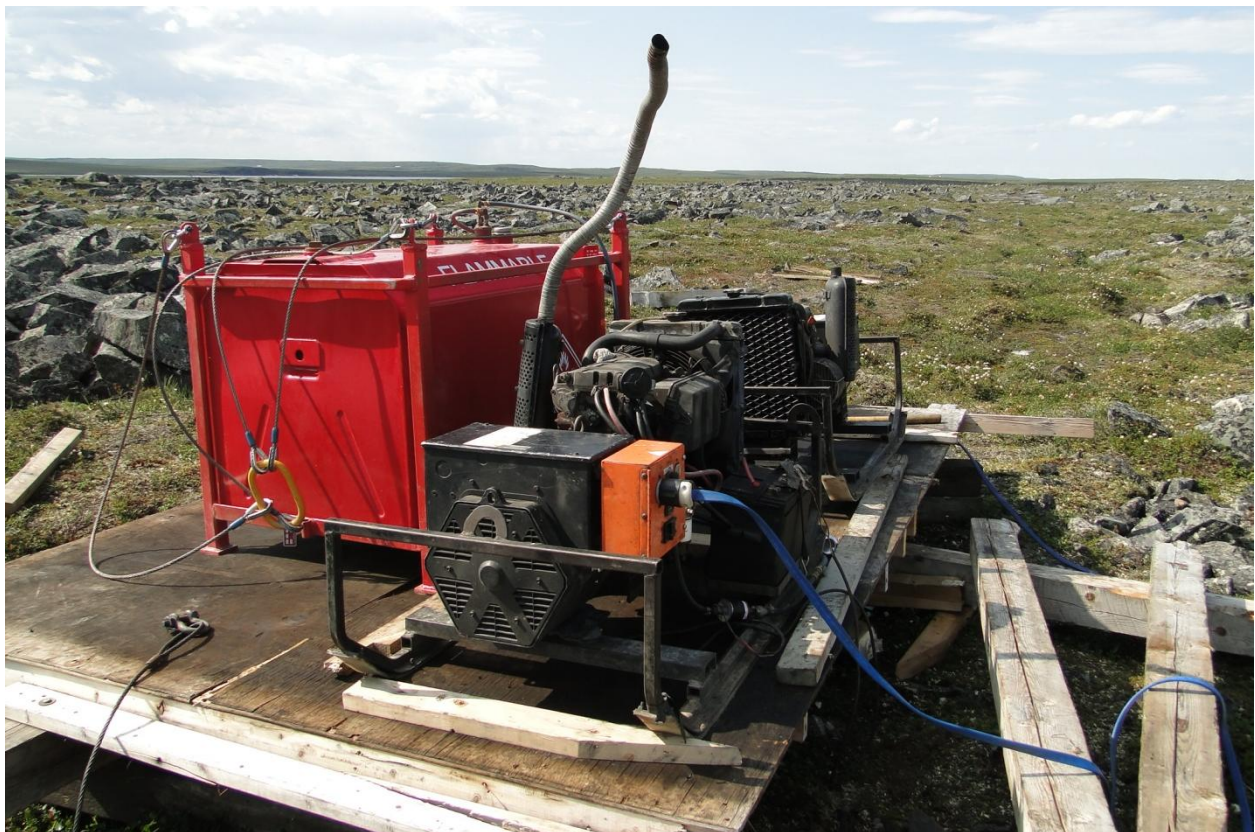
Figure 18. Fuel tank and pump should sit on a hard tray in case of spills or leaks.

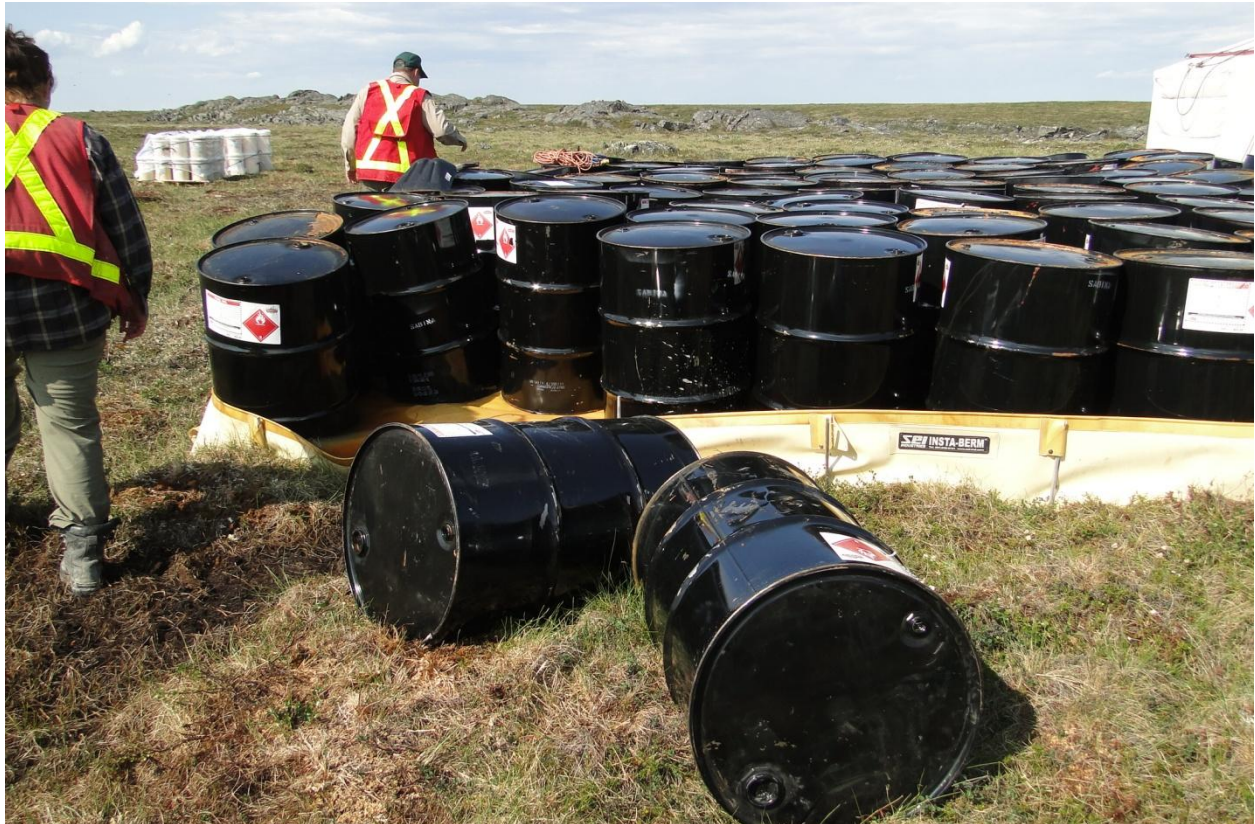
Figure 19. Fuel cache at Umwelt - barrels fallen out and leaked onto tundra.

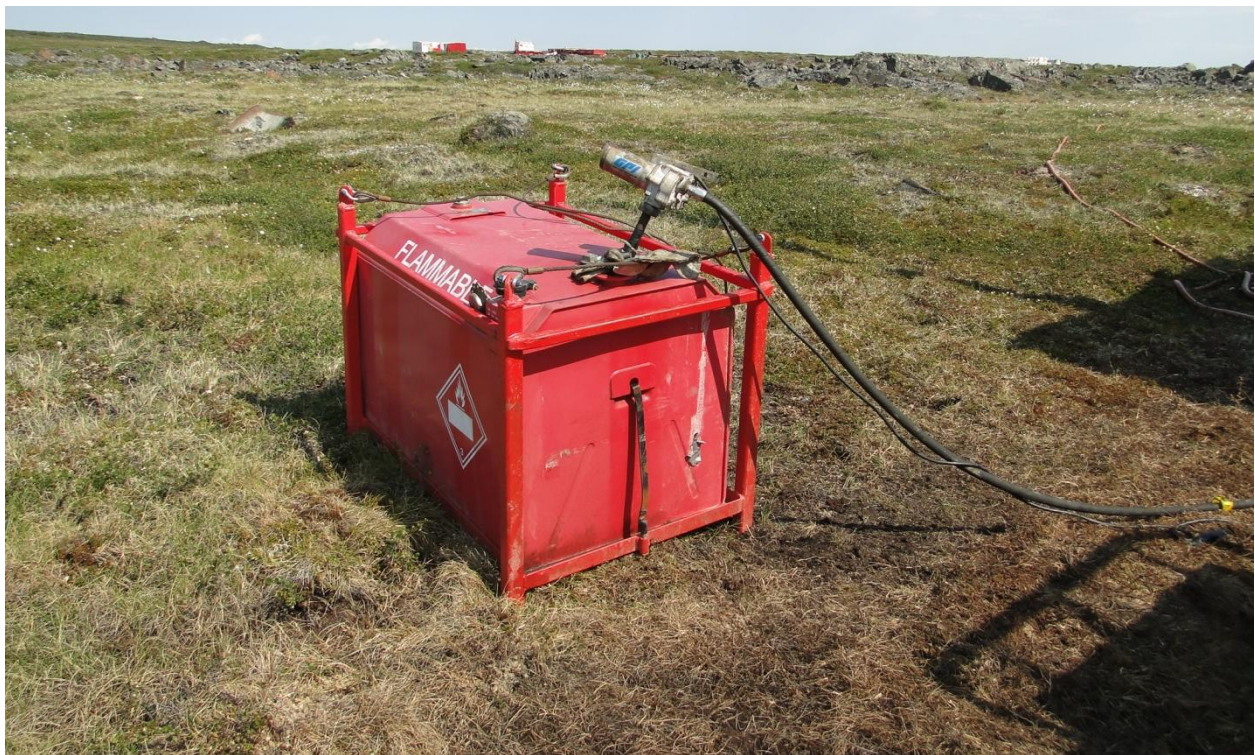
Figure 20. All refuelling is to occur over drip trays.

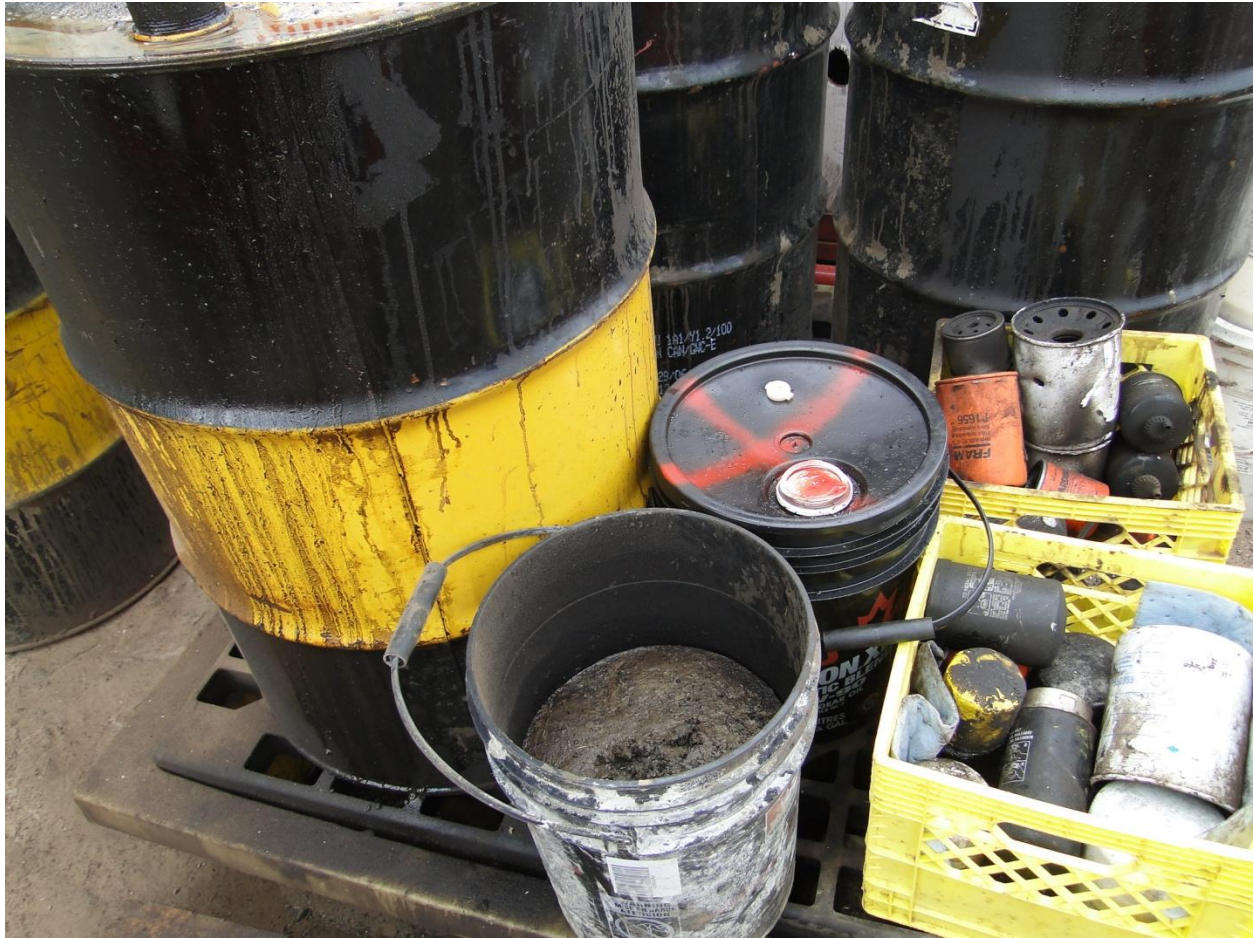
Figure 21. Open haz waste by Major shop. If pail overflows or falls, containment will not be adequate.

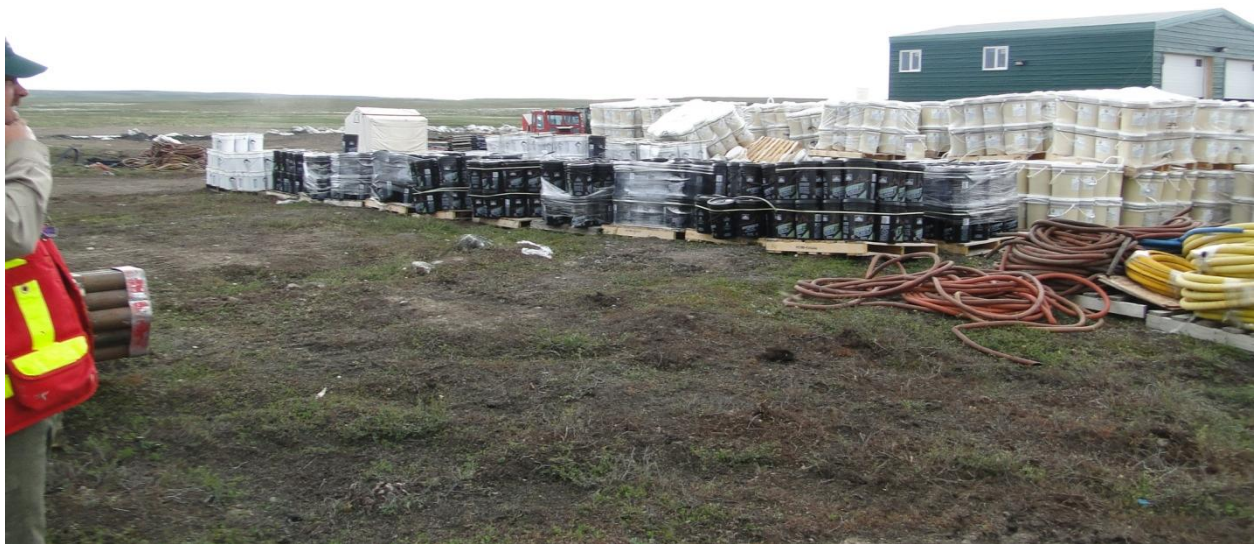
Figure 22. Stock of drill greases and additives to be stored in secondary containment.
