WATER LICENCE INSPECTION FORM

Licensee		Licensee Representative	
Sabina Gold & Silver		Merle Keefe	
Licence No. / Expiry		Representative's Title	
2BE-GOO1520, 2BE-GEO1520, 2BC-BRP1819		Environmental Engineer	
Land / Other Authorizations		Land / Other Authorizations	
Date of Inspection		Inspector	
July 31- Aug 2 2018		Jeremy Fraser	
Activities Inspected			
<input checked="" type="checkbox"/> Camp	<input checked="" type="checkbox"/> Drilling	<input type="checkbox"/> Mining	<input type="checkbox"/> Construction
<input checked="" type="checkbox"/> Roads/Hauling	<input type="checkbox"/> Other:	<input type="checkbox"/> Reclamation	<input checked="" type="checkbox"/> Fuel Storage

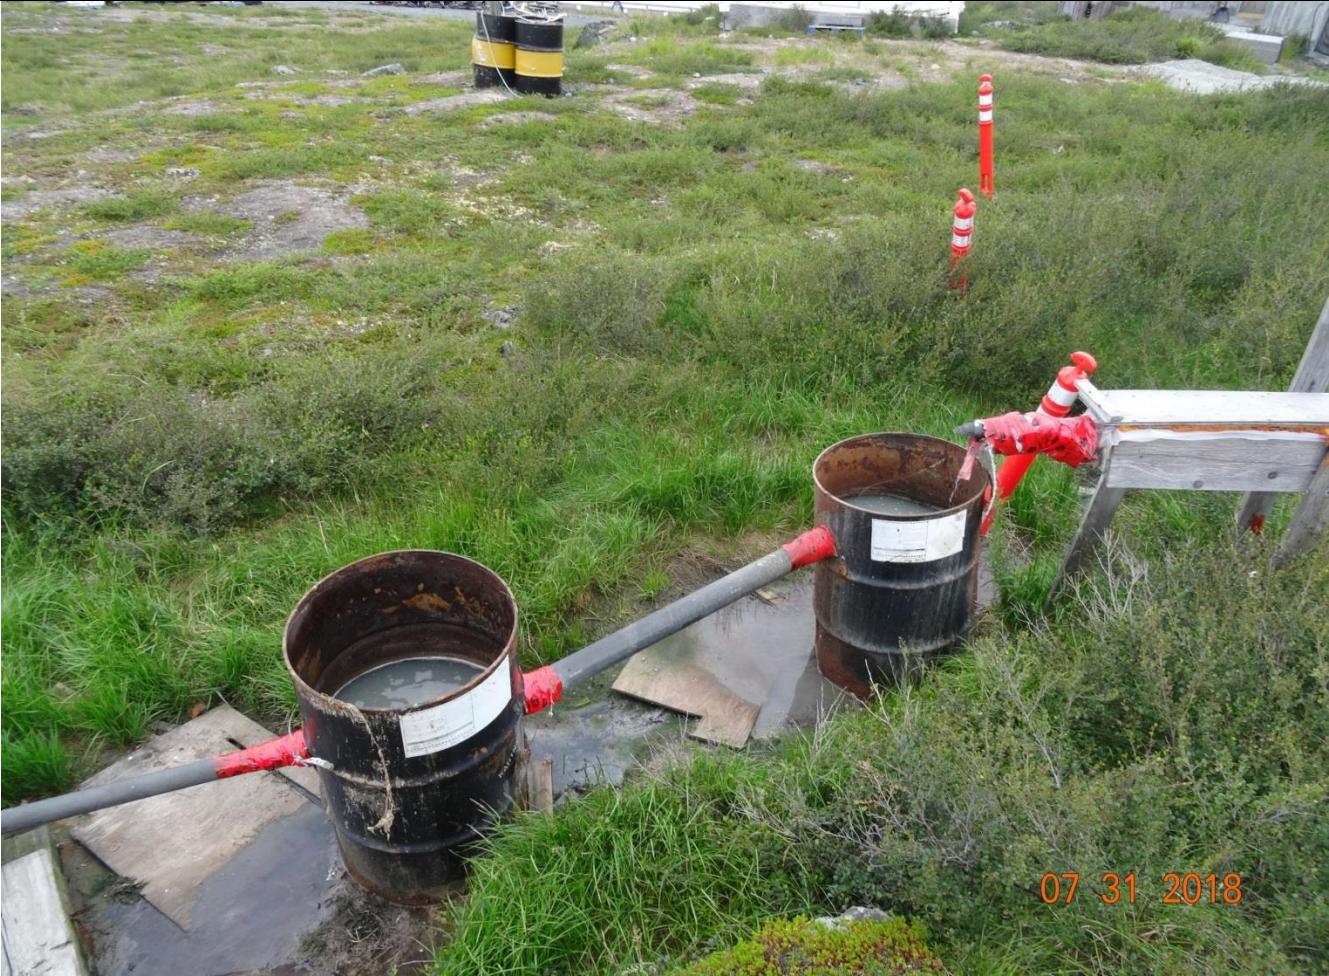
Date	Camera	Inspector	Authorization
July 31 2018	Sony Cyber-shot	Jonathan Mesher	Sabina Water Licenses
Photo Log #		Location (NAD 83 DD MM SS.SS)	
Photo DSC04314		N 65°32'28" W 106°25'38"

Description: Grey water catchment basins from camp kitchen and main dry

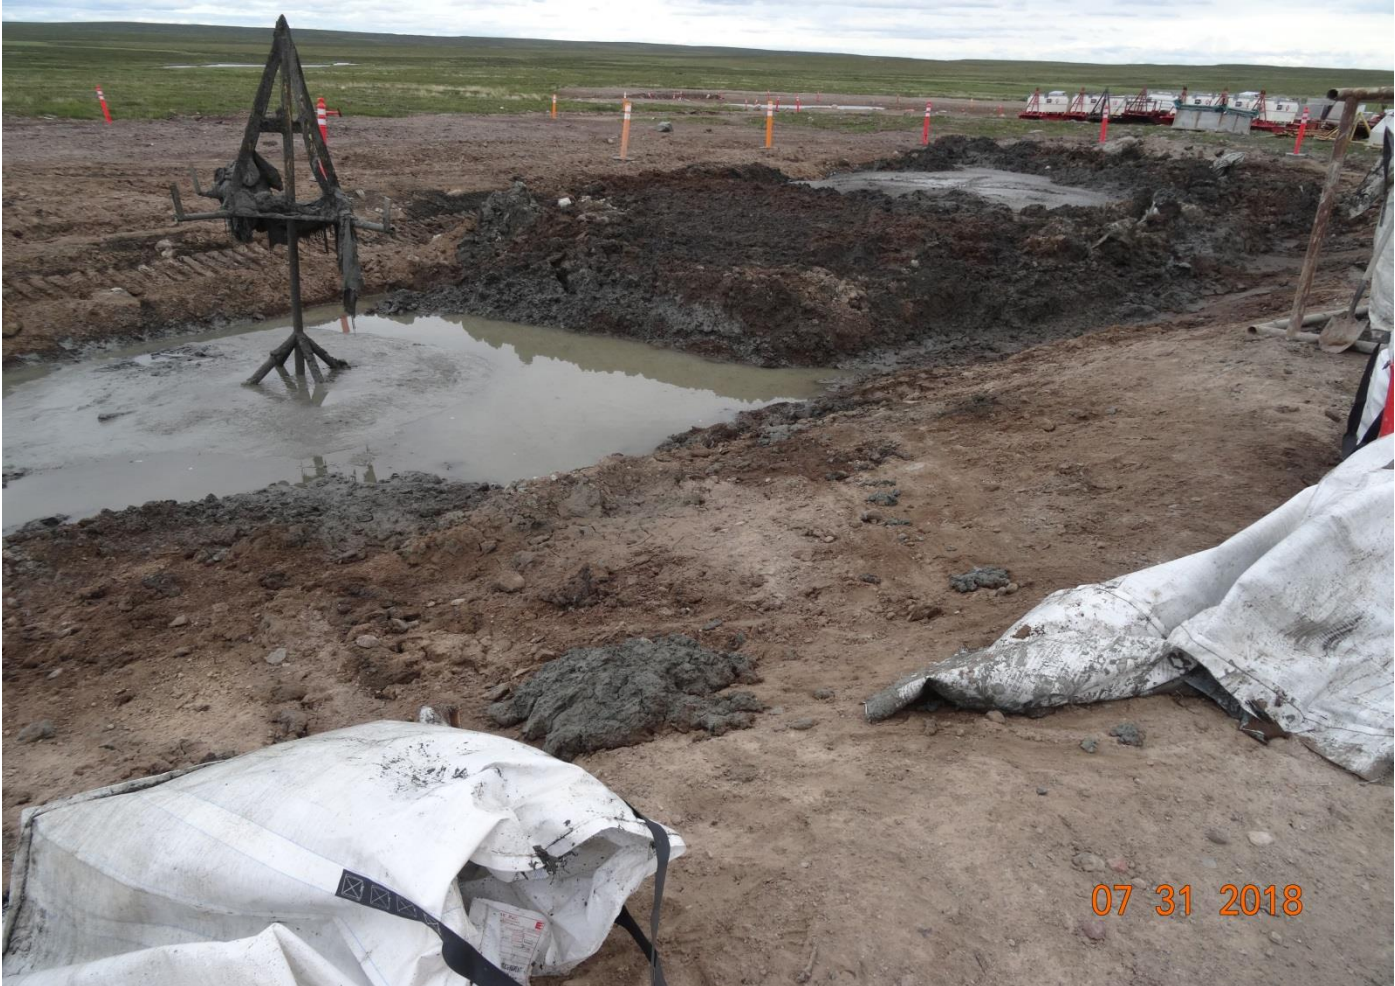
Photo Log #	Location (NAD 83 DD MM SS.SS)
Photo DSC04327	N 63° 32' 35" W 106° 25' 34"

from the drill sites and deposited into a sump east of the Goose camp (*see figure #2*).

Description: Drill cuttings sump located east of Goose camp

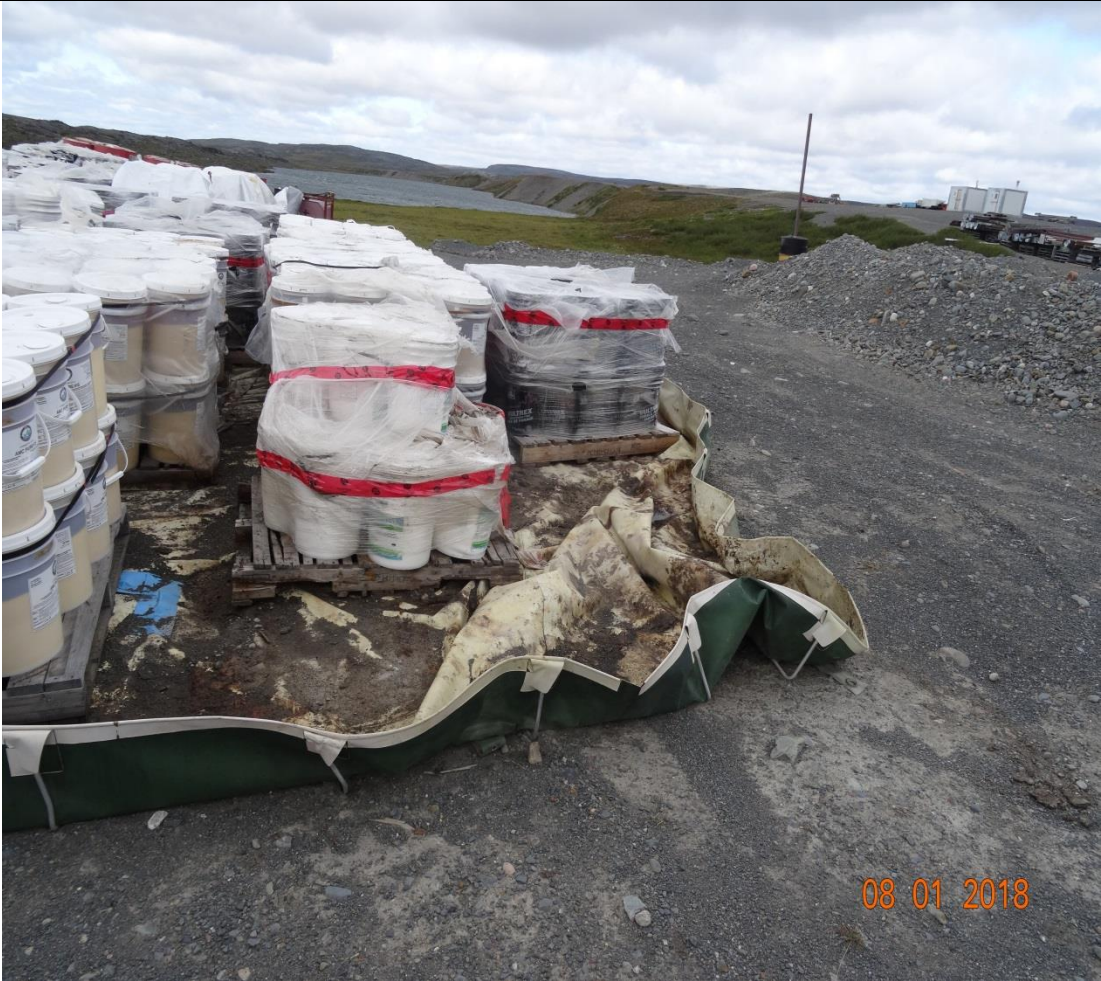
Photo DSC04395

- III. The licensee was storing lubes and oils in a temporary berm on site; this berm was in poor condition and was lacking a plug which allowed the water from within the berm to freely flow into the surrounding environment. The licensee was informed of this issue and agreed to repair and plug it. (*See figure 4-6 for photos of this concern*). This has since been plugged and photographic images have been received by the inspectors. No observation of contamination was found down gradient of this facility.

- 2BC-GEO1520 – Temporary berms installed at the George Camp housing lubricants and oils are in poor condition allowing water from within the berm to flow freely into the environment.

Description: portable Insta-berm in poor condition

SECTION 3	<input type="checkbox"/> Comments	<input type="checkbox"/> Non-Compliance with Act or Licence	<input checked="" type="checkbox"/> Action Required
1. Sample pooling water and remediate historic trench east of Goose camp.			
2. Report all unauthorized discharges to the environment			
3. Restore berm and sample soils and local water bodies at George camp to mitigate further impacts to the receiving environment.

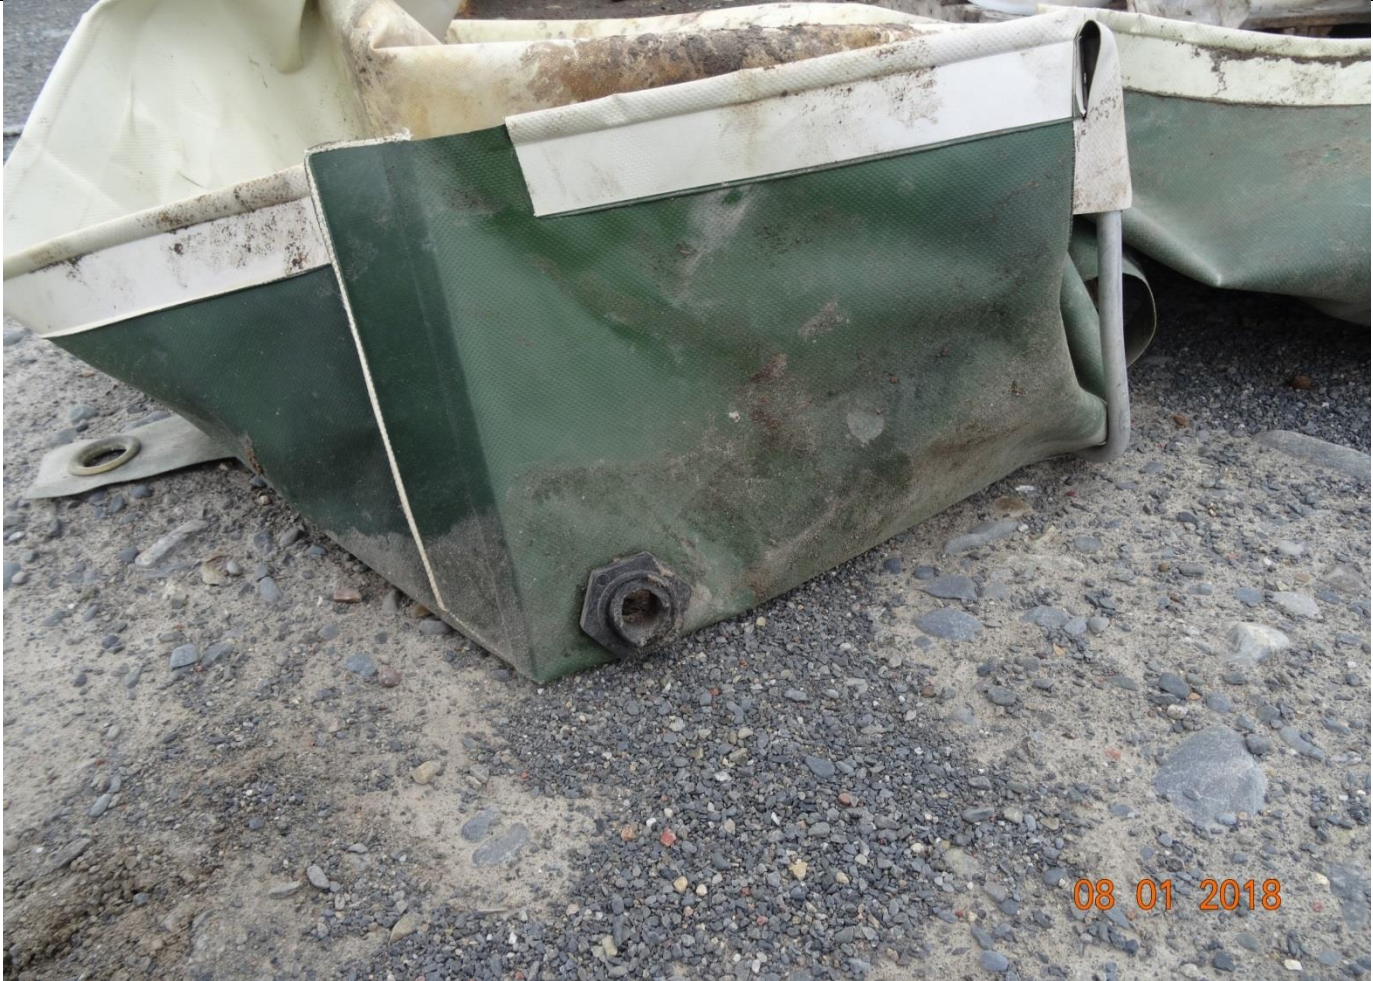
Photo DSC04396

Description: No plug in place to prevent water from entering the surrounding environment
