## WATER LICENCE INSPECTION FORM

Licensee			Licensee Representative		
Sabina Gold and S	Silver Corpora	ation	Rob Davidson		
Licence No. / Expiry			Representative's Title		
2BC-BRP1819, 2BE-GEO1520, 2BE-GOO1520		Site Manager			
Land / Other Authorizations Land / Other Authorizations					
Date of Inspection			Inspector		
October 10 2018			Jeremy Fraser		
Activities Inspected					
□ Camp     □ Roads/Hauling	☑ Drilling ☐ Other:	Mining	☐ Construction☐ Other:	Reclamation	∑ Fuel Storage

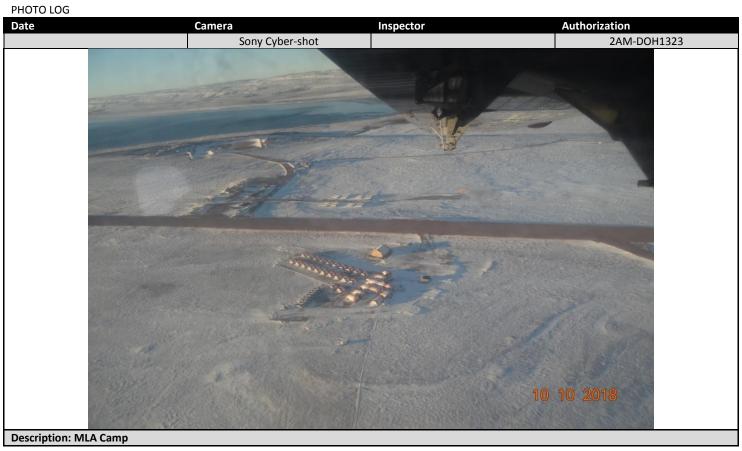
- On October 10, 2018 at approximately 0905hrs CIRNAC inspectors Jeremy Fraser, Justin Hack and Candice Pedersen arrived at the MLA and conducted an inspection of the desalination unit, which is used to withdraw water from Bathurst Inlet to separate salt from water and fill the MLA potable water supply.
- The Bulk fuel storage area, incinerator, laydown areas, and camp pad including fuel supplies for all structures were inspected.
- The inspector noted no issues regarding water use or deposit of waste found on the MLA site (See figure#1).

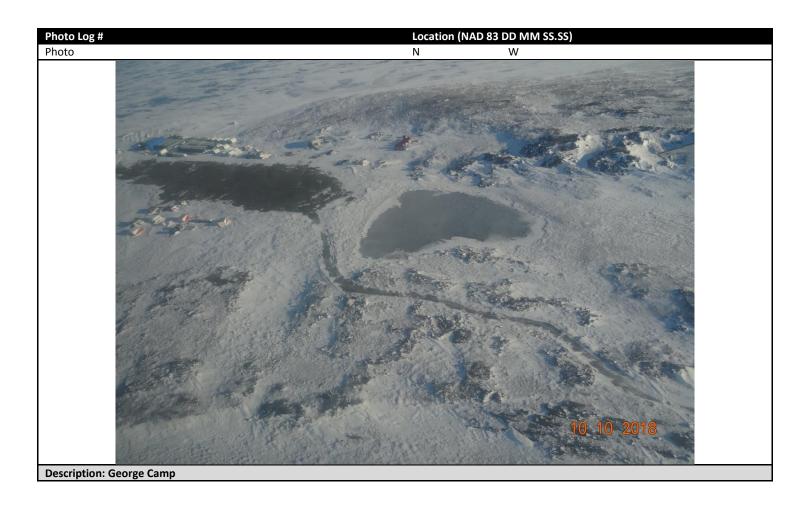
- On October 10, 2018 at approximately 1045hrs CIRNAC inspectors arrived at George Lake camp to conduct an inspection of water licence 2BE-GEO1520. The inspectors walked around the entire facility noting that the camp appears to be closed and not in use during the time of the inspection (see figure #2).
- It was noted that there was significant snow build-up within the insta-berms at this site. This snow should be managed prior to freshet to address possible over-topping of the facility (see figure #3).

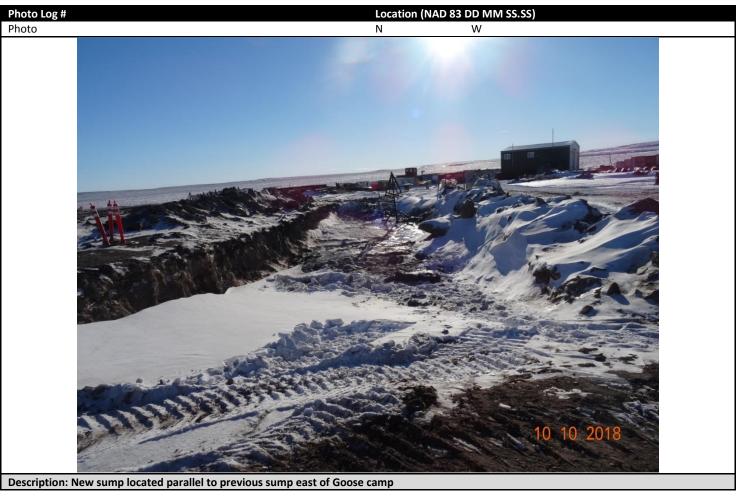
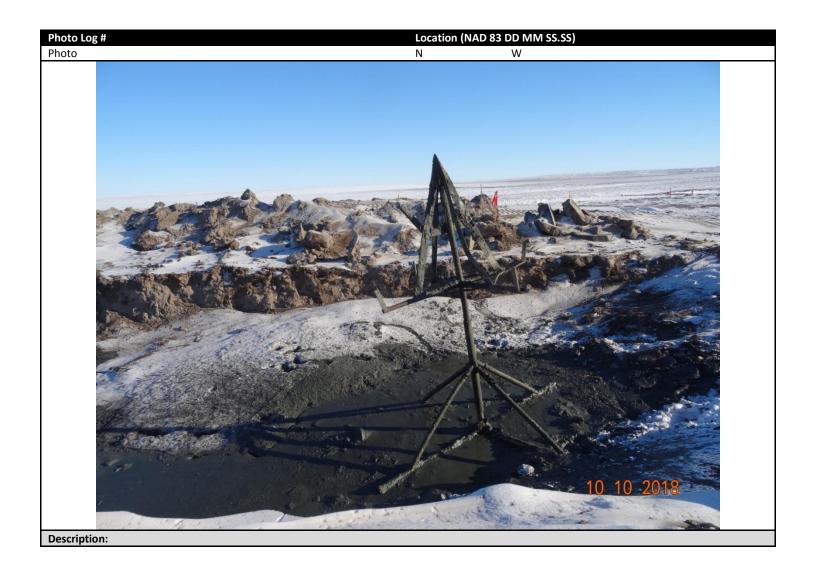
- During the inspection, it was noted that the original sump used to store drill cuttings was no longer being used. It was capped with gravel. A new sump was established parallel to it for all new cuttings. This sump was constructed as per condition Part H, Item 2 in the Water License whereas it was located 31m from the highwater mark, in which direct flow into a water body is not possible. (see figure #4,5)
