WATER LICENCE INSPECTION FORM

Licensee		Licensee Representative	
Aura Silver Resources Inc.		John McNeice	
Licence No. / Expiry		Operator	
2BE-GRE1416, July 2 nd , 2016		Agnico Eagle Gold Mines Ltd.	
Land / Other Authorizations		Contact	
N2015C0006		David Frenette	
Date of Inspection		Inspector	
July 22nd, 2015		WRO C. Wilson	
Activities Inspected			
<input type="checkbox"/> Camp	<input checked="" type="checkbox"/> Drilling	<input type="checkbox"/> Mining	<input type="checkbox"/> Construction
<input type="checkbox"/> Roads/Hauling	<input type="checkbox"/> Other: Waste Discharge		<input checked="" type="checkbox"/> Reclamation
			<input type="checkbox"/> Fuel Storage
			<input type="checkbox"/> Other:

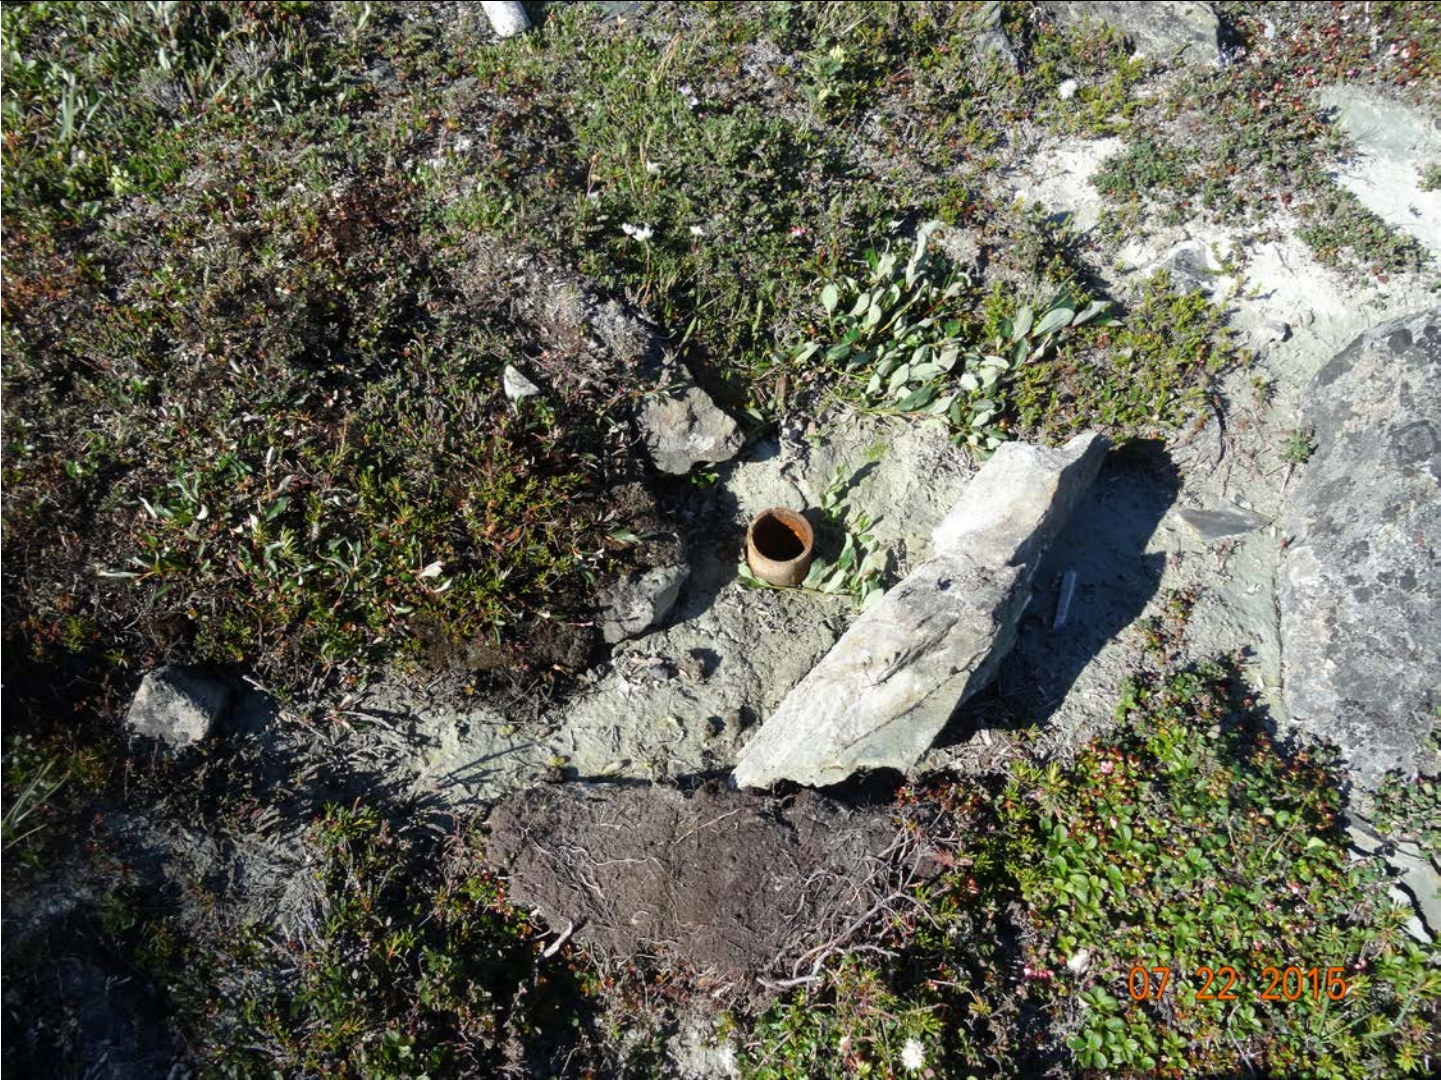
Photo 3

GHD14-007
