# RE: Inspection of Water Licence 2BE-HBP1116 July 10 2013

# **INDUSTRIAL WATER LICENCE INSPECTION REPORT**

<b>Date</b> : July 10, 2013	Licensee Rep. (Name/Title): None				
Licensee: North Arrow Minerals Inc.		Licence No.: 2BE-HBP1116			
I arrived on-site by helicop attention is required.	oter while working in the a	rea. The camp is c	urrently r	not in use. Immediate	
WATER SUPPLY					
Source(s): n/a		Quantity used: NA - inactive			
Indicate: <b>A</b> - Ac	ceptable <b>U</b> - Unacceptab	le <b>NA</b> - Not Applic	able <b>NI</b>	- Not Inspected	
Intake Facilities: NI	Storage Structure: NI	Treatment Syste	ms: NI	Chemical Storage: U	
Flow Meas. Device: NI	Conveyance Lines: NI	Pumping Station	ıs: NI	Screen: NI	
Comments: No water is cu	irrently being used.				
WASTE DISPOSAL  SEWAGE: Sewage Treatment System (Prim./Sec/Ter.): NI  Natural Water Body Wetlands Treatment Continuous Discharge (land or water) Seasonal Discharge Incineration Pit-privy/outhouse  Comments: No human waste is currently being produced. Outhouse pit is to be properly backfilled and contoured.  SOLID WASTE:  Landfill Burn & Landfill Open Burn Incinerate

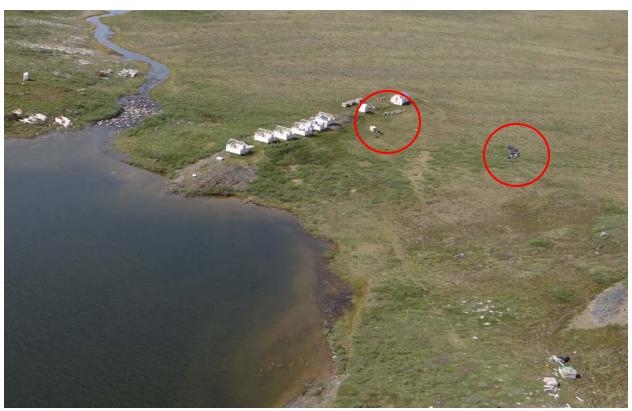
Figure 1. Overview of camp. Barrels visible in several locations.

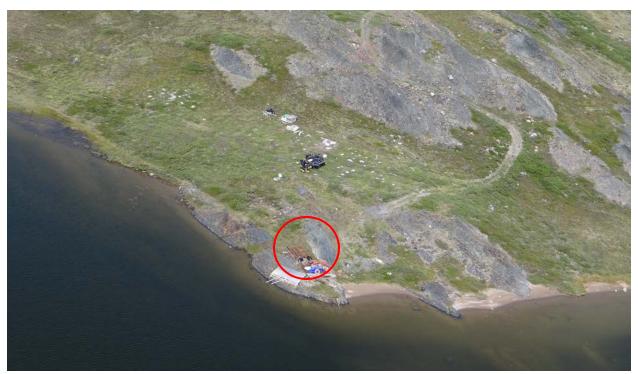
Figure 2. Materials stored on waters' edge. Empty barrels requiring backhaul. Two full barrels by the

water.

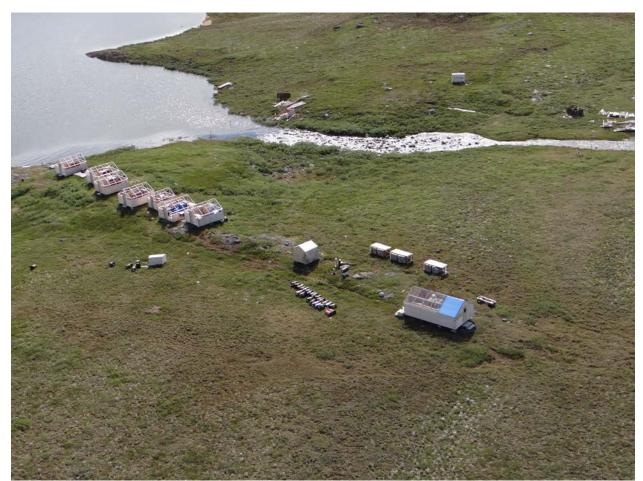
Figure 3. Materials near creek; barrels stored with no containment.

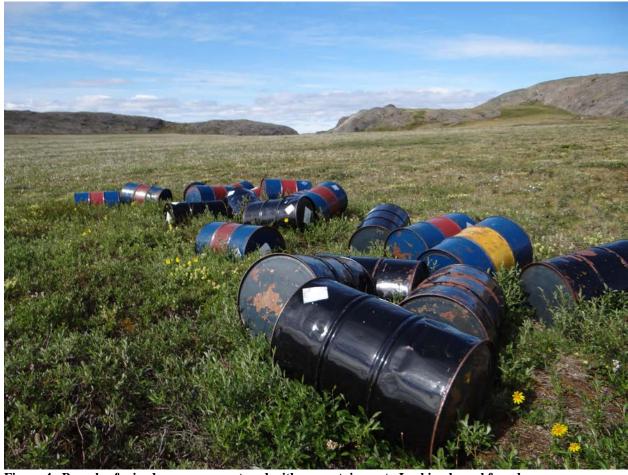
Figure 4. Barrels of mixed provenance; stored with no containment. Leaking barrel found.

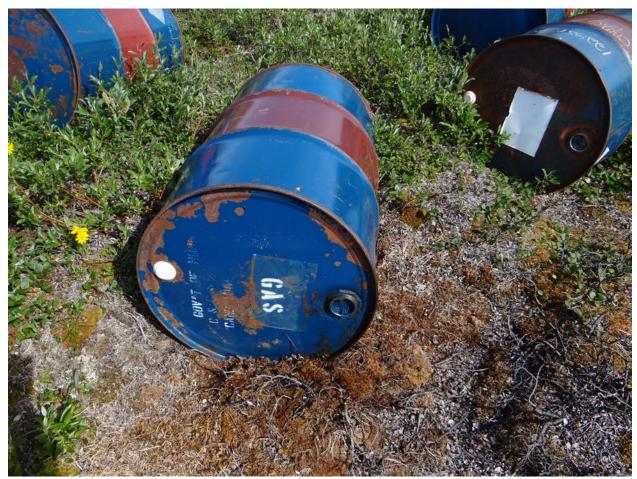
Figure 5. Leaking barrel of gas.

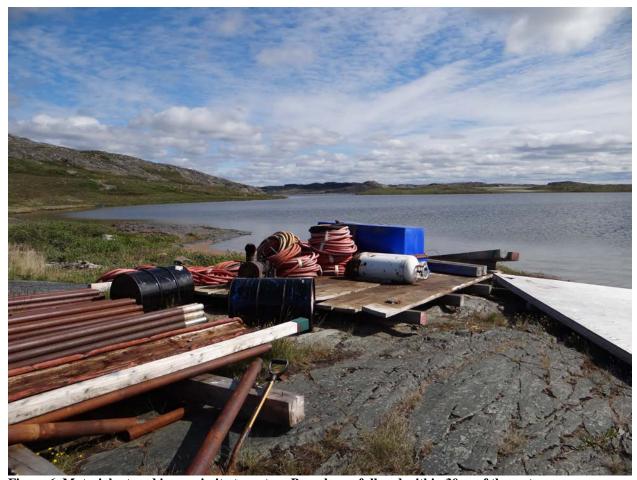
Figure 6. Materials stored in proximity to water. Barrels are full and within 30 m of the water.

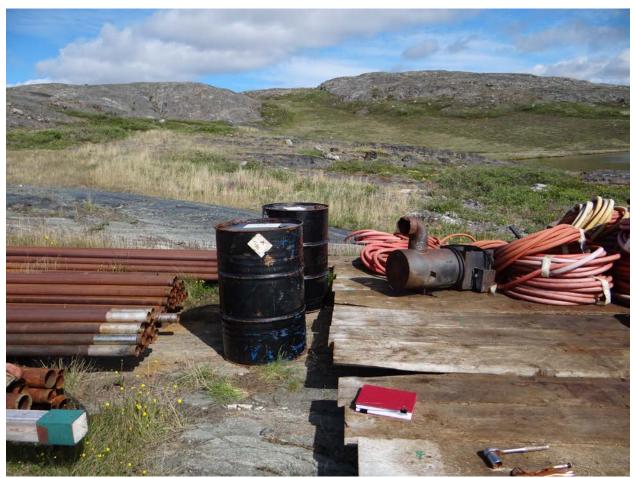
Figure 7. I stood the barrels up to reduce the likelihood of spills.

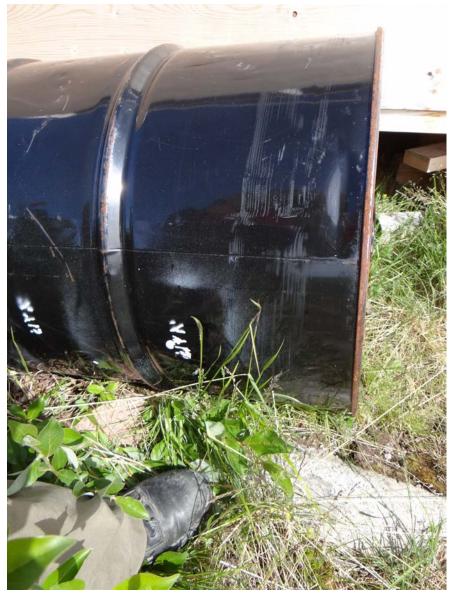
Figure 8. Leaking barrel found behind one tent. I righted it also.
