October 10, 2013

**Re: Inspection of Water Licence SBE-HBP1116**

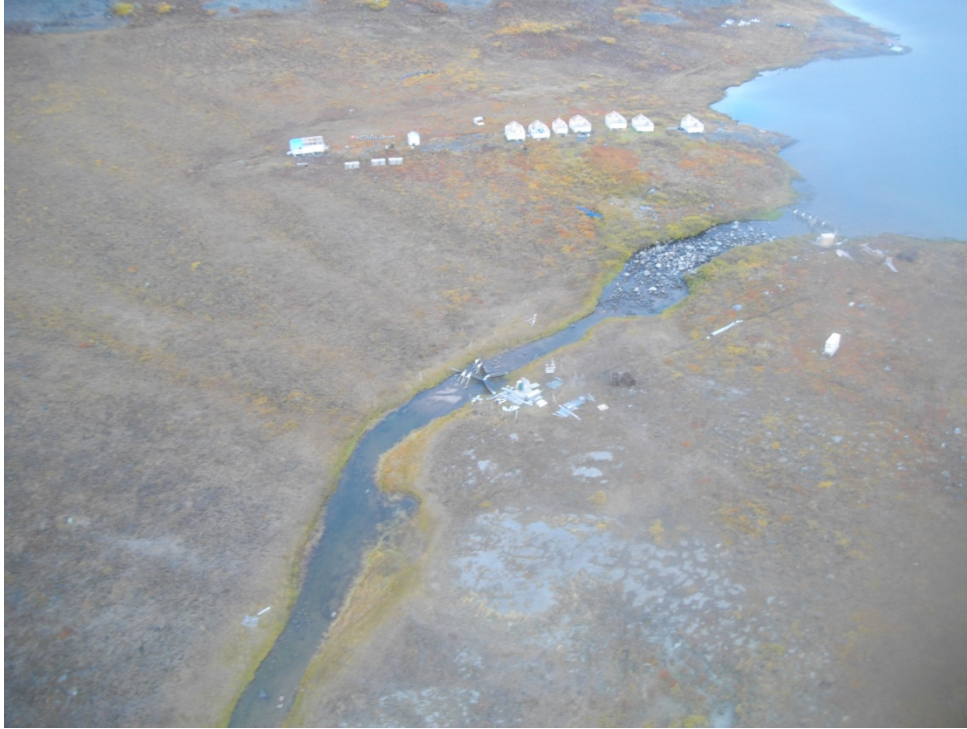
Figure A – Roberts Lake camp before clean up; looking East; note the materials in the foreground around and to the north of the river are TMAC's.

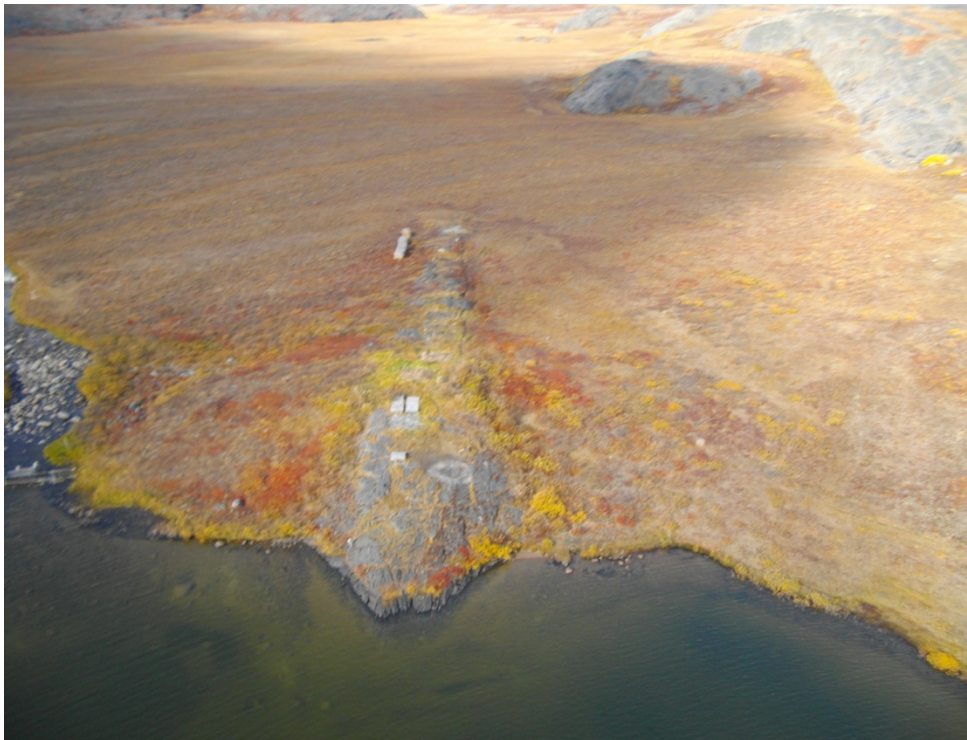
Figure B – Roberts Lake camp after clean up, looking north; drill core is visible in two areas.

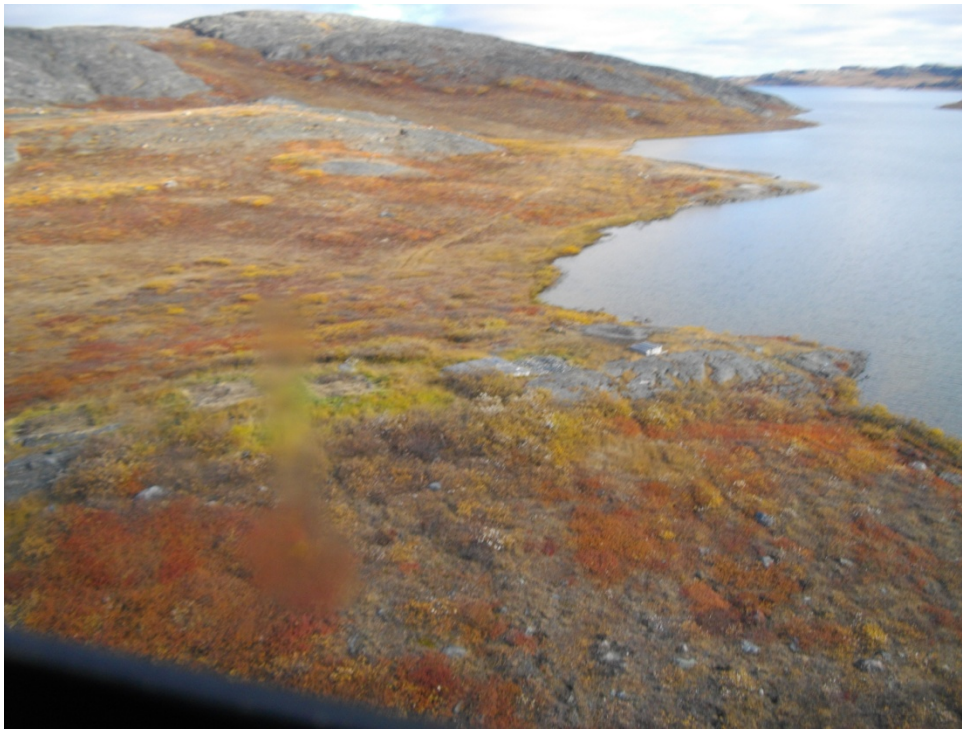
Figure C – Roberts Lake camp area after clean up; looking east over camp to the point on the lake where miscellaneous materials were also located.

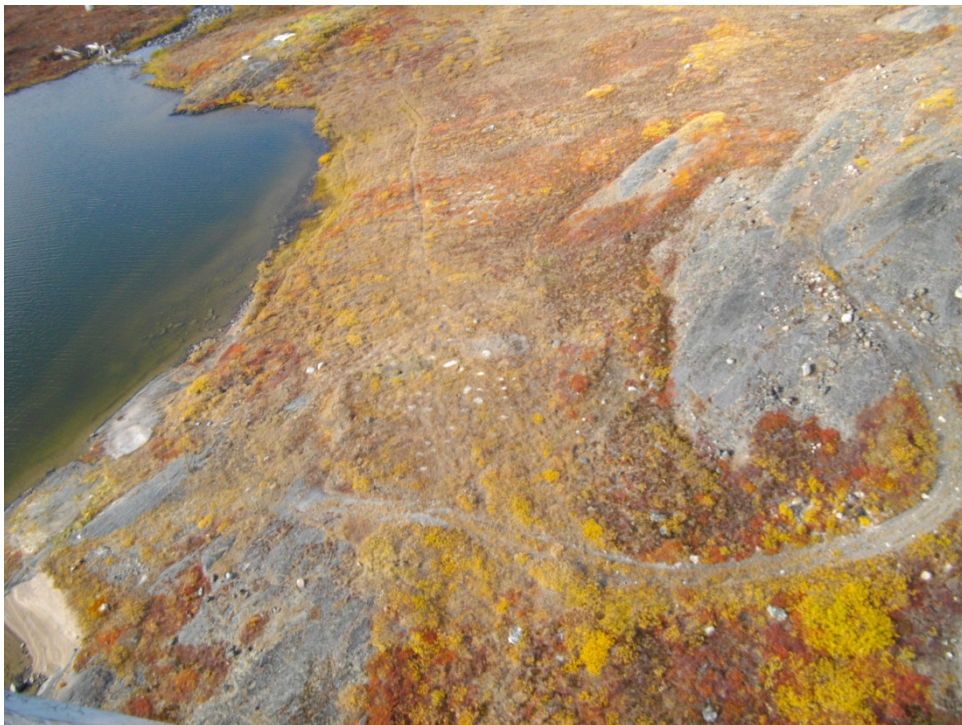
Figure D – Roberts Lake camp area after clean up; looking west; over the eastern areas where materials were located near the shore and the empty drum laydown.

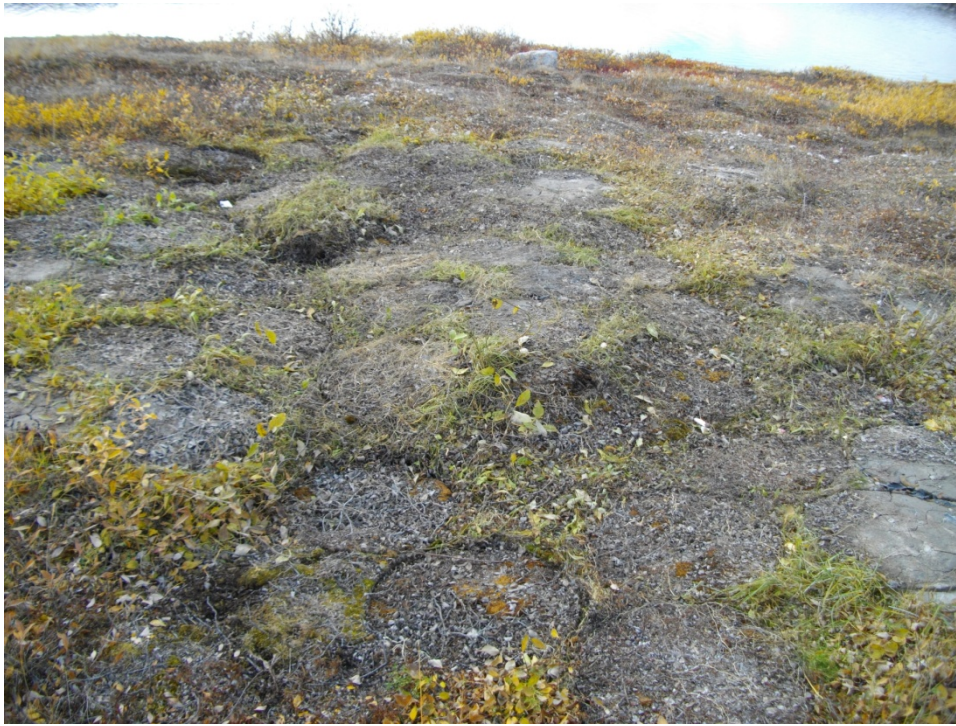
Figure E – Roberts Lake camp site after clean up; location of empty drum pile.

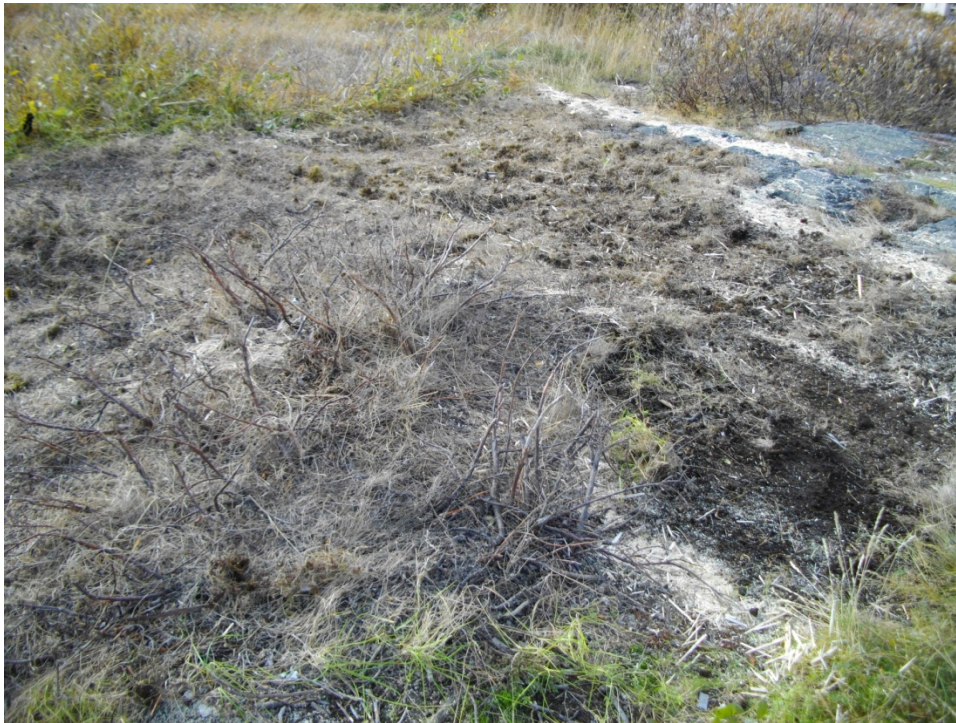
Figure F – Roberts Lake camp after clean up; example of floor removed.

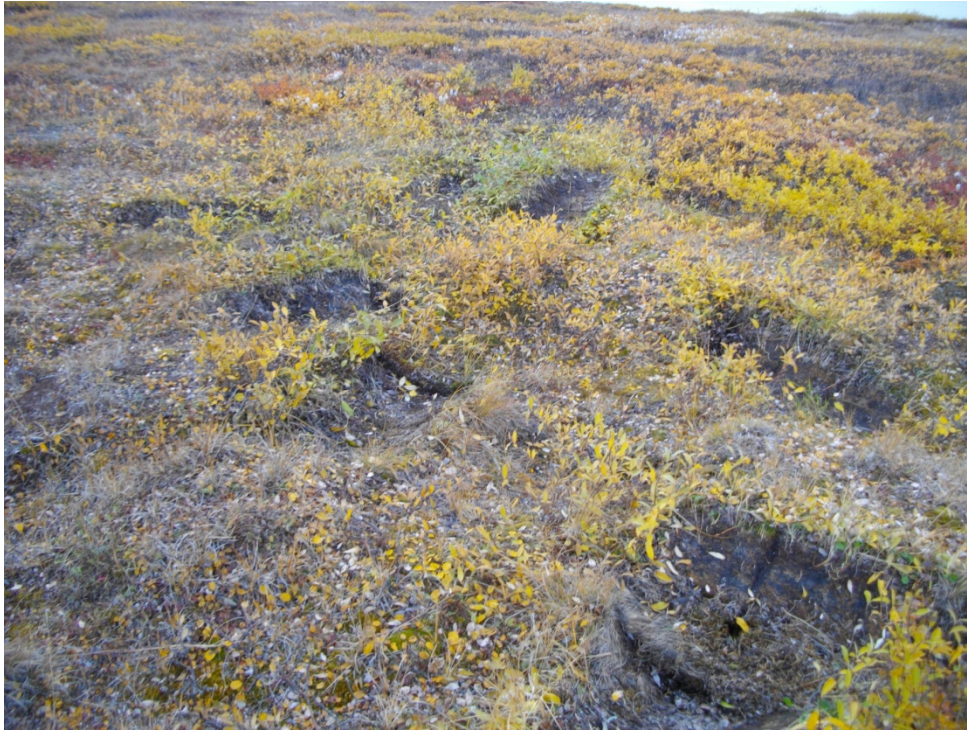
Figure G – Roberts Lake camp after clean up; gas and diesel drum location.

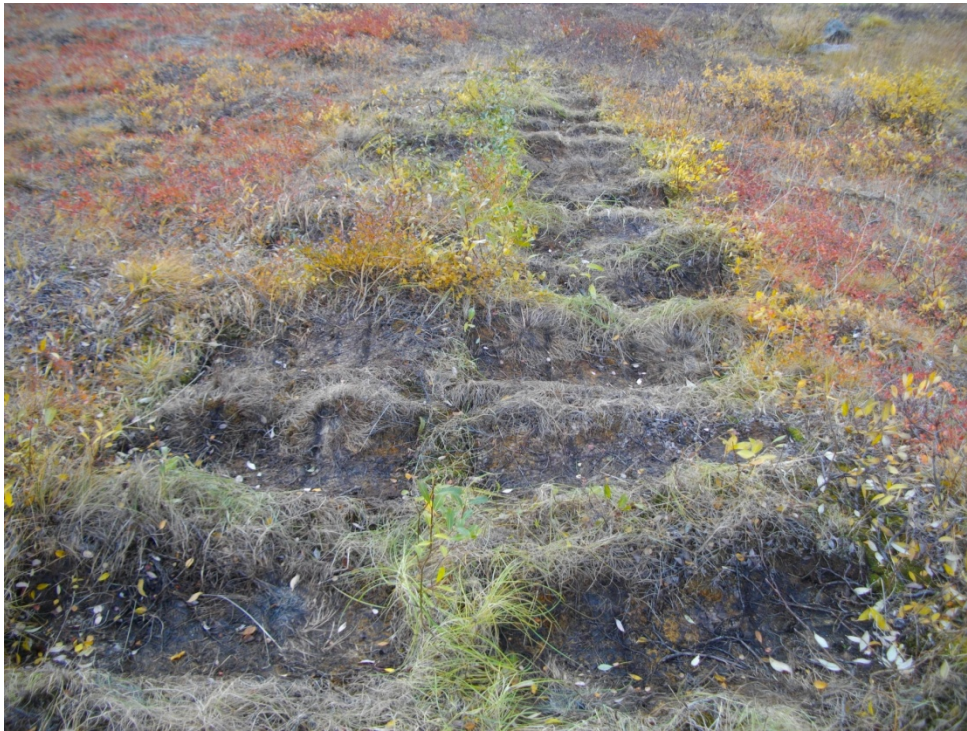
Figure H – Roberts Lake camp after clean up; location of jet B drums.

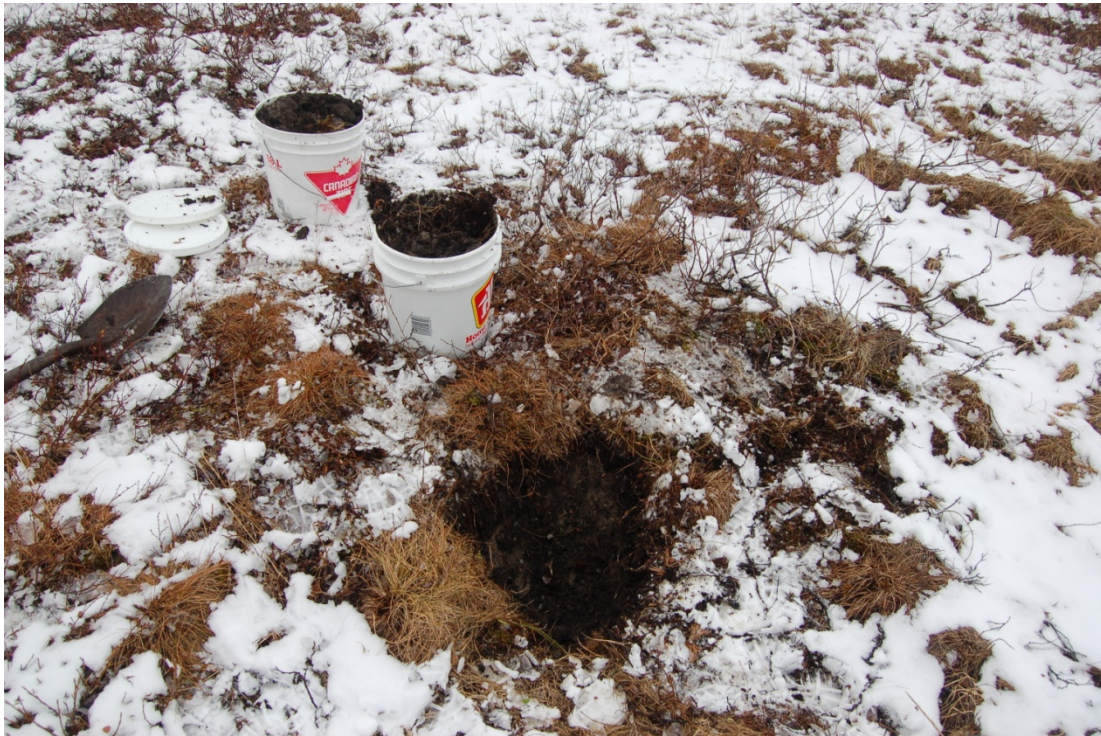
Of particular note, the contractor was advised to investigate and address any spills at the site. They reported back on September 16 that they were unable to locate any indication of spills around the fuel drums. We requested they return to the site and investigate further, with particular attention paid to the area around the gas drum. Aircraft restraints and weather prevented a return to the property until October 4<sup>th</sup>, at which time the contractor recovered two pails of soil from the area of the gas drum (Figures I and J).

Figure I – Roberts Lake camp site; October soil collection

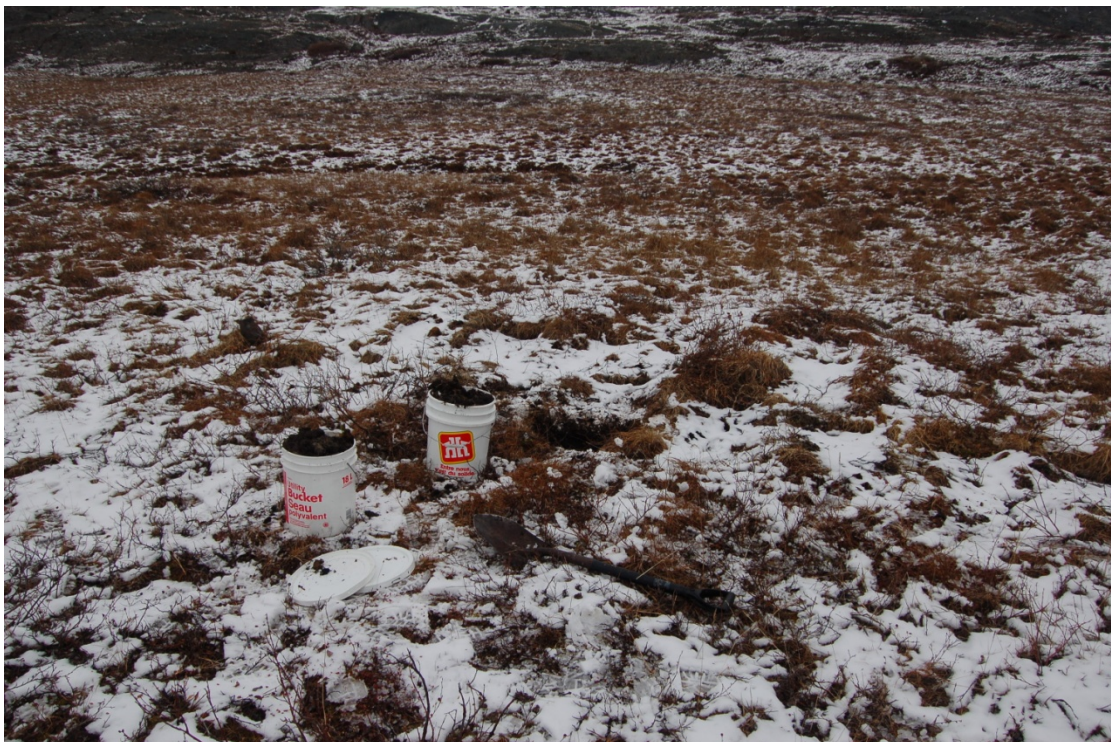
Figure J – Roberts Lake camp area; October soil collection
