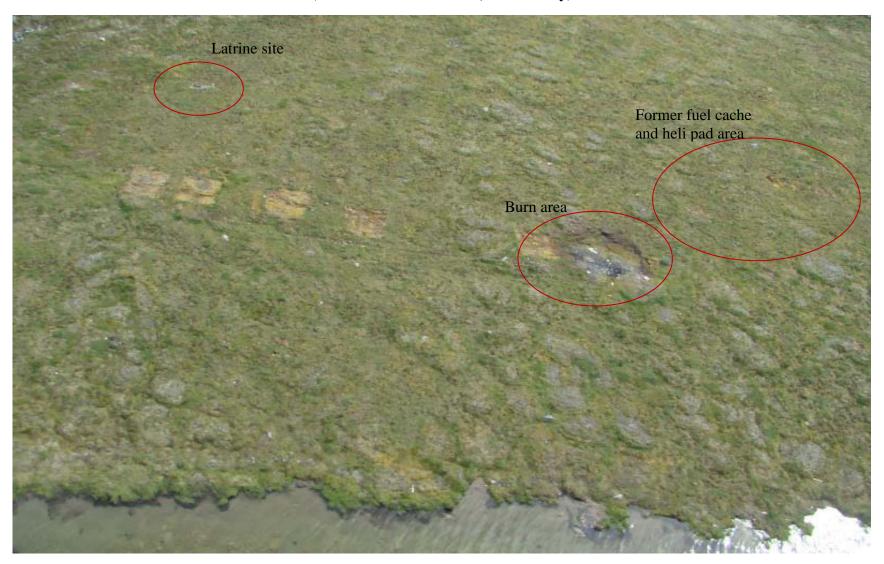
Photograph 1: Aerial survey of former Heequo camp location. Six former tent frame locations, latrine site, former fuel cache and helicopter pad area are identifiable in this view.

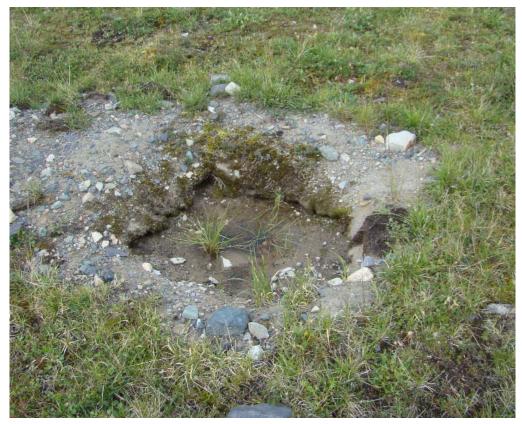
Photograph 2: Former latrine location; water has accumulated in the depression.

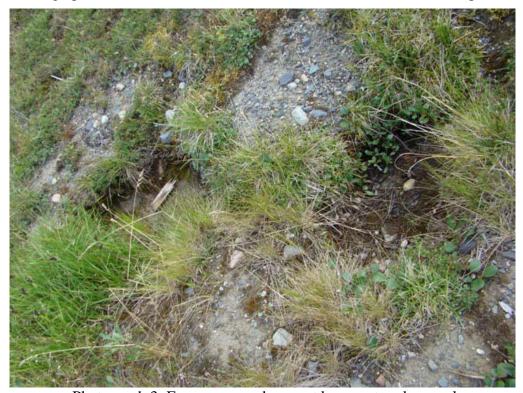
Photograph 3: Former sumps have not been restored properly.

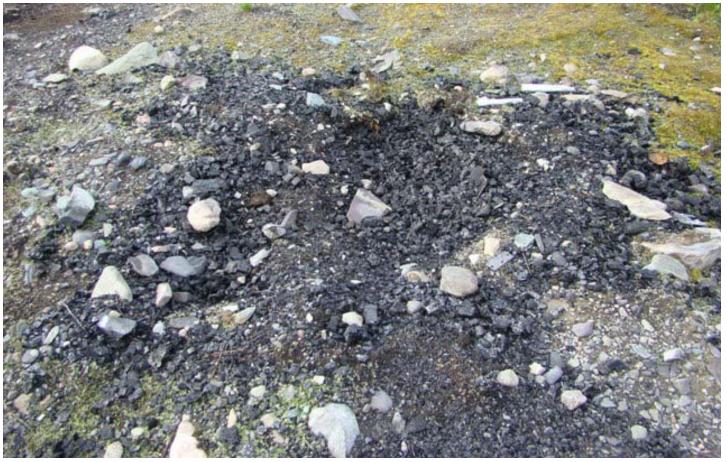
Photograph 4: Burn site has not been cleaned up; coals and metal debris remain.

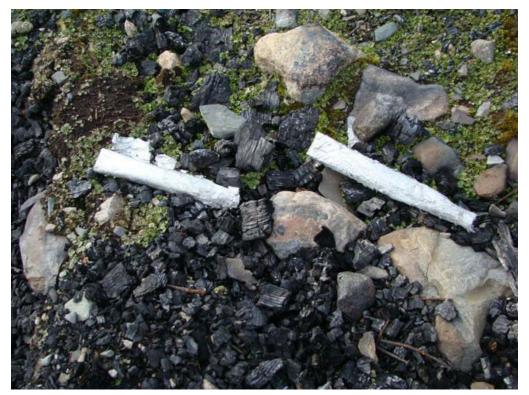
Photograph 5: View of noncombustible material and nails left in the burn area.

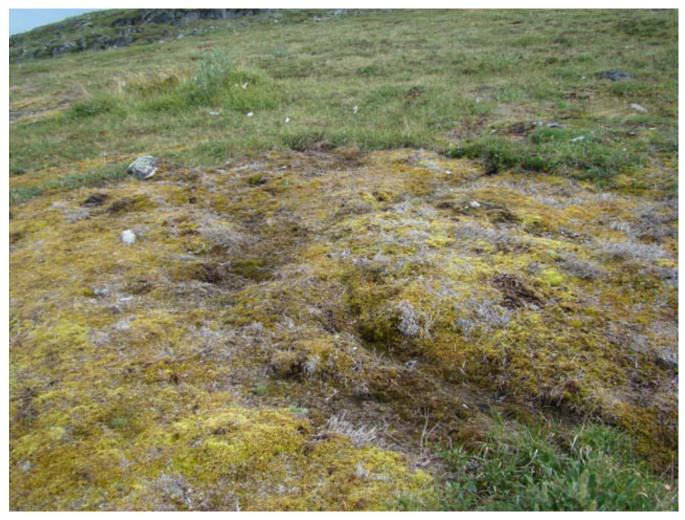
Photograph 5: Closer view of former tent frame area. Vegetation appears to be recovering.
