CROWN LAND USE INSPECTION FORM

Permittee	Representative
MMG Resources INC.	Greg Martin
Permit No. / Expiry	Representative's Title
N2024C0021	
Other Authorizations	Land / Other Authorizations
2BE-HIG2328	
Date of Inspection	Inspector
July 31 2024	Isaiah James Bolt
Activities Inspected	
<input checked="" type="checkbox"/> Camp <input type="checkbox"/> Drilling <input type="checkbox"/> Mining <input type="checkbox"/> Construction <input type="checkbox"/> Reclamation <input type="checkbox"/> Fuel Storage <input type="checkbox"/> Roads/hauling <input type="checkbox"/> Other: <input type="checkbox"/> Other:

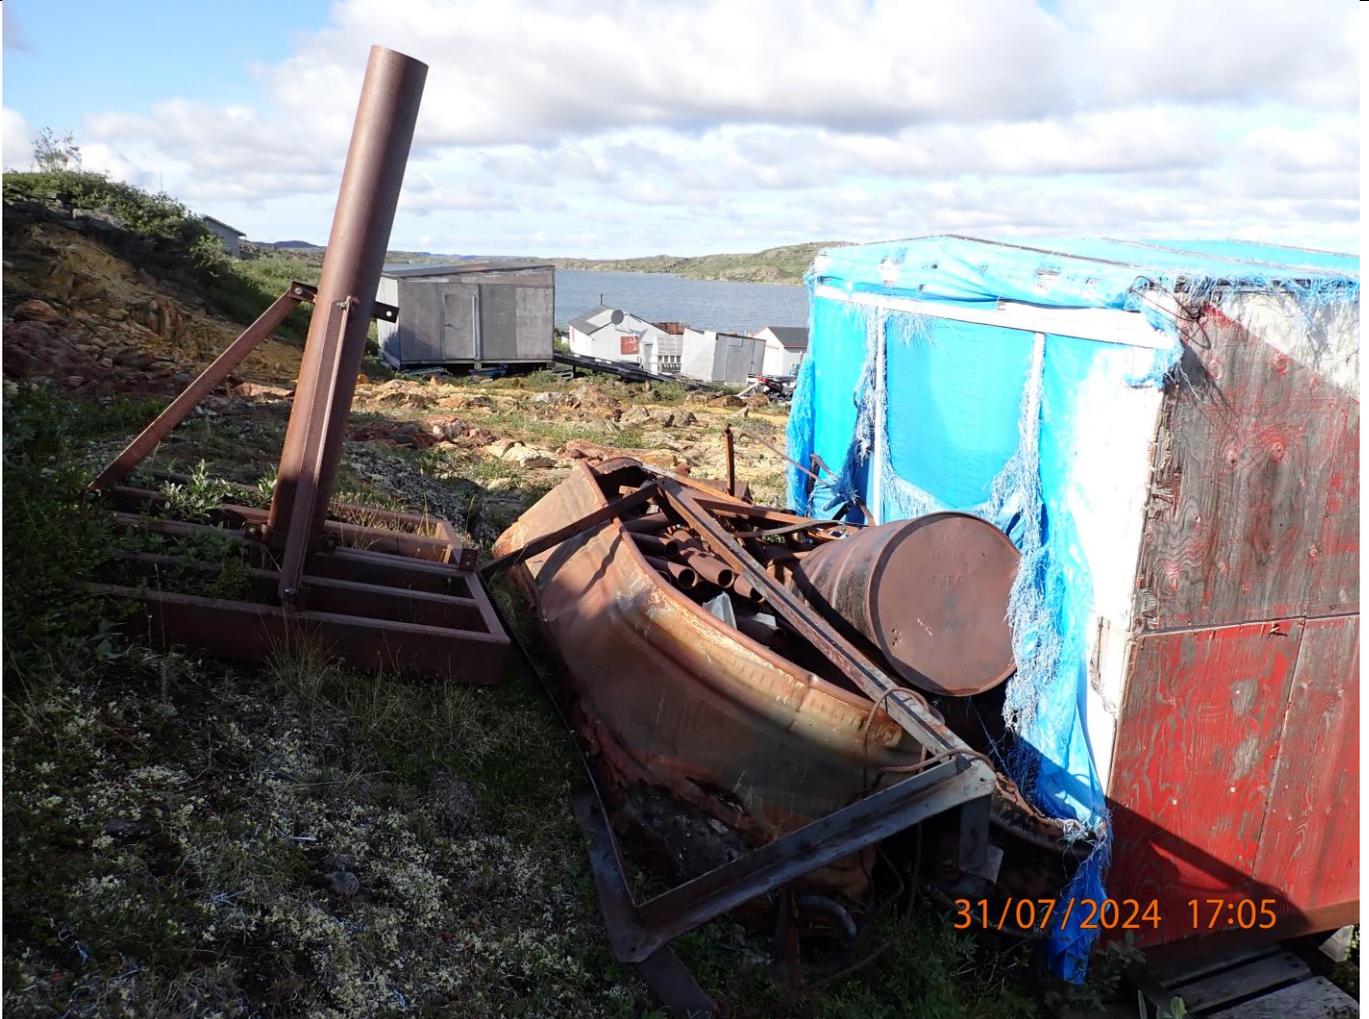
Photo 3

parts, barrels and kegs, buildings and building material.”

Scrap metal and parts

All scrap metal shall be removed form site including any garbage, discarded barrels or debris. All fuel must be stored in secondary containment. All building doors, windows and walls must be repaired and closed to prevent access from wildlife. All drill rods shall be cut to grade, capped and scrap metal rod removed from site. The metal dish should be stored in camp for removal from site or stored in camp for future use. A detailed plan and timeline to achieve the actions required shall be submitted to me at james.bolt@rcaanc-cirnac.gc.ca by December 20 2024. Actions required should be planned for completion prior to July 31 2025.

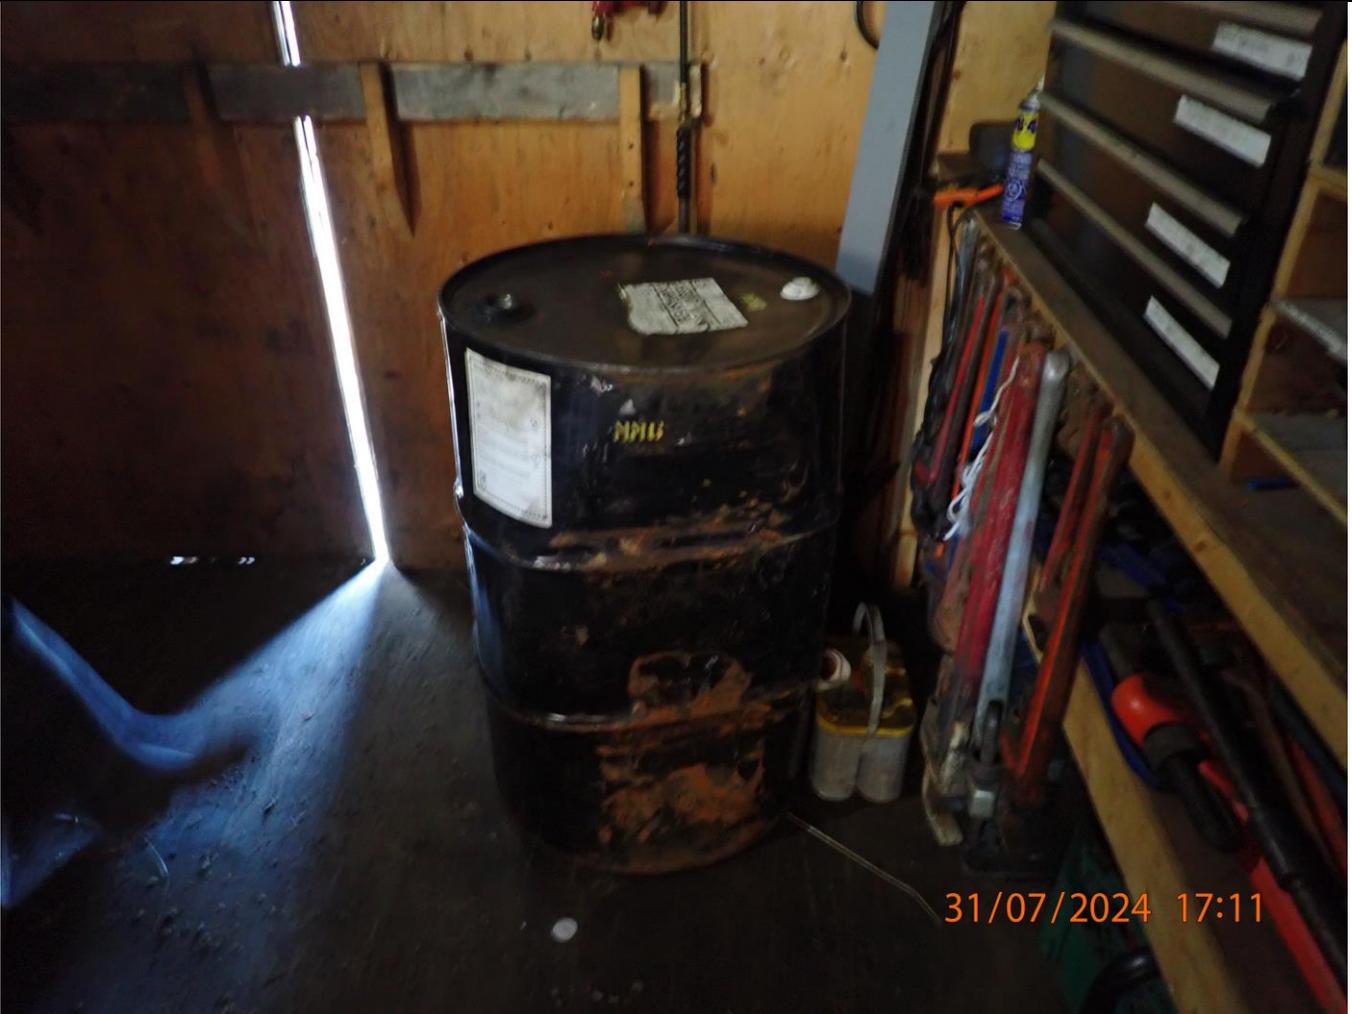
Photo 5

31(1)(k) item 78 of the issued permit states: “The Permittee shall provide approved covered secondary containment for all fuels stored associated with this Land Use Permit.”

1 fuel drum outside of containment inside the mechanic shop

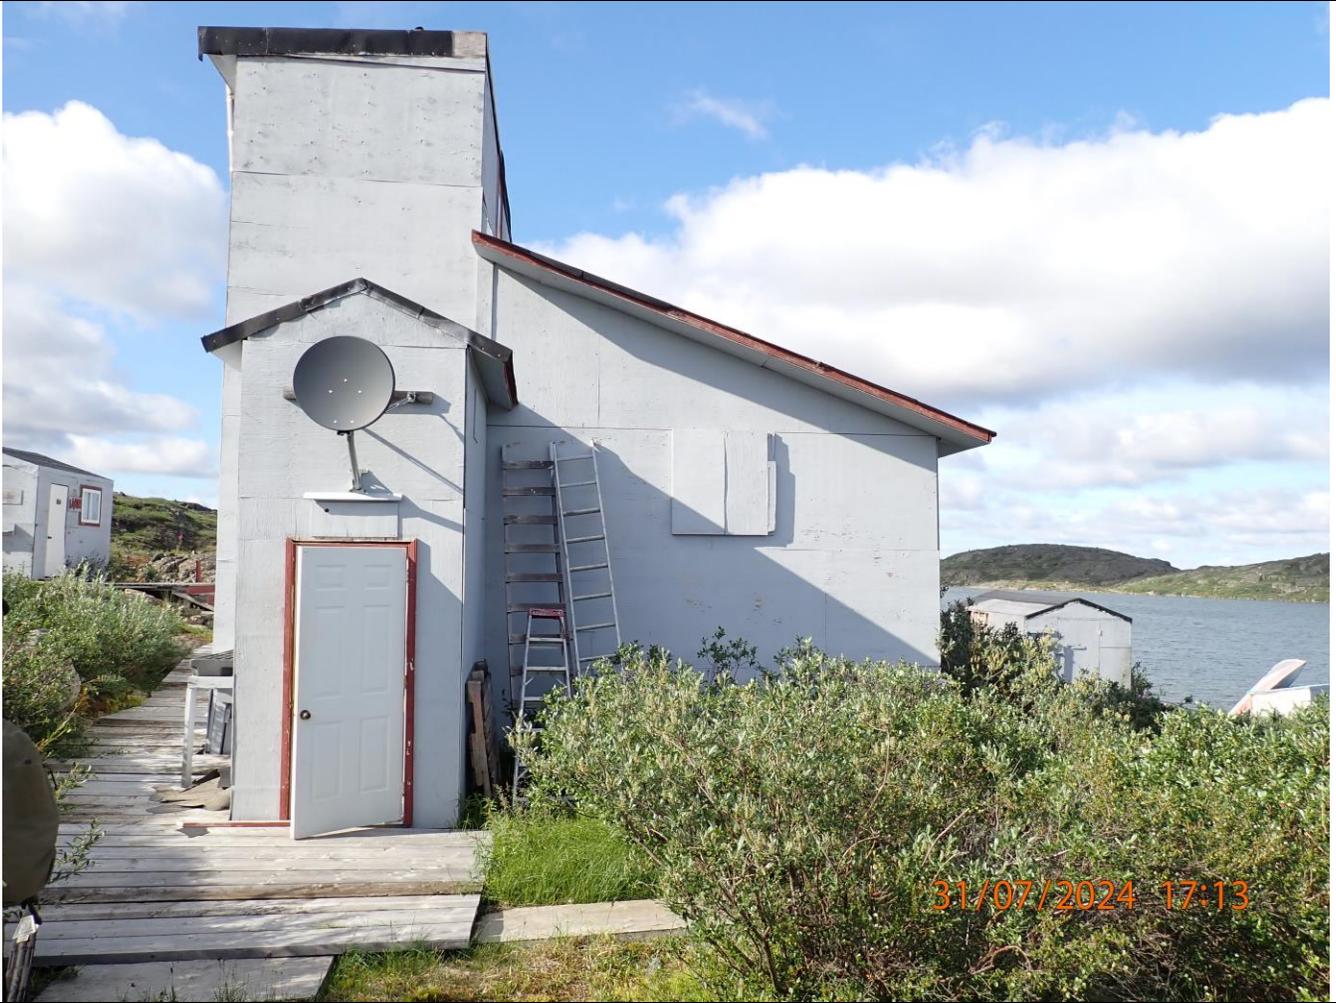
Photo 6

Main building with door open.

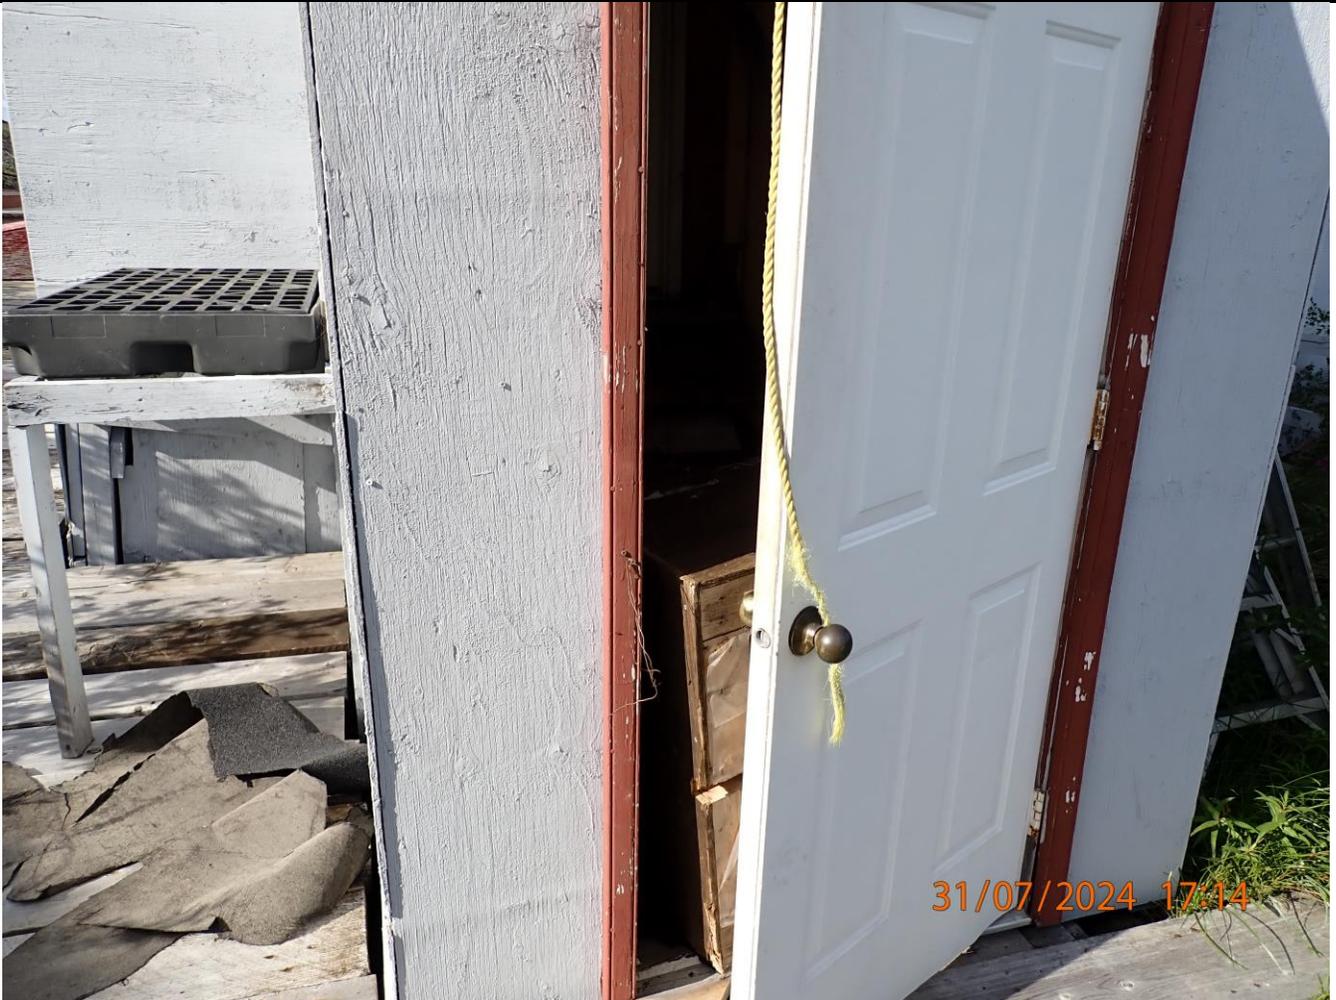
Photo 7

Roofing material outside main building, image shows box in door way. Bear sign is apparent in the building.

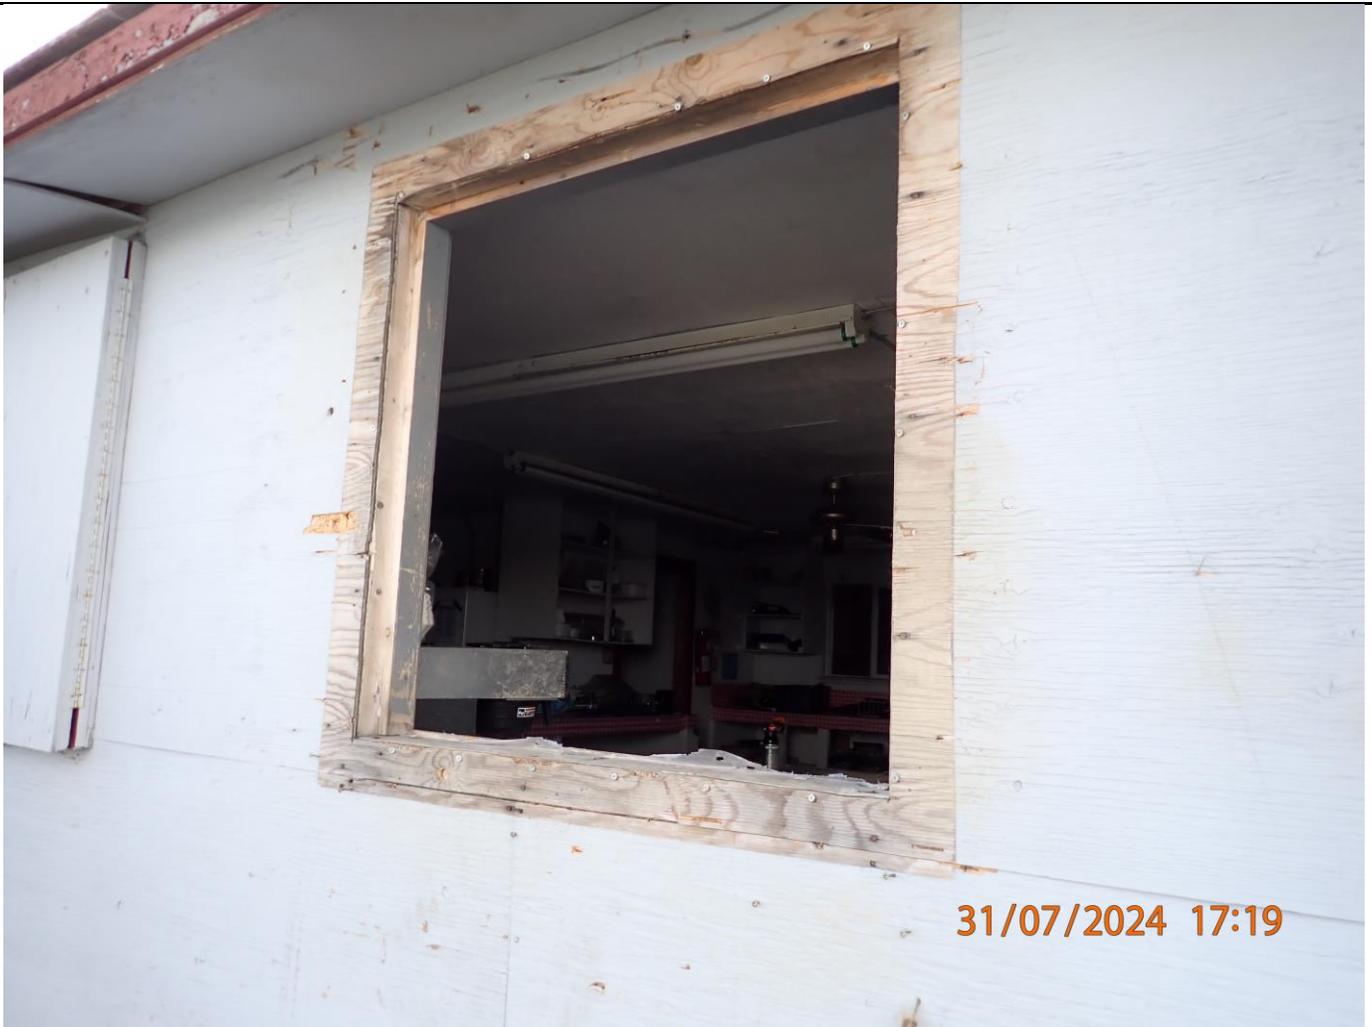
Photo 10

Main building kitchen window open, the plywood was observed on the ground.
