Attachment 12 – Inspections and Responses

WATER LICENCE INSPECTION FORM

CROWN LAND USE INSPECTION FORM

Reference: High Lake Camp Inspection

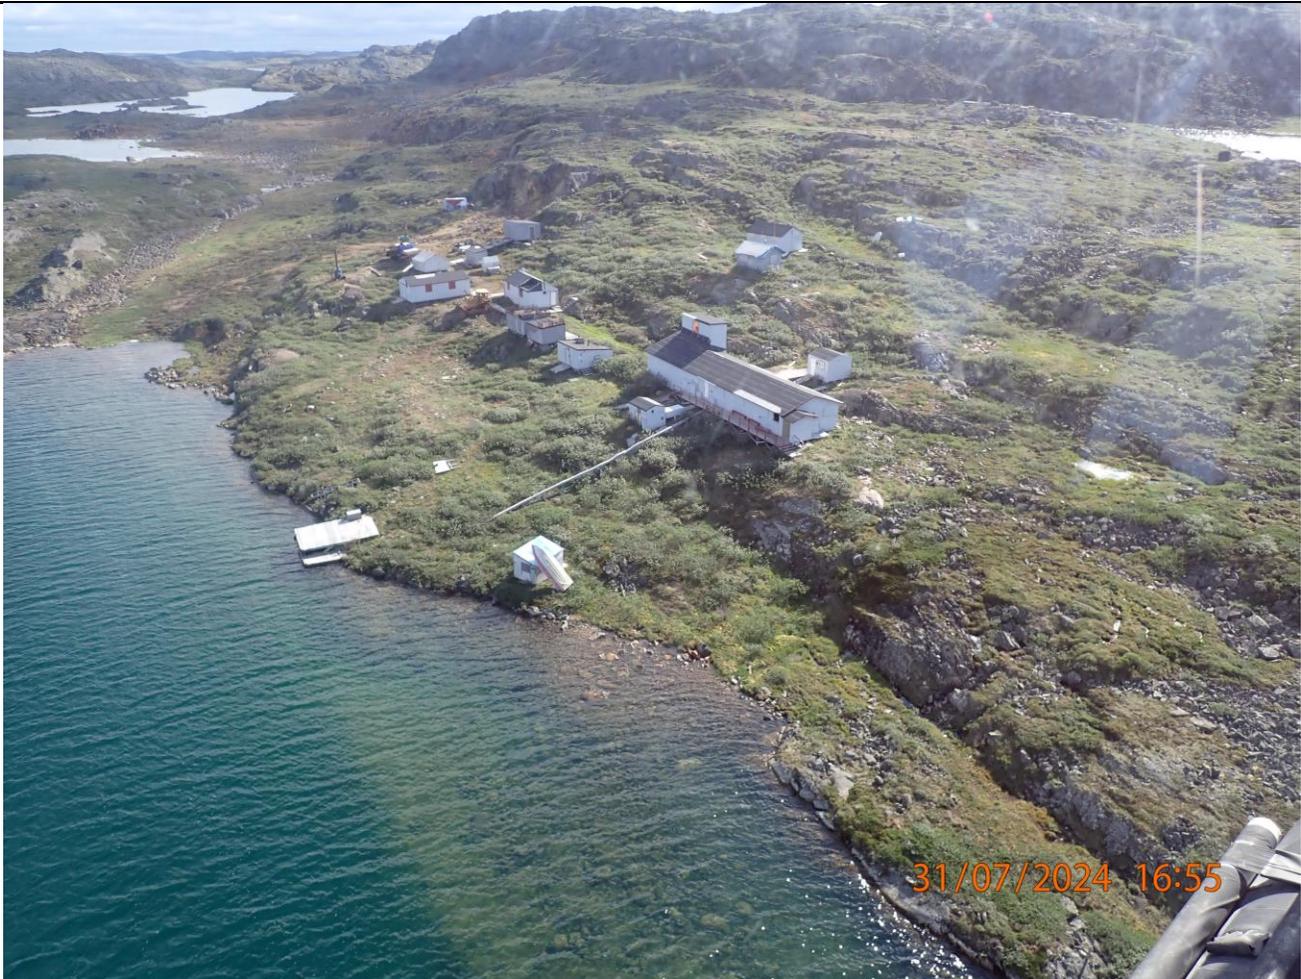
Photo 1

1. Inspectors arrive at 5:00pm, Aerial photos of the Site were taken (Photo#1and #2)
2. A pile of scrap metal was observed beside a drill shack (Photo #3)

High Lake camp Aerial Looking south.

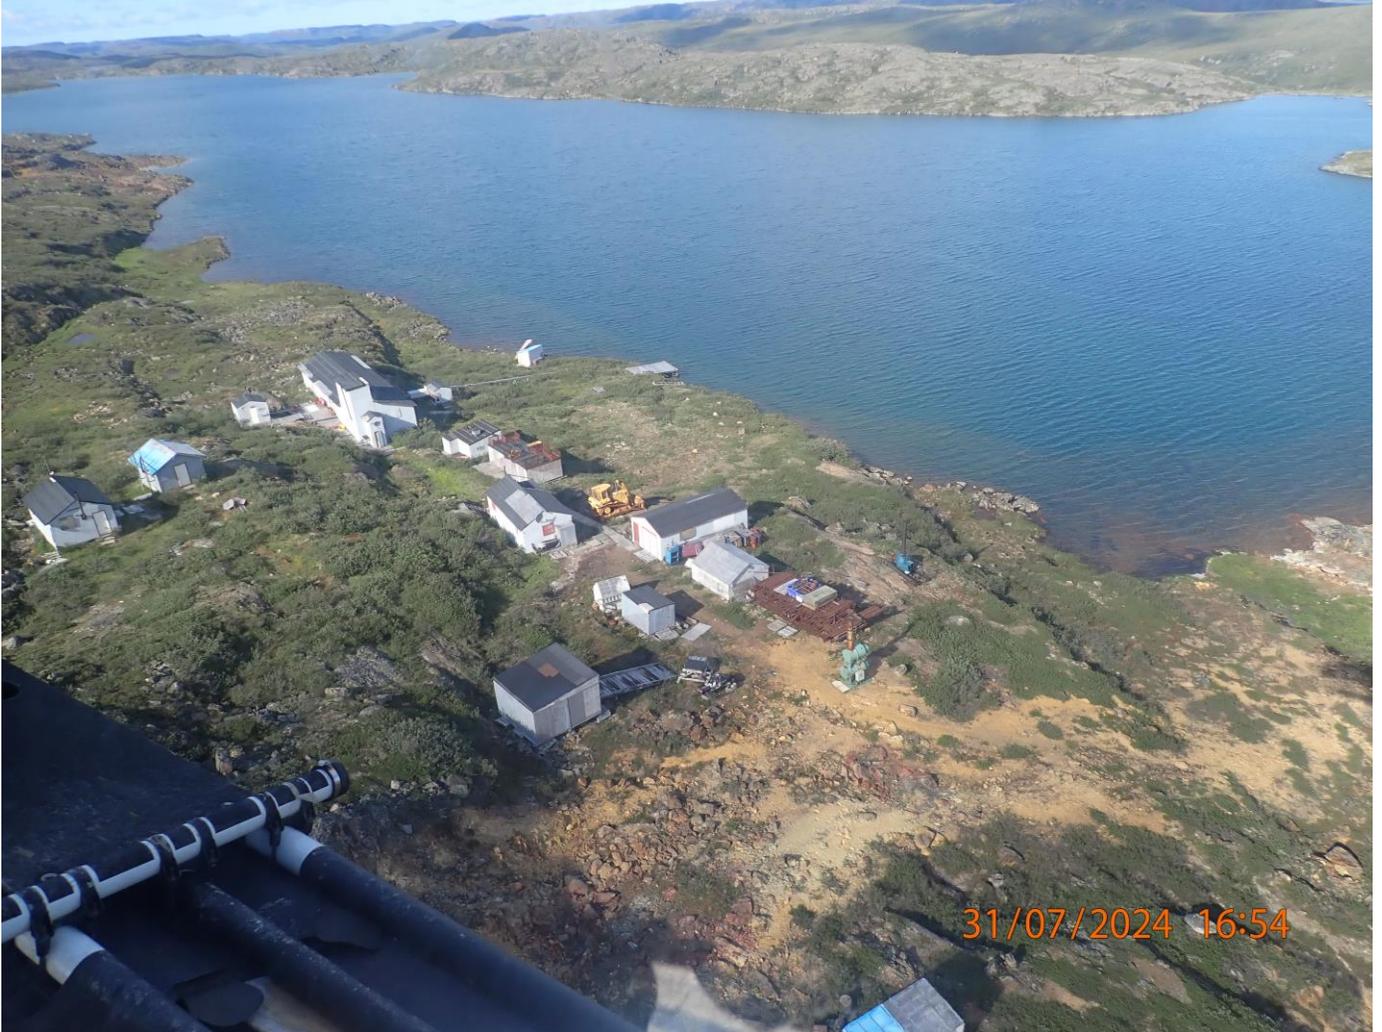
Photo 2

High Lake Looking North

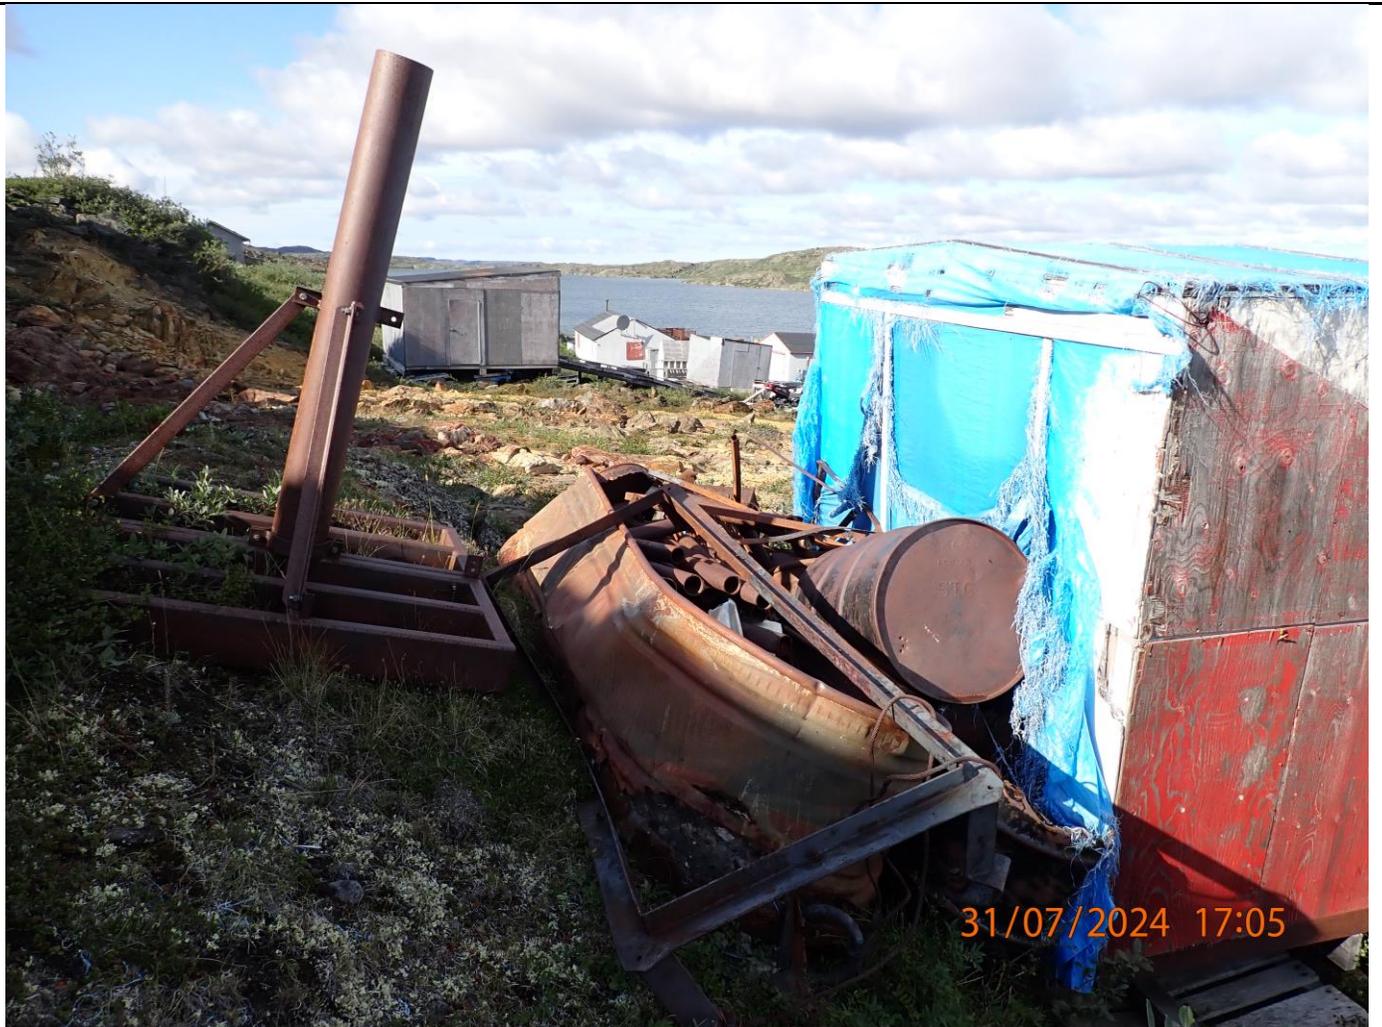
Photo 3

Scrap metal and parts

31(1)(a) item 2 of the issued permit states: "The Permittee shall remove from Territorial Lands, all scrap metal, discarded machinery

parts, barrels and kegs, buildings and building material.”

All scrap metal shall be removed form site including any garbage, discarded barrels or debris. All fuel must be stored in secondary containment. All building doors, windows and walls must be repaired and closed to prevent access from wildlife. All drill rods shall be cut to grade, capped and scrap metal rod removed from site. The metal dish should be stored in camp for removal from site or stored in camp for future use. A detailed plan and timeline to achieve the actions required shall be submitted to me at james.bolt@rcaanc-cirnac.gc.ca by December 20 2024. Actions required should be planned for completion prior to July 31 2025.

All scrap metal shall be removed from site including any garbage, discarded barrels or debris.

MMG remains committed to the removal of scrap metal from site and removal of scrap metal is included in the timeframe before the closure of the permit. The High Lake camp site is currently in long term care and maintenance without occupancy and is anticipated to remain in this state until 2026. The intent of long-term care and maintenance is to provide annual visits to verify that the site remains safe, secure and is not adversely impacting the environment.

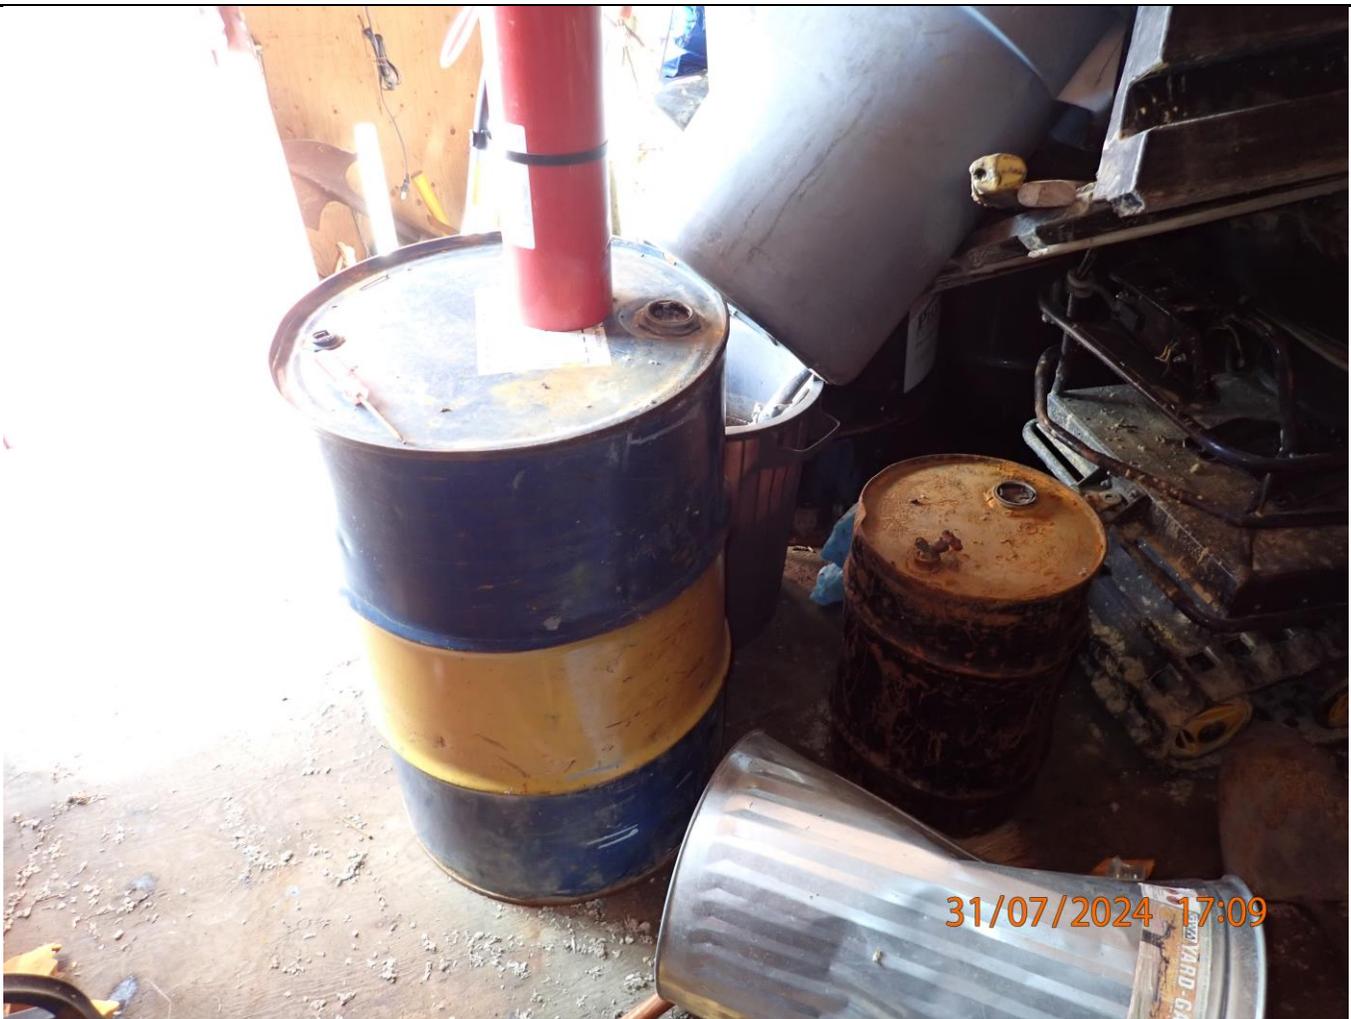
Photo 4

3. 3 drums of fuel inside the mechanic shop were observed out of secondary containment (Photo #4 and #5)
4. A door of the main building was observed open and bear disturbance and poop inside the building was observed. The bear may have entered or exited through the window near the kitchen as the ply wood covering the window was observed on the ground. (Photo #6, #7, #8, #9, #10)

3.0 Site Descriptions of the Spill Contingency Plan states: "A plastic spill container will be placed below each drum and absorbent matting will be fixed around each Bung/fuel supply assembly"

2 fuel containers out of secondary containment inside the mechanic shop.

31(1)(k) item 78 of the issued permit states: “The Permittee shall provide approved covered secondary containment for all fuels stored associated with this Land Use Permit.”

All fuel must be stored in secondary containment.

MMG commits to placement of all fuels within in secondary containment including instaberm, movable rigid spill trays, or similar impermeable containment. Secondary containment will be sized to 110 % of the volume of the largest tank it is to contain, or 100% of the largest tank plus 10% of the aggregate capacity of the stored tanks, whichever is greater. MMG also commits to covering all outdoor spill trays to prevent the containment from filling with precipitation. This will be completed during the next annual care and maintenance site visit.

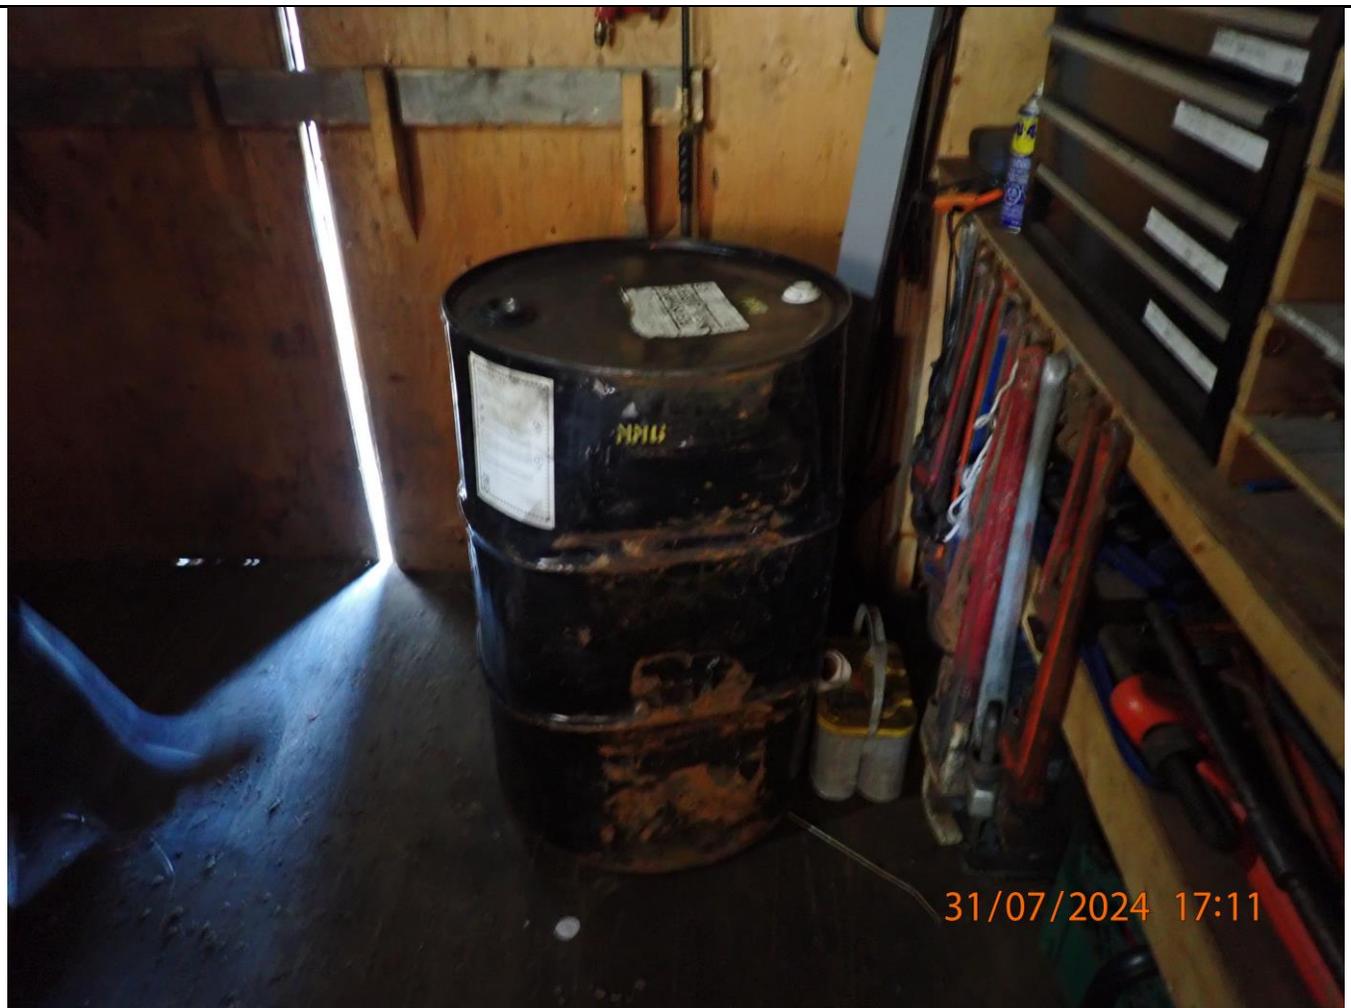
Photo 5

1 fuel drum outside of containment inside the mechanic shop

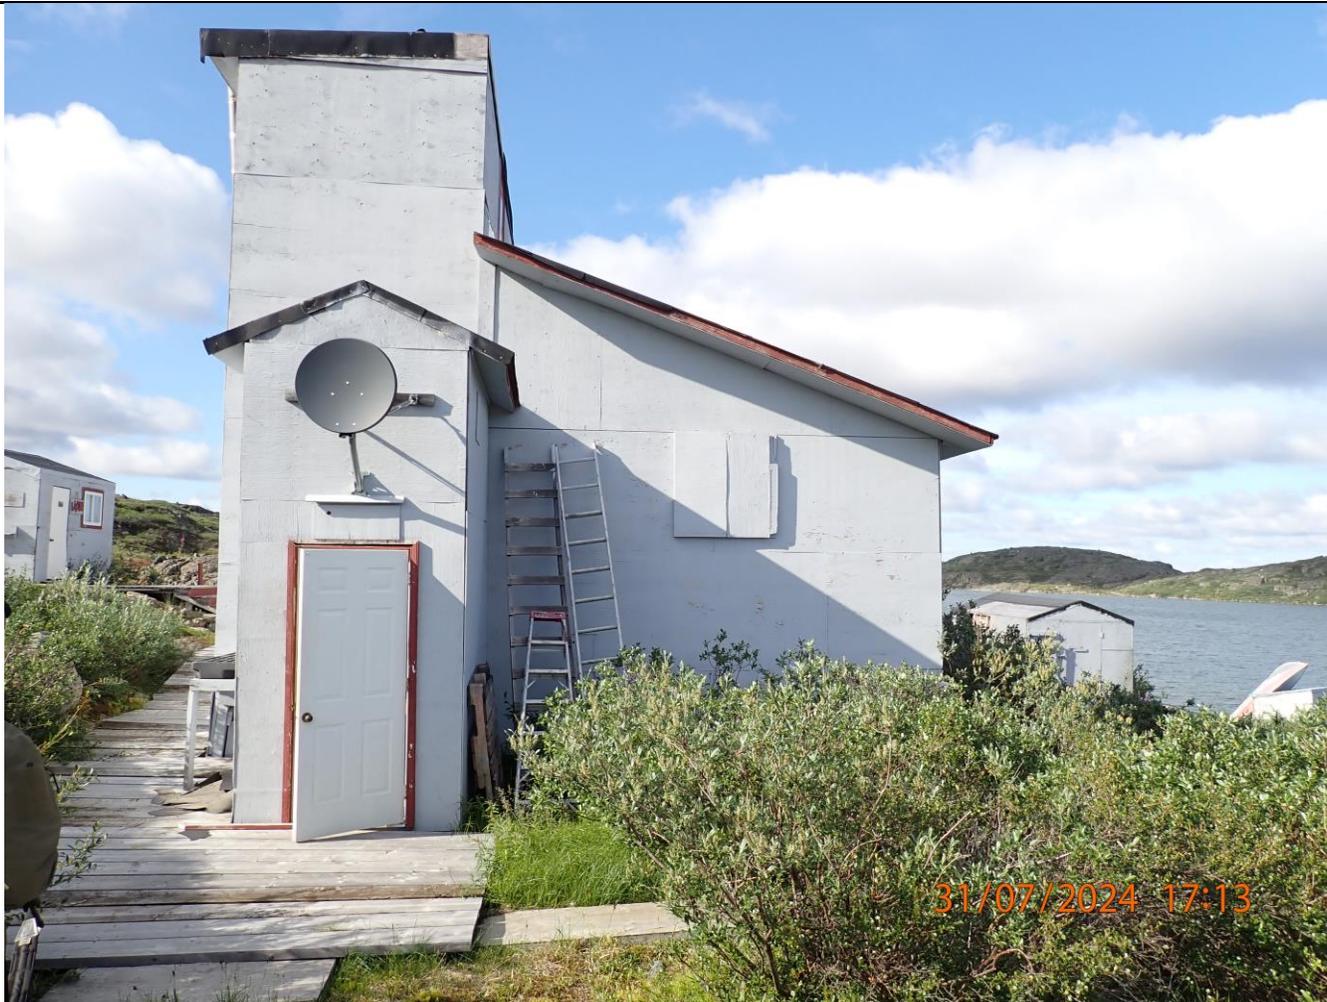
Photo 6

Main building with door open.

All building doors, windows and walls must be repaired and closed to prevent access from wildlife.

MMG completes annual care and maintenance site visits to address any changes to the site condition and return the site to compliance with the water licence and land use permit. MMG commits to clearing buildings of wildlife detritus and fortifying buildings to prevent usage by wildlife. This will be completed during the next care and maintenance site visit.

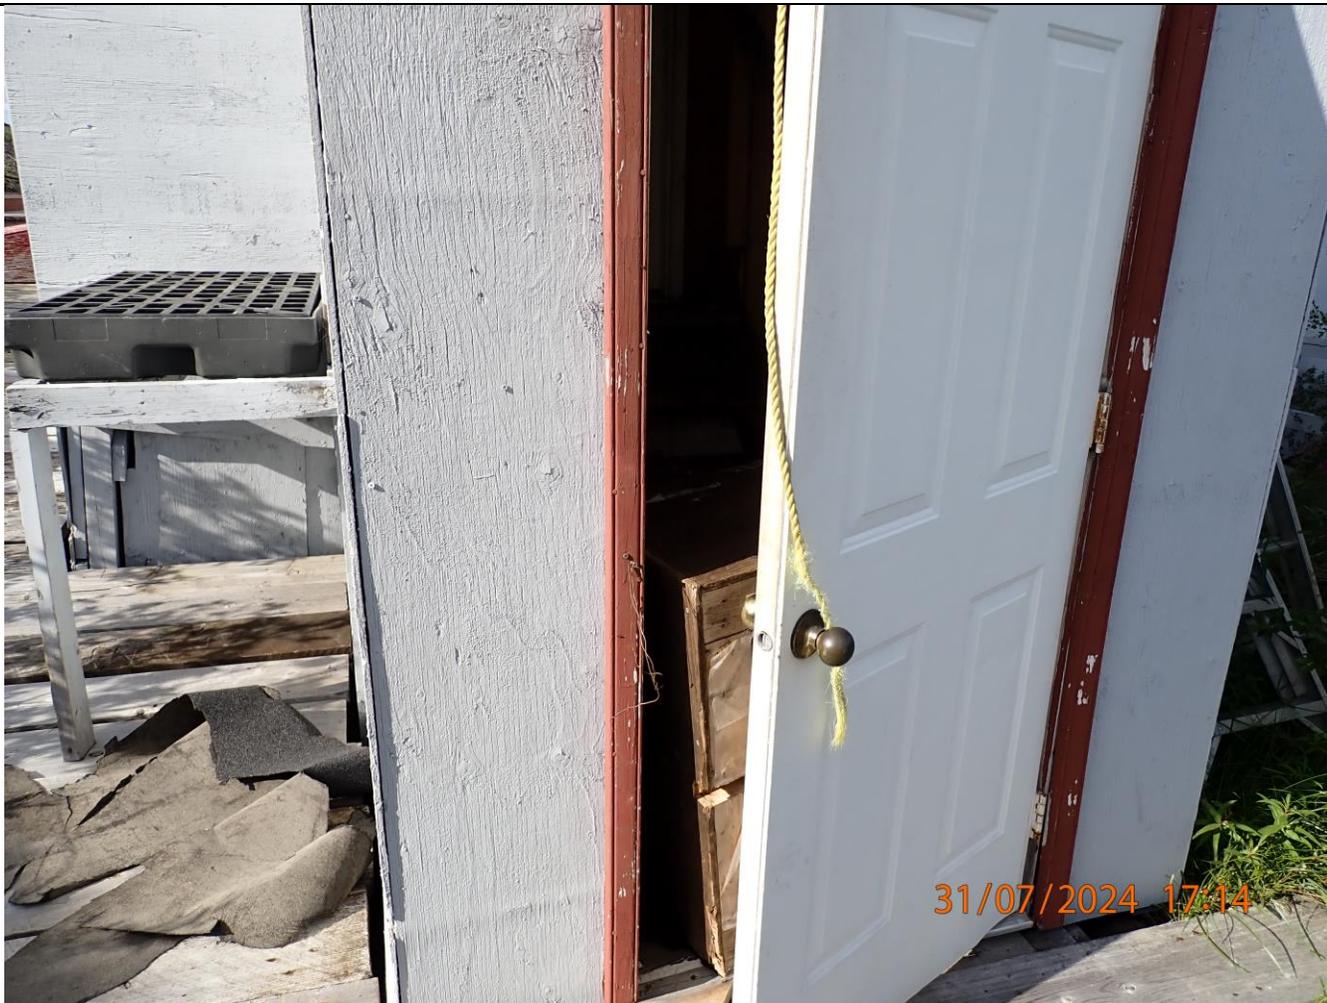
Photo 7

Roofing material outside main building, image shows box in door way. Bear sign is apparent in the building.

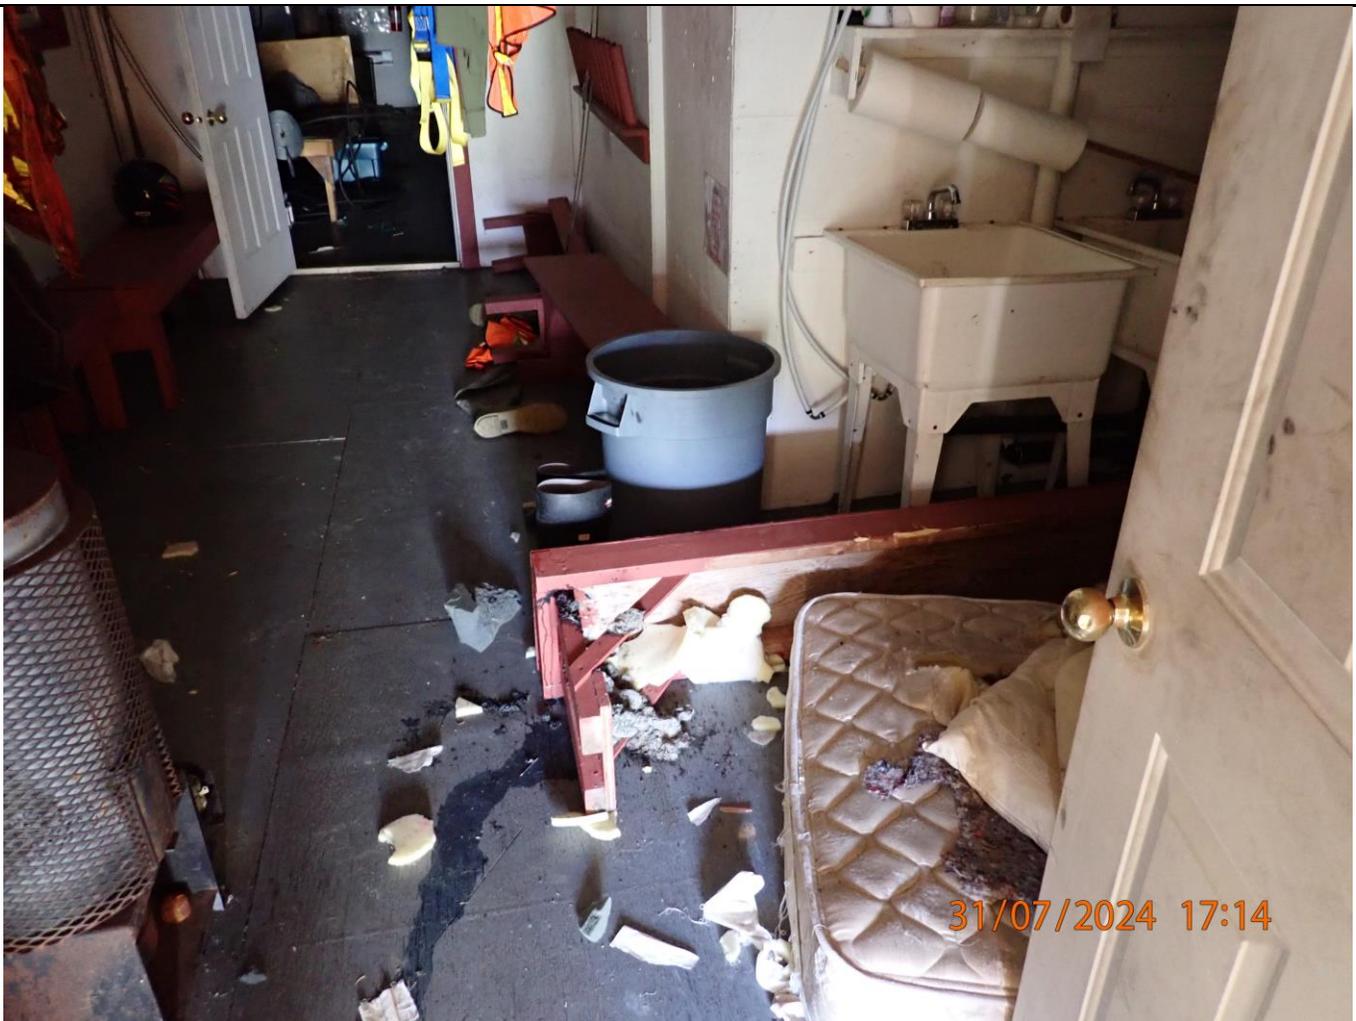
Photo 8

Inside the main building entrance, bear scat is observed on the bench and floor.

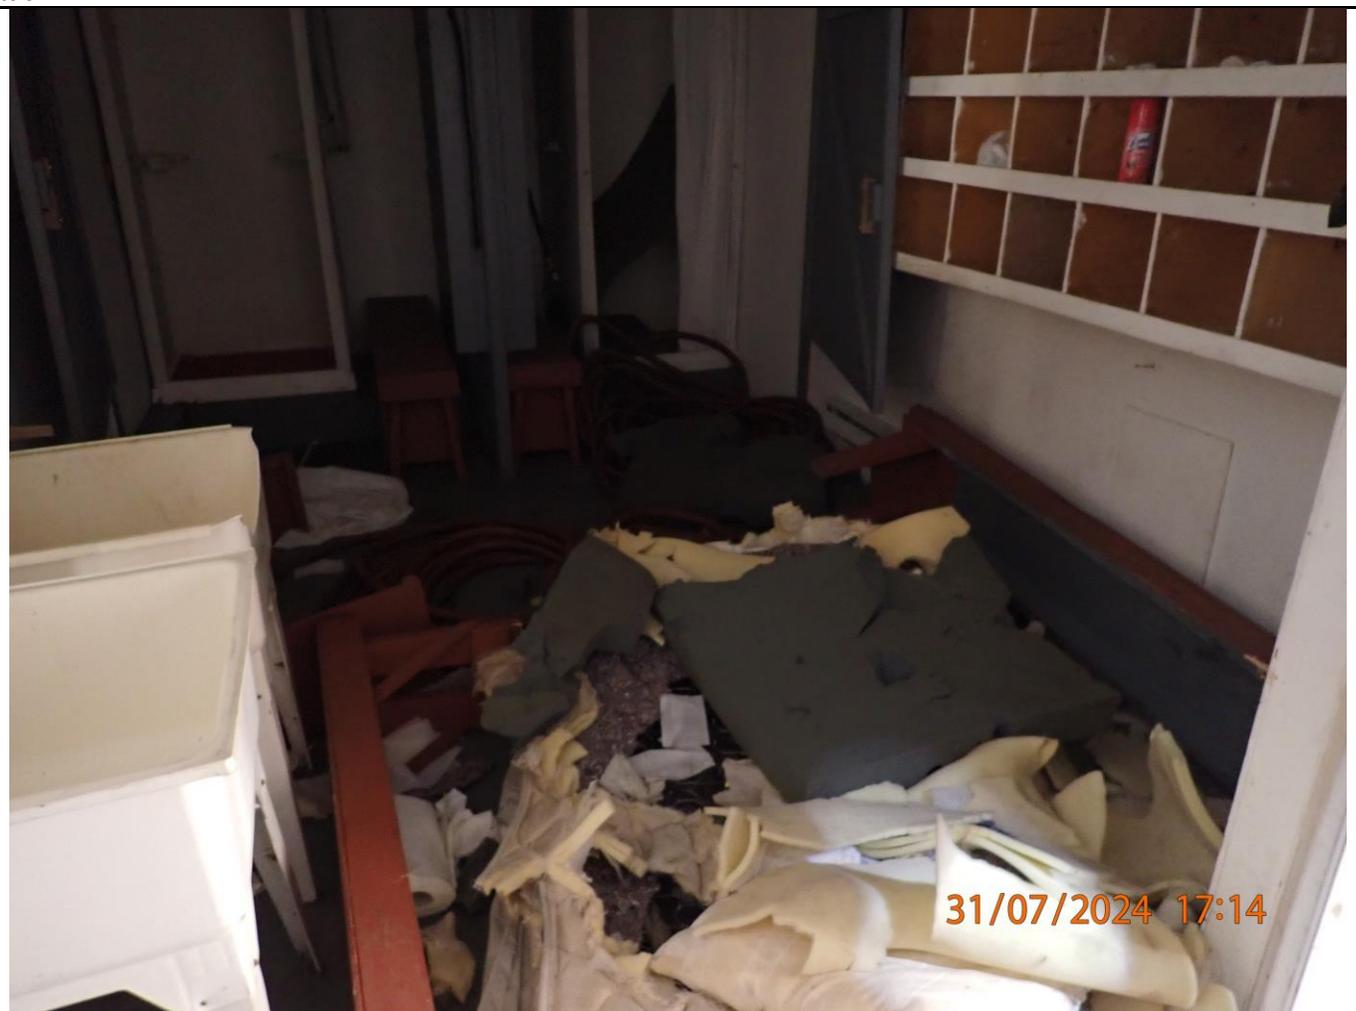
Photo 9

Inside the main building entrance, mess caused by a bear

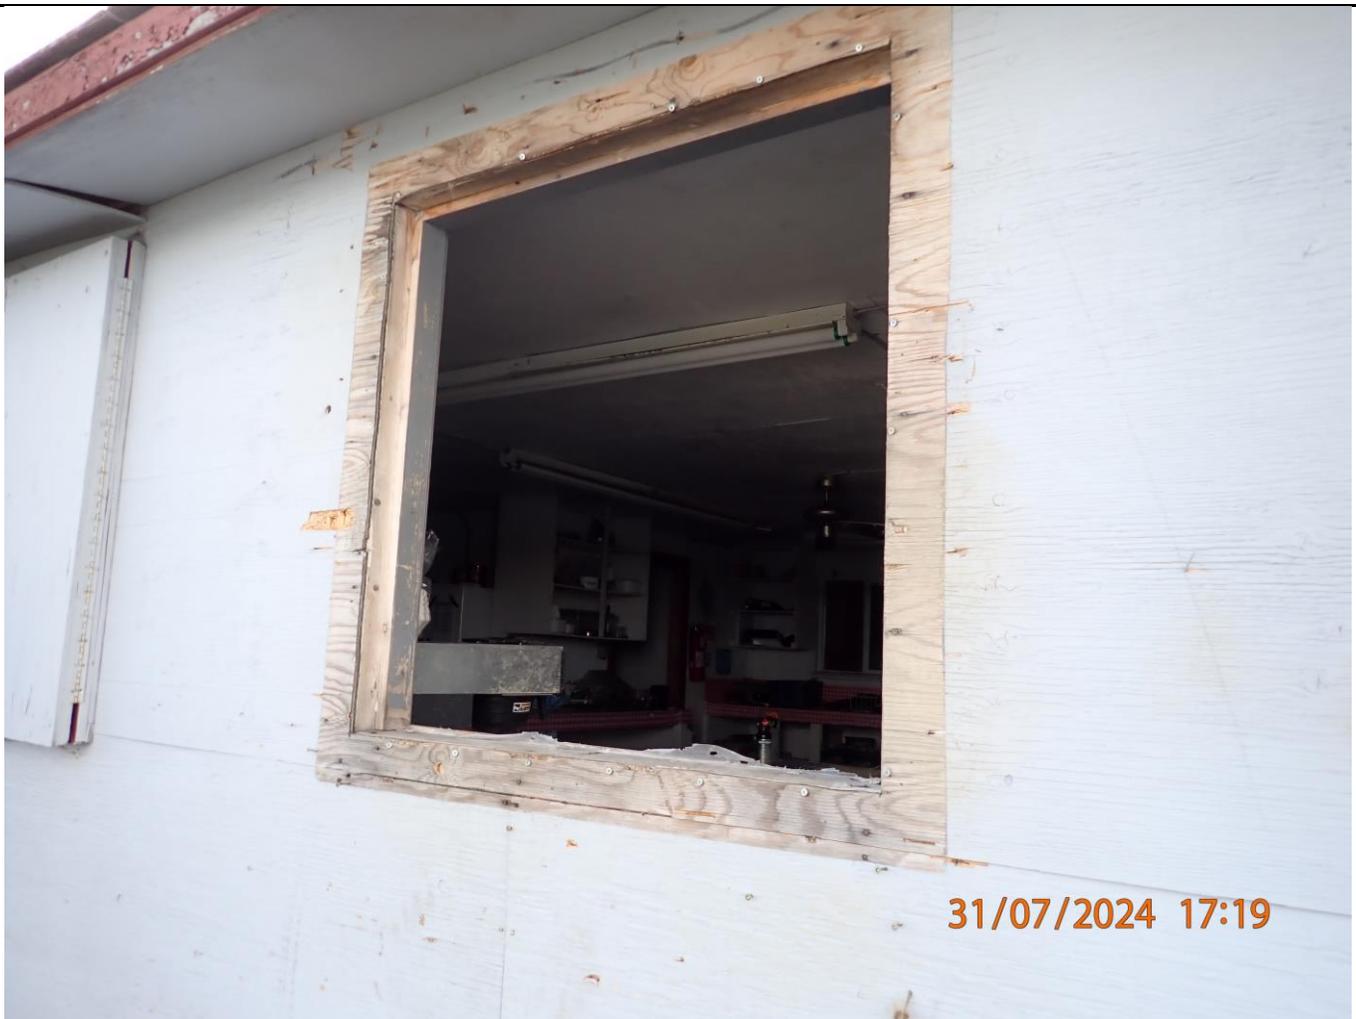
Photo 10

Main building kitchen window open, the plywood was observed on the ground.

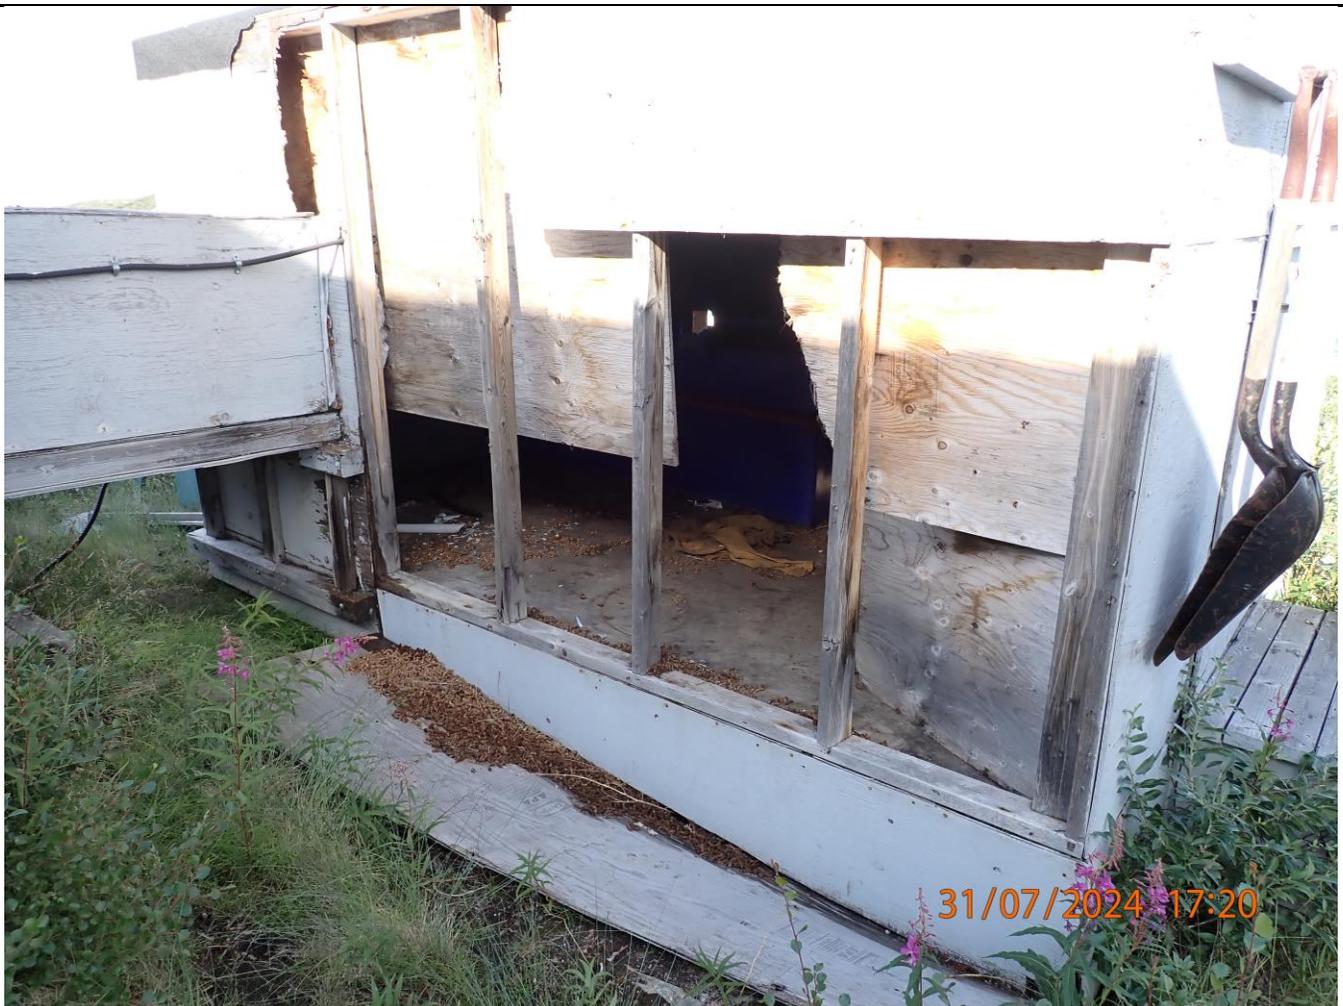
Photo 11

5. A small shack that is connected to the main dry/kitchen building was observed to have broken plywood siding and an open window. A lot of Ptarmigan poop inside the shack and on the side of the shack show that wildlife is using the building for shelter. This small shack may be the generator shack. (Photo #11 and #12)

Small shack beside main building shown with an open side wall and ptarmigan droppings inside.

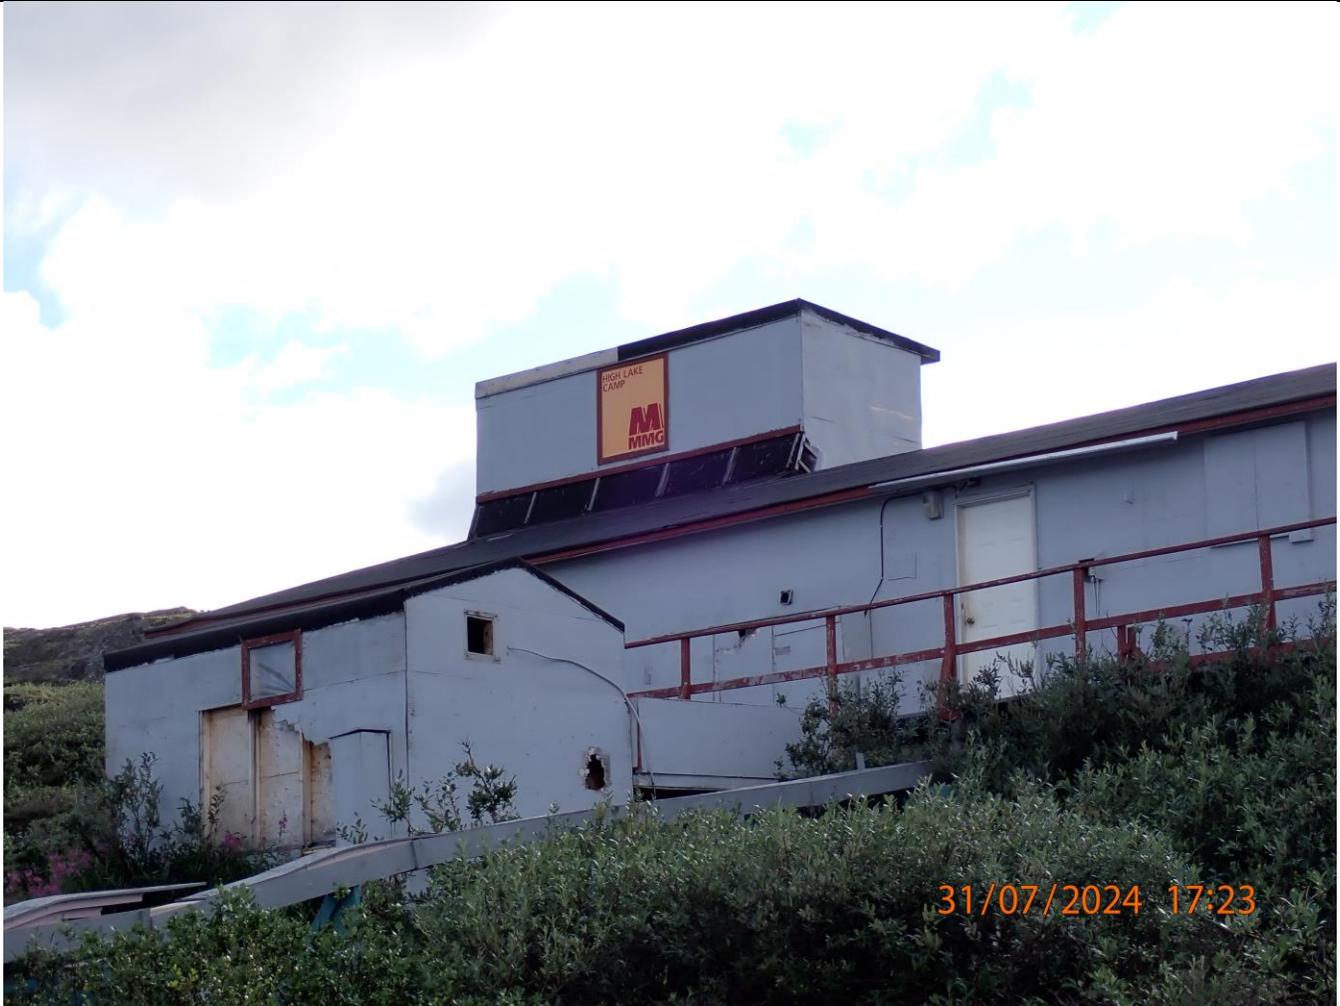
Photo 12

Another view of the shack beside the main building, Plywood from the wall is missing, an open window and a hole in the back wall is shown.

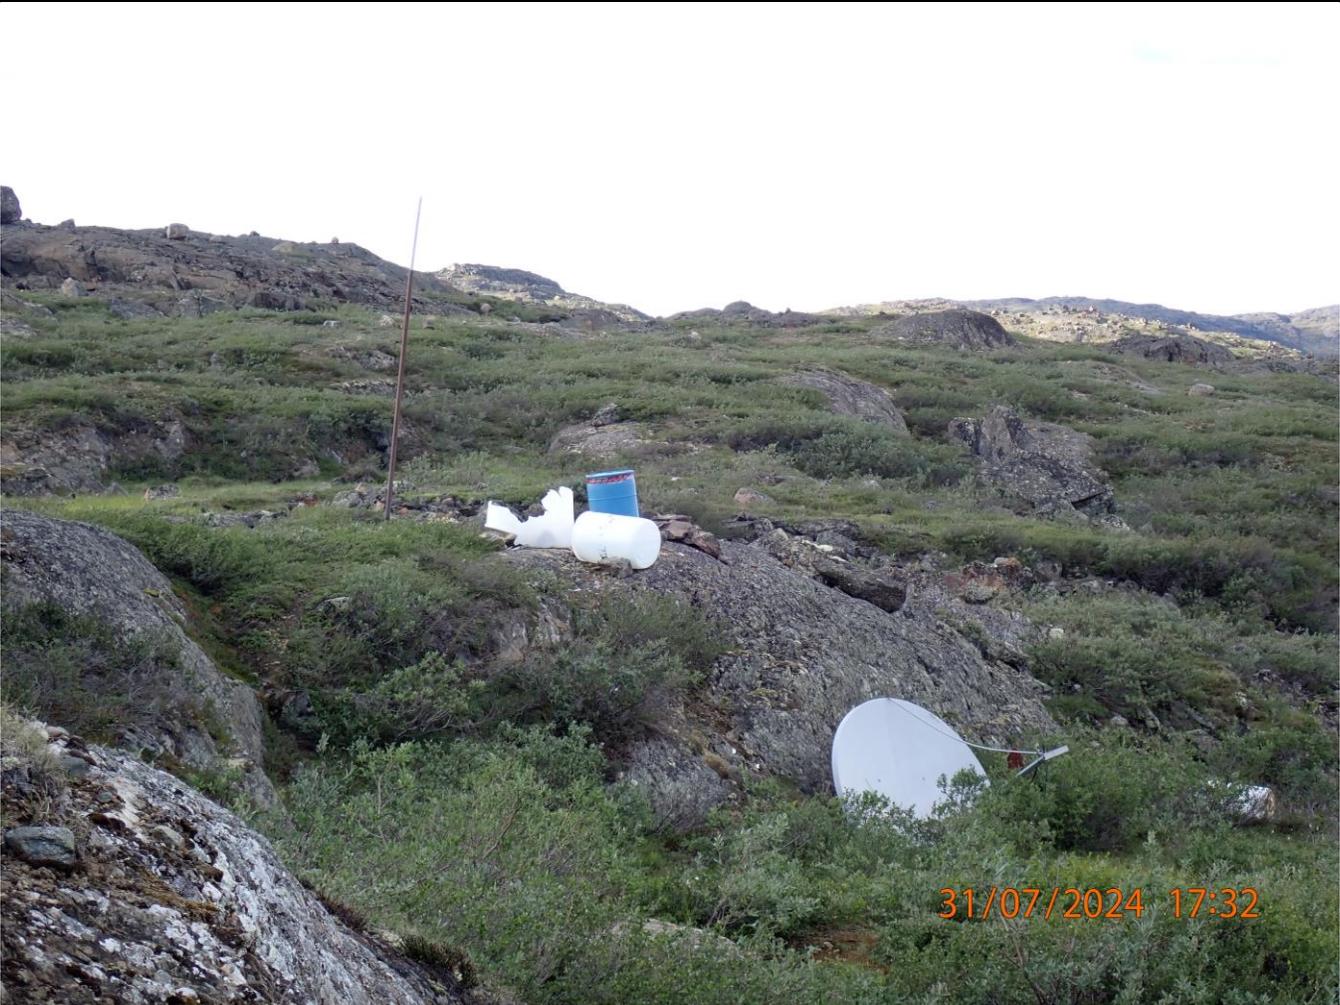
Photo 13

6. 3 52 litre plastic drums were observed on the hill beside a drill rod. 1 of the 3 drums were broken. (Photo #13) The drill rod and the drums should be removed form the hill and stored in camp for eventual removal from site.

7. A large metal satellite dish and another 52 litre plastic drum was observed just below the plastic drums and the drill rod mentioned above. (Photo #13) The dish should and drum should be brought back into camp and stored for removal from site or used in camp.

On the hill above camp. 3 drums are shown in the image and 1 broken drum, a long drill rod post and a satellite dish.

The metal dish should be stored in camp for removal from site or stored in camp for future use.

MMG commits to gathering the plastic drums and satellite dish and storing appropriately during the next care and maintenance site visit. Prior to resumption of activity at High Lake, MMG will review ECCO's publication "Solid Waste Management for Northern and Remote Communities" prior to a change in project phase to ensure High Lake waste management practices are aligned with this guidance.

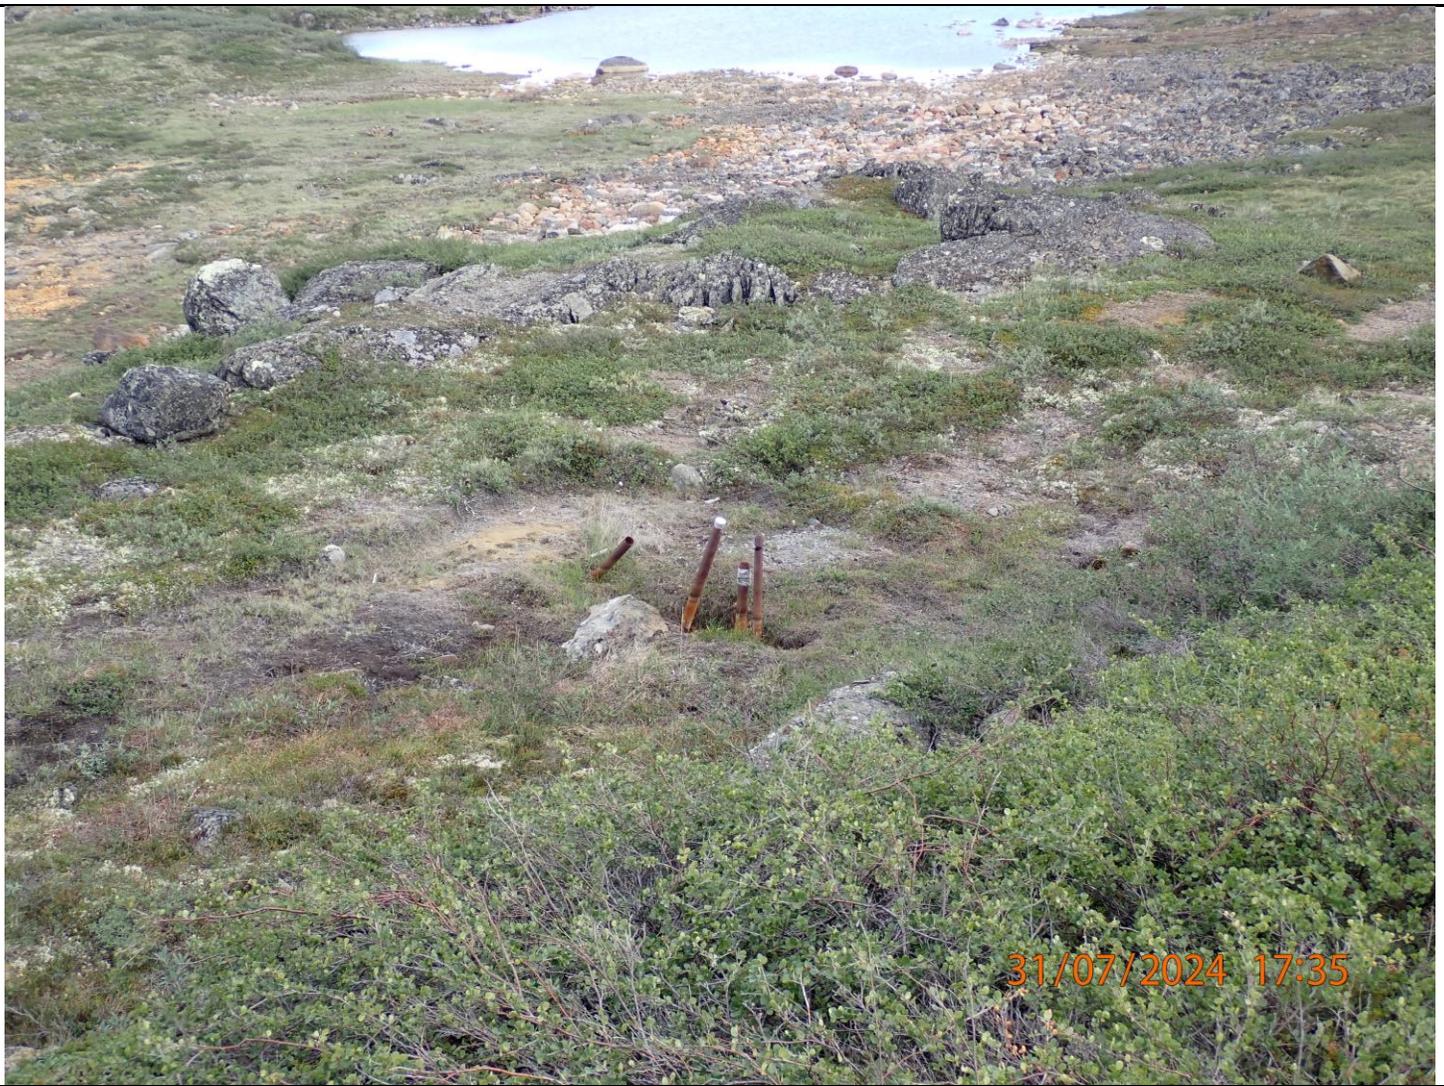
Photo 14

8. 4 drill rods were observed on the east side of camp at 67*22'39.12"N 110*50'36.58"W. All 4 drill rods were over 6 inches long and only 1 of them capped. All 4 need to be cut at grade and capped.

Part I Item 10 of the issued water license states: "The Licensee shall restore all drill holes and disturbed areas to natural conditions immediately upon completion of the drilling. The restoration of drill holes must include the removal of any drill casing materials. Where drill casing cannot be removed the Licensee shall cut off the casing at ground level and identify with signage."

Drill rods at 67°22'39.12"N 110°50'36.58"W

31(1)(d) item 23 of the issued permit states: “The Permittee shall restore all drill holes and disturbed areas to natural conditions immediately upon completion of the activity. Reclamation of drill holes must include the removal of drill casing or cutting at grade and capping of the hole.”

All drill rods shall be cut to grade, capped and scrap metal rod removed from site.

MMG commits to the closure and restoration of all drill holes and disturbed areas upon final closure of exploration tenements at the High Lake Project. At that time, drill casings will be cut at or below ground level and covered with soil. At present, High Lake camp is in a period of extended care and maintenance, with only annual site inspections and necessary site maintenance activities being conducted.

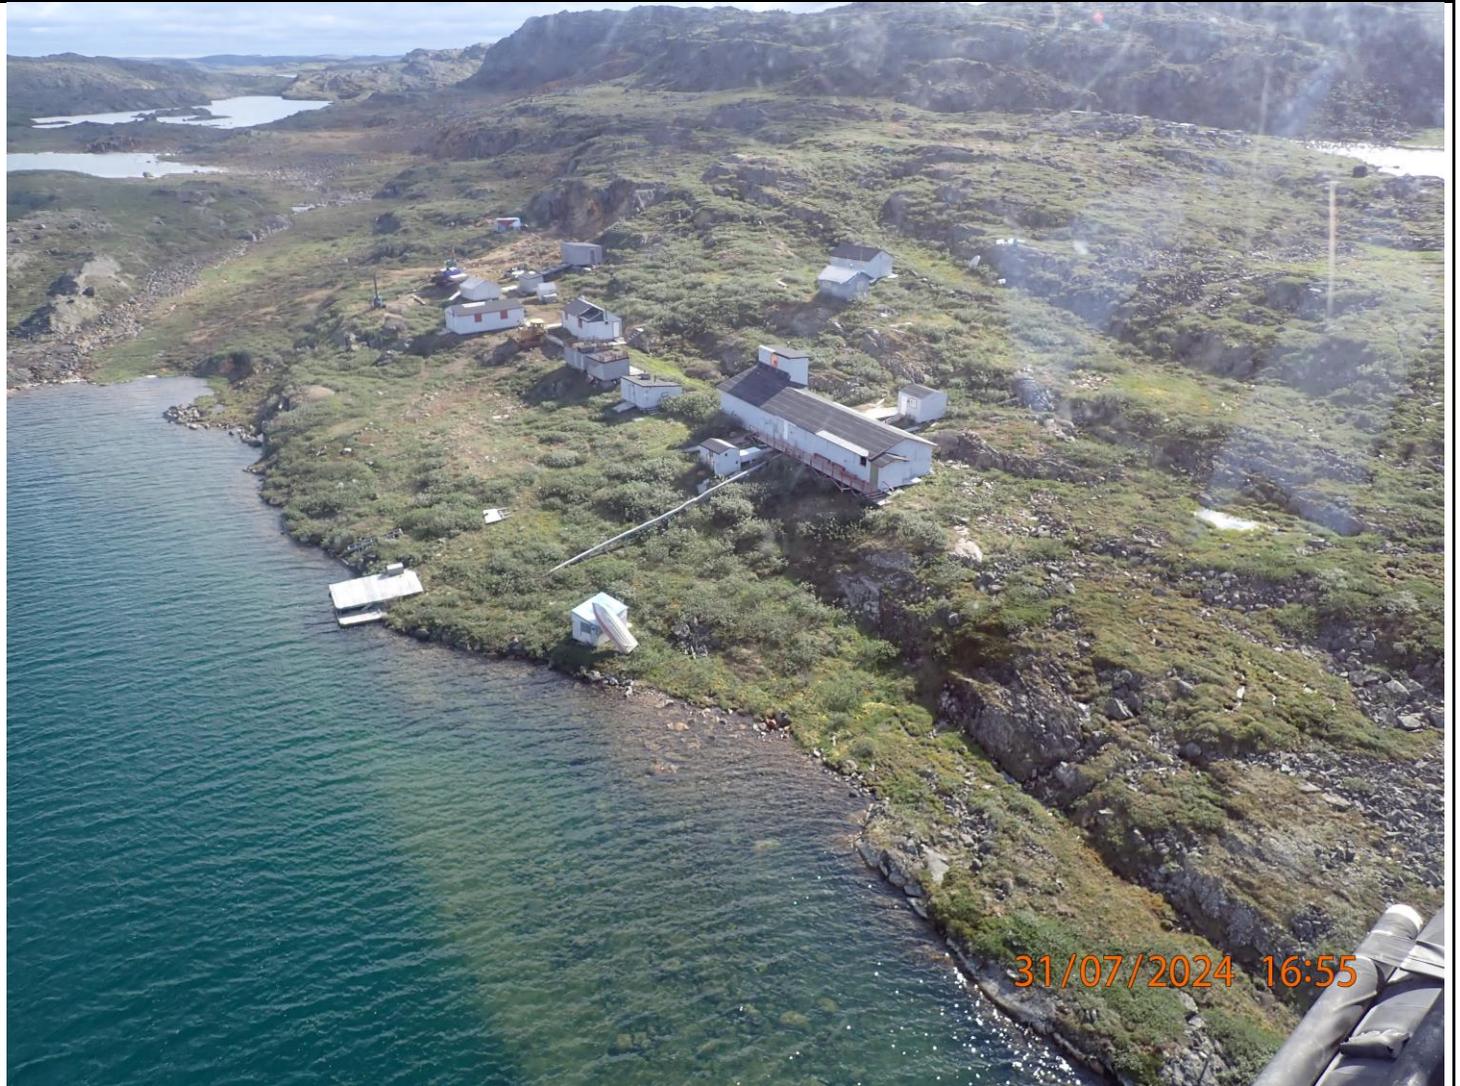
Photo 1

- Inspectors arrive at 5:00pm, Aerial photos of the Site were taken (Photo#1and #2)
- A pile of scrap metal was observed beside a drill shack (Photo #3)

High Lake camp Aerial Looking south.
