Attachment 12 – Inspections and Responses

WATER LICENCE INSPECTION FORM

CROWN LAND USE INSPECTION FORM

Reference: High Lake Camp Inspection

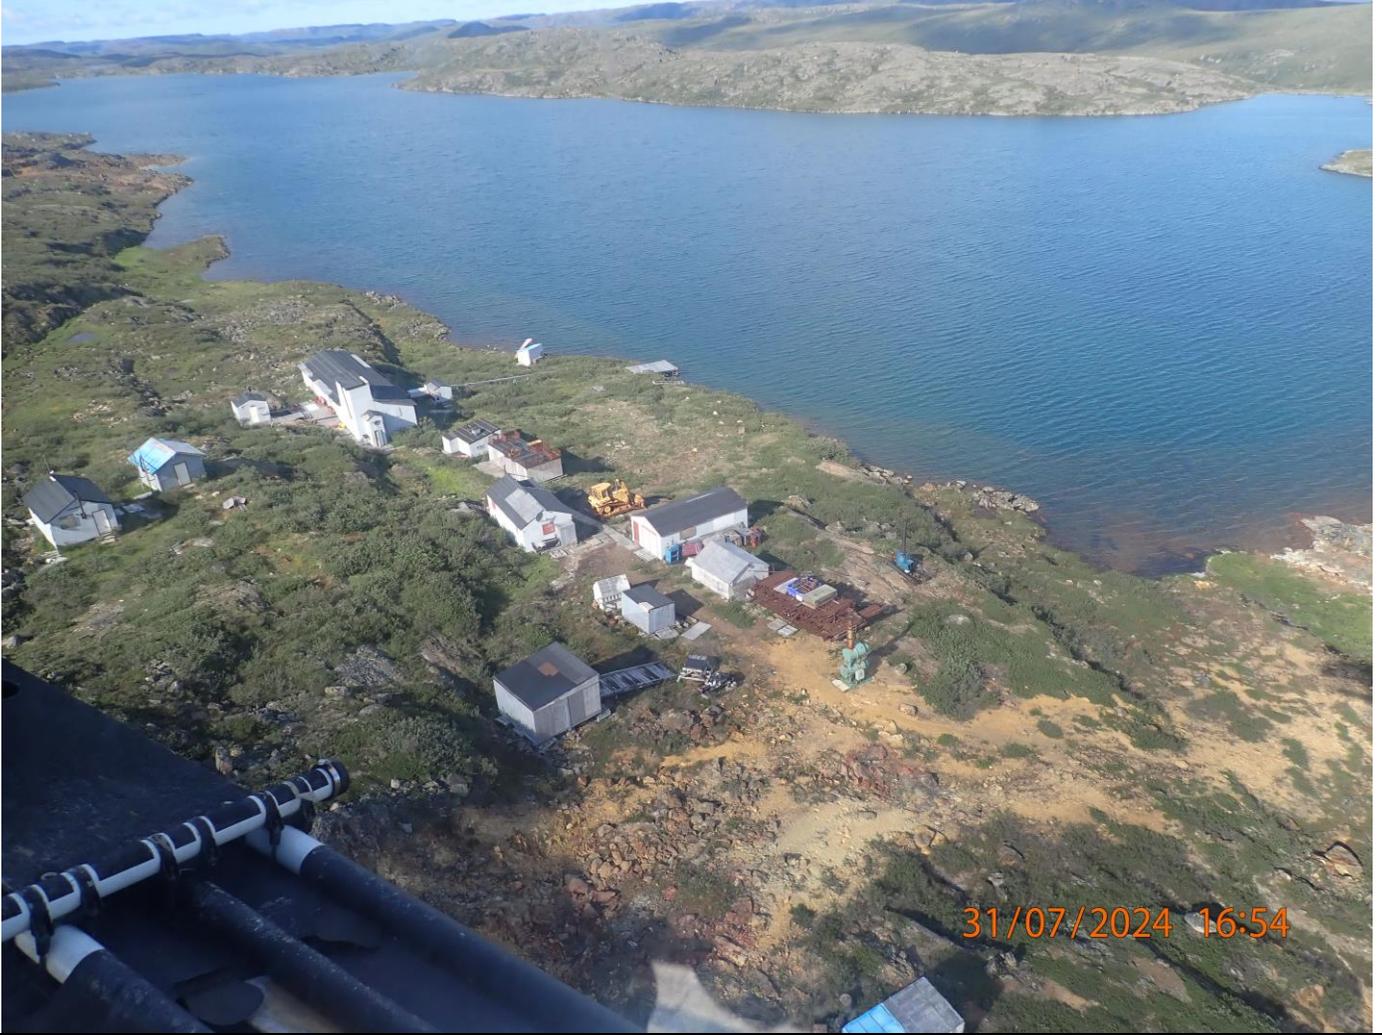
Photo 2

- Inspectors arrive at 5:00pm, Aerial photos of the Site were taken (Photo#1and #2)
- A pile of scrap metal was observed beside a drill shack (Photo #3)

High Lake Looking North

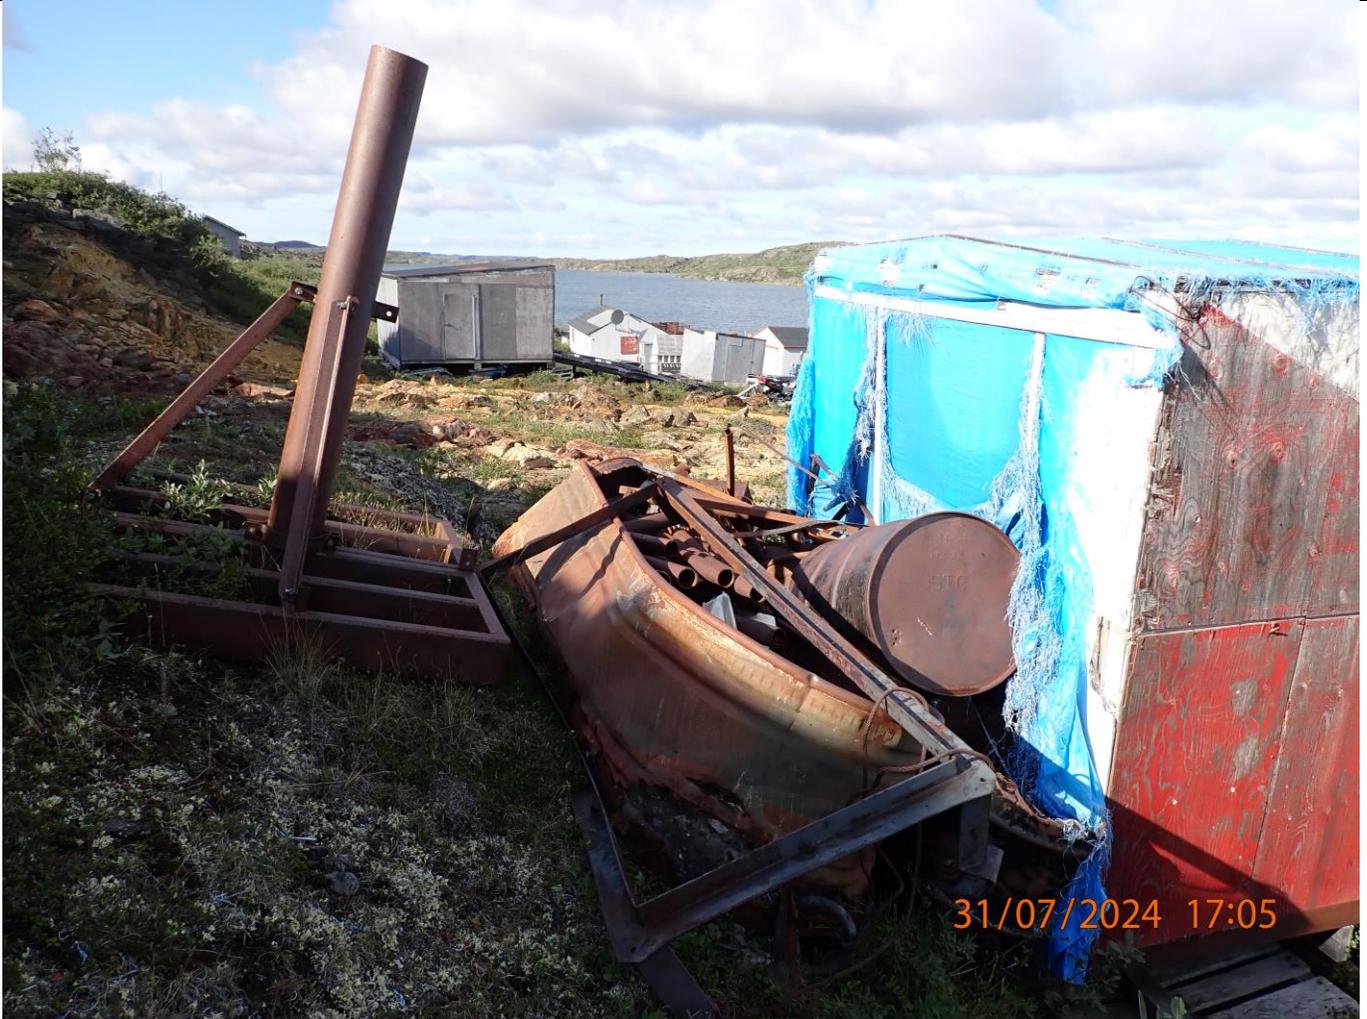
Photo 3

Scrap metal and parts

All scrap metal shall be removed form site including any garbage, discarded barrels or debris. All fuel must be stored in secondary containment. All building doors, windows and walls must be repaired and closed to prevent access from wildlife. All drill rods shall be cut to grade, capped and scrap metal rod removed from site. The metal dish should be stored in camp for removal from site or stored in camp for future use. A detailed plan and timeline to achieve the actions required shall be submitted to me at james.bolt@rcaanc-cirnac.gc.ca by December 20 2024. Actions required should be planned for completion prior to July 31 2025.

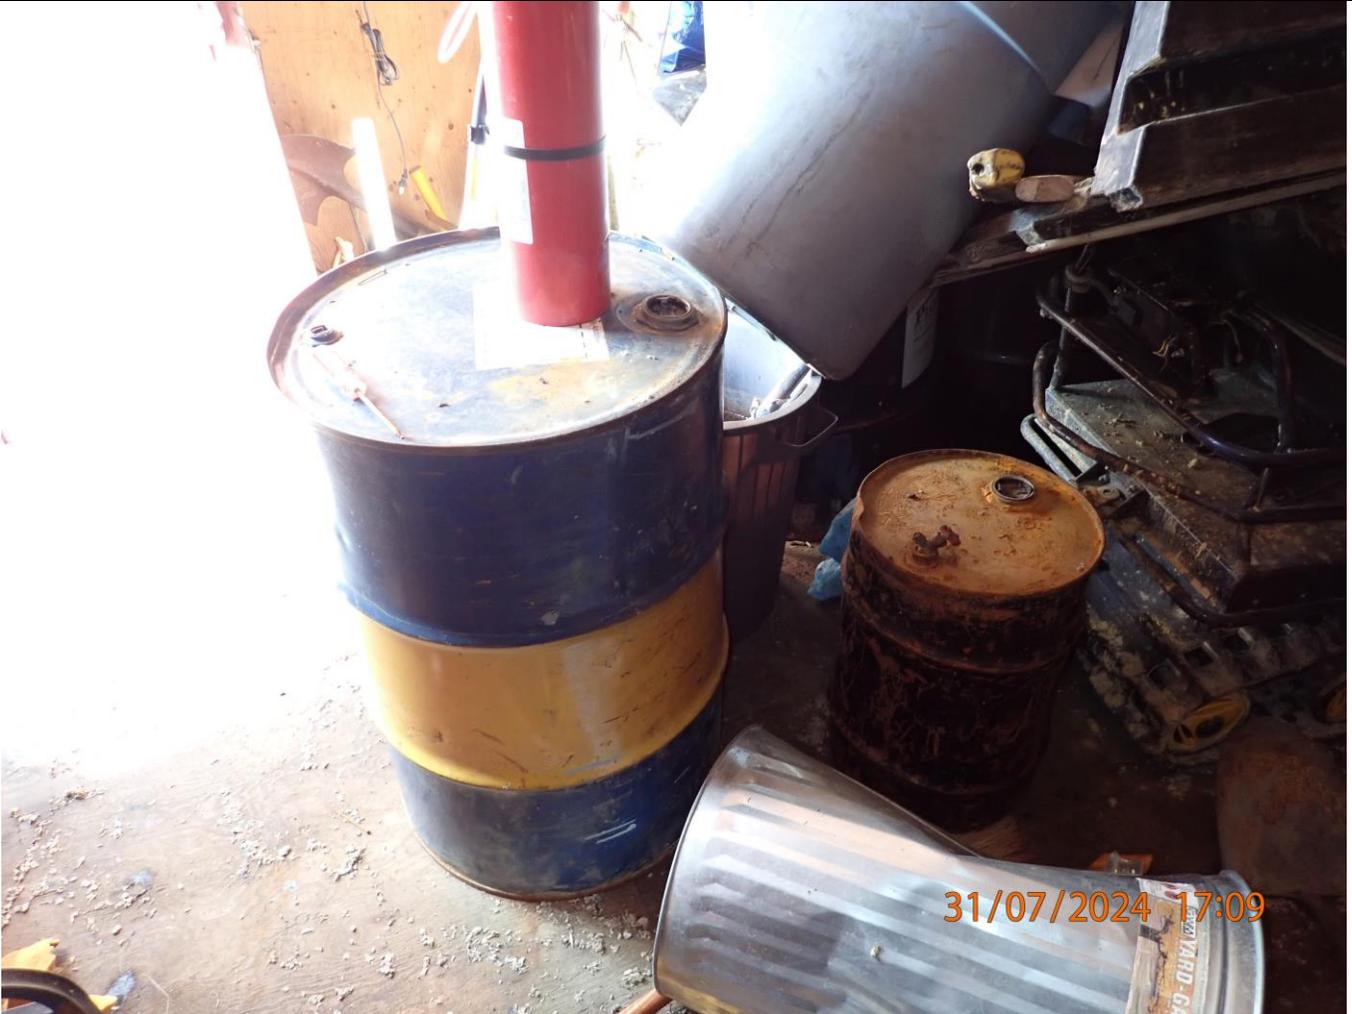
Photo 4

- 3 drums of fuel inside the mechanic shop were observed out of secondary containment (Photo #4 and #5)
- A door of the main building was observed open and bear disturbance and poop inside the building was observed. The bear may have entered or exited through the window near the kitchen as the ply wood covering the window was observed on the ground. (Photo #6, #7, #8, #9, #10)

2 fuel containers out of secondary containment inside the mechanic shop.

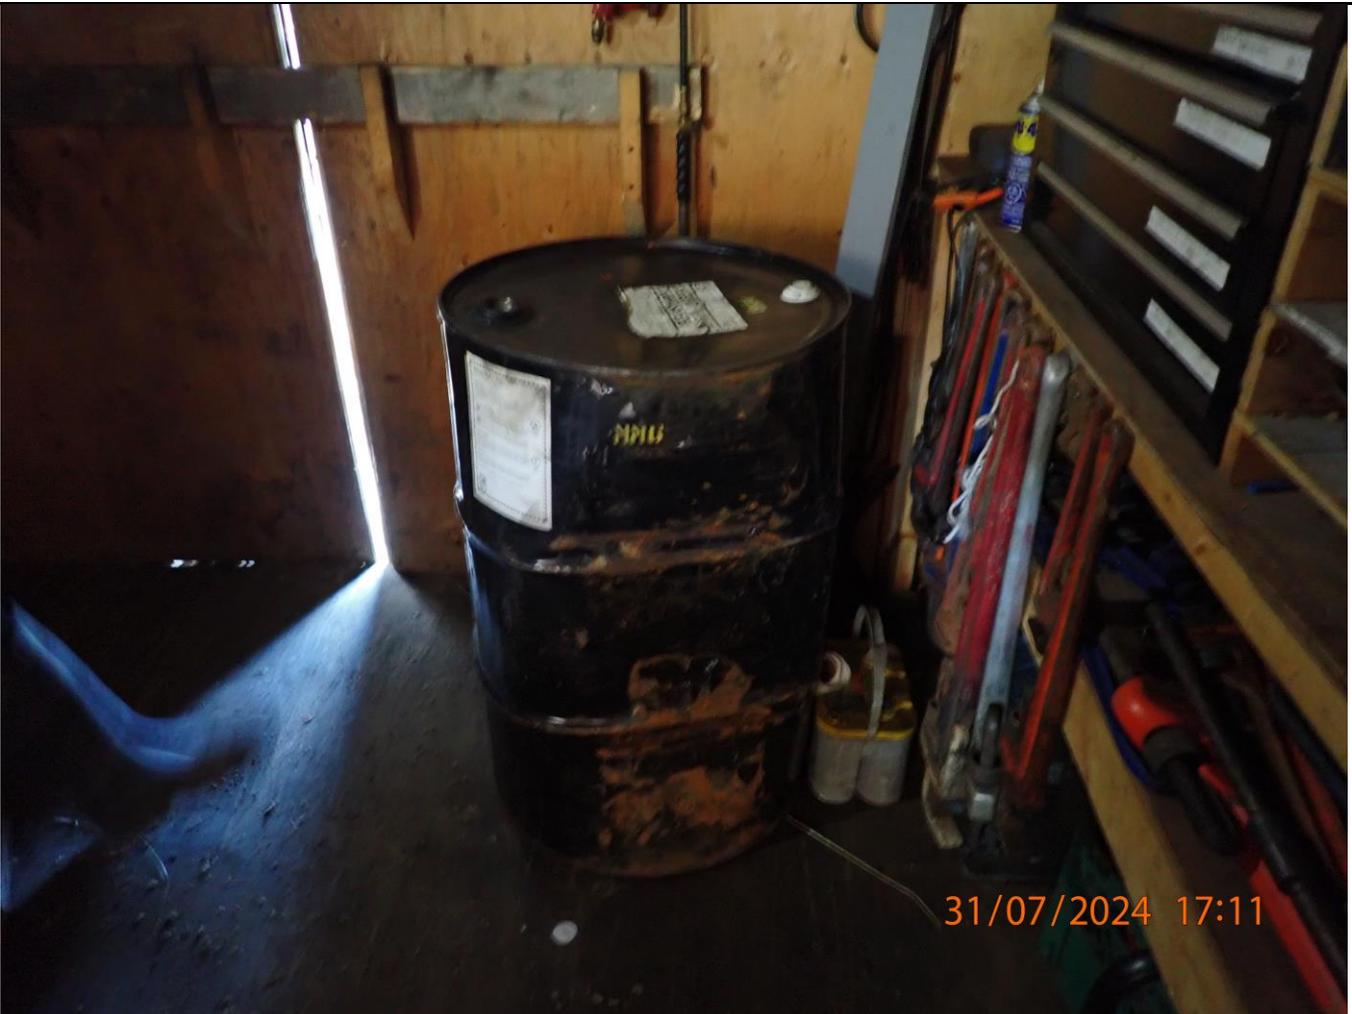
Photo 5

1 fuel drum outside of containment inside the mechanic shop

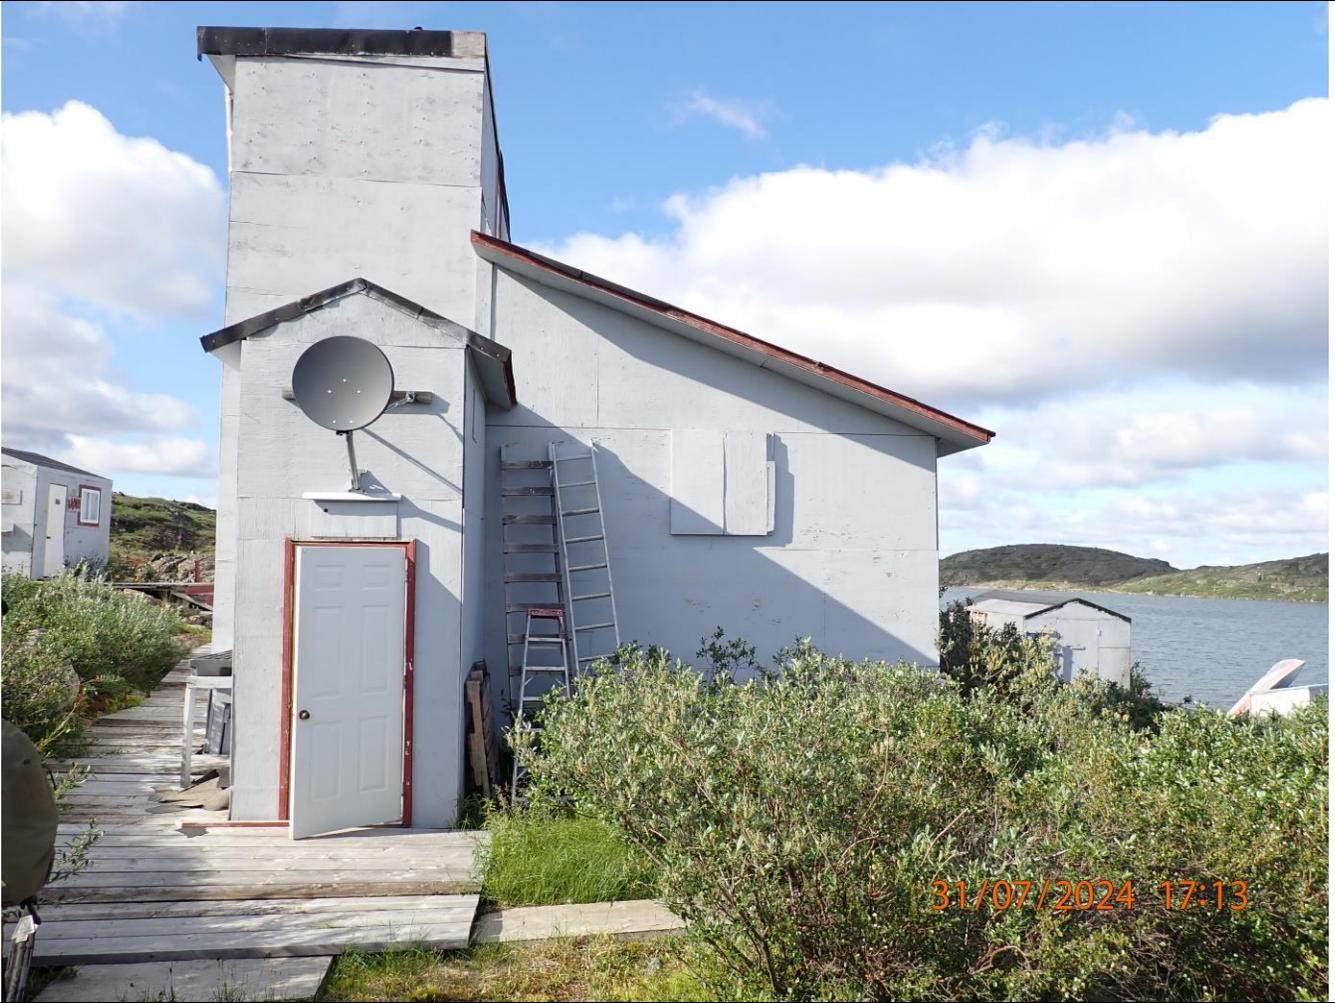
Photo 6

Main building with door open.

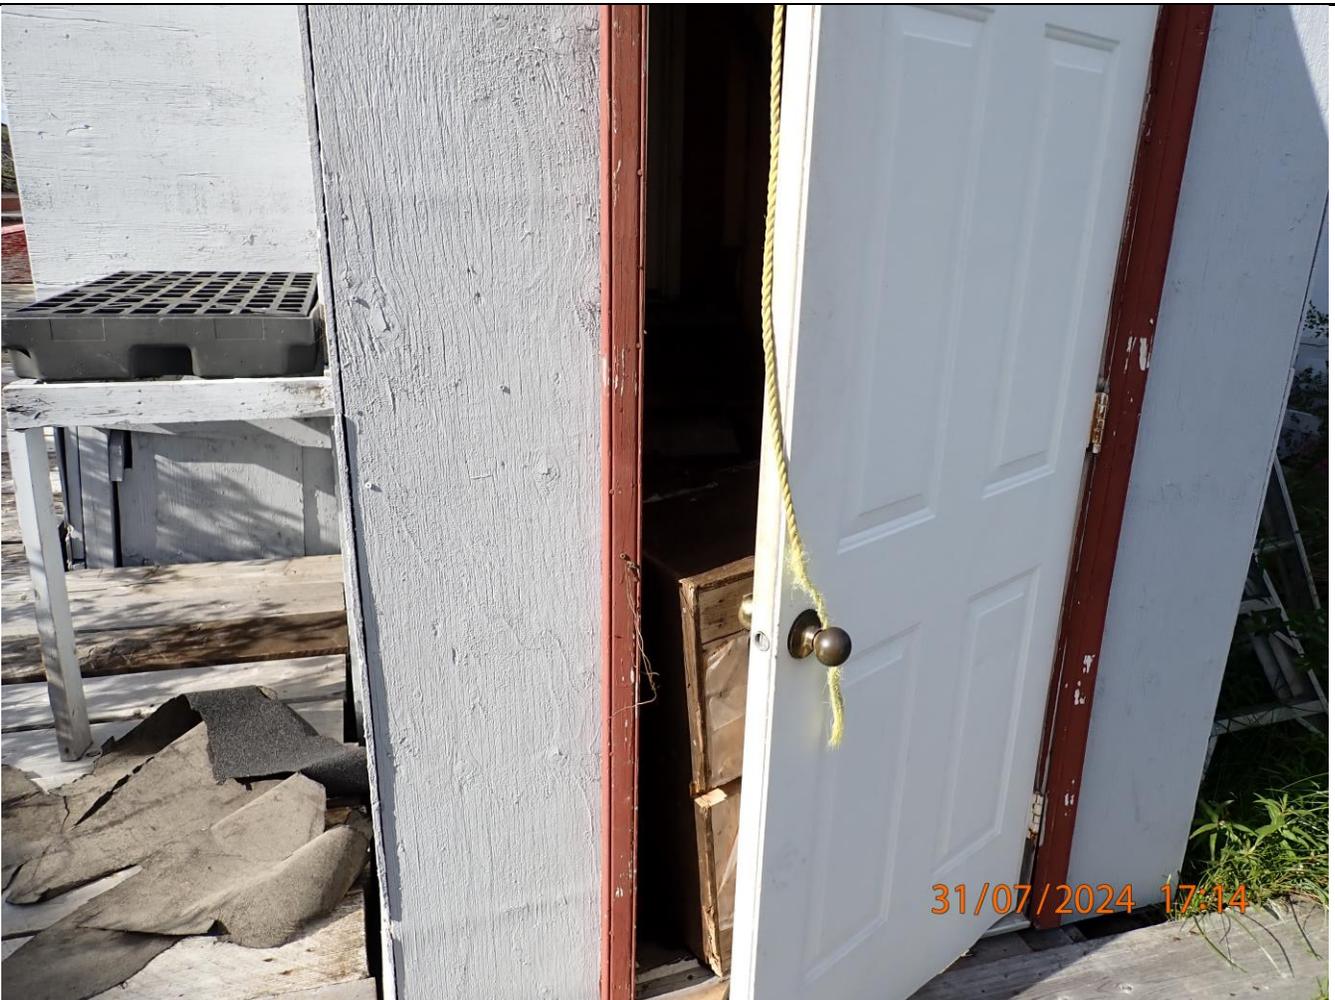
Photo 7

Roofing material outside main building, image shows box in door way. Bear sign is apparent in the building.

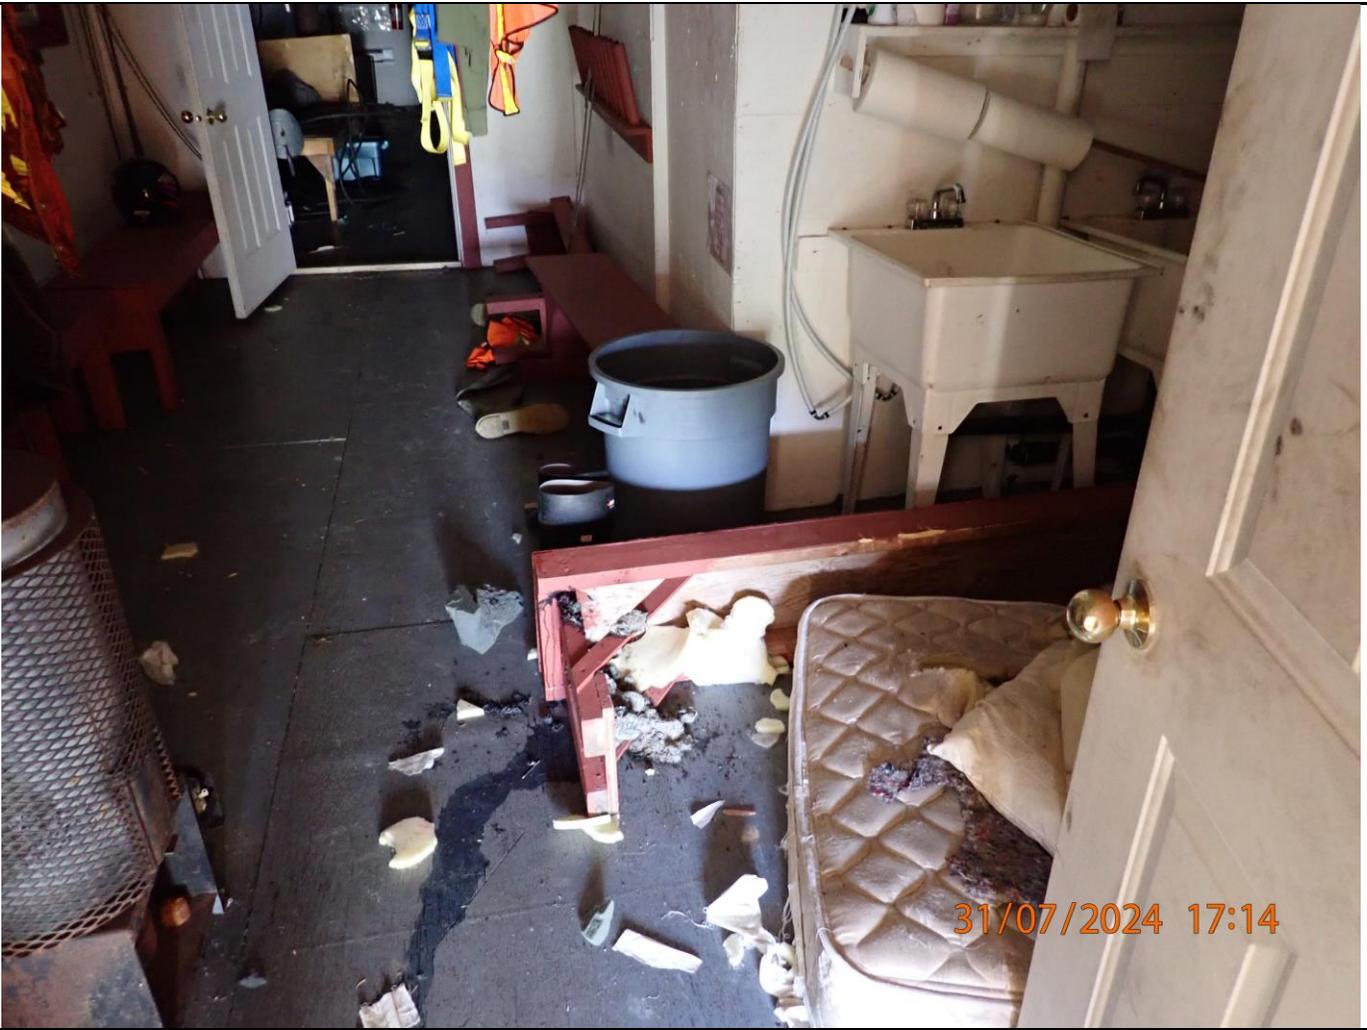
Photo 8

Inside the main building entrance, bear scat is observed on the bench and floor.

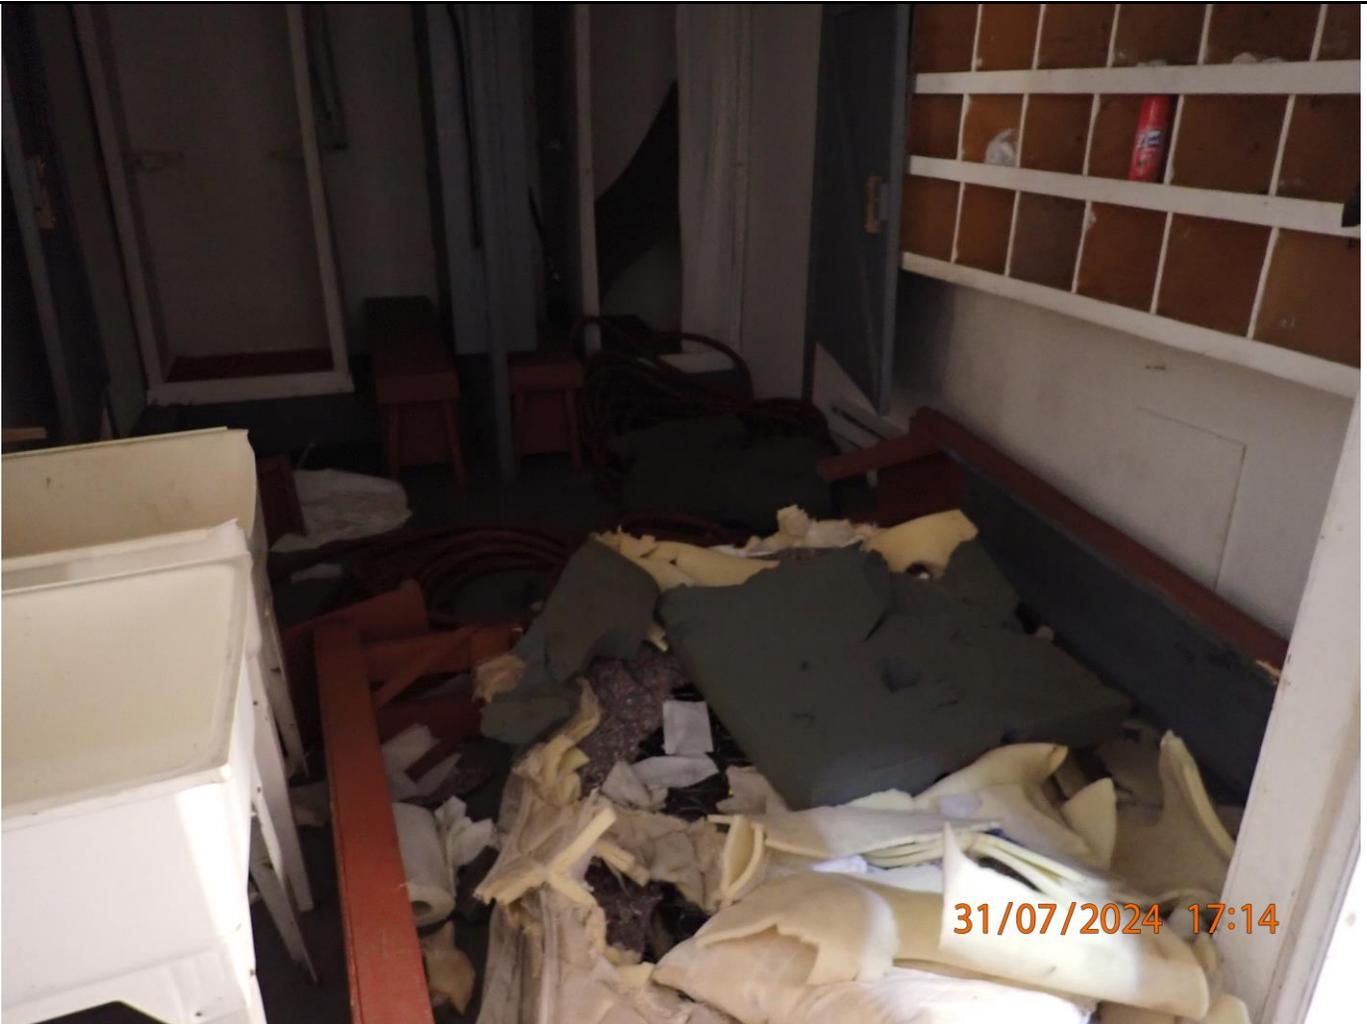
Photo 9

Inside the main building entrance, mess caused by a bear

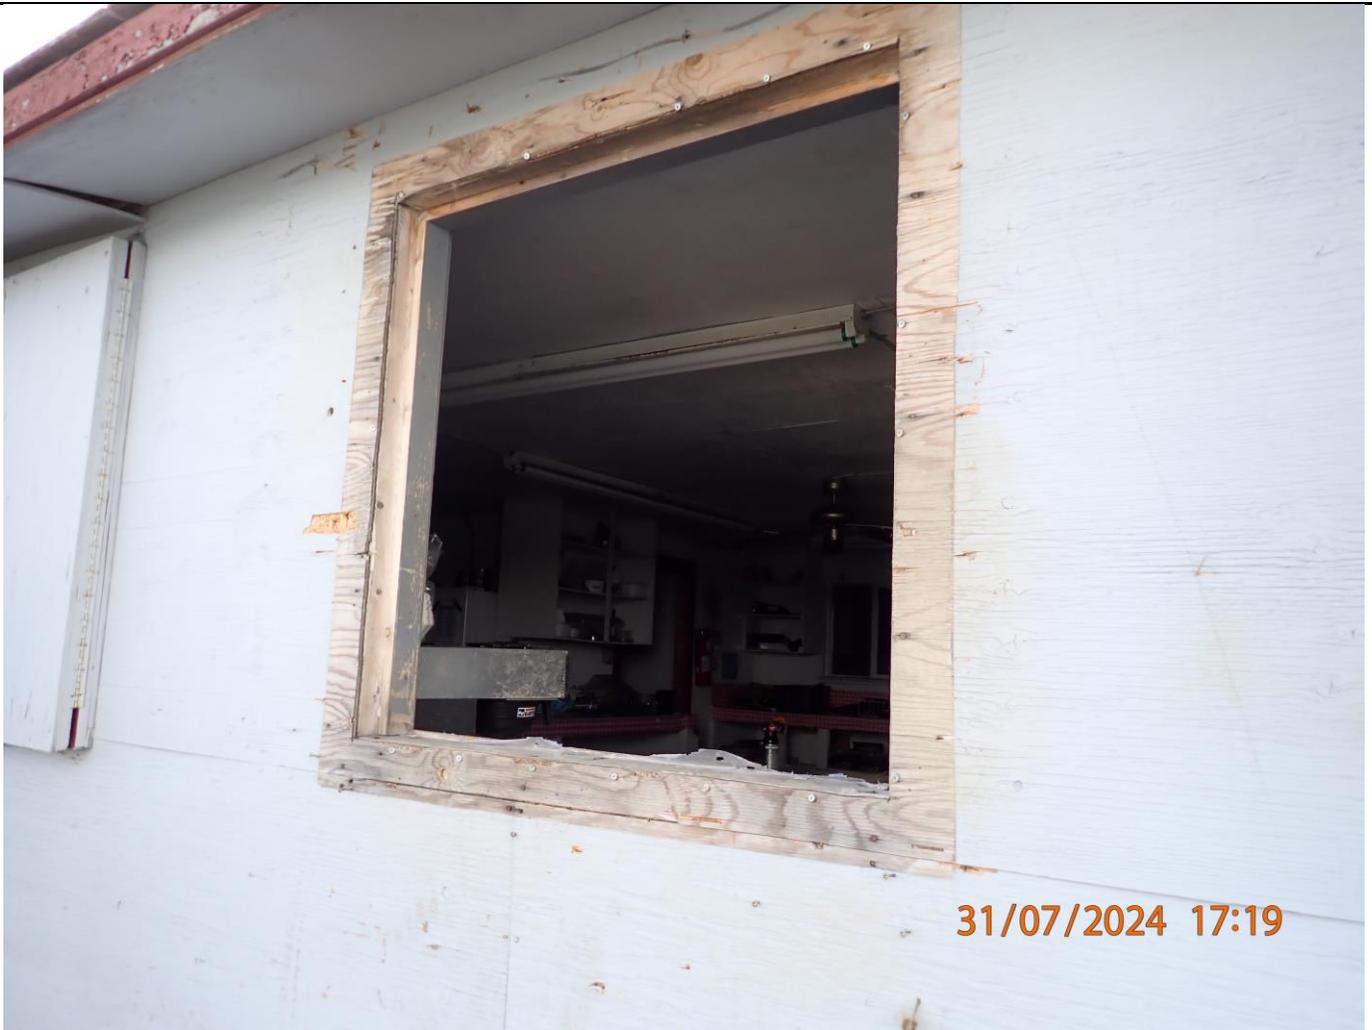
Photo 10

Main building kitchen window open, the plywood was observed on the ground.

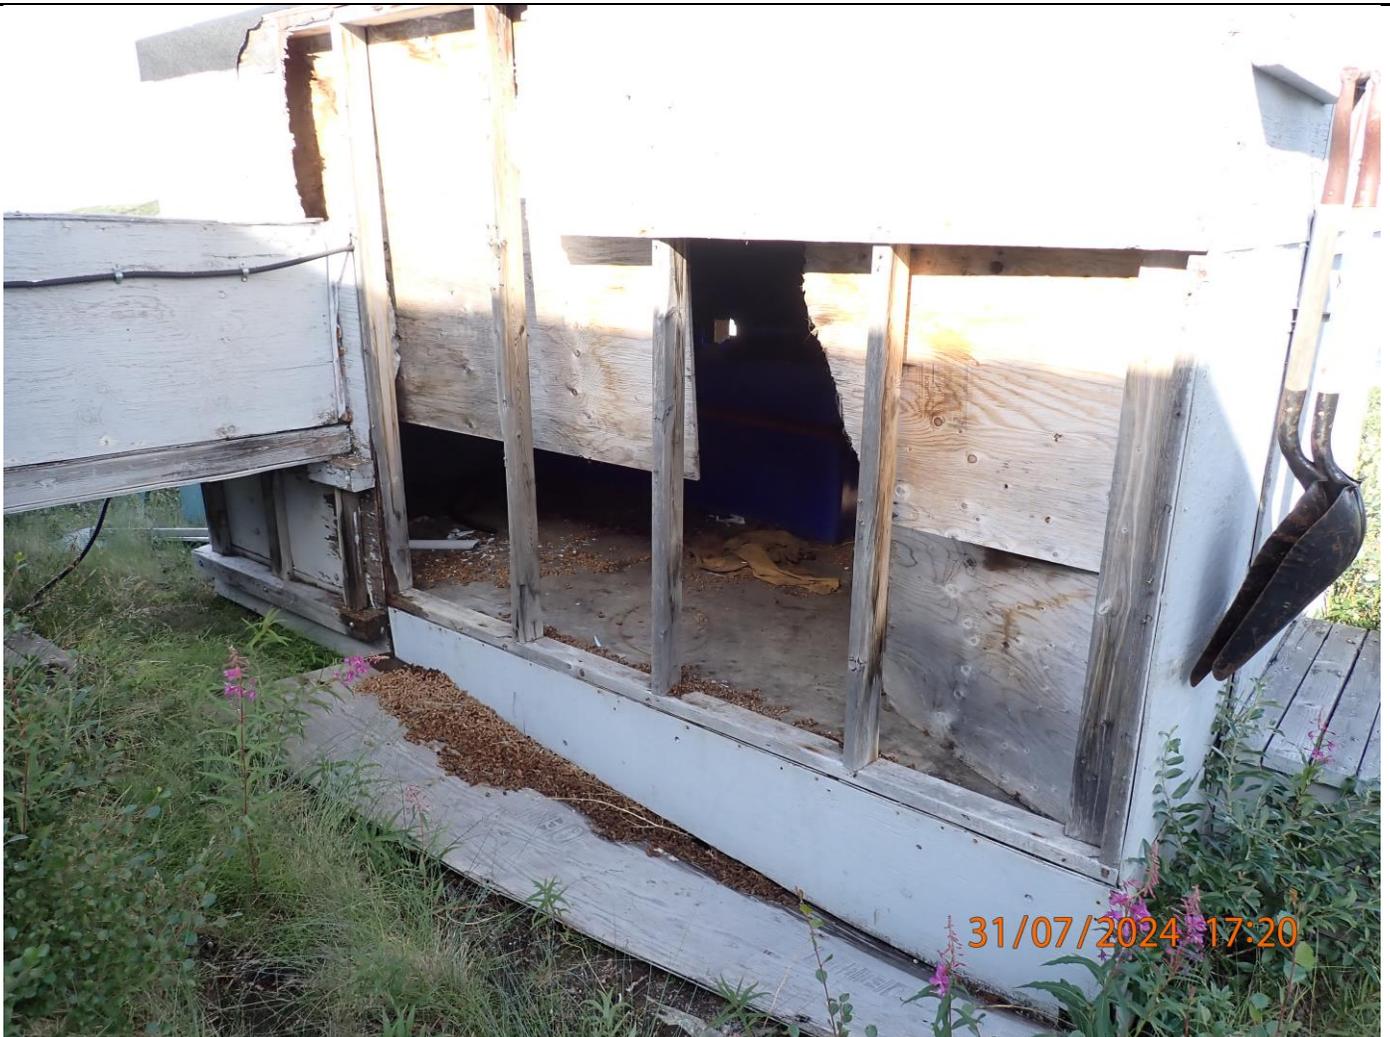
Photo 11

- A small shack that is connected to the main dry/kitchen building was observed to have broken plywood siding and an open window. A lot of Ptarmigan poop inside the shack and on the side of the shack show that wildlife is using the building for shelter. This small shack may be the generator shack. (Photo #11 and #12)

Small shack beside main building shown with an open side wall and ptarmigan droppings inside.

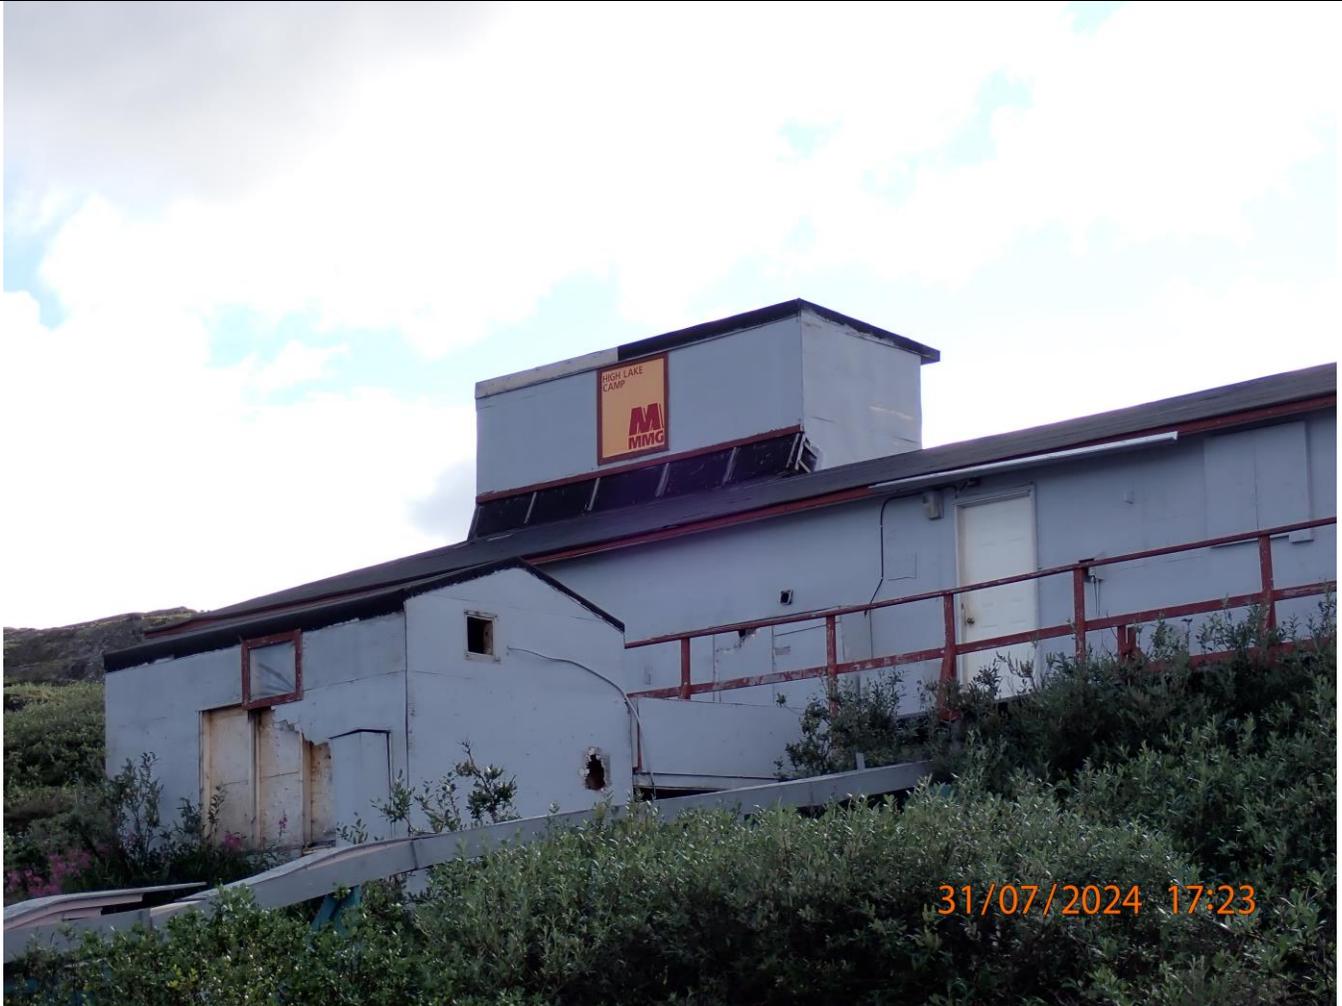
Photo 12

Another view of the shack beside the main building, Plywood from the wall is missing, an open window and a hole in the back wall is shown.

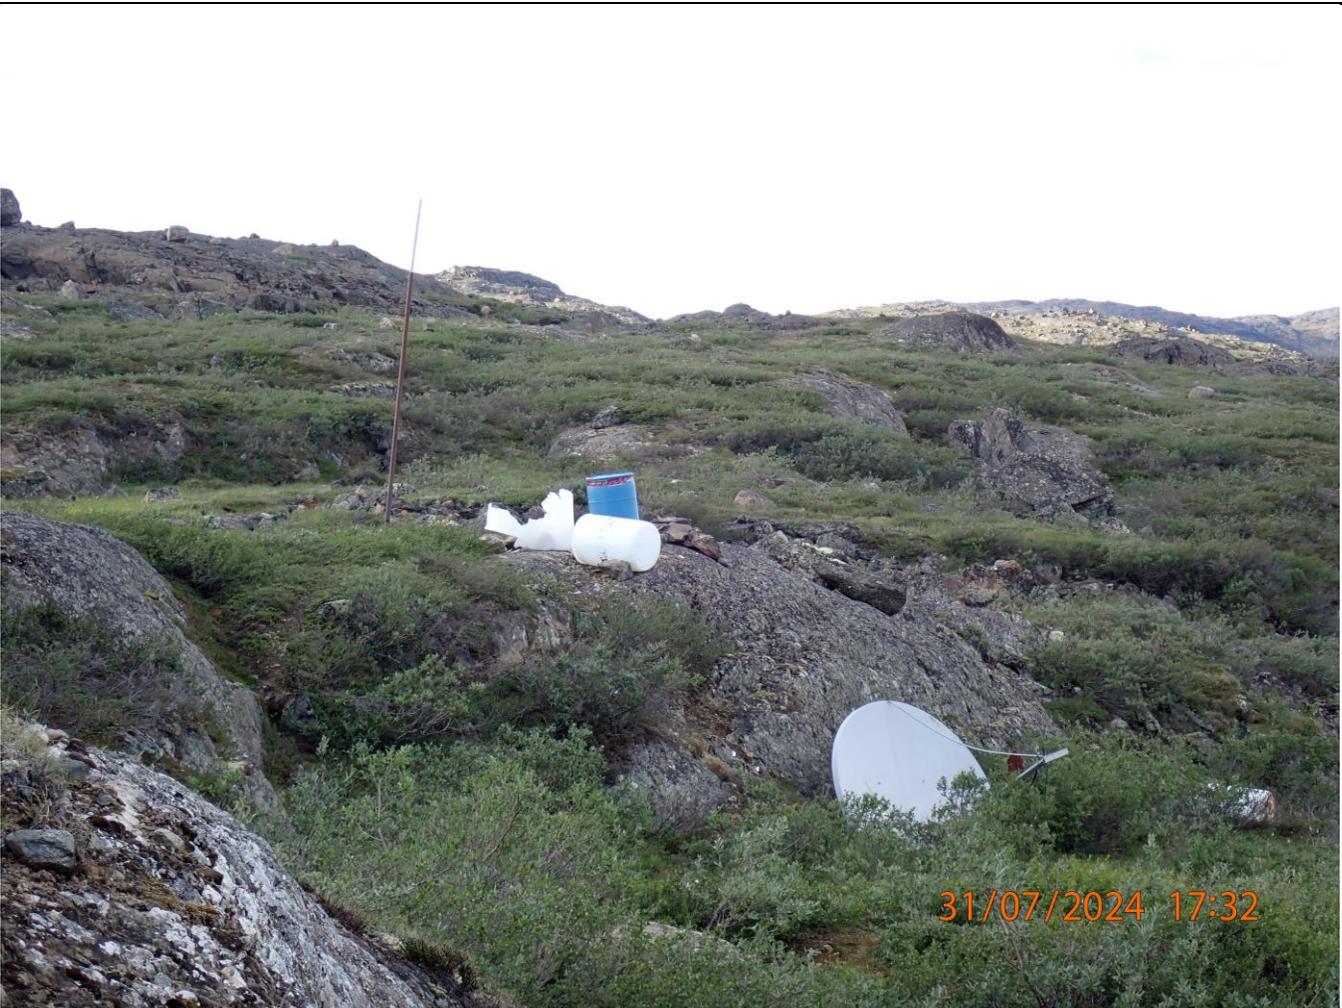
Photo 13

- 3 52 litre plastic drums were observed on the hill beside a drill rod. 1 of the 3 drums were broken. (Photo #13) The drill rod and the drums should be removed form the hill and stored in camp for eventual removal from site.

- A large metal satellite dish and another 52 litre plastic drum was observed just below the plastic drums and the drill rod mentioned above. (Photo #13) The dish should and drum should be brought back into camp and stored for removal from site or used in camp.

On the hill above camp. 3 drums are shown in the image and 1 broken drum, a long drill rod post and a satellite dish.

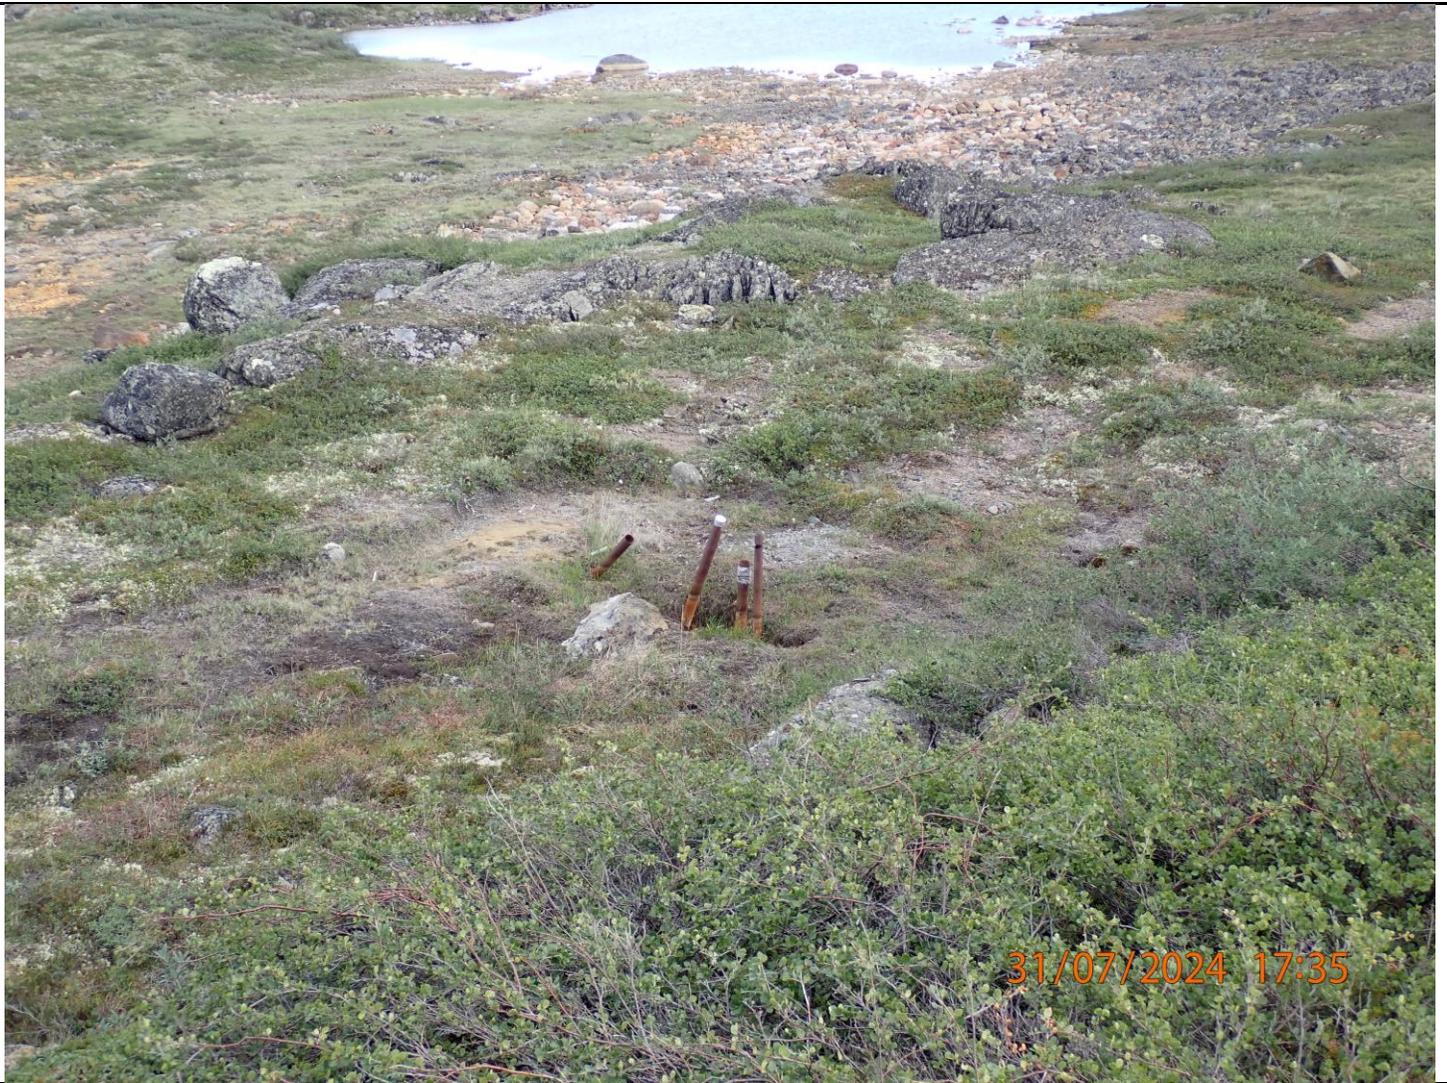
Photo 14

- 4 drill rods were observed on the east side of camp at 67*22'39.12"N 110*50'36.58"W. All 4 drill rods were over 6 inches long and only 1 of them capped. All 4 need to be cut at grade and capped.

Drill rods at 67°22'39.12"N 110°50'36.58"W
