WATER LICENCE INSPECTION FORM

Licensee		Licensee Representative	
MMG Resources Inc.		Theodore Muraro	
Licence No. / Expiry		Representative's Title	
2BE-HIG1722 (was 2BE-HIG1217)			
Land / Other Authorizations		Land / Other Authorizations	
76M/7-1-10 (31-12-2017)		N2011C0033	
Date of Inspection		Inspector	
20-08-2017		Eva Paul	
Activities Inspected			
<input checked="" type="checkbox"/> Camp <input type="checkbox"/> Drilling <input type="checkbox"/> Mining <input type="checkbox"/> Construction <input checked="" type="checkbox"/> Reclamation <input checked="" type="checkbox"/> Fuel Storage			
<input type="checkbox"/> Roads/Hauling <input type="checkbox"/> Other: <input type="checkbox"/> Other:

Photos of August 20 2017 Inspection

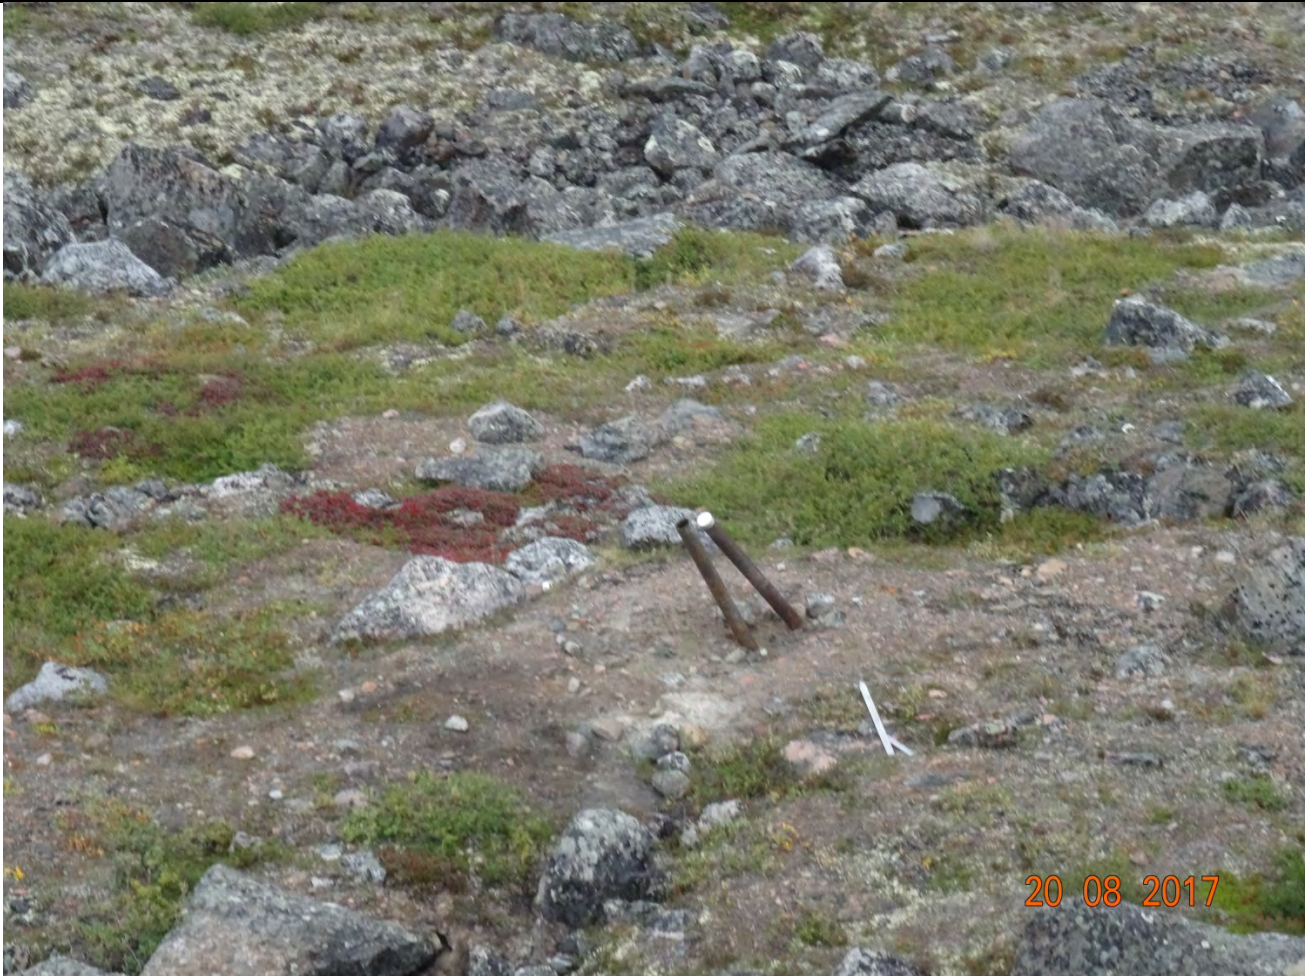
Date	Camera	Inspector	Authorization
August 20, 2017	SONY DSC-HX50V	Eva Paul	N2011C0033
Photo Log # 1		Location (NAD 83 DD MM SS.SS)	
Photo DSC08036		N	W

<table><tr><td>1</td><td>HLE-10-001</td><td>N67 06 10.4 W110 04 56.9</td><td>Nothing found</td></tr><tr><td>2</td><td>HLE-10-005</td><td>N67 06 51.7 W110 04 51.8</td><td>collars/casing</td></tr></table>

Description: HLE-10-005

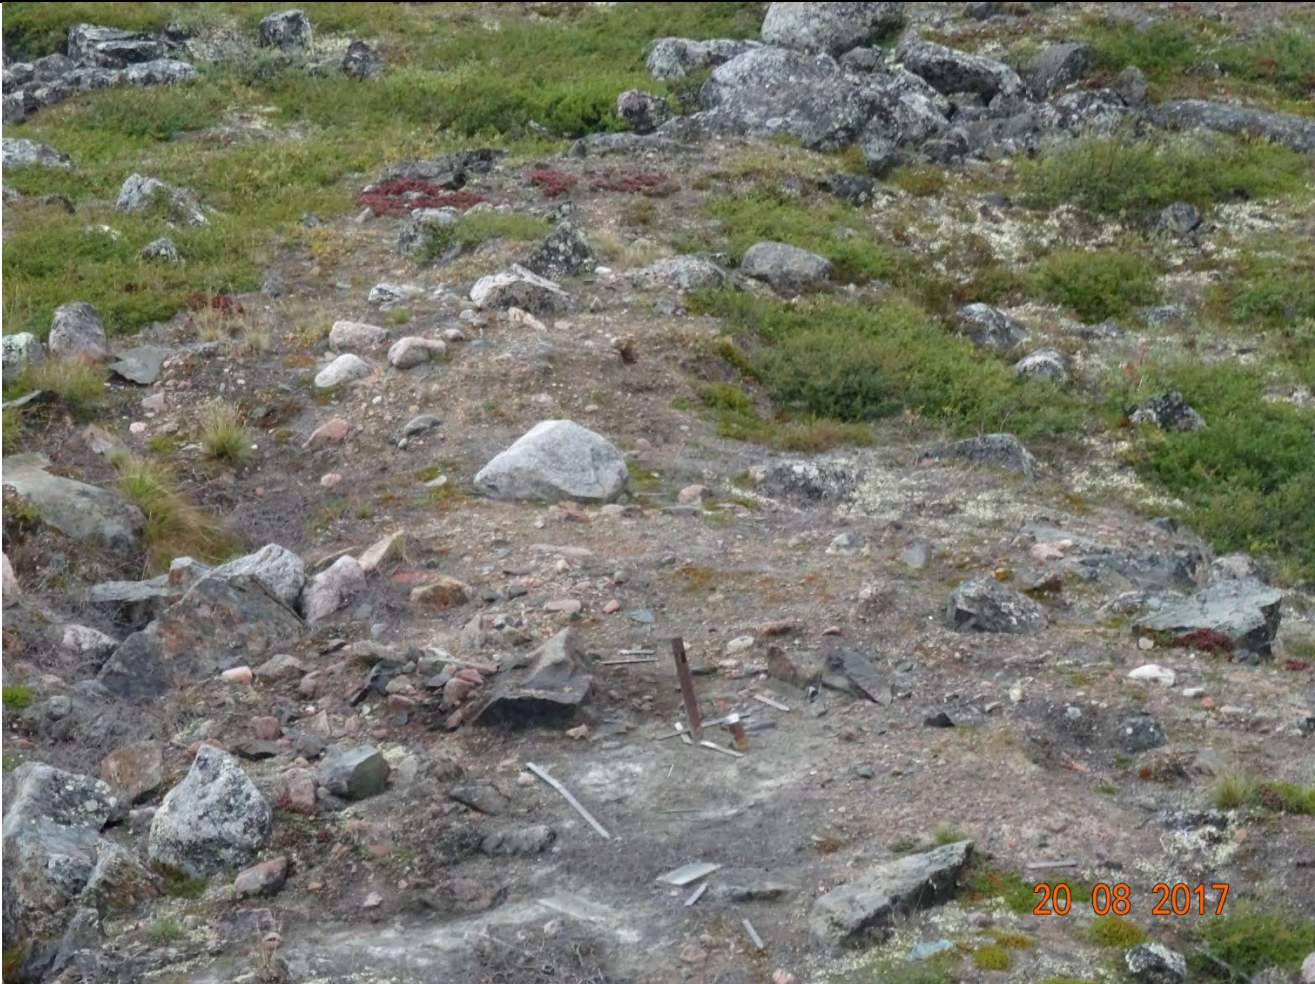
Photo Log # 2	Location (NAD 83 DD MM SS.SS)	
Photo DSC08037	N	W

Description: Other drill holes in proximity to HLE-10-005 (could be HLE-10-008?) All will require the same treatment.

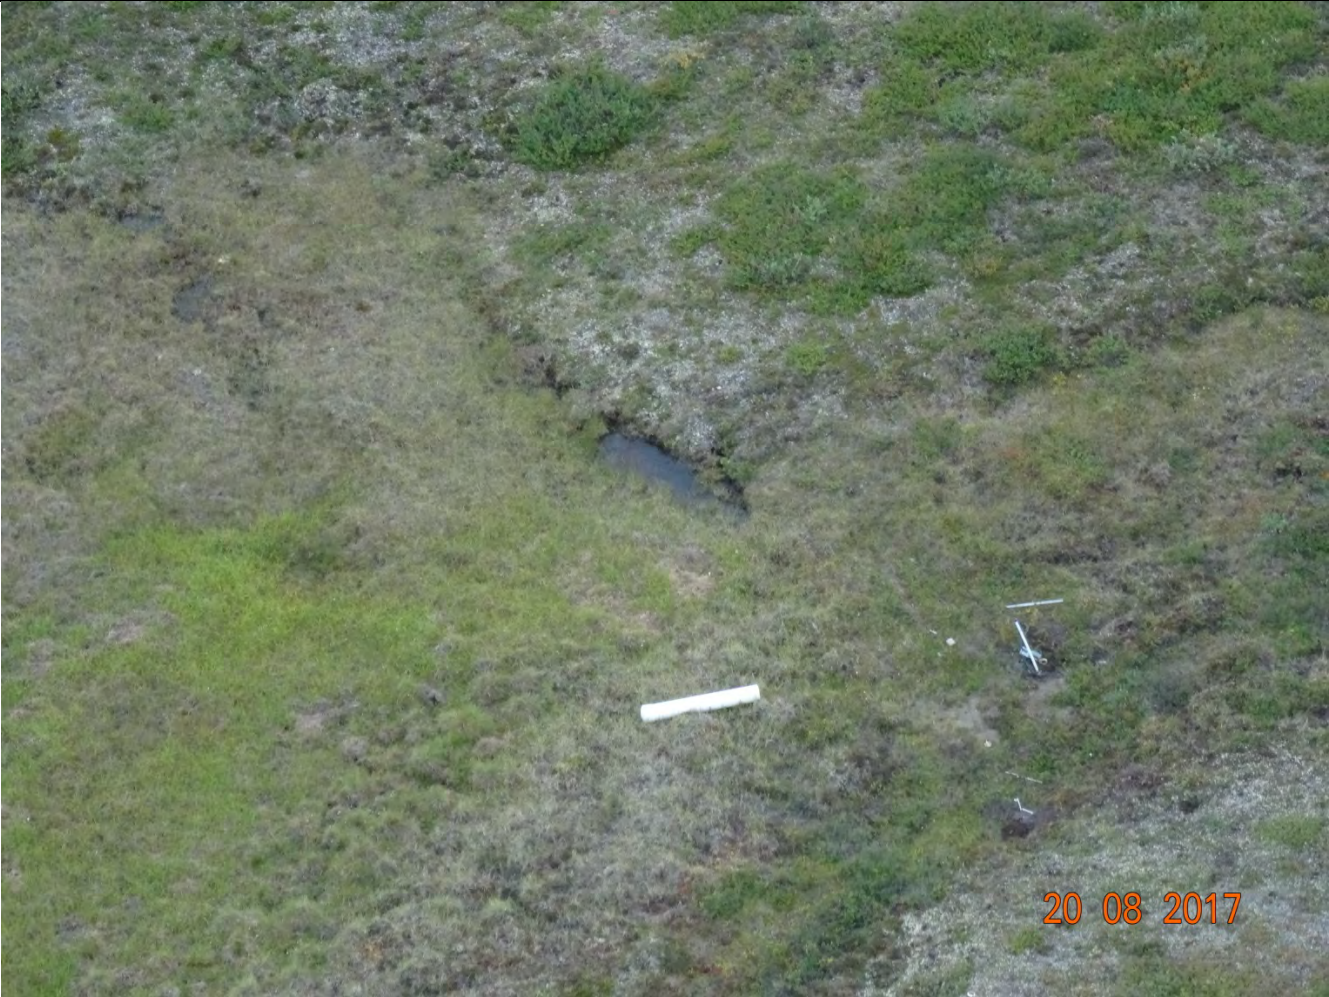
Photo Log # 3

<table><tr><td>1</td><td>HLE-10-001</td><td>N67 06 10.4 W110 04 56.9</td><td>Nothing found</td></tr><tr><td>4</td><td>BGC12-113</td><td>N67 28 35.6 W110 49 06.1</td><td>garbage/debris</td></tr></table>

Description: BGC-12-113

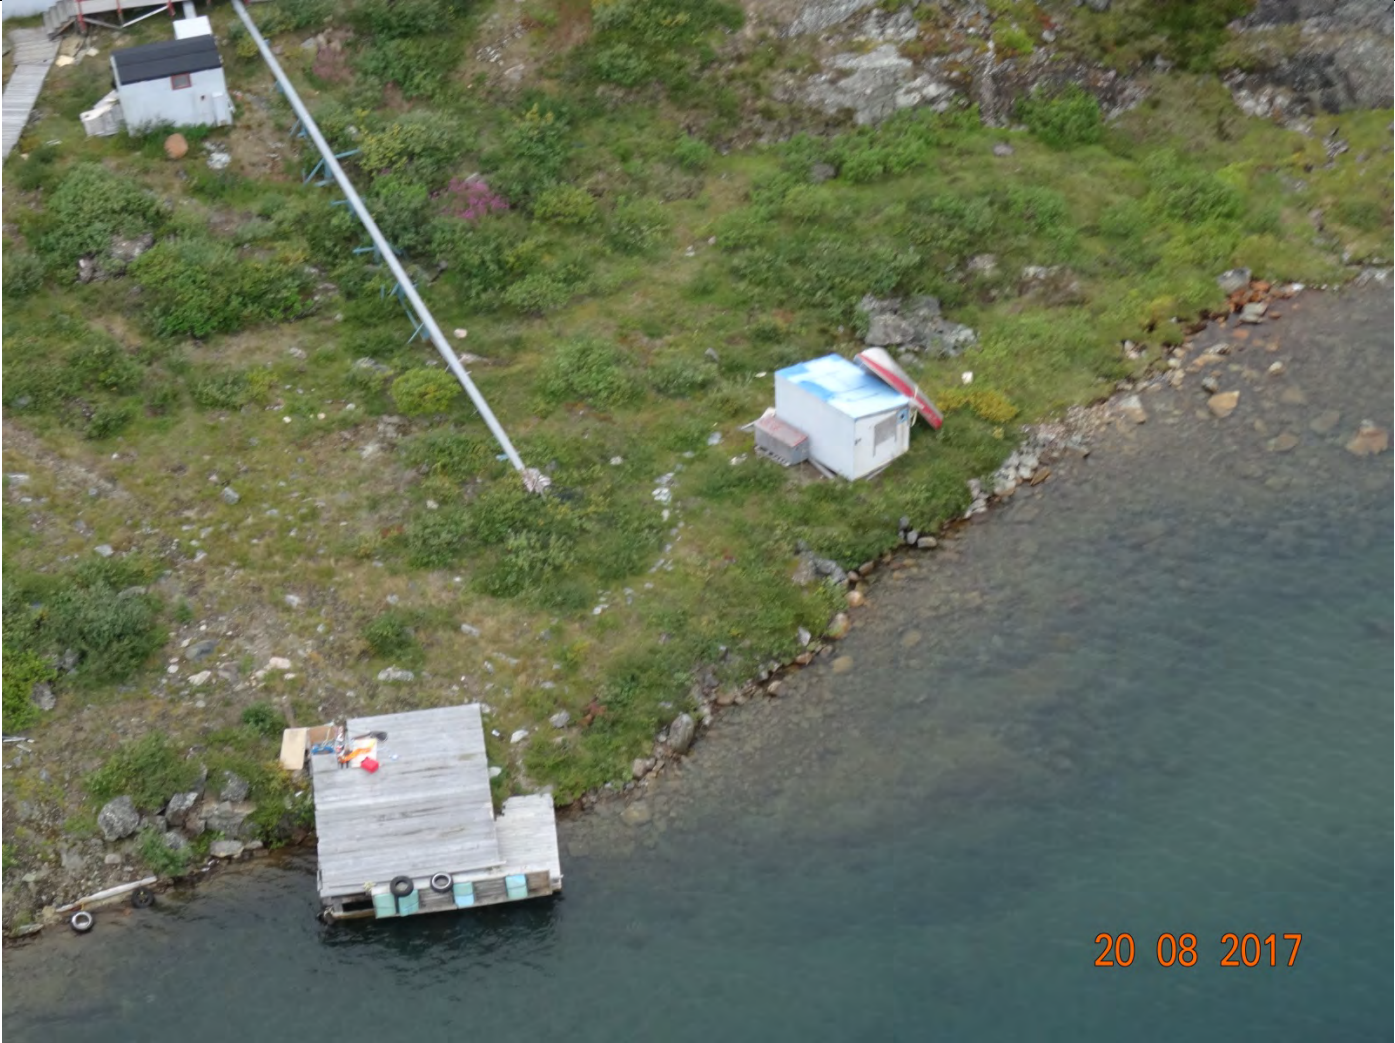
Photo Log # 4

Description: Dock as seen from the air. Contents of storage bin are strewn on the dock.

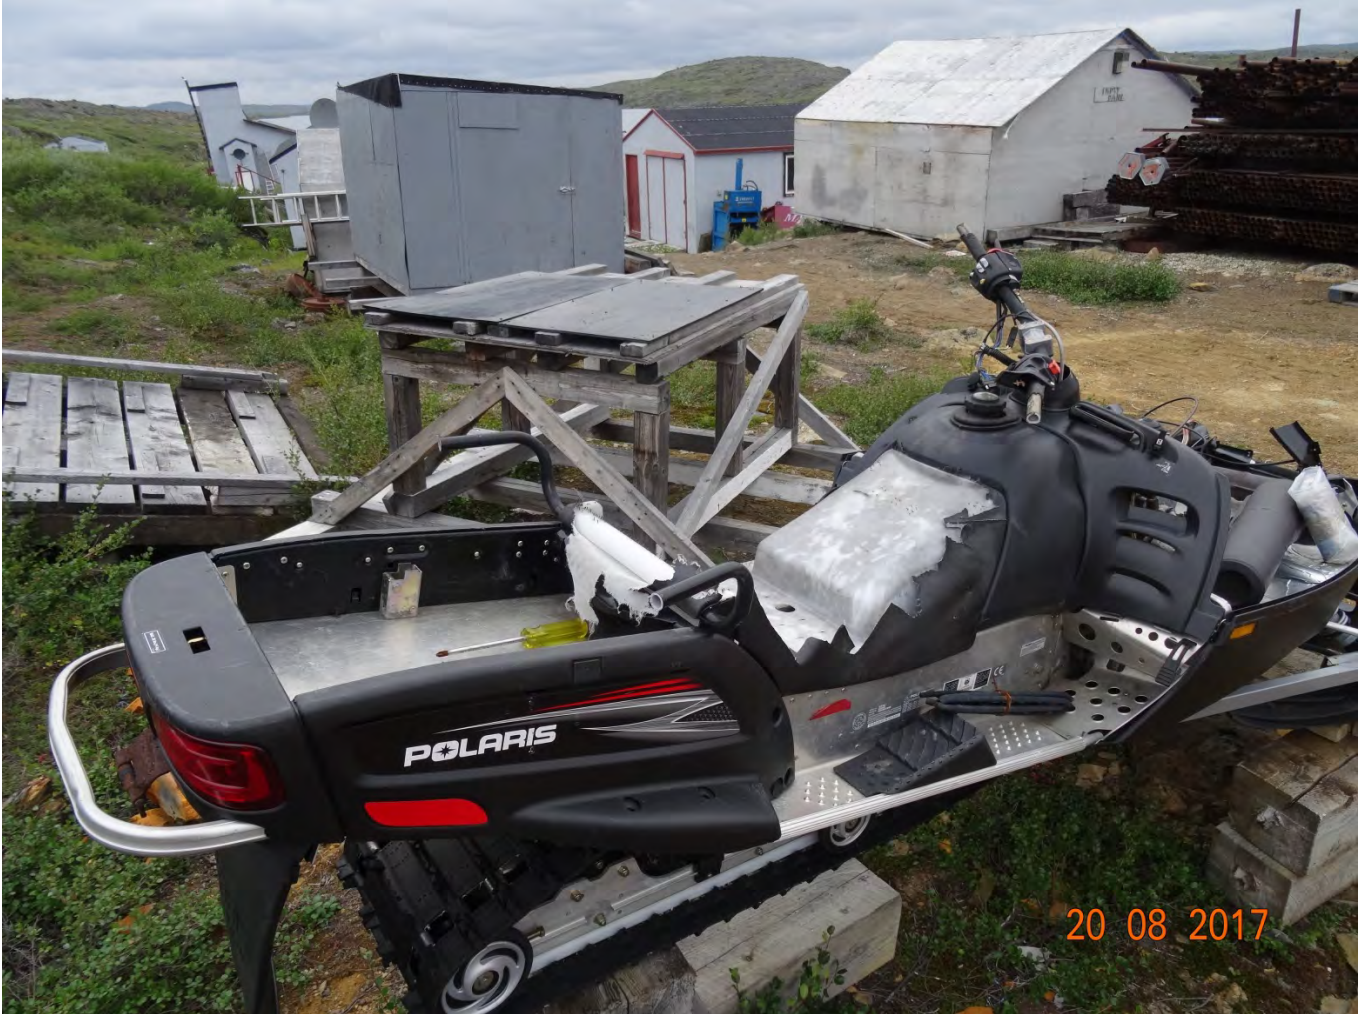
Photo Log # 5

Description: Snowmobile is ripped apart; likely a bear.

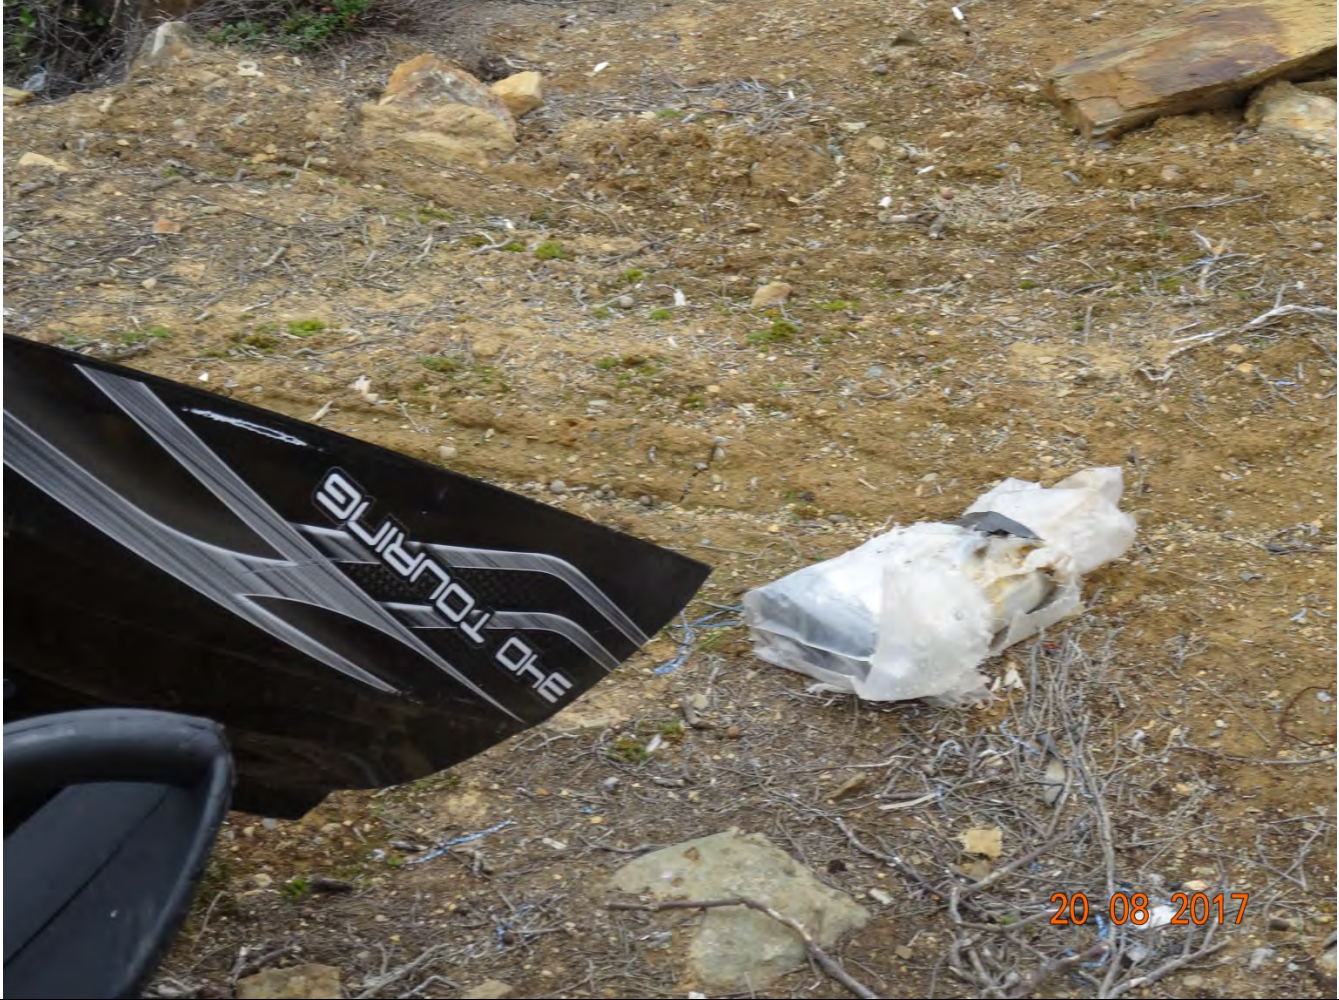
Photo Log # 6

Description: Engine oil and kit from snowmobile.

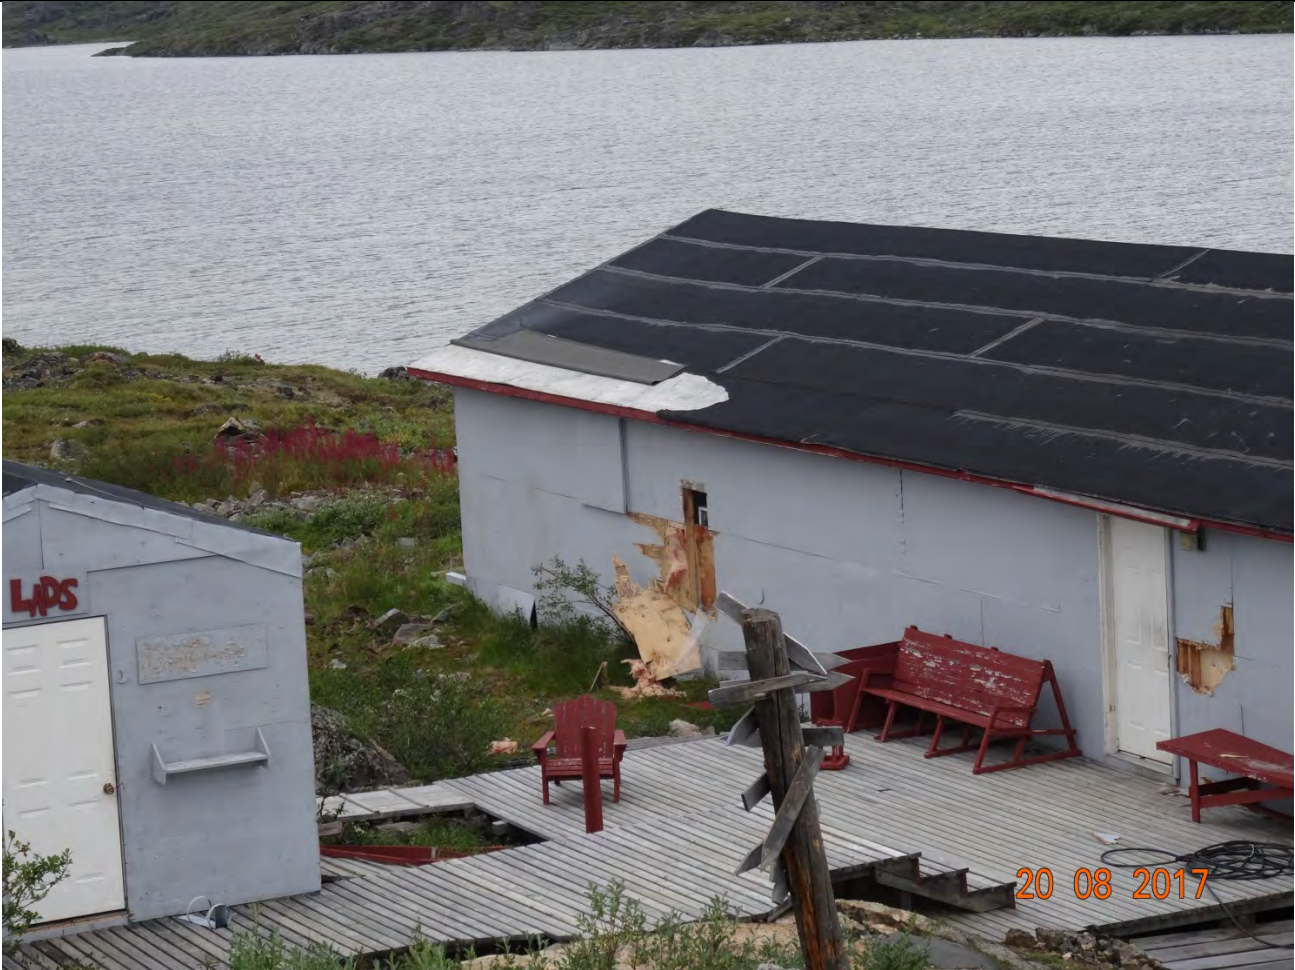
Photo Log # 7

Description: Kitchen torn into.

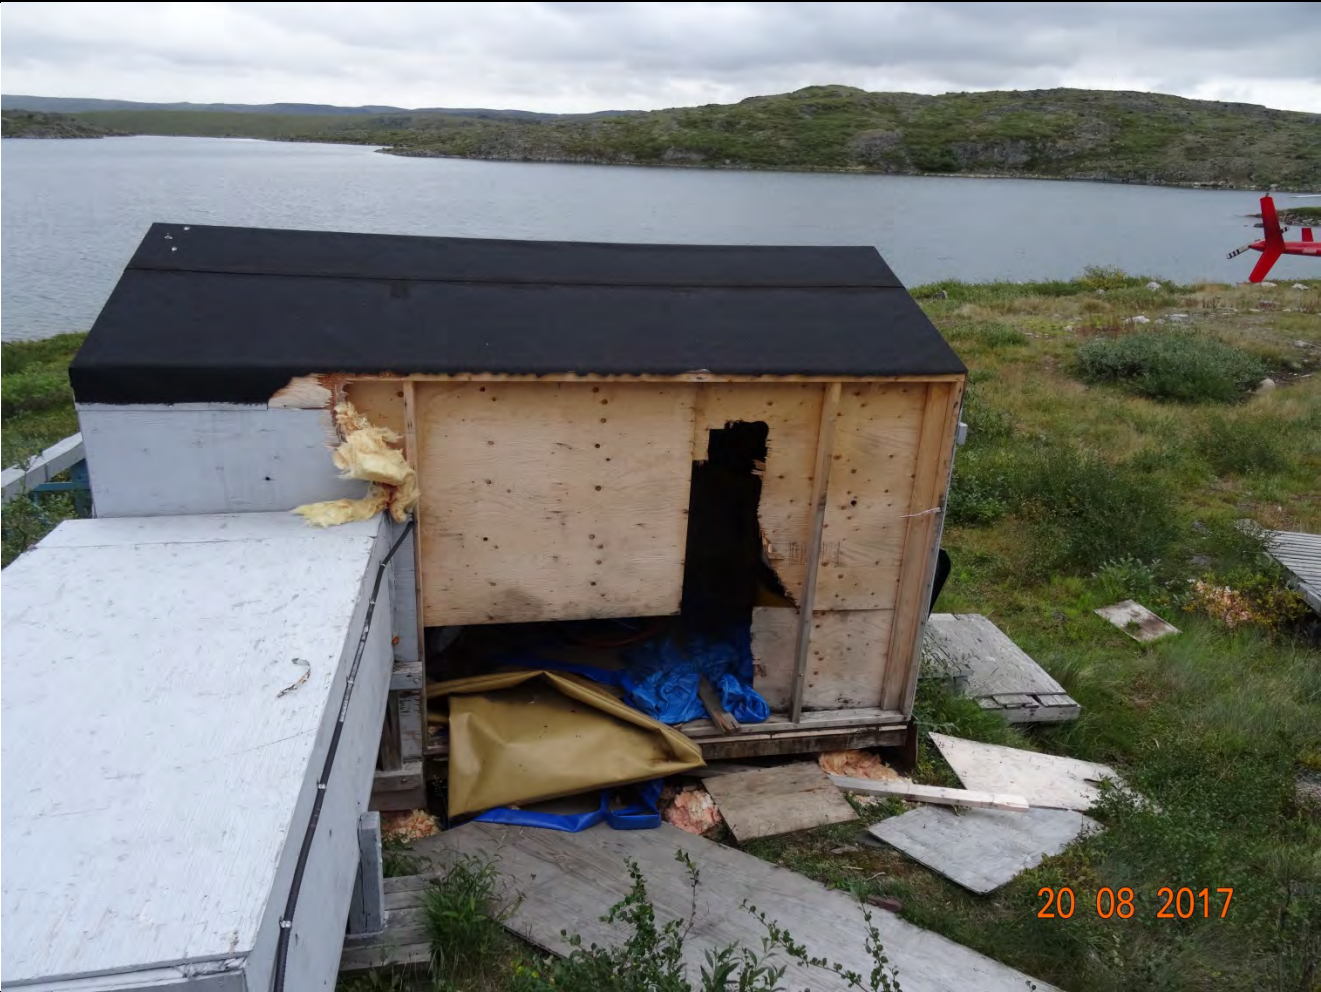
Photo Log # 8

Description: More wildlife damage.

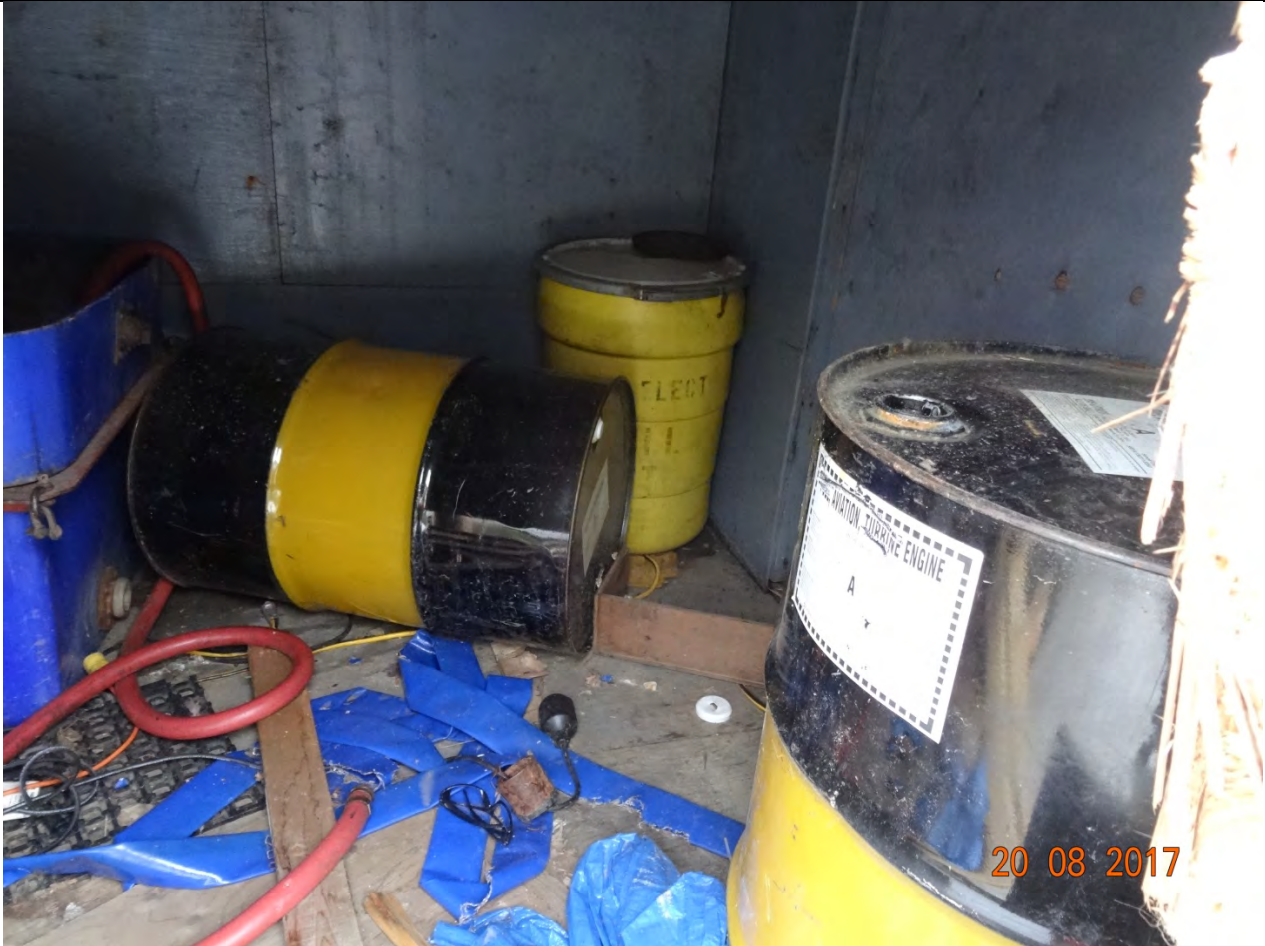
Photo Log # 9

Description: Barrels within outbuilding shown in Photo 8.

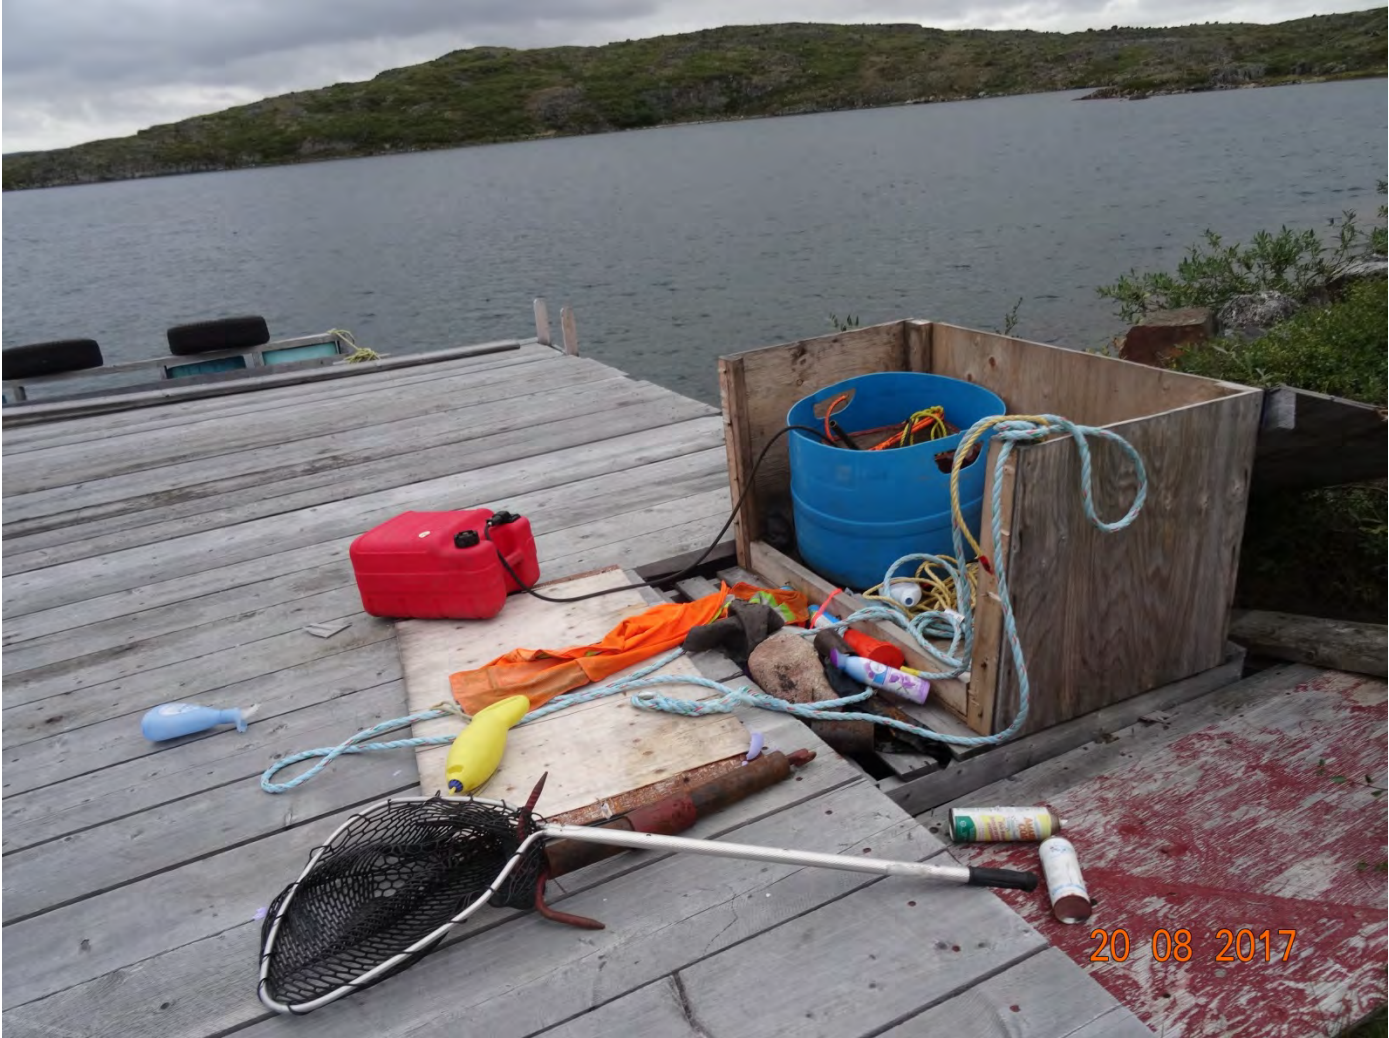
Photo Log # 10

Description: Chemicals and jerry can from dock storage bin.

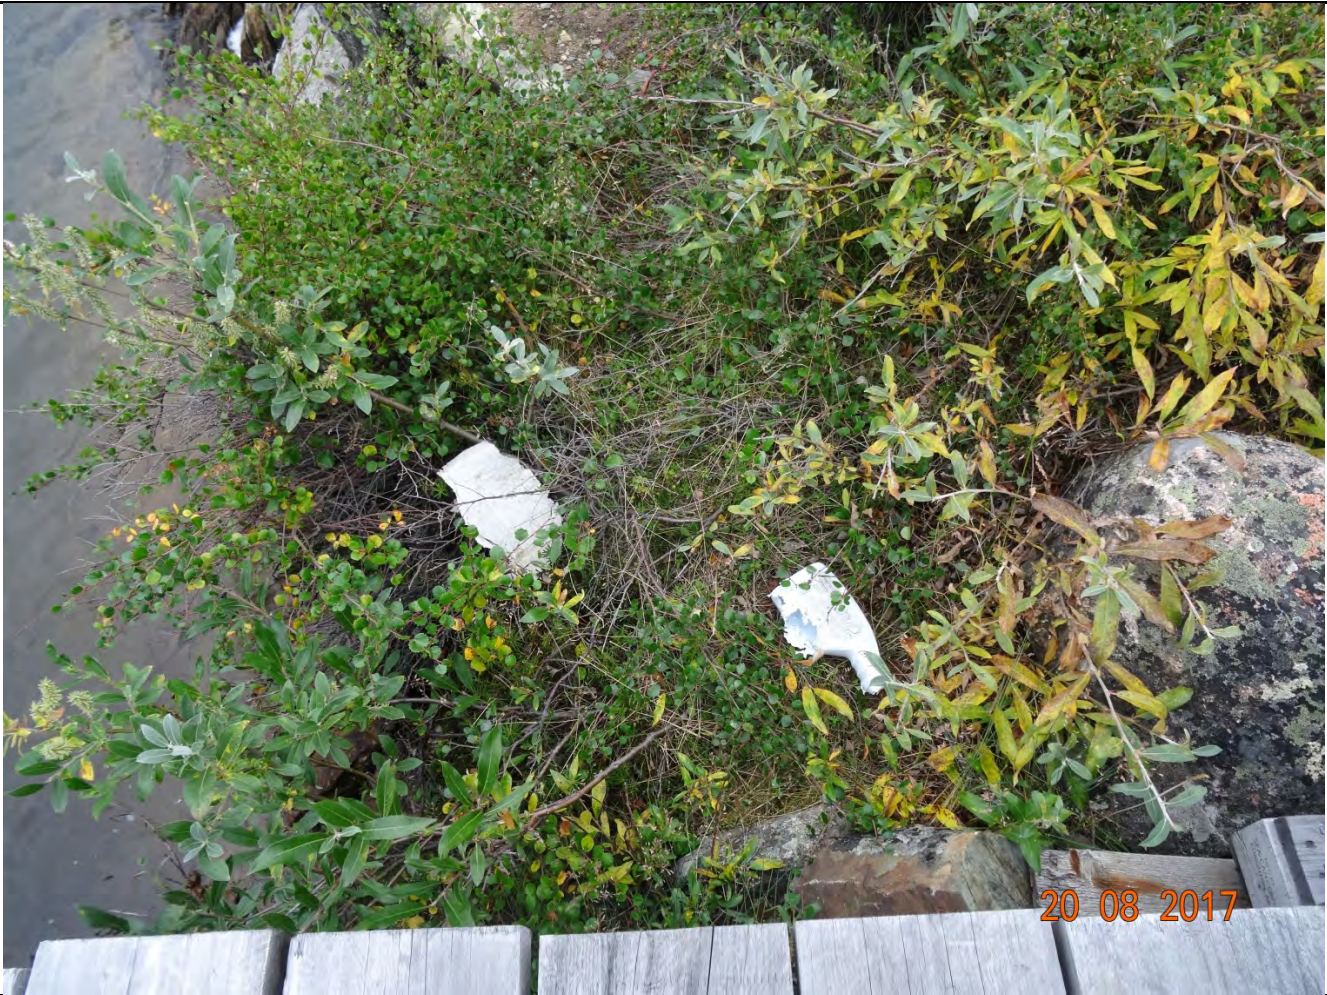
Photo Log # 11

Description: Bottles from dock storage bin, chewed by wildlife and emptied next to the water.

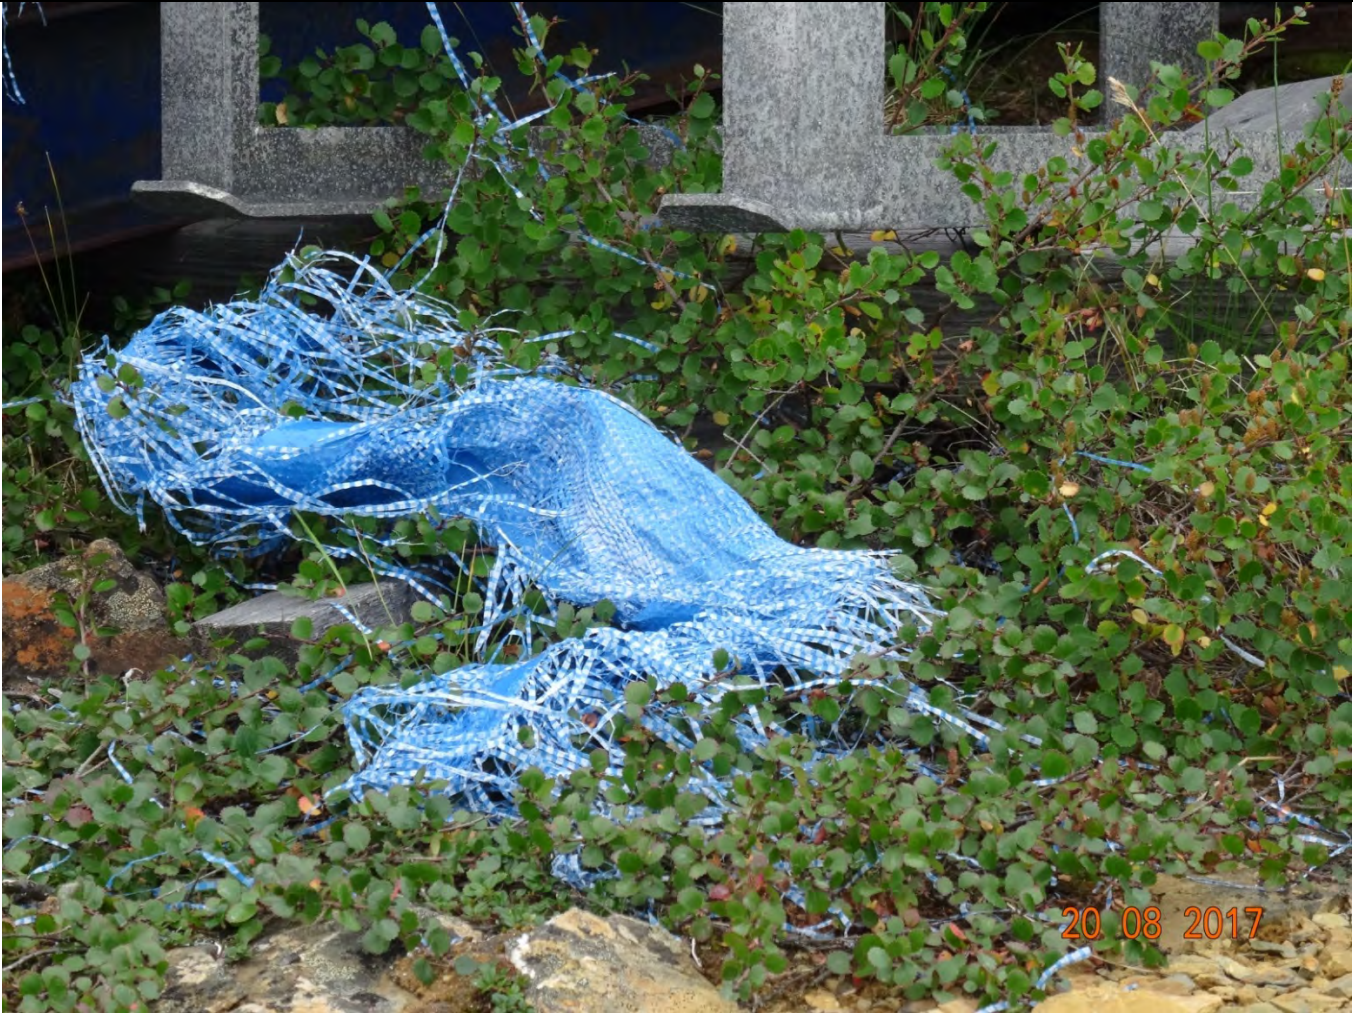
Photo Log # 12

Description: Blue tarp that is shredding with age.

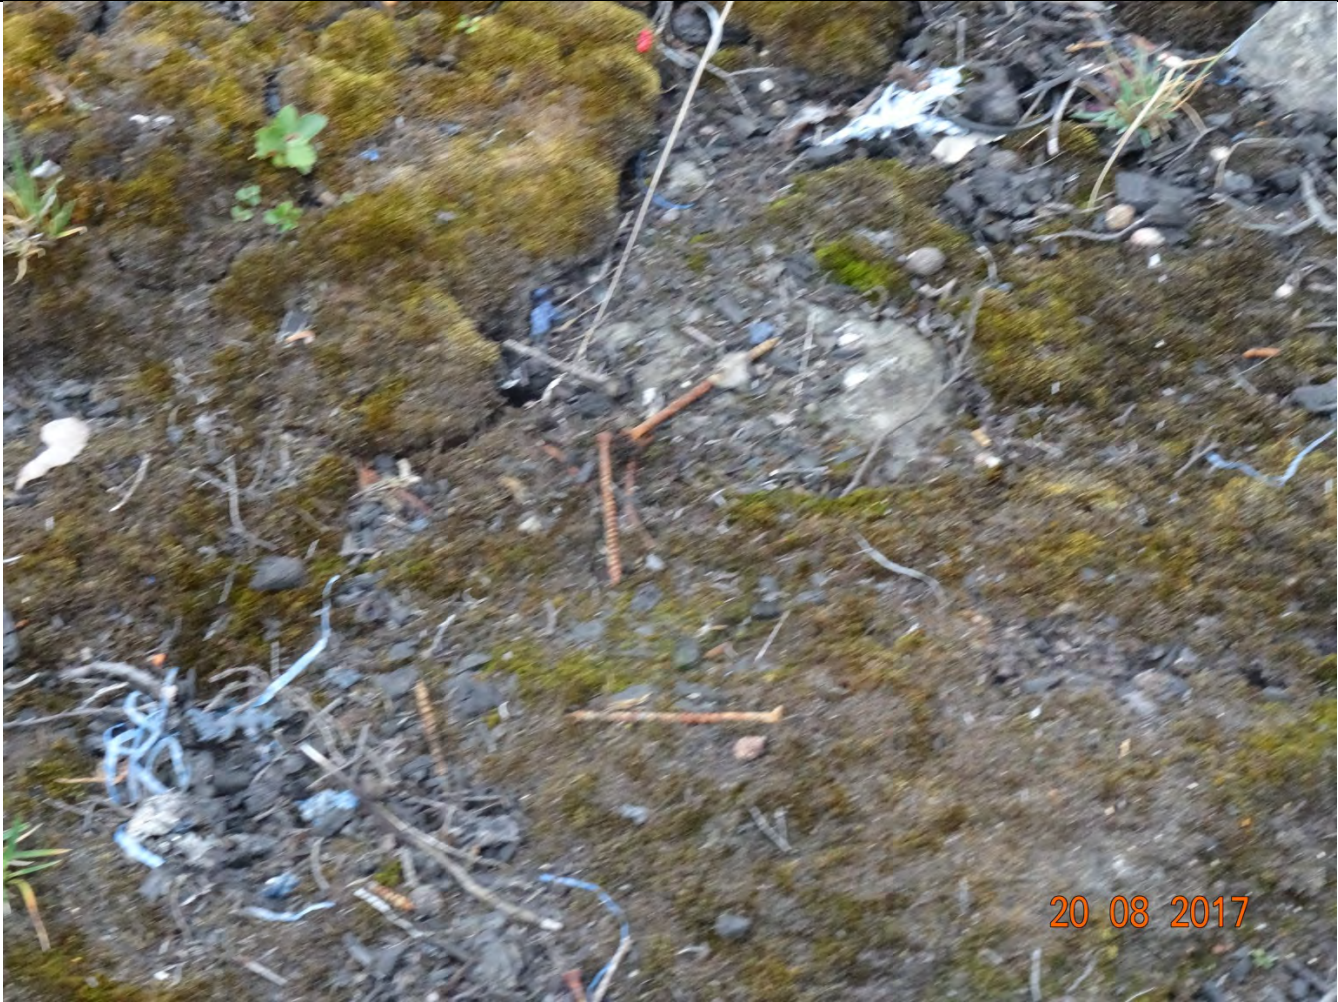
Photo Log # 13

D.4: The Licensee shall not open burn plastics, wood treated with preservatives, electric wire, Styrofoam, asbestos or painted wood to prevent the deposition of waste materials of incomplete combustion and/or leachate from contaminated ash residual, from impacting any surrounding waters, unless otherwise approved by the Board in writing.

Description: Burnt debris from ‘disposal’ of structures. Plastic and metal debris are to be cleaned up.

- A. All locations where structures were burned should be raked for plastic and other debris (nails etc). Any ash contaminated with melted plastic or other contaminants is to be collected and shipped out as waste. This is to be completed in the snow-free season in 2018 and confirmation of completion submitted to the Inspector.
- B. Confirm removal of all chemicals stored less than 31m from the Ordinary High Water Mark.
- C. Undertake regular maintenance visits to the site to ensure compliance with all permits and licences.
- D. Complete reclamation of all historic drilling locations. Any collars that are left purposely to house monitoring equipment should be identified to the Inspector for future reference.

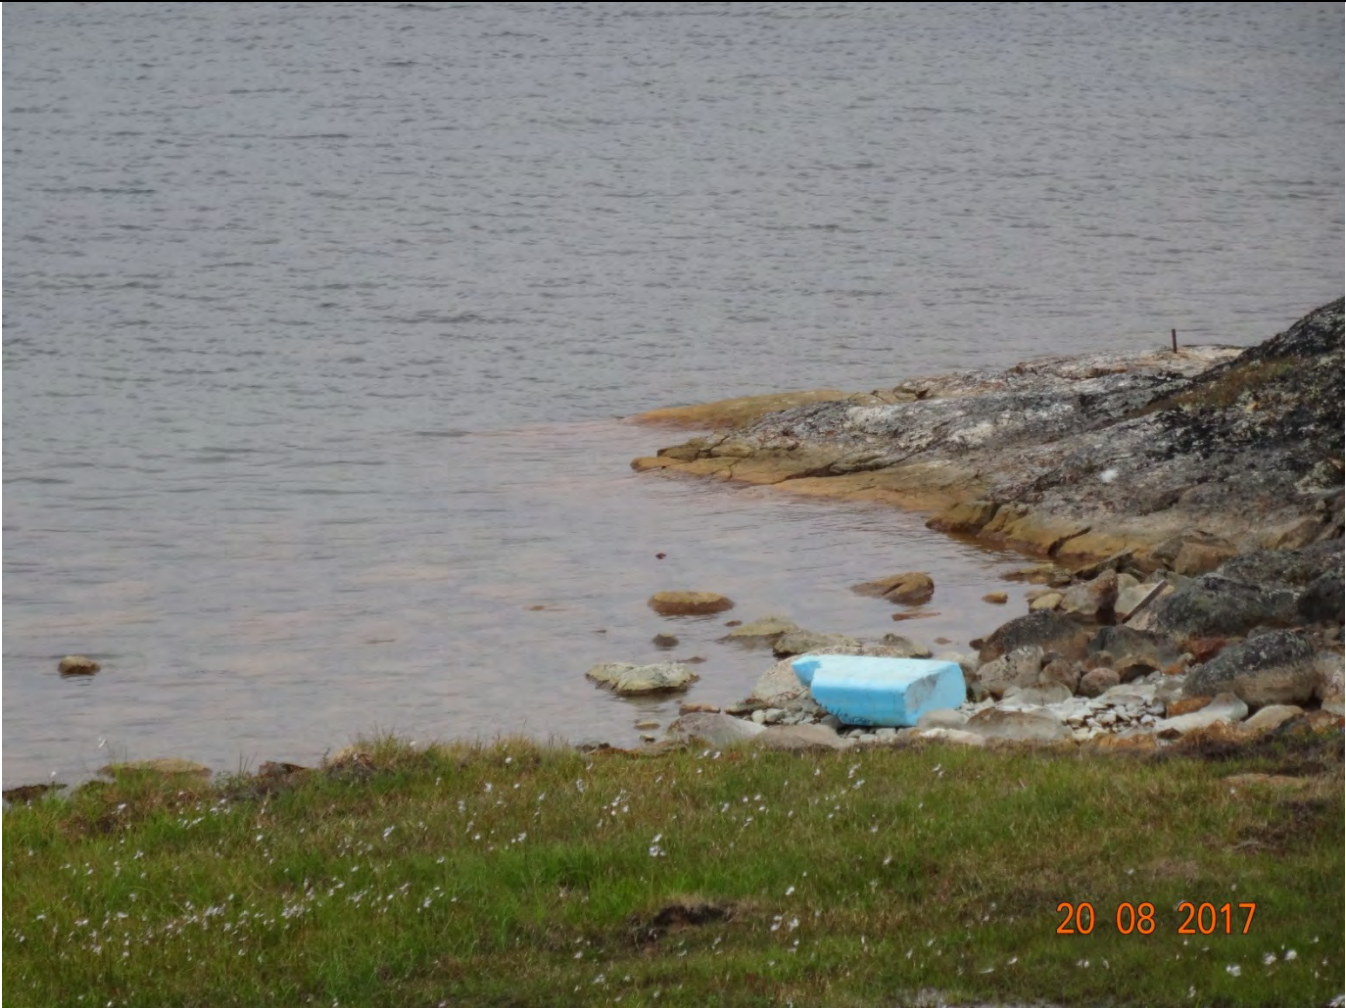
Photo Log # 14

Description: Styrofoam seen at water’s edge from the camp (south of the dock).
